**2006/2007 Annual Inspection  
Report**

**BARATARIA LANDBRIDGE  
SHORELINE PROTECTION  
PROJECT – Phases 1, 2, 3 and 4**

State Project Number (BA-27), (BA-27c) and (BA-27d)  
Priority Project List 7, 9 and 11

June 21, 2007  
Jefferson and Lafourche Parishes

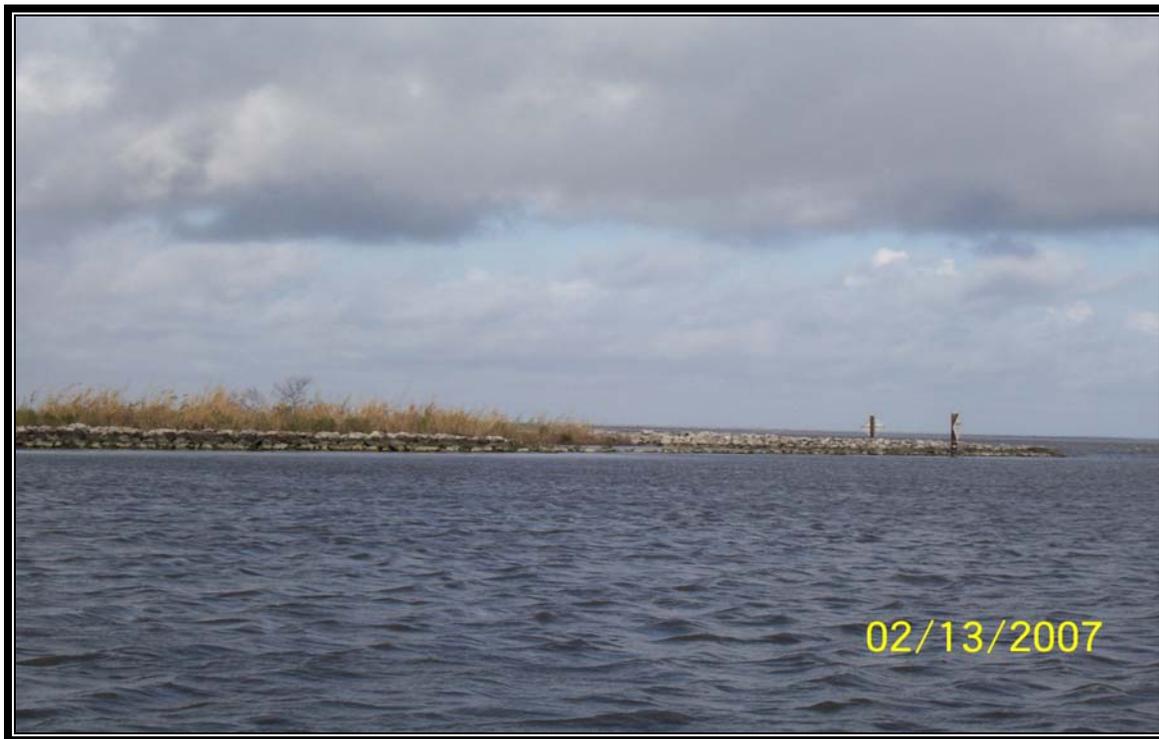
The inspection of Construction Unit #2 began at the east end of the east reach near Sta. 36+83 and proceeded westward to the end of the west reach near Sta. 0+42. As reported on previous field inspections, we noted a low area from Sta. 29+50 to Sta. 31+50. It is apparent that the soils in this area are poor causing consolidation rates to increase during placement of the rock rip rap. As-built drawings indicated that the final crest elevation of the rock dike in this area after construction was +2.0 ft NAVD. From our observations and approximate water elevation at the time of the inspection, we concluded that the rock dike is currently at an elevation of +1.5 ft NAVD. The inspection team will continue to monitor this location on future site visits (Appendix B, Photos 1 & 2).

Photo No. 1 – (BA-27 CU#2) – Beginning of rock dike near the mouth of the Cut Off Canal.

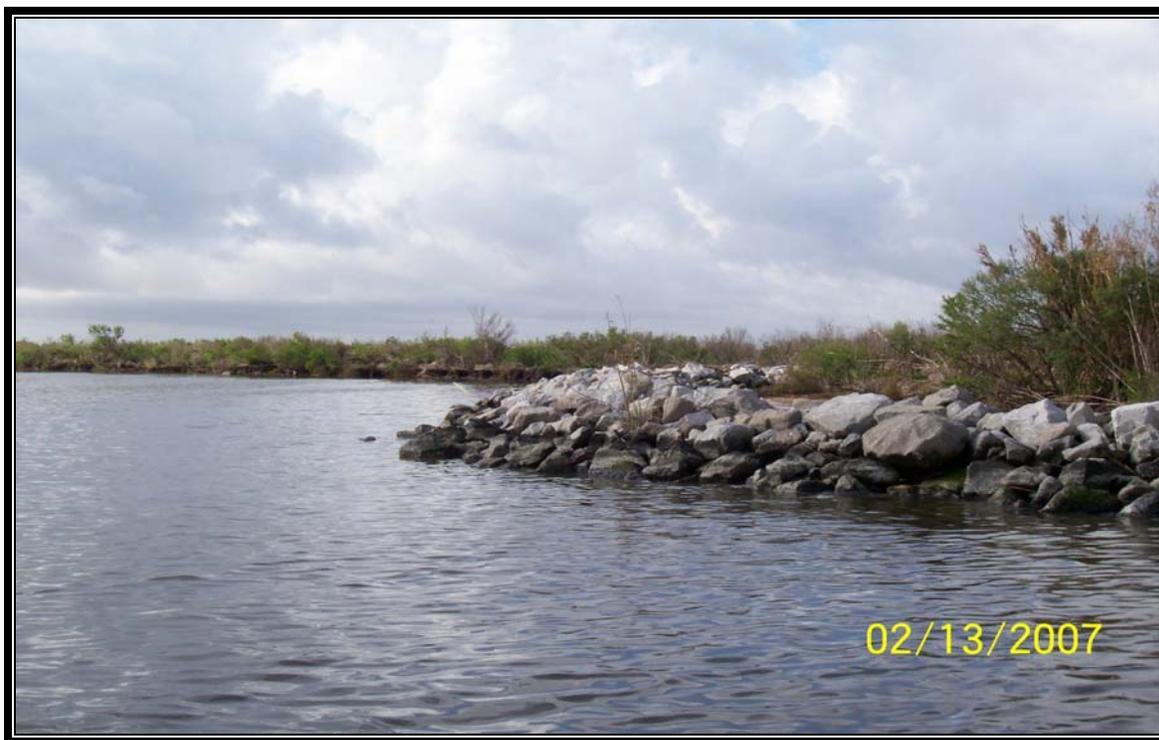
Photo No. 2 – (BA-27 CU#2) – rock dike beginning the west reach in an existing location canal.

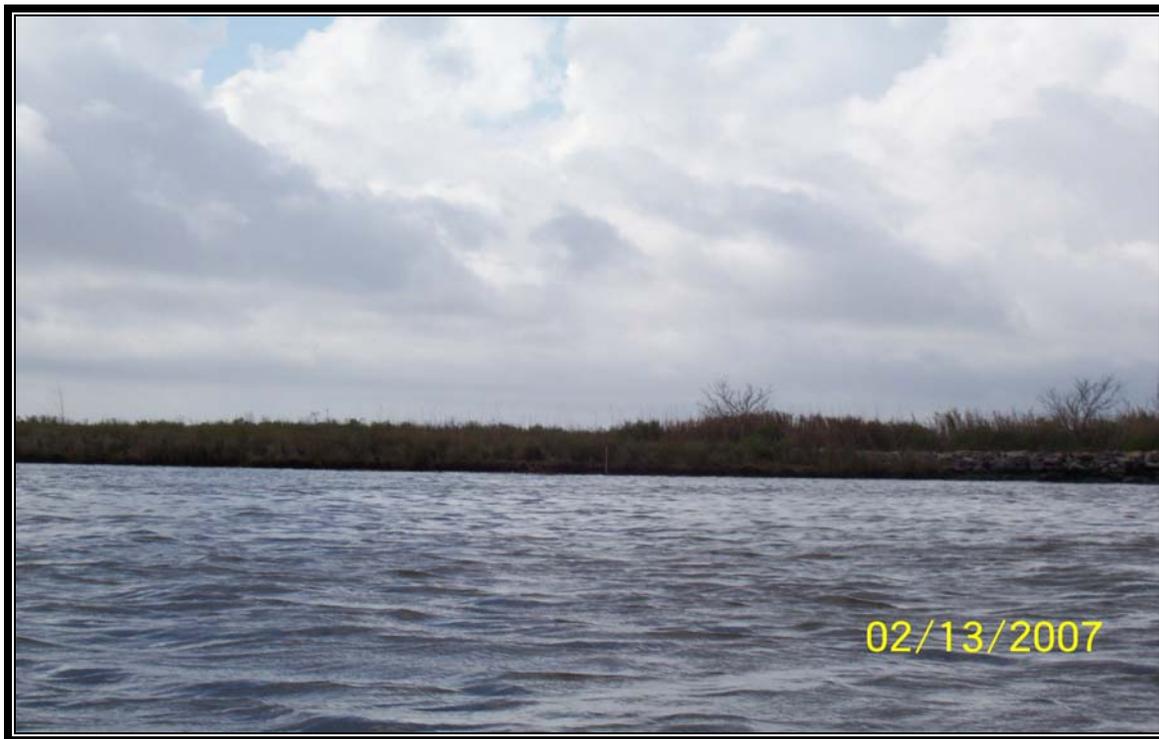
The inspection of Construction Unit #3 began near the mouth of Bayou Perot and northeast bank of Little Lake at Sta. 0+00 and proceeded along the northeast and east bank of Little Lake to the end of the project near Sta. 108+65. A visual inspection of the project revealed that the rock dike was in very good condition with no displacement or settlement since construction of the structure. The marsh tie-ins on both ends of the project were also in very good condition with no noticeable erosion or wash-outs. The marsh disposal areas behind the rock dike appeared to be in good condition with plenty vegetation. Overall, Construction Unit #3 was in very good condition with no noted deficiencies (Appendix B, Photos 3 through 5)

Photo No. 3 – (BA-27 CU# 3) - beginning of rock dike located along the south bank of Bayou Perot.

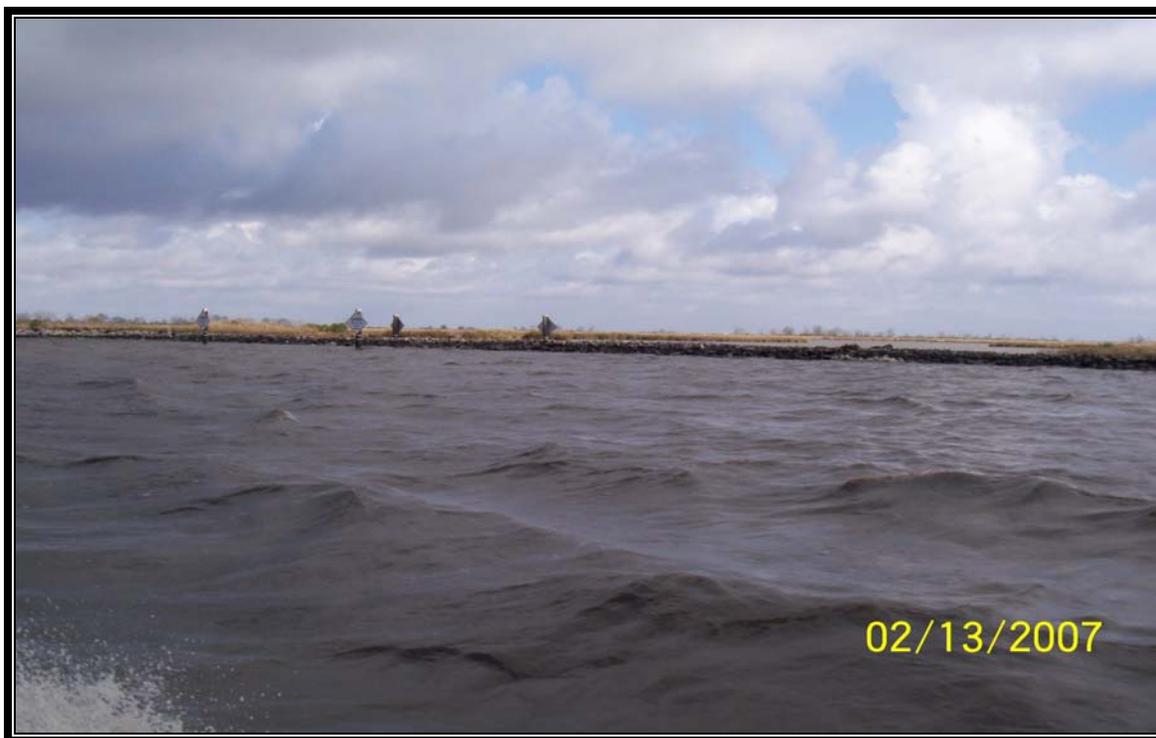
Photo No. 4 – (BA-27 CU# 3) – fish dip in rock dike located along the east bank of Little Lake.

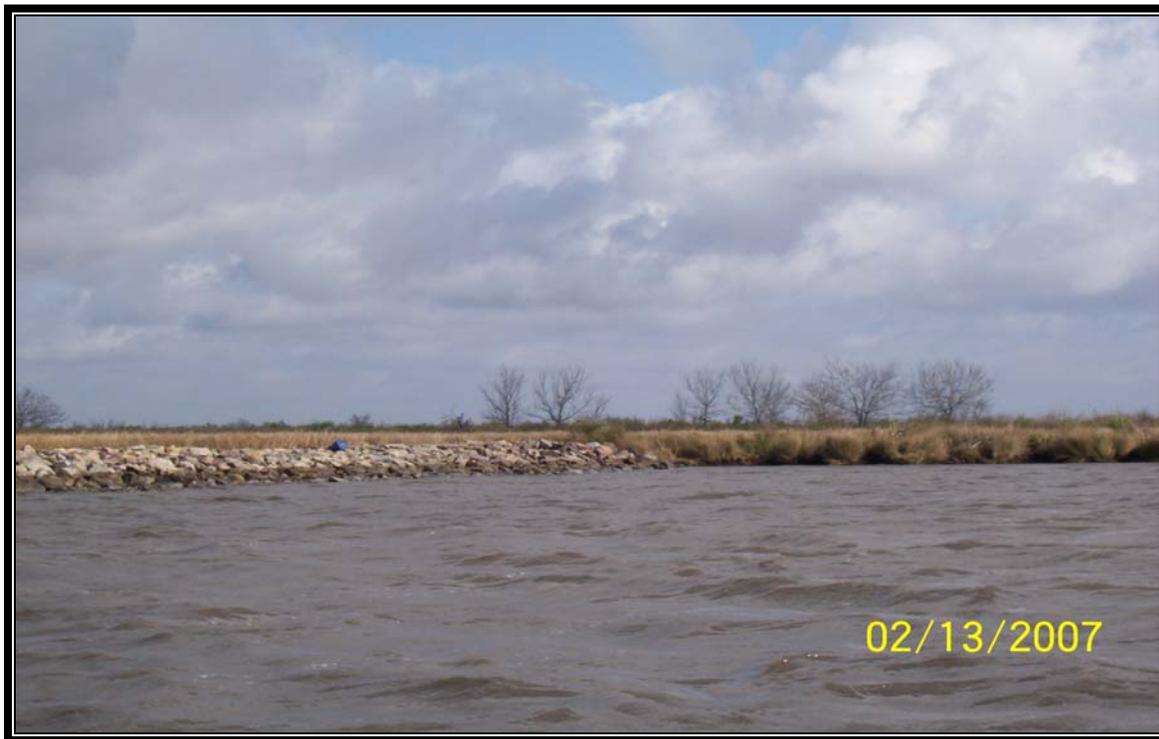
Photo No. 5 – (Ba-27 CU#3) – end of rock dike located on the east bank of Little Lake.

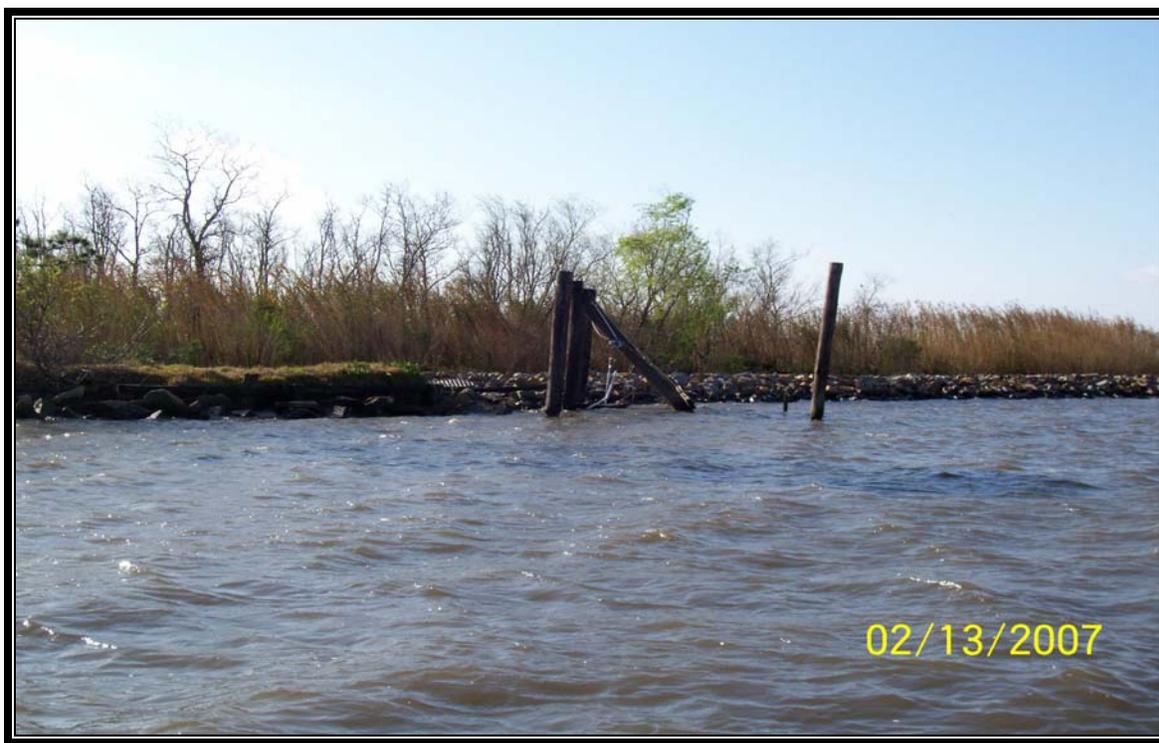
The inspection of Construction Unit #6 began at Sta. 307+78 near the Barataria Waterway and proceed along the east bank of Bayou Rigolettes to Sta. 00+00 near an existing oilfield access canal. The rock dike appeared to be in very good condition with no apparent damage of settlement. All sings and supports located at the fish dip locations were also in good condition. Overall, the foreshore rock dike was in very good condition and will not require any corrective actions. (Appendix B, Photos 6 through 8)

Photo No.6 – (BA-27 CU#6) – rock dike tie-in on the north end of the project near the Barataria Waterway.

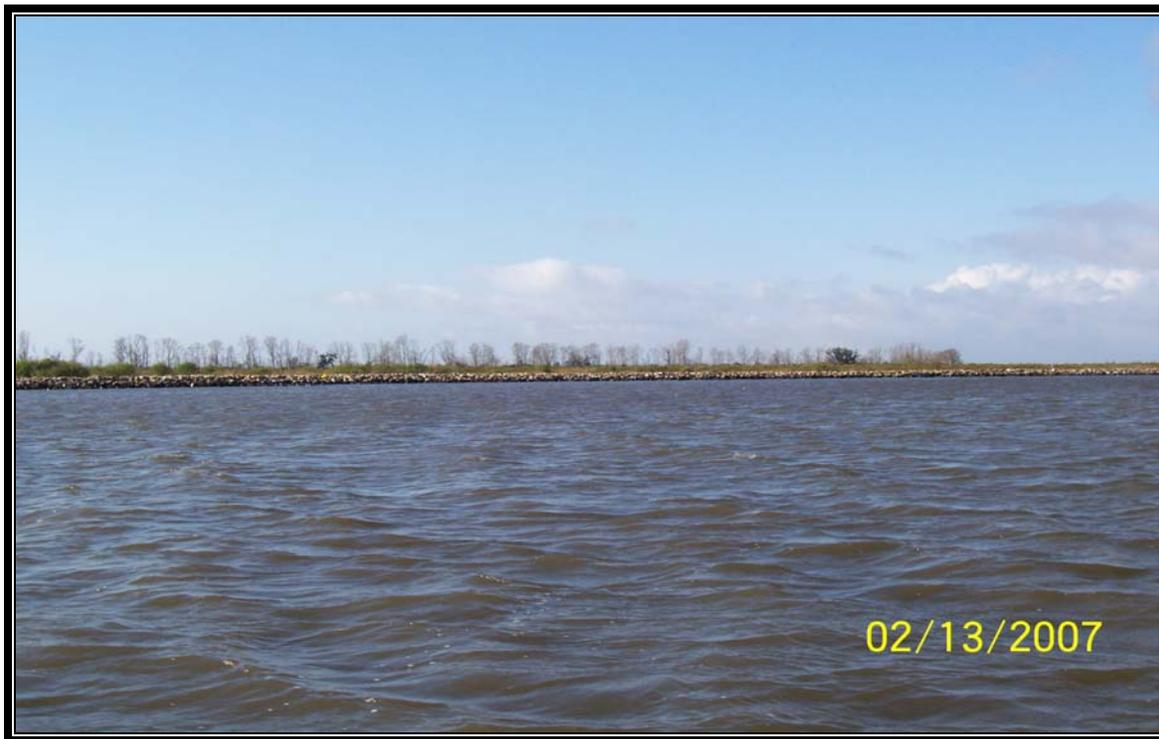
Photo No.7 – (BA-27 CU#6) – rock dike along east bank of Bayou Rigolettes.

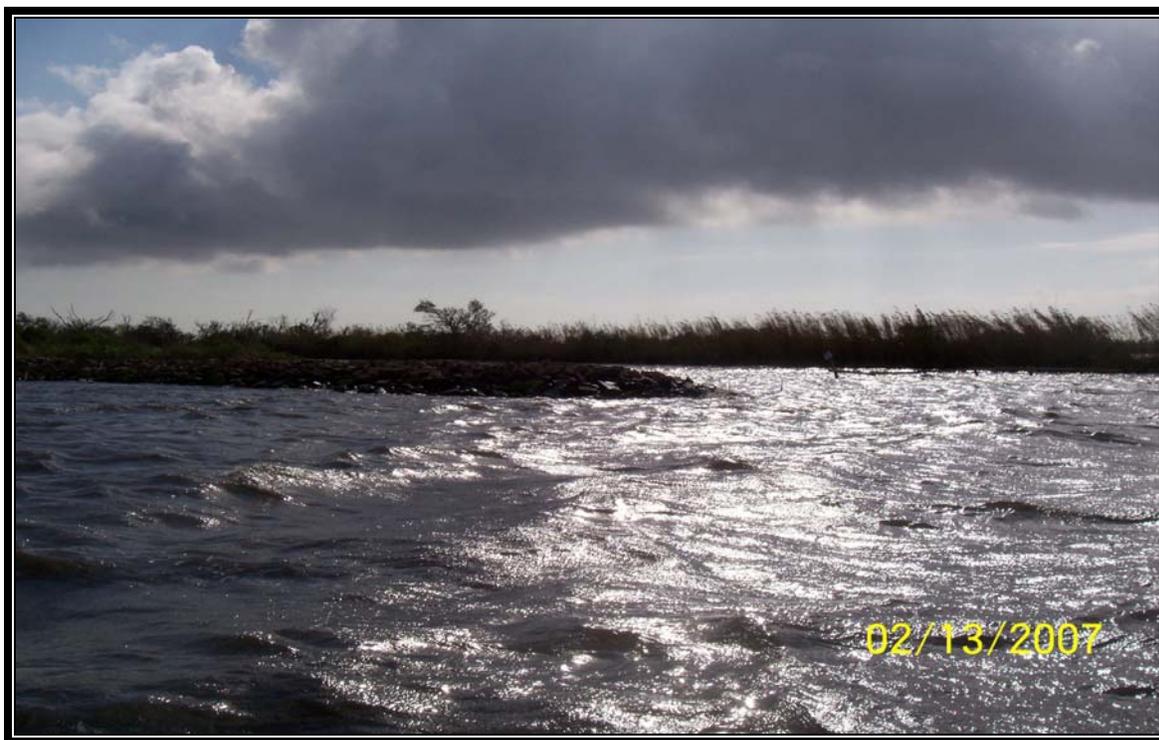
Photo No.8 – (BA-27 CU#6) – end of the rock dike along the east bank of Bayou Rigolettes.

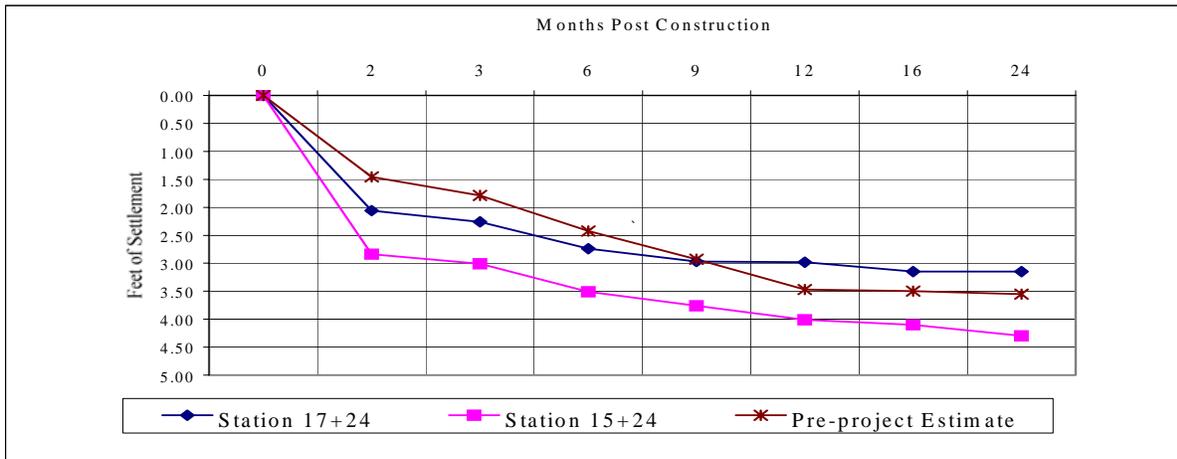
Figure 7. Settlement of Typical Section A (rock breakwater – Station 15+24) and Typical Section A-1 (rock breakwater with earthen core – Station 17+24) versus estimated pre-project settlement at Site 2.

settlements. Figures 7, 8, and 9 illustrate the settlement of the rock (Typical Section A), rock and earth (Typical Section A-1), and rock and LWA (Typical Sections B and C) test sections for the post construction time intervals stated above. Settlement data for Section A and A1 at Site #1 are not presented due to the excessive settlement and bearing capacity failure of these sections. Measured settlement of the concrete sheetpile wall is not illustrated because the surveys have shown no horizontal movement of the concrete sheetpile wall and only minimal vertical movement.
