**2004 Operations, Maintenance  
and Monitoring Report**

**FRITCHIE MARSH  
RESTORATION**

State Project Number PO-06  
Priority Project List 2

May 2007  
St. Tammany Parish

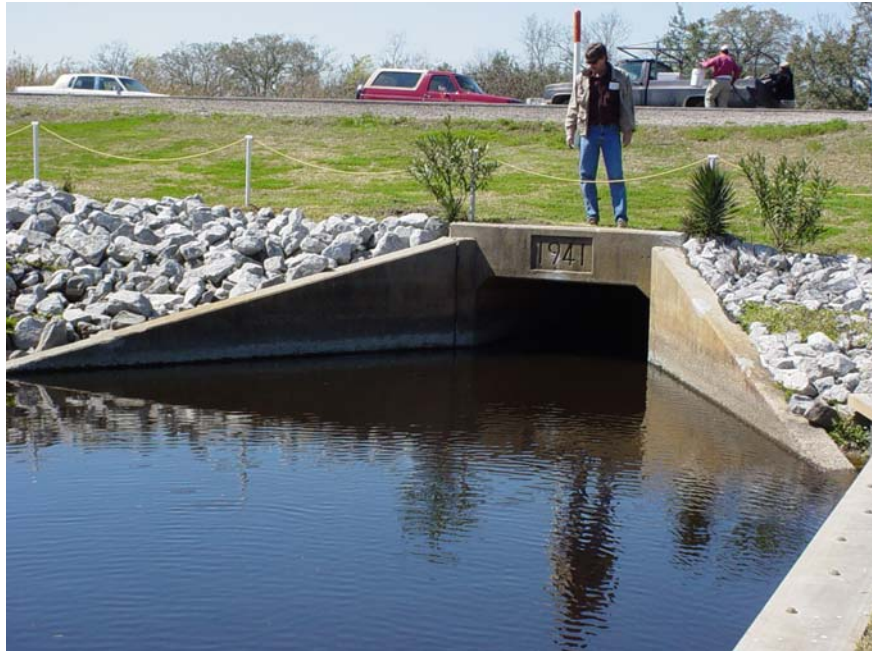
Slight erosion where the left descending bank meets the riprap lining for the Hwy 90 culvert was noted at the final inspection in March 2001, but does not show signs of increasing (Photos 1-4). The 72" x 136 L.F. RCP culvert beneath State Hwy 90 showed no apparent problems. No settlement or blockage of flow was noted. In addition, there were no signs of scour at the pipe ends (Photos 2-4). Some reflective cracking was noted in the asphalt riding surface on Hwy 90; and the aggregate shoulders need regrading in the vicinity of the pipe to remove the drop off between the pavement and shoulder (Photos 5). However, no evidence of settlement of the pipe or roadway has been noted since initial construction was completed in March 2001.

**Photo No. 1**  
**Pre-existing concrete box culvert under Hwy. 90 with adjacent stone riprap erosion protection placed in 2001.**

- Re-grade the shoulders to remove the elevation difference the pavement and shoulder material.
- Monitor the reflective cracking in the asphalt in the vicinity of the RCP culvert.
- Monitor the erosion at the end of the stone riprap on the left descending bank of Salt Bayou.
- Install a staff gauge on the outside of the culvert and tie into network.

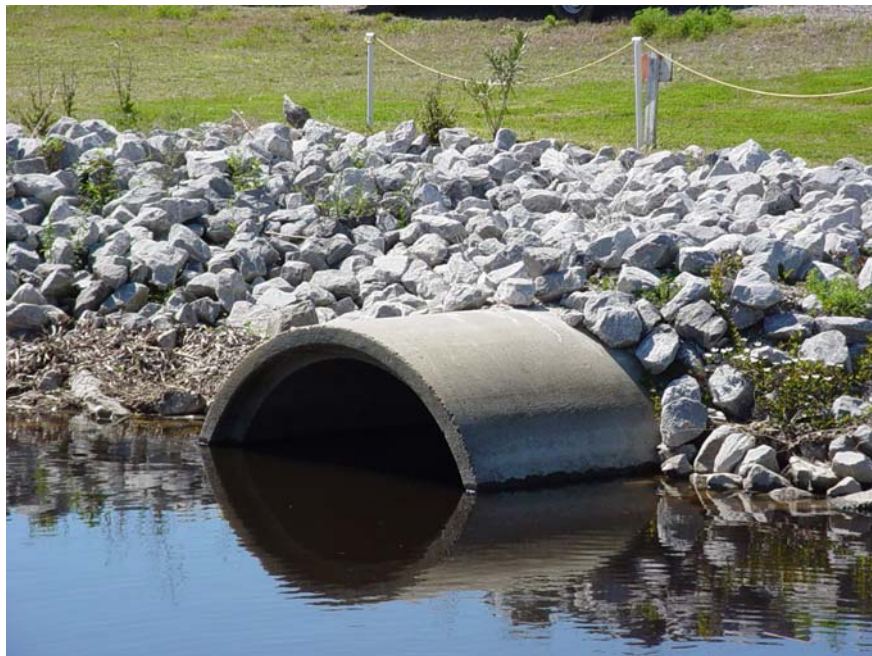
**Photo No. 2**  
**Round 72" concrete culvert under Hwy. 90 with stone erosion protection was completed in 2001.**

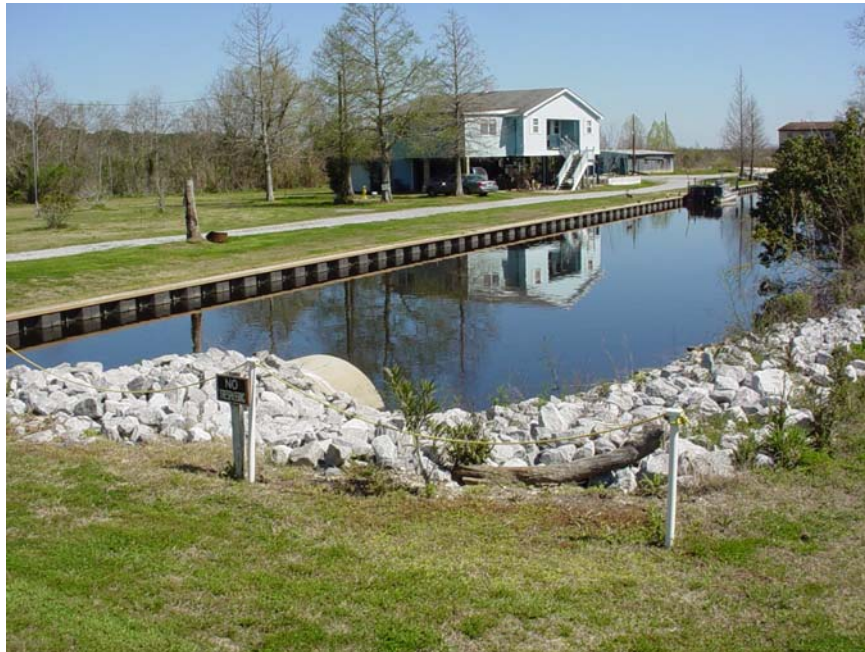
**Photo No. 3**

**Steel sheet pile bulkhead and stone riprap erosion protection located adjacent to 72" concrete culvert on south side of Hwy 90.**

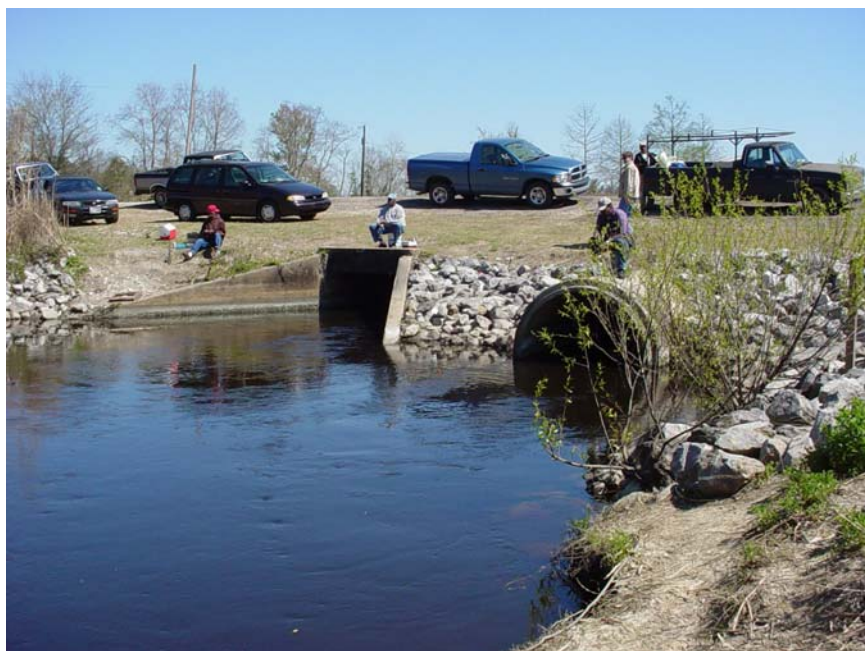
**Photo No. 4**

**Riprap stone erosion protection placed on bank on both sides of culverts on the north side of Hwy 90.**

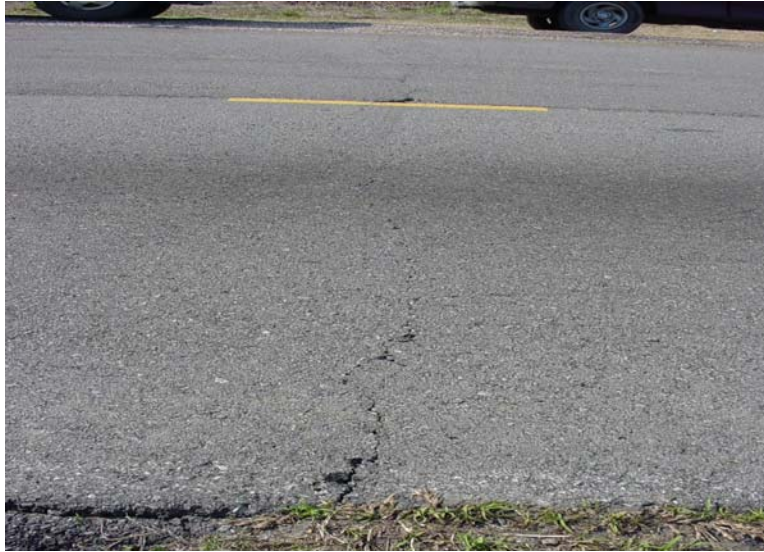
**Photo No. 5**

**Newly placed asphalt surface at culvert crossing on Hwy 90 shows some slight cracking with little separation.**

Overall, the constructed features of the Fritchie Marsh Restoration Project are in good to excellent physical condition with only minor maintenance problems noted. Slight reflective cracking was noted in the asphalt pavement of Hwy 90 directly above the RCP culvert and some settlement of the shoulder material was observed. Slight erosion at the end of the stone riprap was noted on an earlier inspection but has not increased.

- b. Monitor the reflective cracking in the asphalt in the vicinity of the RCP culvert.
  - c. Monitor the erosion at the end of the stone riprap on the left descending bank of Salt Bayou.

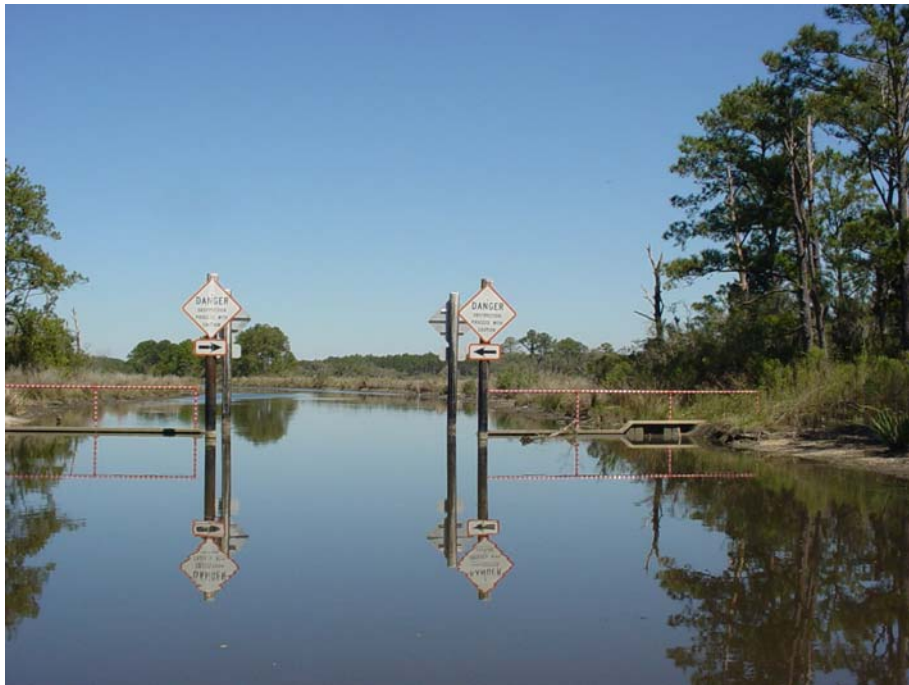
**Photo No. 6**

Structure is in excellent condition (Photo 6). All permanent signage was undamaged and in excellent condition. Hand rails were well marked with reflective tape and were undamaged. All

hardware was un-corroded. Tie-ins to the bank were well vegetated and showed no signs of erosion.

Spoil areas supported stable vegetation with no signs of significant settlement or erosion (Photo 6). Channel cross sections were not checked quantitatively as the dredging was recently completed.

**W-14 Weir Structure looking east**
