**2005/2006 Annual Inspection
Report**

**GIWW/CLOVELLY
HYDROLOGIC RESTORATION**

State Project Number BA-02
Priority Project List 1

August 17, 2006
Lafourche Parish

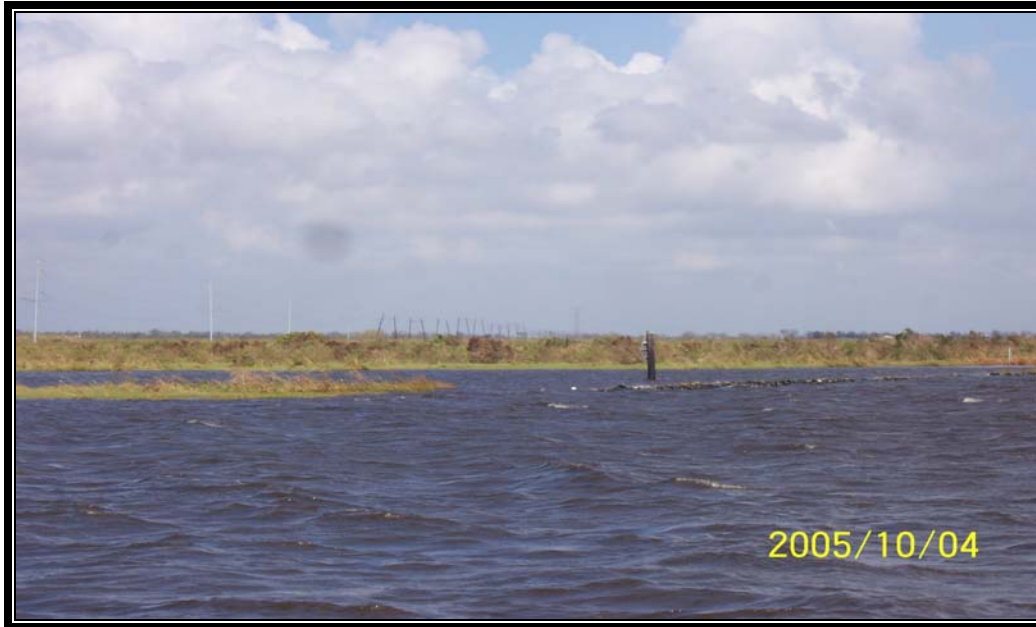
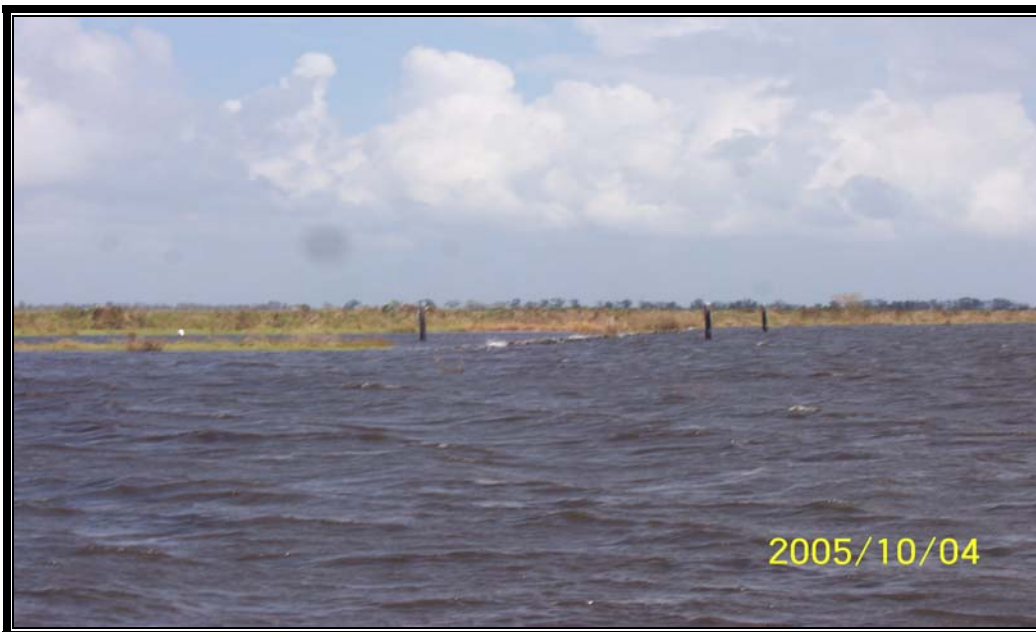
Structure 4A&B – large section of marsh eroded around the south side of the existing rock plug creating a breach allowing unimpeded flow behind structure looking northwest.

Structure 4A&B – large section of marsh eroded around the south side of the existing rock plug creating a breach allowing unimpeded flow behind structure looking north.

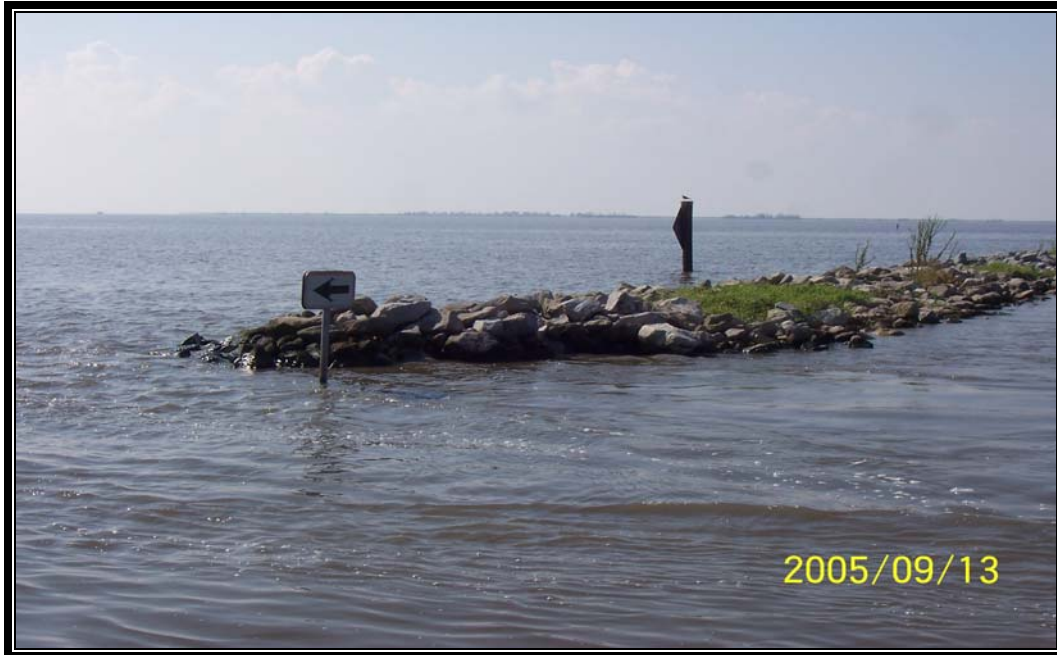
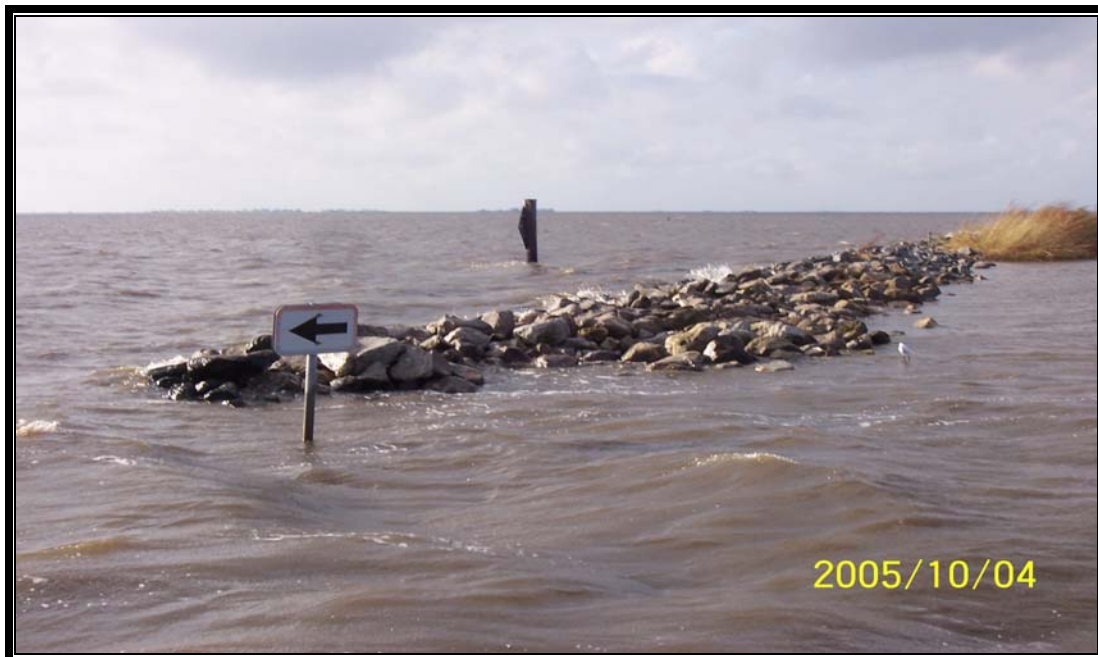
Damage assessments of Hurricane Katrina revealed visible damage at structures #14A and #35 and along the earthen embankments. Upon inspection of the rock weir with barge bay located at the end of Clovelly Canal near Little Lake, we discovered that a 15’ x 10’ wide

section (approximate measurement) of the rock weir on the southeast corner of the barge bay had been displaced by the storm. It does not appear that any other damage has occurred at structure 14A from Hurricane Rita (Photos: Page 11).

Structure 14A – displaced rock along rock weir south end of barge bay (Post Hurricane Katrina). Water level at time of photo approximately 1.6' NAVD.

Structure 14A – displaced rock along rock weir south end of barge bay (Post Hurricane Rita). Water level reading at time of inspection was approximately +2.25' NAVD.

Structure #14A – repair the southeast corner of the rock weir near the barge bay by recapping the sections of the rock weir which was dispersed during the storm with rip rap. From post storm inspections after Hurricanes Katrina and Rita, we determined that the damage to Structure #14A was caused by Hurricane Katrina.

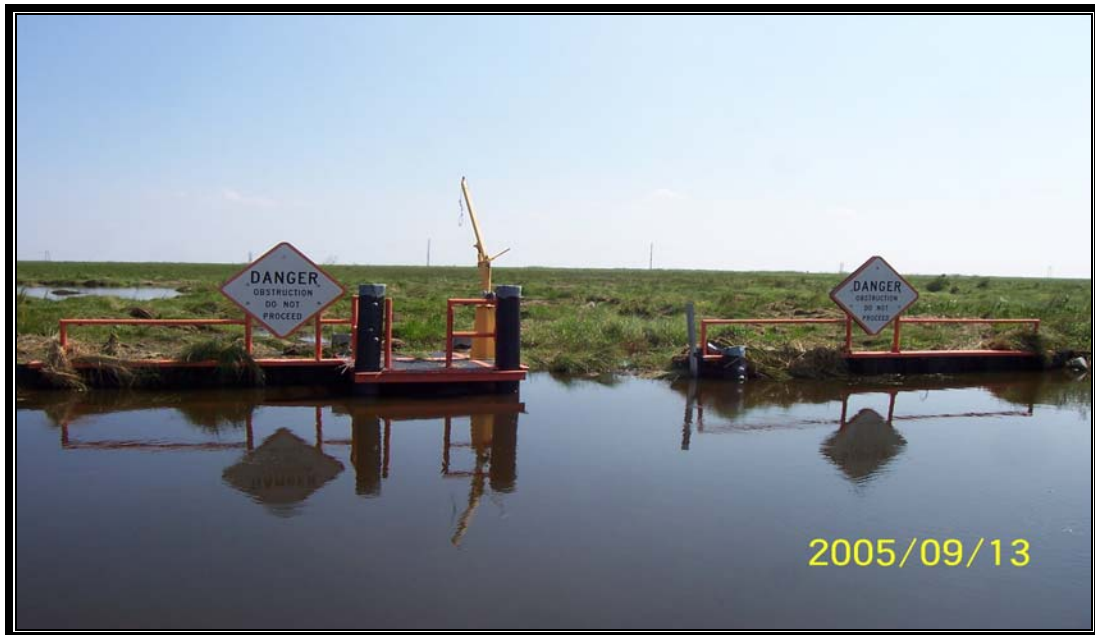
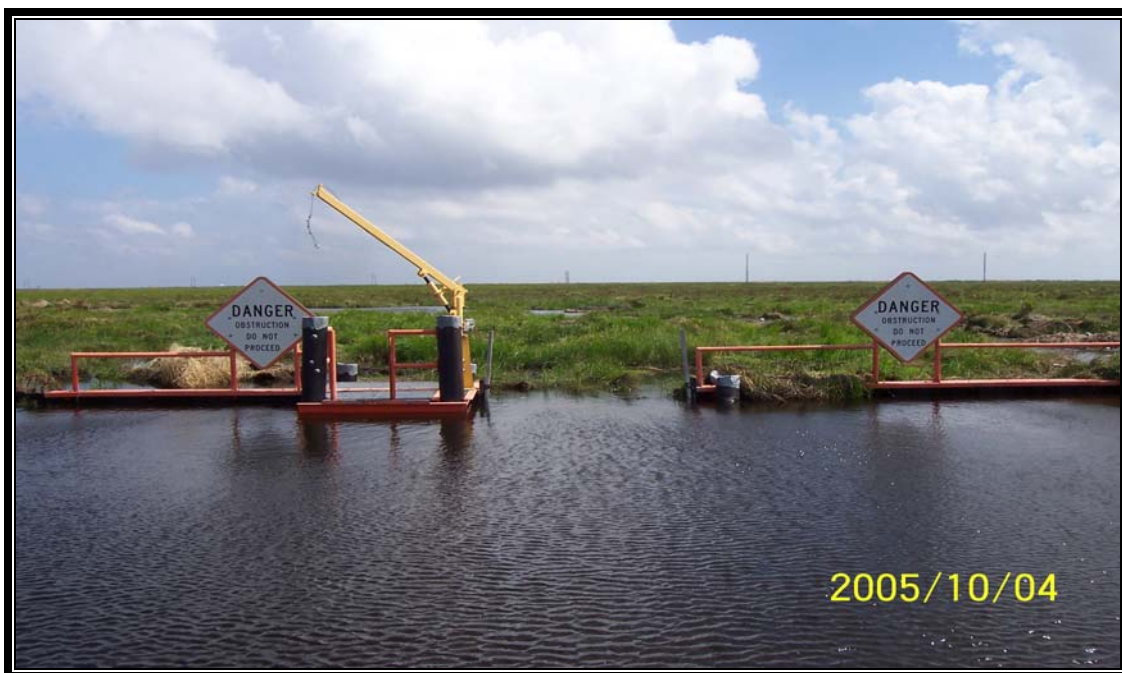
Inspection of the variable crest weir structure #35 located at the end of an existing oilfield canal off of Brenton Canal revealed that a large section of the interior marsh had floated directly behind the structure filling the channel connecting the water control structure to the interior ponds, thus blocking the flow of water and rendering the structure inoperable. We concluded that the movement of marsh had taken place during Hurricane Katrina (Photos: Page 13).

Structure #35 – movement of marsh behind structure blocking flow through structure (Post Hurricane Katrina). Water level at time of photo was approximately 1.5' NAVD.

Structure #35 – movement of marsh behind structure blocking flow through structure (Post Hurricane Rita). Water level at time of photo was approximately 1.5' NAVD.

Structure #35 – reopen the existing channel connecting the water control structure to the interior marsh by excavating material adjacent to the water control structure to open interior ponds to re-establish water flow. From inspection performed after both Hurricanes Katrina and Rita, it was determined that the movement of marsh behind structure #35 was caused by Hurricane Katrina.

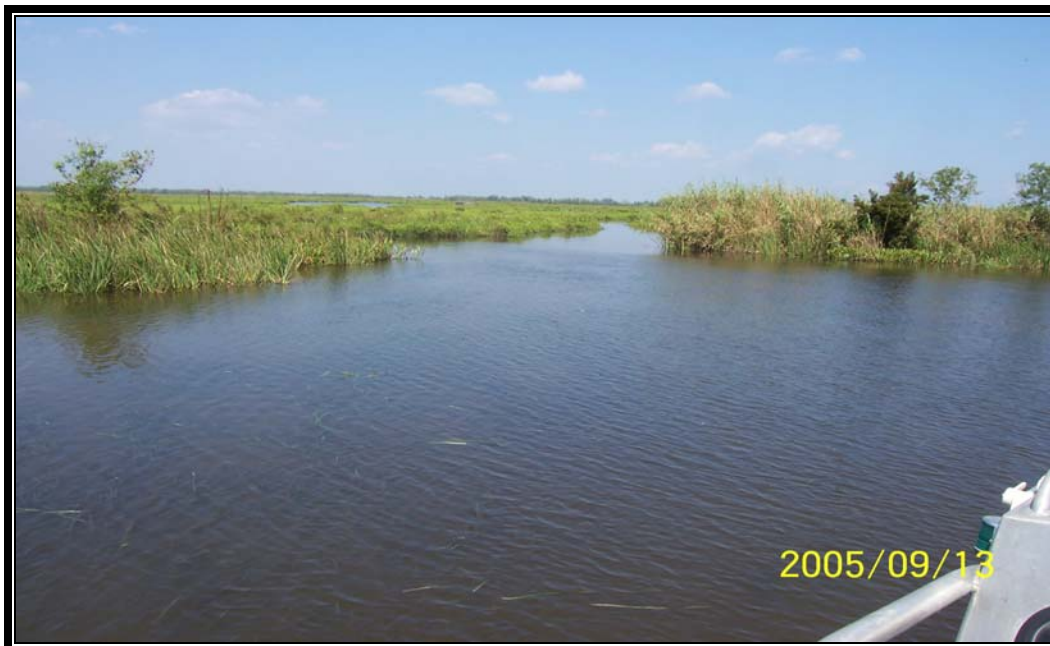
Breach 2 – located along oilfield canal adjacent to Superior Canal leading to Structure #91 on the west bank.

Earthen embankments – repair the three (3) breaches caused by Hurricanes Katrina and Rita as well as breaches identified on previous inspection prior to the storm. The method of repair

for all breaches shall use dredge material from the adjacent canal and re-construct the earthen embankment to design elevations (Breach locations are shown on sheets 20 & 21).

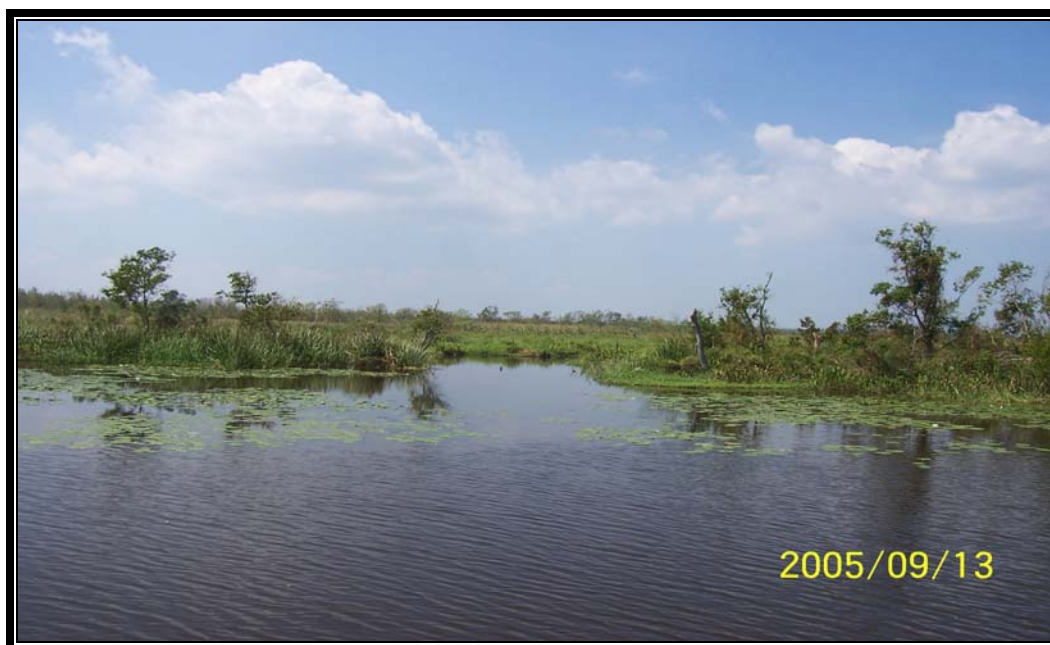
Breach 3 – located along the same canal as breach 2 further northward on the west bank.

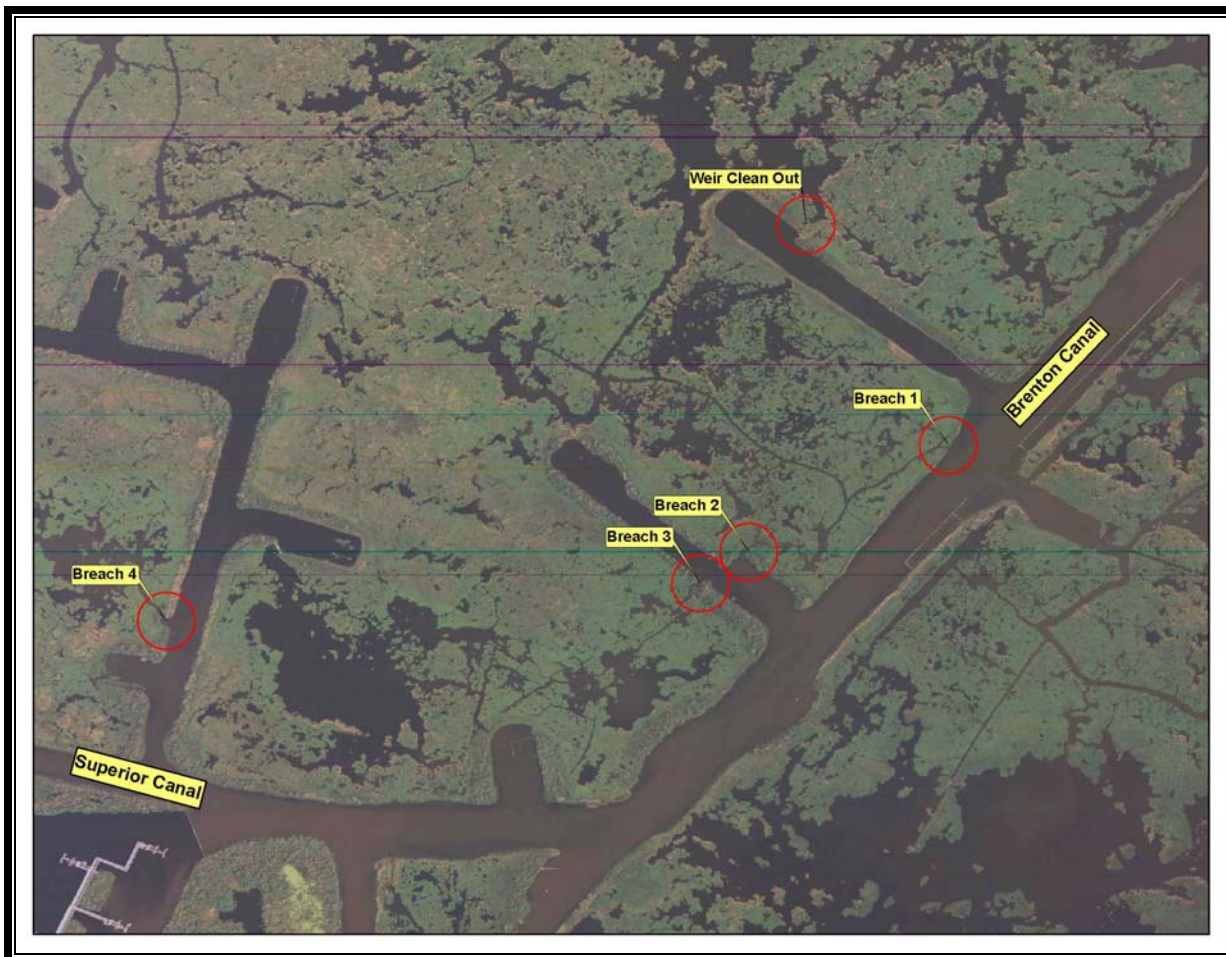
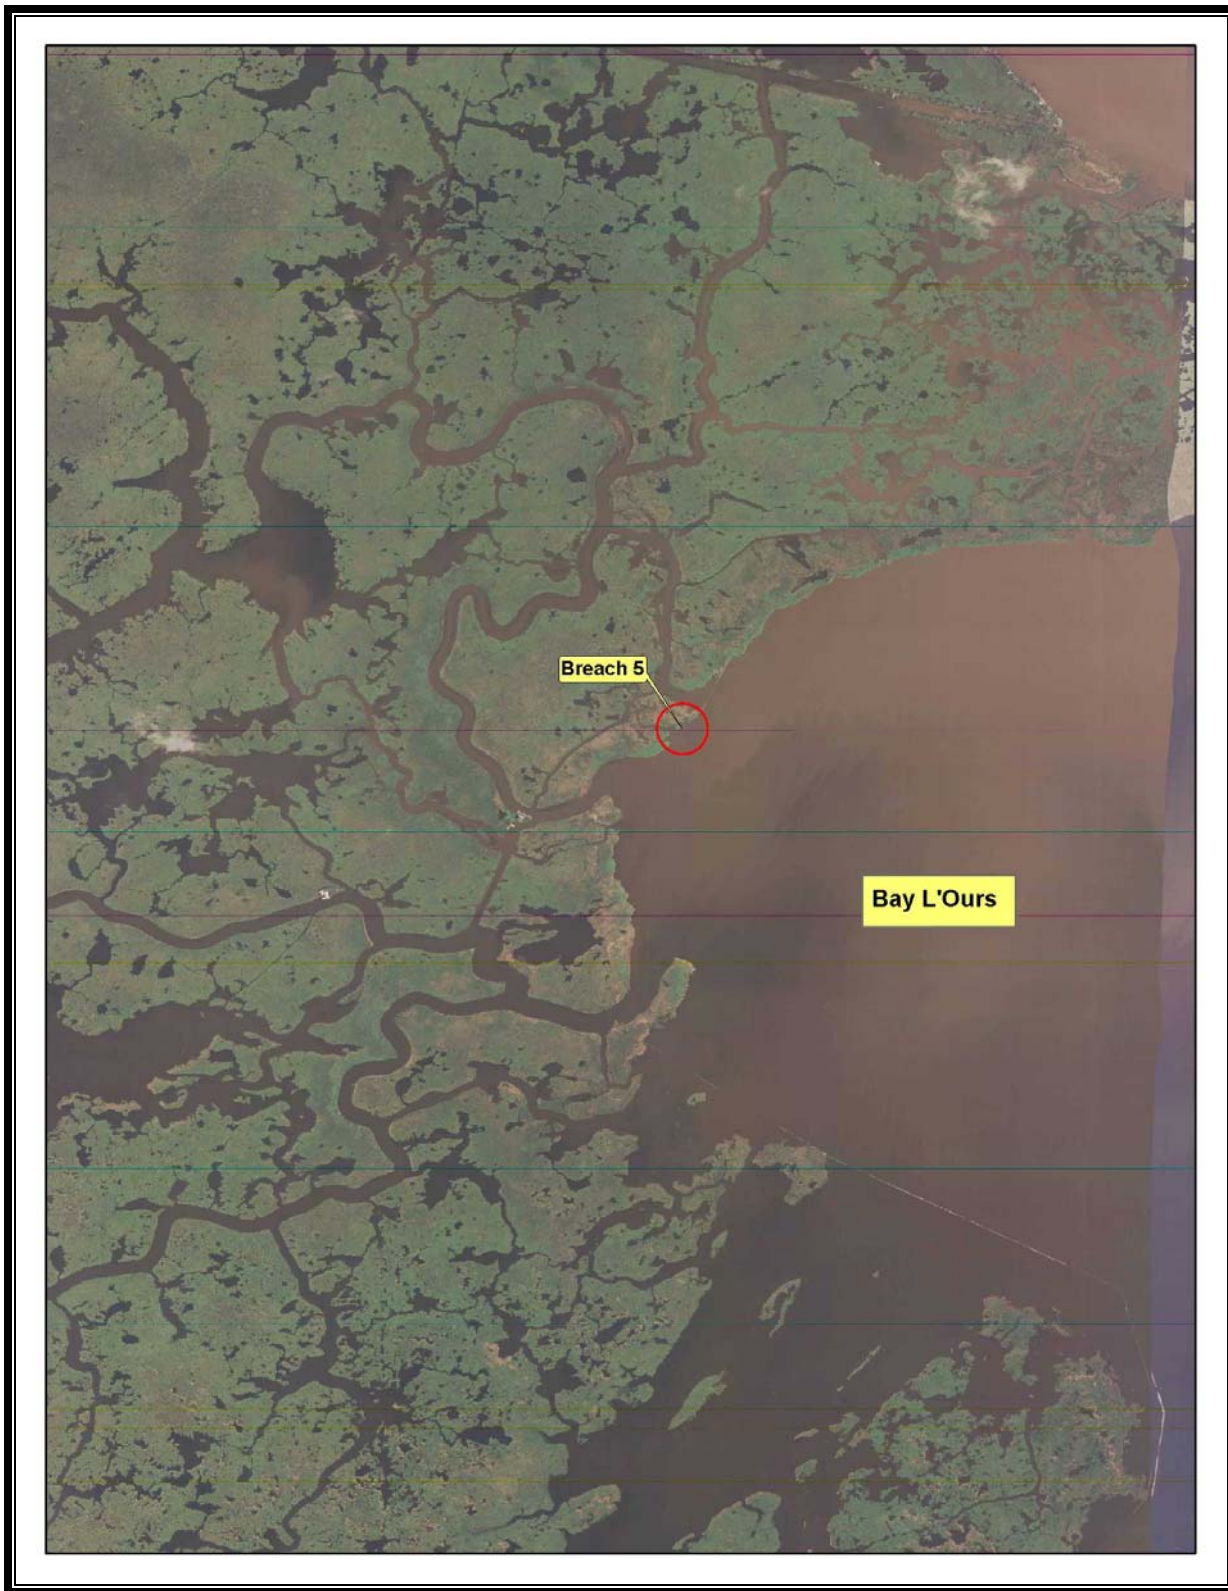
Location of Breaches

While inspecting the existing earthen embankments along various oilfield canals, we noted three (3) breaches in the existing embankment that were caused by the storm in addition to the breaches noted on previous inspections (Photos: Page 14).
