**State of Louisiana
Department of Natural Resources
Coastal Restoration Division**

2006 Annual Inspection Report

**CAERNARVON OUTFALL
MANAGEMENT**

State Project Number BS-03a
Priority Project List 2

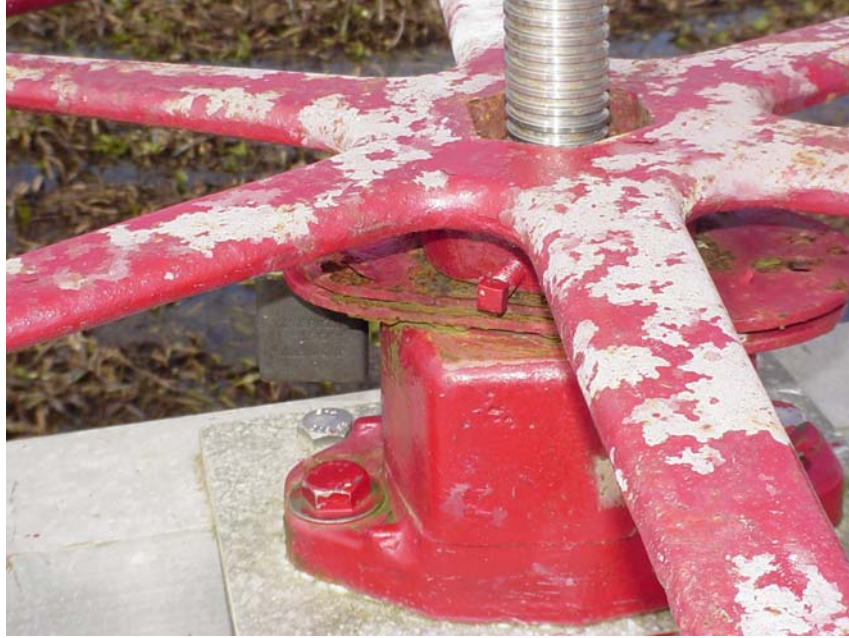
- A. Site/Structure # 13** – The entire structure is covered with marsh debris from the storm. The culvert is also clogged with debris and gates are not operable. (Photo 1,2 are from 2005 inspection)

Photo # 1 Site 13 (view 1) Corrosion of locking plates caused them to separate making locking impossible.

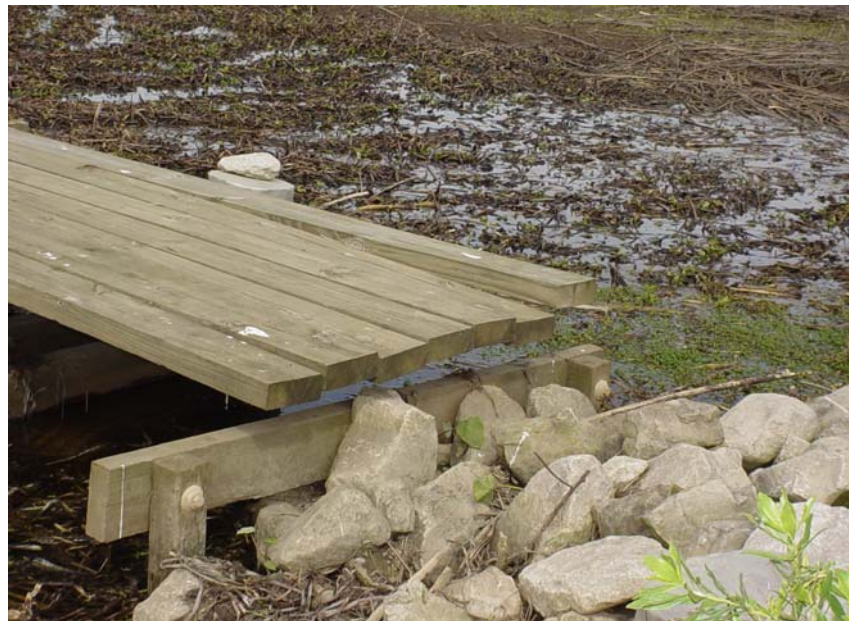
Photo # 2 Site 13 (view 2) This photo is from the 2005 Inspection. The entire structure along with rock closure, gate and walkway are covered with storm debris.

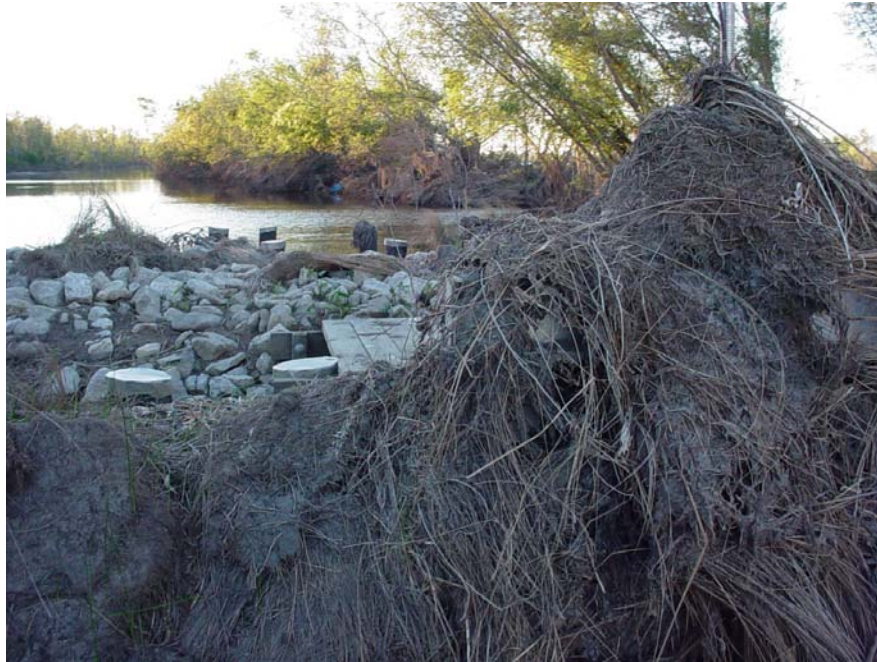
- B. Site/Structure # 25** –The entire structure is covered with marsh debris from the storm. The culverts are clogged with debris and are not operable. (Photos 3, 4 from 11/05)

Photo # 3 Site 25 (view 1) Looking down the Forty Arpent Canal behind Braithwaite in Plaquemines Parish.

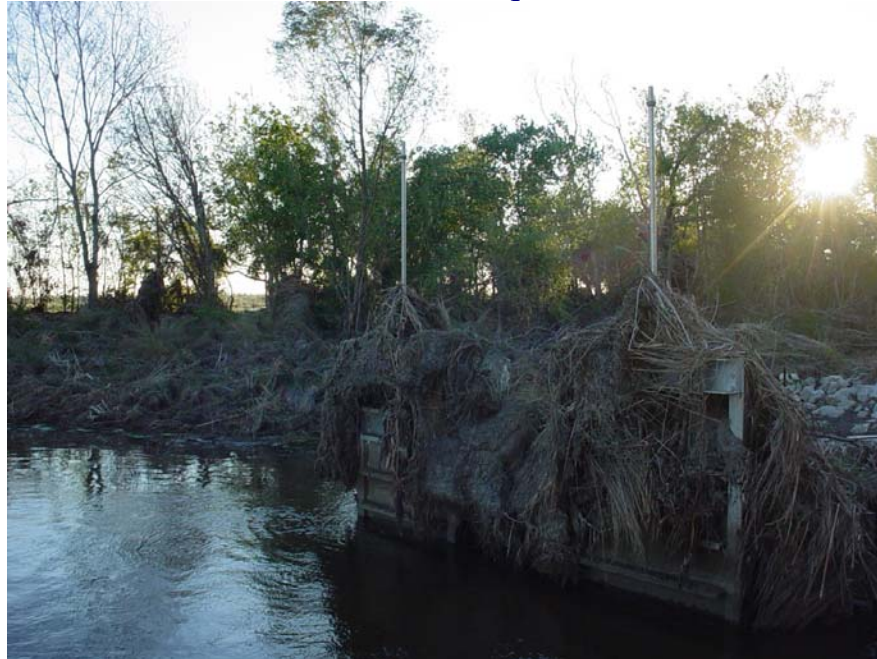
Photo #4 Site 25 (view 2) View from the structure looking South. As noted, the entire structure, including the rock closure is covered with storm debris.

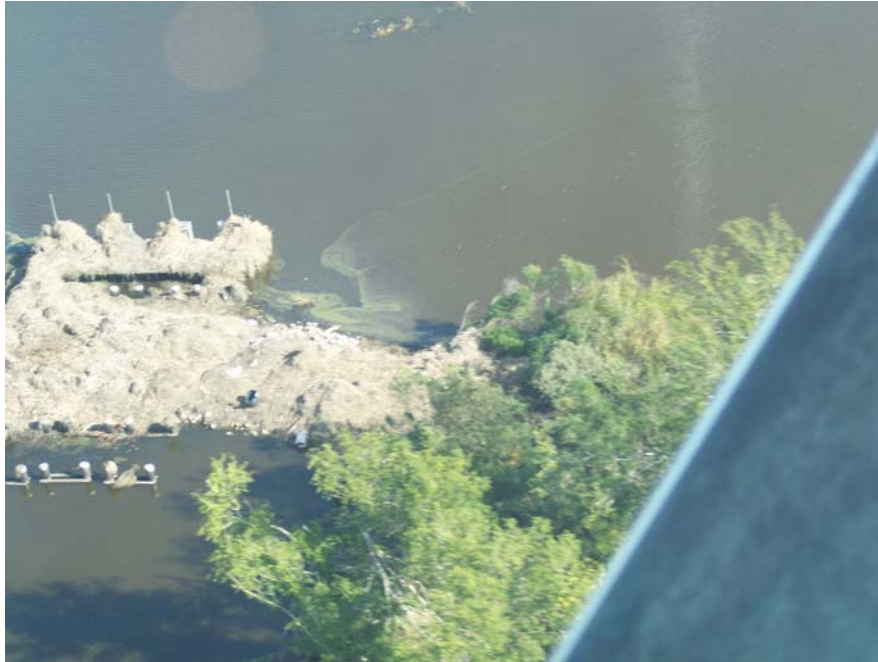
- C. Site/Structure # 26** – The structure is still in place but is completely covered with storm debris. All 4 culverts are clogged with debris and the gates are inoperable. The flow meter that was installed before the storm event was not recovered. (Photos 5, 6 from 11/05)

Photo # 5 Site 26 (view 1) Structure is entirely covered with storm debris.

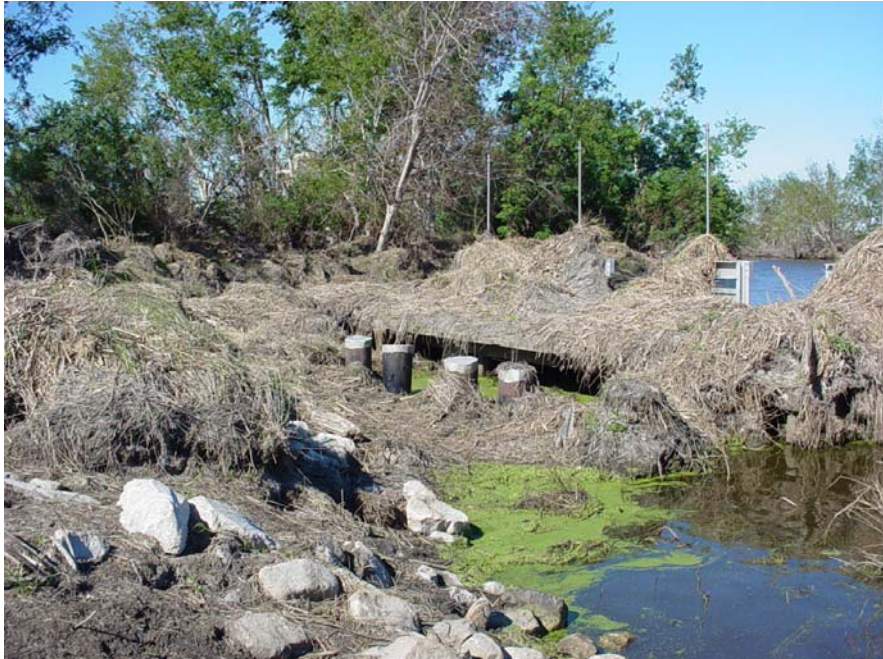
Photo # 6 Site 26 (view 2) A flow meter was installed on this structure. The recorder box was also located on one of the piling. None of the equipment was recovered.

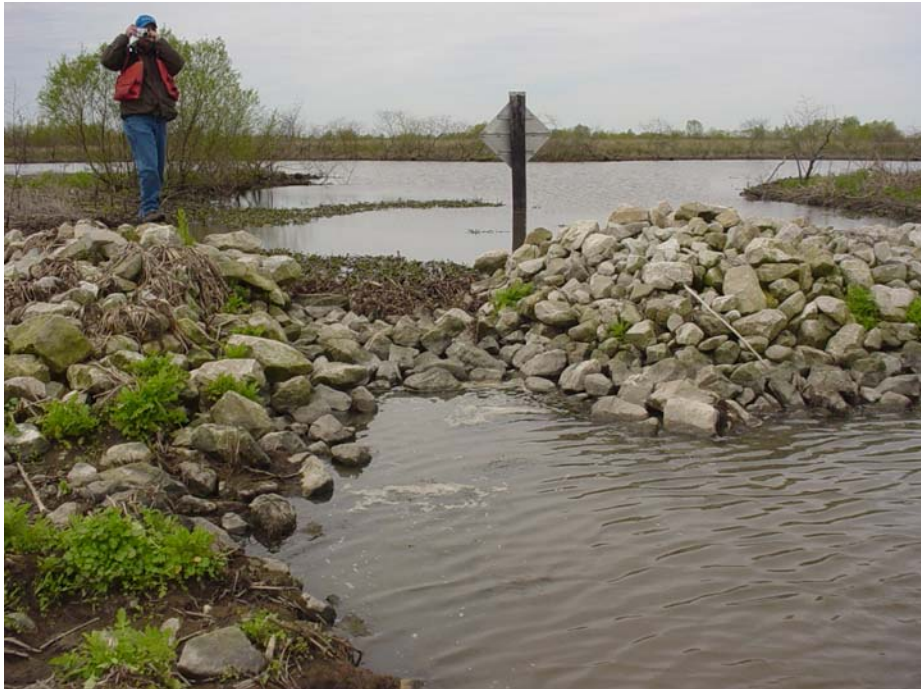
- D. Site/Structure # 32** –Overall condition was good with the exception of the area that was vandalized in early 2003. That area was partially repaired by the 2003 inspection team; however, that repair was again vandalized to the original depth. The condition of the closure appears to have not changed but is now covered with storm debris. This structure was constructed to keep diversion water from entering Lake Leary from the western lake rim; the storm devastated that portion of the lake rim rendering this structure ineffective. (Photos 7, 8 from 2005 inspection)

Photo # 7 Site 32 (view 1) This site was opened to the water line by vandals and was partially repaired by the 2003 inspection team. It was then vandalized again. This photo is from the 2005 inspection, debris now covers the structure.

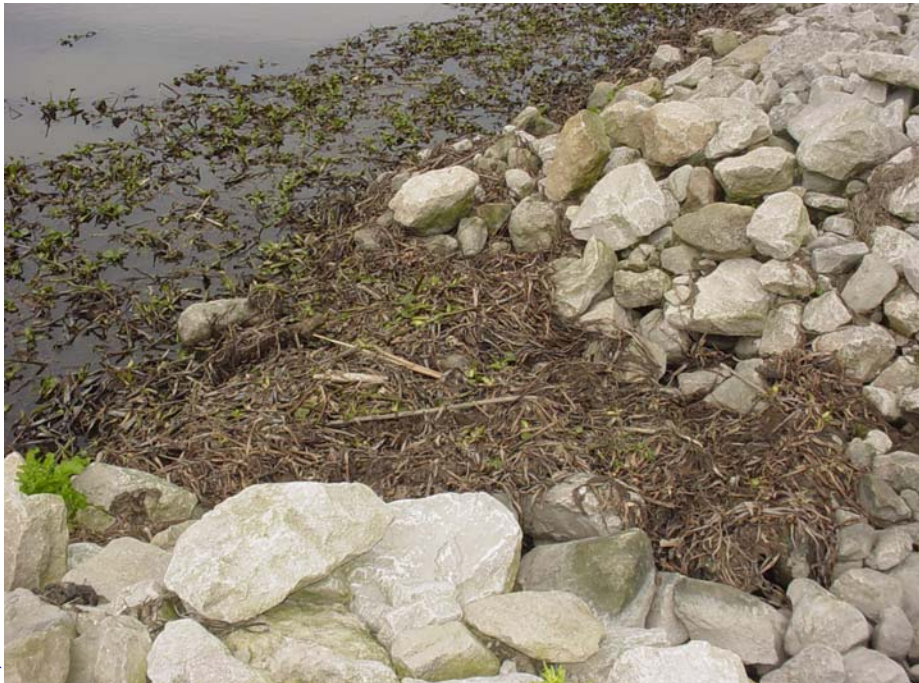
Photo # 8 Site 32 (view 2) This closer view shown that the removed rock was placed just adjacent to the opening.

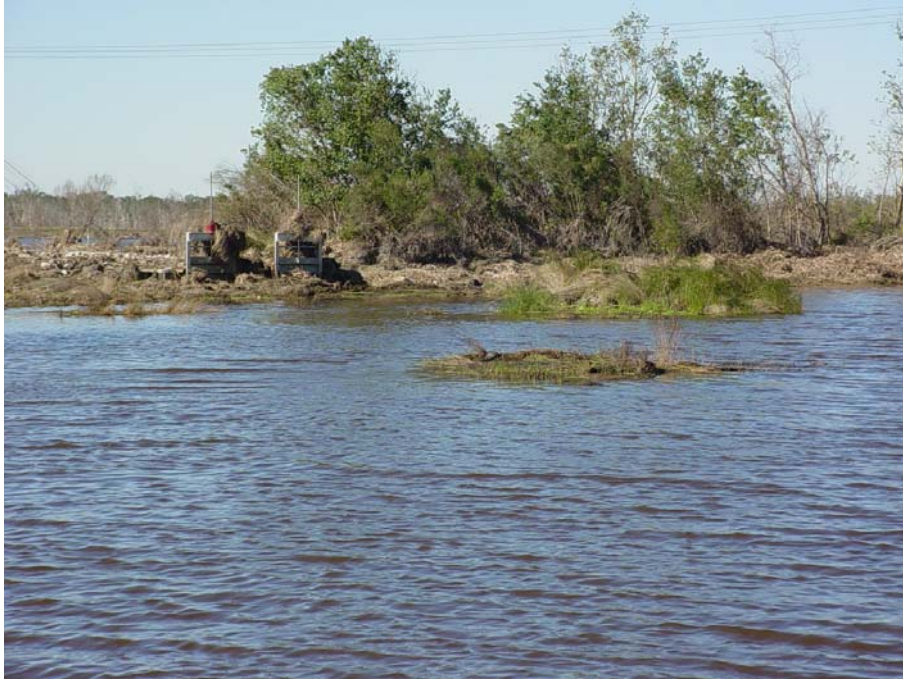
- E. Site/ Structure # 40** – The entire structure is covered with marsh debris. The culverts are also clogged with storm debris and are inoperable. The flow meter was recovered from this structure. (Photos 9, 10 from 11/05)

Photo # 9 Site 40 (view 1) Storm debris covers the entire structure and also completely blocked both culverts.

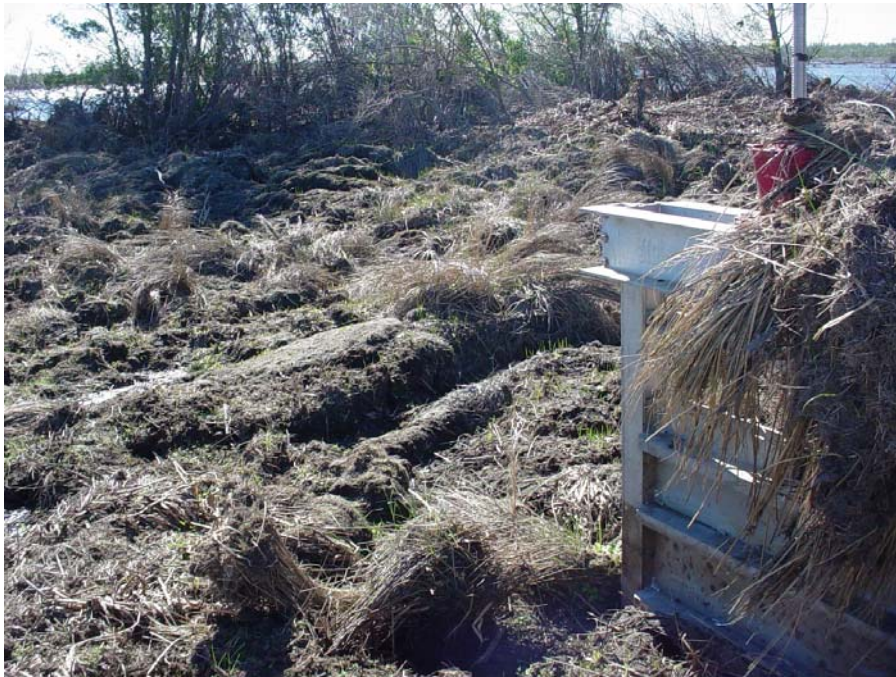
Photo # 10 Site 40 (view 2) Another view looking south along the rock closure.

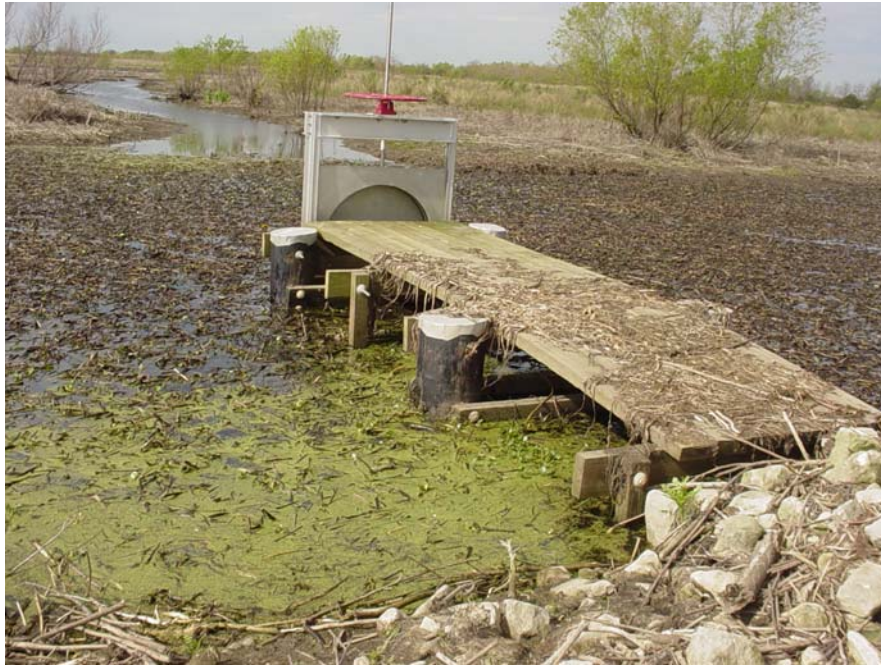
- F. Site/Structure # 50** – The entire structure is covered with storm debris, marsh balls, marsh grass, etc. The gate is inoperable and the culvert completely blocked and ineffective. Photos (11, 12 from 2005 inspection)

Photo # 11 Site 50 (view 1) This entire structure is covered with storm debris. The debris has blocked the 48” culvert.

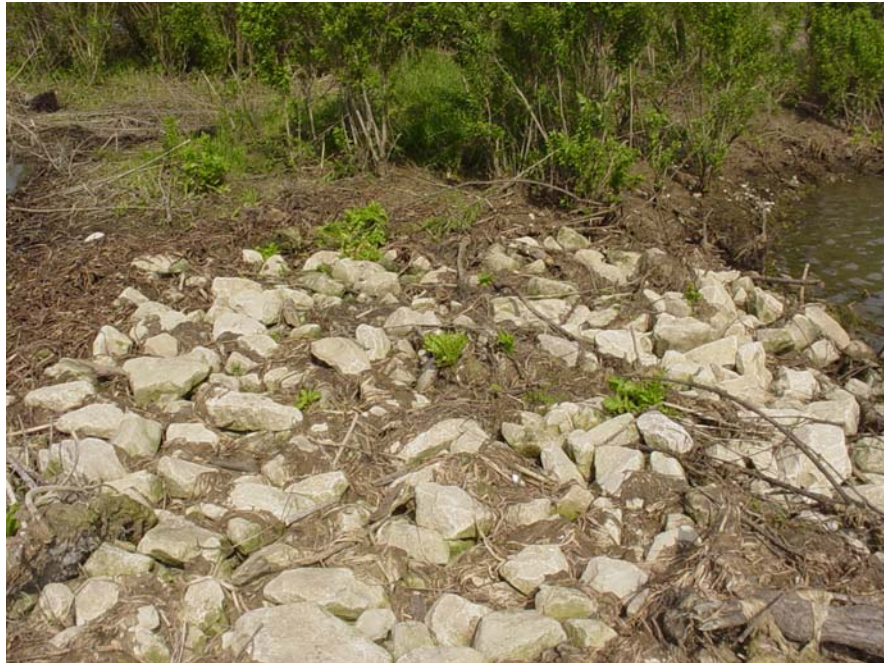
Photo #12 Site 50 (view 2) Slight erosion is evident on both sides of the rock plug where it ties into the earthen embankment.

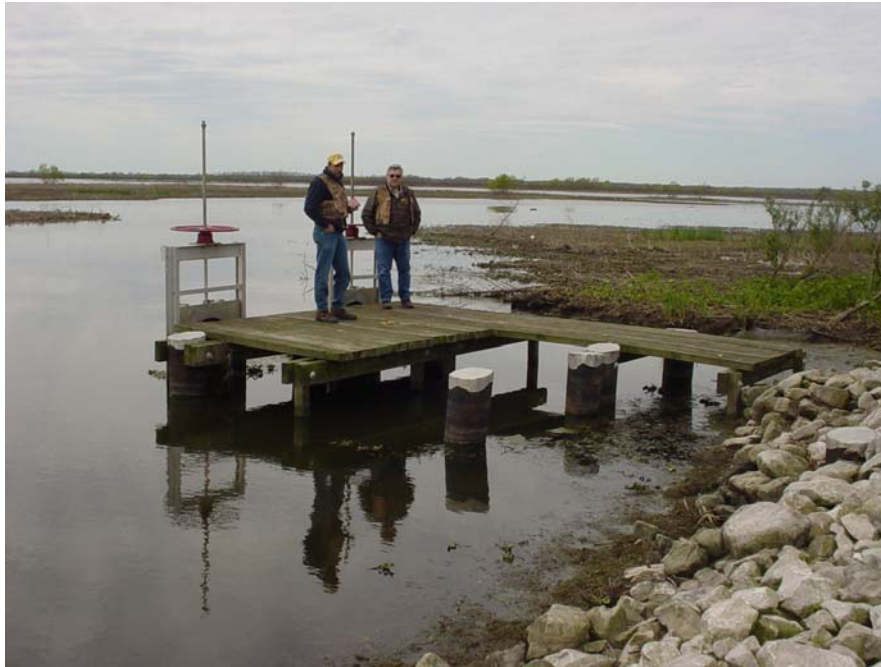
- G. Site/Structure #52** – The entire structure and rock plug is completely covered with marsh debris, marsh ball, etc. The gates are also covered with marsh grass and marsh balls and are inoperable. The culverts are completely blocked and ineffective. (Photo 13, 14 from 2005 inspection)

Photo # 13 Site 52 This photo is from the 2005 inspection
The entire structure is now covered with storm debris.
The culvert is completely blocked.

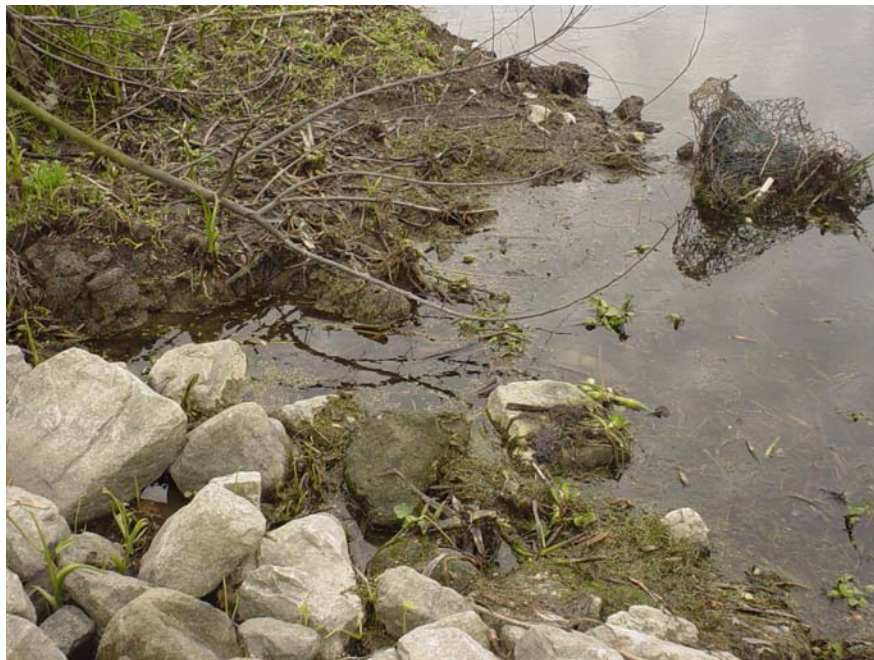
Photo # 14 Site 52 Slight erosion is evident in the areas
where the rock closure ties into the earthen embankment in
this 2005 inspection photo. Debris covers entire structure.

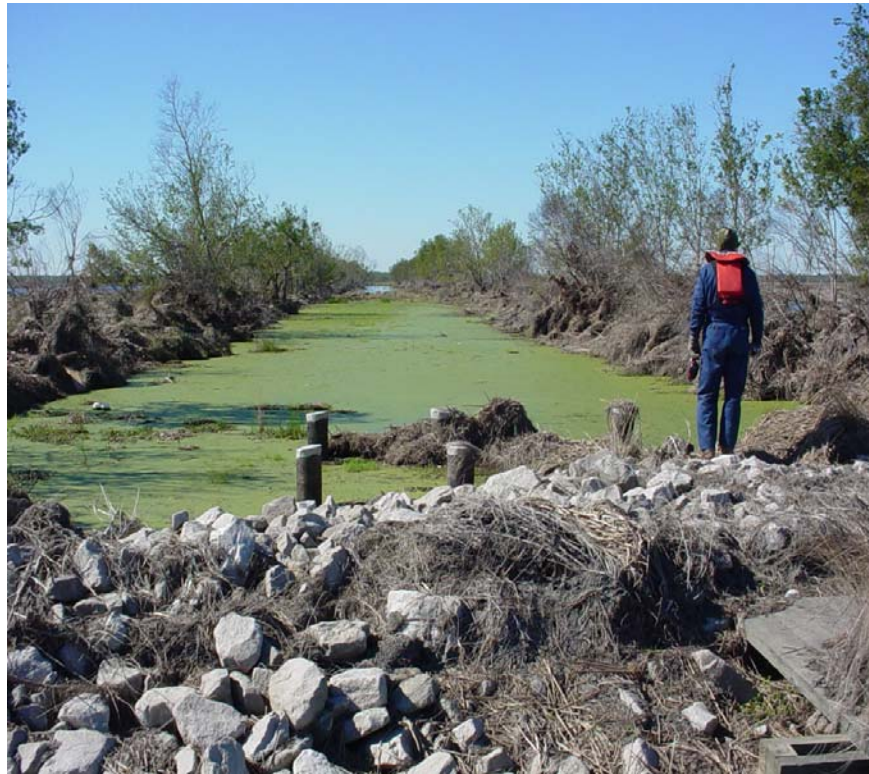
- H. Site/Structure # 54** – Marsh debris covers the entire structure, the gates and the rock closure. The culverts are completely clogged and the gates are inoperable. The flow meter that was installed at this site was missing after the storm. Small amount of

earthen embankment erosion is still noticeable on both sides of closure.(Photo 15, 16 from 11/05)

Photo # 15 Site 54 (view 1) Debris covers entire structure
Culverts are also completely blocked.

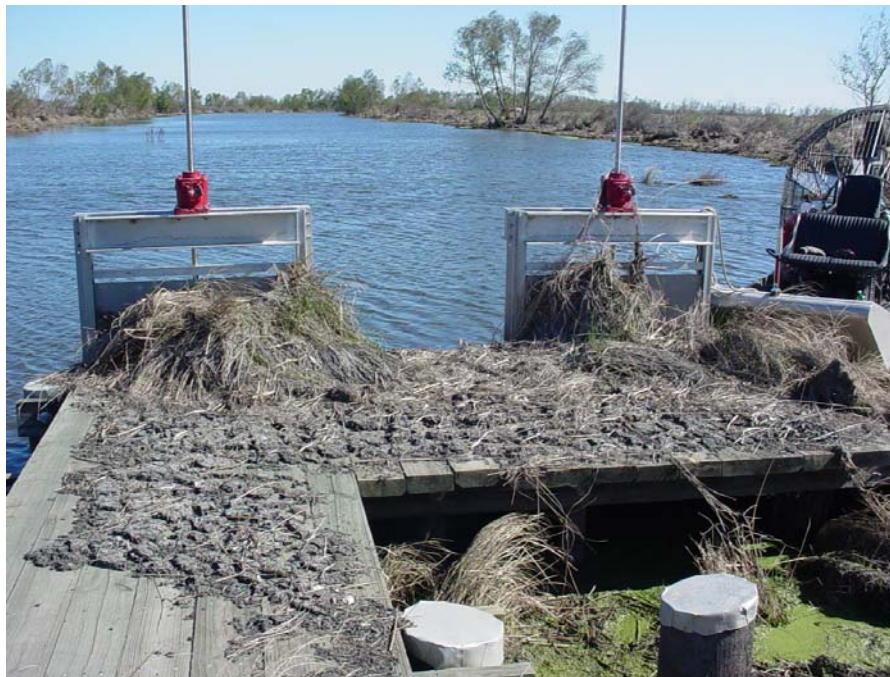
Photo # 16 Site 54 (view 2) This view taken from the structure
looking west. The flow meter and all attachments were destroyed
by the storm.

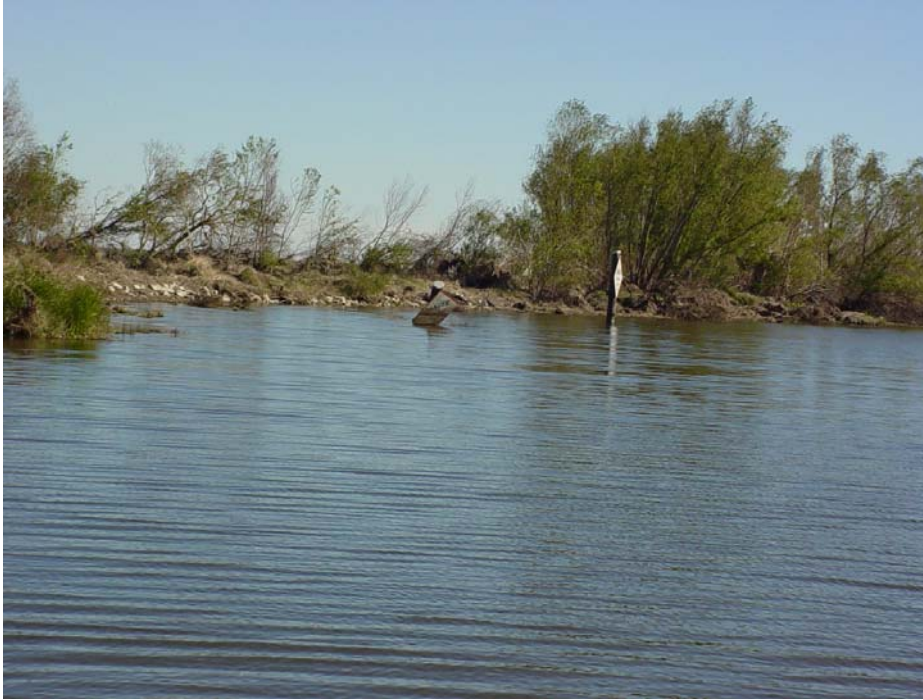
- I. Site/ Structure # 56** - No subsidence was noted in this rock structure since the 2005 inspection. The entire rock closure is covered with storm debris and the canal that was closed by the structure is completely clogged with marsh that was placed there by the storm. Both warning signs were damaged during the storm.(Photo 17 from 11/05)

Photo # 17 Site 56 Overall condition of the canal rock closure appears to be good No appreciable subsidence has occurred since the 2005 inspection. The rock closure and the canal are completely covered with storm debris.

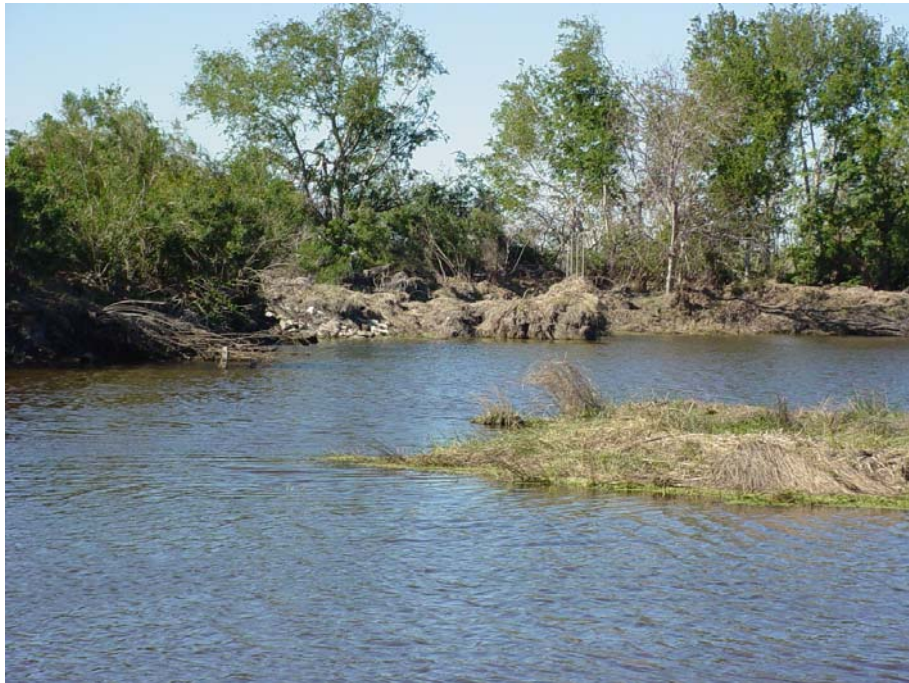
- J. Site # 57** – The entire reach of spoil bank along the east side of the Reggio Canal was inundated with storm debris. It appears that most of the vegetation that was destroyed while being covered with debris. What high standing vegetation that was there before the storm was flattened. (Photo 18 was from 2005 inspection)

Photo # 18 Site 57 Embankment is covered with storm debris. It appears that it is also very badly eroded.

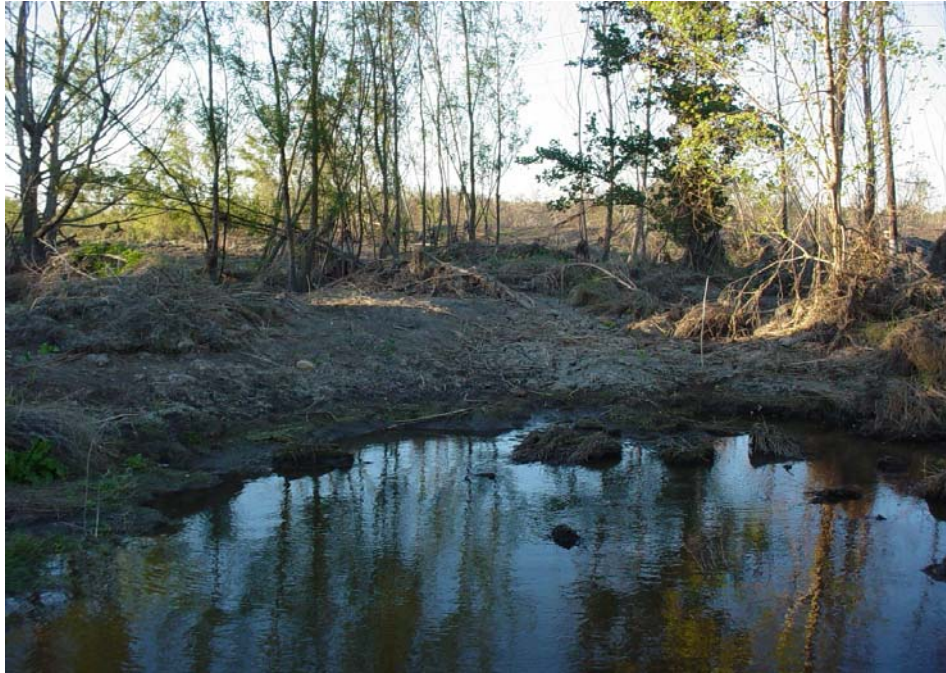
- K. Site # 58** – The entire reach of spoil bank restoration along the west side of Bayou Mandeville was destroyed by the storm. The tidal wave and storm debris took its toll on this west bank and destroyed what there was of any bank restoration that was done. (Photo 19, 20 from 11/05)

Photo # 19 Site 58 Selective erosion has progressed slightly in this 2005 inspection photo. The entire bank line is very badly eroded from the storm, and is covered with storm debris.

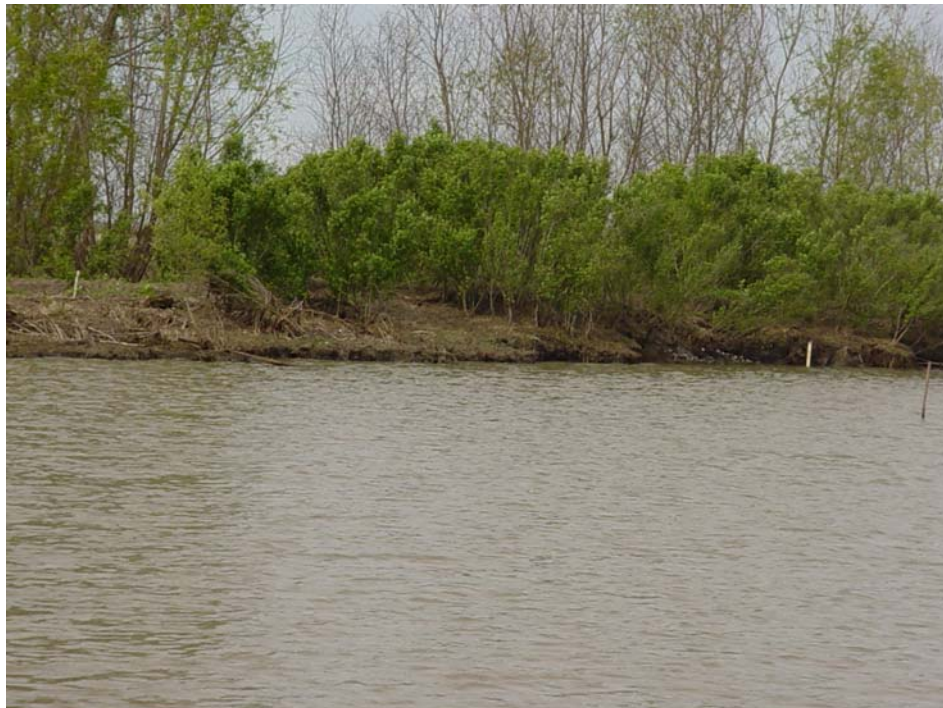
Photo # 20 Site 58 Selective erosion is in areas throughout snite; however, it is located in the slope and has not threatened the embankment crown.

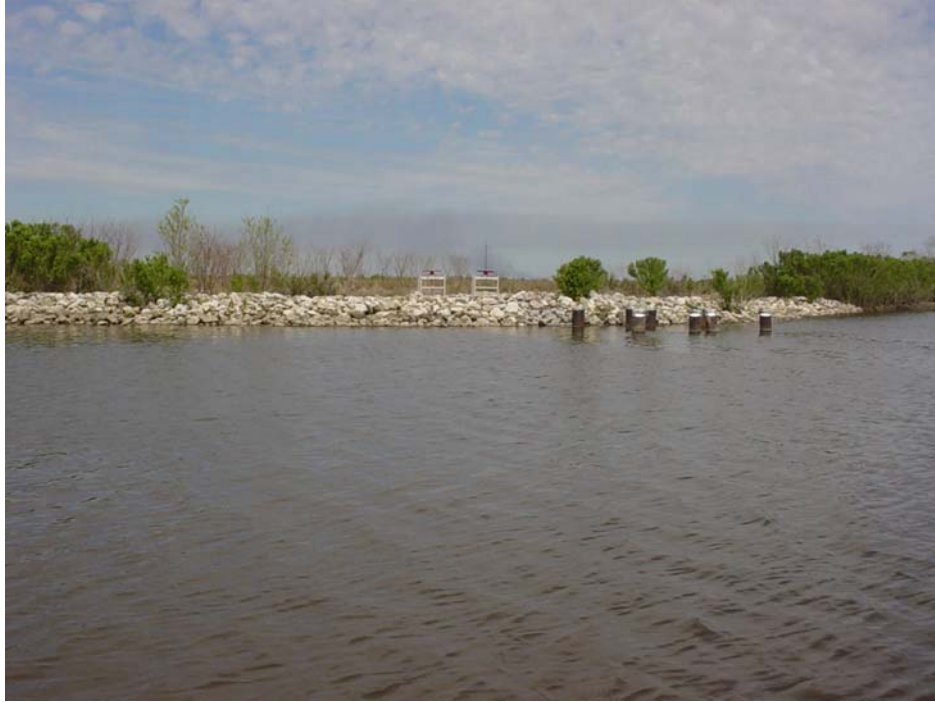
- L. Site/Structure # 60** – Both of the structures were completely covered with storm debris. Both culverts were completely blocked with marsh balls and marsh grass placed there by the storm making the structure inoperable. (Photo 21, 22 from 2005 inspection)

Photo # 21 Site 60 Entire structure is in excellent condition in this 2005 inspection photo; however, the entire structure is covered with storm debris.

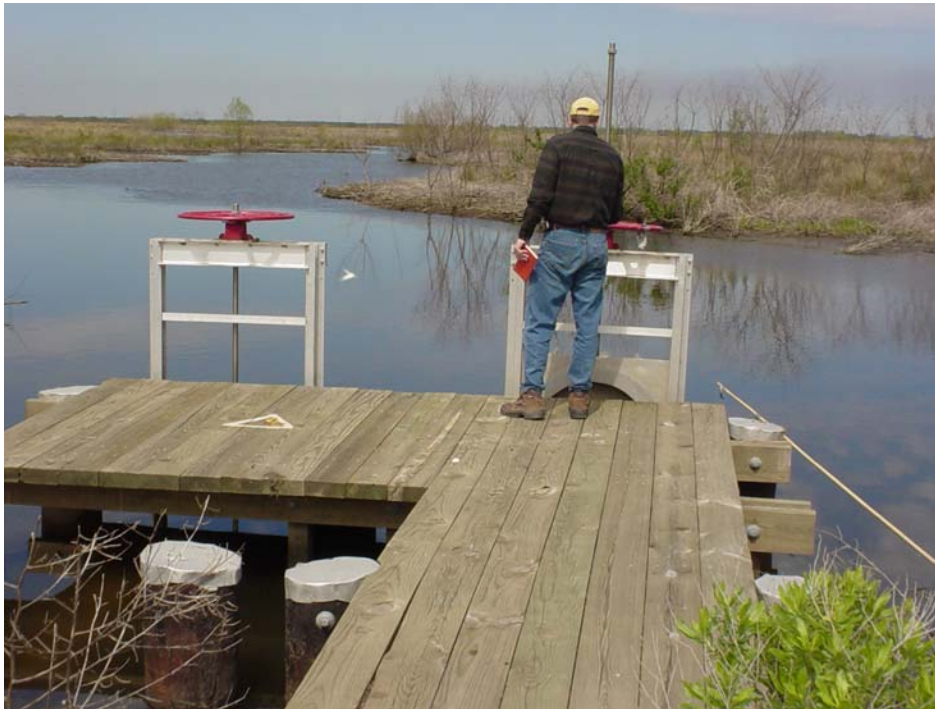
Photo # 22 Site 60 The decking at the structure site is in excellent condition in this 2005 inspection photo. The entire structure and inflow channel are inundated with storm debris and floating marsh balls.
