**State of Louisiana  
Department of Natural Resources  
Coastal Restoration Division**

**2006 Annual Inspection Report**

**Fritchie Marsh Restoration**

State Project Number PO-06  
Priority Project List 2

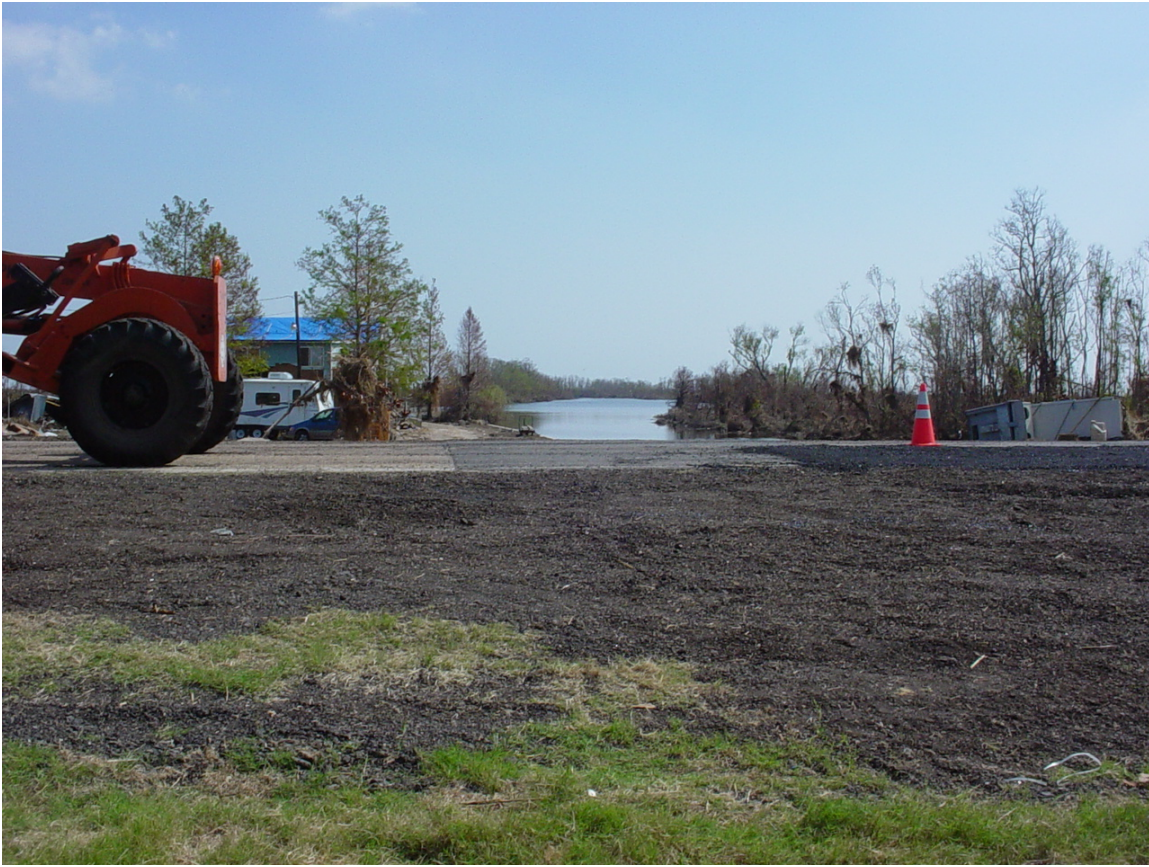
The only visible damage to this structure was to the asphalt patch on the highway. However, this was already being repaired by LaDOTD when we arrived for the inspection (Photo #1). During the last inspection it was noted that there was some scour along the north bank of Salt Bayou just west of the culverts. It appears that the Hurricane may have caused additional damage to this section of bank (Photo #2). If this bank were to completely breach, the hydrologic exchange between the marsh and Salt Bayou would be altered.

**Photo #1 – Salt Bayou Culverts at Hwy 90.** Looking East from inside the project area. Note the work being done to repair the damages to the road.

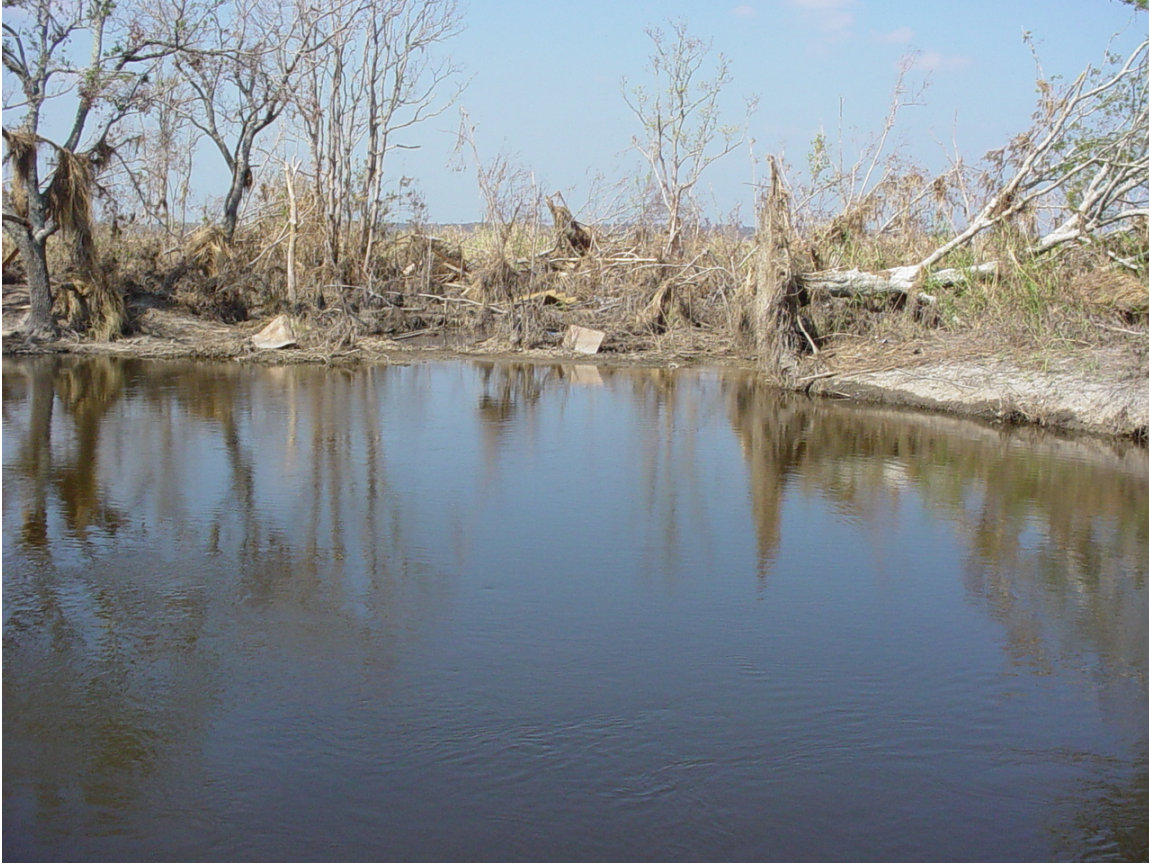
**Photo #2 – Salt Bayou Scour.** Looking at the north bank of Salt Bayou inside the project area from the Hwy 90 Culverts. Note the large section of bank which has been scoured out.

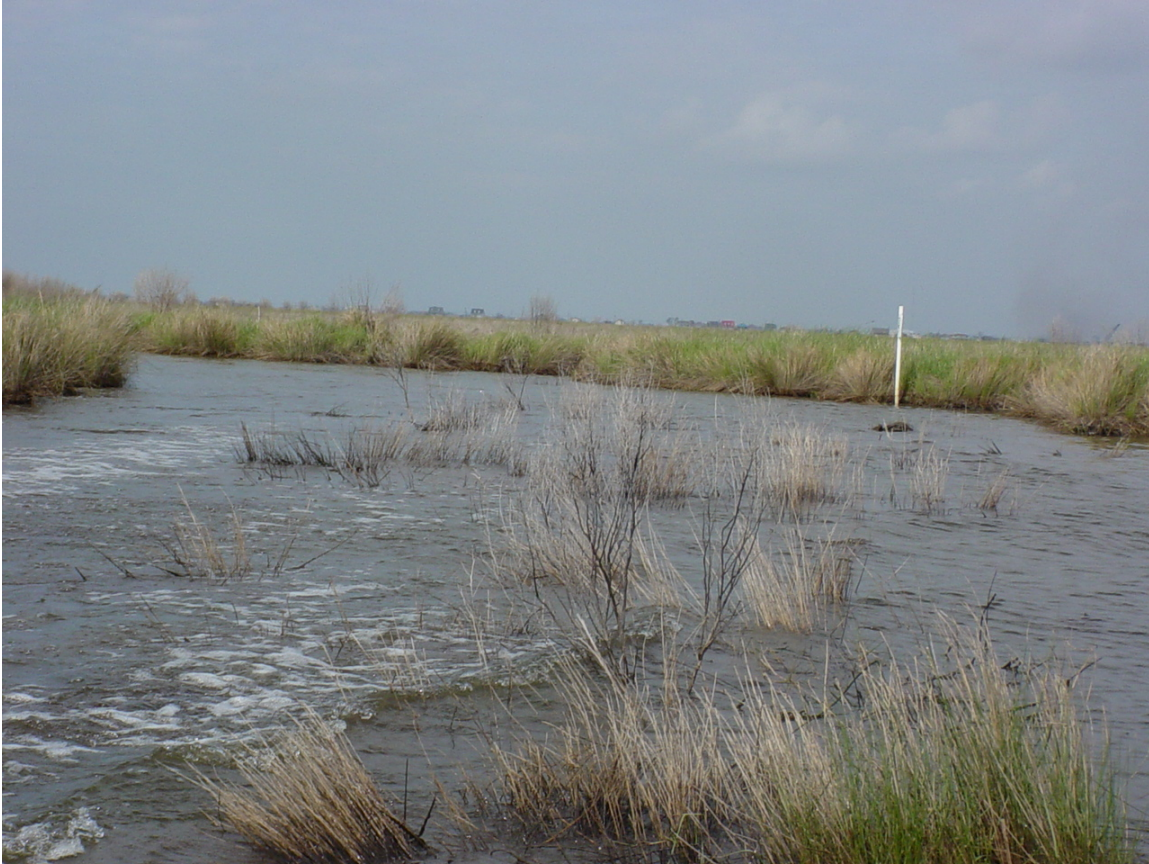
During the second inspection (March 2006), it was noted that a considerable amount of Salt Bayou was inaccessible due to the large amount of marsh that had been deposited into the bayou by to the Hurricane. There were several locations where large sections of sheared marsh completely filled the bayou, greatly reducing the movement of water. (Photo #3)

**Photo #3 – Salt Bayou.** Notice the large amount of stray marsh inside the channel.
