**2005/2006 Annual Inspection
Report**

**BRADY CANAL HYDROLOGIC
RESTORATION**

State Project Number TE-28
Priority Project List 3

August 17, 2006
Terrebonne Parish

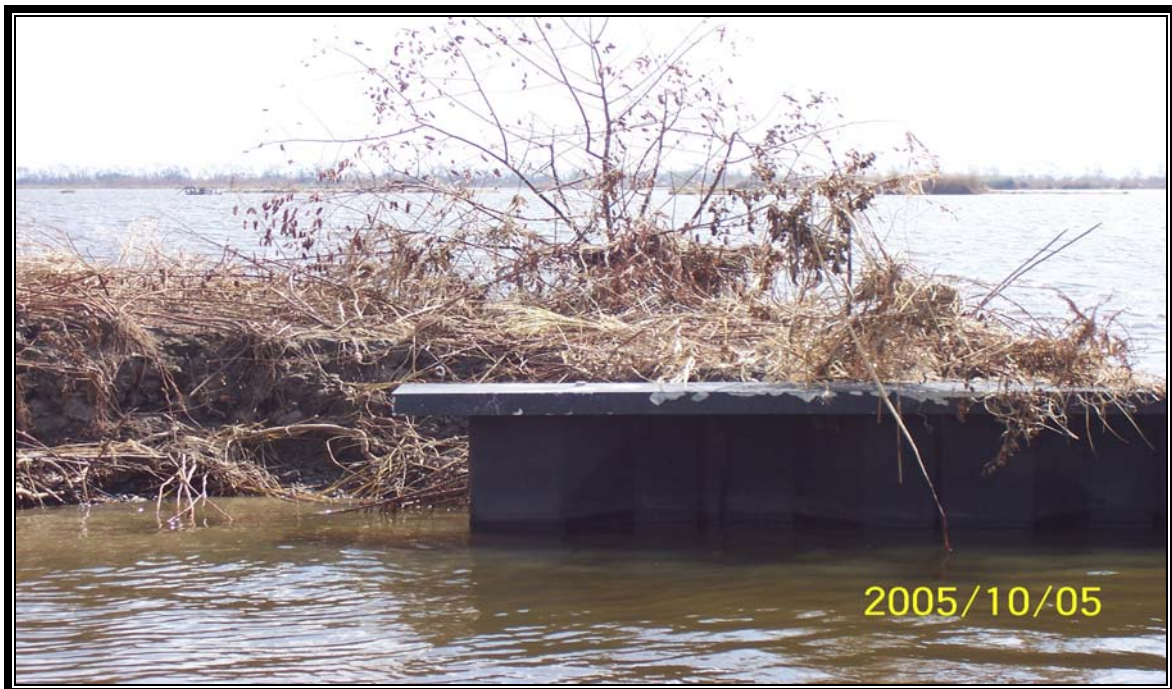
Structure No. 23 – Upon inspection of structure no. 23, we observed that the earthen embankment tie-in on the north side of the structure had eroded around the structure exposing the end of the steel bulkhead. There is a small portion of the earthen embankment remaining behind the structure on the marsh side preventing a breach from forming. This has been an area of concern during previous inspections and will require maintenance in the near future.

Structure #23 – significant erosion on the north side of the structure exposing the bulkhead.

Structure 23 - north earthen tie-in has eroded around steel bulkhead but has not breached. Watch closely in future site visits. No significant damage from storm. TBS installing stop logs.

The damage assessment of the Brady Canal Hydrologic Restoration Project (TE-28) revealed several breaches along the east bank of Carencro Bayou and Little Carencro Bayou and significant erosion adjacent to Structure No. 23 directly related to the storm surge produced by Hurricane Rita. It is recommended that the damaged mentioned above be restored using dredge material from the adjacent bayous and lake to raise the breached overflow banks and earthen tie-ins to their design elevation.

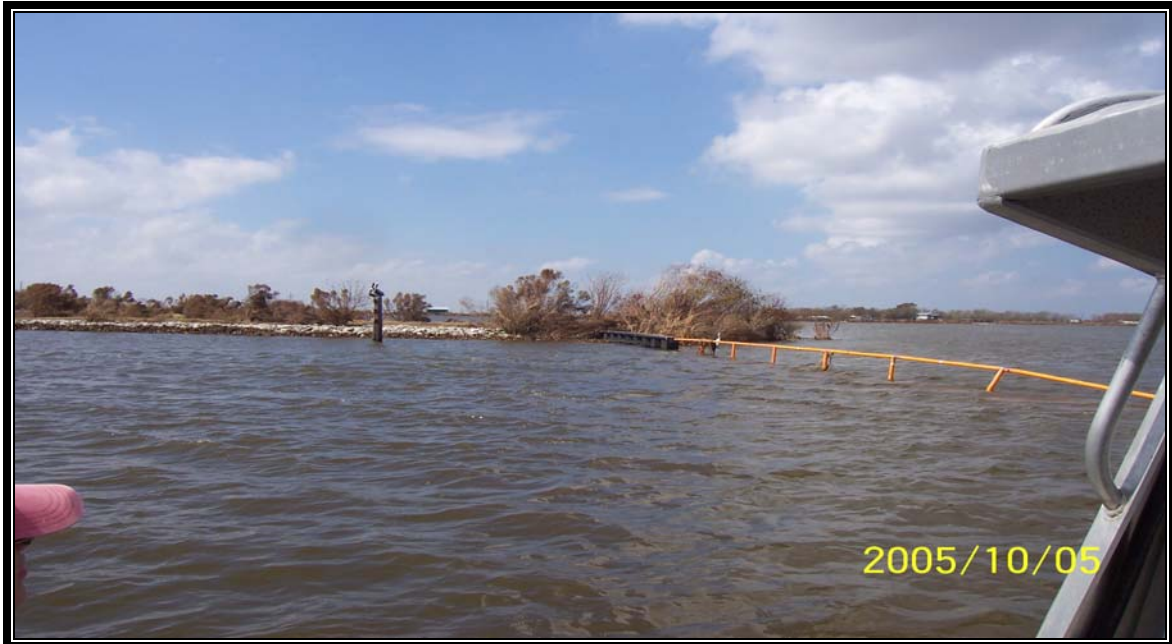
Structure No.6 – while inspecting the fixed crest weir with barge bay, we observed the guard rail at entrance to the barge bay on the west side was bent. This damage appears to be caused by oilfield barges accessing the barge bay and colliding with the bulkhead. No storm damage was noted.

Structure #6 – photo of bent guard rail on the west side of barge bay.

Structure No 6 - weir at barge bay in good condition west side of steel pile wall damaged at entrance to barge bay. Staff gauge behind structure damaged.
No Reading

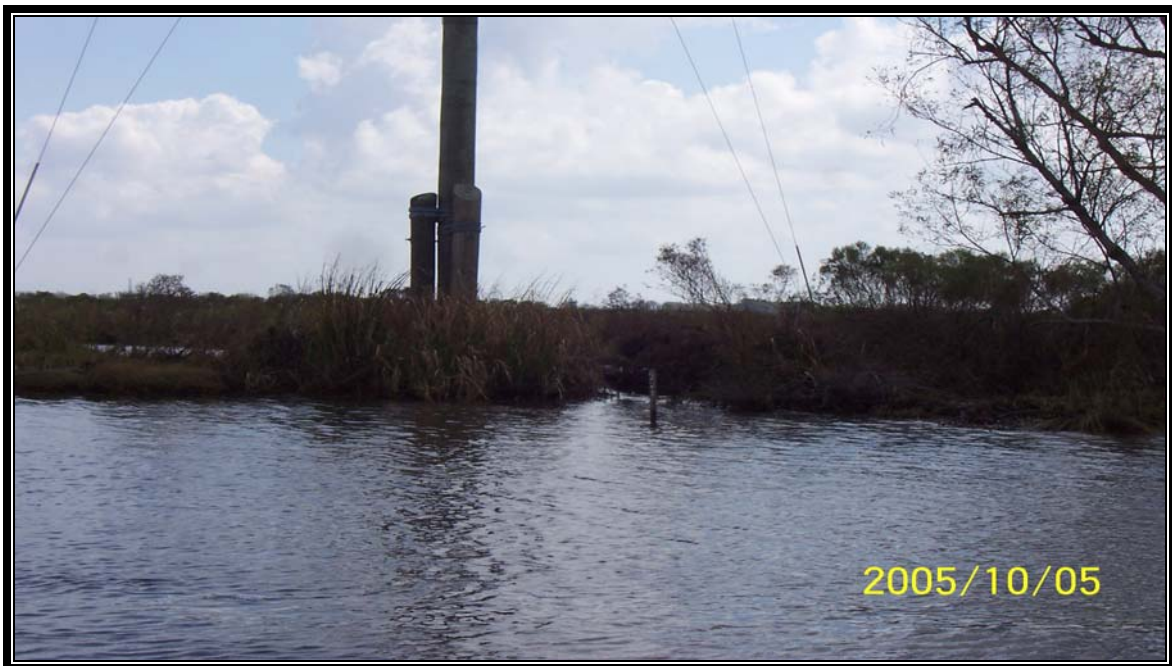
As noted in previous inspections, there is a small breach (approximately 5 feet wide) located on the east bank of Carencro Bayou across from an existing camp location between an electrical pole and guide wire. The breach doesn't appear to have worsened as a result of Hurricane Rita.

Photo of breach located along Carencro Bayou near electrical pole.

Small breach located along Corwin's Bayou access from camp has not worsened from storm surge. Approx. 5' wide.

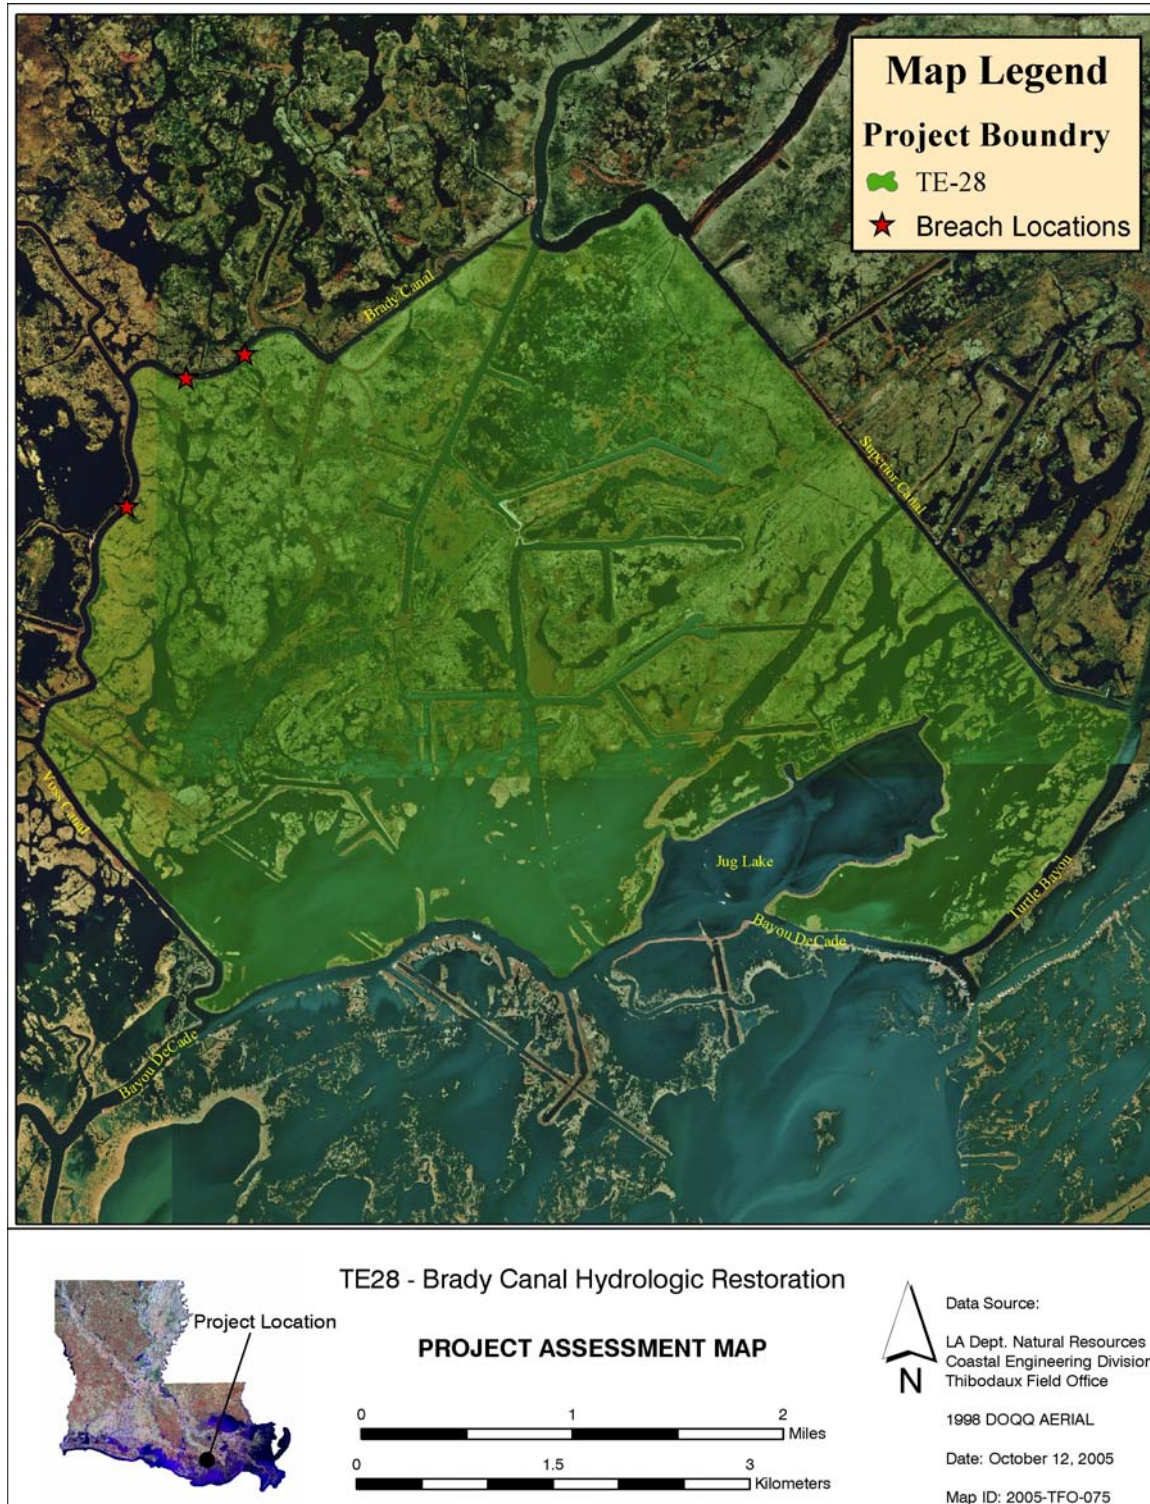
While inspecting the overflow banks along Carencro Bayou and Little Carencro Bayou, we observed three (3) breaches which were a direct result of Hurricane Rita. These earthen banks were in good condition and intact prior to the storm. Below is a map showing the approximate locations of these breaches along with photographs:

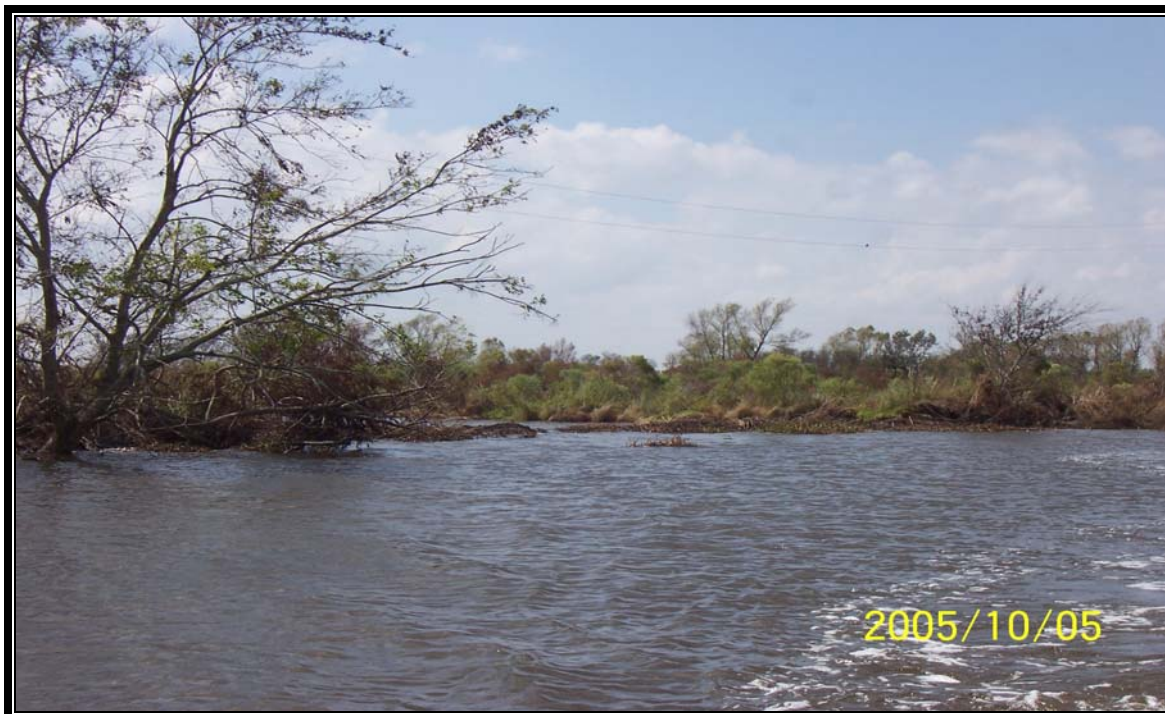
Photo of breach (approximately 20 ft. wide) located along east bank of Carencro Bayou.

Small breach^① along Caraculo Bayou
(5' wide) - coordinates taken.
Breach due to storm.

As a result of the post storm damage assessments, recommendations were made for the repair of three (3) breaches located along the east bank of Carencro and Little Carencro Bayous and levee refurbishment of low area adjacent to the variable crest weir structures.

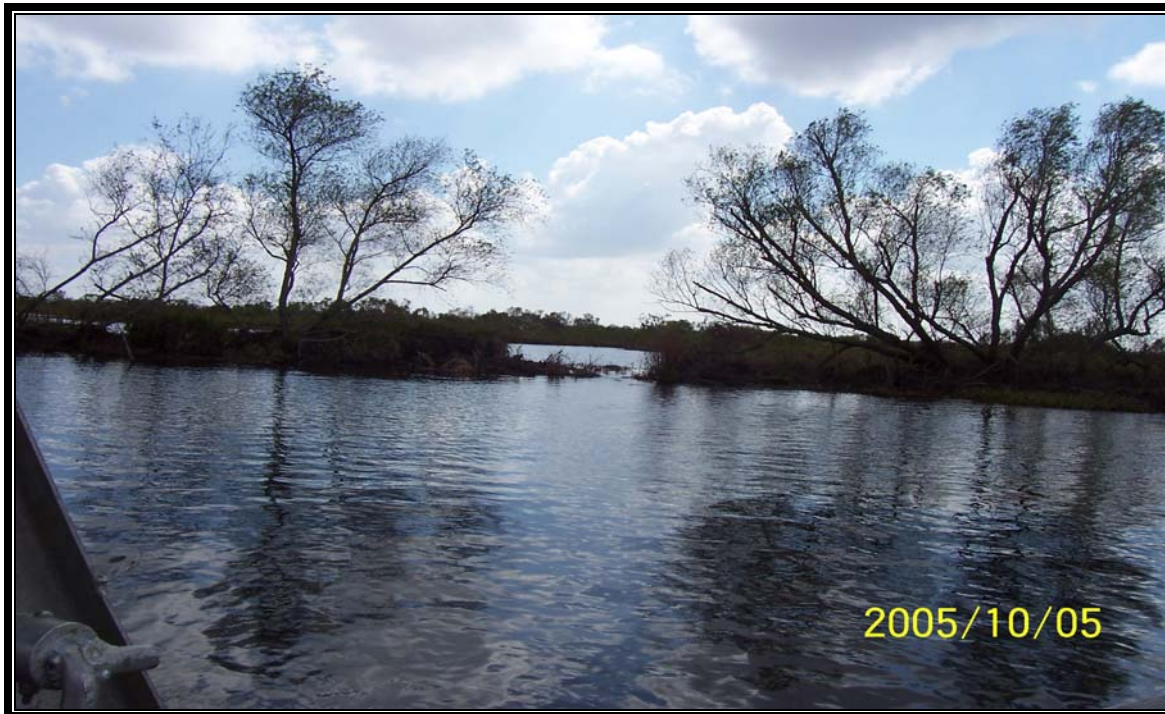
Photo of breach (approximately 25 ft wide) located along east bank of Little Carencro Bayou.

Little Caraculo Breach^② 694,690 4' wide
Bayou 325,4630

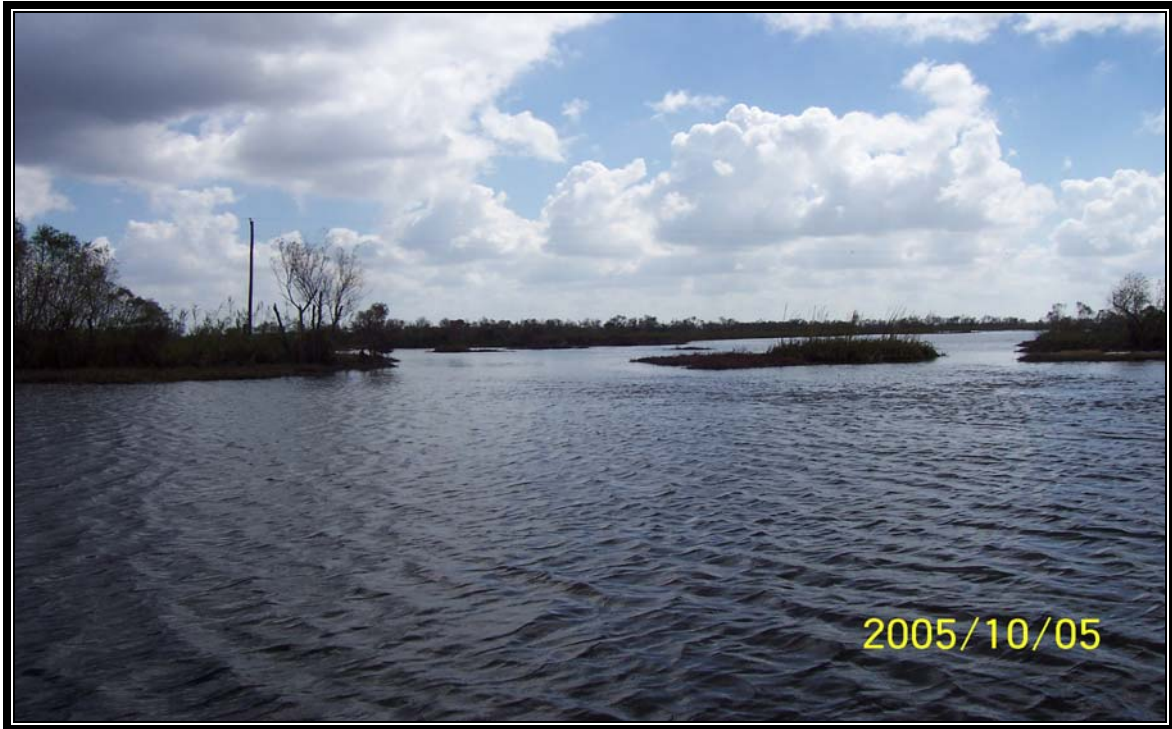
Photo of breach (approximately 80 ft wide) located along east bank of Little Carencro Bayou.

Breach^③ 695,090
approx. ~~3,243~~ 3,254,863
80' wide
