**State of Louisiana
Department of Natural Resources
Coastal Restoration Division**

**2006/2007 Annual Inspection
Report**

**CAERNARVON OUTFALL
MANAGEMENT
(BS-03a)**

State Project Number BS-03a
Priority Project List 2

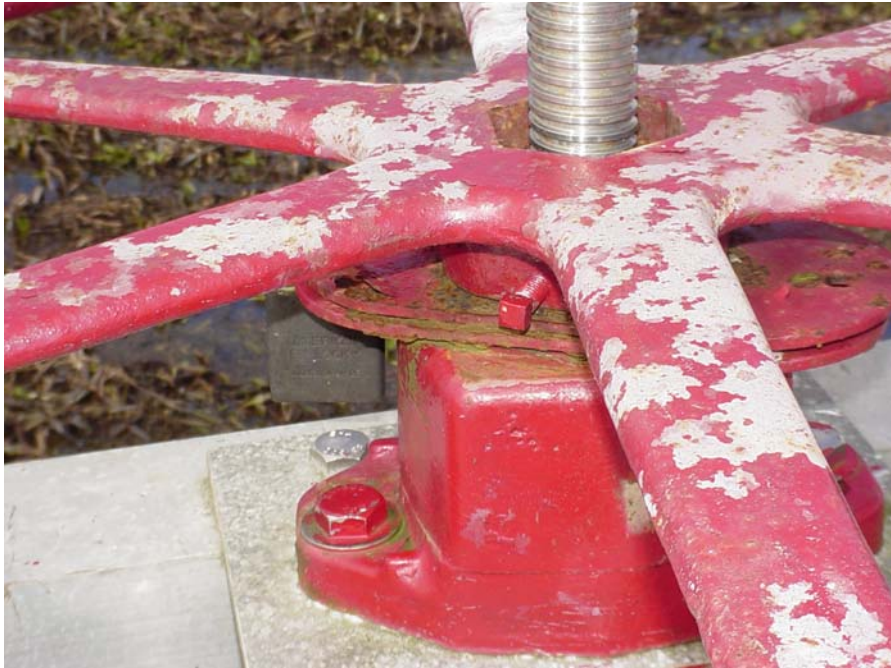
Photo # 1 Site 13 (view 1) Corrosion of locking plates caused them to separate making locking impossible. (Photo from 2005 inspection)

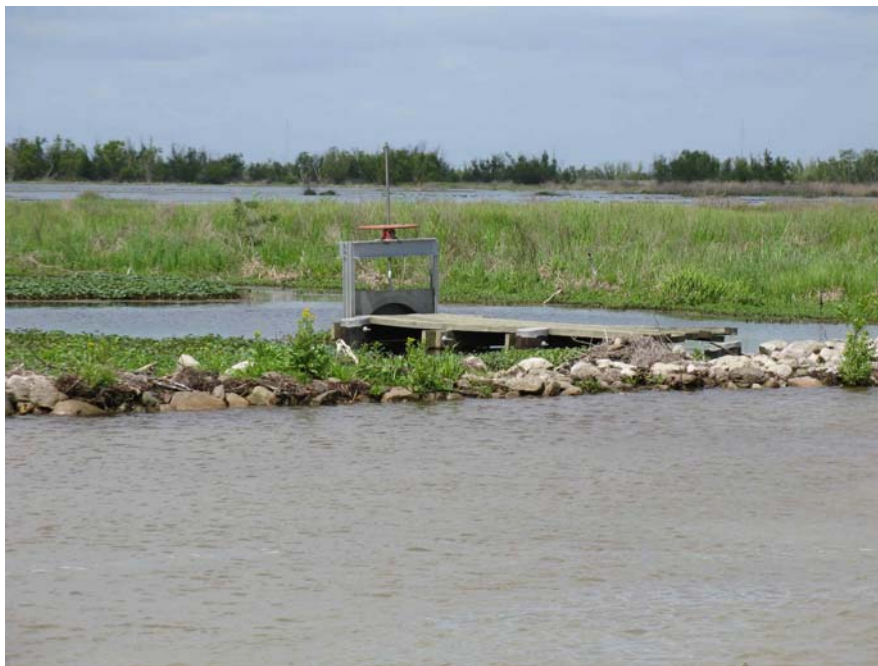
- A. Site/Structure # 13** – The gate was in the open position at the time of the inspection. Water flow was not visible, possibly due to a lack of sufficient differential head, therefore it was not evident how much (if any) blockage remains due to storm debris. The timber walkway has separated from its support beam at one end.

Photo # 2 Site 13 (view 2) The extent of blockage of the culvert due to storm debris is unknown. Note the high water stages, both in Bayou Mandeville and in the interior marsh.

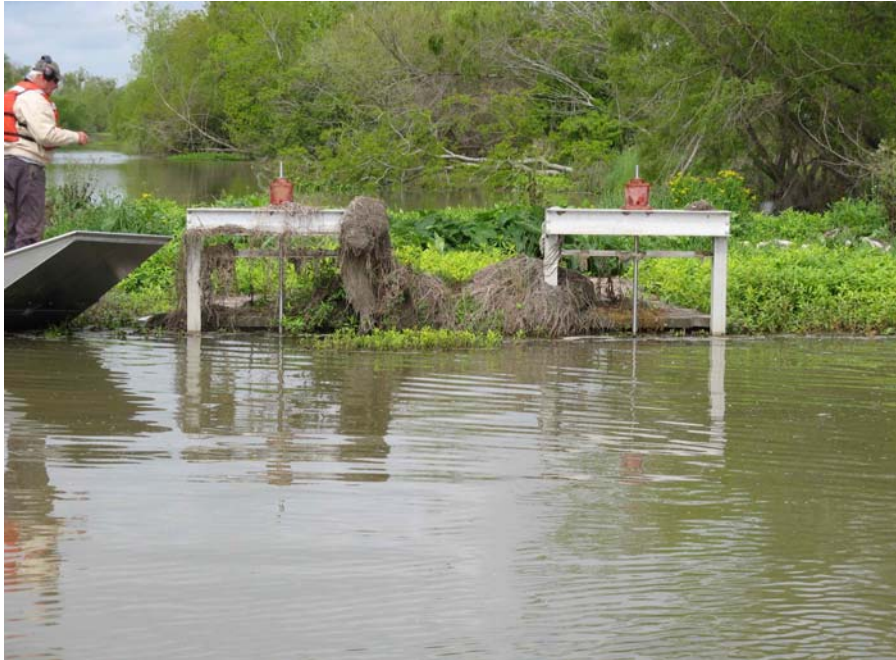
- B. Site/Structure # 25** –The structure remains covered with marsh debris from the storm. The gates were padlocked closed at the time of the inspection. It was not evident how much (if any) blockage remains due to storm debris.

Photo # 3 Site 25 The structure remains covered with storm debris. Both of the gates remained closed to reduce flow to the Braithwaite area where the USACE is constructing an emergency levee contract.

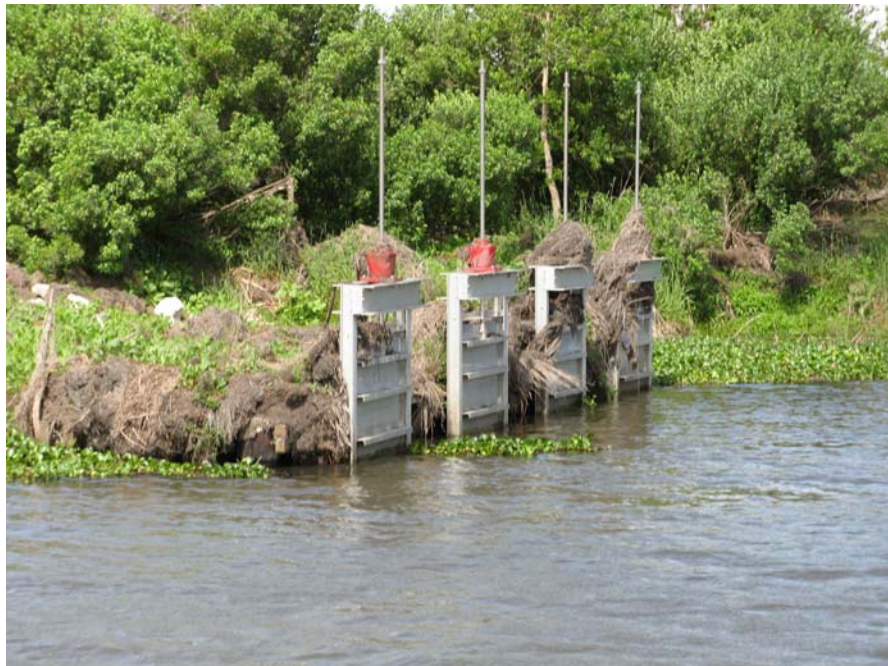
- C. Site/Structure # 26** – The structure is still covered with storm debris. The gates were in the open position at the time of the inspection. Water flow was not visible, possibly due to a lack of sufficient differential head, therefore it was not evident how much (if any) blockage remains due to storm debris.

Photo #4 Site 26 The structure remains covered with storm debris. The extent of blockage of the culverts by storm debris is unknown. The flowmeter and all attachments were destroyed by the storm.

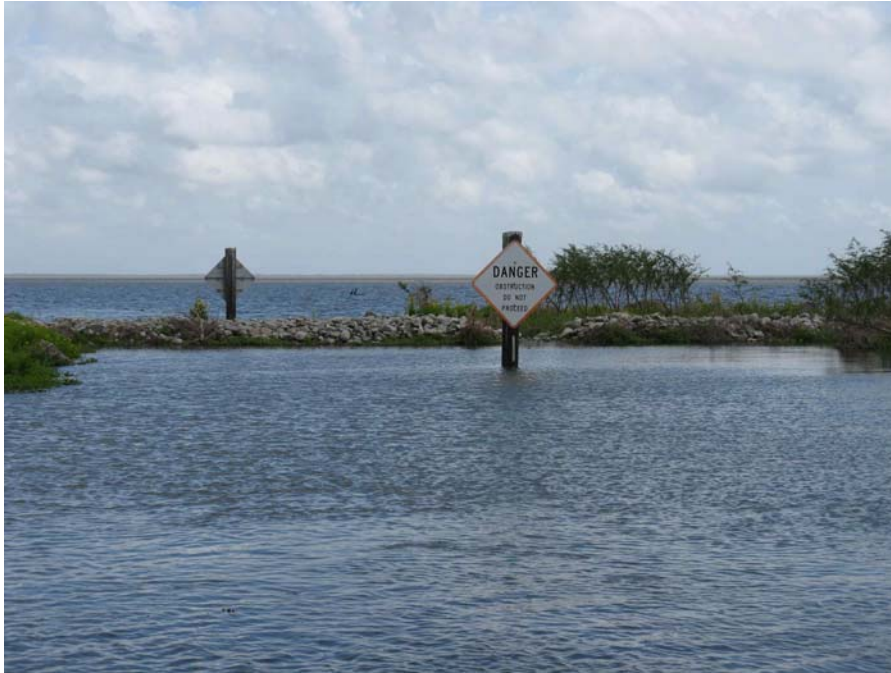
- D. Site/Structure # 32** –Overall condition was good with the exception of the area that was vandalized in early 2003. That area was partially repaired by the 2003 inspection team; however, that repair was again vandalized to the original depth. The condition of the closure appears not to have changed, most of the storm debris is gone. This structure was constructed to keep diversion water from entering Lake Leary from the western lake rim; the storm devastated that portion of the lake rim rendering this structure ineffective. Nothing needs to be done until the Lake Lery shoreline is rebuilt.

Photo # 5 Site 32 (view 1) This structure was opened to the waterline by vandals and was partially repaired by the 2003 inspection team. It was then vandalized again. Lake Leary is in background.

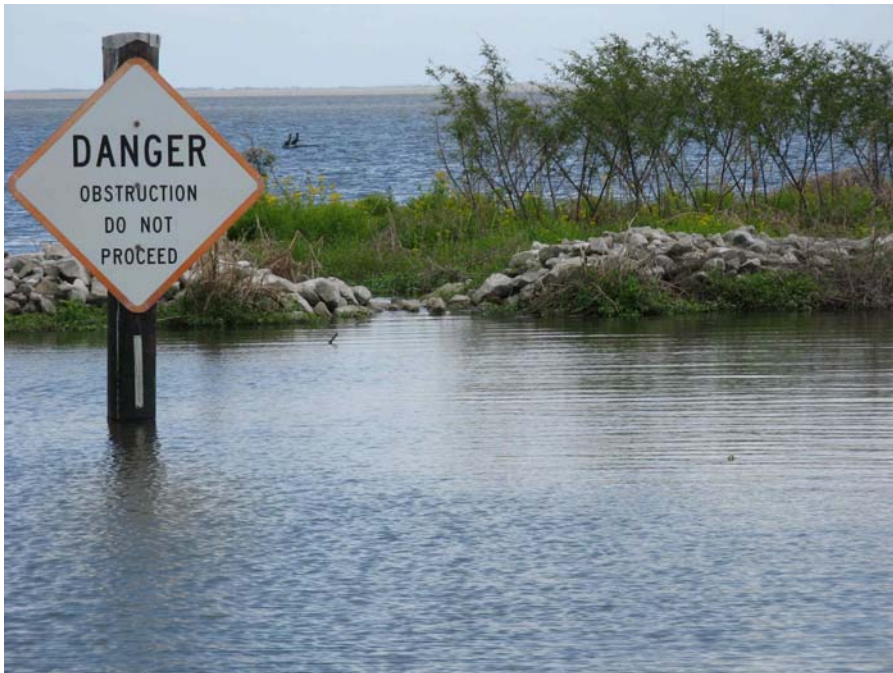
Photo # 6 Site 32 (view 2) Close up view of the vandalized area. Approximately 30% of the west lake rim was destroyed by the storms.

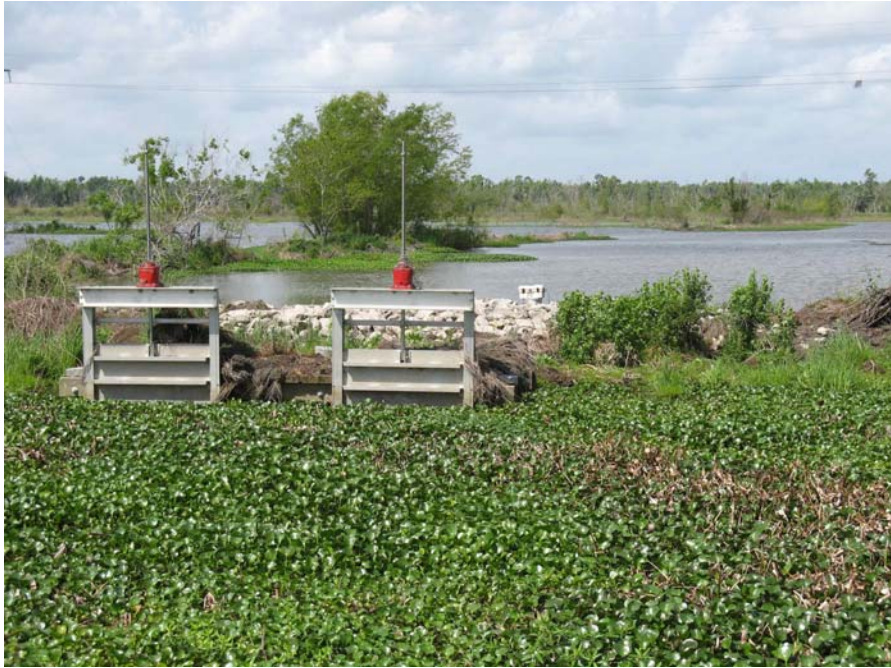
- E. Site/ Structure # 40** – The structure is still covered with storm debris. The gates were in the open position at the time of the inspection. Water flow was not visible, possibly due to a lack of sufficient differential head and water hyacinths on the surface, therefore it was not evident how much blockage remains due to storm debris.

Photo # 7 Site 40 The structure remains covered with storm debris. The extent of blockage of the culverts by storm debris is unknown. The flowmeter was damaged but recovered. Note the high water stages from the structure westward to the Plaquemines east bank hurricane levee in the background.

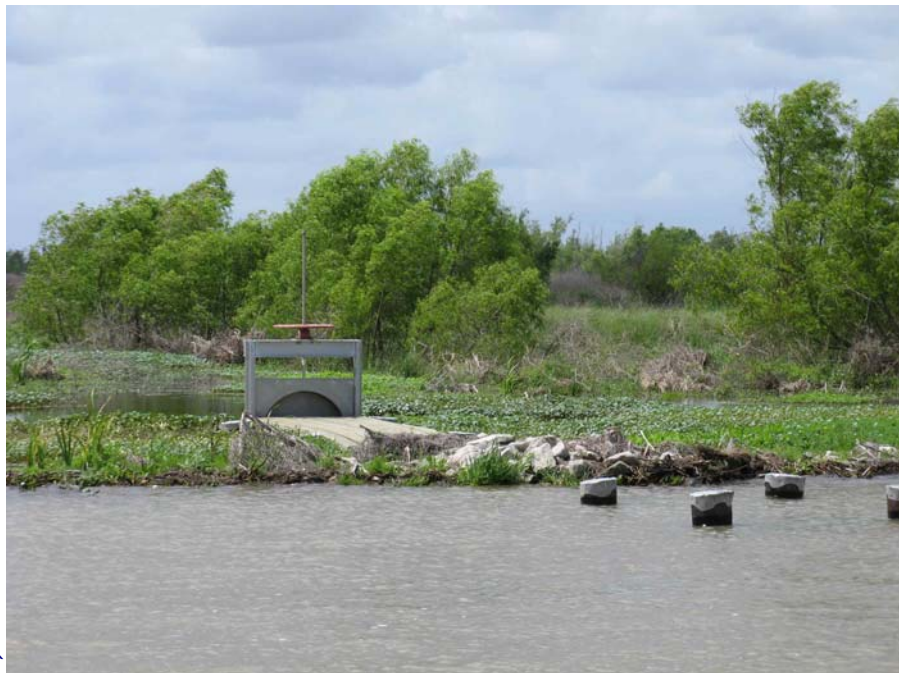
- F. Site/Structure # 50** – The gate was in the open position at the time of the inspection. Water flow was not visible, therefore it was not evident how much (if any) blockage remains due to storm debris. The timber walkway is slightly bowed.

Photo # 8 Site 50 The extent of blockage of the culverts by storm debris is unknown. Slight erosion was evident on both sides of the rock plug where it ties into the earthen embankment. High flows such as this, allow water to flow around the structures to flood the marsh.

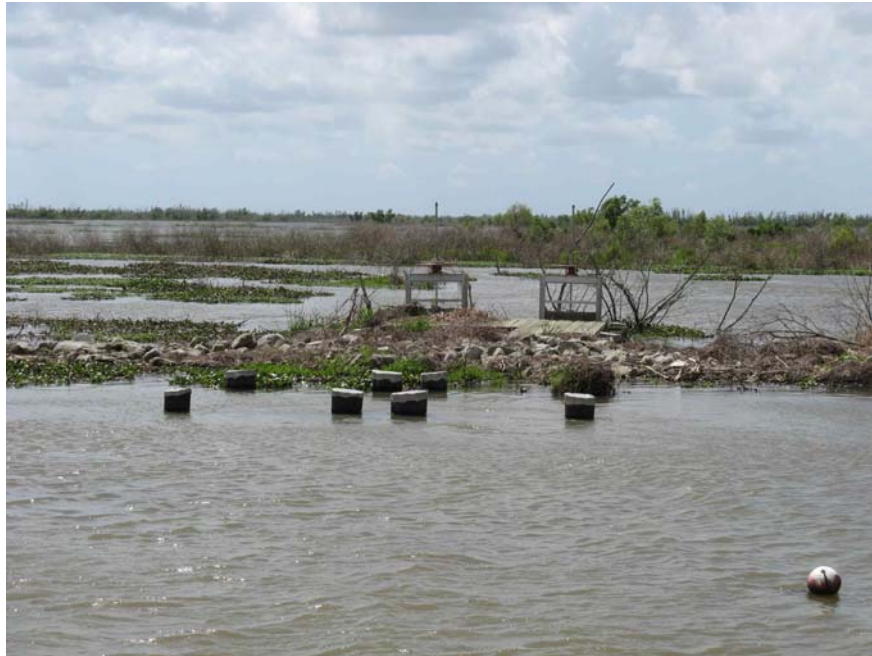
- G. Site/Structure #52** – The gates were in the open position at the time of the inspection. There appeared to be a vortex on the water surface near the inlet of the right hand culvert indicating some water flow. It was not evident how much blockage remains due to storm debris in the culverts. There was a breach of the spoil bank to the right and left of the plug allowing flow from the canal to the marsh.

Photo # 9 Site 52 (view 1) Some storm debris remains. The extent of blockage of the culverts by storm debris is unknown. Slight erosion was evident on both sides of the rock plug where it ties into the earthen embankment.

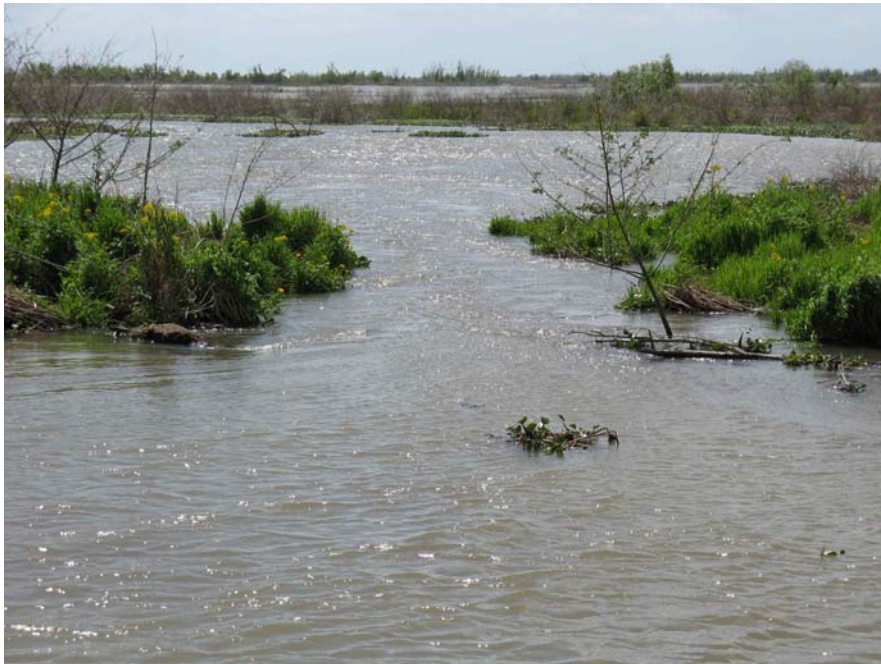
Photo # 10 Site 52 (view 2) This breach in the earthen embankment is approximately 100 yards to the west of the rock plug. Many of these breaches are evident throughout the outfall area allowing free flowage from the conveyance channels into the interior marshes.

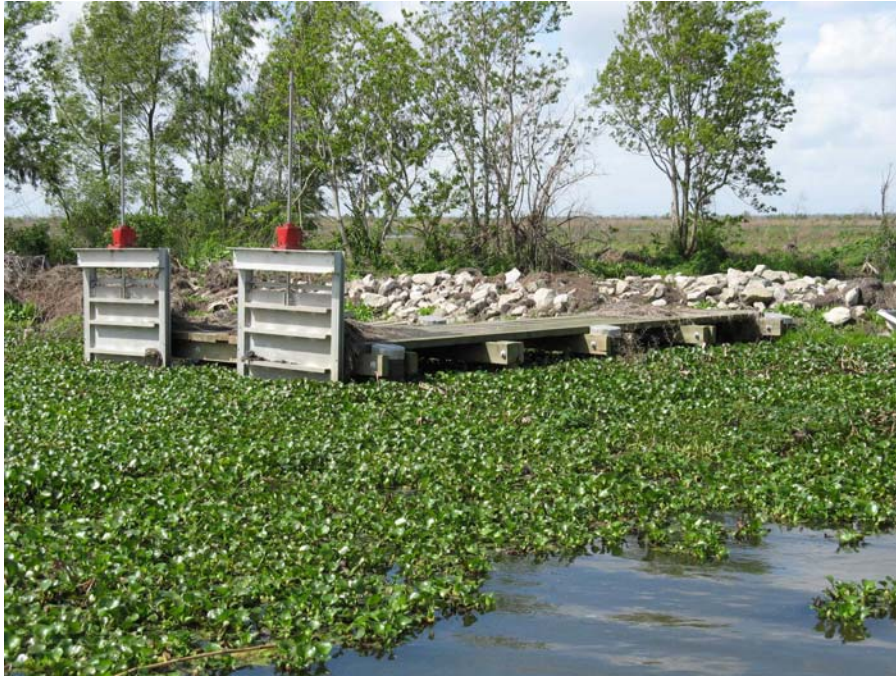
- H. Site/Structure # 54** – The structure still has some storm debris. The gates were in the open position at the time of the inspection. Water flow was not visible, due to a lack of sufficient differential head therefore it was not evident how much blockage remains due to storm debris.

Photo # 11 Site 54 Some storm debris remains. The extent of blockage of the culverts by storm debris is unknown. The flowmeter and all attachments on this structure were destroyed by the storm.

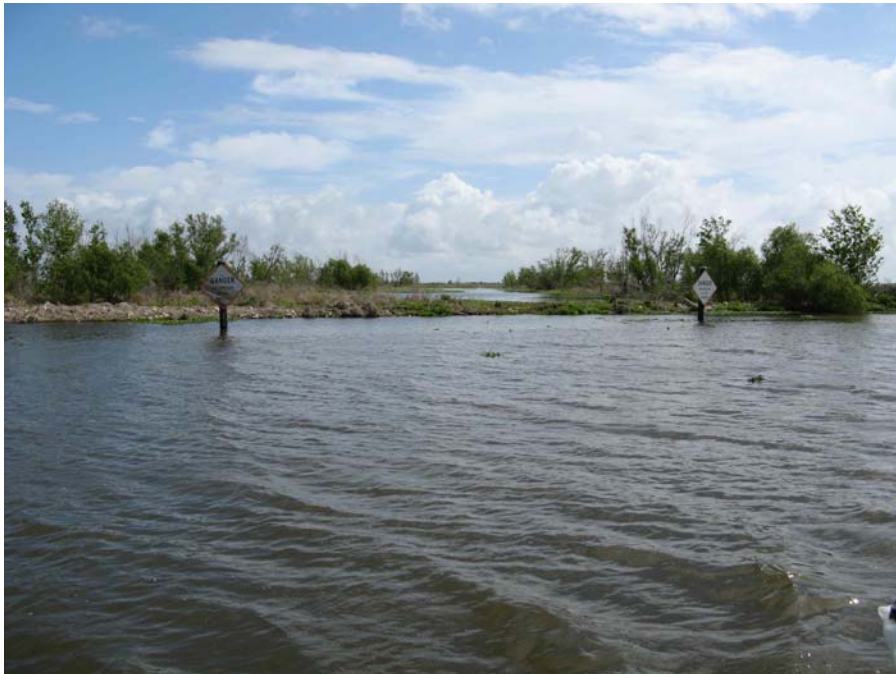
- I. Site/ Structure # 56** - No subsidence was noted in this rock structure since the 2005 inspection. Some storm debris remains on the entire rock closure. The warning signs that were damaged during the storm have been reset.

Photo #12 Site 56 The overall condition of the rock closure appears to be good. No appreciable subsidence has occurred since the post-storm inspection. Note the greater subsidence occurred at the center of the closure.

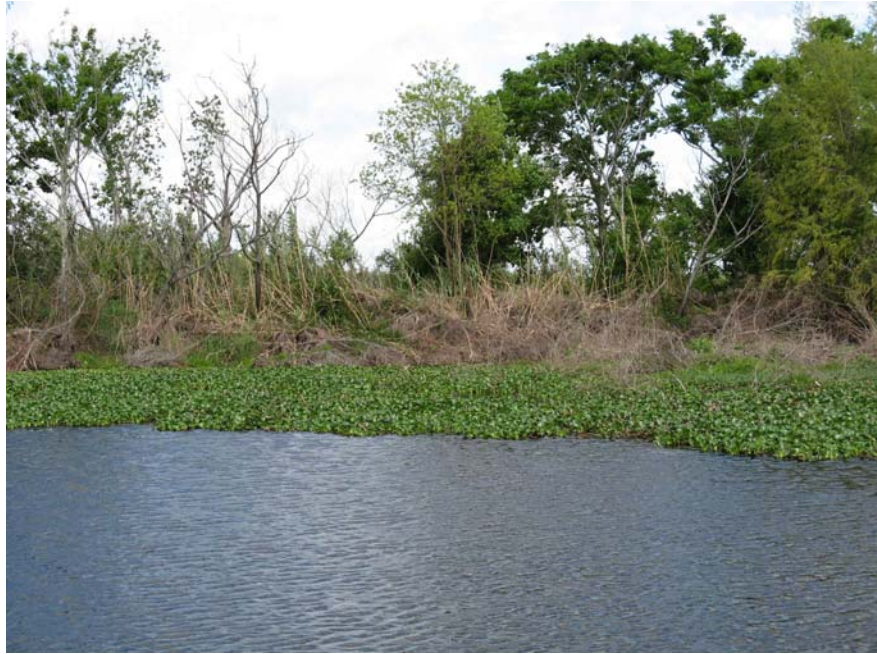
Photo # 13 Site 57 (view 1) Reggio Canal spoil bank. Storm damage is still visible, but vegetation is recovering slowly.

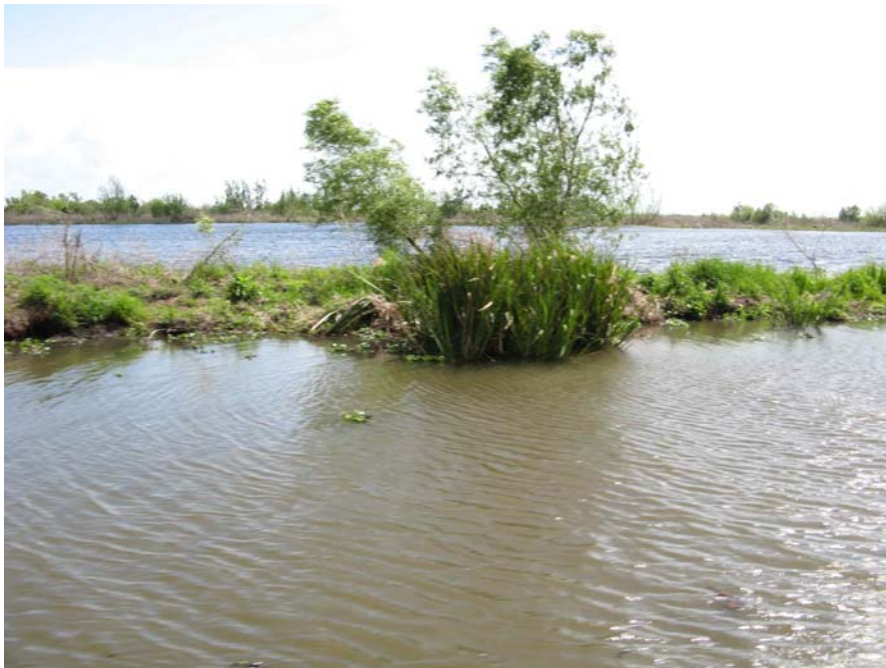
Photo # 14 Site 57 (view 2) Reggio Canal spoil bank. More recovering vegetation. Water levels in the marsh and the conveyance channel remains equal due to amount of damage to the spoil banks.

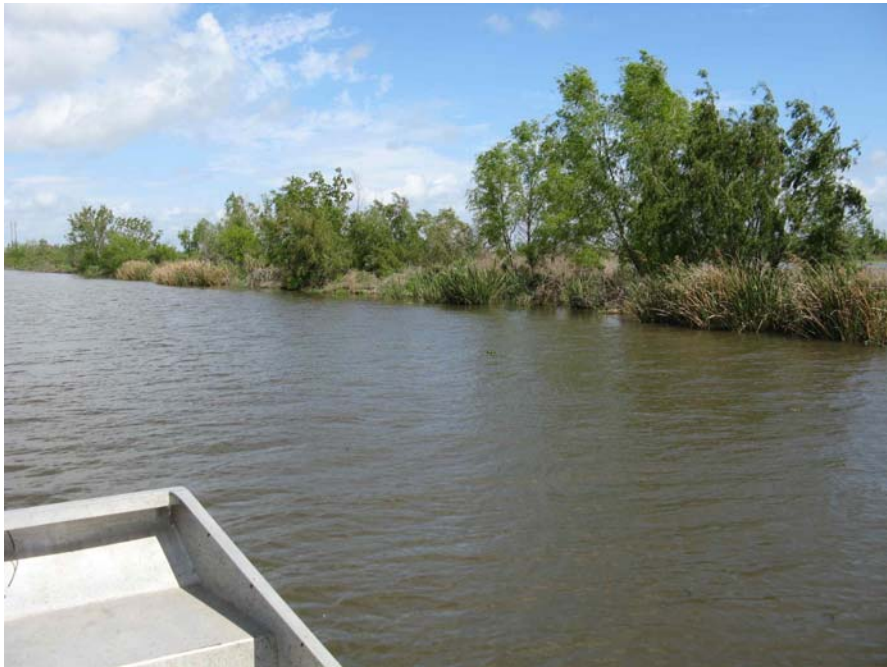
Photo # 15 Site 57(view 3) Reggio Canal spoil bank. More recovering vegetation. Note the gaps on the spoil bank caused by the storms.

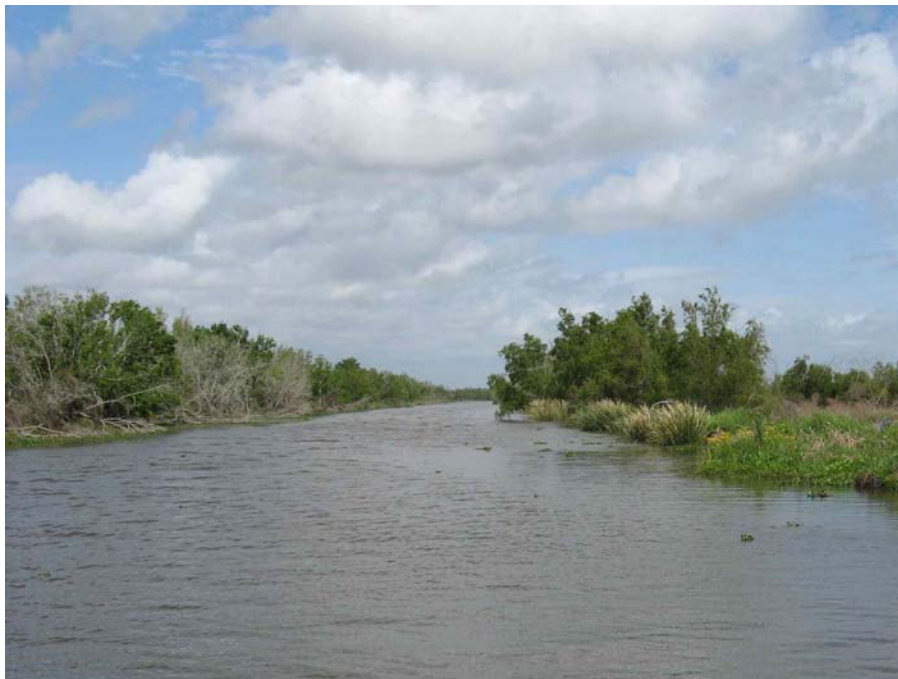
Photo # 16 Site 57 (view 4) Reggio Canal spoil bank. More recovering vegetation.

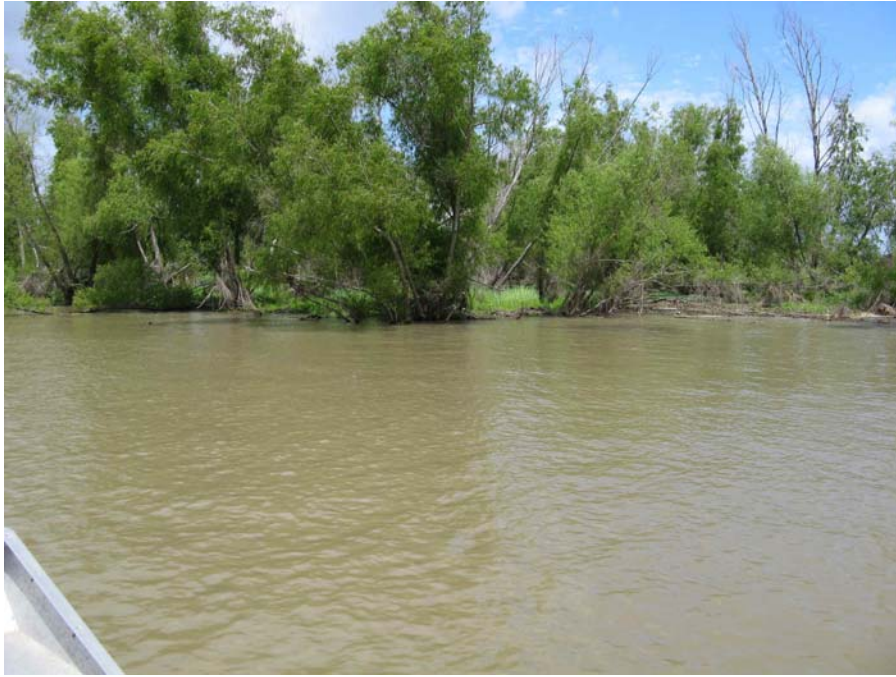
Photo # 17 Site 58 (view 1) Bayou Mandeville spoil bank. Many damaged trees along the bank line are being removed by the landowner.

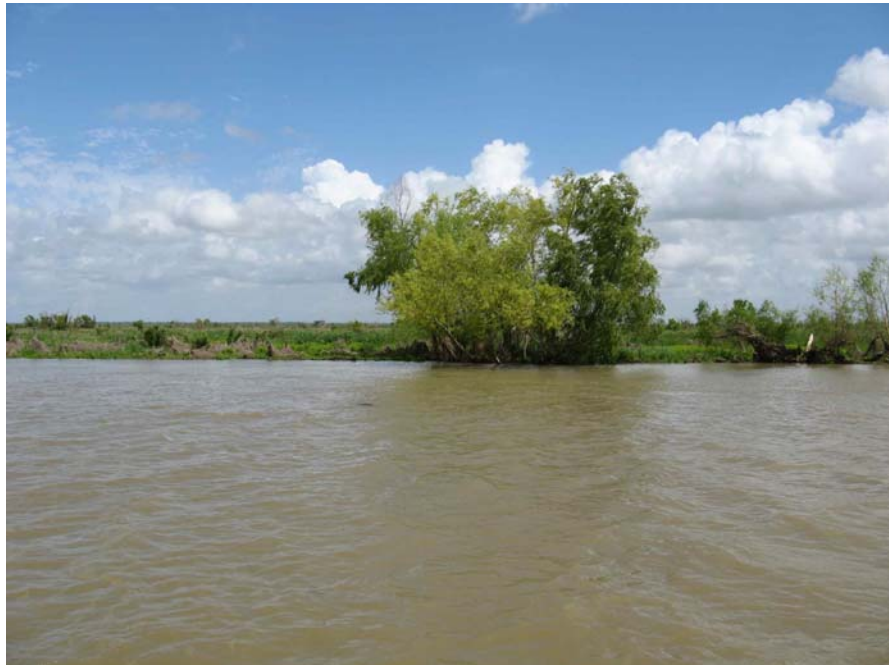
Photo # 18 Site 58 (view 2) Bayou Mandeville spoil bank. Most of the interior marsh along this channel is flooded with river water from the diversion. Notice the amount of sediment that is visible in this area just north of Lake Leary.

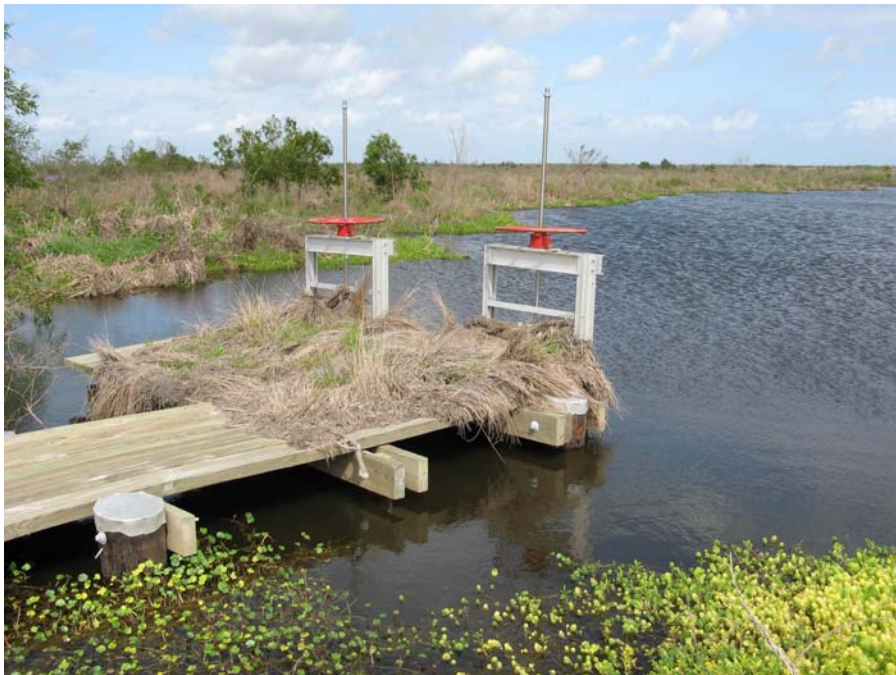
Photo # 20 Site 60 Storm debris remains on the structure. The extent of blockage of the culverts due to storm debris is unknown. Some flow was visible through the culverts.
