**State of Louisiana
Department of Natural Resources
Coastal Engineering Division**

**2006/2007 Annual Inspection
Report**

**BOSTON CANAL/VERMILION
BAY SHORE RESTORATION
PROJECT
(TV-09)**

May 1, 2007
Vermilion Parish

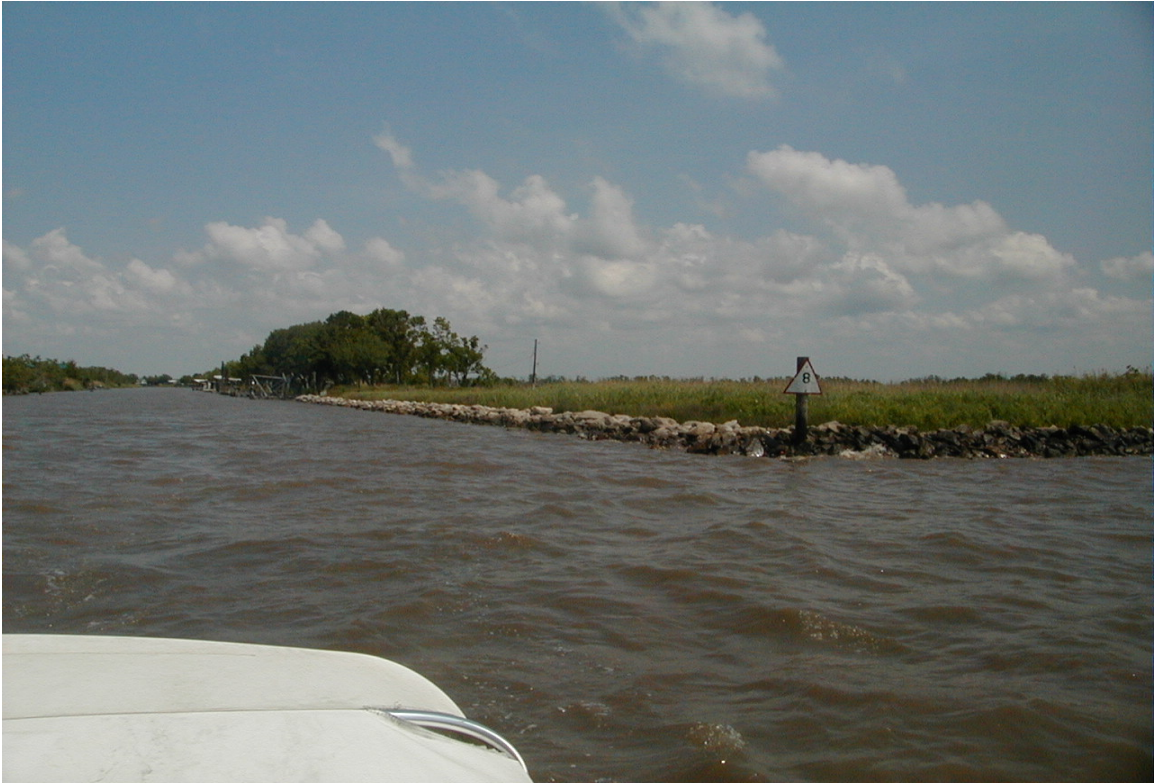
For the most part, the breakwaters are in excellent post construction condition. There is no apparent toe scour or rock displacement. The western end of the dike where it ties into the Vermilion Bay shoreline has not significantly worsened. A small gap left during original

Photo 1—east side of Boston Canal

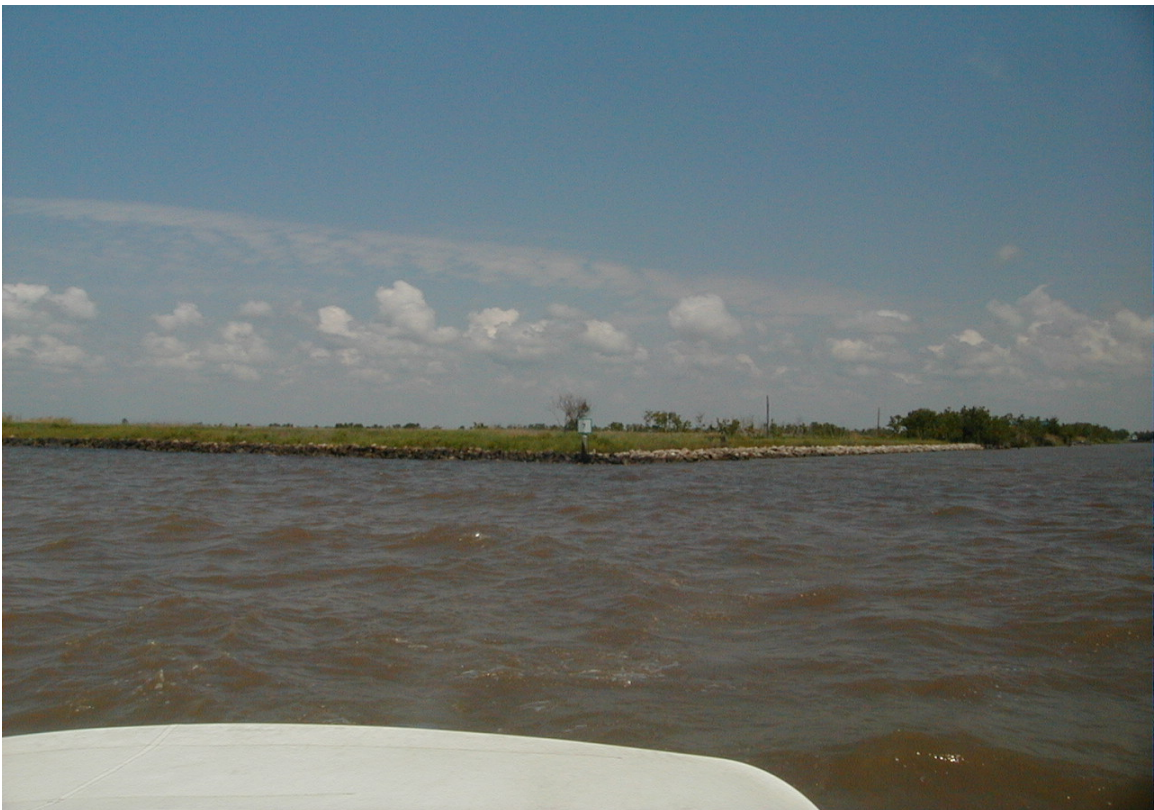
Photo 2—west side of Boston Canal

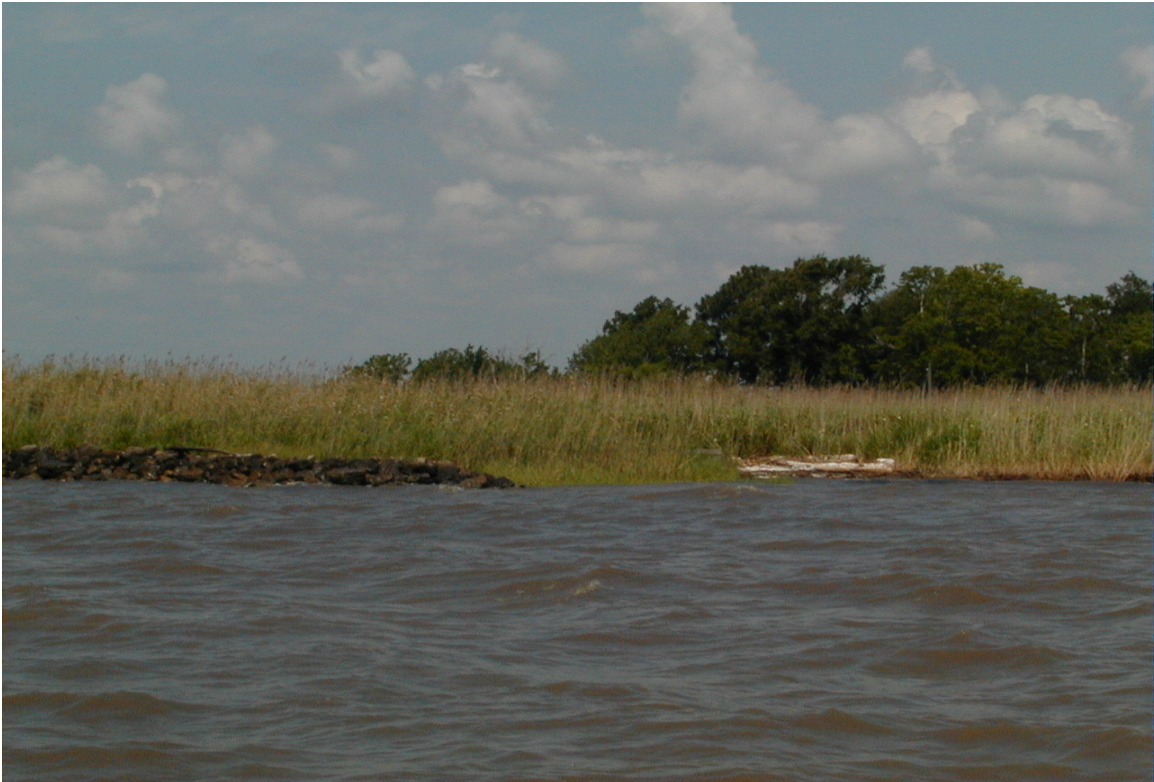
construction appears to have caused this problem. While the situation is similar on the SE tie-in, it is not as severe. No gap was left on this end during construction. Recommendations made to repair these gaps during the O & M inspection of June 2003 have been reconsidered due to costs and logistics associated with such repairs. These areas have been and will continue to be closely monitored, and should the situation significantly worsen, steps will be taken to close/stabilize these areas. Signage and associated pilings are stable and functioning. (Photos: Appendix B, Photos 1 - 4)

Photo 3—south east tie-in of rock dike

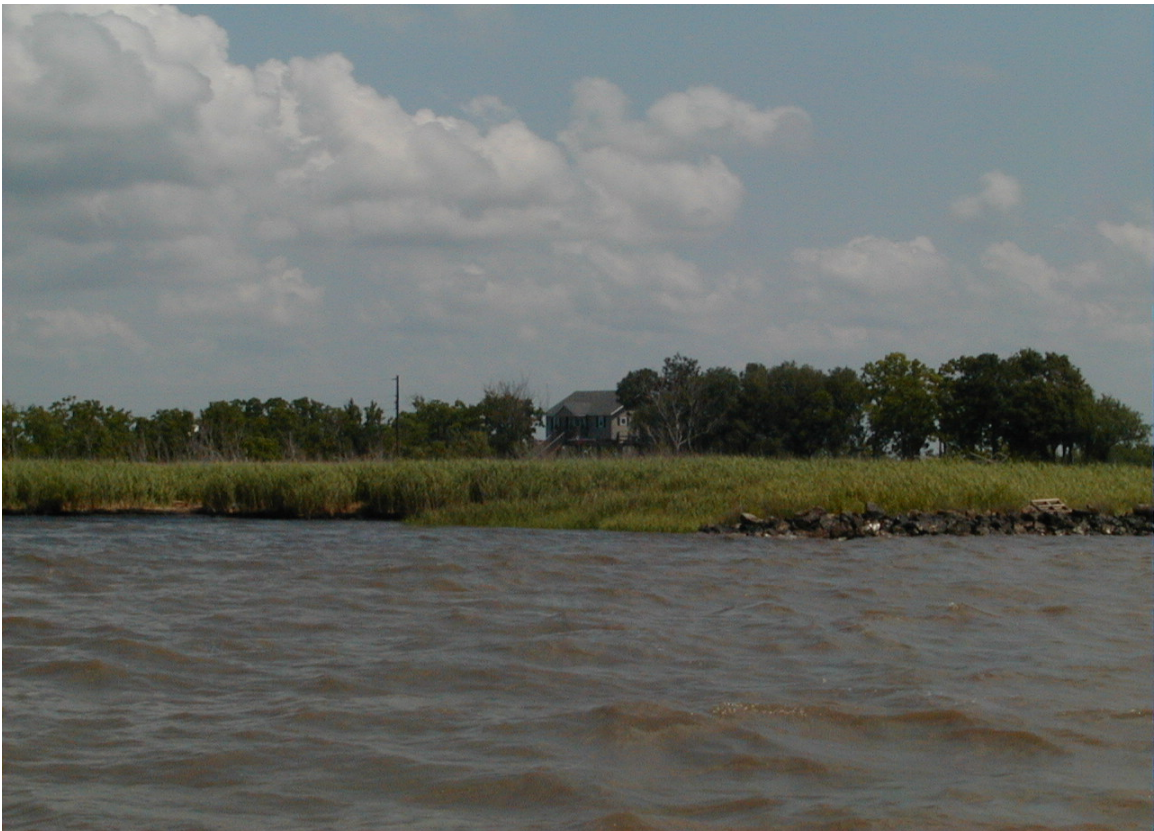
Photo 4—south west tie-in of rock dike
