**State of Louisiana
Department of Natural Resources
Coastal Engineering Division**

**2006/2007 Annual Inspection
Report**

**LAKE PORTAGE LAND
BRIDGE PROJECT
(TV-17)**

June 19, 2007
Vermilion Parish

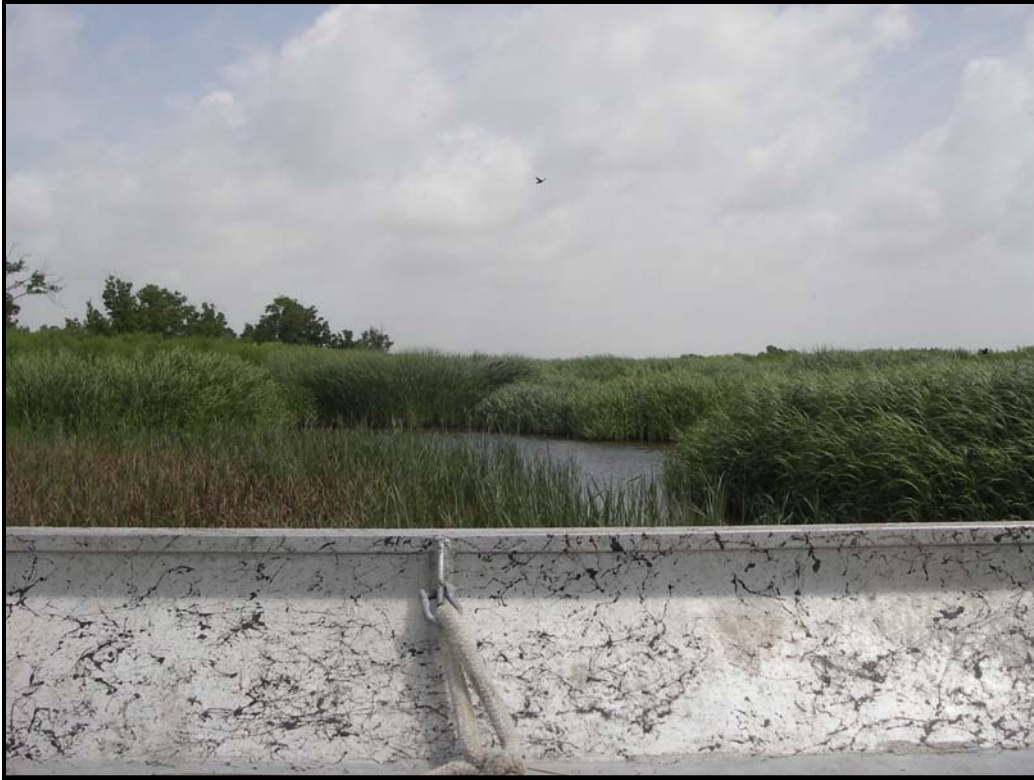
Area 1 is in good condition and vegetation has continued to expand from the containment banks moving towards the center of the channel and is approximately 90-95 per cent vegetated. The center part of the filled in channel was wet, passable only by airboat. Salinity was measured at 4 ppt in Lake Portage near the bulkhead. As a result of the inspection of Area 1, LDNR and NRCS agree that no corrective actions will be required this year. (Photos: Appendix B, Photo 1).

Photo 1, Area 1, Note vegetation is 90-95 % covered. (June 19, 2007)

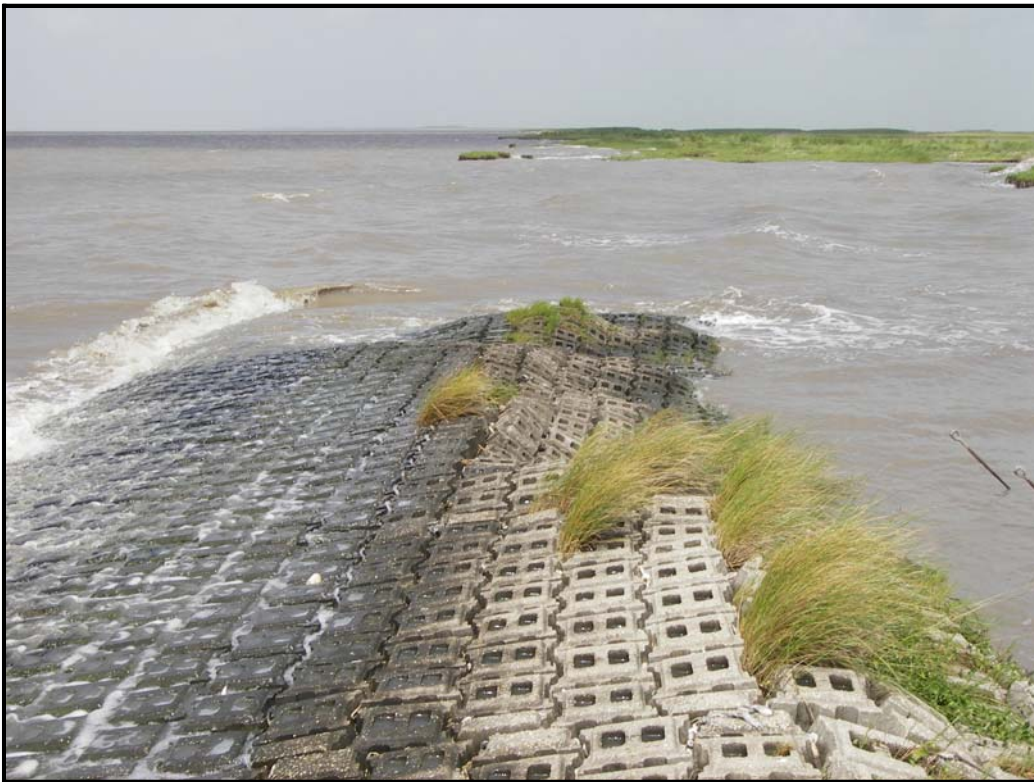
Area 2 is also in good condition and is fully vegetated, such that this reach was preexisting with additional dredge material added through this project to fill in any trevasses. Some erosion at the ends of the concrete mats along the Gulf shoreline has occurred over time and part of the mat system is showing signs of failure. Although the concrete mat system is not a feature to be maintained as part of this project, this area needs to be monitored closely on future annual inspections and if it is determined that the erosion is threatening the integrity of the overall project, then a maintenance event will be proposed. Edmond Mouton with LDWF indicated that the concrete mats were installed by the pipeline company and perhaps the repair of the mats and nearby erosion could be performed by them. LDNR and NRCS agree that no maintenance will be required at this time. (Photos: Appendix B, Photos 2, 3, & 4).

Photo 2, Area 2, West side of concrete mats. (June 19, 2007)

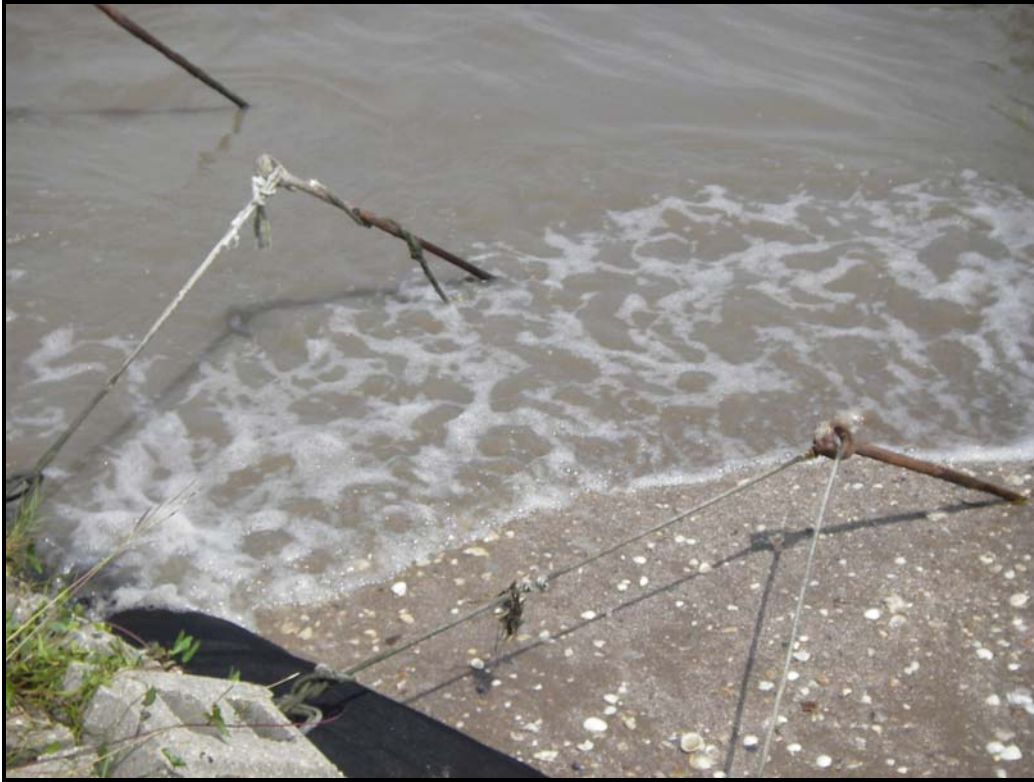
Photo 3, Area 2, Close up view of erosion on west side of concrete mats. (June 19, 2007)

Item	Condition	Physical Damage	Corrosion	Photo #	Observations and Remarks
Timber Bulkhead / Caps	Good			6	Some erosion each side of timber bulkhead north side of Area 3.
Steel Grating	N/A				
Salinity Readings					Area 1 Lake Portage - 4 ppt
Concrete Mats	Good			2,3,4	Some erosion each side of concrete mats along Gulf shoreline.
Timber Piles	Good				
Timber Wales	N/A				
Galv. Pile Caps	N/A				
Vegetation	Good			1,5	Area 3 fully vegetated, Area 2 existing vegetation, Area 1 vegetation spreading.
Signage /Supports	Good				
Rip Rap (fill)	N/A				
Earthen Embankment	Good				
Dredge Spoil	Good				Channel area wet, slight settlement.

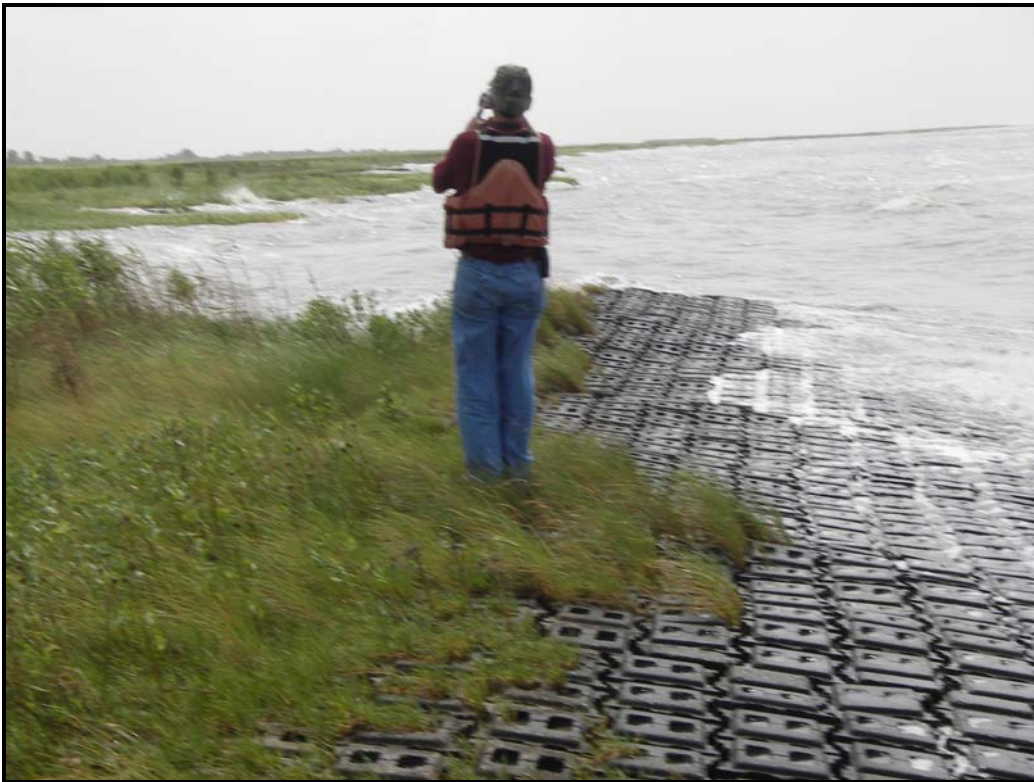
Photo 4, Area 2, East side of concrete mats. (June 19, 2007)

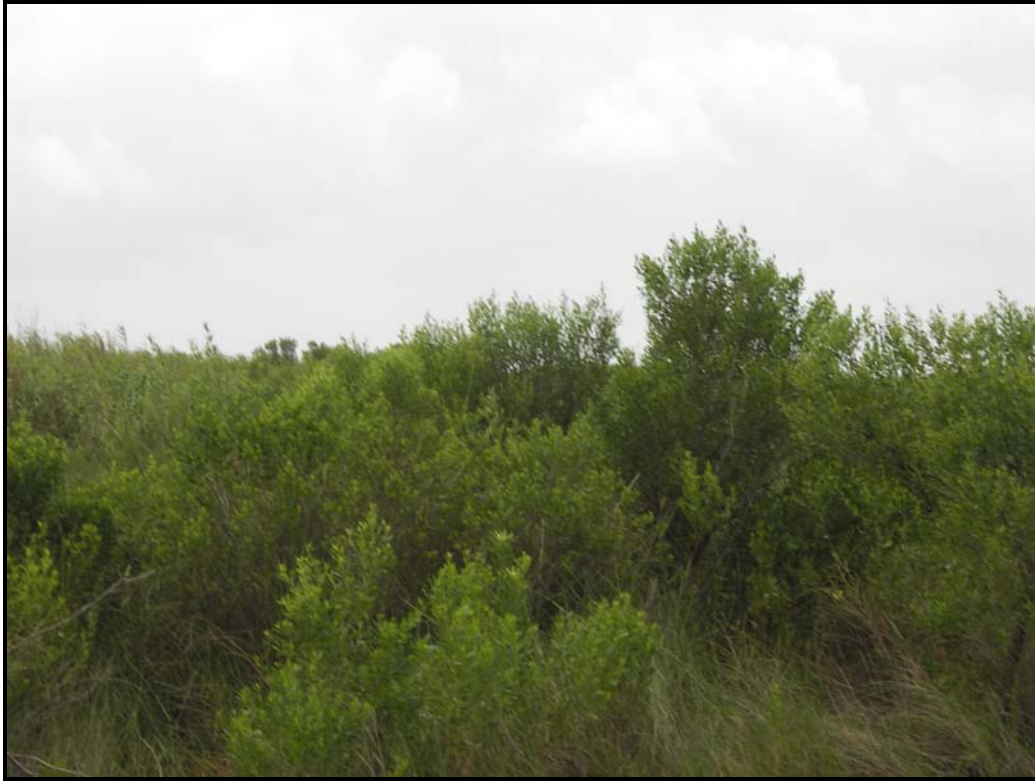
Area 3 also is in good condition. The northern part of this reach is fully vegetated, mainly due to the fact that this reach was constructed first, and has been in place since May, 2003. There is some minor erosion occurring on each side of the northern timber bulkhead which will need to be monitored on future annual inspections. LDNR and NRCS agree that this area is in good condition and no maintenance will be required at this time. (Photos: Appendix B, Photos 5 & 6).

Photo 5, Area 3, Still fully vegetated. (June 19, 2007)

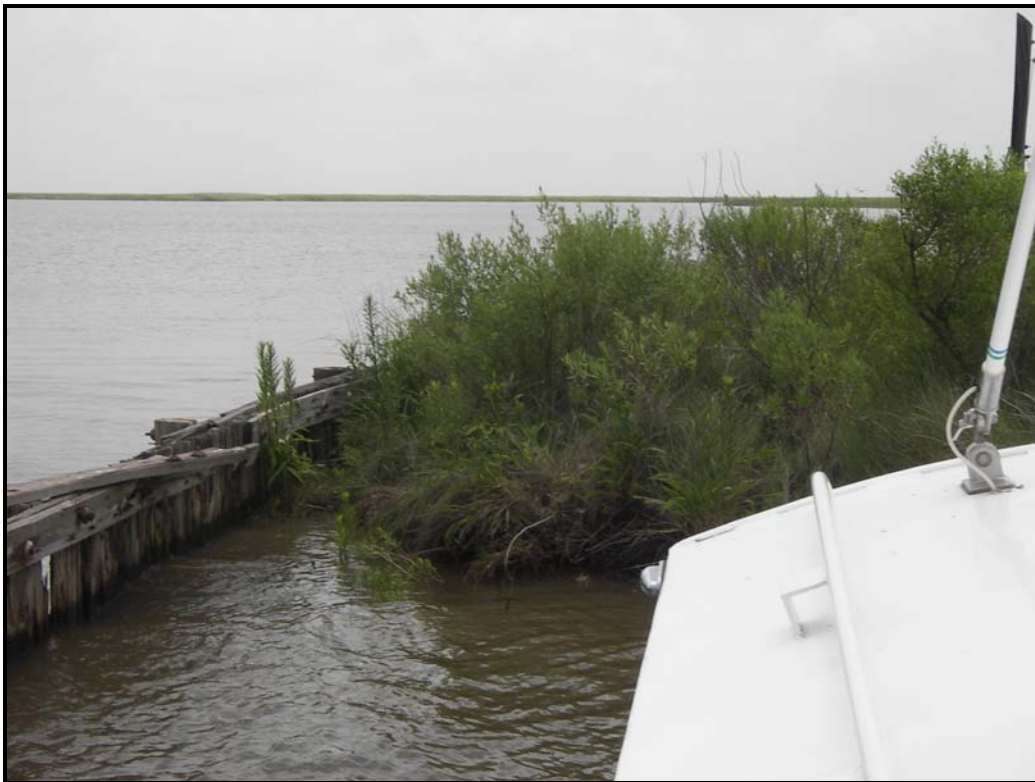
Photo 6, Area 3, Showing erosion along west side of timber bulkhead. (June 19, 20
