**State of Louisiana
Department of Natural Resources
Coastal Restoration Division and
Coastal Engineering Division**

**2007 Operations, Maintenance,
and Monitoring Report**

East Mud Lake Marsh Management

State Project Number CS-20
Priority Project List 2

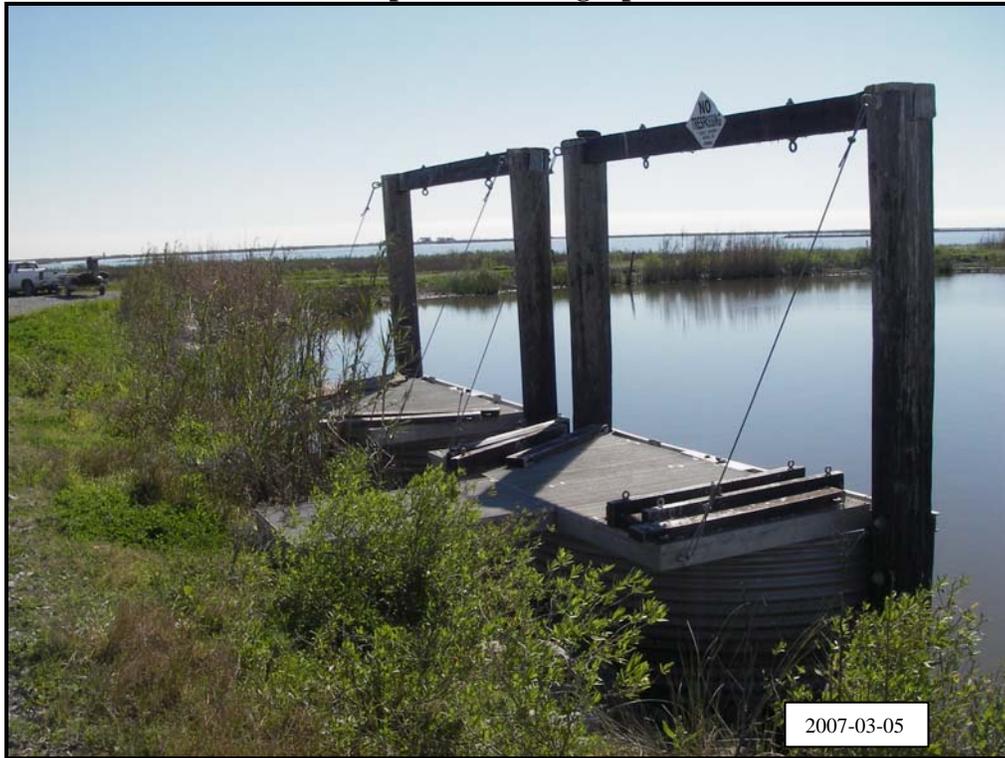
The overall condition of Structure No. 6 appears to be very good. Water level gauges weren't available near the structure. The timber piles, stop logs, grating, etc. are in good condition; however, the metal pile caps are rusting out. Rock placed around the outlet side of the structure has held up well and stabilized the shoreline. Erosion is occurring on the bank line adjacent to the inlet side of the structure. The ends of the outlet pipes are clogged with marsh and other debris. The padlocks on the stop log locking devices have rusted and cannot be operated. As a result of the inspection of Structure No. 6, LDNR and NRCS agree that approximately 114 tons of stone needs to be added on the cut bank lines adjacent to the access

Photo 1, Structure No. 6, view looking southeast.

roadway, padlocks replaced, metal pile caps replaced, and marsh debris cleaned out of ends of both outfall pipes. (Photos: Appendix A, Photos 1 & 2).

- ES-6 – add rock rip rap for bank erosion, replace padlocks and metal pile caps, clean out culverts.
- ES-7 – add rock rip rap for bank erosion, replace padlocks and metal pile caps, replace staff gages, clean out culverts.

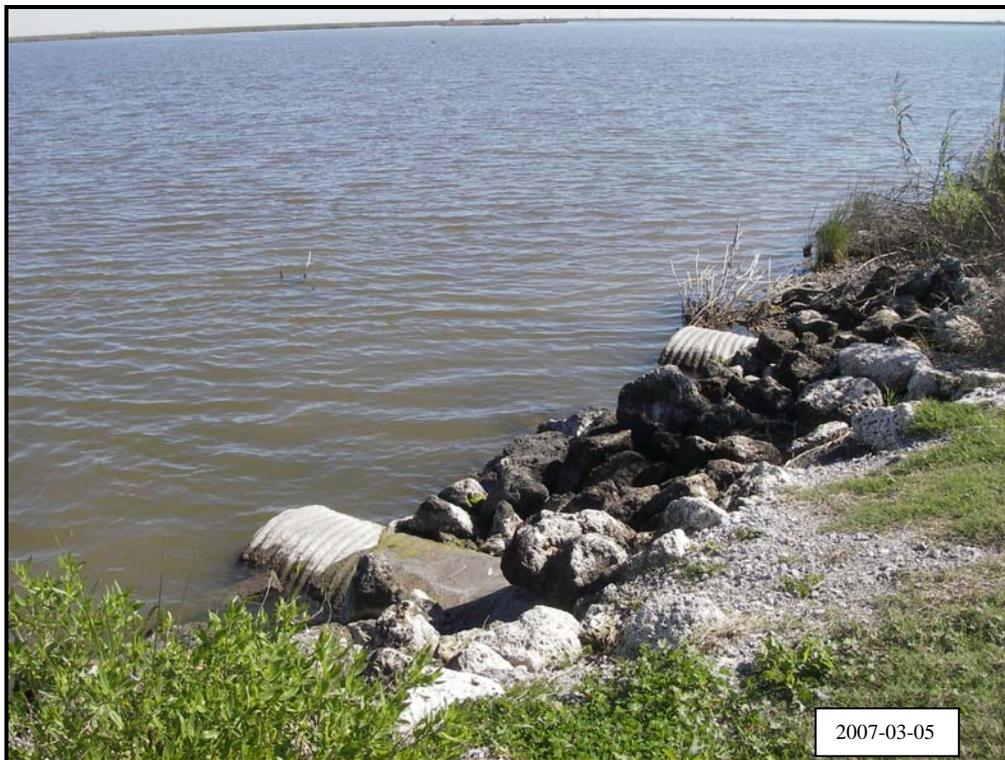
Photo 2, Structure No. 6, showing outlet pipes.

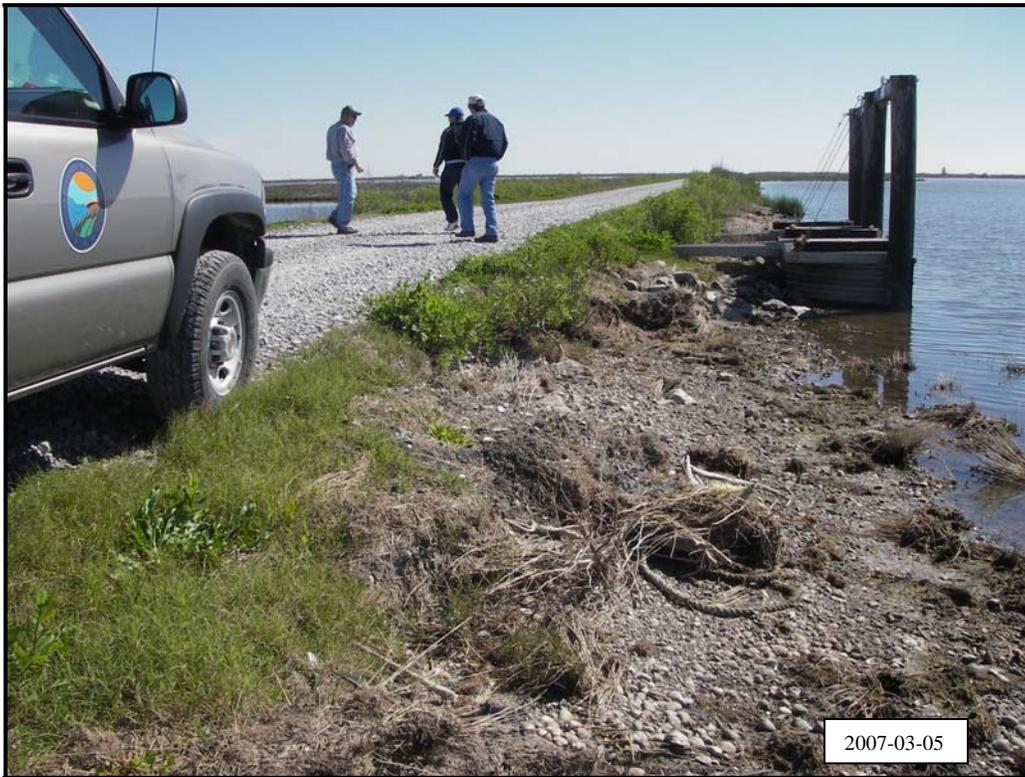
Structure No. 7 appears to be in very good condition. The water level gauge on the inside was missing and the outside gauge was not readable. Both ends of this structure are clogged with marsh debris and have silted up. Erosion is occurring on the bank line adjacent to the inlet side of the structure. The padlocks on the stop log locking devices have rusted and cannot be operated. As a result of the inspection of Structure No. 7, LDNR and NRCS agree that approximately 66 tons of stone needs to be added on the cut bank lines adjacent to the access roadway, padlocks replaced, metal pile caps replaced, staff gages on inlet and outlet side of the structure replaced, and marsh debris cleaned out of ends of both outfall pipes. (Photos: Appendix A, Photos 3 & 4).

Photo 3, Structure No. 7, view looking east and showing bank line erosion.

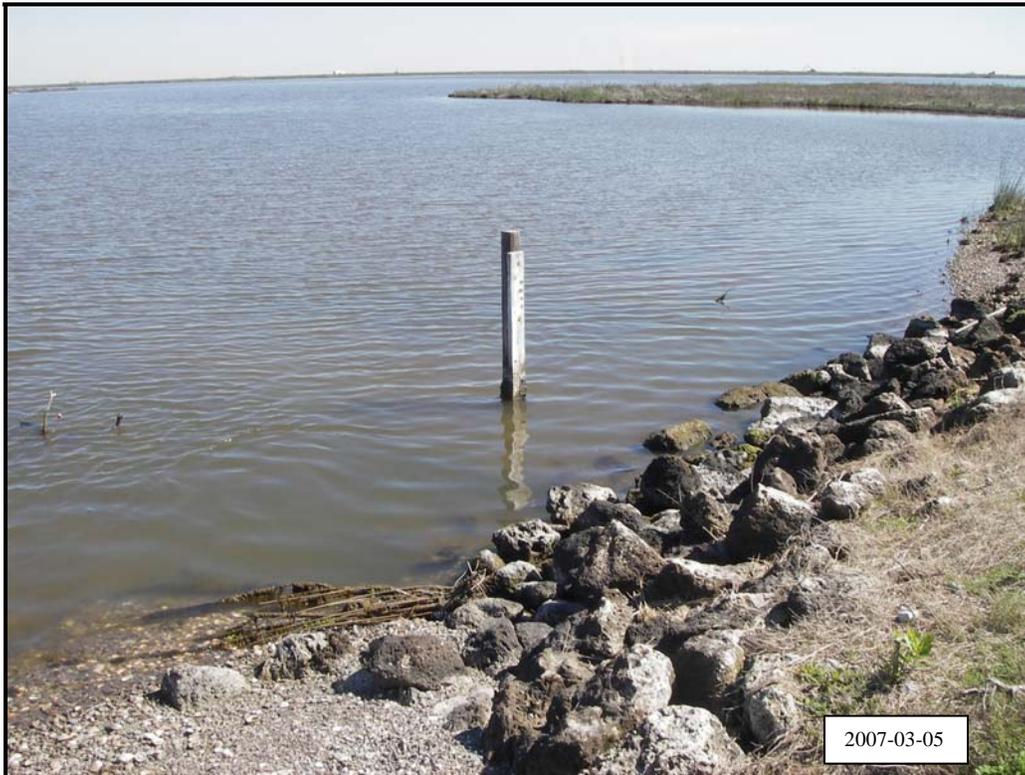
Photo 4, Structure No. 7, outlet pipe location; however, pipes not visible.

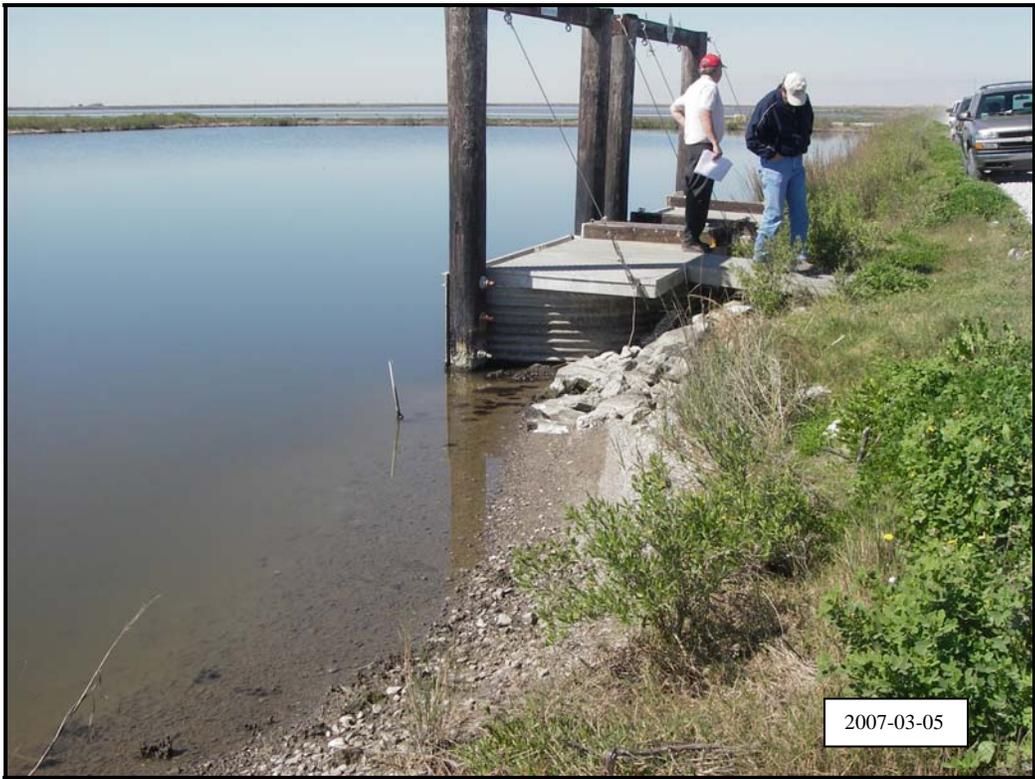
Structure No. 8 appears to be in very good condition. Water level gauges were unavailable. Both ends of this structure are clogged with marsh debris and have silted up. It appears very little flow is going through the pipes due to washover of the access road rock material into the water. Erosion is occurring on the bank line adjacent to the inlet side of the structure. The padlocks on the stop log locking devices have rusted and cannot be operated. LDNR and NRCS agree that this structure requires clean out of the ends of outlet pipes, placement of approximately 66 tons of rock along cut bank lines adjacent to the structure, replacement of padlocks, and replacement of metal pile caps. (Photos: Appendix A, Photo 5).

Photo 5, Structure No. 8, view looking southwest, showing bank line erosion.

- ES-8 – add rock rip rap for bank erosion, replace padlocks and metal pile caps.
- ES-9a – replace metal pile caps, clean out culvert, replace staff gages, replace padlocks and repair flapgate handle.

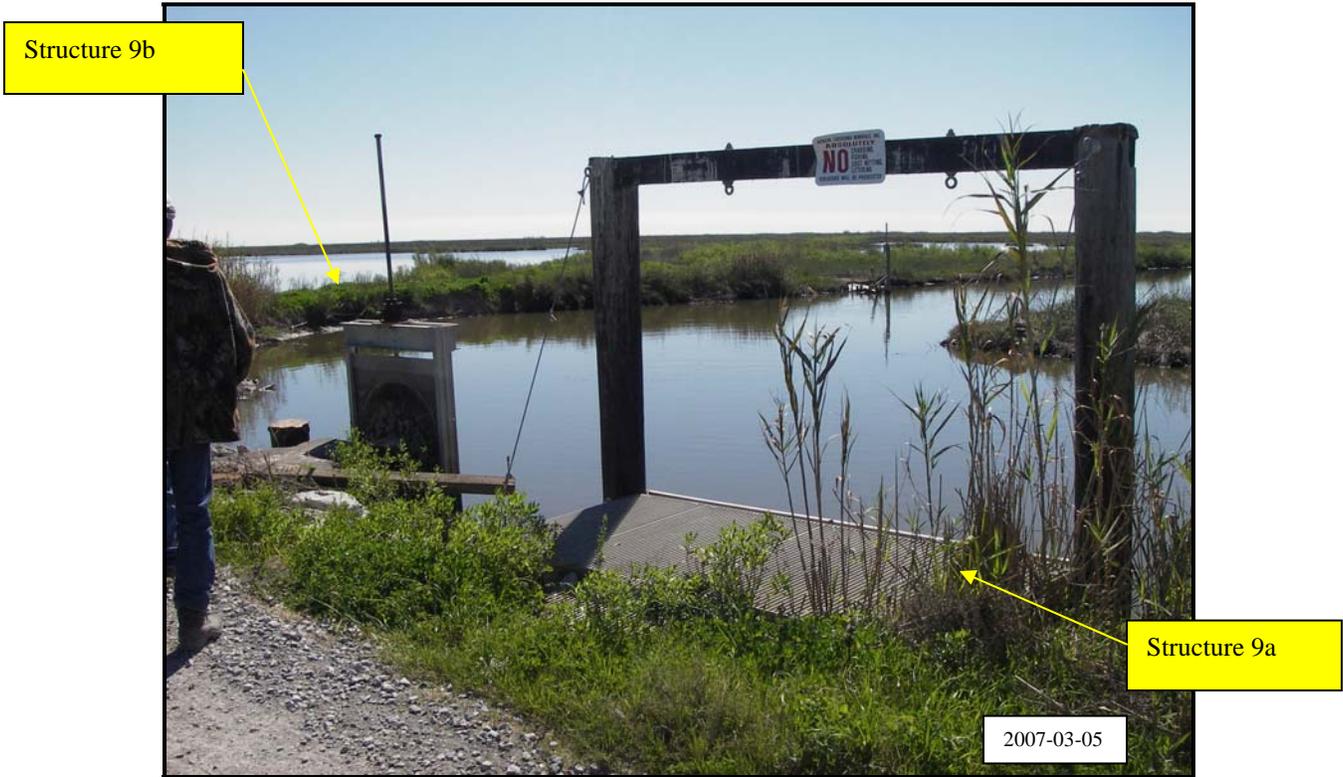
Structure No. 9a is in good condition. The staff gage on the inside was leaning and not readable and the gage on the outside was also not readable. Both ends of this structure are clogged with marsh debris and have silted up. The handle on the outlet pipe flap gate has been broken off. The metal pile caps on the pilings have rusted out. The padlocks on the stop log locking devices have rusted and cannot be operated. LDNR and NRCS agree that this structure requires replacement of the metal pile caps, clean out of the ends of outlet pipes, replacement of staff gages inside and out, replacement of padlocks, and repair of the flapgate handle. (Photos: Appendix A, Photos 6 & 7).

Structure No. 9b is in good condition. Both ends of this structure are clogged with marsh debris and have silted up. The staff gage on the inside was leaning and not readable and the outside gage was also not readable. The handle on the outlet pipe flap gate has been broken off. The gear box on the sluice gate is showing signs of rust and the stem cover is missing. Apache personnel have reported that it, so far, is not a problem; however, it will probably need to be addressed. Metal pile cap covers have rusted out. The seat flange on the flap gate

Photo 6, Structure No. 9a & 9b, view looking south.

- ES-9b – replace gear box and stem cover, replace seat flange on flap gate, clean out culvert, replace padlocks and metal pile cap covers, repair flapgate handle.

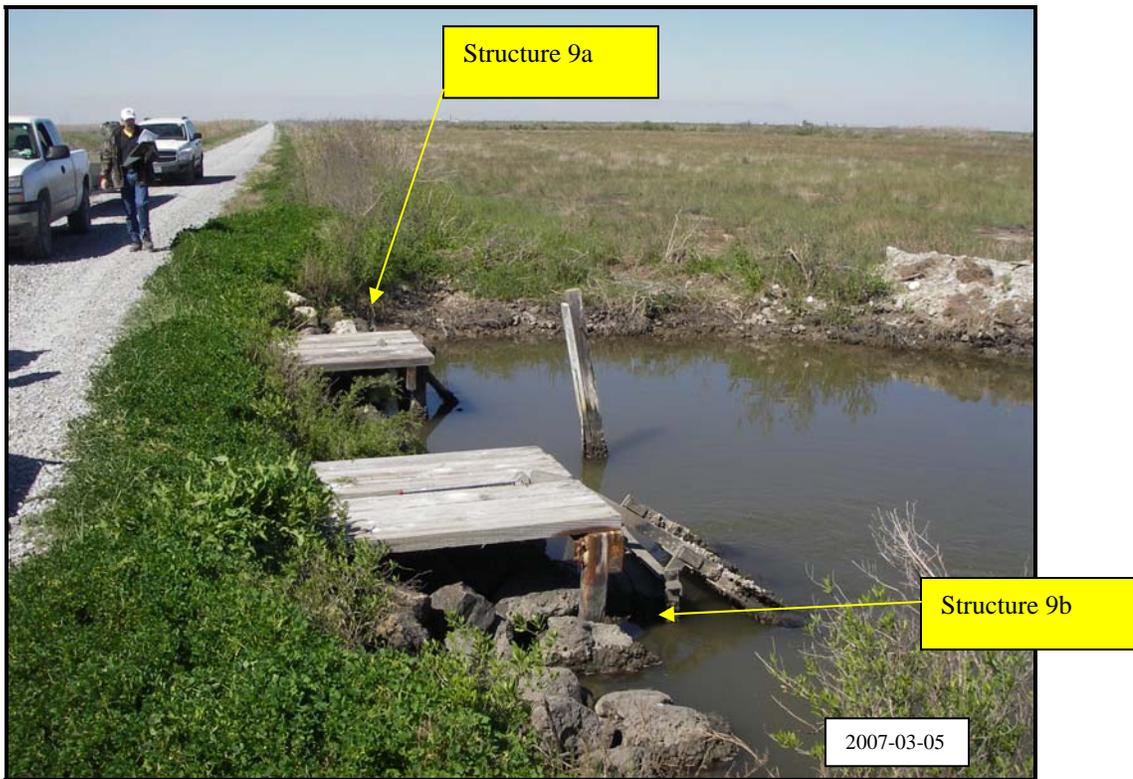
Photo 7, Structure No. 9a & 9b, showing outlet pipe flap gates.

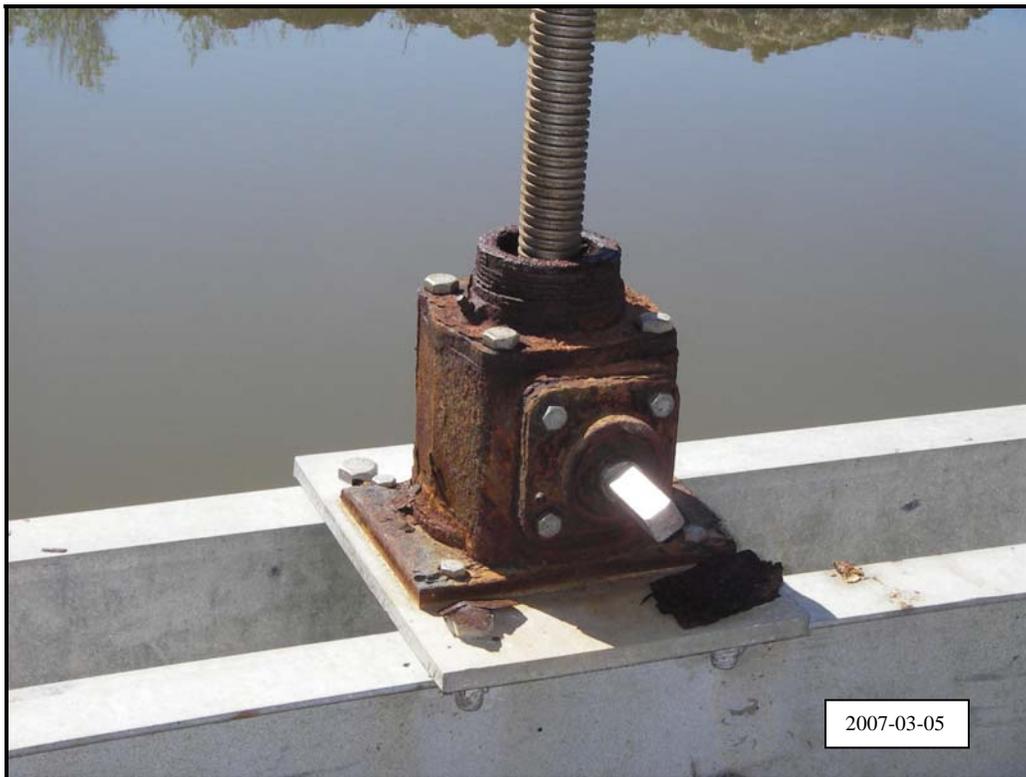
Photo 8, Structure No. 9b, showing corrosion on gear box & missing stem cover.

is broken. LDNR and NRCS agree that this structure is in operable condition and maintenance will be required to replace the gear box and stem cover, replace the seat flange on the flap gate, clean out the ends of the outlet pipes, replace padlocks, replace metal pile caps, and repair the flapgate handle. (Photos: Appendix A, Photos 6, 7, & 8).

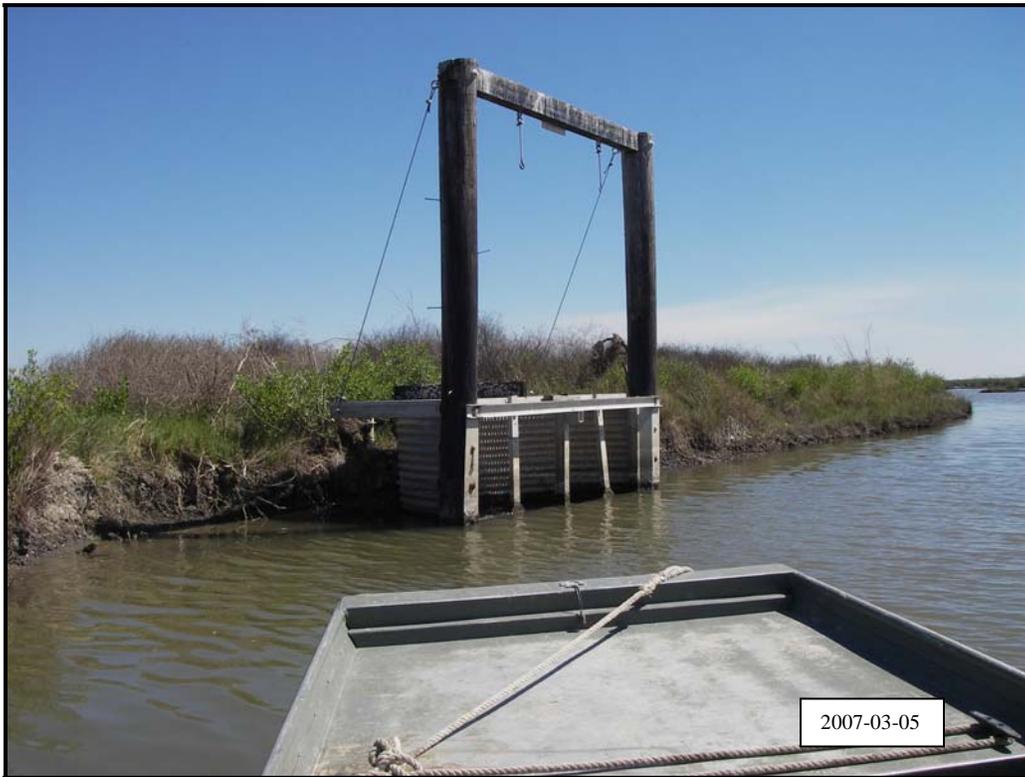
The structure is in good condition. Water level could not be determined on the outside staff gage. The staff gage on the inside of the structure is missing. There is some erosion of the bank on both the inlet and discharge sides of the structure. Approximately 228 tons of man size rip rap will be required to reinforce the bank around the structure. The bank line near the outlet flap gate has eroded and the boardwalk is not accessible. The metal pile cap covers have rusted out. The padlocks on the stop log locking devices have rusted and cannot be operated. LDNR and NRCS agree that maintenance work is required to add rip rap on both sides of the structure, extend the wooden boardwalk, replace metal pile caps, replace padlocks, and replace staff gages inside and out. (Photos: Appendix A, Photos 9 & 10).

Photo 9, Structure No. 11, view showing erosion either side of structure.

- ES-11 – add rock rip rap for bank erosion, extend boardwalk, replace metal pile cap covers and padlocks, replace staff gages.
- ES-5 – add rock rip rap for bank erosion, replace metal pile cap covers, replace padlocks, replace boardwalk, replace staff gages.

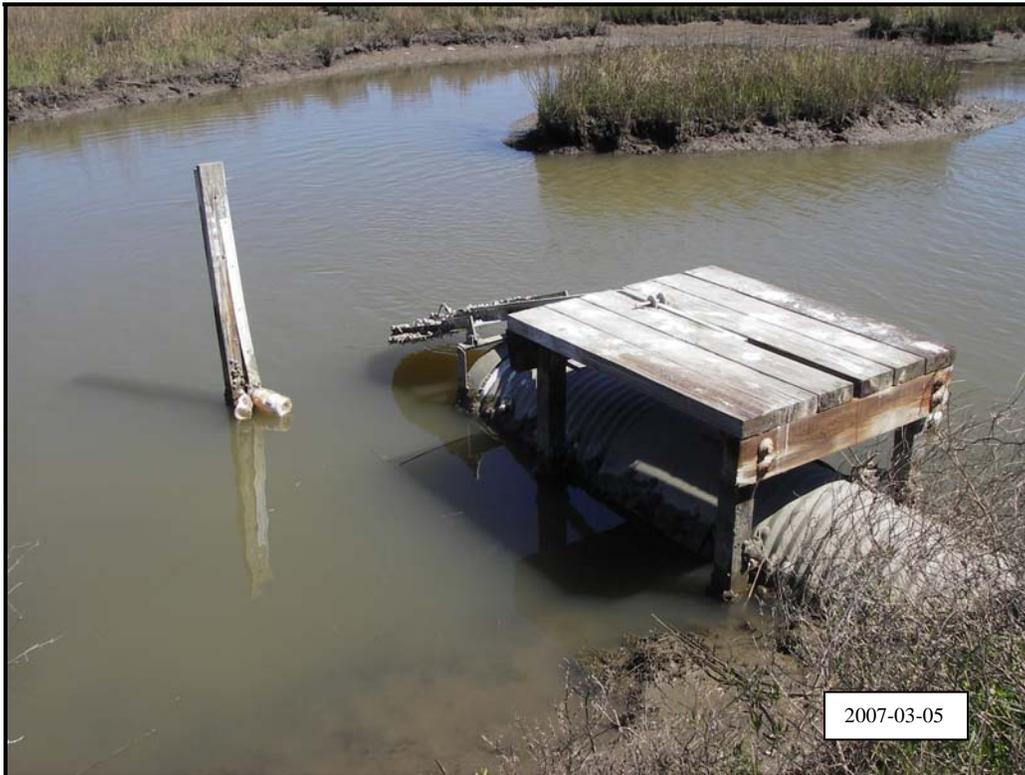
Photo 10, Structure No. 11, outlet pipe and flap gate.

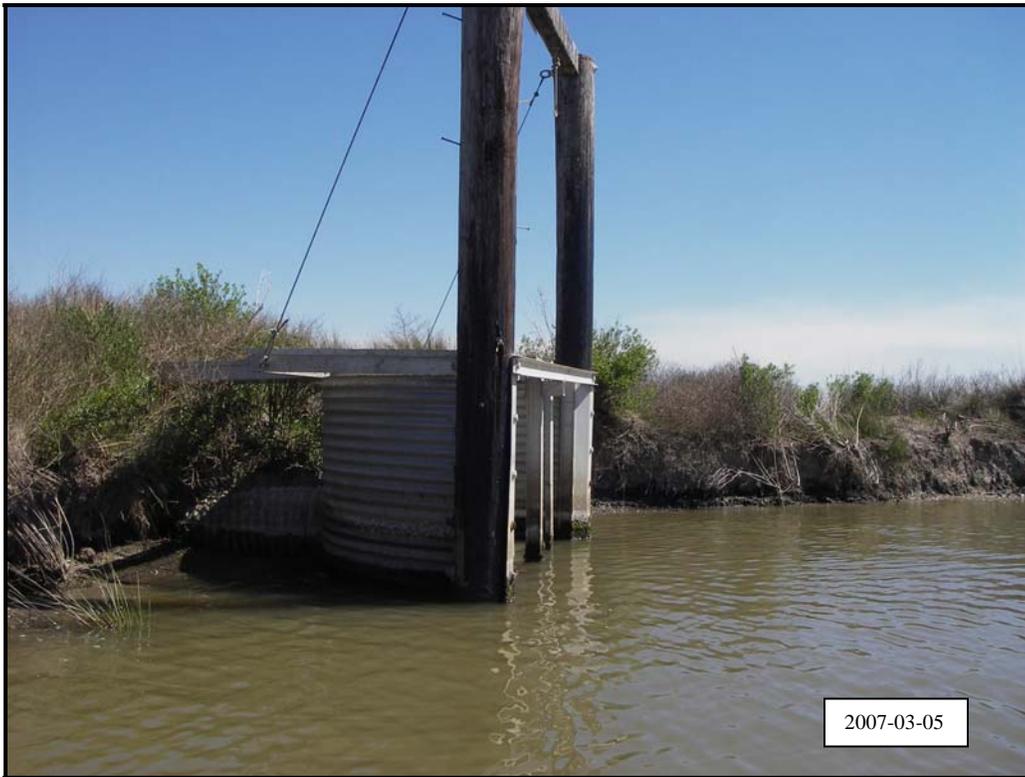
The structure itself is in good condition. Staff gauges inside and outside of the structure are damaged and not readable. Erosion was noted along the bank on both the inlet and discharge sides of the structure. Approximately 342 tons of rock will be needed to reinforce the bank around this structure. The boardwalk at the outlet pipe flap gate is missing. The metal pile cap covers have rusted out. The padlocks on the stop log locking devices have rusted and cannot be operated. LDNR and NRCS agree that maintenance work is required to add rip rap, replace metal pile caps, replace padlocks, replace the wooden boardwalk, and replace staff gages inside and out. (Photos: Appendix A, Photos 11 & 12).

Photo 11, Structure No. 5, showing erosion either side of structure.

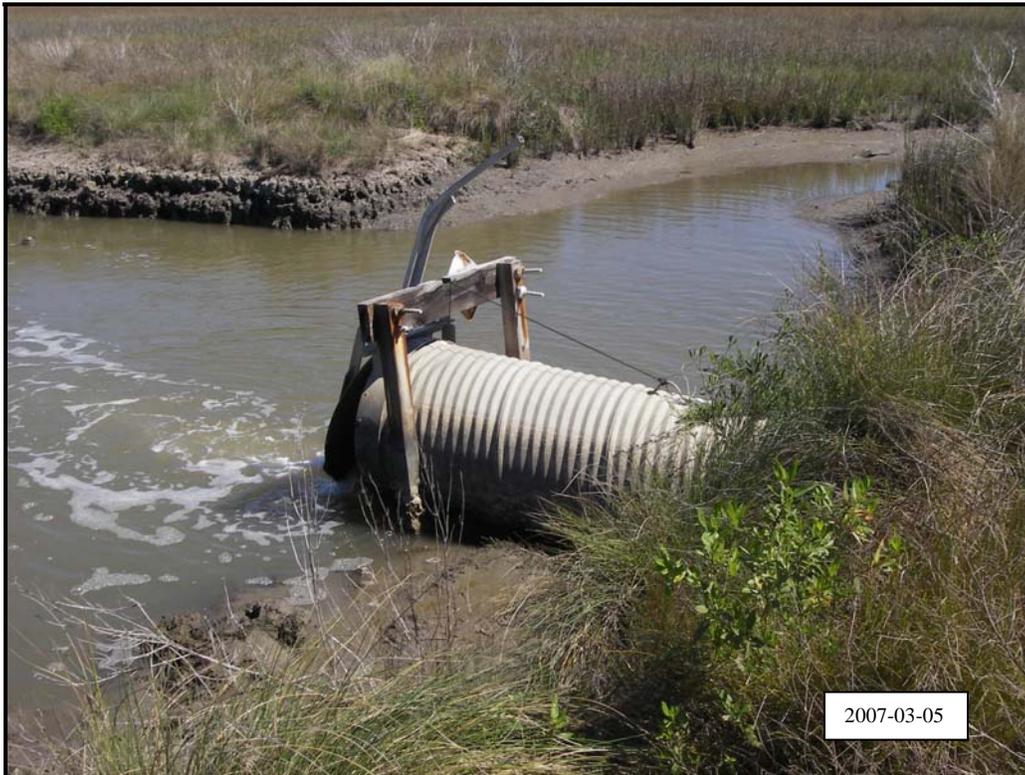
Photo 12, Structure No. 5, showing outlet pipe and flap gate with missing boardwalk.

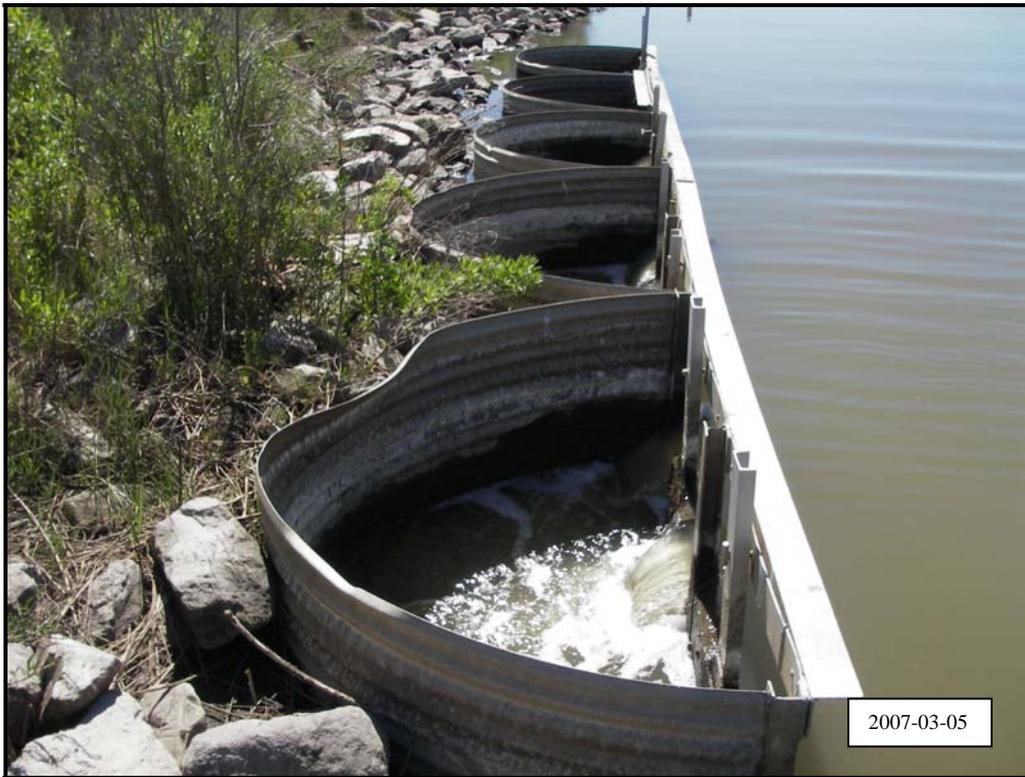
This structure is a pre-existing structure that was incorporated into the CS-20 project. It is in disrepair and needs to be replaced. A new structure was let out for bids on February 10, 2005; however, it was over budget and the bid was rejected. This structure will be replaced with a structure similar to ES-13, and the existing structure will be abandoned in place. Staff gauge readings were not available. (Photos: Appendix A, Photo 13).

Photo 13, Structure No. 4, view looking south.

- ES-4 – replace structure, abandon existing structure in place.
- ES-3 – add rock rip rap for bank erosion, clean out culvert, replace boardwalks, replace padlocks and staff gages.

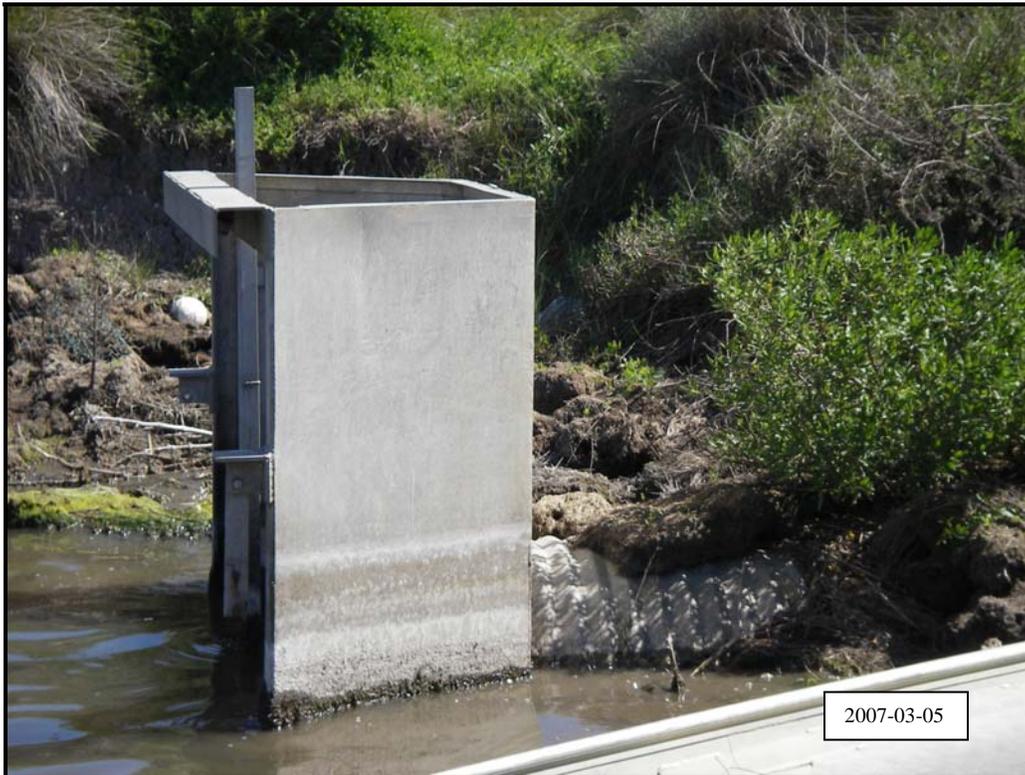
This is also a pre-existing structure that was incorporated into the CS-20 project. The wooden walkways on the outside and the inside of the structure are missing. The structure is silted up with marsh debris. The bank, however, is showing signs of some erosion and will require approximately 209 tons of man-size rip rap for reinforcement. The staff gages on the outside and inside are not readable. The padlocks on the stop log locking devices have rusted and cannot be operated. LDNR and NRCS agree that maintenance work is required to add rip rap, clean out debris, replace both walkways, replace padlocks, and replace staff gages inside and out. (Photos: Appendix A, Photos 14 & 15).

Photo 14, Structure No. 3, showing erosion and missing boardwalk.

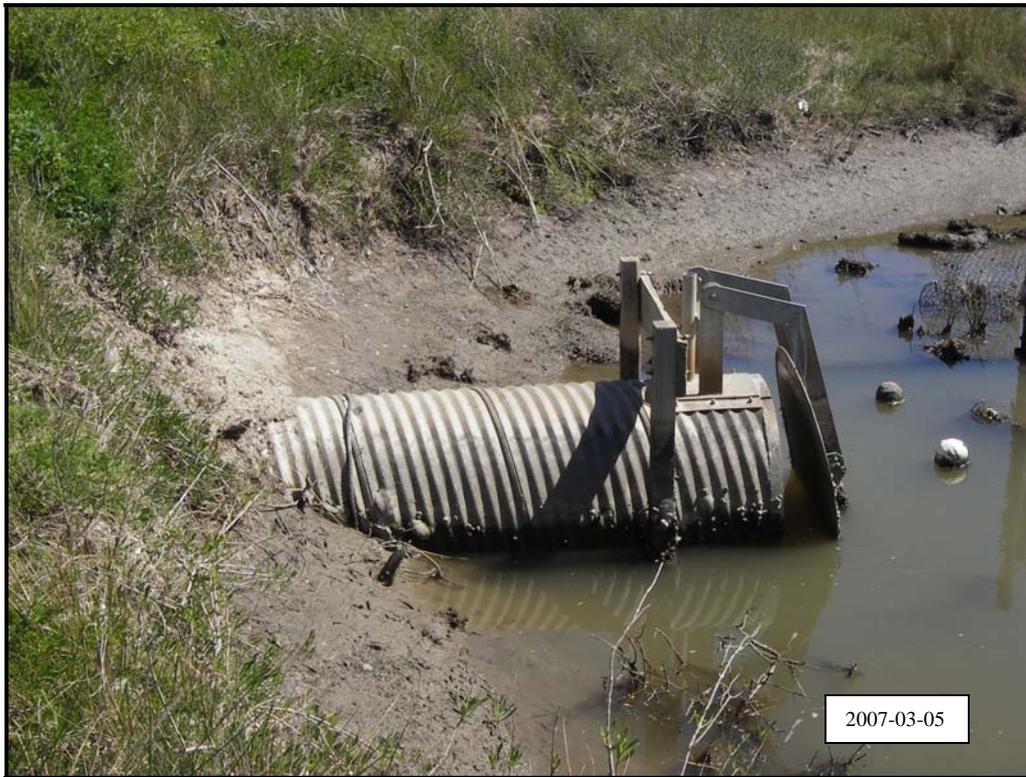
Photo 15, Structure No. 3, showing outlet pipe and flap gate.

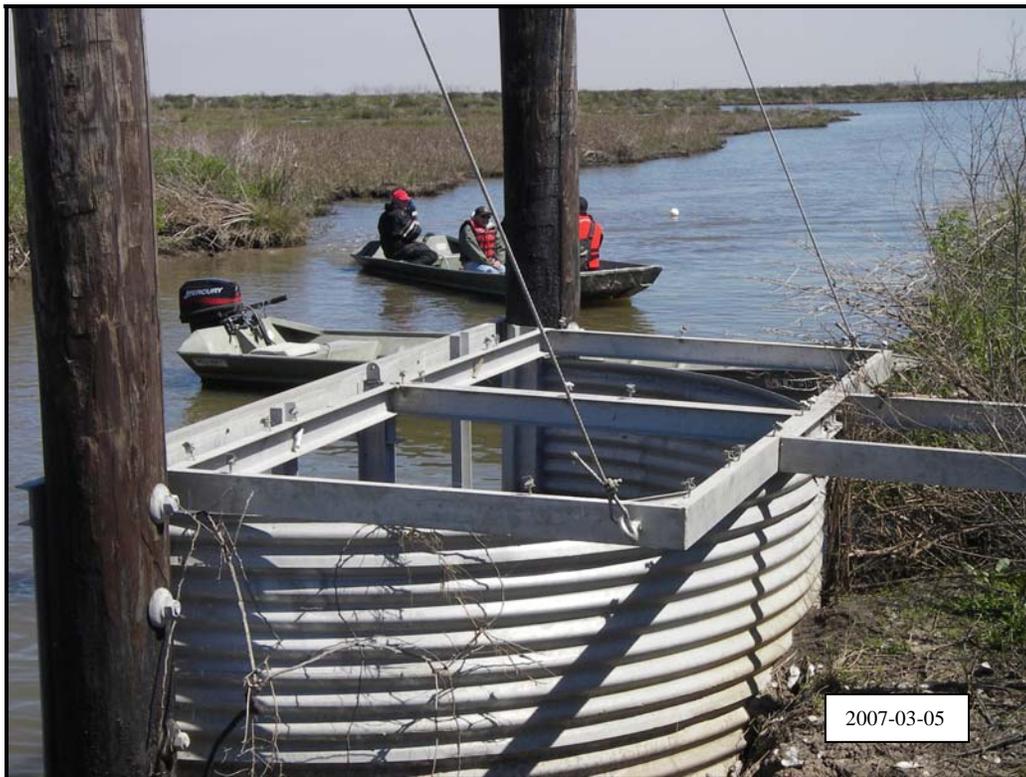
Vandals have stolen all of the grating on the inlet side of the structure. The structure is silted up with marsh debris. The bank, however, is showing signs of some erosion and will require approximately 470 tons of man-size rip rap for reinforcement. The staff gages on the outside and inside are not readable. The padlocks on the stop log locking devices have rusted and cannot be operated. The metal pile cap covers have rusted out. The wooden boardwalk needs to be extended. LDNR and NRCS agree that maintenance work is required to add rip rap, clean out debris, extend the boardwalk, replace metal pile caps, replace padlocks, and replace staff gages inside and out. (Photo: Appendix A, Photos 16 & 17).

Photo 16, Structure No. 1, showing missing grating and erosion around structure.

- ES-1 – add rock rip rap for bank erosion, extend boardwalk, replace metal pile cap covers and padlocks, replace staff gages.
- ES-17 – replace warning sign, replace pile cap on sheet pile wall, replace staff gage, replace metal pile cap covers, padlocks, and locking tabs.

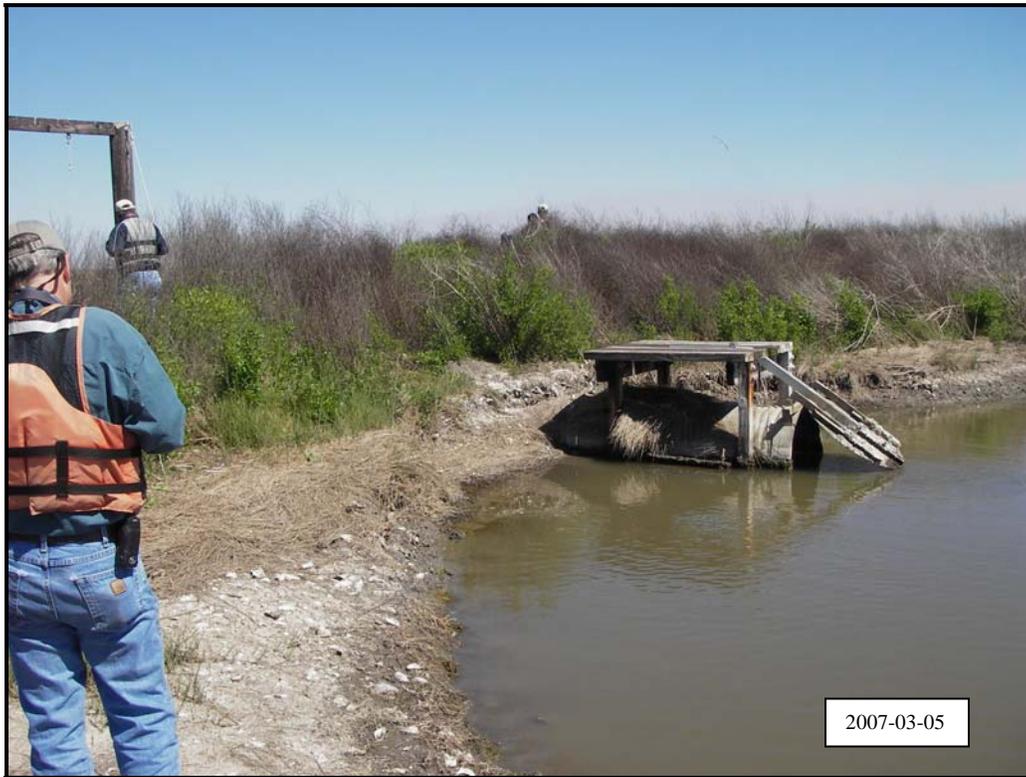
Photo 17, Structure No. 1, showing outlet pipe flap gate and erosion around structure.

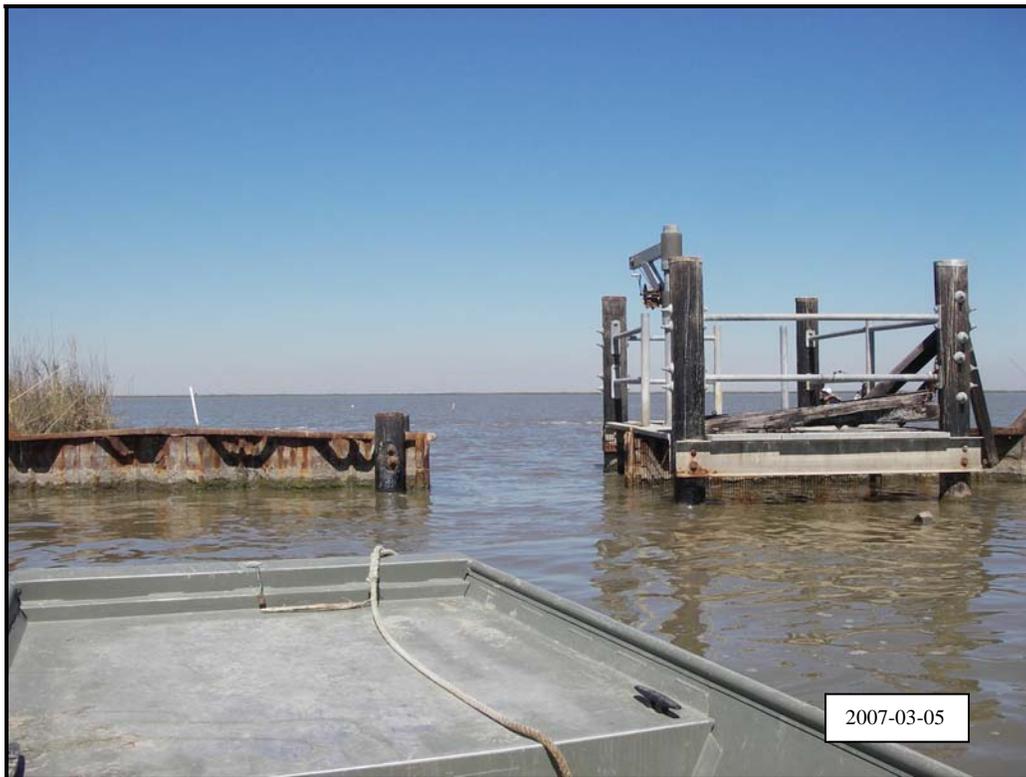
The sheet pile cap is severely rusted out on both sides of the structure. The locking tabs on the landing side of the stop log slots are missing. The warning sign is missing. The padlocks on the stop log locking devices have rusted and cannot be operated. The staff gauge is leaning and not readable. The metal pile cap covers are rusted out. LDNR and NRCS agree that maintenance work is required to replace the sign and pile cap on the sheet pile wall, replace the staff gage, replace metal pile cap covers, replace padlocks, and replace locking tabs. (Photos: Appendix A, Photo 18).

Photo 18, Structure No. 17, view looking north.

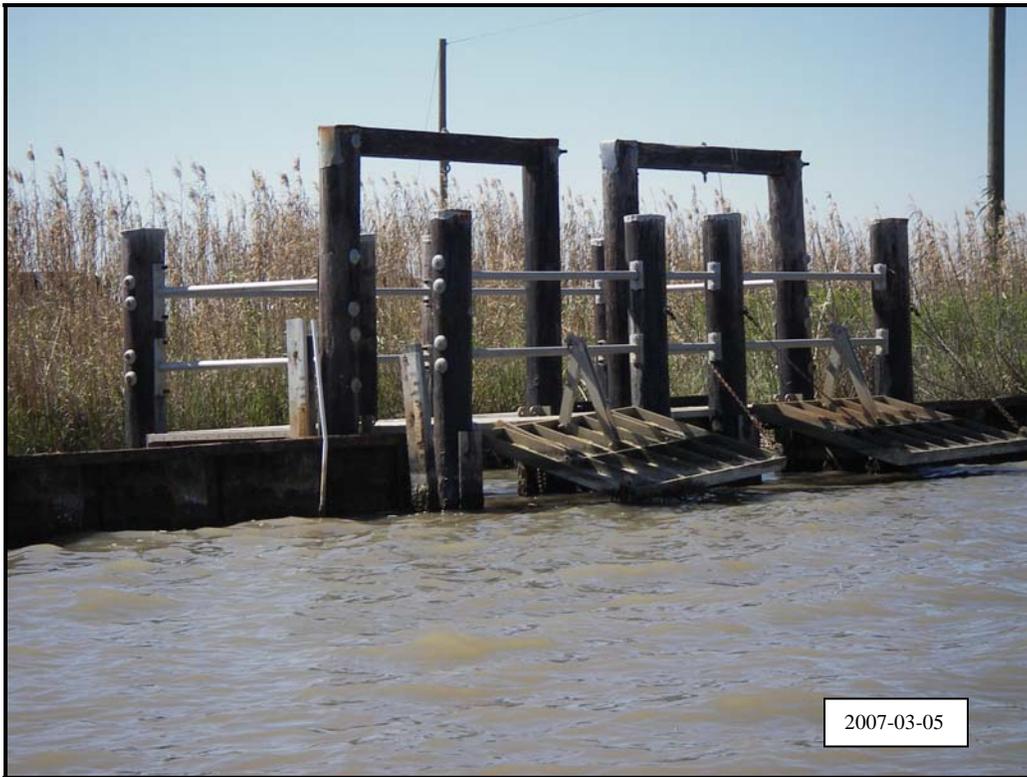
The warning sign is missing. Staff gages outside and inside were not readable. The structure is silted up with marsh debris. The padlocks on the stop log locking devices have rusted and cannot be operated. The metal pile cap covers have rusted out. The sheet pile cap on top of the sheet pile wall is severely rusted. LDNR and NRCS agree that maintenance is required to replace the warning sign, replace the metal pile cap covers, replace staff gages inside and out, clean out marsh debris, replace padlocks, and replace sheet pile cap on both sides of the structure. (Photos: Appendix A, Photos 19 & 20).

Photo 19, Structure No. 13, view looking west.

- ES-13 – replace warning sign, replace metal pile cap covers, replace staff gages, clean out debris, replace padlocks, replace metal pile cap on sheet pile wall.
- Levee/Step canal – repair levees and remove trash/debris and silt from canal.

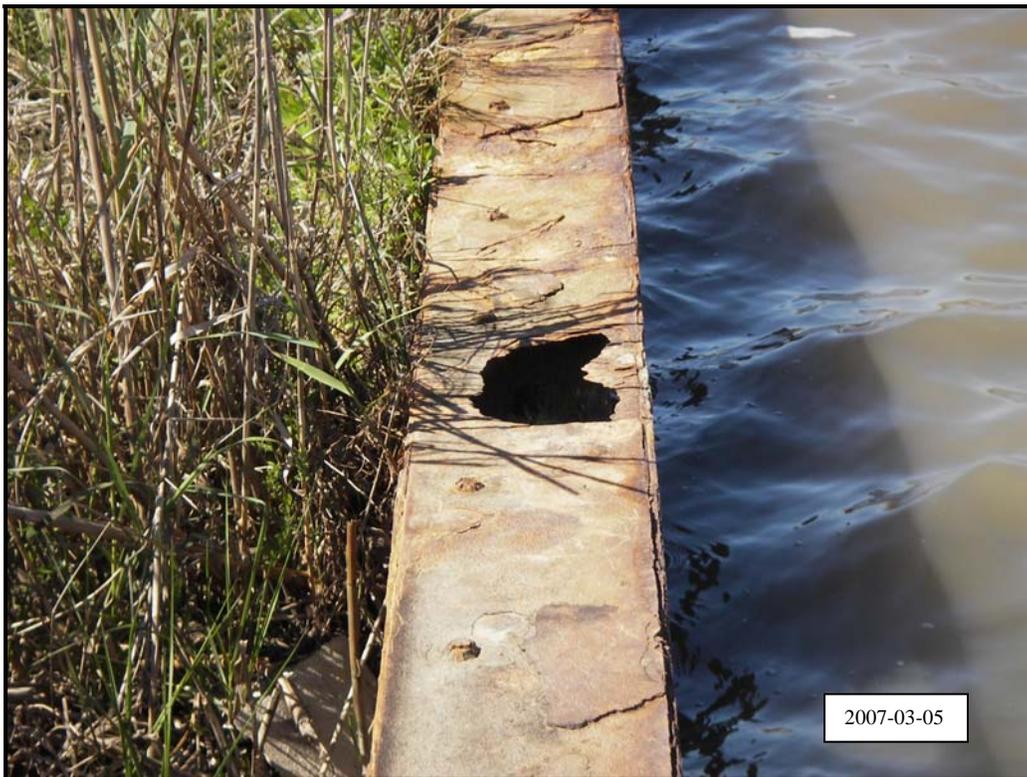
Photo 20, Structure No. 13, showing corrosion on sheet pile cap.

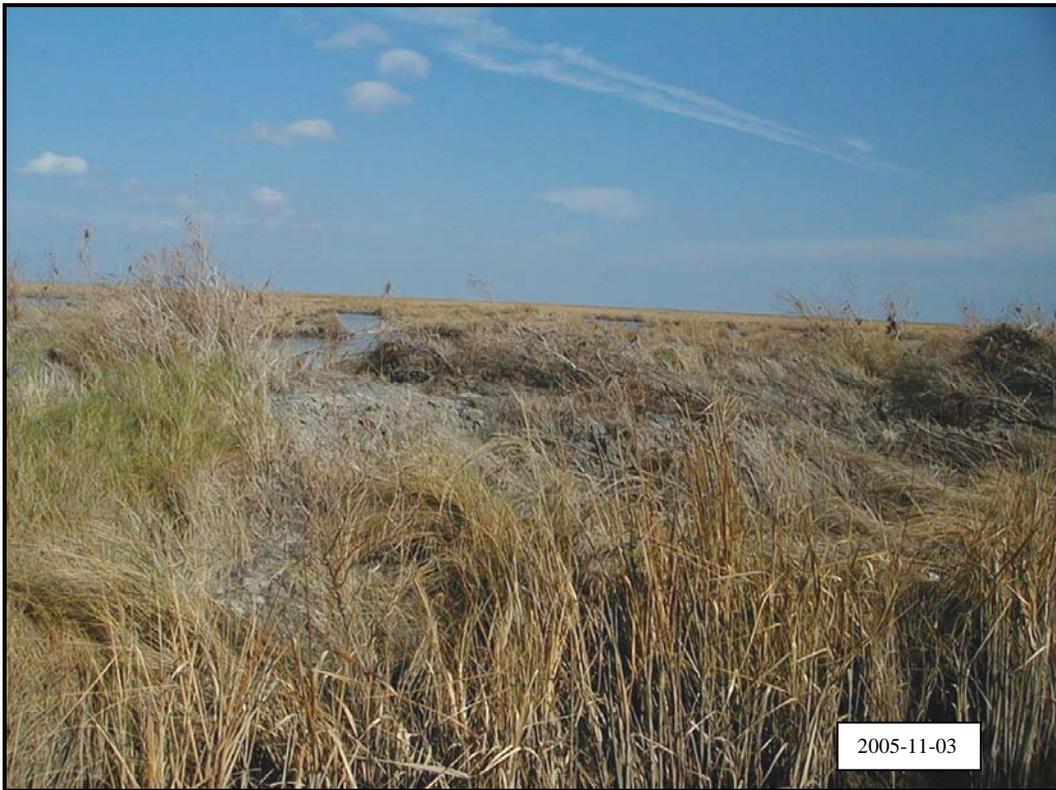
The inspection of the earthen levee consisted of a visual inspection of the entire length of levee along the Step Canal. In addition to the erosion noted above, the storm surge has eroded portions of the levee in various locations. In addition the storm surge has placed large amounts of marsh and other debris into the east-west sections of the Step Canal. In these areas of the canal, the water depth was very shallow. The north-south sections appear to be relatively free of any obstructions. LDNR and NRCS agree that maintenance is required to repair the levees and remove trash from the canal. (Photos: Appendix A, Photos 21 & 22).

Photo 21, North Levee, looking east, showing washout of top portion of levee.

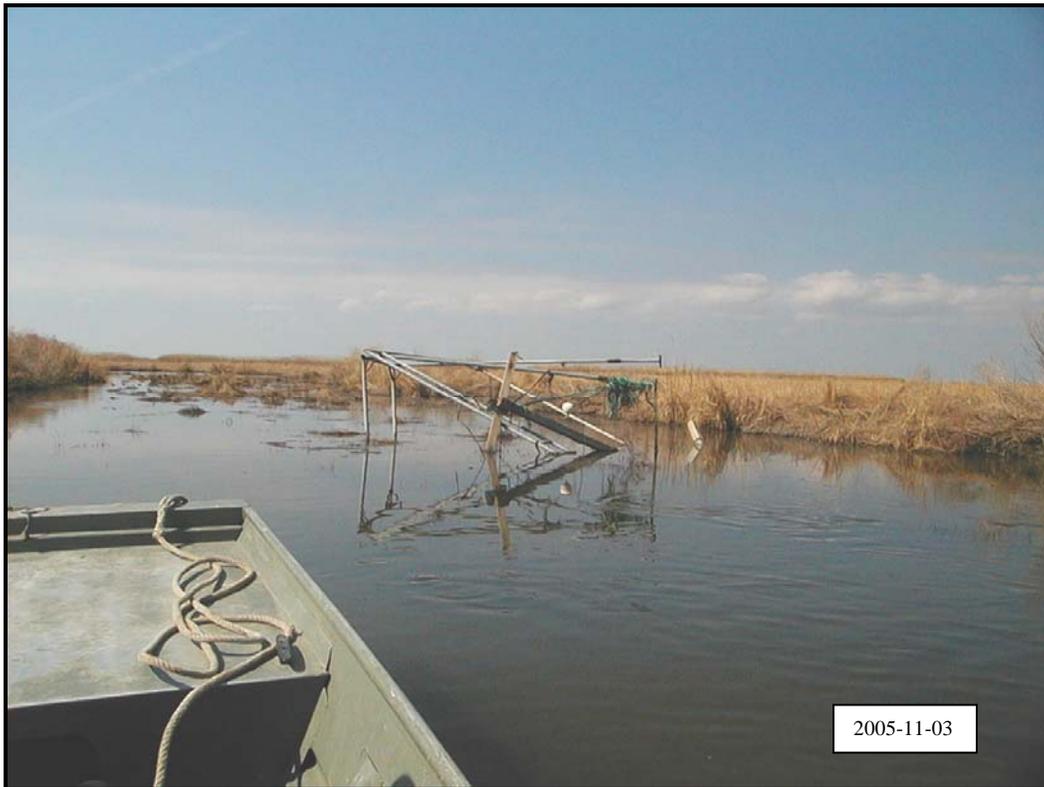
Photo 22, Step Canal, view looking west, showing marsh/siltation and other debris in the canal.
