**2007 Operations, Maintenance,  
and Monitoring Report**

**Highway 384  
Hydrologic Restoration**

State Project Number CS-21  
Priority Project List 2

August 2007  
Cameron Parish

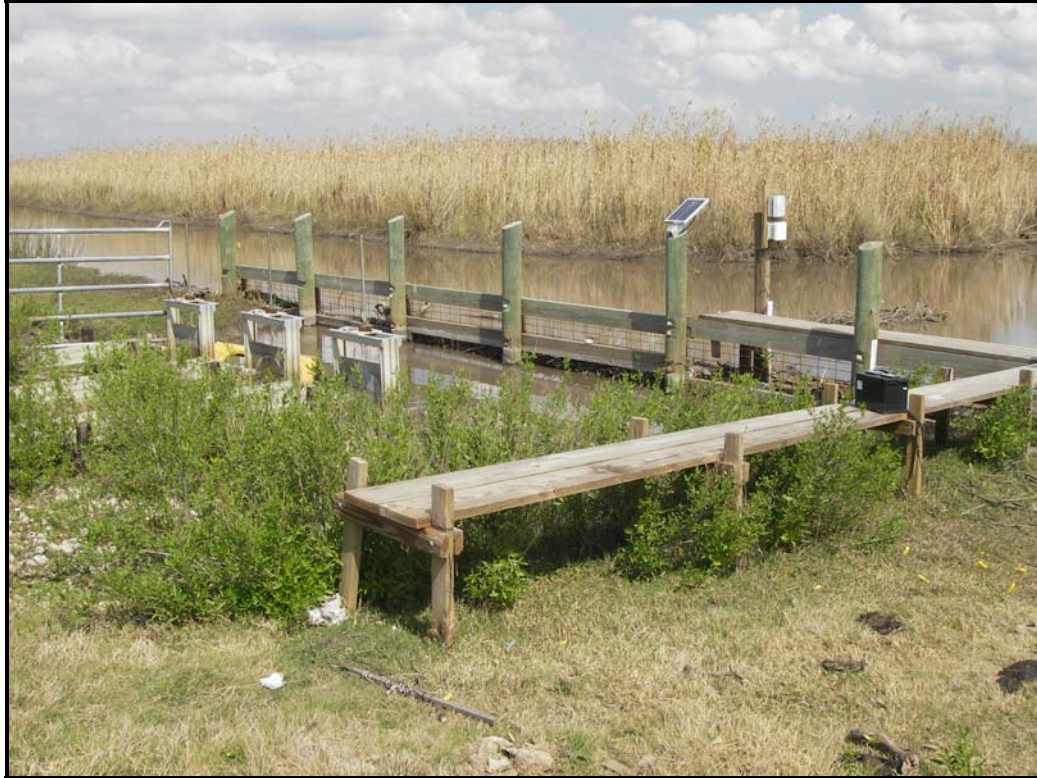
The structure is in good condition. Water level on the outside was elevation +0.9 and the level inside could not be determined because the staff gauge was not readable. The staff gauge was replaced on 7/8/2007. Rock placed on the bank during the maintenance event of June 2002 is stable and in no need of repair. The hyacinth fence is in good condition; however, there is trash from Hurricane Rita that is between the fence and the sluice gates which needs to be removed. The road/levee leading up to the structure is in good condition since it was repaired in June 2006. The recently installed Portable Multi-Parameter Water Quality Troll 9500 – 29r is in good

condition and operating properly. The solar panel should be cleaned and bird excluder devices installed. Sluice gates were in the open position and flap gates were partially open. (Photos: Appendix B, Photos 1-5)

**Photo 1.** View showing hyacinth fence and sluice gates at Structure No. 1. (March 8, 2007)

Install bird excluder device on the solar panel and replace the staff gauge at Structure #1. Replace the metal pile cap covers and install bird excluder device on the solar panel at Structure #12.

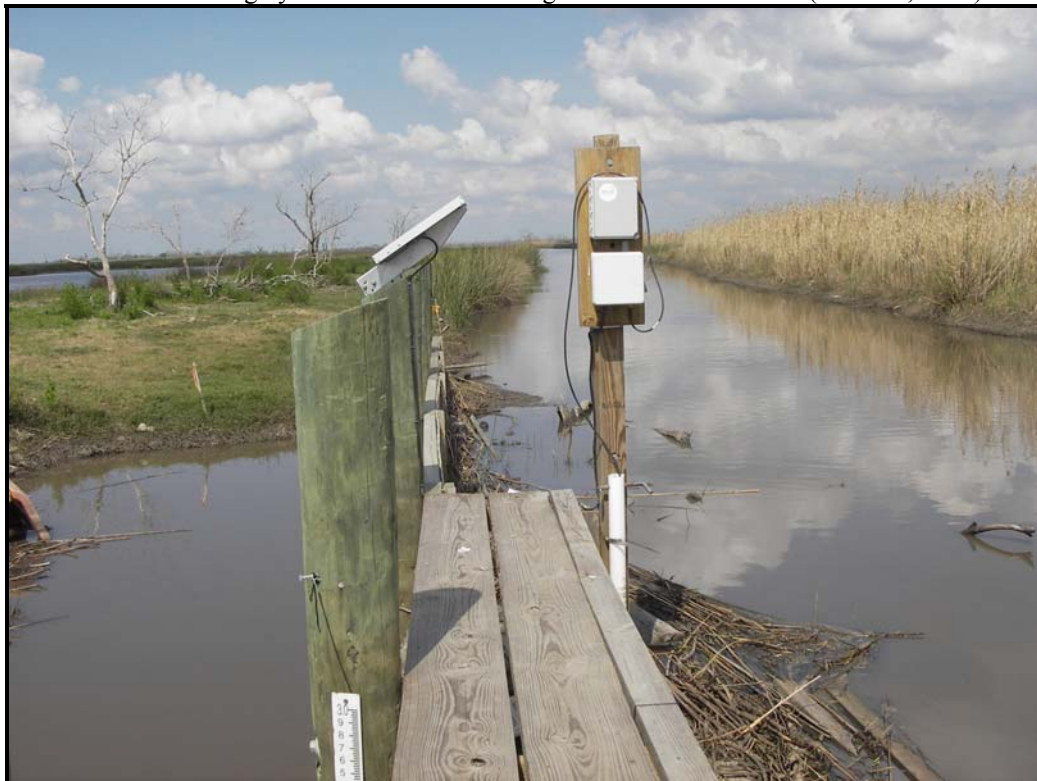
**Photo 2.** View showing Portable Multi-Parameter Water Quality Troll 9500 (29r) with wooden boardwalk at Structure No. 1. (March 8, 2007)

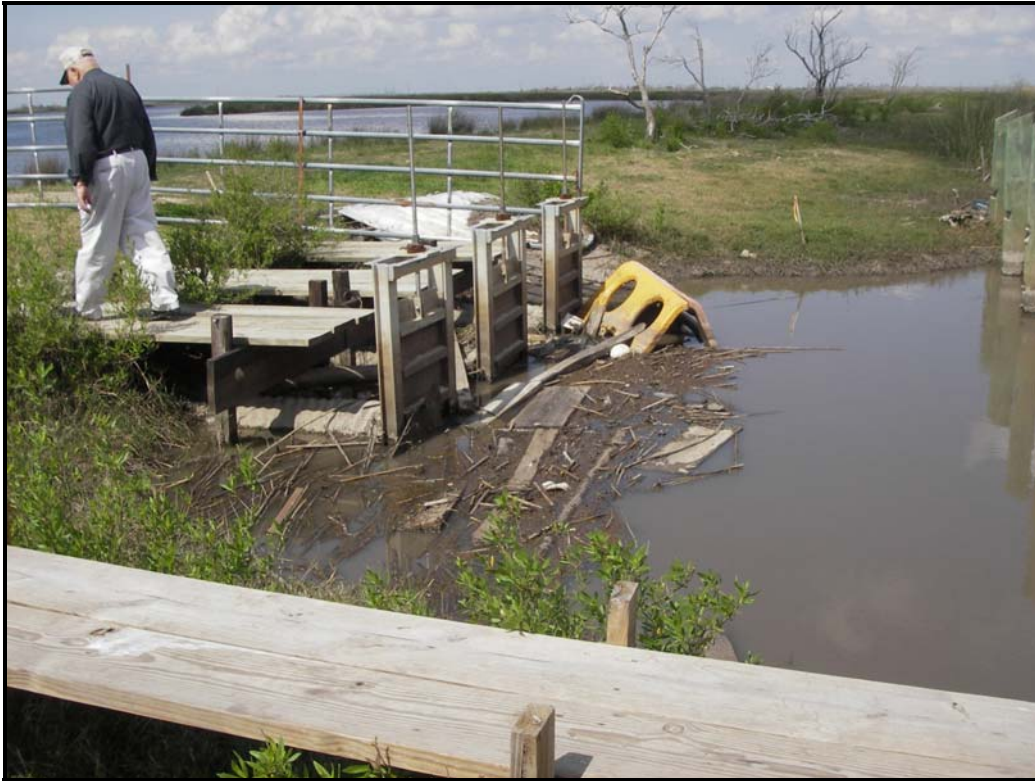
Overall, the Highway 384 Hydrologic Restoration project structural components are in good condition and functioning as designed with only minor problems noted. The hyacinth fence that was installed during the maintenance project of June 2002 as well as the rock reinforcement of the bankline is performing well and should be incorporated into all structures of this type in the future. The access road repair with recycled concrete material turned out well and was economical. The two Portable Multi-Parameter Water Quality Troll 9500 units used for operation of this project are working very well and should be considered for future projects. A maintenance event is planned during 2007/2008 for the items listed below.

**Photo 3.** View showing trash and debris within hyacinth fence that needs to be removed. (March 8, 2007)

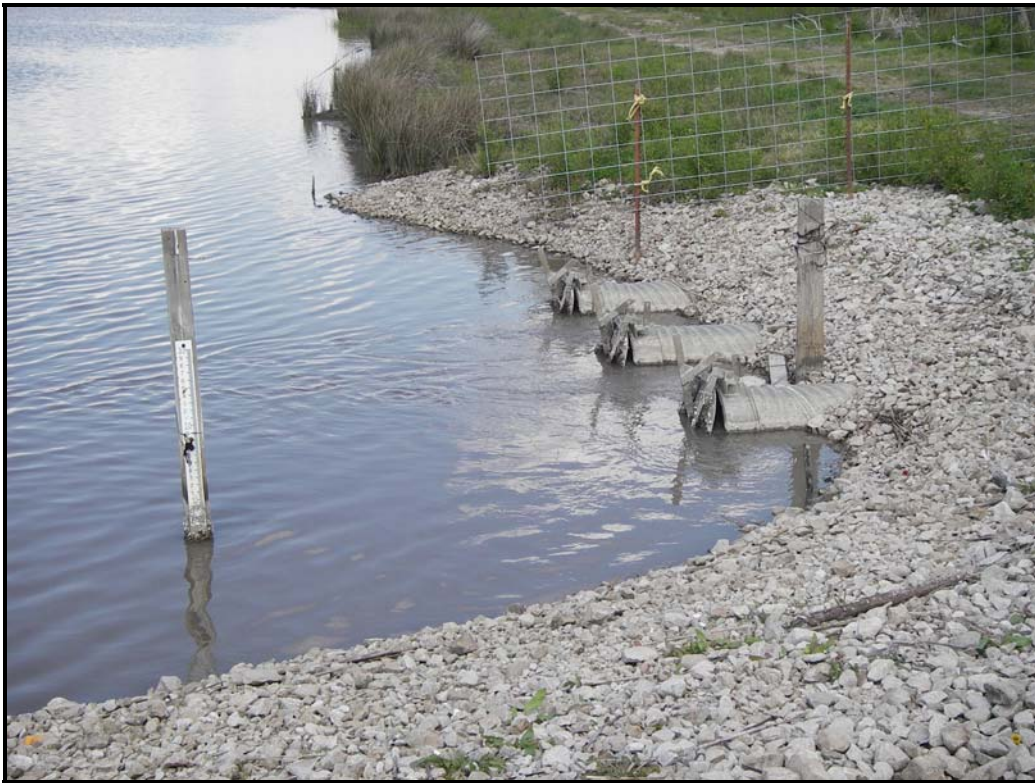
**Photo 4.** Outlet side of Structure No. 1. (March 8, 2007)

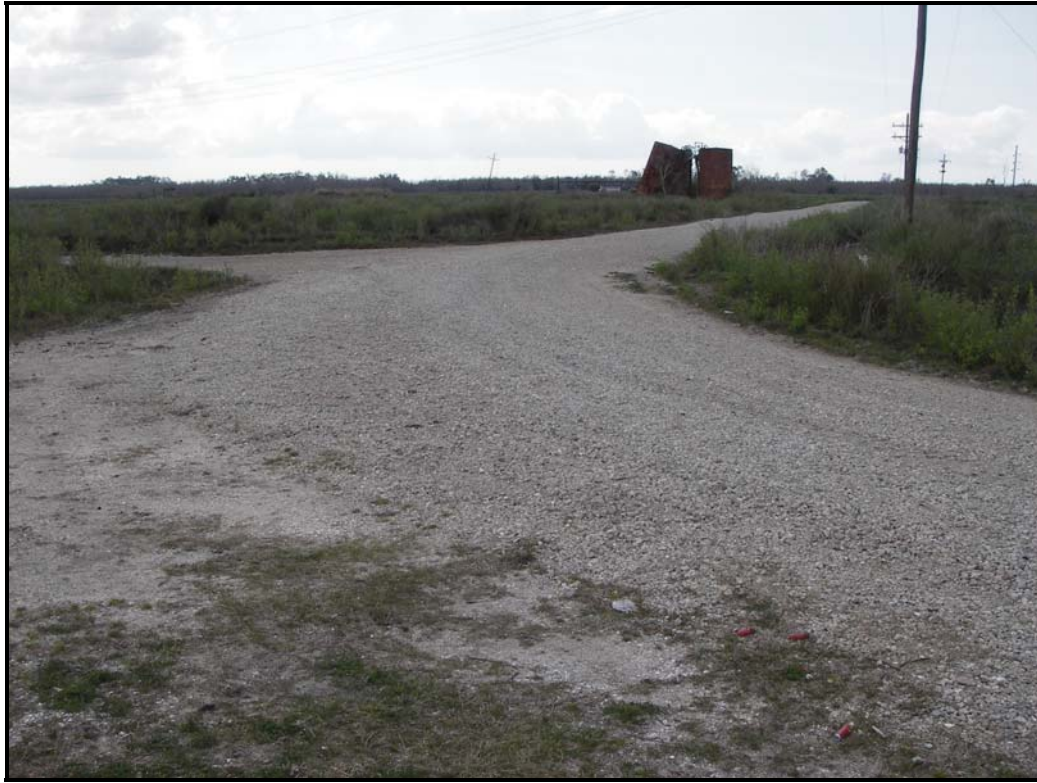
The access road repair with recycled concrete material turned out well and was economical in comparison to limestone aggregate.

**Photo 5.** Access roadway to Structure No.1, recently repaired with recycled concrete. (March 8, 2007)

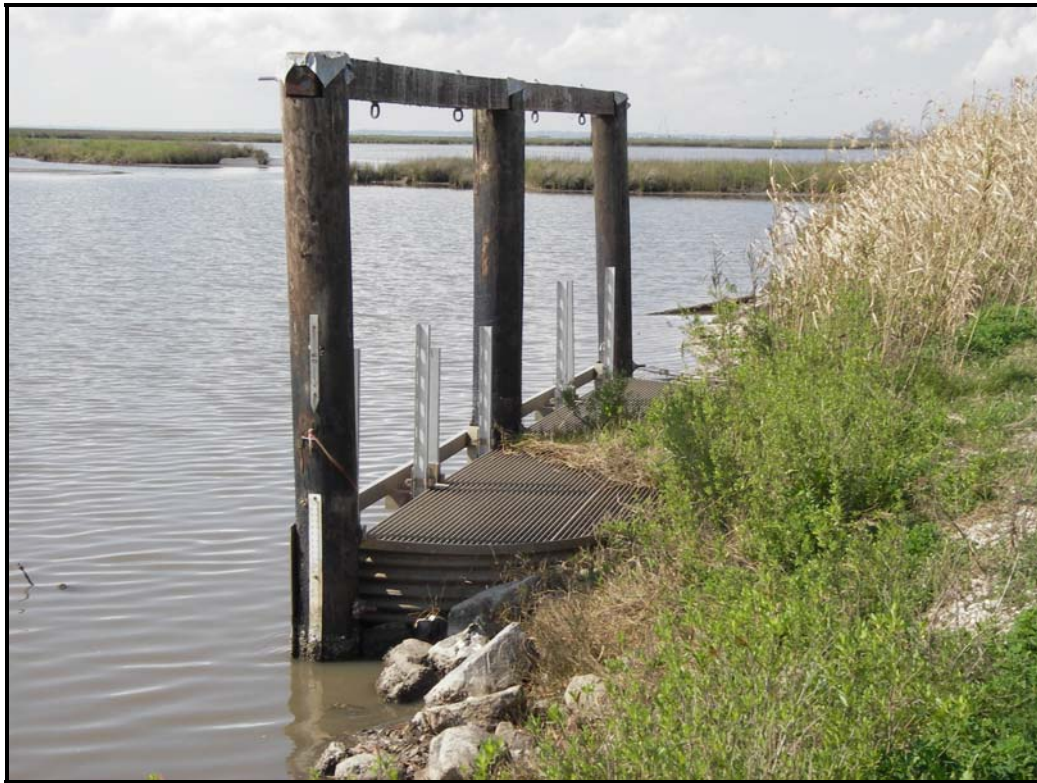
The structure is in good shape. Water levels were +0.9 outside and +0.5 inside. Pile caps on the outlet side and the padlocks on the stop log locking devices have rusted and will eventually need to be replaced. Rock that was placed during the maintenance of Nov. 2000 is stable. The road/levee leading up to the structure is in good condition since it was repaired in June 2006. The recently installed Portable Multi-Parameter Water Quality Troll 9500 – 15r is in good condition and operating properly. The solar panel should be cleaned and bird excluder devices installed. The flap gates were in the closed position and the positions of the stoplogs were unknown. (Photos: Appendix B, Photos 6-9)

**Photo 6.** Inlet side of Structure No. 12. (March 8, 2007)

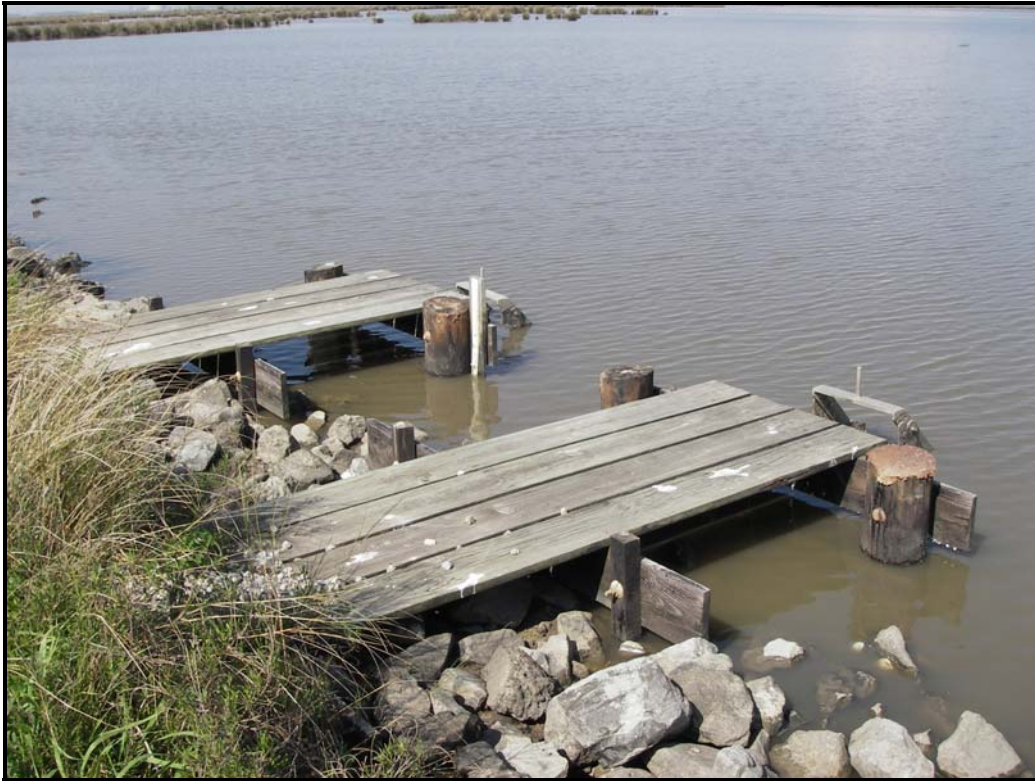
**Photo 7.** Outlet pipes for Structure No. 12. (March 8, 2007)

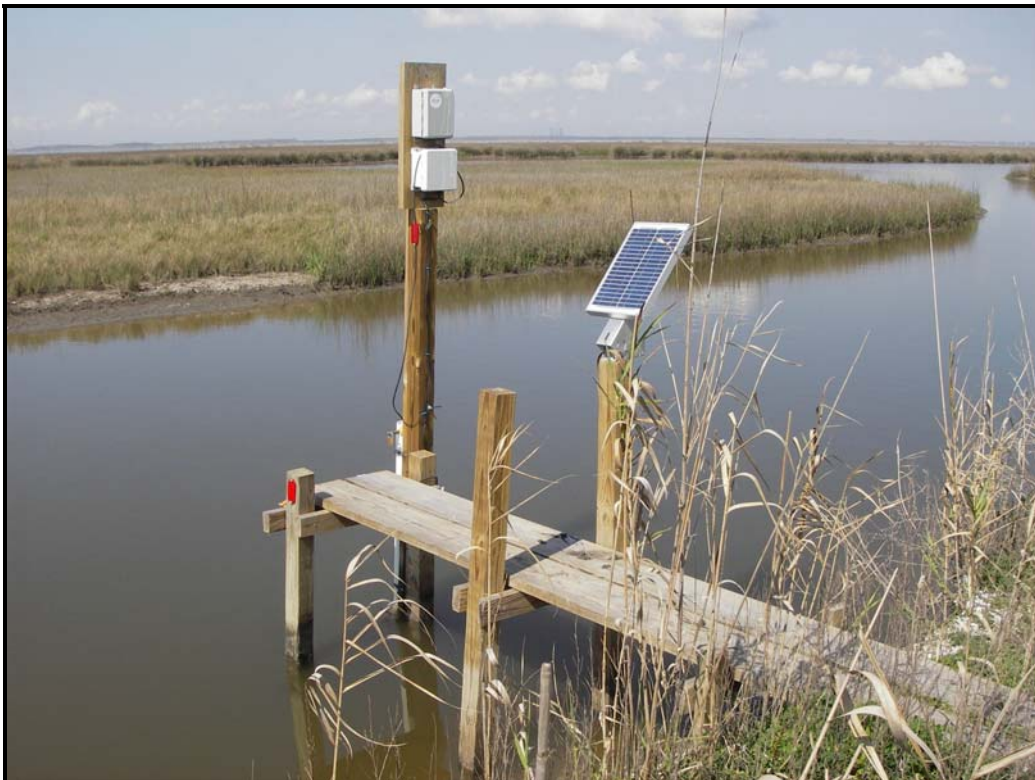
**Photo 8.** View showing Portable Multi-Parameter Water Quality Troll 9500 (15r) with wooden boardwalk near Structure No. 12. (March 8, 2007)

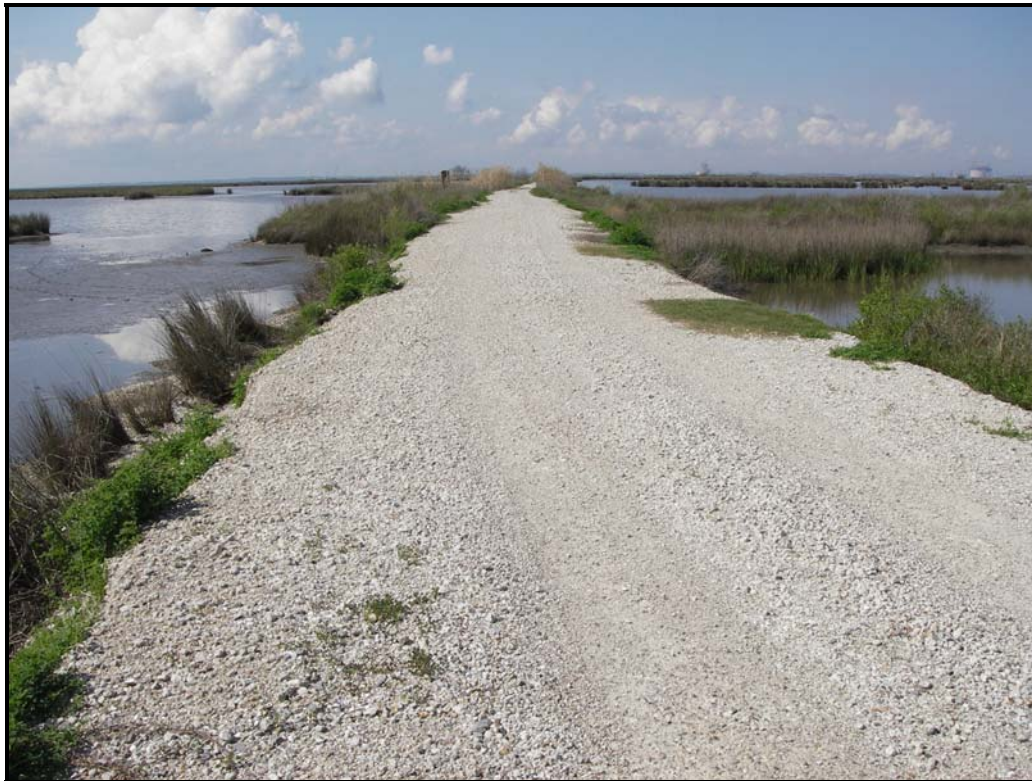
**Photo 9.** Access roadway to Structure No. 12, recently repaired with recycled concrete. (March 8, 2007)

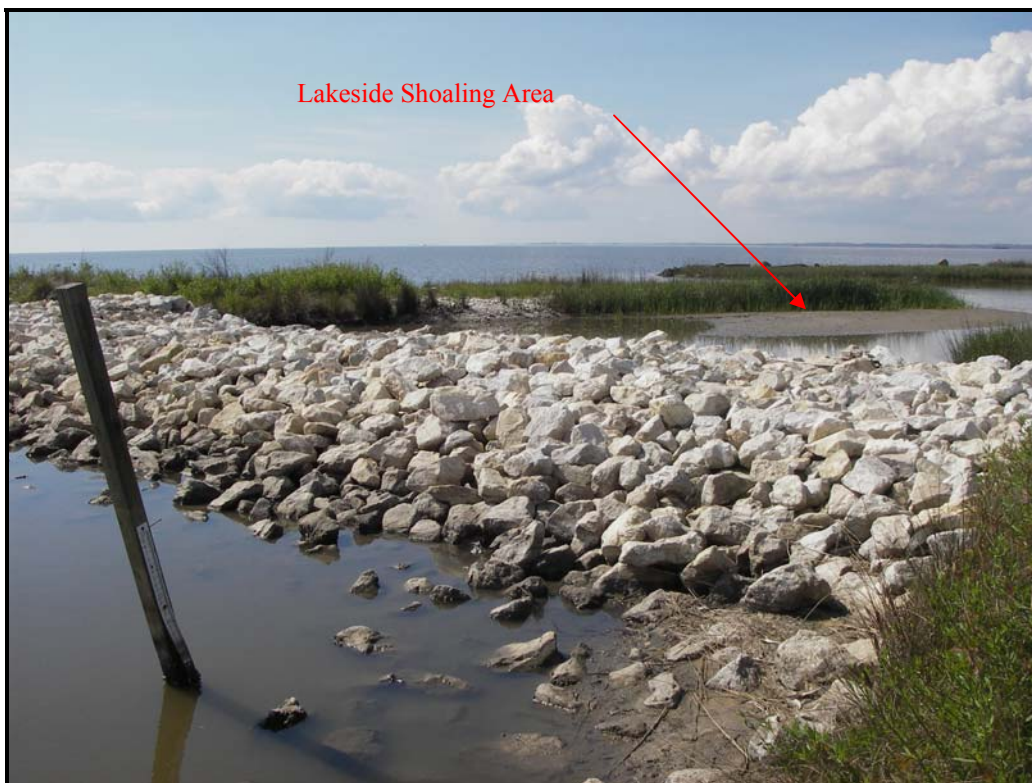
The rock plug is in good condition. Water levels could not be determined because the outside staff gauge is missing and the inside staff gauge was leaning and not readable. Both staff gauges will need to be replaced. The recently completed maintenance work in May 2005 to repair the plug from vandalism held up well under the high storm surge waters. The lakeside area of the rock plug is showing signs of shoaling. (Photos: Appendix B, Photo 10)

**Photo 10.** Rock plug at Structure No. 8. (March 8, 2007)
