**2007 Operations, Maintenance,
and Monitoring Report**

**BRADY CANAL HYDROLOGIC
RESTORATION**

State Project Number TE-28
Priority Project List 3

August 2007
Terrebonne Parish

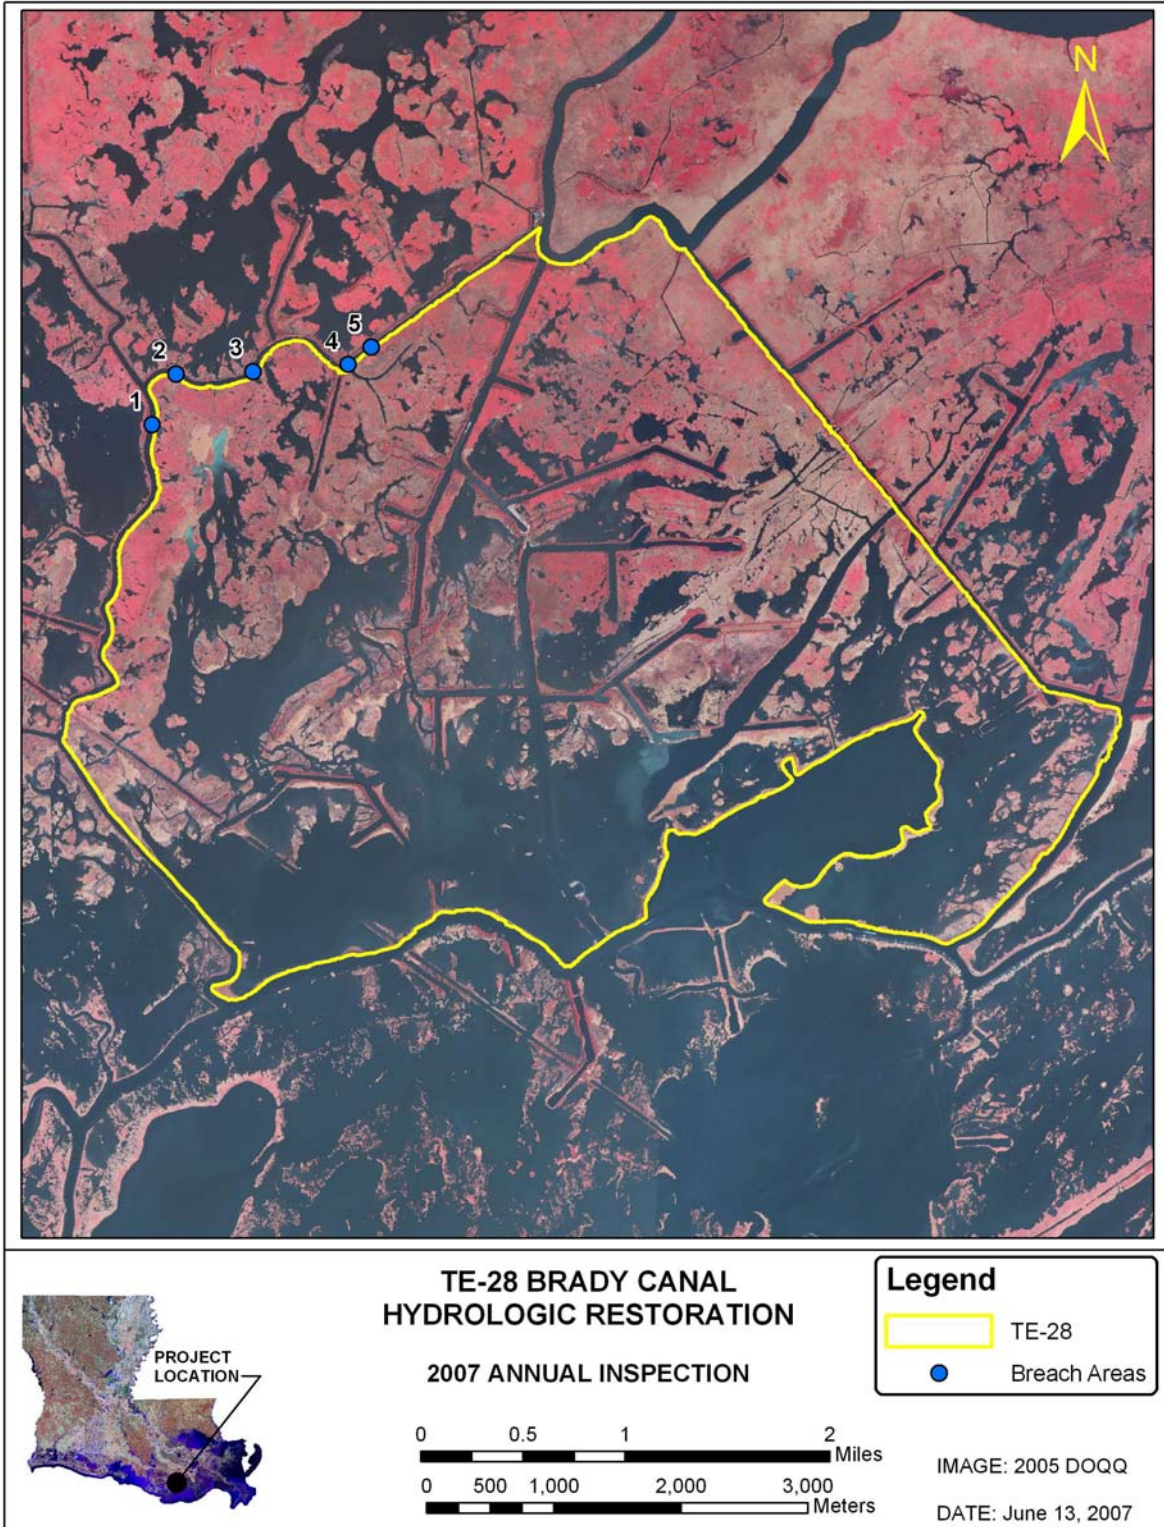
Figure 3. Breach locations identified during the 2007 annual inspection.

northeast of structure 6 (Appendix A, Photos 32 through 34). We also identified several breaches in the overflow banks along Bayou Carencro and Brady Canal (Appendix A, Photos 35 through 37; Figure 3). The landowner has indicated that he may be interested in reinforcing the low areas and repairing breaches identified during the inspection under their in-kind services agreement with LDNR and NRCS. LDNR and NRCS will continue to work with the landowners on facilitating levee reinforcement and breach repairs as needed. Overall, the earthen embankments bordering the project area appear to be in fair condition. The inspection team will continue to monitor the condition of levees and overflow banks on future site visits.

As outlined in the inspection results of the earthen embankments and overflow banks, we did identify several breaches along Carencro Bayou and Brady Canal that will require maintenance and repairs (Figure 3). Over the past few years, we have noticed a frequent reoccurrence of breaches in the overflow banks along the northern boundary of the project (Little Carencro Bayou, Carencro Bayou, and Brady Canal).

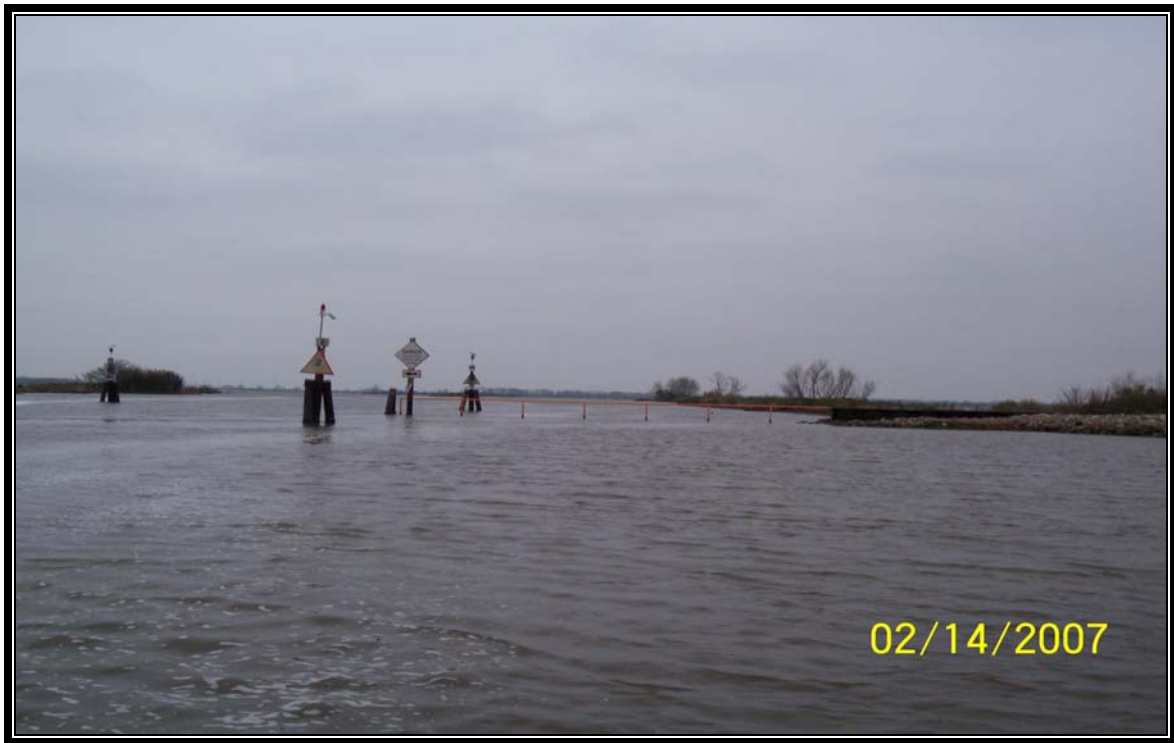
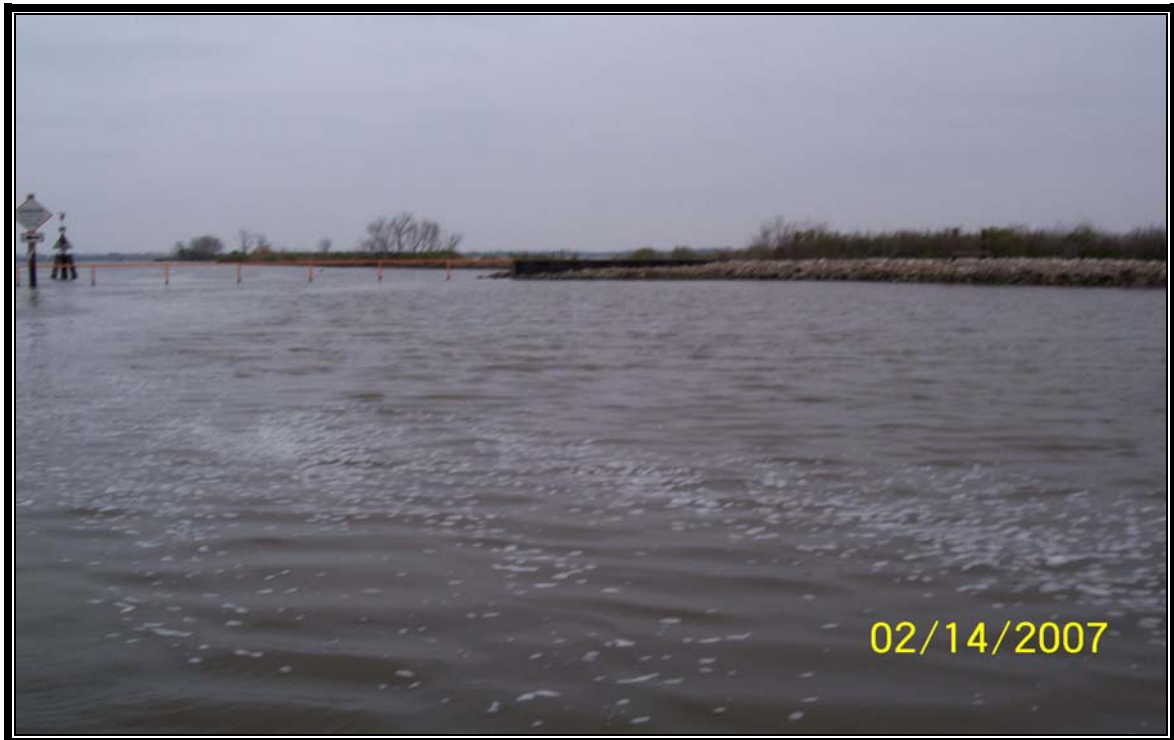
Overall, the condition of structure 6 was good with moderate erosion noted along the earthen embankment tie-in on the west side of the structure. The timber dolphin supporting the navigation lights on the southwest side of the structure along Bayou Decade was damaged from vessels accessing the barge bay. The batter piling was off center and split down the middle and the steel cable tying the piling together was very loose. The landowner indicated that maneuvering through the barge bay is sometimes difficult because barges and tugs have to turn perpendicular to the bank line in shallow waters to clear the structure. The inspection team will continue to monitor the condition of the timber dolphin. We noted that the steel pipe railing and timber pile guards on the west side of the barge bay opening were damaged. The timber piling on the west side of the entrance was missing and the steel pipe railing attached to the channel cap was bent. The signs and navigational lights appear to be in good condition with no apparent damage. The navigational aids at this structure are included in the maintenance contract awarded to Automatic Power, Inc. of Larose in January 2007. Automatic Power's contract includes quarterly inspections, and diagnostic and maintenance repairs (Appendix A, Photos 1 through 5).

Photo 1 – (Structure 6) – fixed crest weir with barge bay along the north bank of Bayou Decade.

Photo 2 – (Structure 6) – northeast bank tie-in of structure 6.

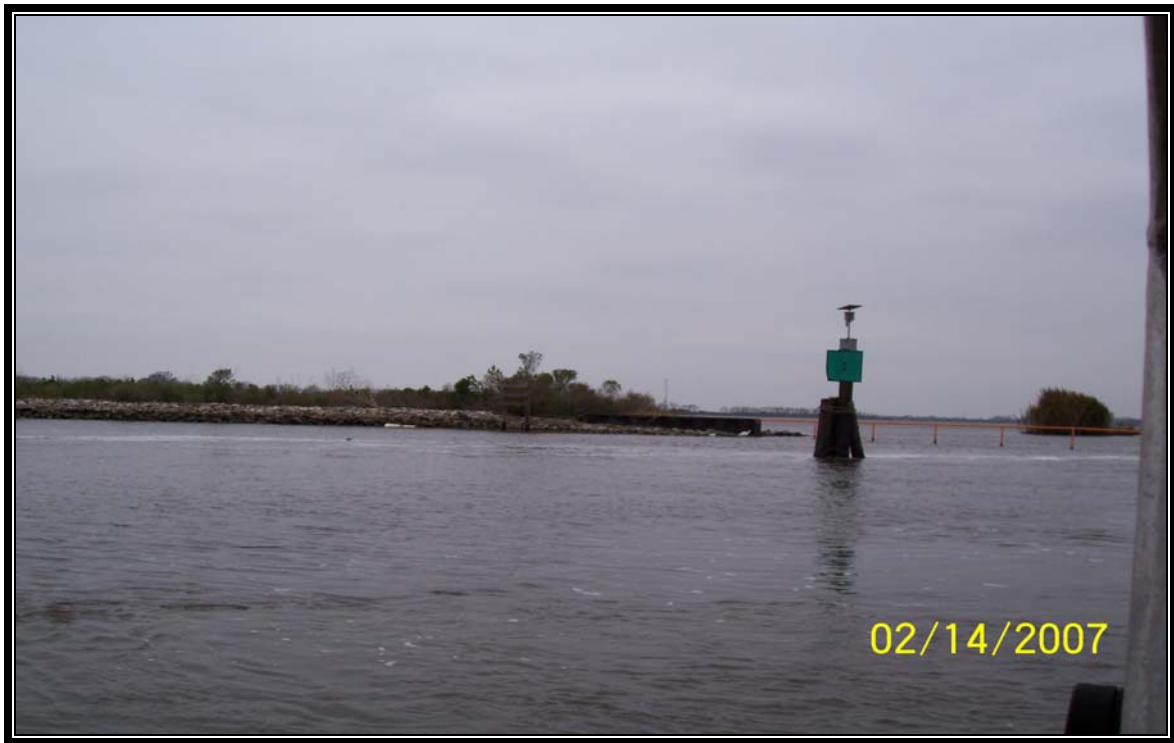
Photo 3 – (Structure 6) – southwest bank tie-in of structure 6.

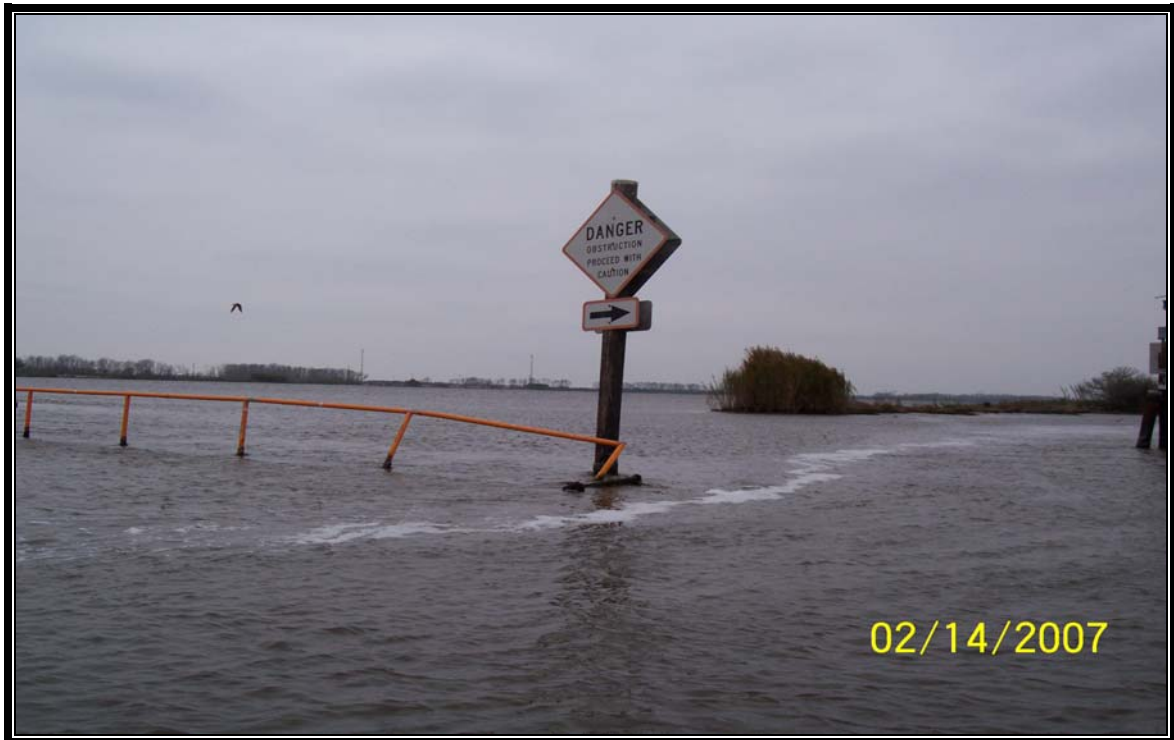
Photo 4 – (Structure 6) – location of missing timber piling and damage to guardrail on bulkhead.

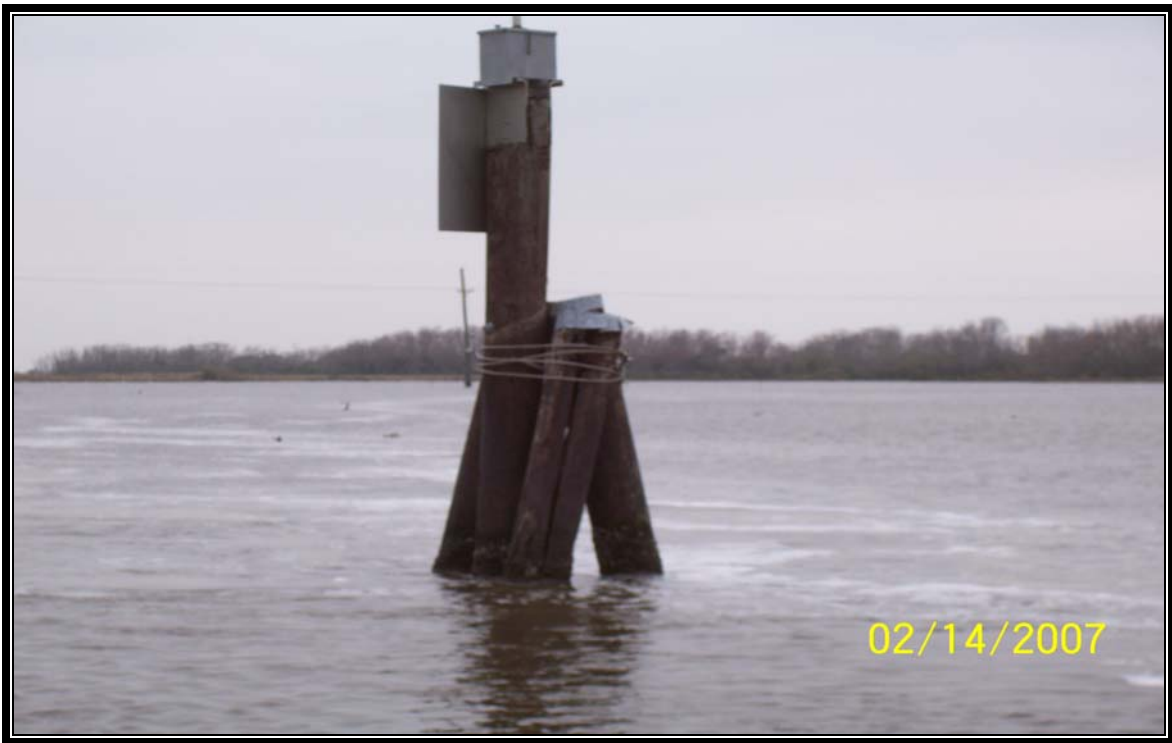
Photo 5 – (Structure 6) – damaged timber pile cluster on the southwest side of structure 6.

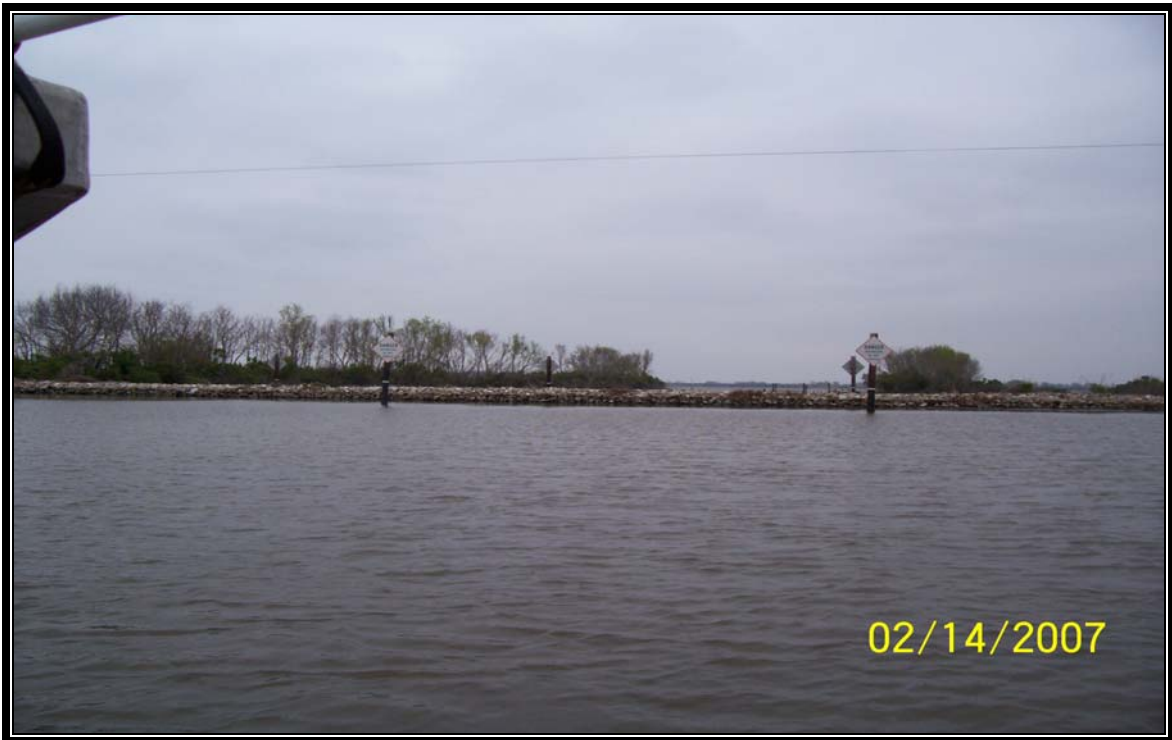
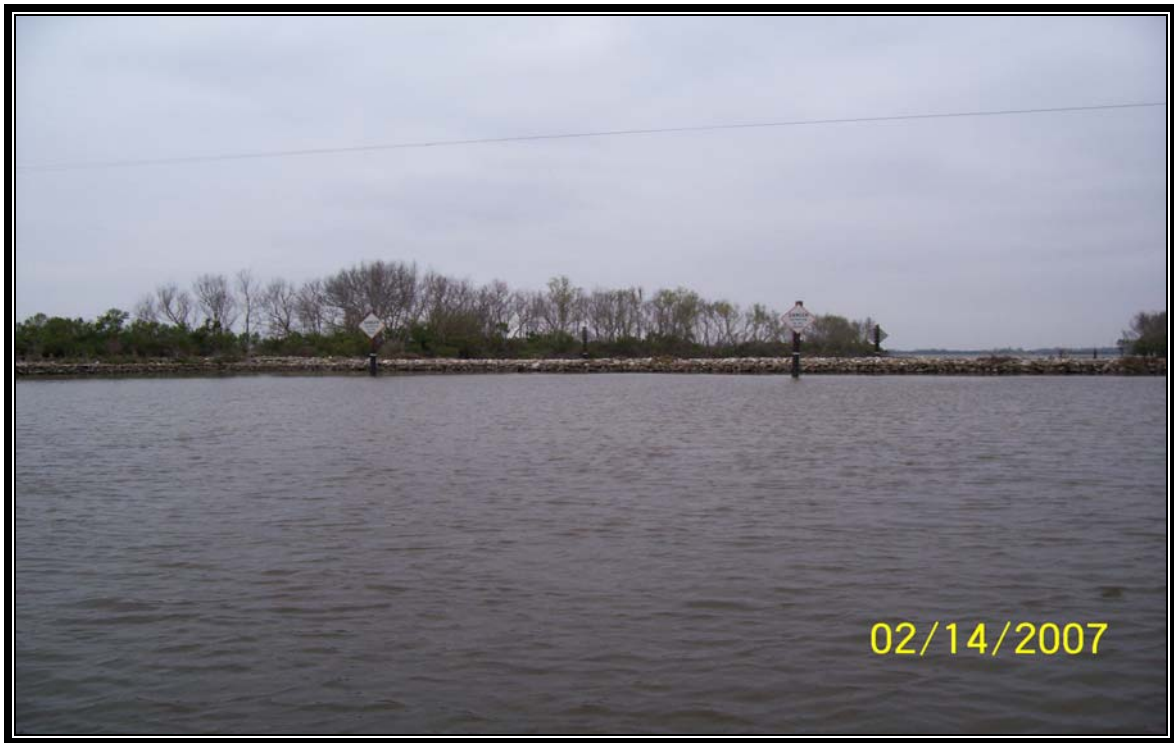
Other than debris littering the rock plug, structure 7 was in very good condition with no visible settlement or breaching around the ends of the structure. The signs and timber supports were also in good condition (Appendix A, Photos 6 and 7).

Photo 6 – (Structure 7) – rock channel plug located along the north bank of Bayou Decade.

Photo 7 – (Structure 7) – rock channel plug located on the north bank of Bayou Decade.

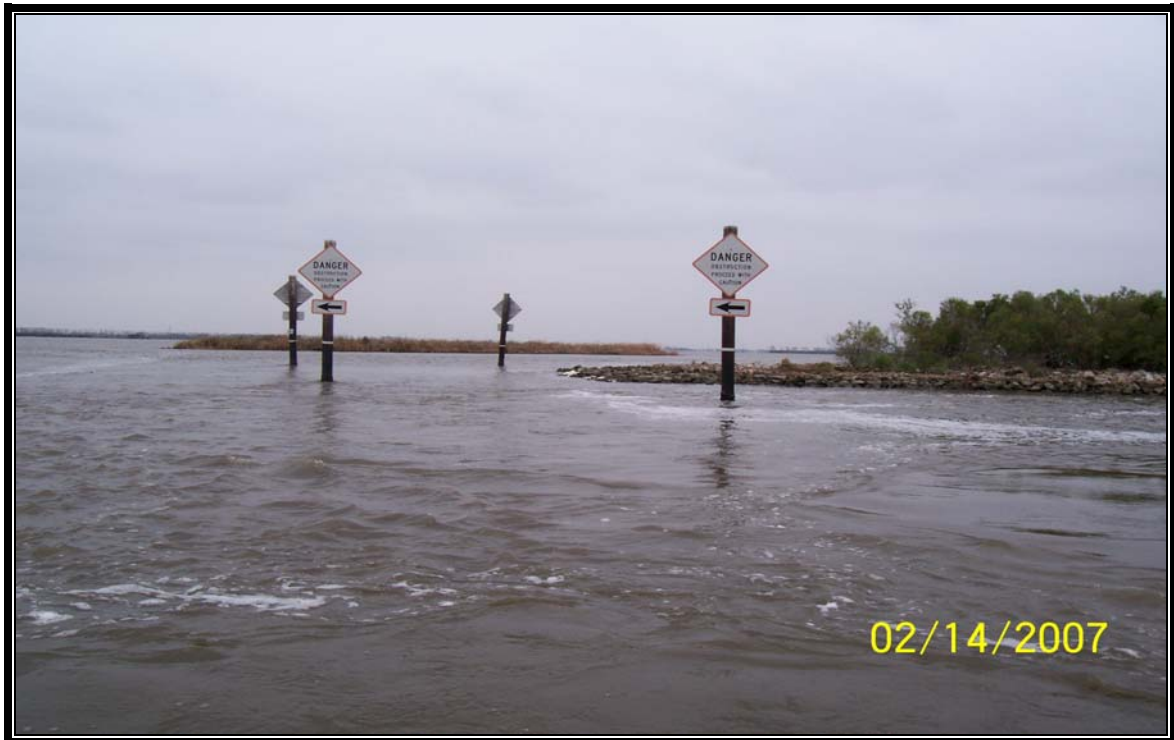
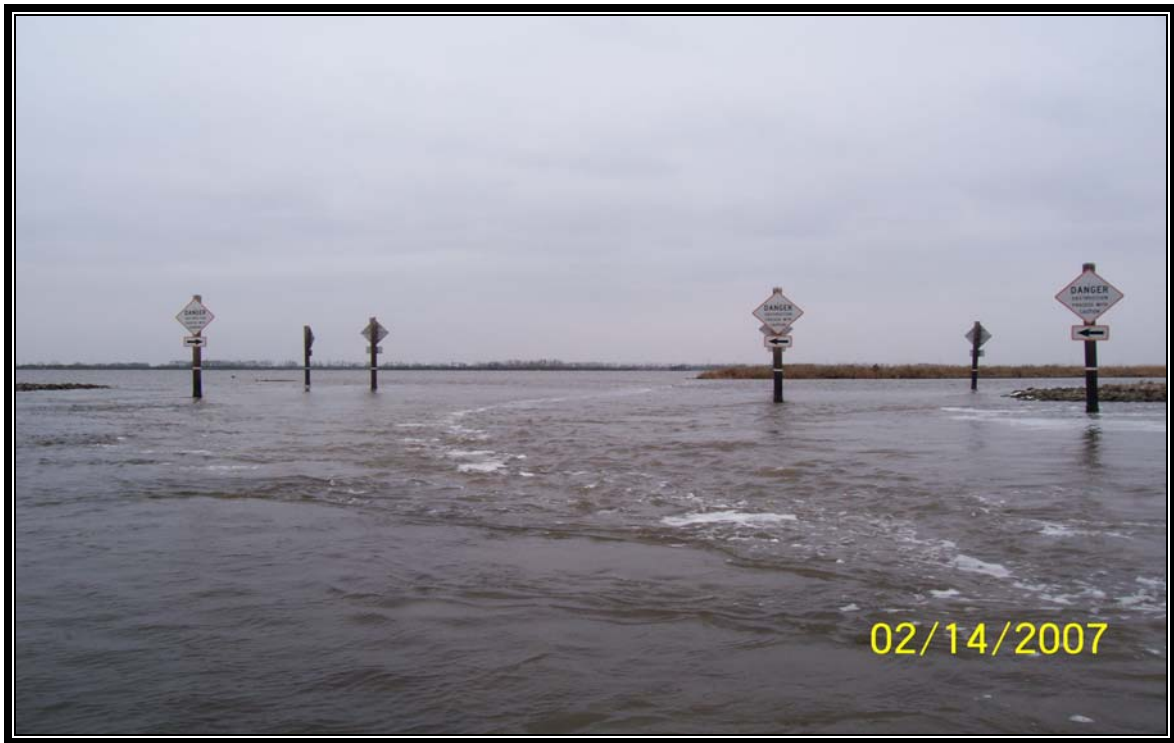
The rip-rap lined channel along the Voss Canal appeared to be in very good condition with no noticeable settlement along the rock embankments of the structure. The visual assessment of the structure is limited since a large portion of the channel liner is below the water line. Without a survey profile of the centerline of the structure, we are unable to determine if the rock rip rap below the water line has settled. At some point

Photo 8 – (Structure 10) – south bank of rock lined channel along Voss Canal.

Photo 9 – (Structure 10) – rock lined channel located along Voss Canal.

in the future, it is recommended that a maintenance survey be performed to determine the degree of settlement, if any. The signs and timber supports were also in good condition (Appendix A, Pages 8 and 9).

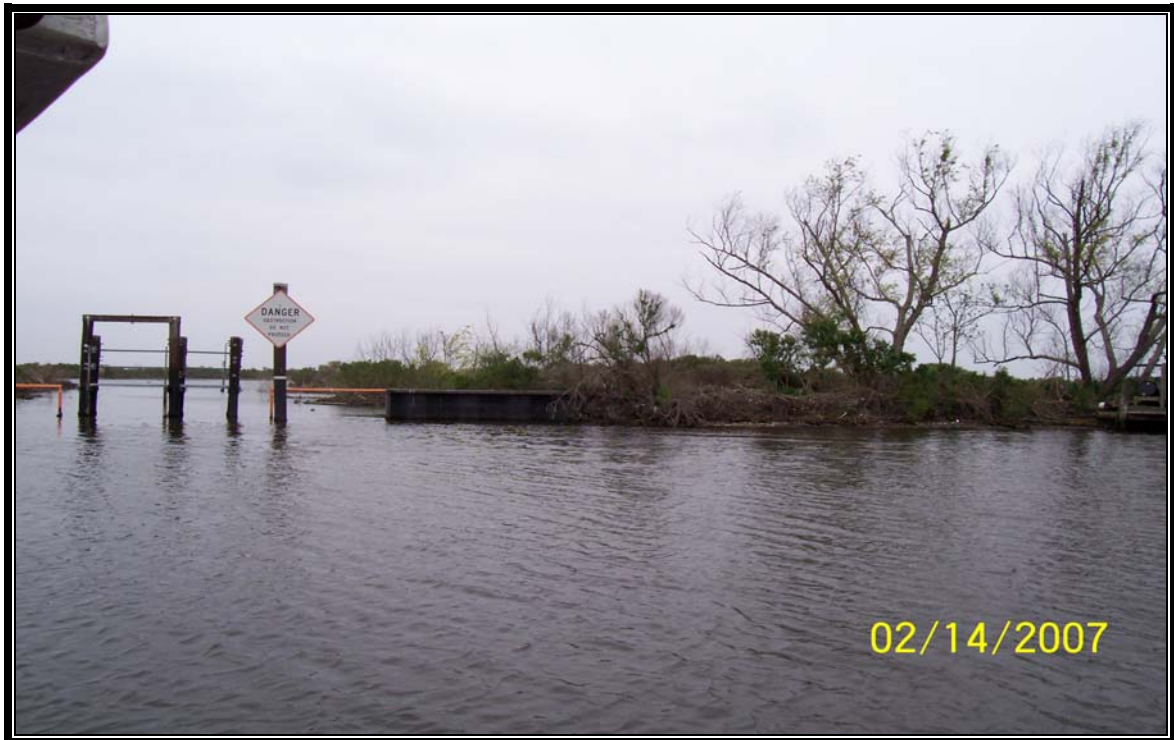
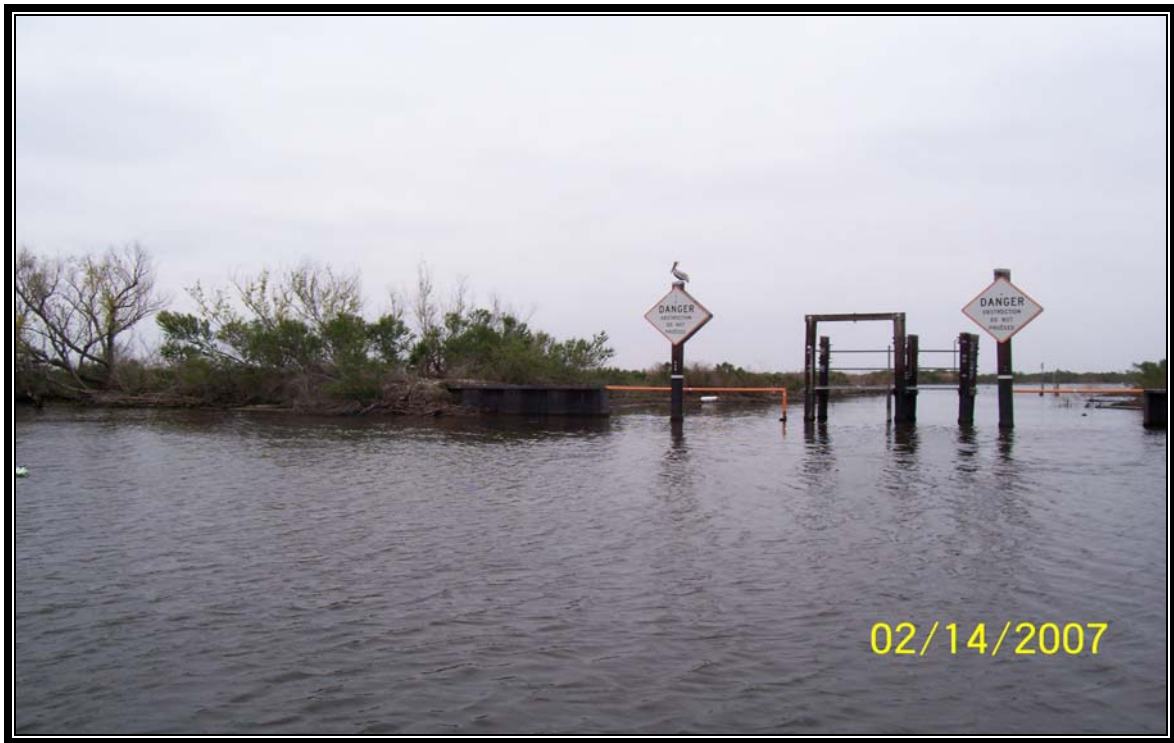
The steel sheet pile weir and bulkhead was in good condition with no physical damage or major corrosion noted. The inspection team did notice moderate erosion and cut banks along the earthen tie-ins on both sides of the structure. The earthen tie-ins remain stable and no breaching is expected to occur during this maintenance cycle. A visual inspection of the marsh adjacent to the structure revealed that the depth of water was very shallow. Without further investigation, the inspection team does not believe that the shallow water is negatively impacting the operations of the structure. This structure was last operated in March 2007 by T. Baker Smith under Indefinite Deliverable Indefinite Quantity (IDIQ) contract to LDNR. Nine (9) stop logs were removed on March 16, 2007, to a crest elevation of -5.57 ft NAVD88. The structural components, signs, and timber supports were in good condition. The erosion noted at the earthen bank tie-ins shall be monitored on future site visits (Appendix A, Photos 10 and 11).

Photo 10 – (Structure 14) – southern tie-in of variable crest weir structure along Carencro Bayou.

Photo 11 – (Structure 14) – northern tie-in of variable crest weir along Carencro Bayou.

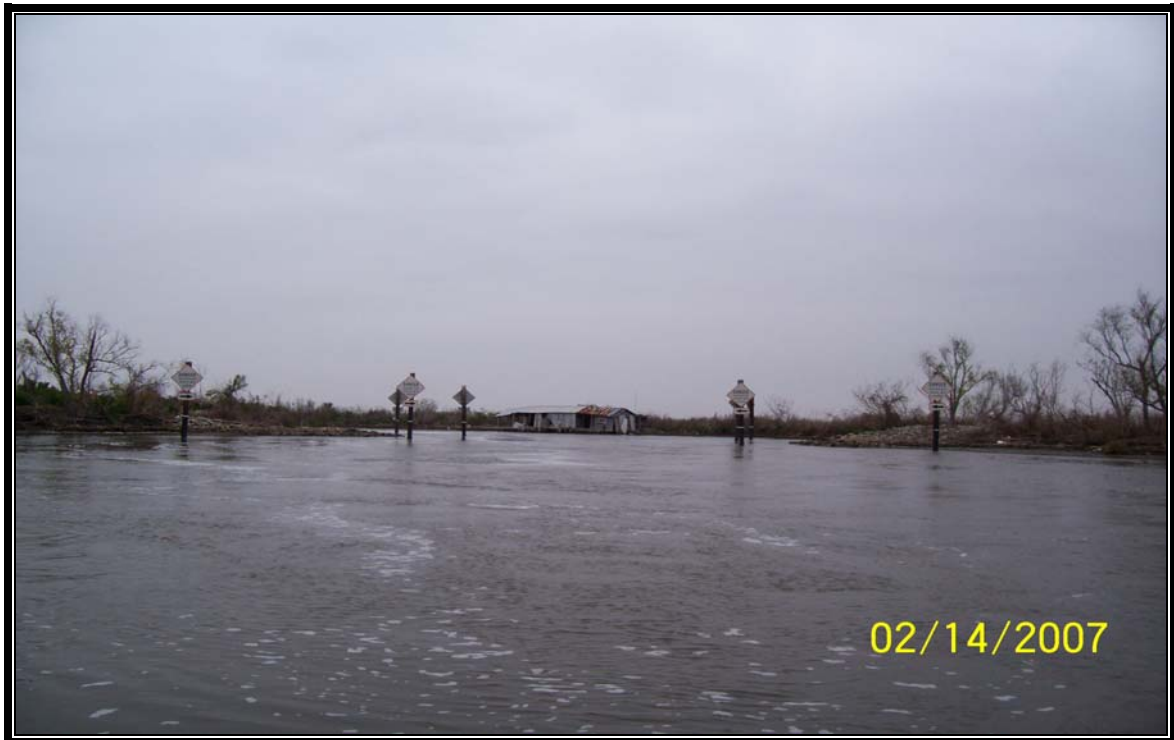
The rip-rap lined channel located along the west bank of Jug Lake appeared to be in very good condition with no noticeable settlement along the rock embankments of the structure above the water line. Without a survey profile of the structure, we are unable to determine if the rock rip rap lining the channel has settled over the years. At some point in the future, it is recommended that a maintenance survey be performed to determine the degree of settlement, if any. The signs and timber supports were also in good condition (Appendix A, Photo 12).

Photo 12 – (Structure 20) – rock lined channel located on the southwest side of Jug Lake.

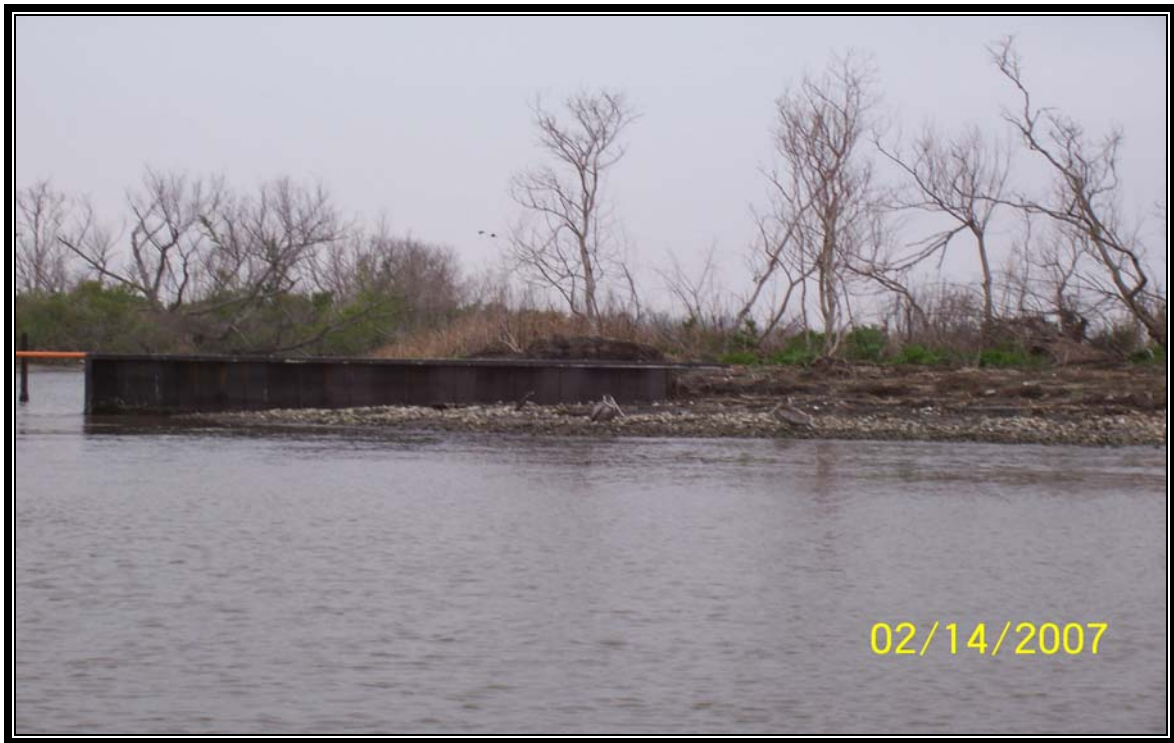
The variable crest weir structure appears to be in good condition. The earthen wing walls were recently refurbished in October 2006 by the Apache Corporation under in-kind services agreement and are holding up well. The water elevation at the time of the inspection was 0.54 ft NAVD88 measured from the hex bolt benchmark on the steel sheet pile wall. All signs and timber supports were also in good condition. The variable crest weir structure was operated on March 16, 2007, at which time a total of 17 stop logs were removed (5 logs east bay, 10 logs center bay, 2 logs on the west bay). The structure components, signs, and timber pile supports were all in good condition (Appendix A, Photo 13 - Note: Other photos taken the day of the inspection are not available).

Photo 13 – (Structure 21) – earthen embankment tie-in on the north side of the structure.

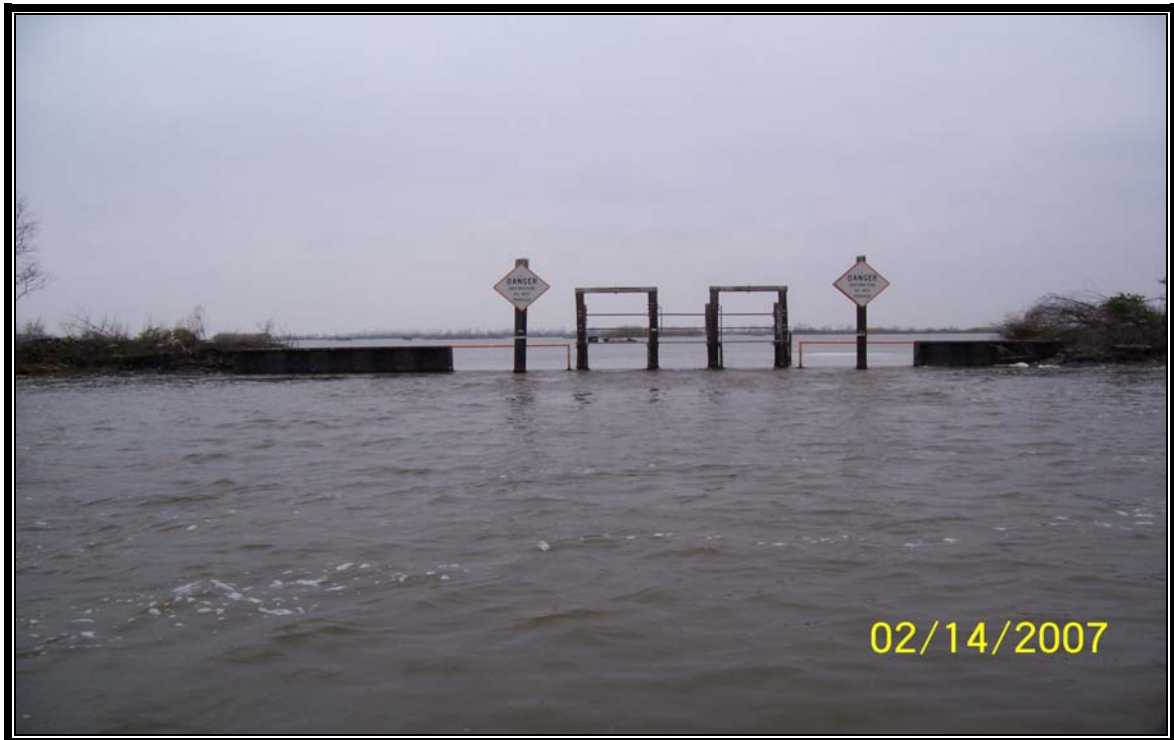
The variable crest weir structure appeared to be in good condition. The earthen wing walls on both sides of the structure were recently reinforced in October 2006 by Apache Corporation under their in-kind services agreement with LDNR. The structural components, signs, and timber supports were all in good condition with no visible sign of damage. The variable crest weir structure was operated by T. Baker Smith on March 16, 2007, at which time a total of 20 logs were removed (10 logs from the north bay and 10 logs from the south bay)(Appendix A, Photo 14 – Note: Other photos taken the day of the inspection are not available).

Photo 14 – (Structure 23) – variable crest weir located along the northeast bank of Jug Lake.

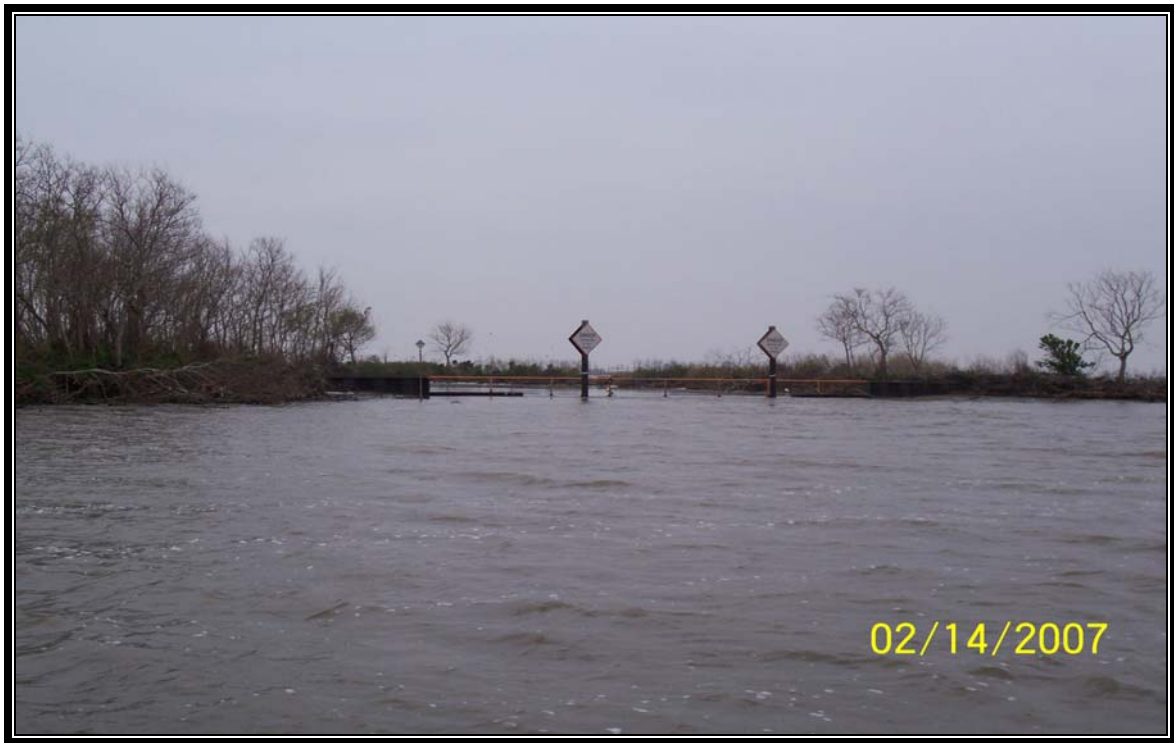
The fixed crest weir structure appeared to be in good condition. The earthen wing walls were recently repaired in October 2006 by Apache Corporation under their in-kind services agreement with LDNR. The structural components, signs, and timber supports were also in good condition (Appendix A, Photo 15).

Photo 15 – (Structure 24) – fixed crest weir structure along the east bank of Jug Lake.

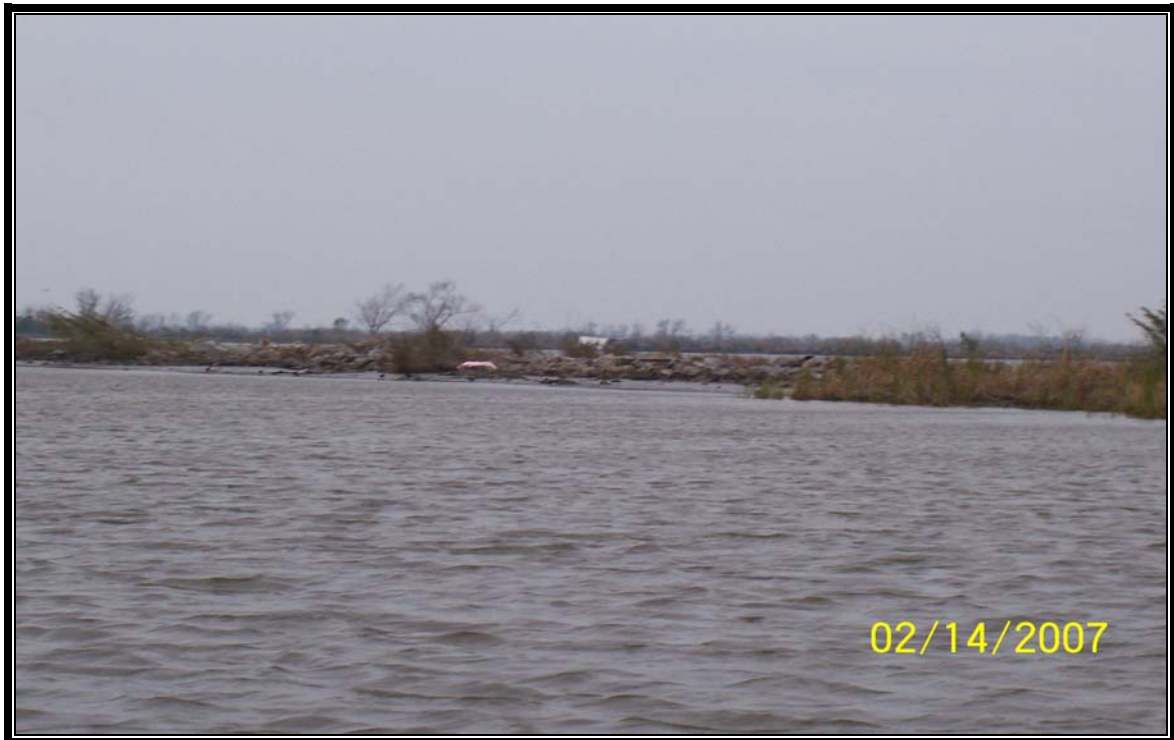
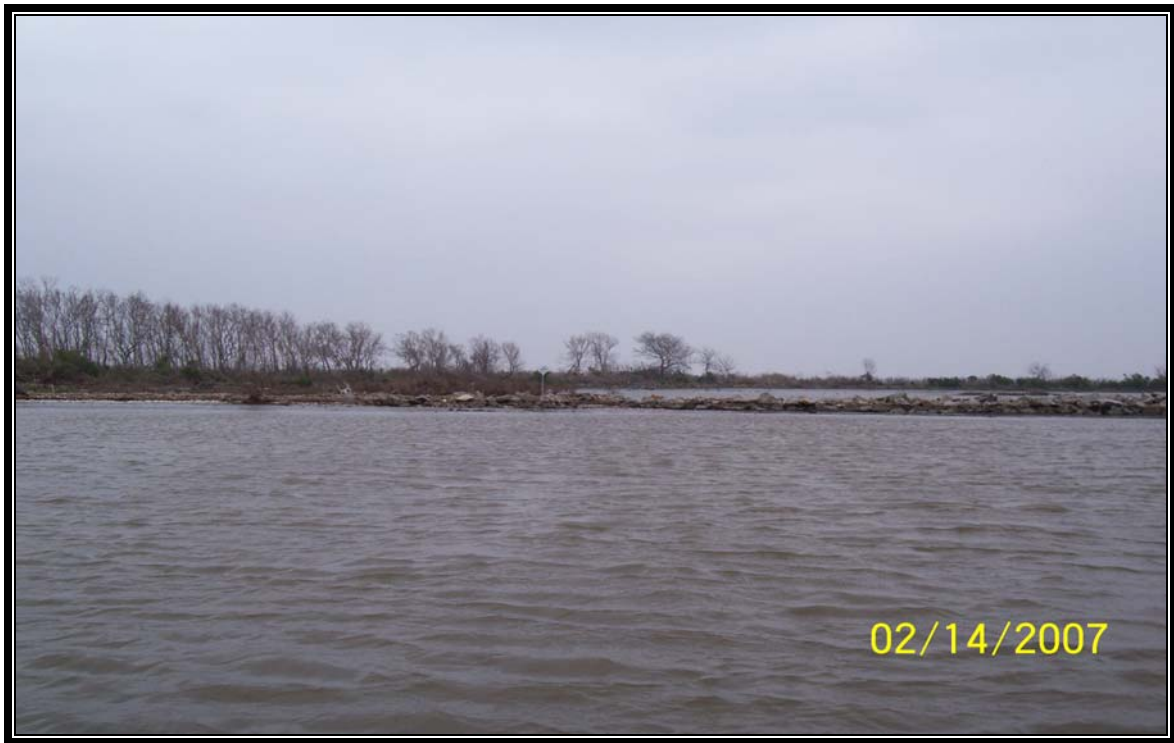
Breach Repair 1 through 4 involved the closure of large openings in the low-lying levee along Bayou Decade (Figure 2). Due to the elevation of the existing bank line and the size of the openings in the levee, a rock dike was constructed along the length of Bayou Decade from Turtle Bayou to Jug Lake. The rock dike was in fair condition with several low areas and moderate displacement of rock from Hurricane Rita. The earthen embankment tie-ins on both sides of the lengthy structure are areas of concern. These areas were not repaired under the 2003 maintenance project and remain low and vulnerable to erosion. The inspection team will continue to monitor the condition of the tie-ins (Appendix A, photos 16 and 17).

Photo 16 – (Breach Repair 1 through 4) - rock dike constructed in 2003 to close large openings in the bank.

Photo 17 – (Breach Repair 1 through 4) – rock dike constructed in 2003 to close large openings in the bank.

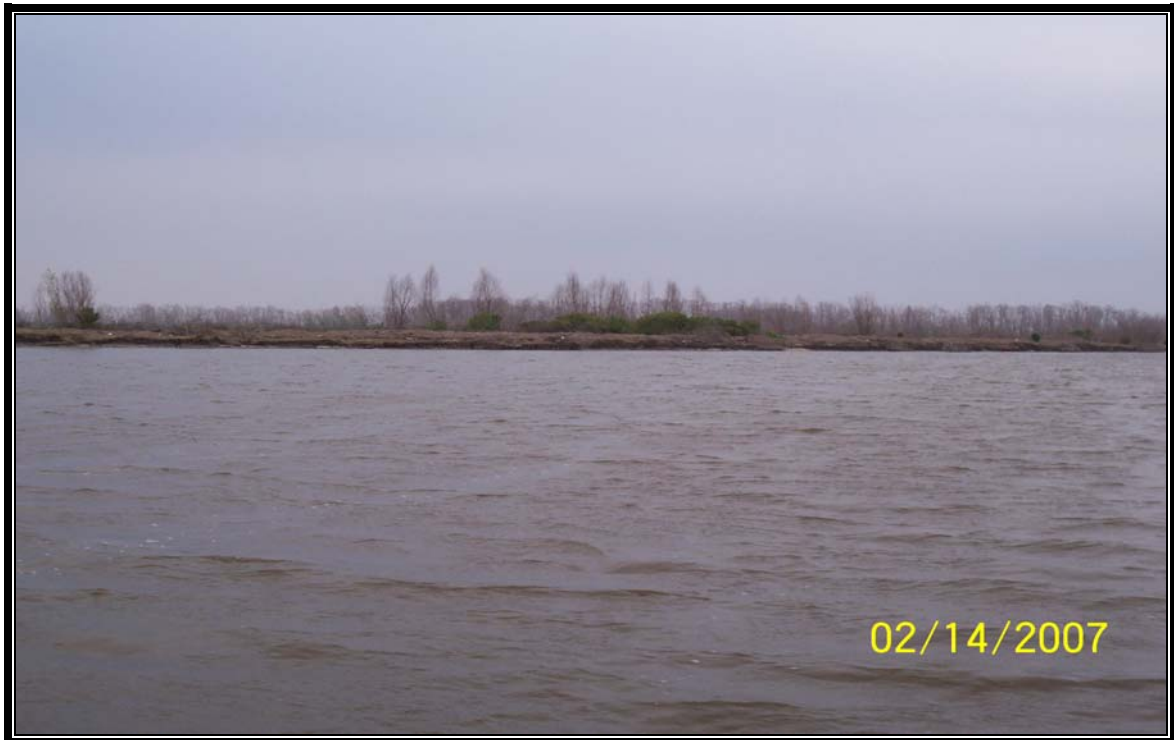
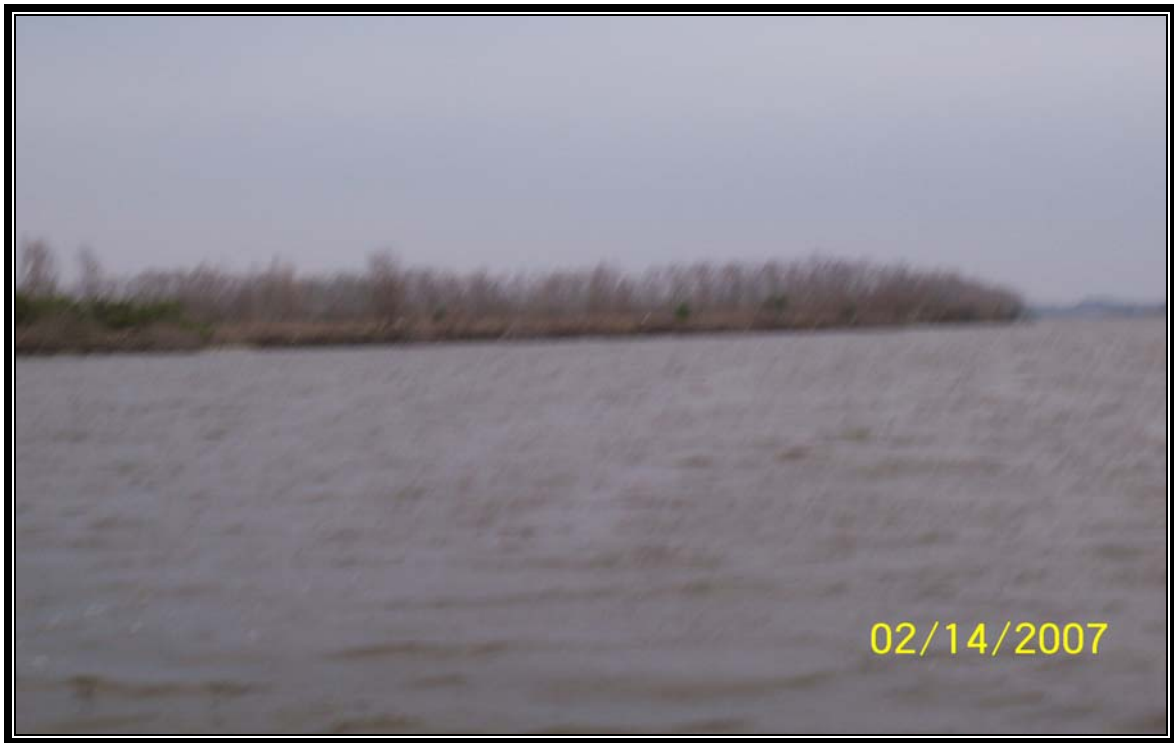
Breach Repair 5 and 6 – consisted of a low area along Turtle Bayou from the mouth of Superior Canal 1500 ft southward. This low area was refurbished using dredge material from Turtle Bayou. The overall length of the refurbished levee is in good condition. However, we did notice moderate cut banks along the entire length of the levee. Although erosion is evident, the embankment is structurally sound and in good condition (Appendix A, Photos 18 and 19).

Photo 18 – (Breach Repair 5 and 6) – Levee refurbishment along Turtle Bayou completed in 2003.

Photo 19 – (Breach Repair 5 and 6) – Levee refurbishment along Turtle Bayou completed in 2003.

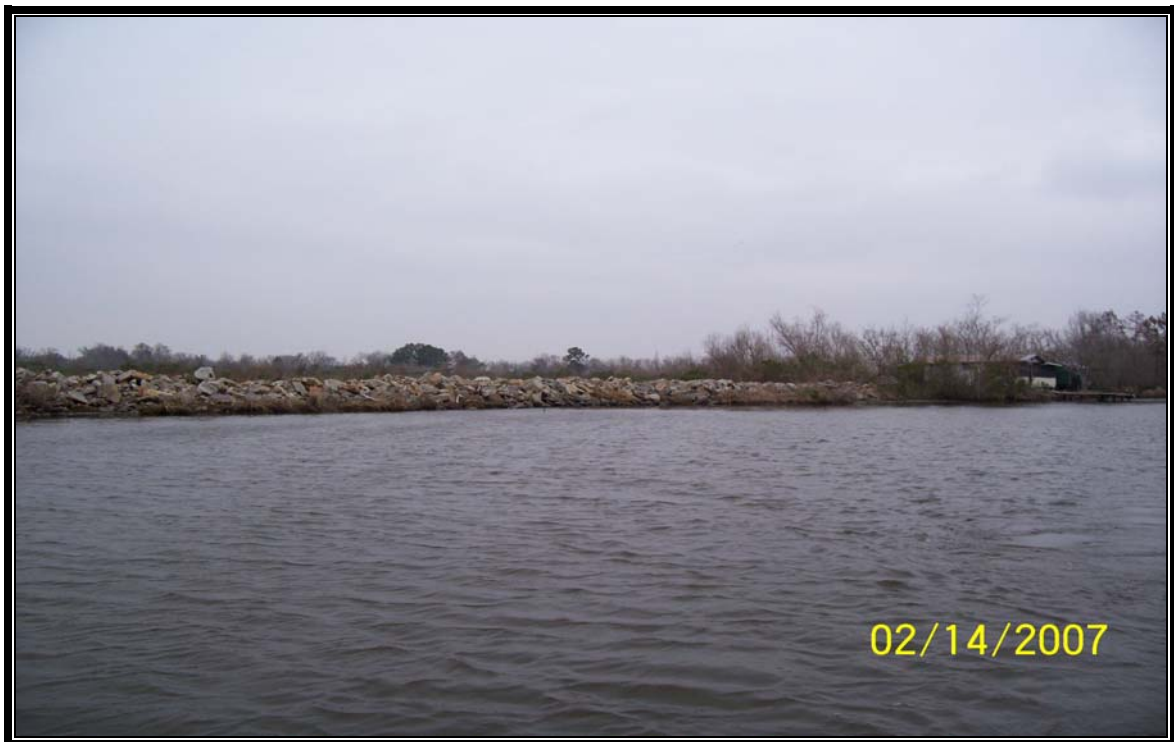
Breach Repair 7 – located along an existing oilfield canal off of Superior Canal. Due to the depth of the opening in the levee, rock rip rap was used to close the breach (Appendix A, Photo 20). The rock rip-rap plug looked to be in very good condition with no noticeable settlement. It was estimated that the crown elevation of the rock plug was +3.5 ft NAVD88. A small breach located across the canal from structure 7 was repaired in 2006 by the Apache Corporation (Appendix A, Photo 21).

Photo 20 – (Breach Repair 7) – rock dike along location canal off of Superior Canal completed in 2003.

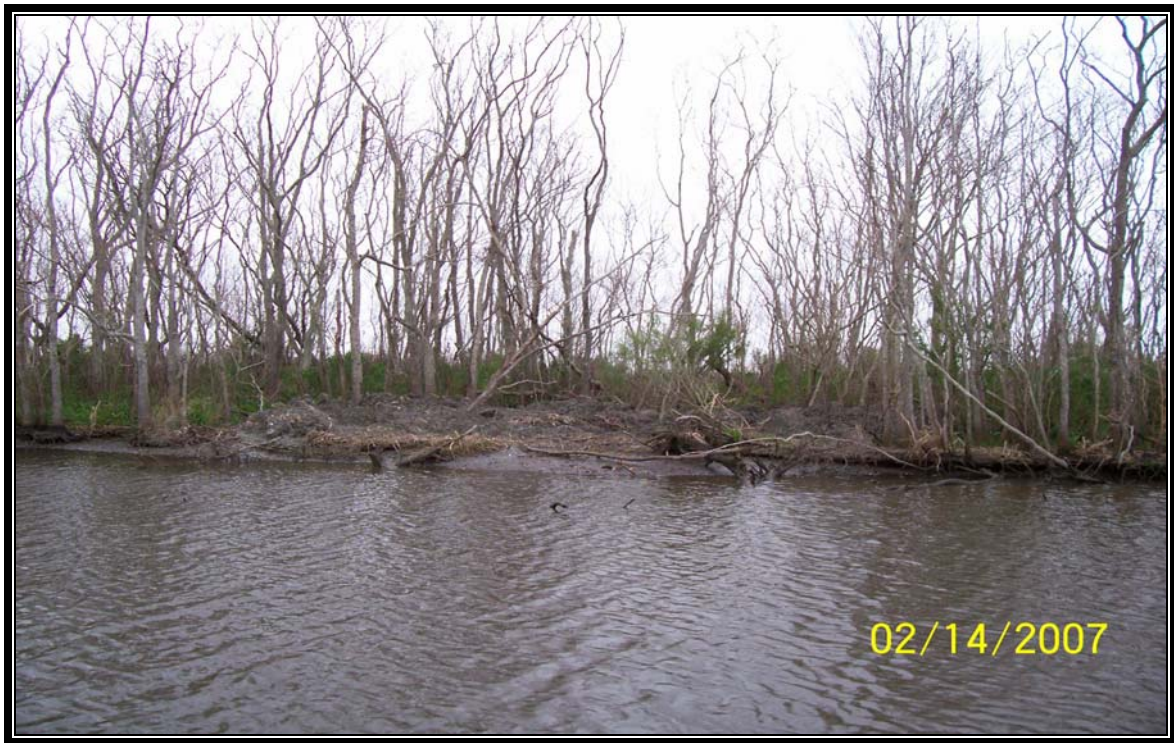
Photo 21 – Breach repair located along Breach 7 completed in 2006 by Apache Corporation.
