**2007 Operations, Maintenance,
and Monitoring Report**

**BRADY CANAL HYDROLOGIC
RESTORATION**

State Project Number TE-28
Priority Project List 3

August 2007
Terrebonne Parish

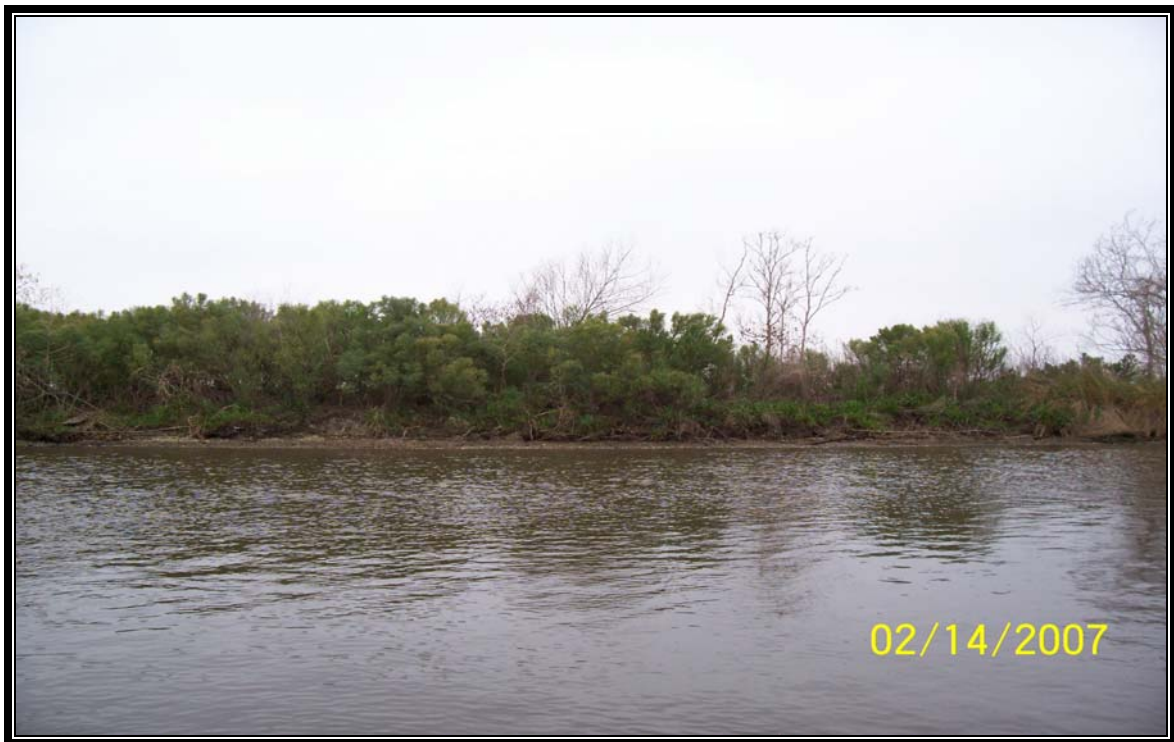
Breach Repair 8 – approximately 200 ft long located along Superior Canal adjacent to an existing pipeline right-of-way. This breach was repaired using dredge material from Superior Canal. The earthen embankment in this area was in good condition. We did note that cut banks along the face of the embankment have developed since the breach repair. The vegetation along the breach repair was thick and plentiful (Appendix A, Photo 22).

Photo 22 – (Breach Repair 8) – levee refurbishment along Superior Canal completed in 2003.

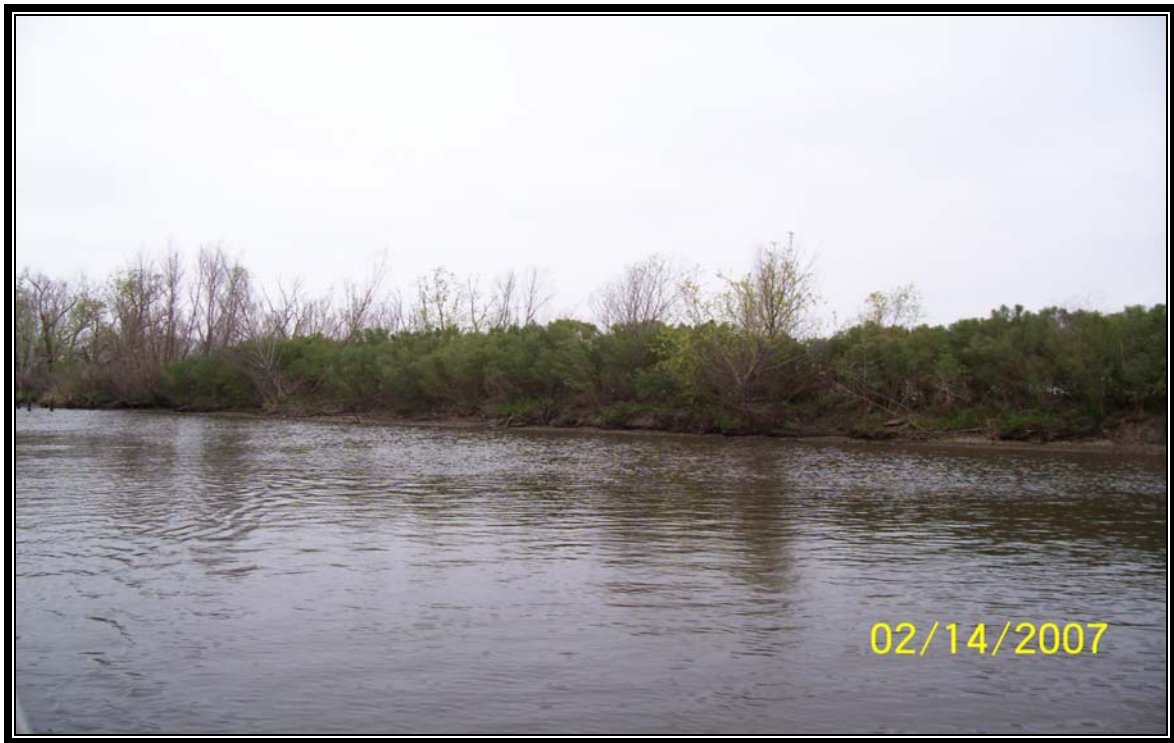
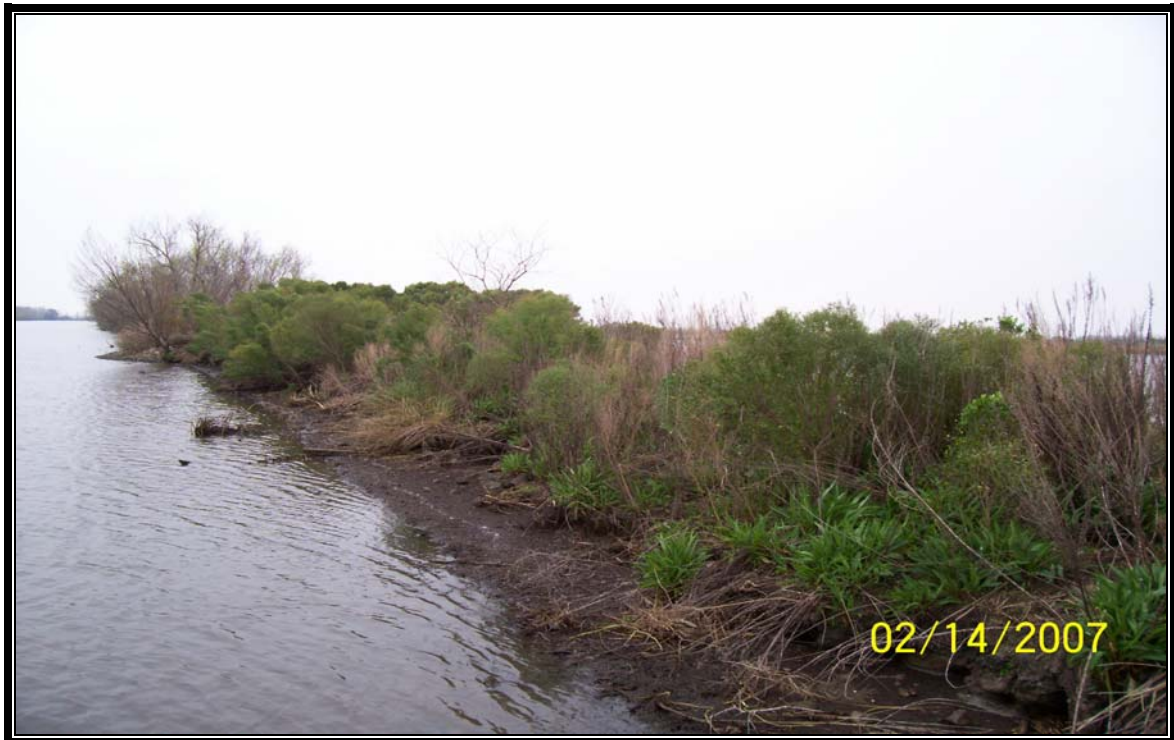
Breach Repair 9 – approximately 250 ft long located along Superior Canal near the bend. This breach was repaired using dredge material from Superior Canal. The earthen embankment in this area was in good condition with no noticeable erosion or settlement. Vegetation was plentiful (Appendix A, Photo 23 and 24).

Photo 23 - (Breach Repair 9) – levee refurbishment along Superior Canal completed in 2003.

Photo 24 – (Breach Repair 9) – levee refurbishment along Superior Canal completed in 2003.

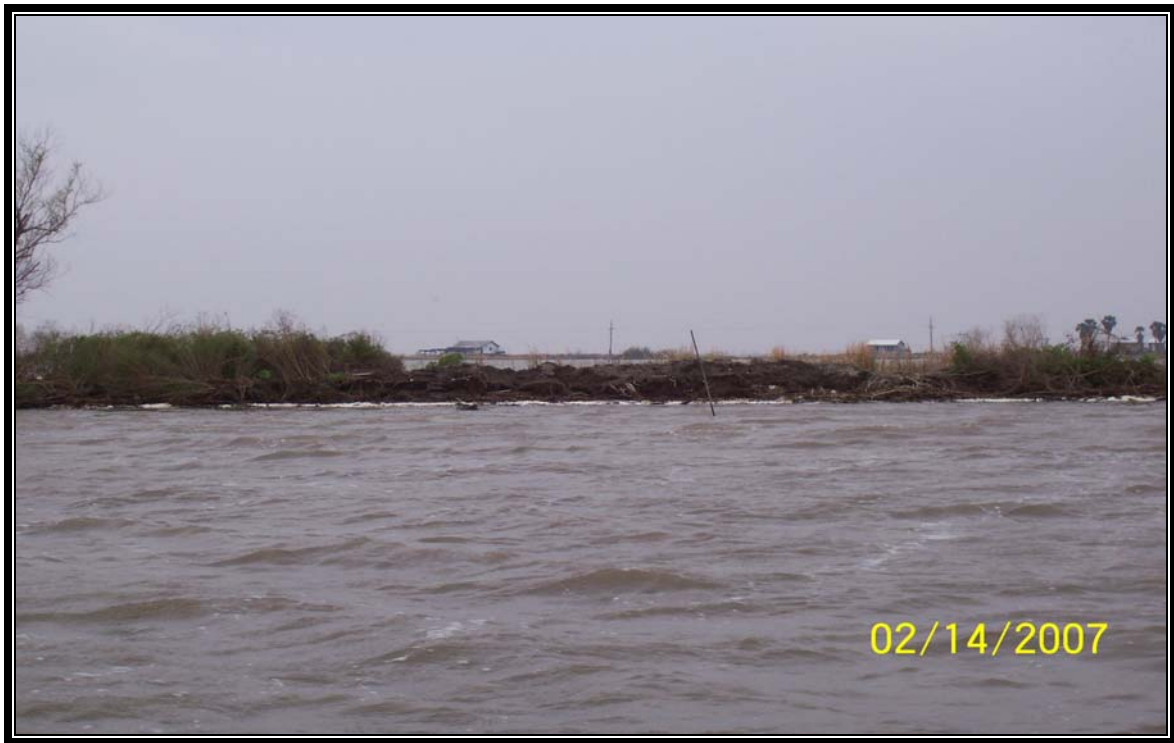
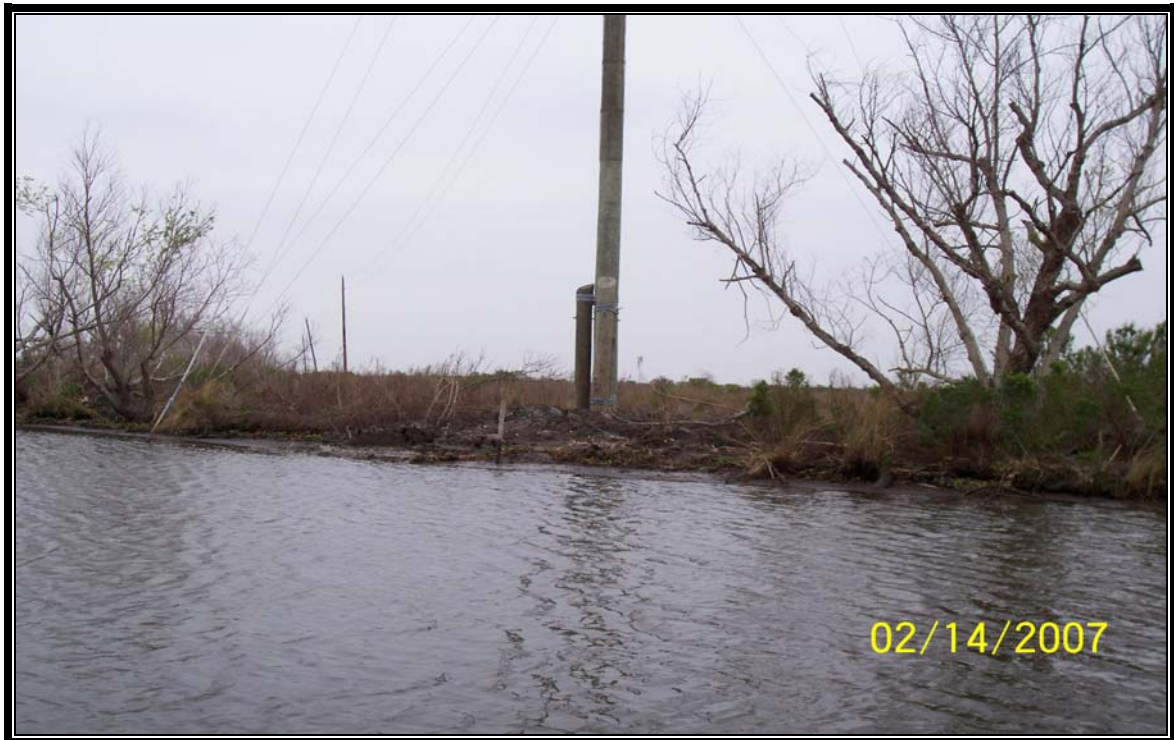
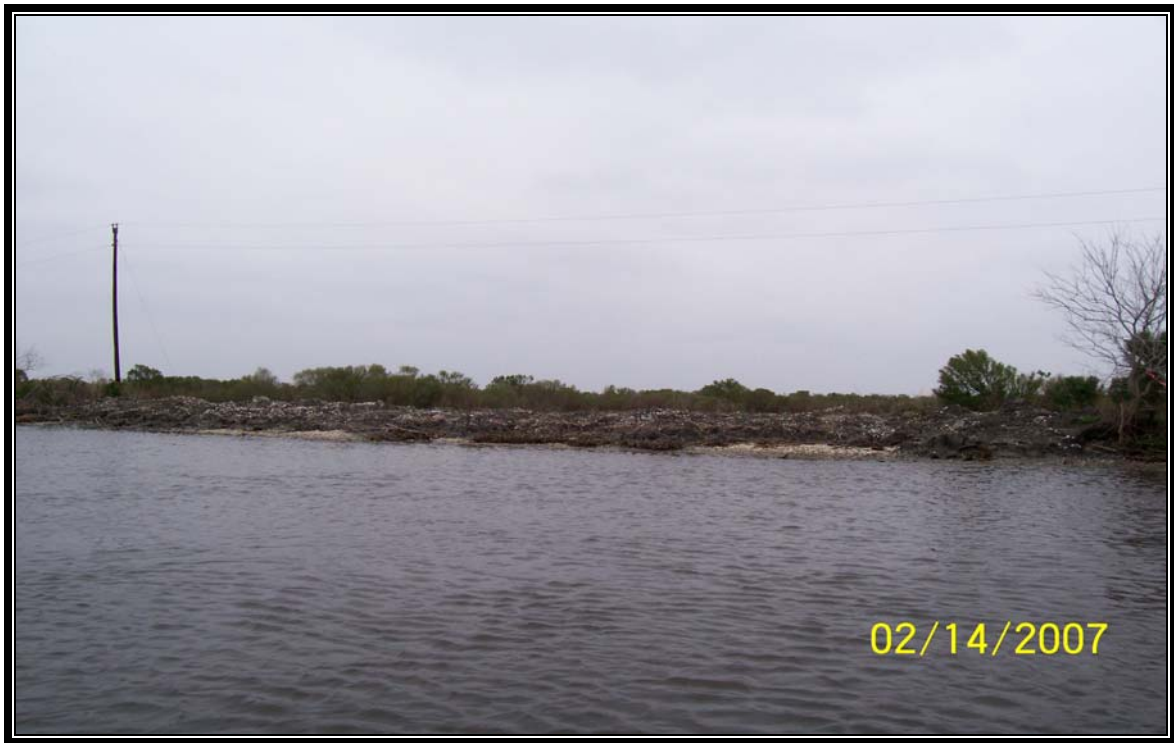
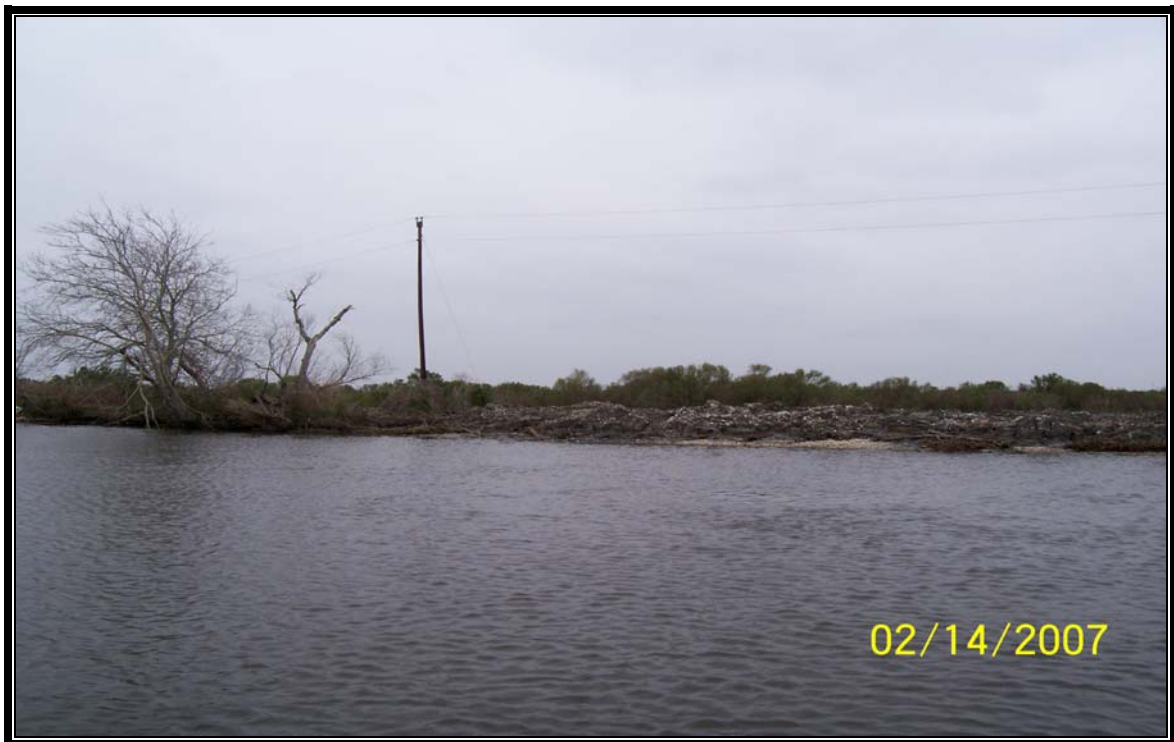
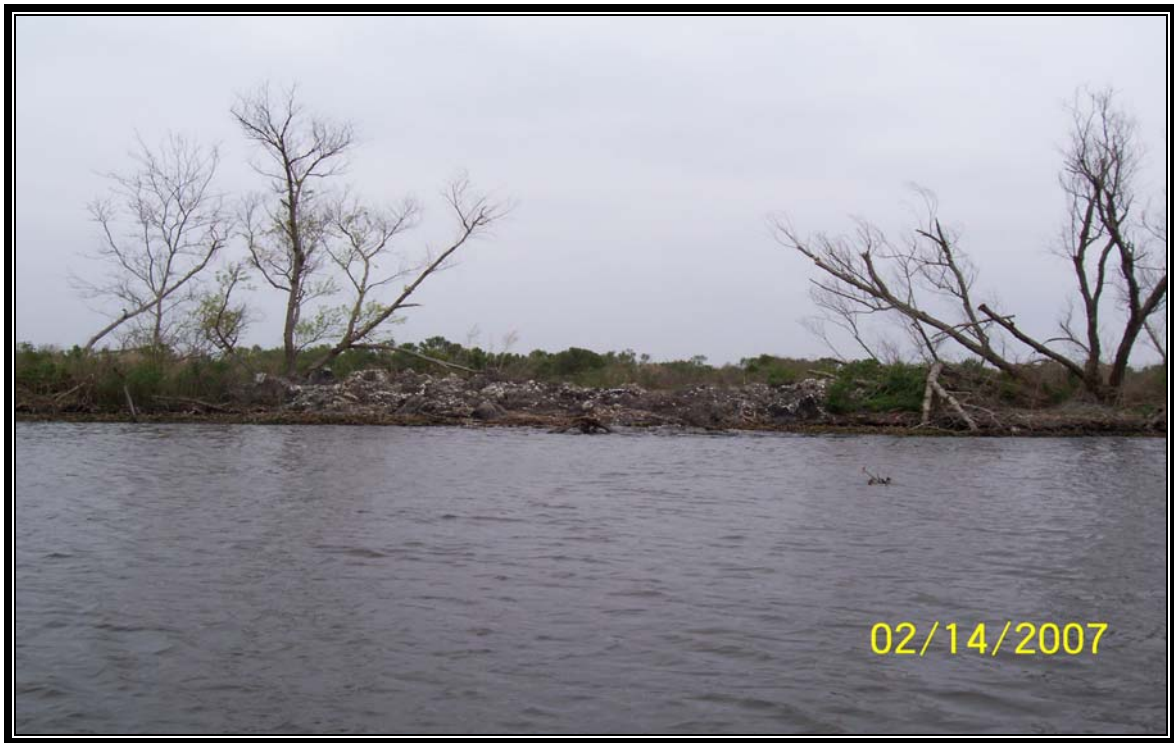
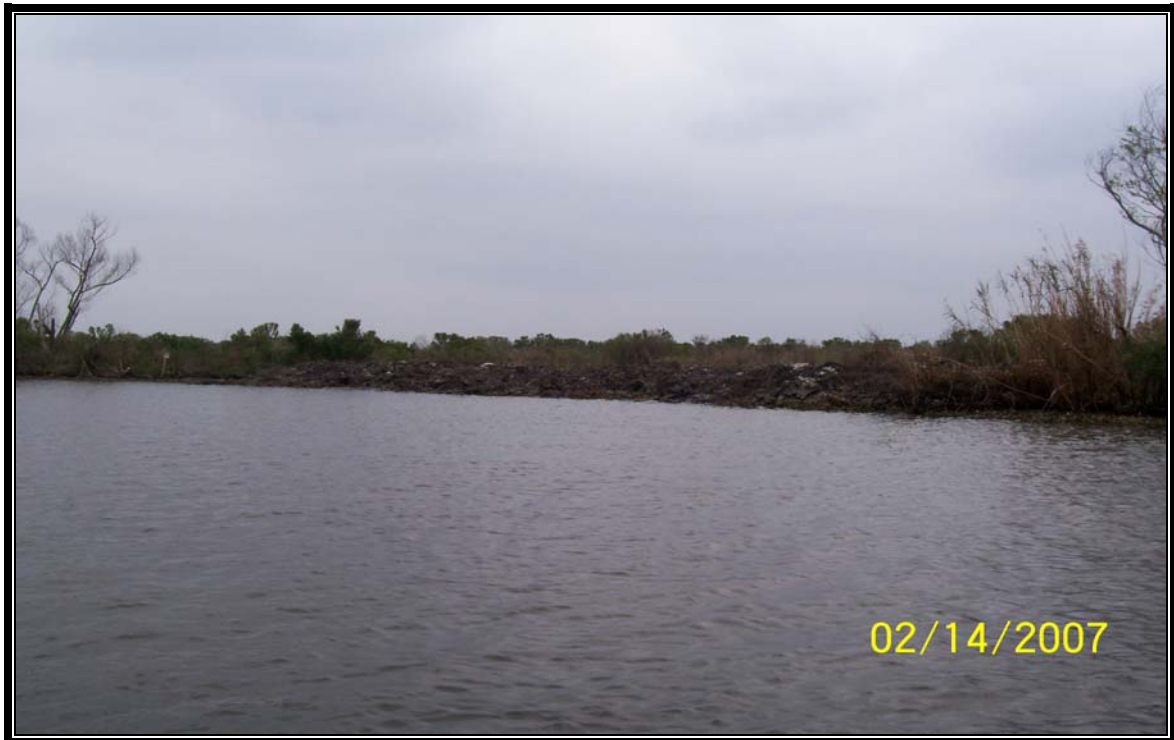
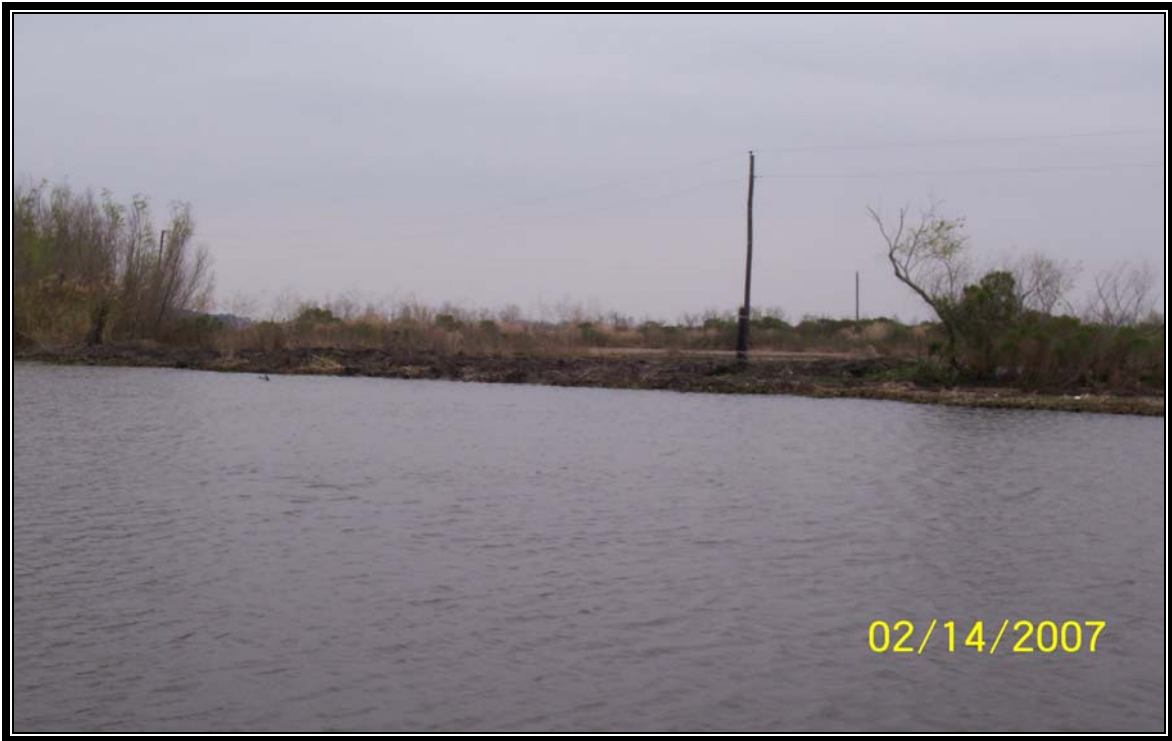
In 2006, the Apache Corporation completed breach repairs along the east bank of Jug Lake, along Carencro Bayou and Brady Canal, and the tie-ins to wing walls of structures 21, 23, and 24 (Appendix A, Photos 25 through 31).

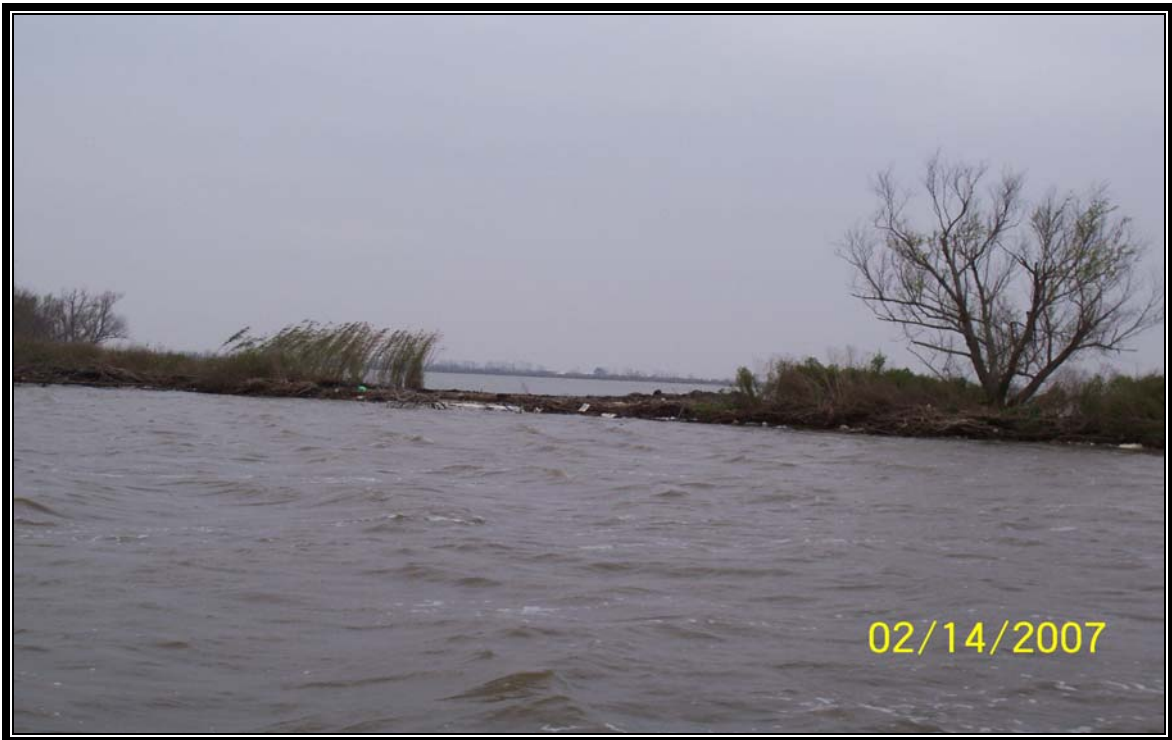
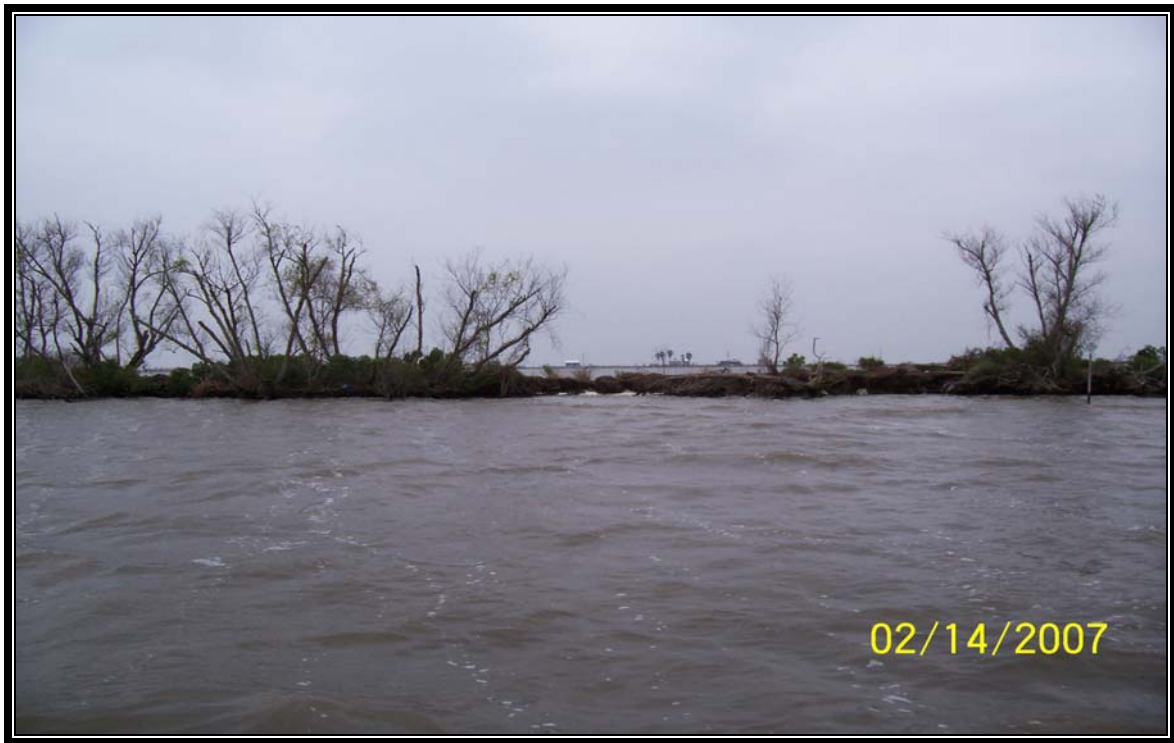
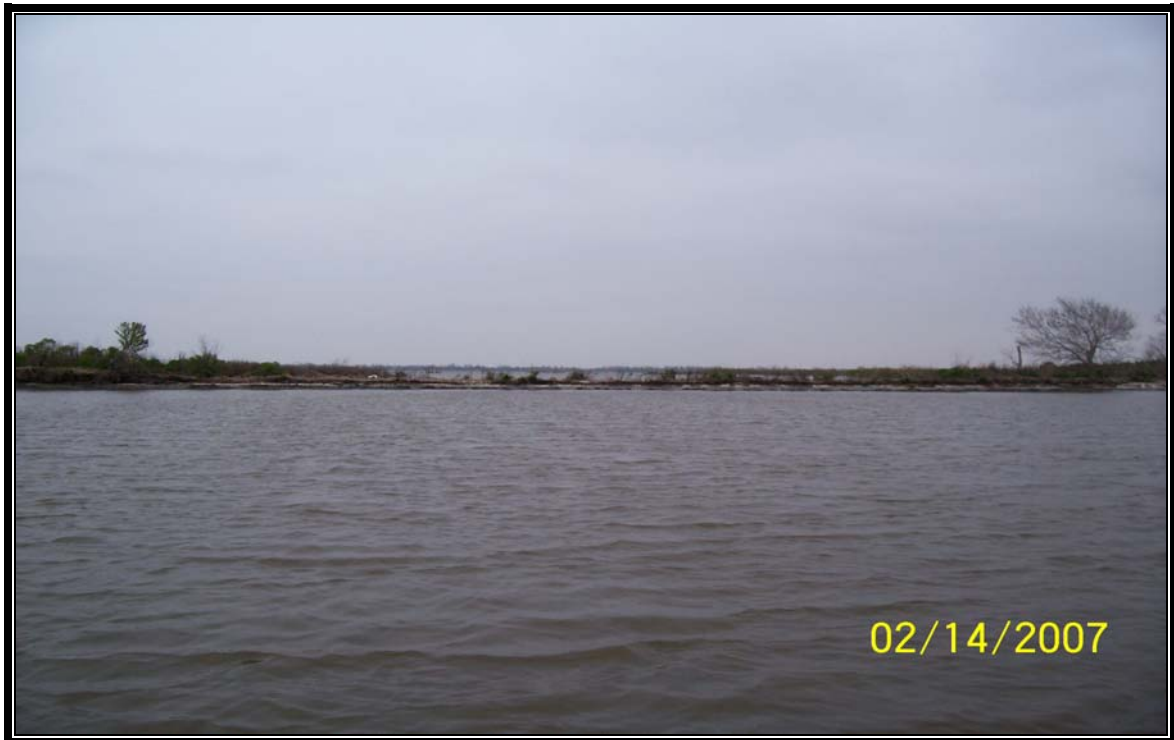
northeast of structure 6 (Appendix A, Photos 32 through 34). We also identified several breaches in the overflow banks along Bayou Carencro and Brady Canal (Appendix A, Photos 35 through 37; Figure 3). The landowner has indicated that he may be interested in reinforcing the low areas and repairing breaches identified during the inspection under their in-kind services agreement with LDNR and NRCS. LDNR and NRCS will continue to work with the landowners on facilitating levee reinforcement and breach repairs as needed. Overall, the earthen embankments bordering the project area appear to be in fair condition. The inspection team will continue to monitor the condition of levees and overflow banks on future site visits.

Photo 32 – Low area along the east bank of Jug Lake southwest of structure 24.

Photo 33 – Low area along the east bank of Jug Lake southwest of structure 24.

Photo 34 – Low area along the north bank of Bayou Decade north east of structure 6.

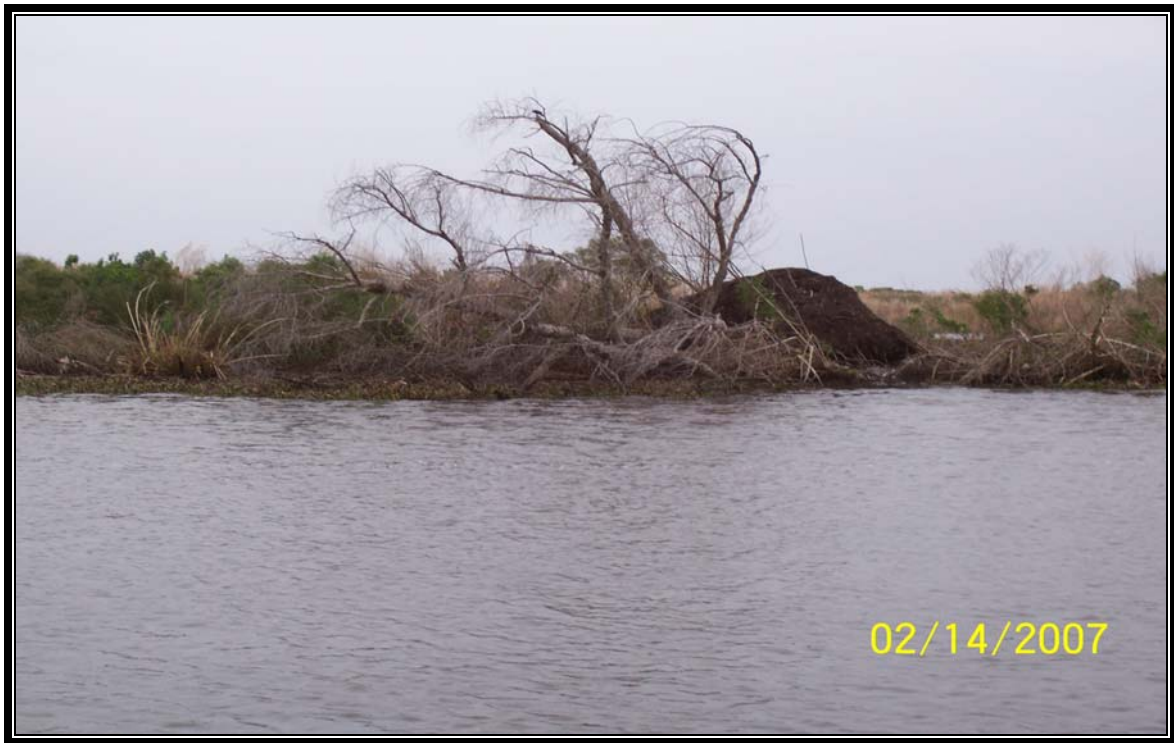
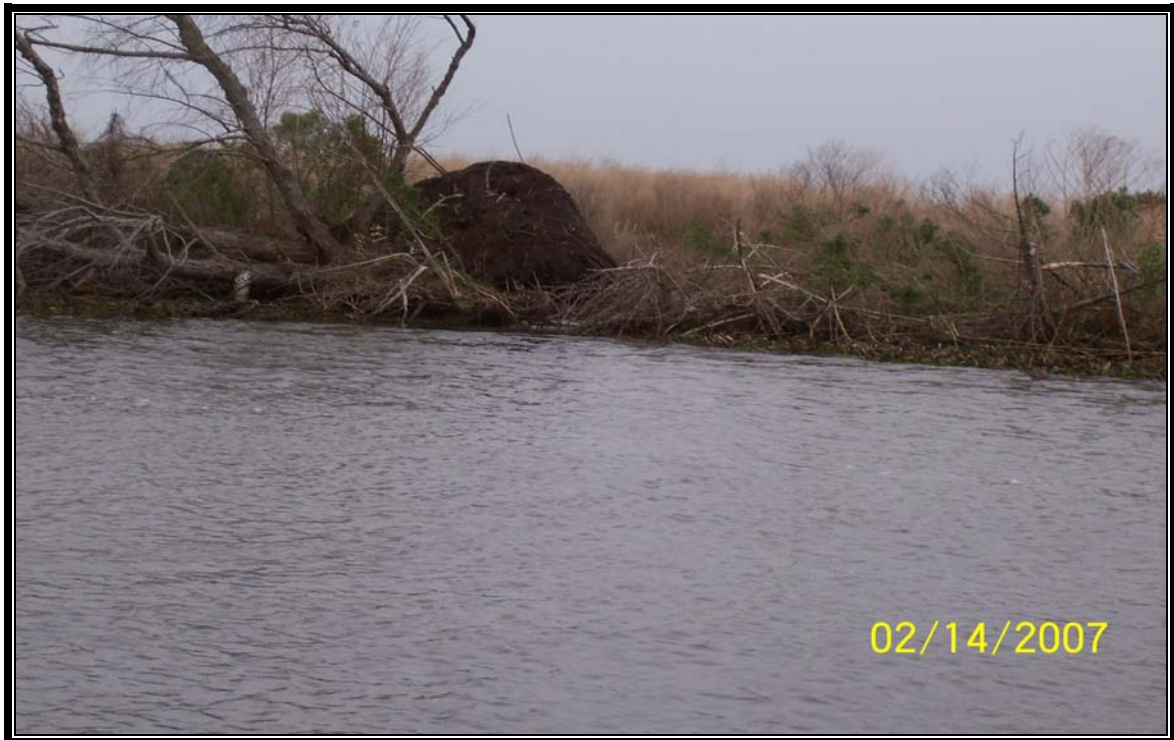
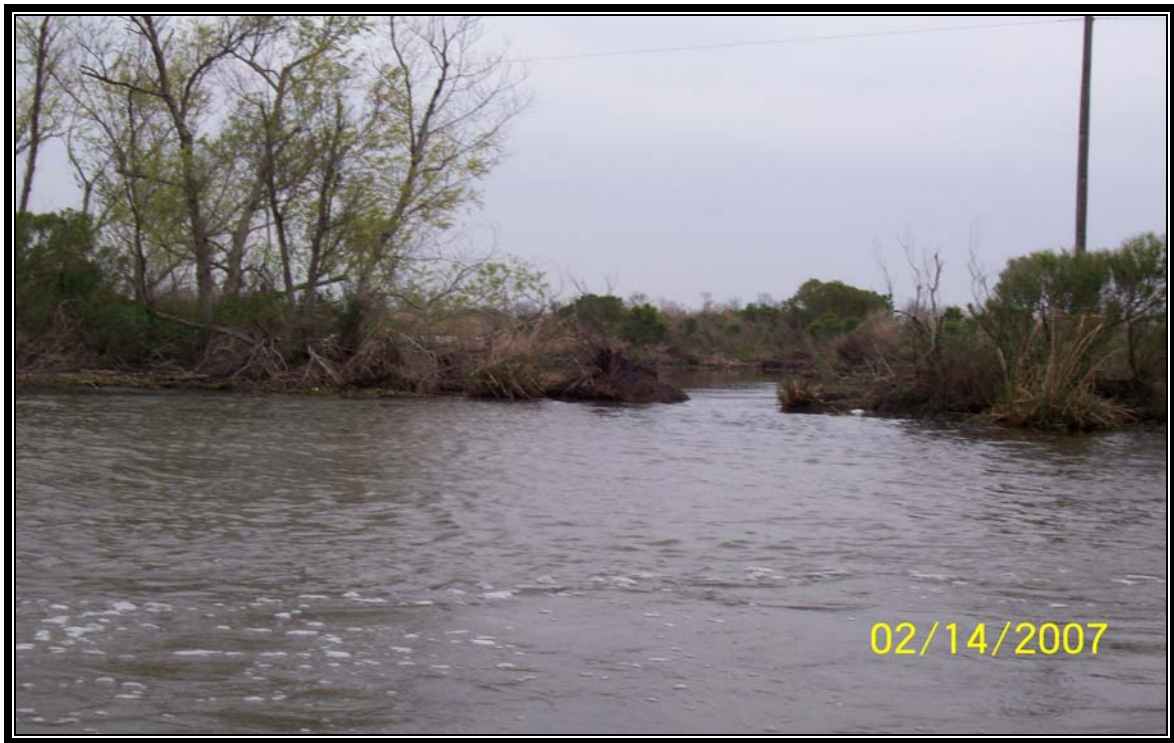
Photo 35 – Newly discovered breach along Carencro Bayou caused by uprooted tree.

Photo 36 – Newly discovered breach along Carencro Bayou uprooted tree.

Photo 37 – Newly discovered breach along the south bank of Brady Canal on the northern boundary of the project.

As outlined in the inspection results of the earthen embankments and overflow banks, we did identify several breaches along Carencro Bayou and Brady Canal that will require maintenance and repairs (Figure 3). Over the past few years, we have noticed a frequent reoccurrence of breaches in the overflow banks along the northern boundary of the project (Little Carencro Bayou, Carencro Bayou, and Brady Canal).
