**2005 Operations, Maintenance, and
Monitoring Report**

**Humble Canal Hydrologic
Restoration**

State Project Number ME-11
Priority Project List 8

June 2005
Cameron Parish

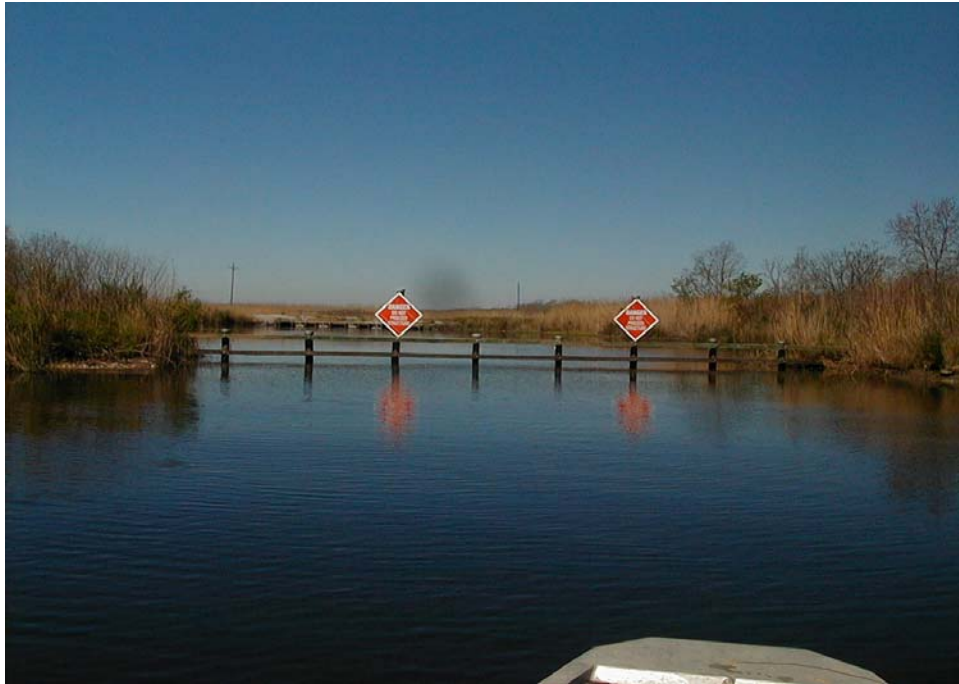
The structure is in excellent condition. Some shrinkage of the sign lettering has occurred. Bank tie-ins, pile caps, hardware, etc. are in excellent condition. No maintenance is required at this time. (Photos: Appendix B, Photos 1 & 2)

Photo 1—marine barrier

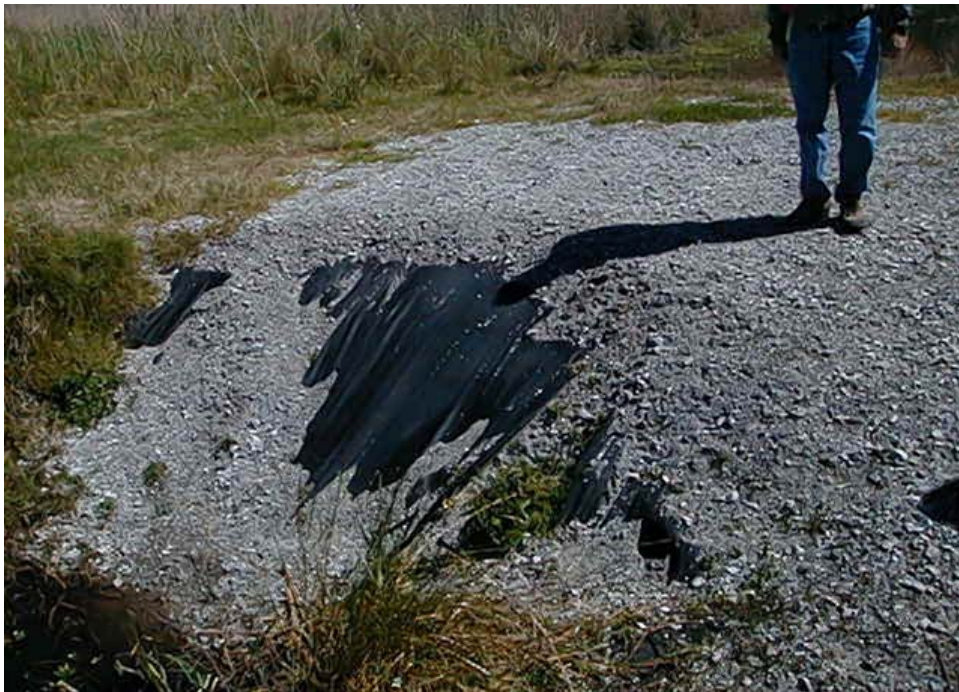
Overall, the structure is in excellent post-construction condition. Some slight sloughing of the rock-armored earthen embankment on both the weir inlet and flapgate sides of the structure has occurred. This situation was noted in the 2003/2004 Annual Inspection and will continue to be monitored. As of now, no maintenance is recommended or required. Hardware, grating, etc. associated with the structure is in excellent condition. Water levels on the inside of the project area were +2.3 ft NAVD. Stoplogs had been removed to approximately -0.5 ft NAVD88 as allowed in the permit. Although no cross-sections were performed, both the inlet and outfall channels appear to be experiencing no slope failures. Both agencies agreed to perform a structural assessment survey in 2006/2007 for comparison to previous as-built surveys.

Photo 2—sloughing rock around structure

| Item | Condition | Physical Damage | Corrosion | Photo # | Observations and Remarks |
|---|---|---|---|---|---|
| Eathern Embankment | fair | | | | Some slight sluffing near the structure has occurred, and geo-textile is exposed. It doesn't appear to have been caused by water scour, but possibly just because of the steep slope involved. This situation will be monitored to see if it worsens. |

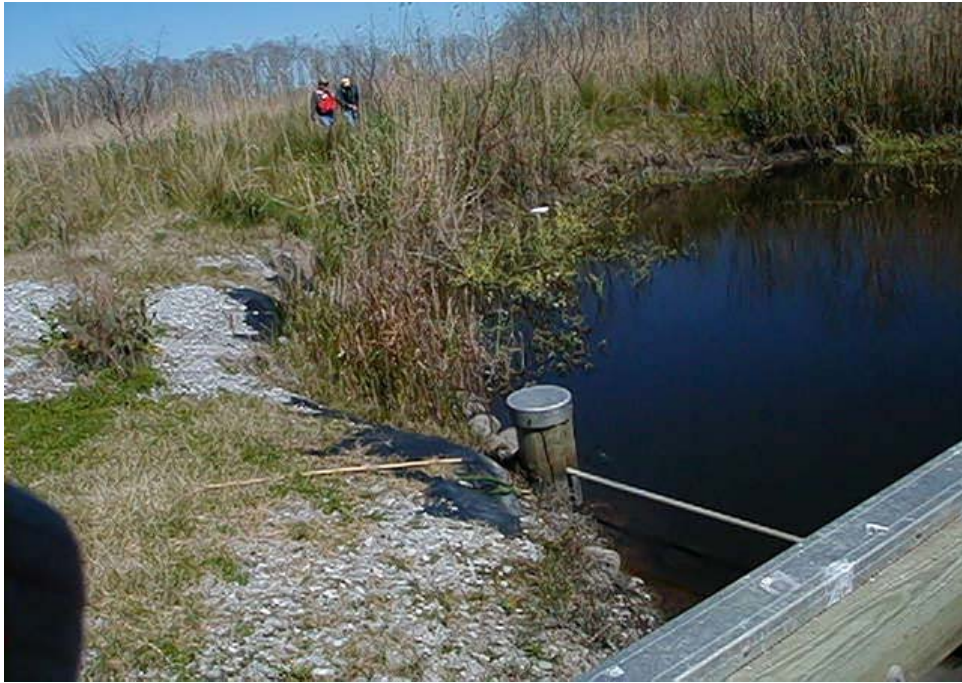
Photo 3—exposed cloth around structure

Stable on both the inlet and outlet channels. Assessment survey to be performed in '05-'06. Exposed cloth near the structure as noted.

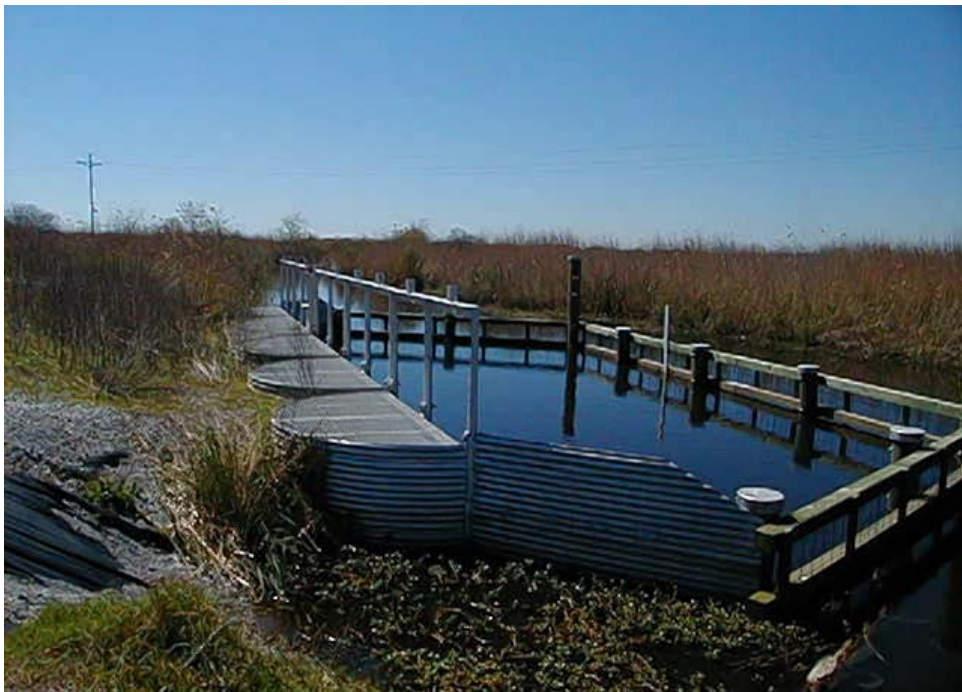
The structure is in excellent condition. No maintenance is required at this time. (Photo: Appendix B, Photo 3)

Photo 4—inlet side of structure and hyacinth guard
