**2005 Operations, Maintenance,
and Monitoring Report**

**Freshwater Bayou Canal Bank
Stabilization**

State Project Number ME-13
Priority Project List 5

June 2005
Vermilion Parish

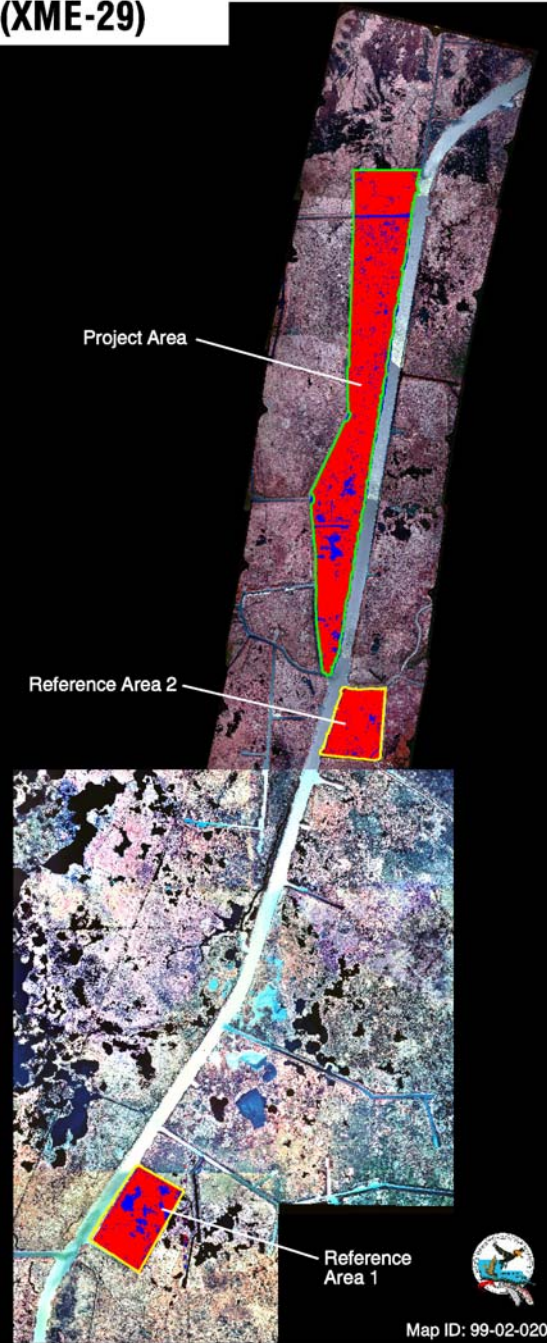
Aerial photography obtained pre-construction on December 19, 1996, (and January 11, 1997, for reference area R2) was analyzed to determine land-water ratios. The project area comprised 86.9% land to 13.1% water, while Reference 1 was 92.9% land to 7.1% water, and Reference 2 was 82.6% land to 17.4% water (figure 2).

Figure 2. Pre-construction land to water relationships in the Freshwater Bayou Canal Bank Stabilization (ME-13) project and reference areas.

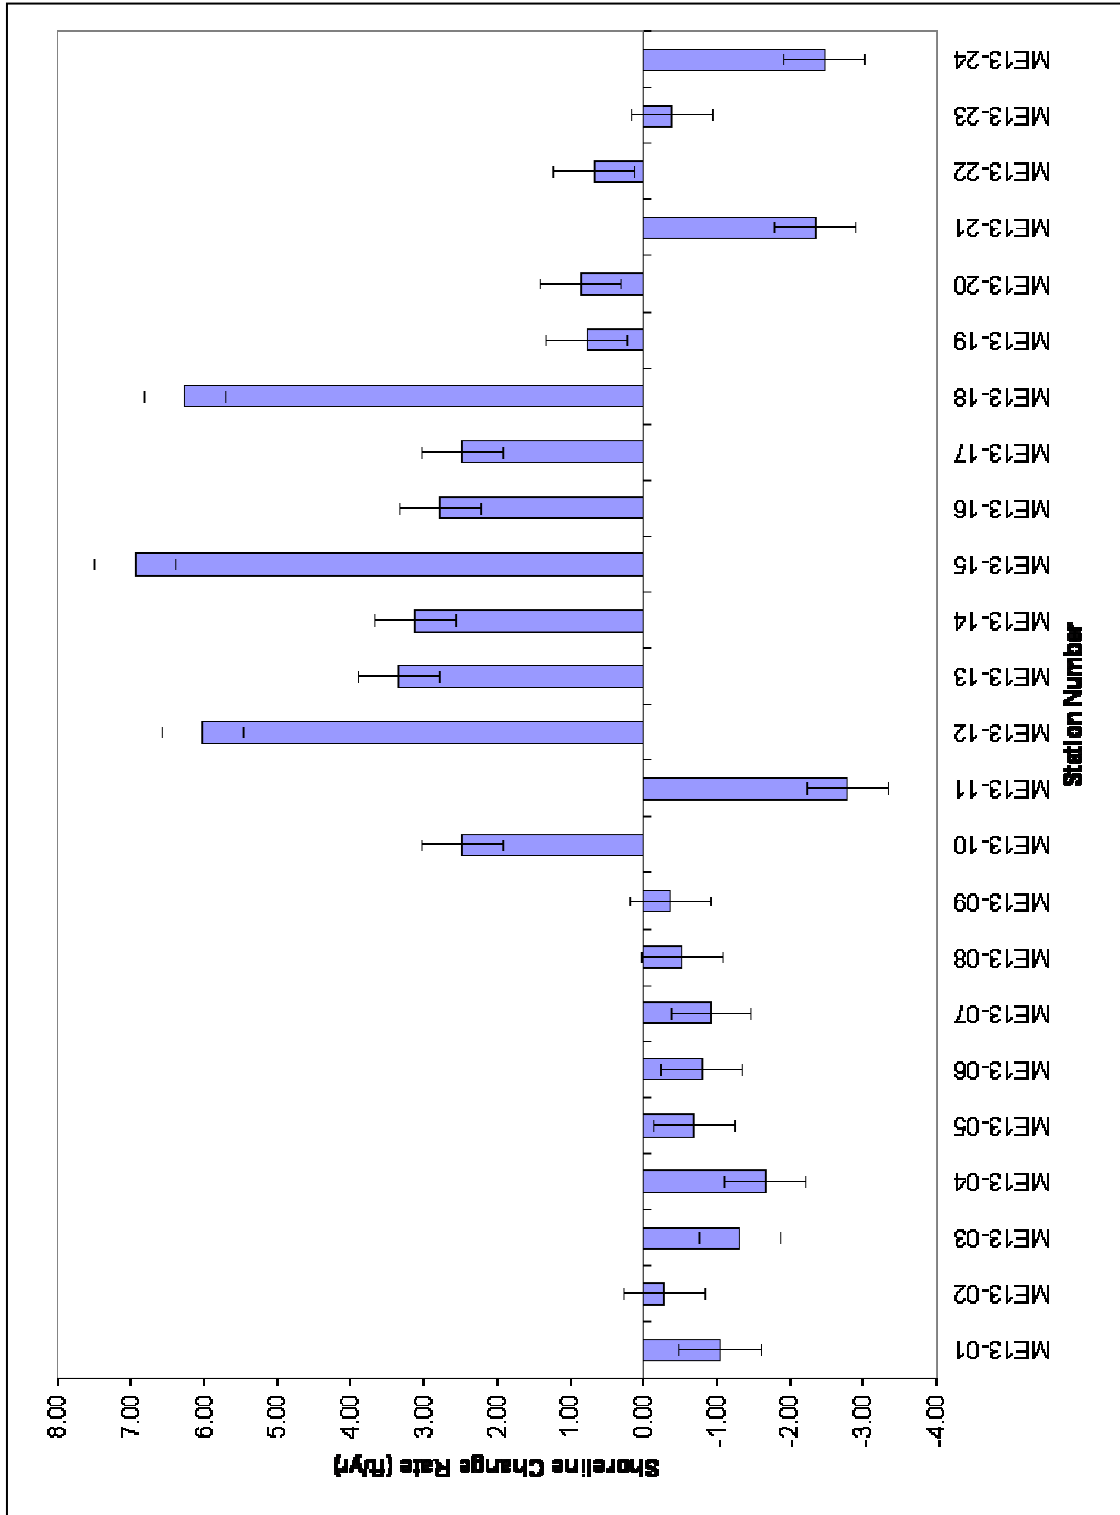
- The project area shoreline prograded at an average rate of 0.84 ft/yr (0.26 m/yr) (figure 3), and the reference area shorelines eroded at an average rate of -11.94 ft/yr (-3.64 m/yr) (figure 4).
- The highest rate of shoreline erosion occurred at the north end of reference areas R2 (north unit) at station ME13-25R, where the shoreline retreated 89.0 ft (27.1 m).
- The variability in shoreline change along the project area shoreline was significantly different than the variability along the reference area shorelines ($p < 0.0001$) for this time period.

Figure 3. Shoreline change rate (ft/yr) along Freshwater Bayou Canal at the ME-13 project area stations for the July 23, 1998 – July 21, 2003 time period. Error bars represent ± 1 standard error of the mean of all stations.

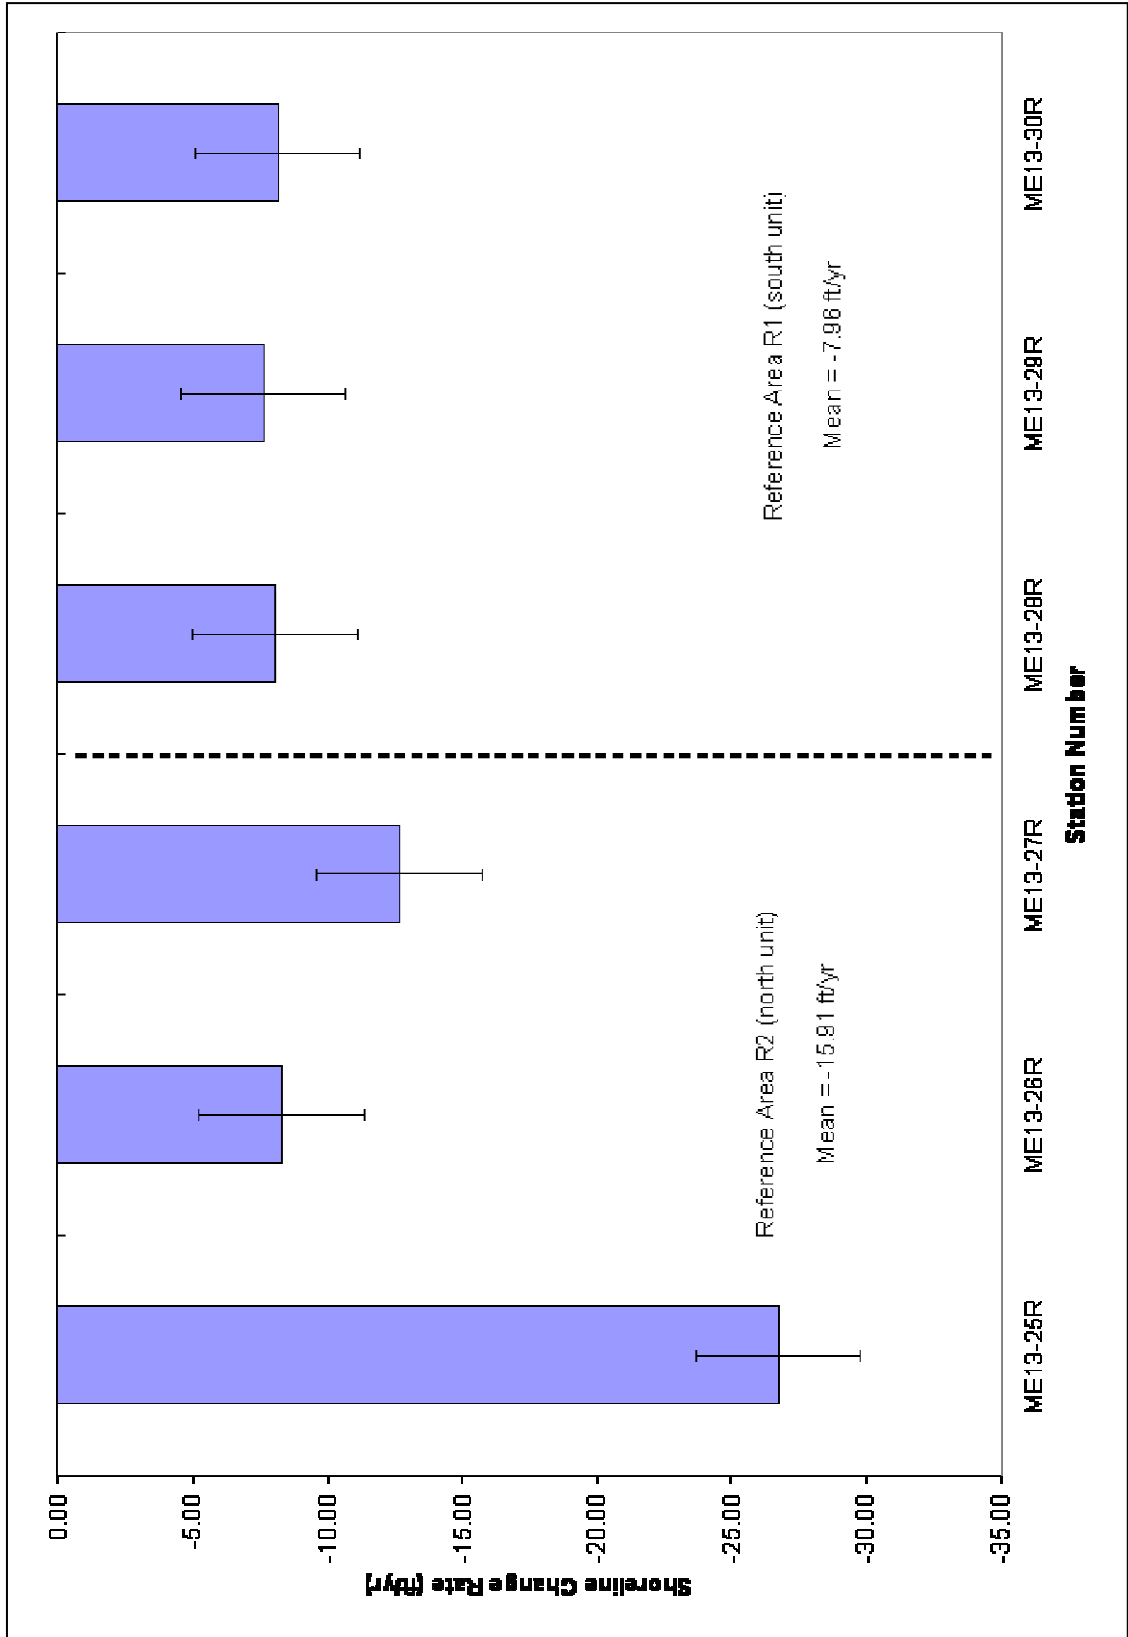
Figure 4. Shoreline change rate (ft/yr) along Freshwater Bayou Canal at the ME-13 reference area monitoring stations for the 23 July 1998 – 21 July 2003 time period. Error bars represent ± 1 standard error of the mean of all six reference stations.
