**2005 Operations, Maintenance,
and Monitoring Report**

**BRADY CANAL HYDROLOGIC
RESTORATION**

State Project Number TE-28
Priority Project List 3

June 2005
Terrebonne Parish

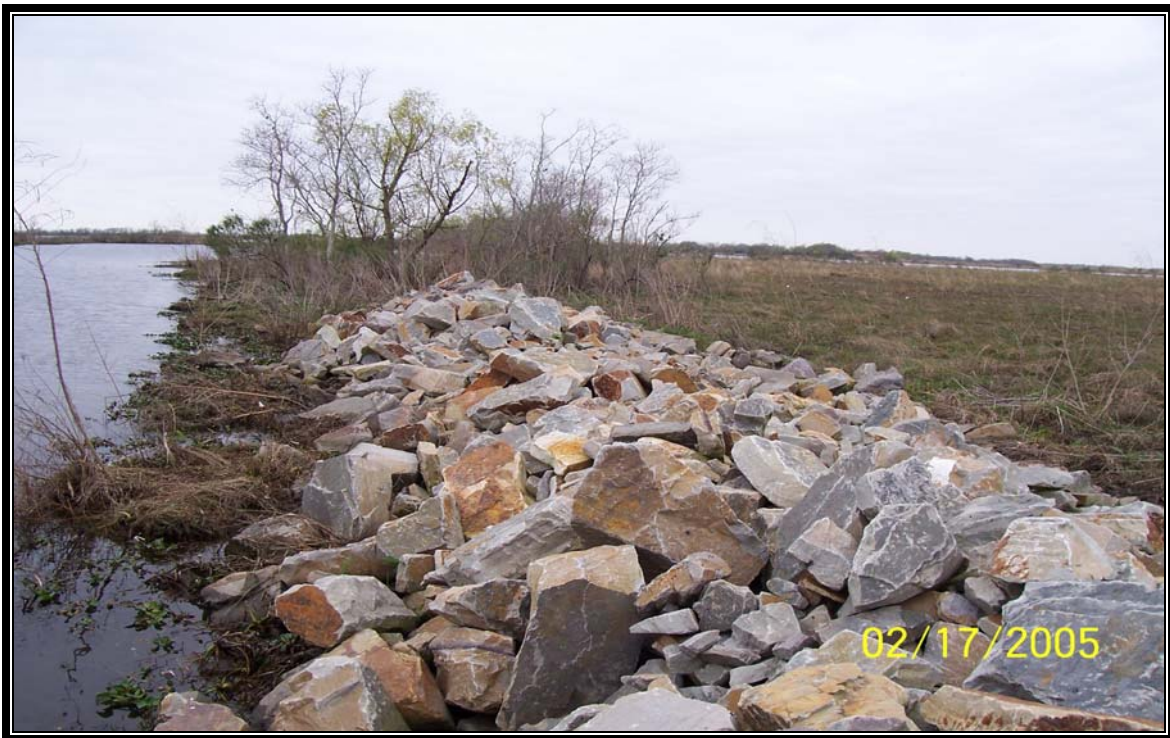
Breach 7 – Existing Breach repair under 2003 Maintenance Project located at the end of an oil field location canal west of Superior Canal. (Photo 2, looking west)

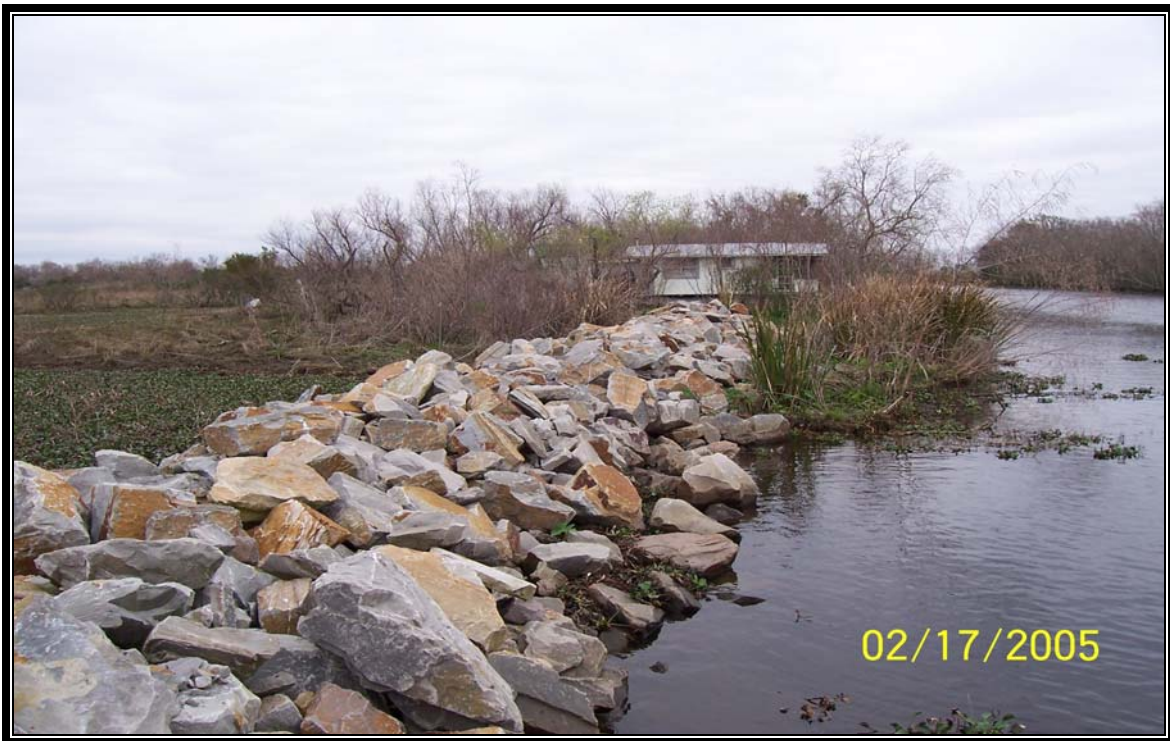
Breach 7 – Existing breach repair under 2003 Maintenance Project located at the end of an oil field location canal west of Superior Canal (Photo 3, looking east)

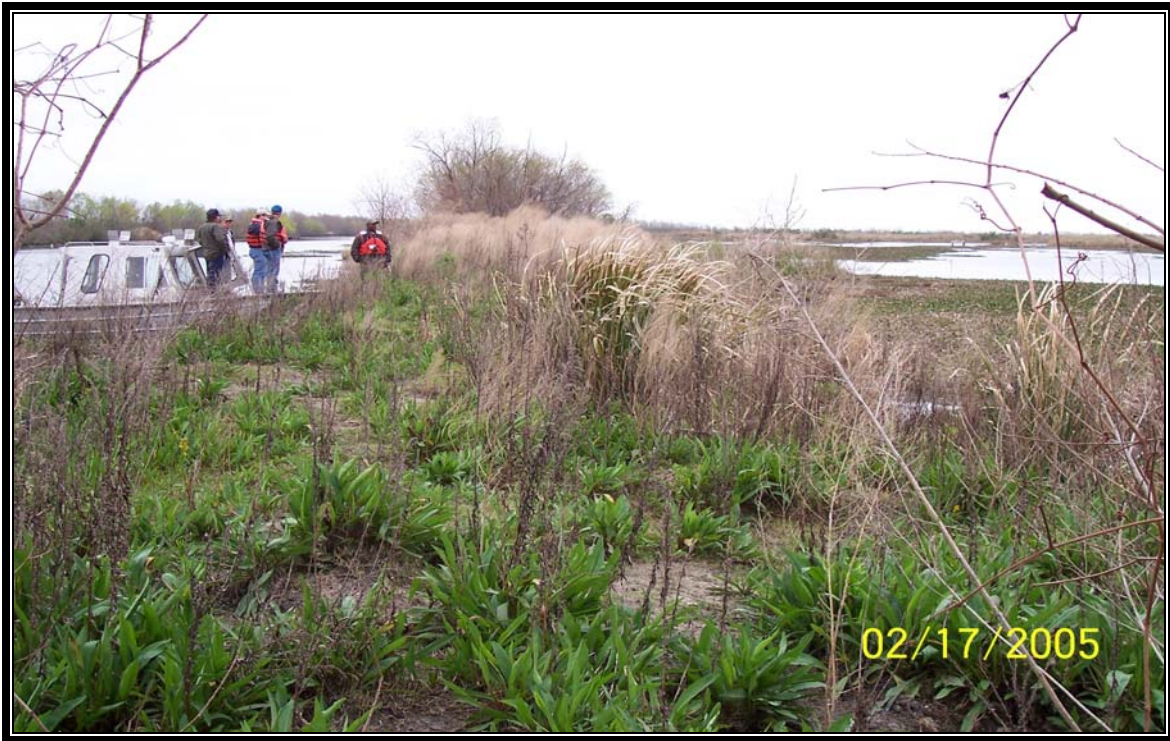
Breach 8 – Breach 8 consisted of a 200-ft- (60.9-m-) wide low-lying area along Superior Canal adjacent to an existing pipeline right-of-way. The low areas of the embankment were repaired using dredge material from Superior Canal (Appendix A, Photo 10). The earthen embankment in this area appeared to be in good condition with thick vegetation present. No maintenance was required at this site.

Breach 8 – Earthen embankment refurbishment along Superior Canal completed under the 2003 Maintenance Project (Photo 10, looking south)

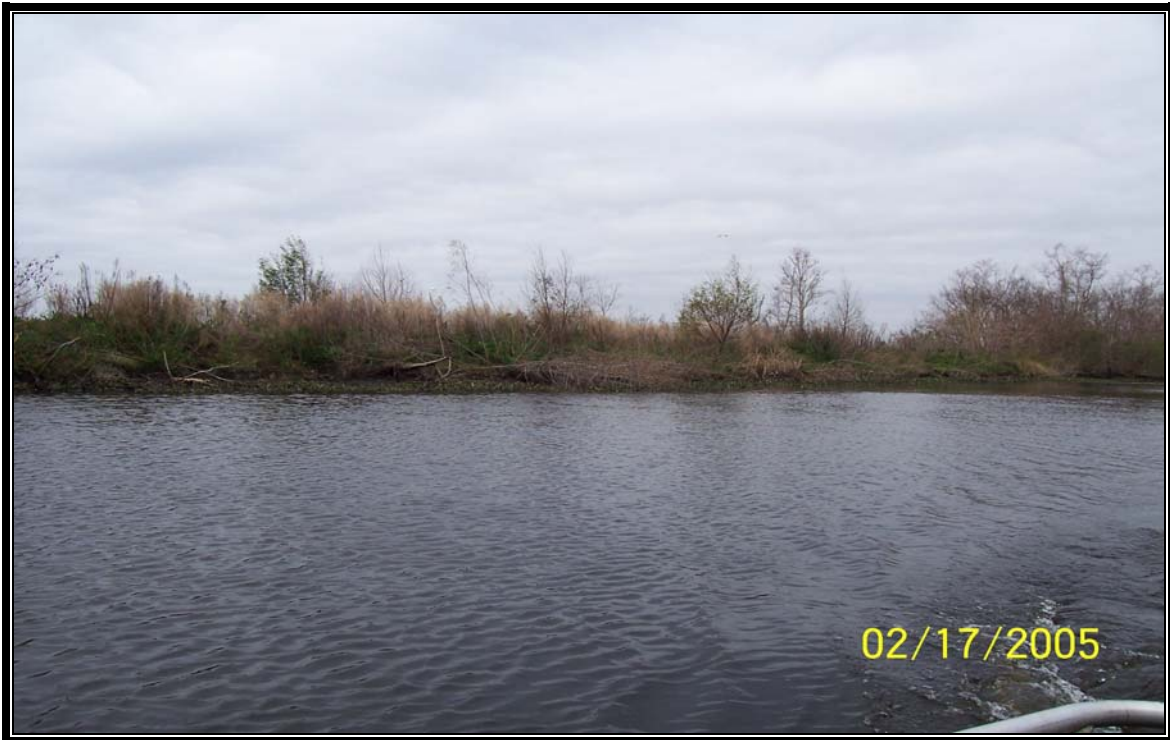
Breach 9 – Breach 9 is located along Superior Canal near the bend and consisted of a 250-ft (76.2-m) section of earthen embankment which had settled significantly. This section of levee was also repaired using dredge material from Superior Canal (Appendix A, Photo 12). The earthen embankment in this area appeared to be in very good condition with no noticeable erosion or settlement since refurbishment in 2003. No maintenance was required.

Breach 9 – Earthen embankment refurbished along Superior Canal completed under the 2003 Maintenance Project (Photo 12, looking west)

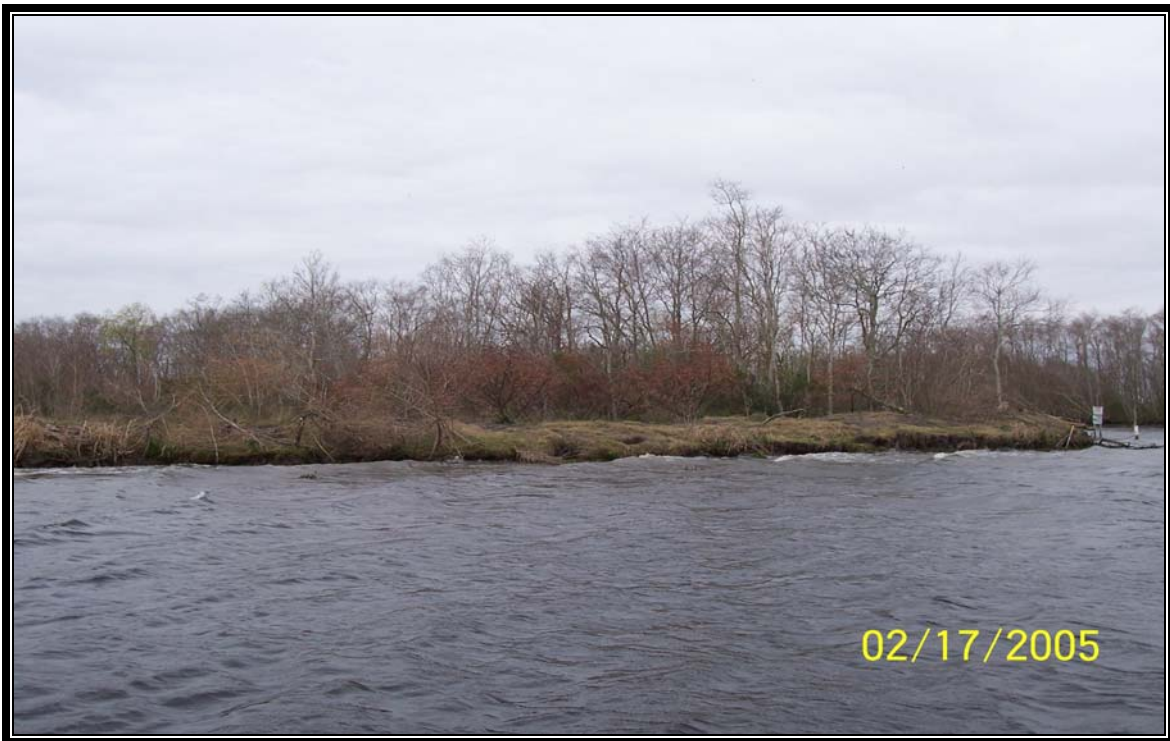
Breaches 5 and 6 – Breaches 5 and 6 consisted of a low area along the earthen embankment along Turtle Bayou from the mouth of Superior Canal 1500 ft (457.2 m) southward. The earthen embankment was refurbished using dredge material from Turtle Bayou (Appendix A, Photos 13 and 16). The earthen embankment repairs appear to be in good condition with the exception of small cut banks along the face of the levee. No maintenance is required.

Breach 5&6 – Levee refurbishment along Turtle Bayou beginning near Superior Canal and commencing 1,500' southward completed under the 2003 Maintenance Project. (Photo 13, looking west)

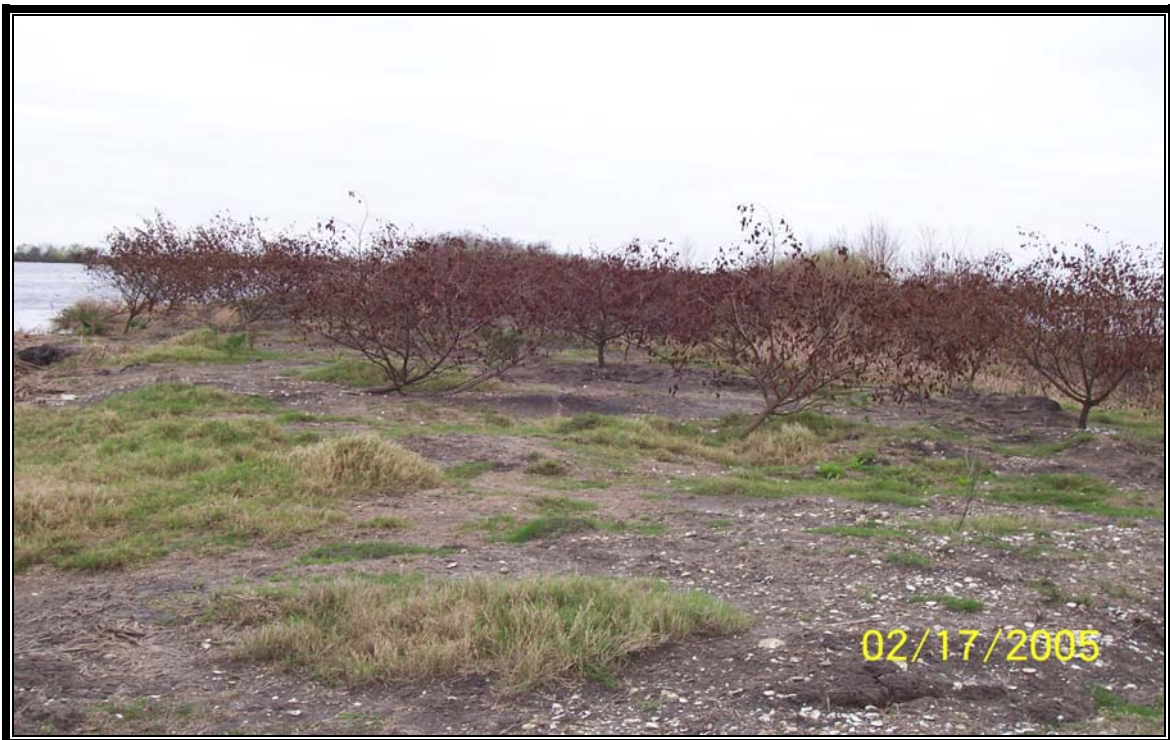
Photo of vegetation and small tree growth along breach 5 & 6 located along Turtle Bayou (Photo 16, looking southeast)

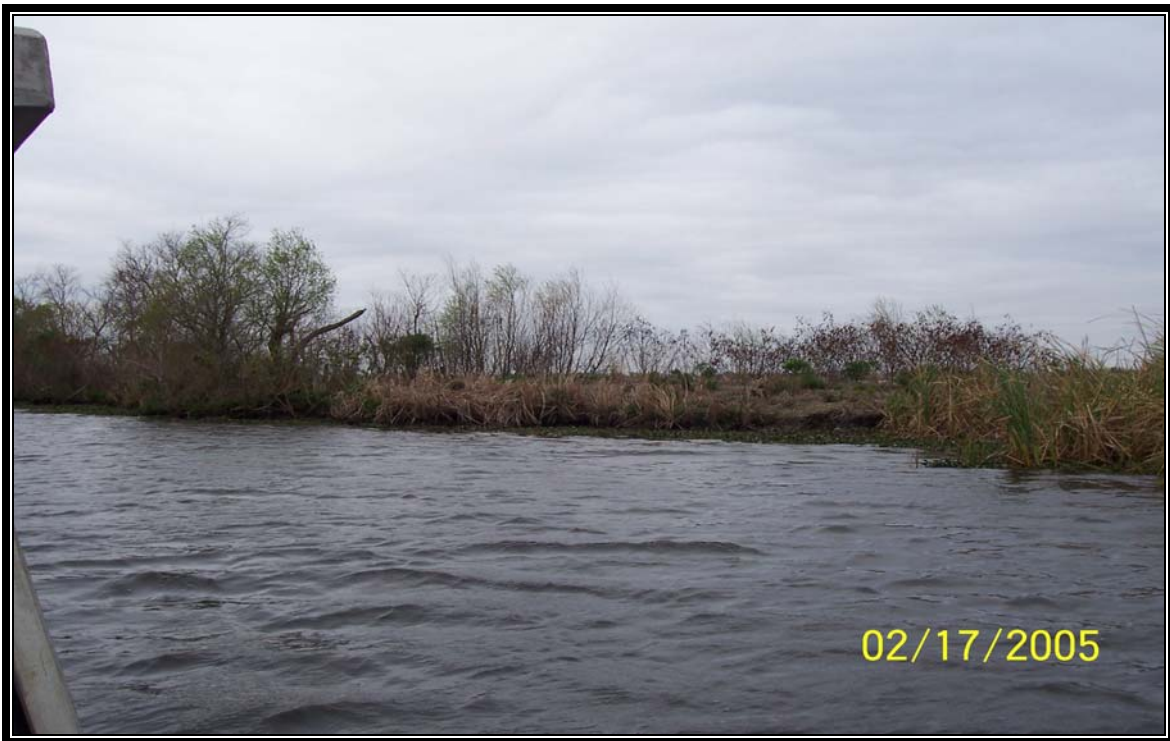
Location of breach repaired by Apache Corporation along the west bank of Turtle Bayou (Photo 21, looking west)

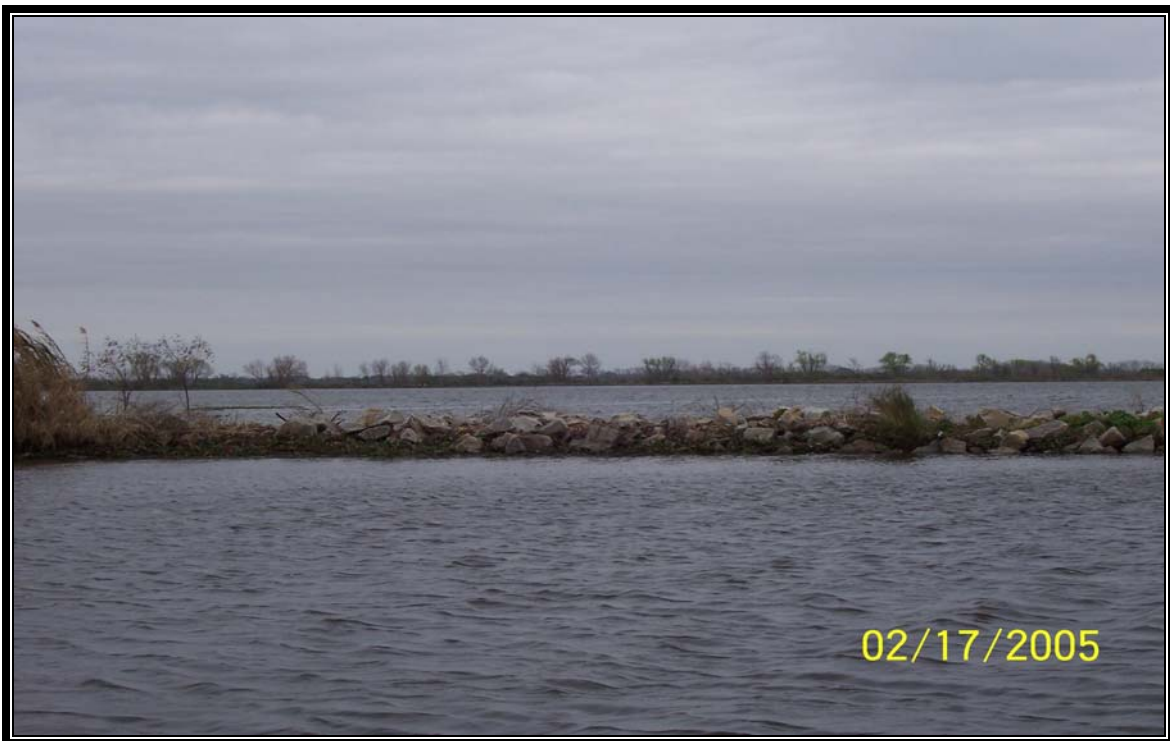
Breaches 1 through 4 - Breaches 1 through 4 consisted of a low-lying bank along Bayou de Cade with large openings in the levee exposing the interior marsh (Appendix A, Photo 22). Due to the elevation of the existing bank line and exposure to significant wave action, a rock dike was constructed along the length of Bayou de Cade from Turtle Bayou to Jug Lake. At the time of the inspection, the rock dike was in fair condition with several low areas along the

length of the structure. We feel that the rock dike is not settling and the low areas are due to the fact that the design elevation of the rock dike was not achieved during construction. The rock dike appeared to be in fair condition and no maintenance will be required.

Breach 1 thru 4 – rock dike constructed under the 2003 Maintenance Project to shore up an existing earthen embankment along Bayou Decade between Jug Lake and Turtle Bayou which was breached in several locations (Photo 22, looking north)

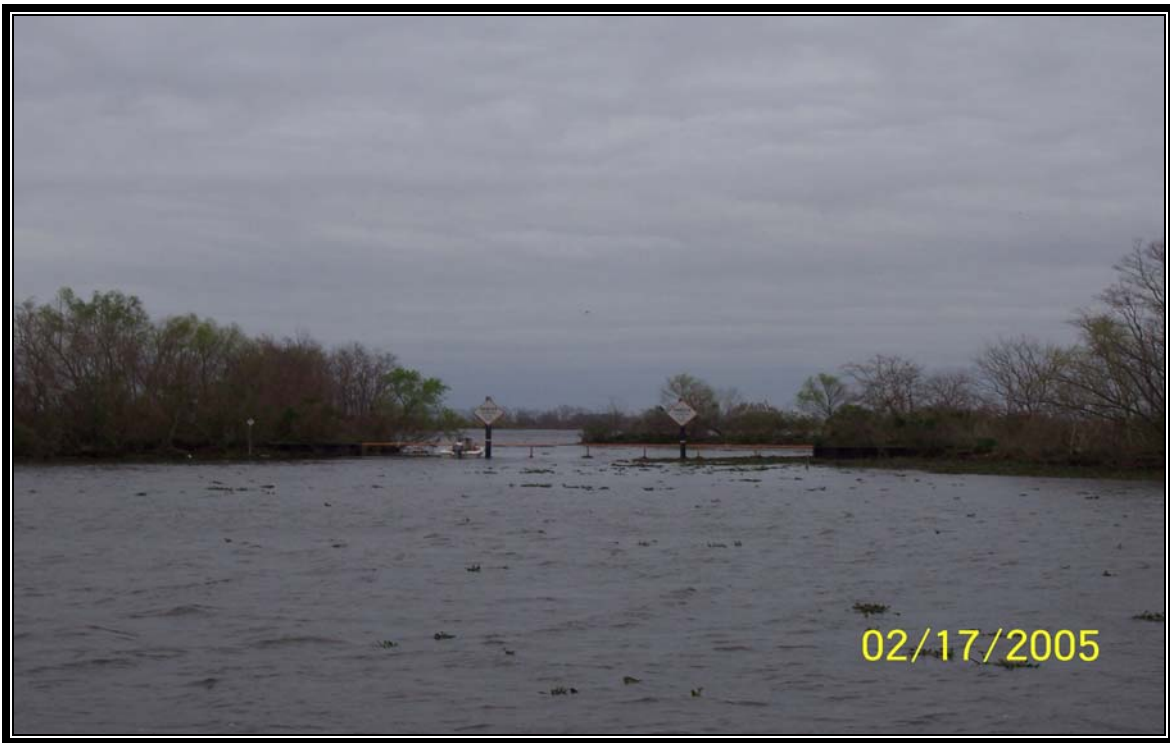
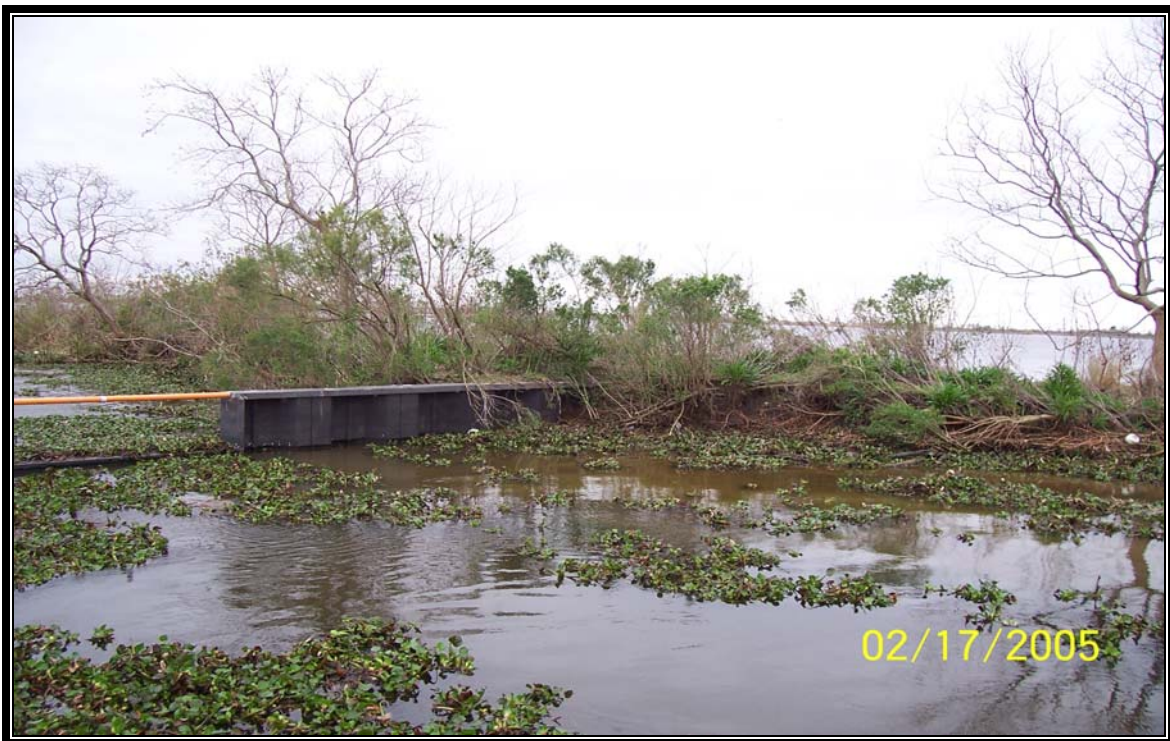
Upon visual inspection of Structure No. 24, it was determined that the structure itself was in good condition with no signs of structural damage (Appendix A, Photos 25 and 26). We did observe that the paint along the guardrail appeared to be chipping. Since the underlying material is galvanized, as in the case of all water control structure on this project, the affects of corrosion resulting from deterioration of the paint is unlikely. Moderate erosion was also noted along the earthen embankment on both sides of the structure with the most severe case being on the south side. It is recommended that the earthen embankment be refurbished on the next maintenance cycle. All signs and supports were in good condition.

Structure No.24 – fixed crest weir structure located along the east bank of Jug lake (Photo 25 – looking east)

Structure No.24 – south bank tie-in of the fixed crest weir structure looking southeast (Photo 26).

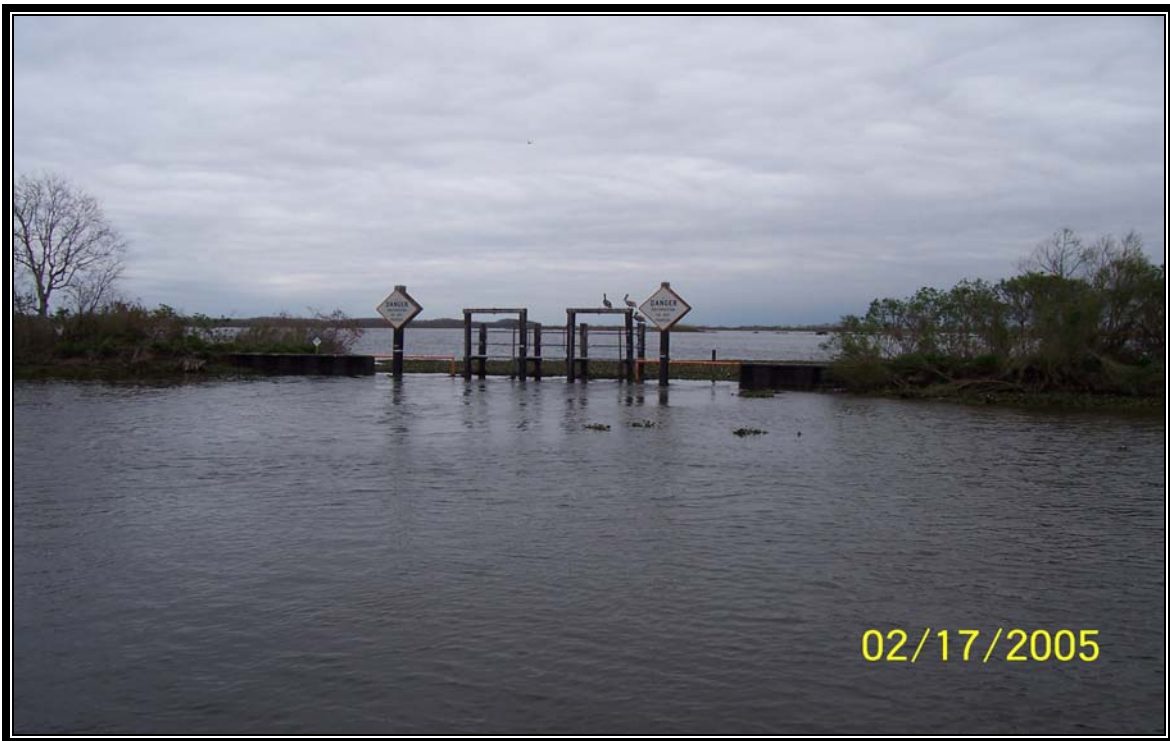
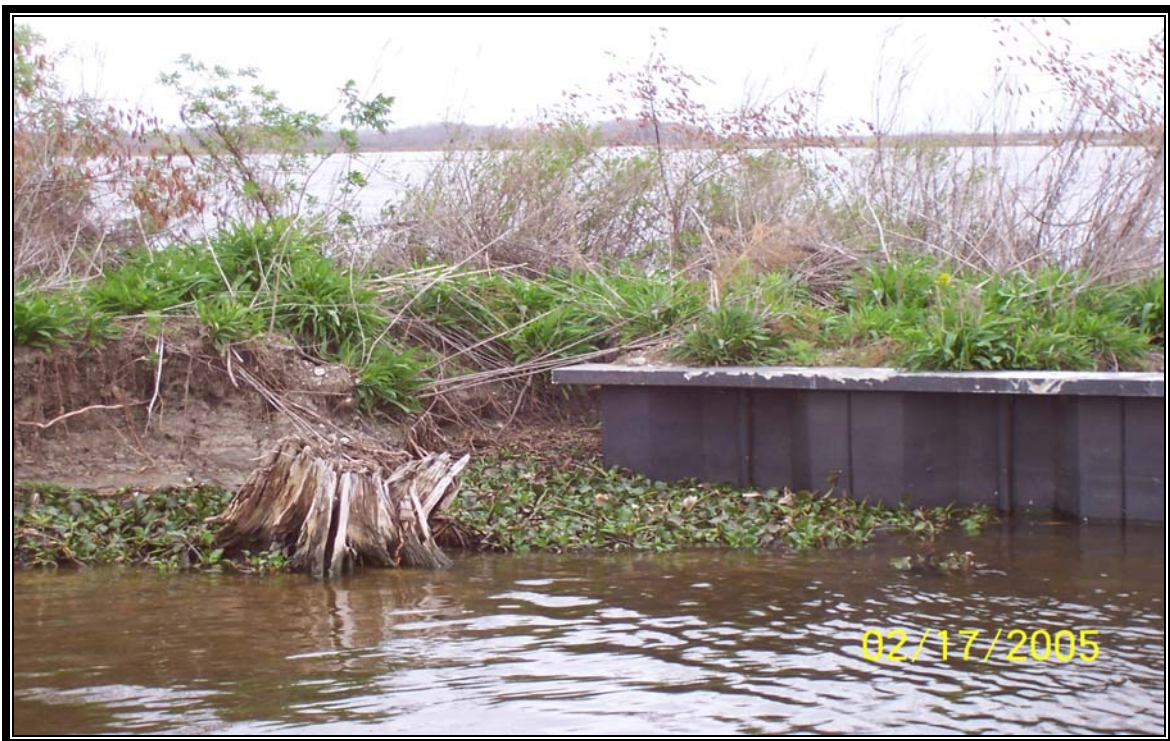
The variable crest weir structure appeared to be in good condition with no physical or structural damage noted (Appendix A, Photos 30 and 37). As in the case of Structure No. 21, we did observe significant erosion of the earthen embankments on both sides of the structure. The top of the steel bulkhead on the north side of the structure was exposed from apparent water flow around the structure during extremely high tides. It is recommended that the earthen embankment adjacent to the water control structure be refurbished during the next maintenance cycle. From the existing temporary benchmark located on the structure, it was determined that the water elevation at the time of the inspection was 1.2 ft (0.4 m) NAVD88. All signs and timber supports were in good condition.

Structure No.23 – Fixed crest weir structure with two (2) variable crest weir sections located along the north shoreline of Jug Lake (Photo 30, looking northeast)

Structure No.23 – earthen embankment tie-in on the north side of the structure were erosion around the sheet pile wall is evident (Photo 37, looking east)

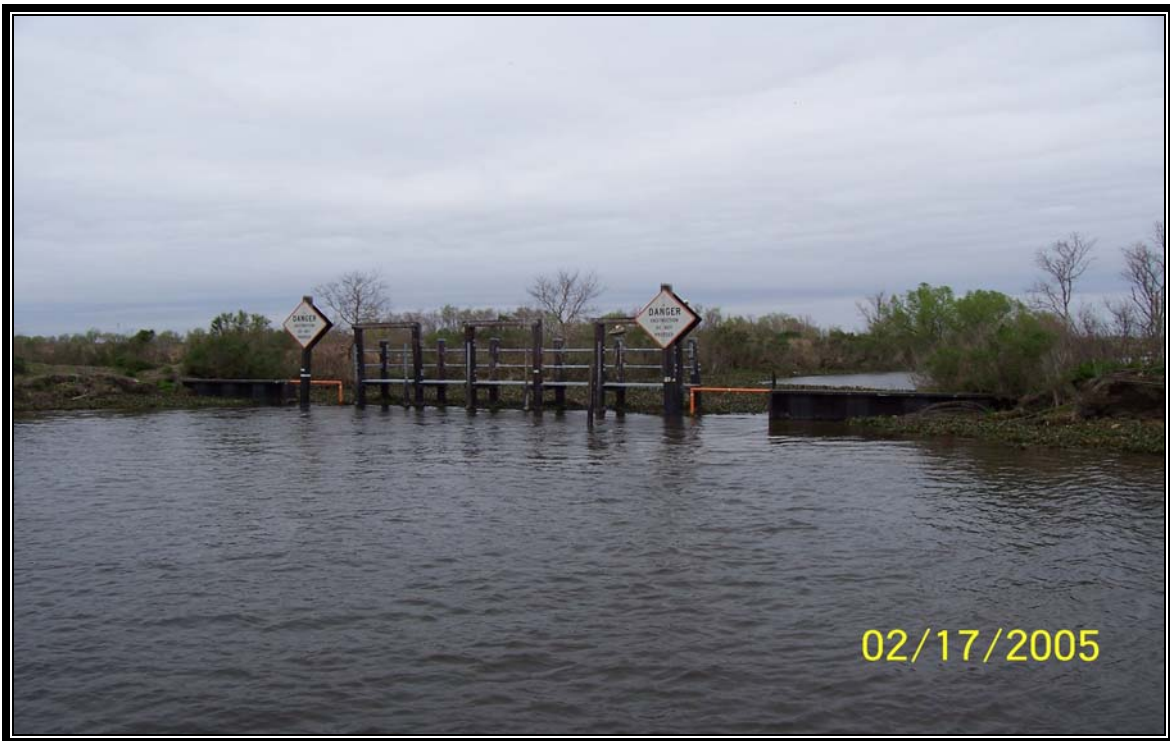
The variable crest weir structure was in good condition with no physical or structural damage noted (Appendix A, Photo 38). However, we did observe large cut banks along the earthen embankment tie-ins on both sides of the structure, with more pronounced erosion on the north side. While no breaching was evident, we consider the erosion along the earthen embankment to be moderate to severe. It is recommended that the earthen embankment be refurbished under the next maintenance cycle to prevent the potential for breaching.

Structure No.21 – fixed crest weir structure with three (3) variable crest sections located along the northwest bank of Jug Lake. (Photo 38, looking west)

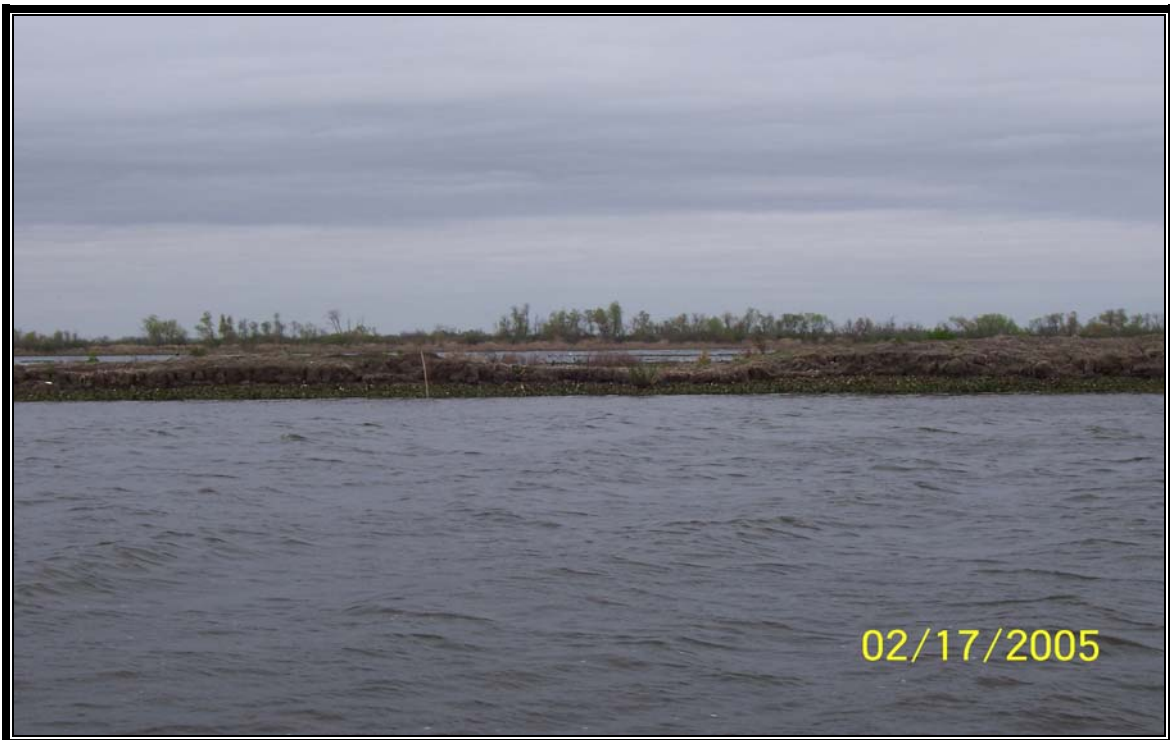
Earthen embankment along the west bank of Jug Lake refurbished by the Apache Corporation in 2003 with in-kin service credits. (Photo 46, looking west)

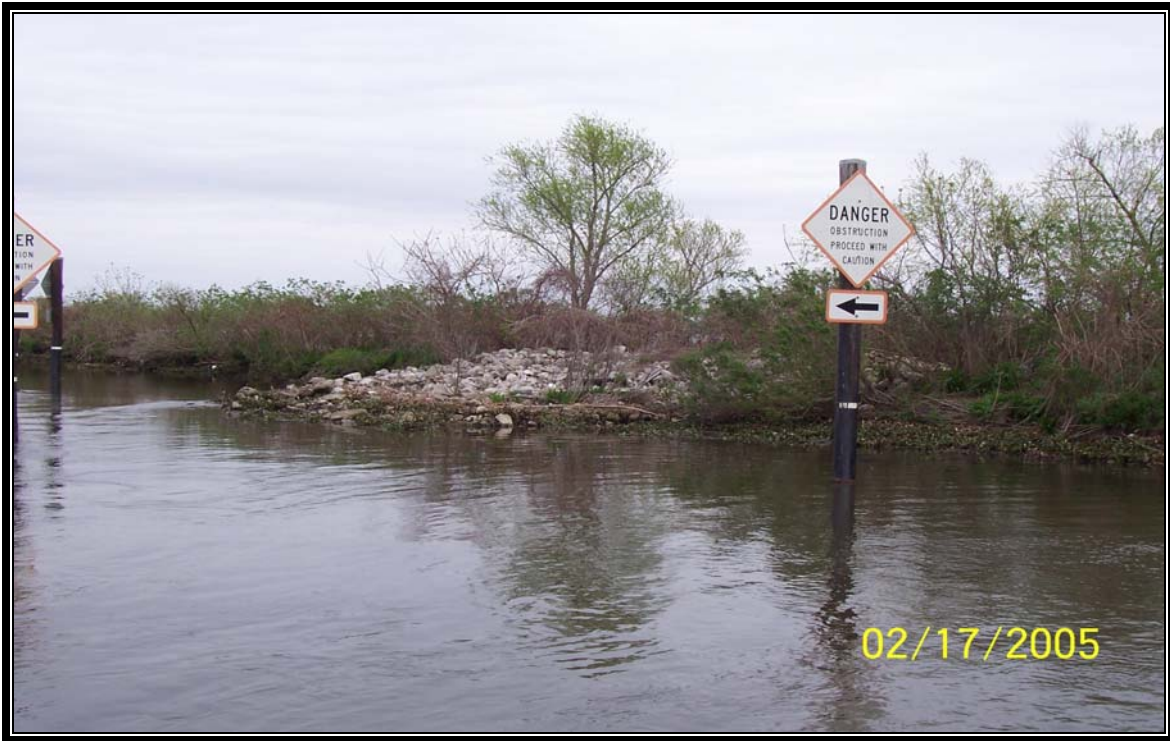
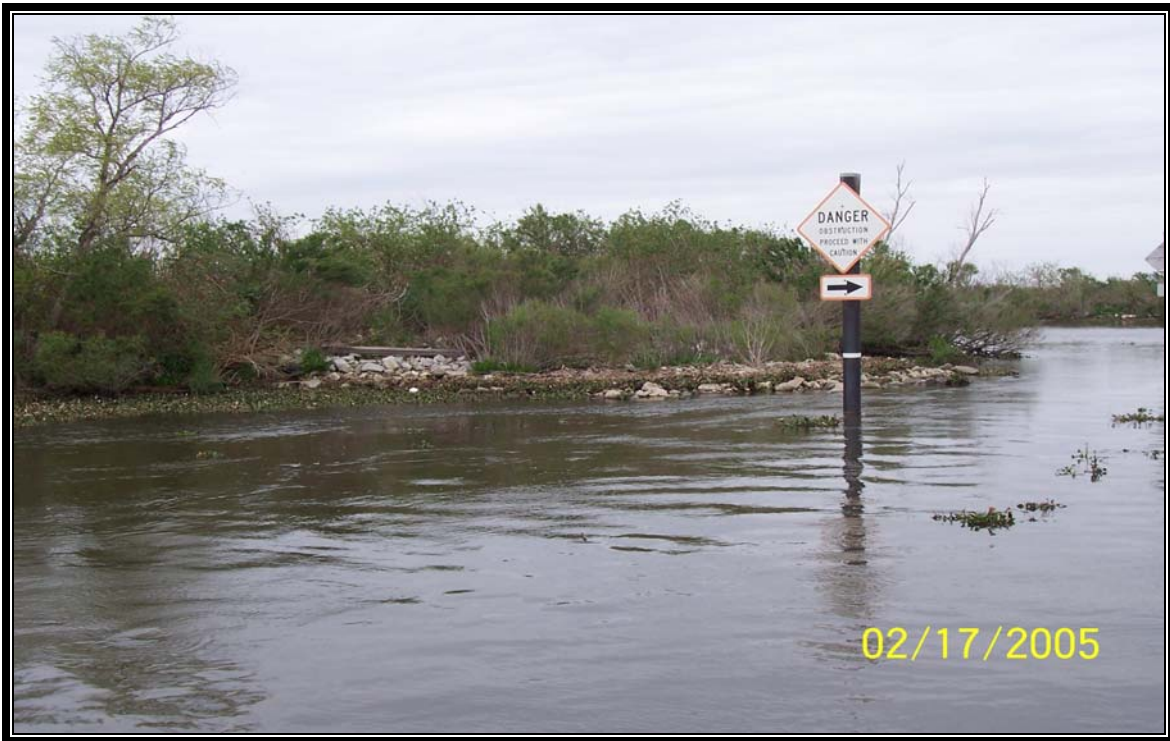
Structure No. 20 appeared to be in good condition with no signs of settlement along the portion of the rock armor above the waterline (Appendix A, Photo 48). Similar to Structure No. 6, the condition of the rock armor along the channel bottom is difficult to determine without further investigation. At some point, a centerline profile may be needed to properly assess the condition of the rock-lined channel below the water

surface. Timber piles, supports, and signage were also in good condition. No immediate repairs are necessary at this time.

Structure No.20 – north side of rock riprap lined channel across Bayou Loutre entering the west bank of Jug Lake. (Photo 48, looking west)

Structure No.20 – south side of riprap lined channel section across Bayou Loutre entering Jug Lake (Photo 49, looking west)

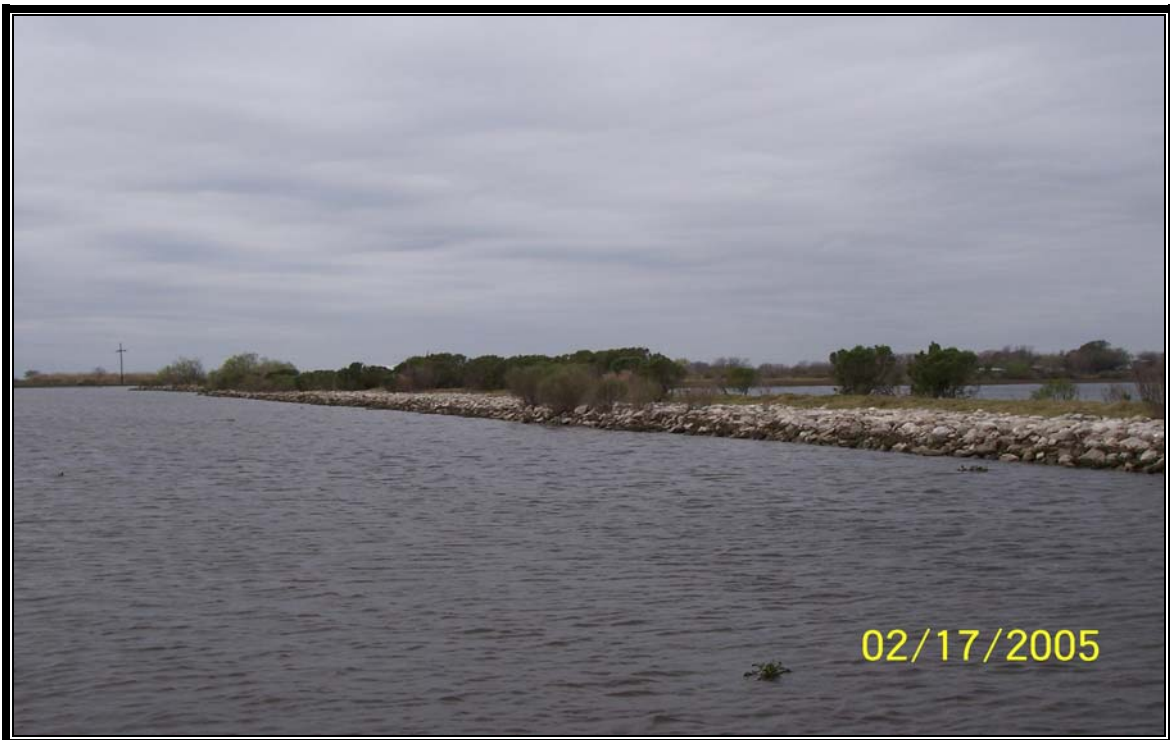
Earthen embankment with rock revetment located along the north bank of Bayou Decade. (Photo 55, looking northwest)

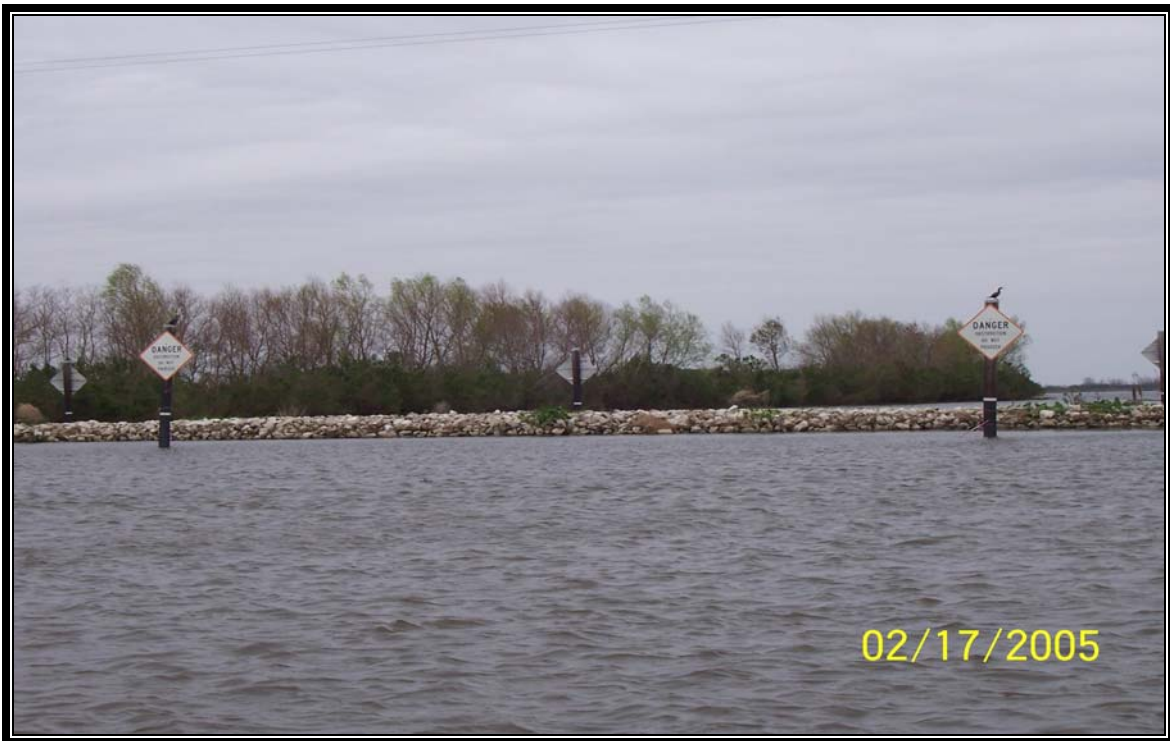
The rock plug appeared to be in very good condition with no obvious signs of settlement along the length of the structure. The timber piles and warning signs adjacent to the structure were also in good condition (Appendix A, Photo 59). No maintenance or corrective actions are recommended.

Structure No.7 – rock riprap plug located along the north bank of Bayou Decade south of Bay Long. (Photo 59, looking north)

Item	Condition	Physical Damage	Corrosion	Photo #	Observations and Remarks
Steel Bulkhead / Caps	N/A			59	Observation:
Earthen Wingwalls	N/A				Structure 7 appeared to be in very good condition. No signs of settlement along the structure.
Stop Logs Bays timbers, locks hoist etc.	N/A				
Handrails					
Grating	N/A				
Hardware etc.					
Timber Piles	N/A				
Timber Wales	N/A				
Galv. Pile Caps	N/A				
Cables	N/A				
Signage /Supports	Very Good				
Rock Embankment	Very Good				Structure Description:
Earthen Embankment	N/A				415 linear ft. rock riprap plug (approximately 6,000 tons of riprap installed) across as oil field access canal on the north side of Bayou Decade west of Site 6. The top of the riprap plug is was constructed to an elevation of +4.0' NAVD which corresponds to the earthen embankment on each side to the structure. Aluminum warning signs are located in front of the structure along Bayou Decade.

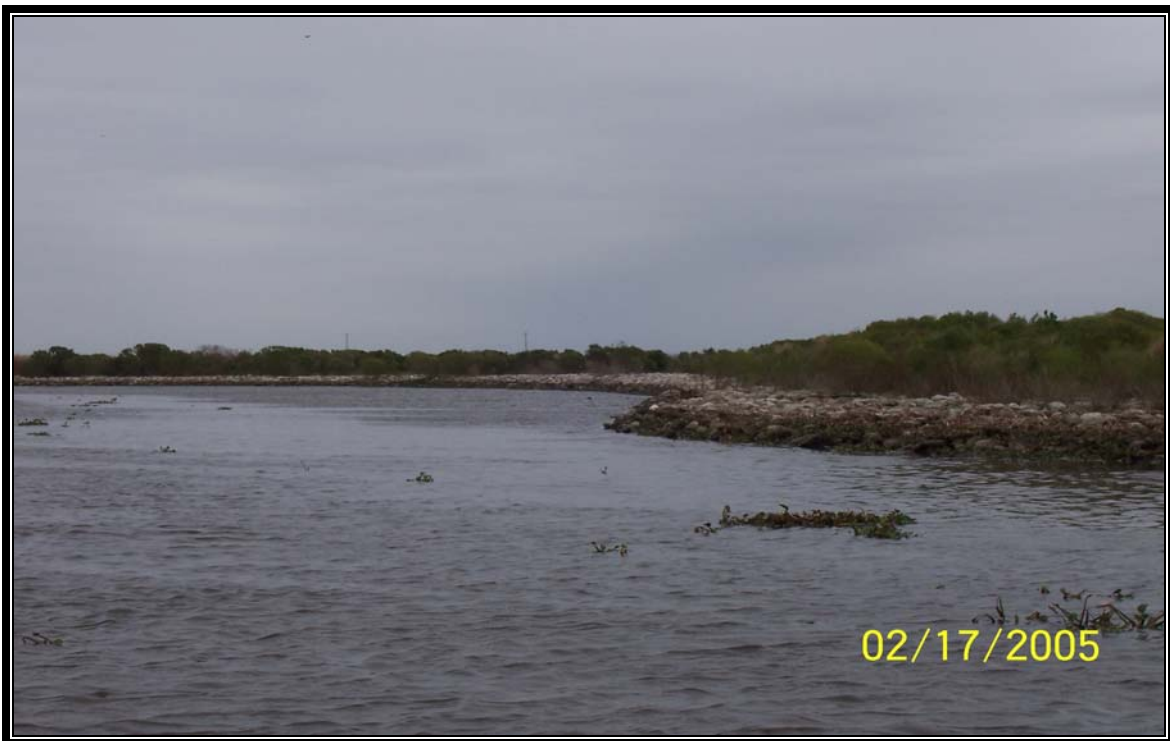
Shoreline Protection – earthen embankment with rock revetment located along Voss Canal south of Structure No.10. (Photo 67, looking north)

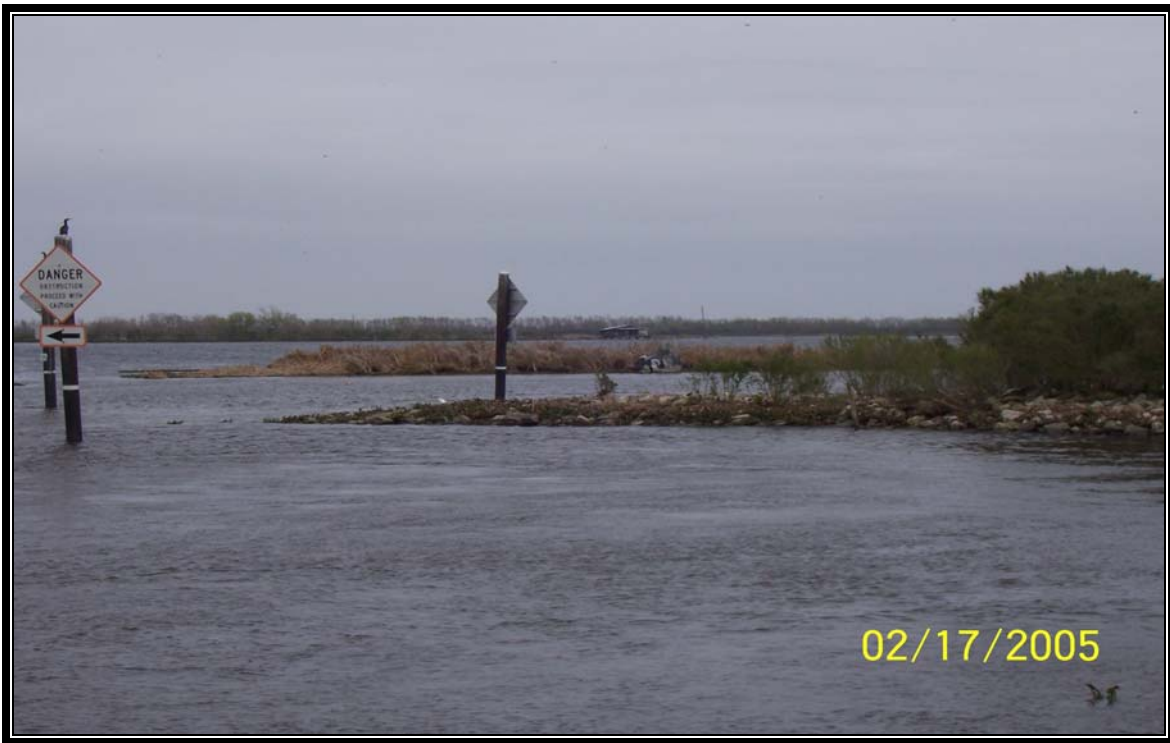
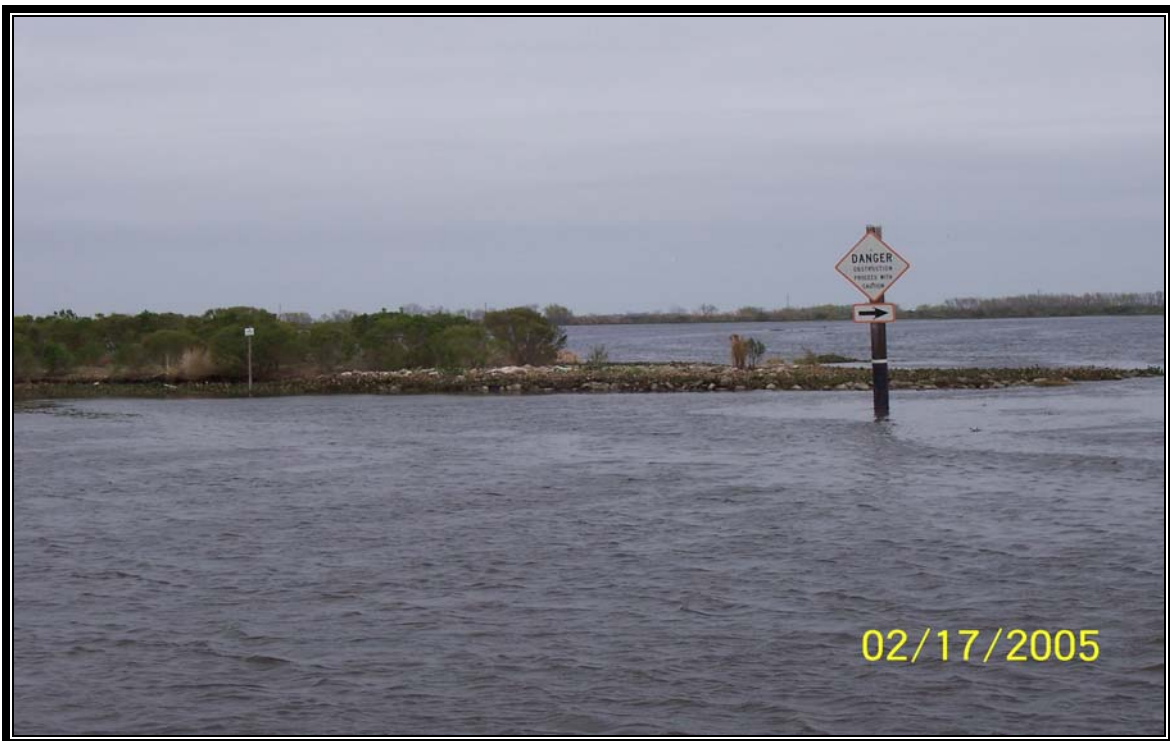
The physical condition of Structure No.10 appeared to be very good with no signs of settlement along the portion of the rock armor above the waterline (Appendix A, Photos 68 and 69). The condition of the rock armor along the channel bottom is difficult to determine without further investigation. At some point in the future, a centerline profile may be needed to properly assess the rock-lined channel submerged below the waterline. Timber piles supports and signage were in very good condition. No deficiencies were discovered which would require immediate repairs or maintenance.

Structure No.10 – south bank tie-in of rock riprap lined channel entering Bay Long from Voss Canal (Photo 68, looking east)

Structure No.10 – north bank tie-in of rock riprap lined channel located at the entrance to Bay Long from Voss Canal. (Photo 69, looking east)

Item	Condition	Physical Damage	Corrosion	Photo #	Observations and Remarks
Steel Bulkhead / Caps	N/A			68 & 69	The rock lined channel section appeared to be in good condition with no settlement of the weir section on each side. Earthen tie also looked to be in good condition.
Earthen Wingwalls	N/A				It is unclear, from a visual inspection, whether the section below the water surface is settling or not. A profile survey may be required in the future to assess this portion of the structure.
Stop Logs Bays timbers, locks hoist etc.	N/A				
Handrails					
Grating	N/A				
Hardware etc.					
Timber Piles	Good				
Timber Wales	N/A				
Galv. Pile Caps	N/A				
Cables	N/A				
Signage /Supports	N/A				
Rock Embankment	Good				Structure Description: 275 ft. x 45 ft. wide rock riprap channel liner three (3) feet minimum thickness lining the opening of a interior channel located on the west end of Bay Long intersecting Voss Canal. Aluminum warning signs attached to timber piles are located on both sides of the structure.

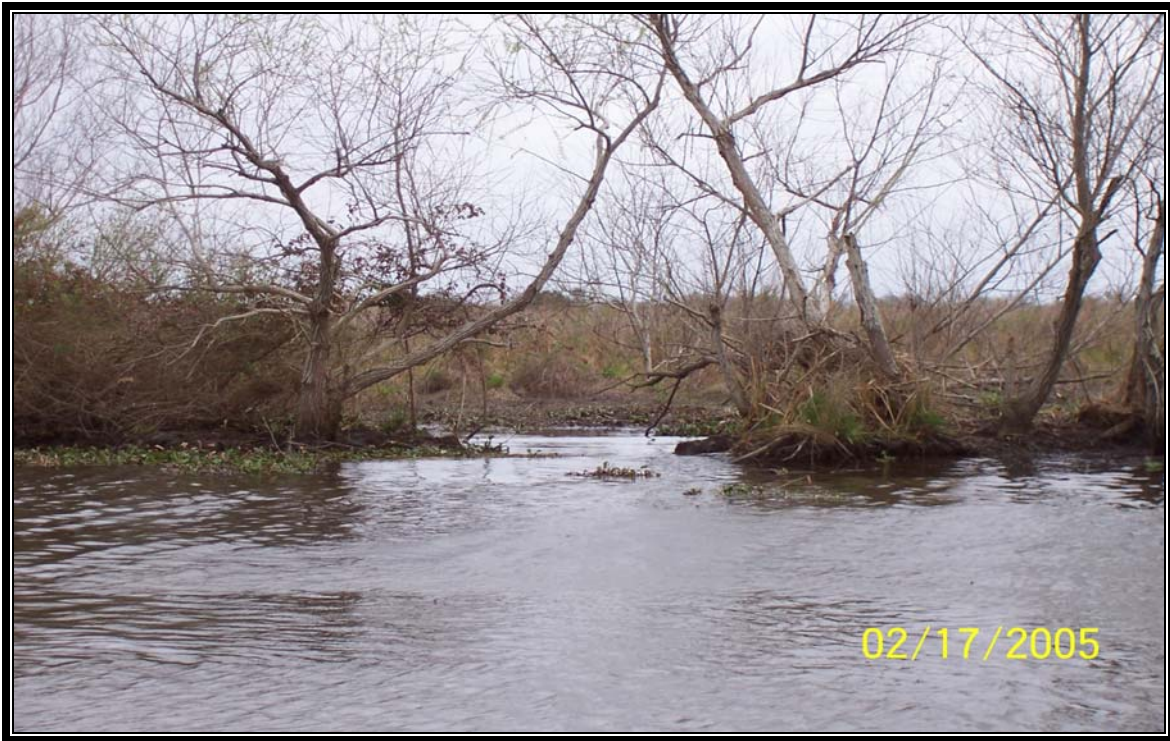
Small breach located along Carencro Bayou south of Structure No. 14 near an existing power line. (Photo 71, looking east)
