**2005 Operations, Maintenance,
and Monitoring Report**

**BRADY CANAL HYDROLOGIC
RESTORATION**

State Project Number TE-28
Priority Project List 3

June 2005
Terrebonne Parish

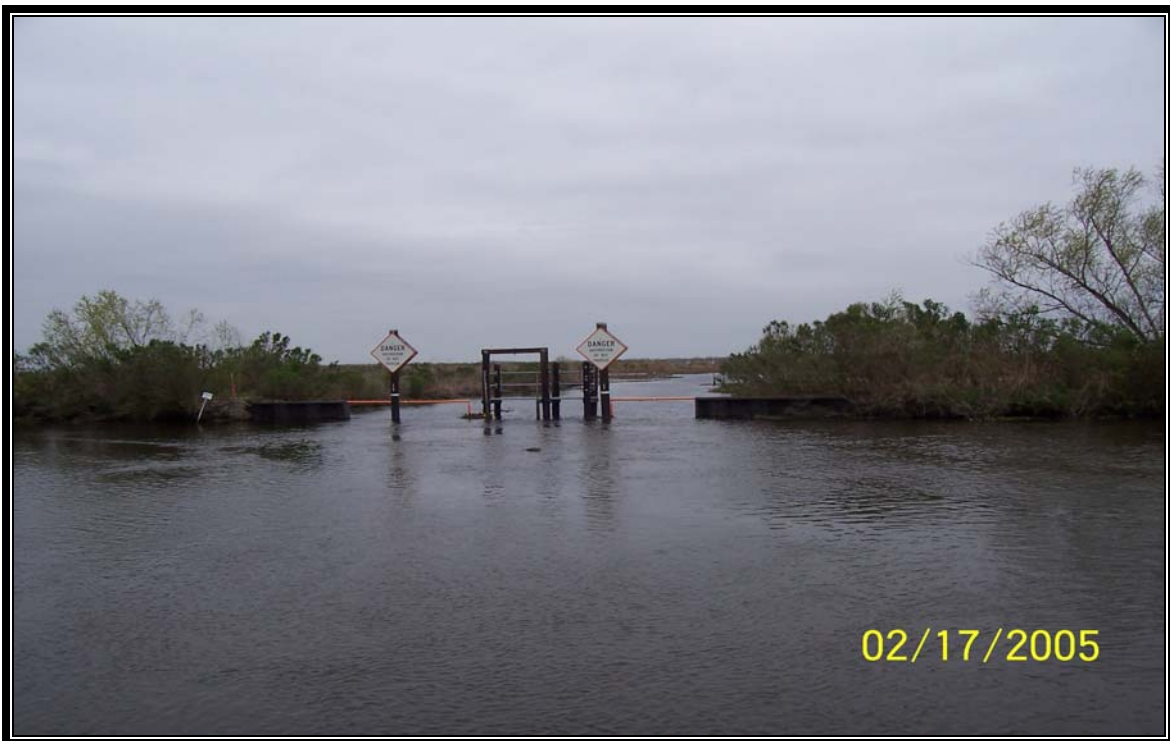
Upon a visual inspection of Structure No. 14, we found that there was moderate erosion of the earthen embankment tie-ins on both sides of the structure (Appendix A, Photo 72). While the erosion of the earthen embankment continues to worsen over time, we believe that the quantity of material directly behind the sheetpile wall will provide the necessary protection from breaching for the time being. However, it is recommended that the earthen embankment be refurbished during the next maintenance cycle. The steel structure, timber pile supports, and signage appear to be in very good condition with no obvious defects or structural damage.

Structure No.14 – fixed crest weir structure with a single variable crest section located along the east bank of Carencro Bayou just south of the “Better Livin” camp (Photo 72, looking east)

Item	Condition	Physical Damage	Corrosion	Photo #	Observations and Remarks
Steel Bulkhead / Caps	Good	None	minor paint chipping	72, 73, 74	Slight erosion was noted on the earthen bank tie-ins on both sides of the structure. No breaching around the structure was occurring. The structure itself was in good condition with minor flaking of paint on the handrails of the structure.
Earthen Wingwalls	Fair	moderate erosion			Large cut banks were also noted along the earthen embankments adjacent to the structure.
Stop Logs Bays timbers, locks hoist etc.	Good				Stop logs were in place at the time of the inspection. Logs are scheduled to be removed in mid March.
Handrails					
Grating	Good				
Hardware etc.					
Timber Piles	N/A				
Timber Wales	N/A				
Galv. Pile Caps	Good				
Cables	N/A				
Signage /Supports	Good				Structure Description: 82 linear ft. steel pile fixed crest weir with a six (6) ft. wide variable crest weir structure. This structure consist of 36 ft. fixed crest weir structure (18 ft. on each side of the stop log bay) set at an elevation of 1.0 ft. BML. The six (6) ft. wide variable crest section contains 10 - 4" x 6" stop logs, steel channel guides, locking channels and locks, steel grating walkways, handrails, etc. Aluminum warning signs are located adjacent to structure.

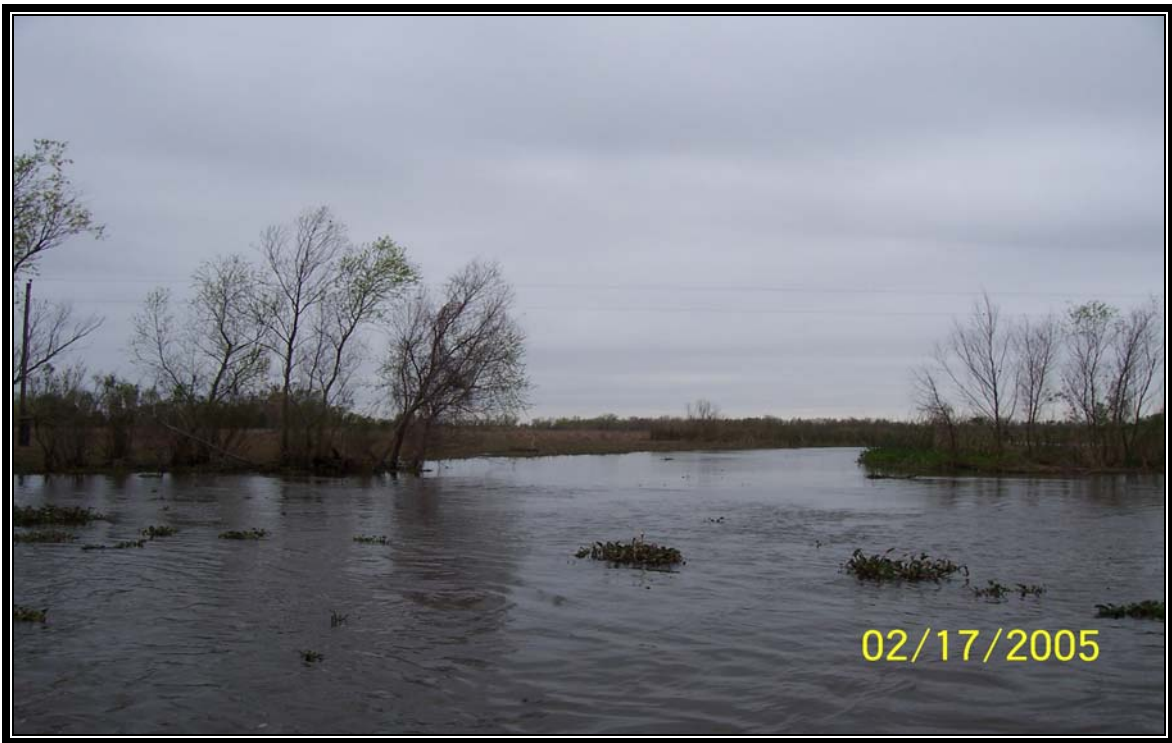
Large breach located along the south bank of Brady Canal southwest of the Apache camp. Breach connects to a second breach located along Bayou Penchant. (Photo 75, looking southeast)

As a result of the 2005 Annual Inspection, recommendations were made for the repair of two (2) large breaches located near the intersection of Brady Canal and Bayou Penchant and several small breaches located along Little Carencro Bayou as well as levee refurbishment of low areas adjacent to structures 6, 14, 21, 23 & 23. (See detailed cost breakdown in Section II of the 2005 Annual Inspection Report).
