**State of Louisiana  
Department of Natural Resources  
Coastal Restoration Division and  
Coastal Engineering Division**

**2005 Operations, Maintenance,  
and Monitoring Report**

**Boston Canal/ Vermilion Bay  
Shoreline Stabilization**

State Project Number TV-09  
Priority Project List 2

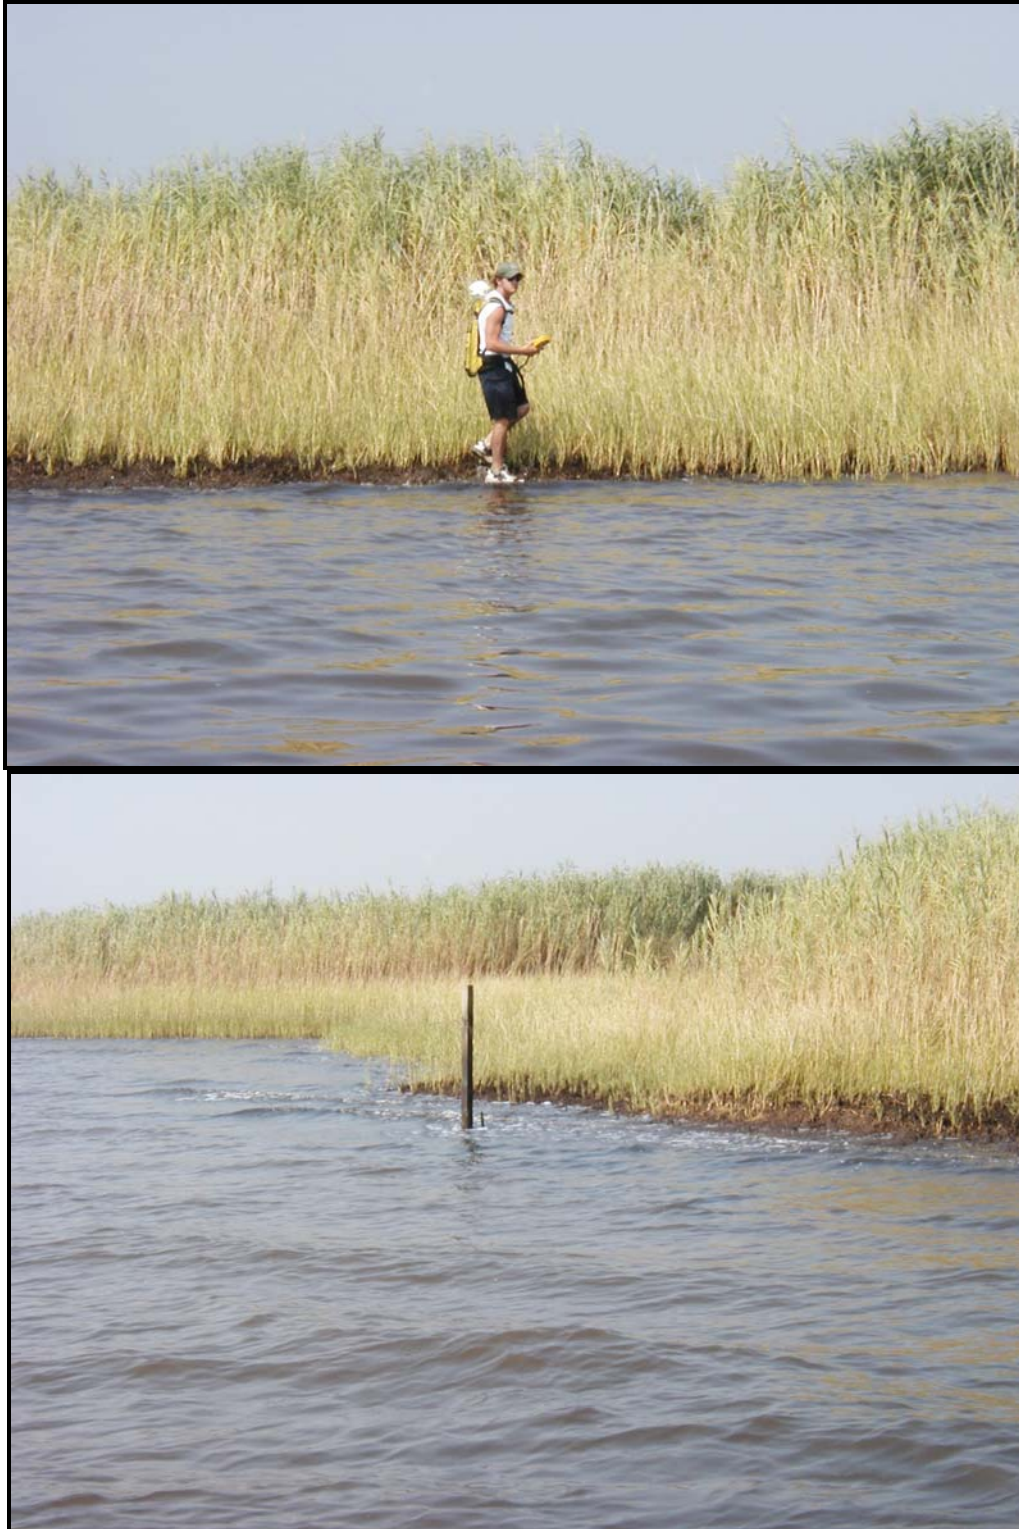
4-6). During the 2004 shoreline mapping the vegetation along some of the shoreline was photographed and appeared to be in good condition (figure 7).

**Figure 7.** Boston Canal/Vermilion Bay Shoreline Stabilization Project GPS shoreline survey September 29, 2004. The wooden post in the lower photo indicates erosion behind the vegetation planting at this monitoring station.

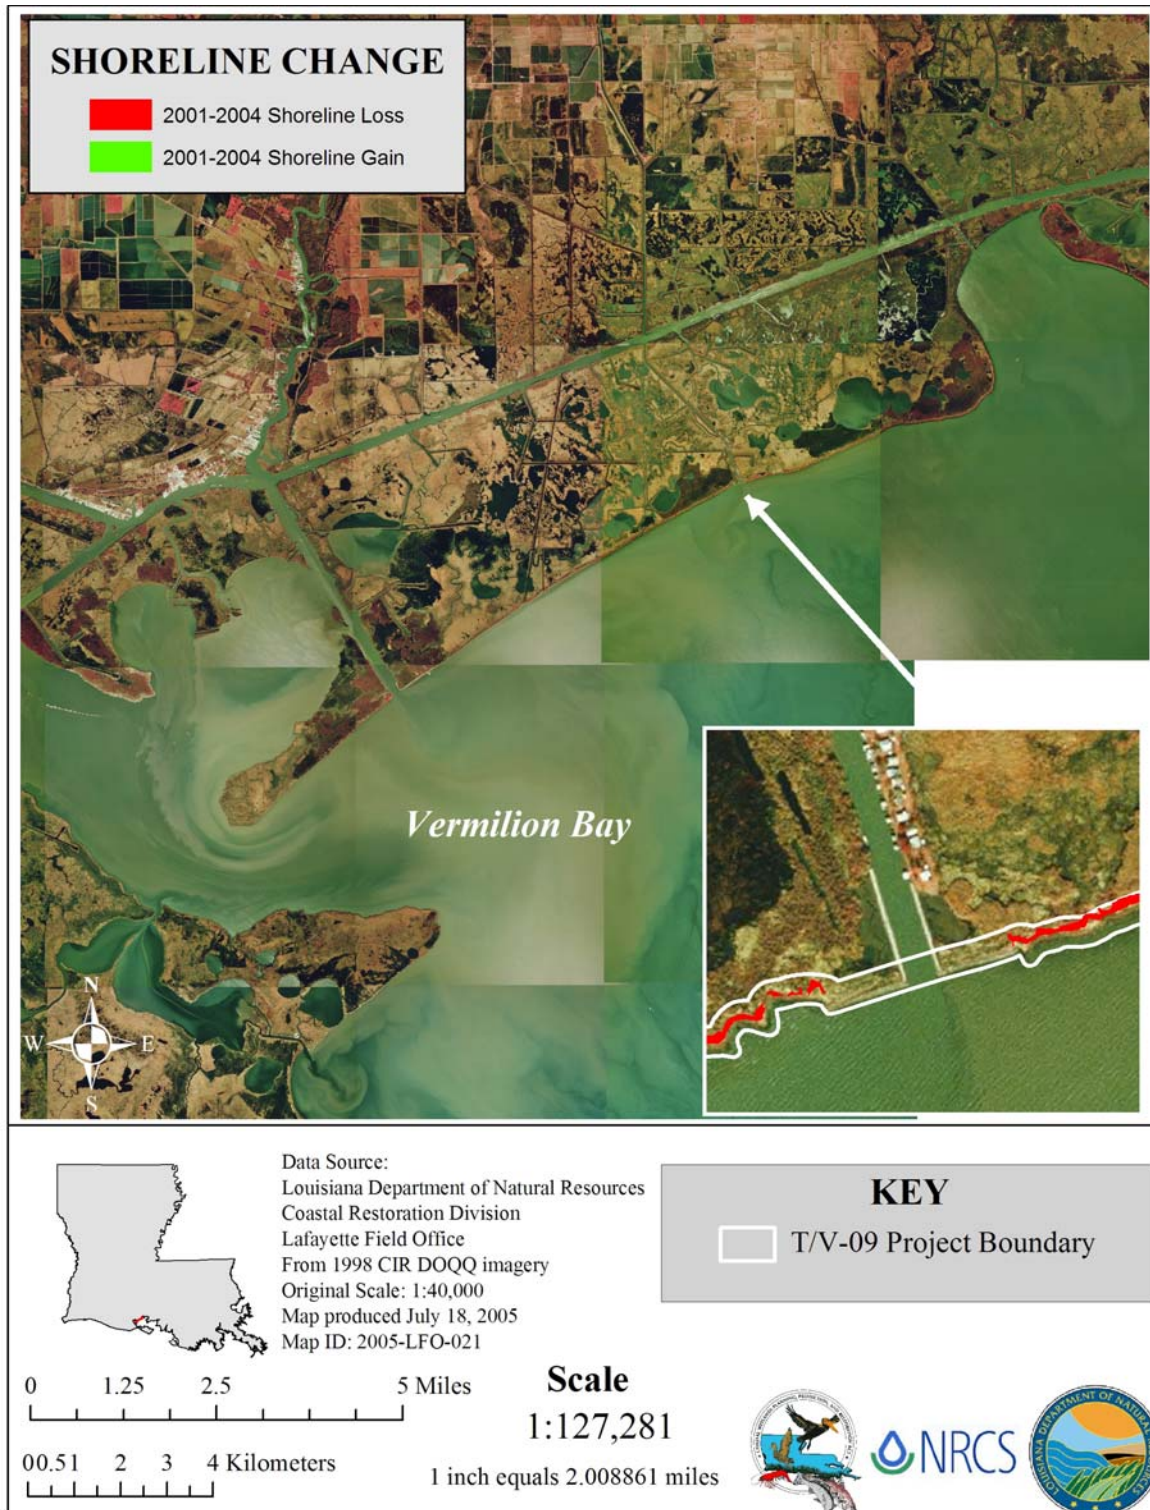
**Figure 9.** Shoreline position change for Boston Canal/Vermilion Bay Shoreline Stabilization (TV-09) project using 2001 and 2004 differential global positioning system mapping data.

The project is experiencing erosion along the Vermilion Bay shoreline despite the success of the plantings. Between 2001 and 2004, 7.6 ac/yr (3.08 ha/yr) were lost while 0.27 ac/yr (0.11 ha/yr) were gained, based on GPS of the shoreline. The shoreline erosion rate between 2001 and 2004 is 5.04 ft/yr (1.54 m/yr). Hurricane Lili struck the Louisiana coast east of Vermilion Bay near Cote Blanche in October 2002. Considering that the monitoring results from the first monitoring interval showed accretion occurred along some section of shoreline and a net gain in acreage was achieved, it is highly probable that the wave energy from the storm produced the erosion and resulting net loss. Although the plantings of *S. alterniflora* have become well established and are indistinguishable from each other along most of the shoreline, the plantings cannot protect shorelines from hurricane-force wave energy.

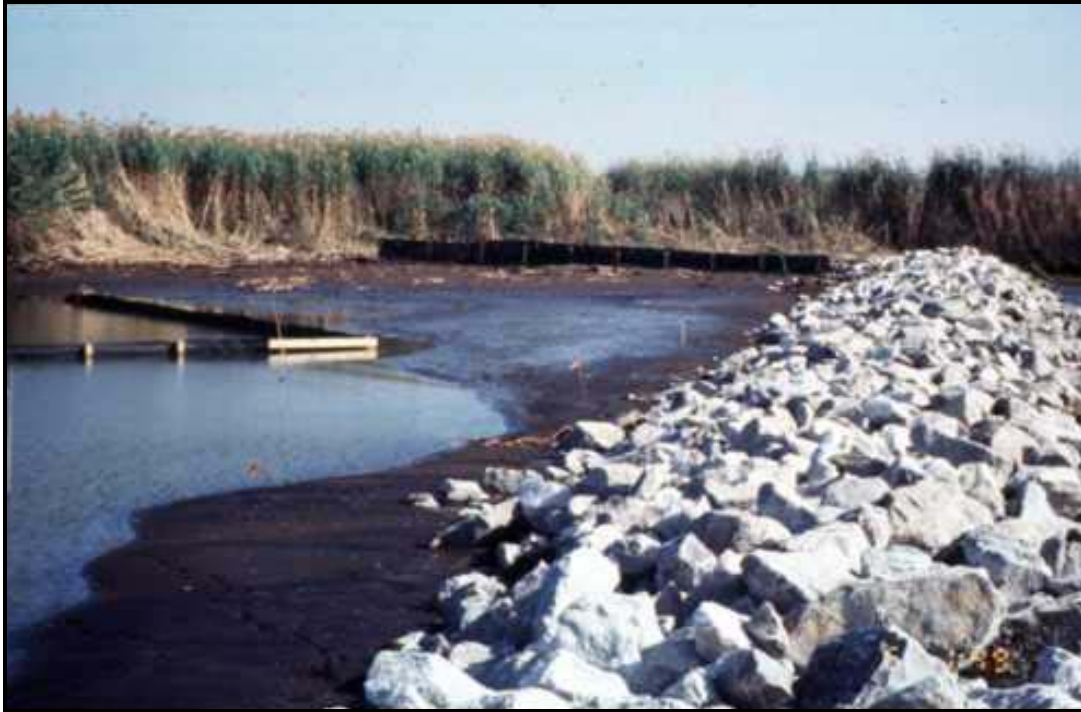
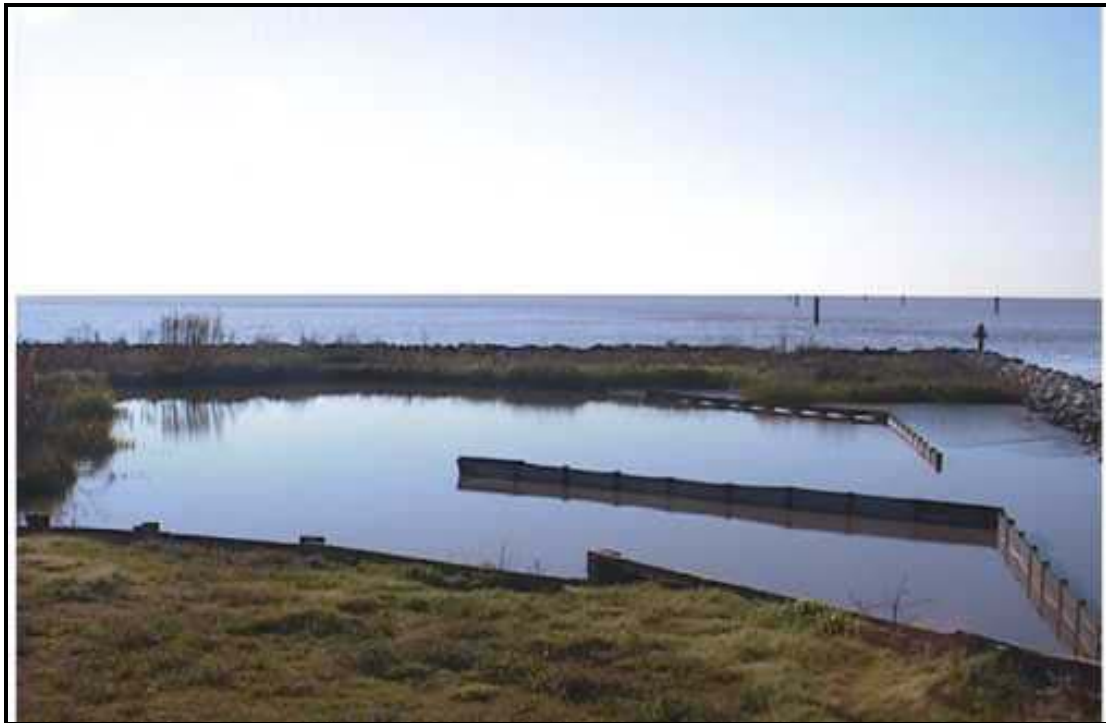
Sediment build-up behind the dike on the east and west sides is continuing and vegetation has taken over the exposed mud flats (figures 11-13). Elevation data show an increase in sedimentation behind the rock breakwater.

**Figure 11.** Boston Canal/Vermilion Bay Shoreline Stabilization (TV-09) photographs: (Upper) sedimentation behind the dike December 1994; (Lower) vegetation growing behind the dike in February 1998.

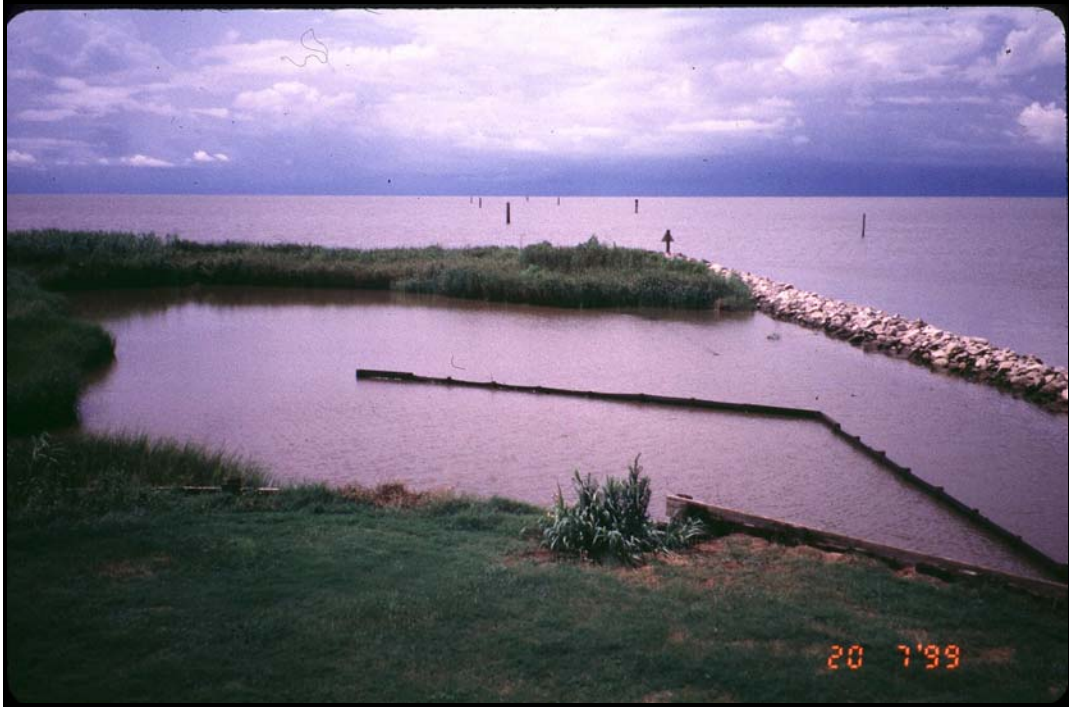
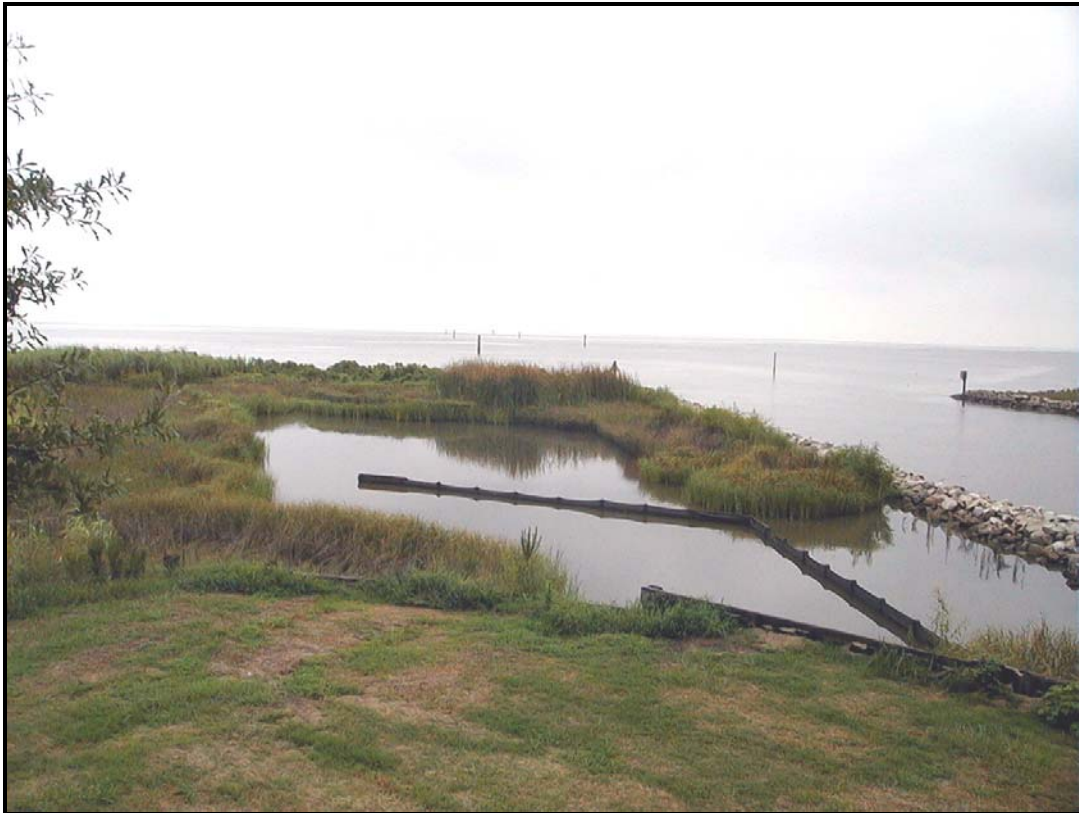
**Figure 12.** Boston Canal/Vermilion Bay Shoreline Stabilization (T/V-09) photographs: (Upper) vegetation behind the dike (July 1999); (Lower) vegetation behind the dike in October 2001.

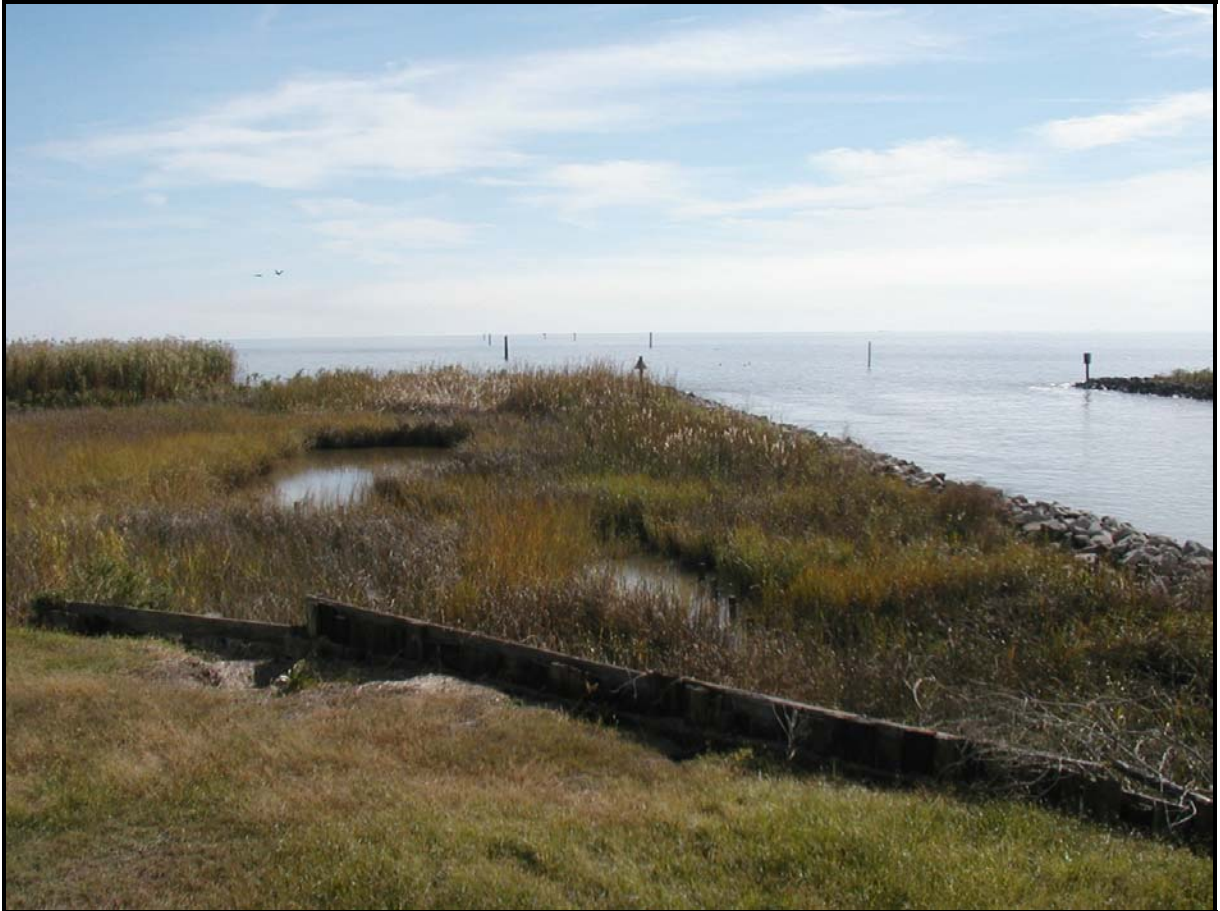
Figure 13. Boston Canal/Vermilion Bay Shoreline Stabilization Project (TV-09) behind the eastern rock dike, November 9, 2004.

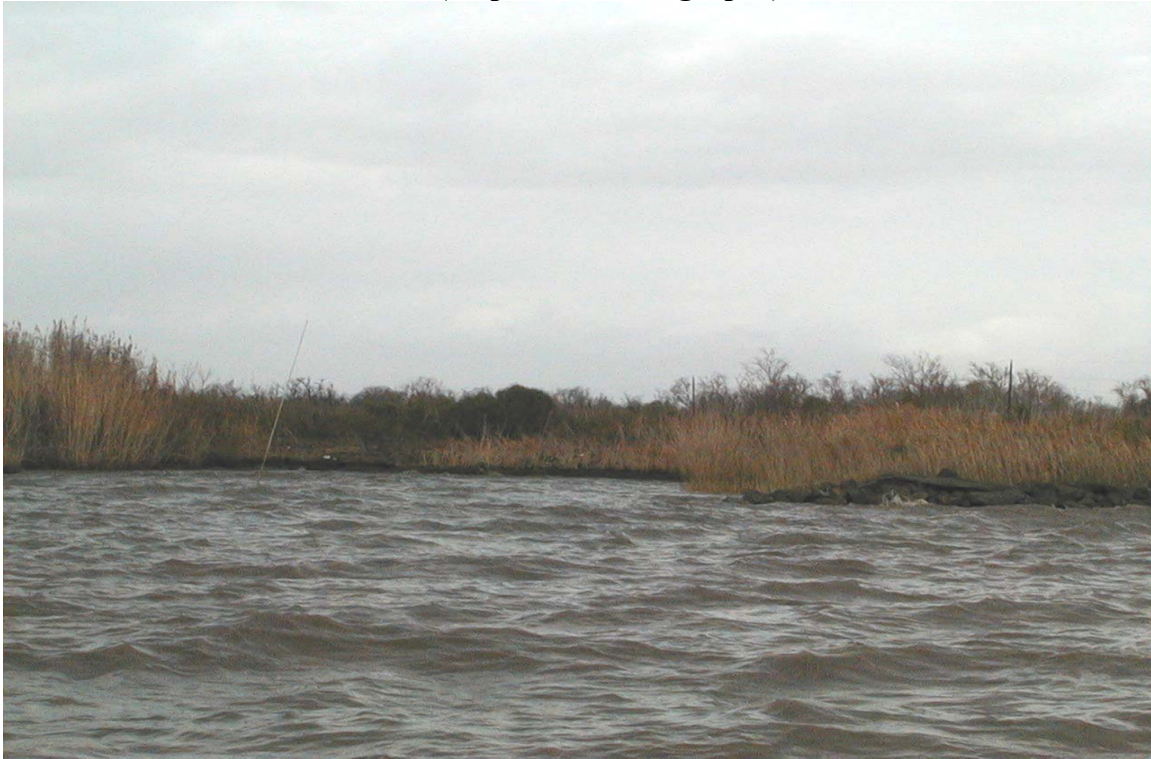
Photo 1—Southwest tie-in

For the most part, the breakwaters are in excellent post-construction condition. There is no apparent toe scour or rock displacement. The western end of the dike where it ties into the Vermilion Bay shoreline continues to worsen. A small gap left during original construction appears to have caused this problem. While the situation is similar on the southeast tie-in, it is not as severe. No gap was left on this end during construction. Recommendations made to repair these gaps during the O & M

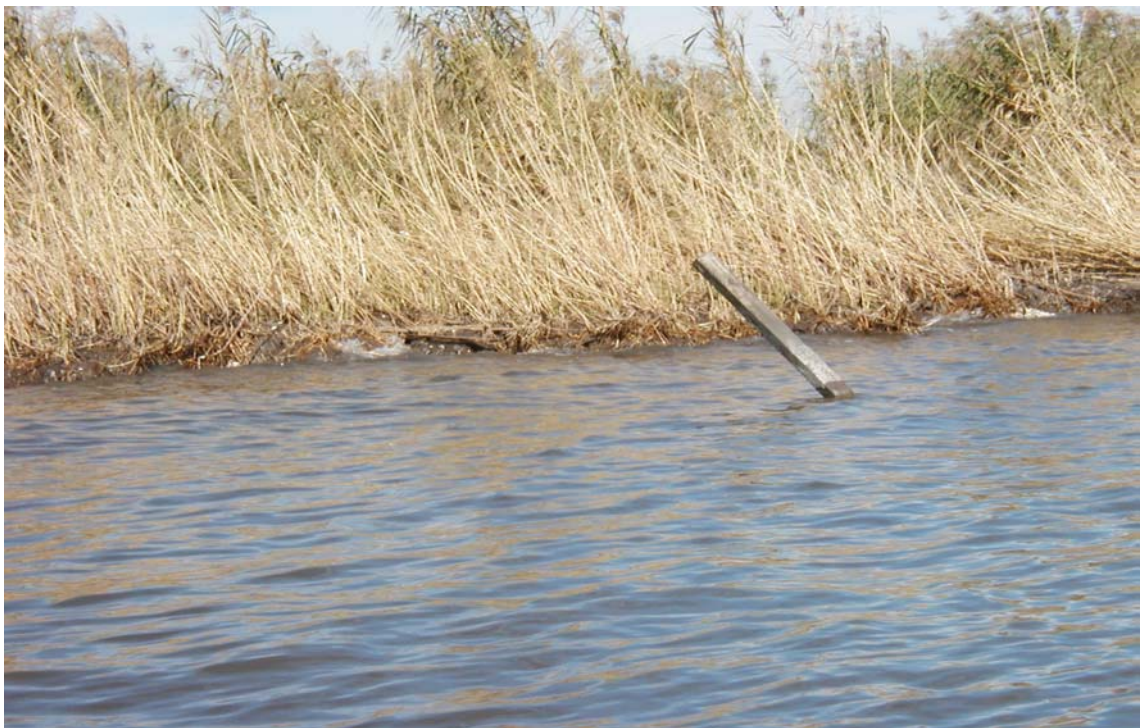
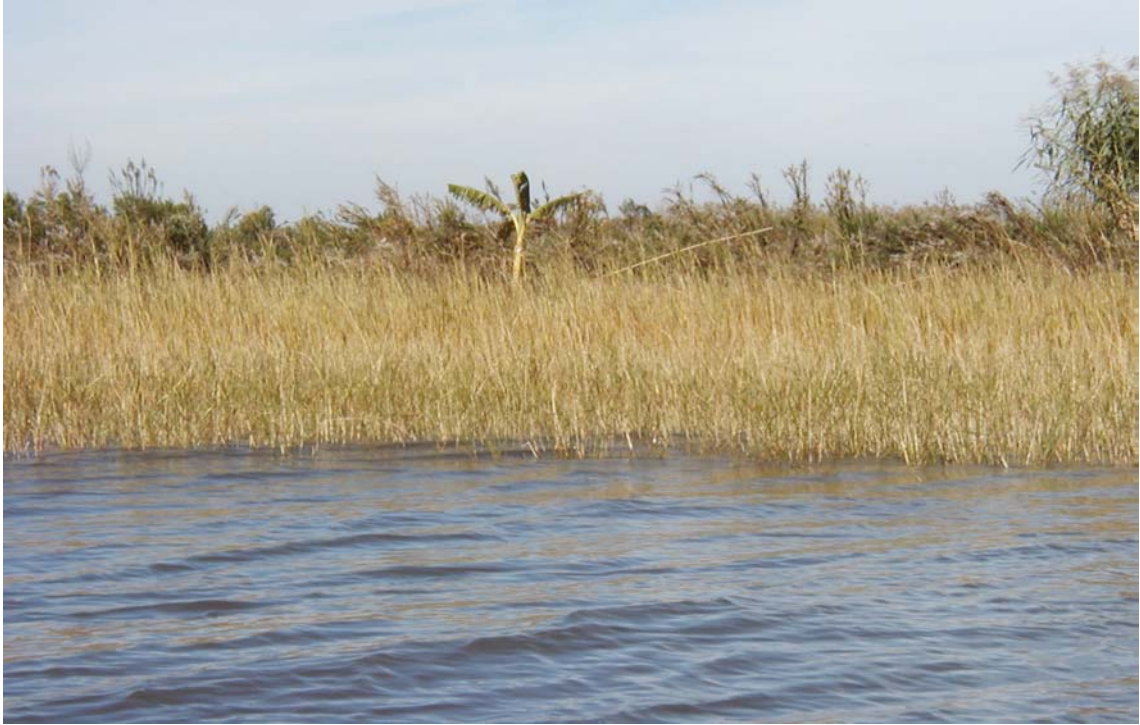
inspection of June 2003 have been reconsidered due to the high unit costs and logistics associated with such minor repairs. These areas will be closely monitored, and should the situation significantly worsen, steps will be taken to close/stabilize these areas. Signage and associated pilings are stable and functioning. (Photos: Appendix A, Photos 5 - 6)

Photo 5- Vegetation along bayshore

Photo 6 – Vegetation along bayshore
