**2007/2008 Annual Inspection  
Report**

**CAMERON PRAIRIE REFUGE  
PROTECTION PROJECT  
(ME-09)**

State Project Number ME-09  
Priority Project List 1

May 1, 2008  
Cameron Parish

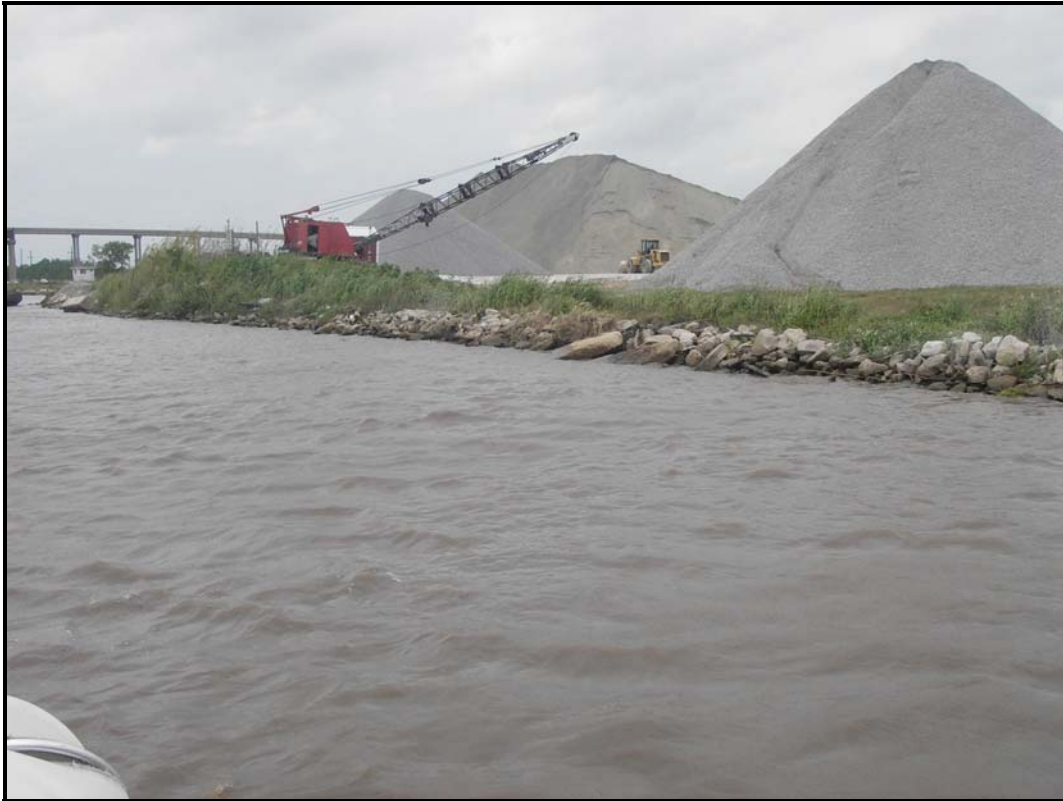
The foreshore rock dike is in excellent post construction condition. There is a short section of dike that is low with some displaced rock. Evidence of increased vegetation behind the foreshore rock dike was noted. No need for any maintenance in the foreseeable future however a staff gage is required. (Photos: Appendix B, Photos 1 - 3)

**Photo 1**, western tie-in along north bank of GIWW

Item	Condition	Physical Damage	Corrosion	Photo #	Observations and Remarks
Steel Bulkhead / Caps	N/A				
Steel Grating	N/A				
Stop Logs	N/A				
Hardware	N/A				
Timber Piles	N/A				
Timber Wales	N/A				
Galv. Pile Caps	N/A				
Cables	N/A				
Signage / Supports	Good				
Rip Rap (fill) (foreshore dike)	Excellent			1, 2 & 3	One area of dike is low with displaced rock.
Earthen Embankment	N/A

- Install staff gage along rock dike.

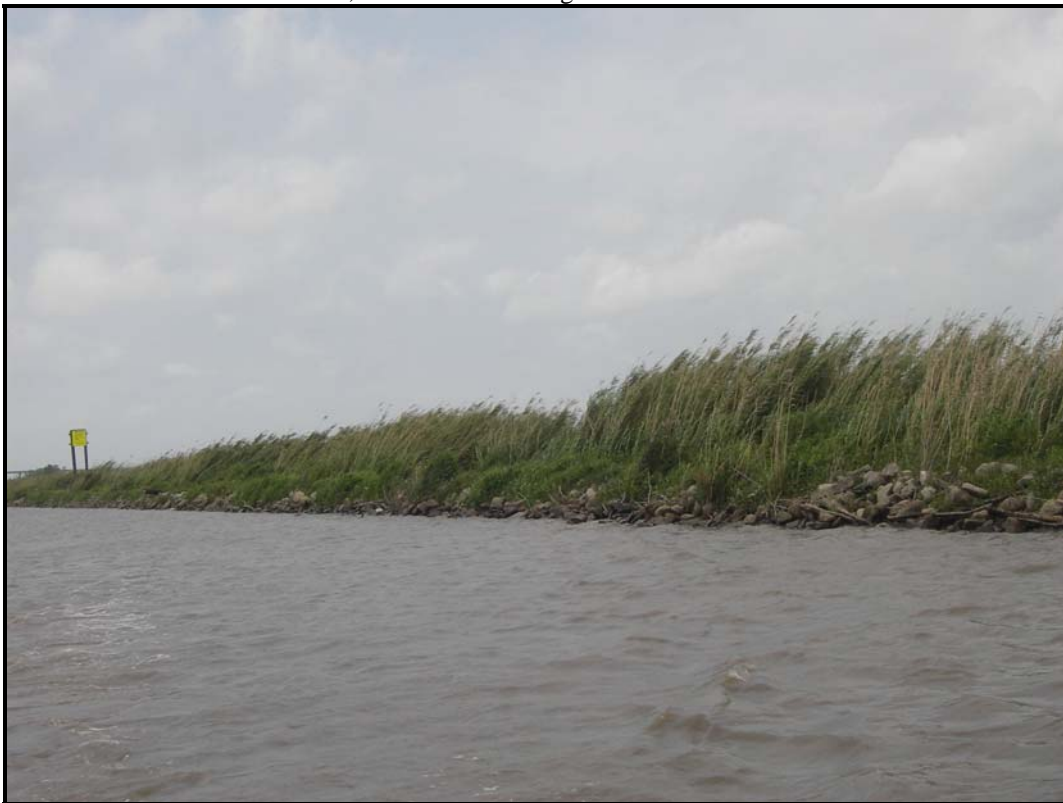
**Photo2**, Typical foreshore dike section.

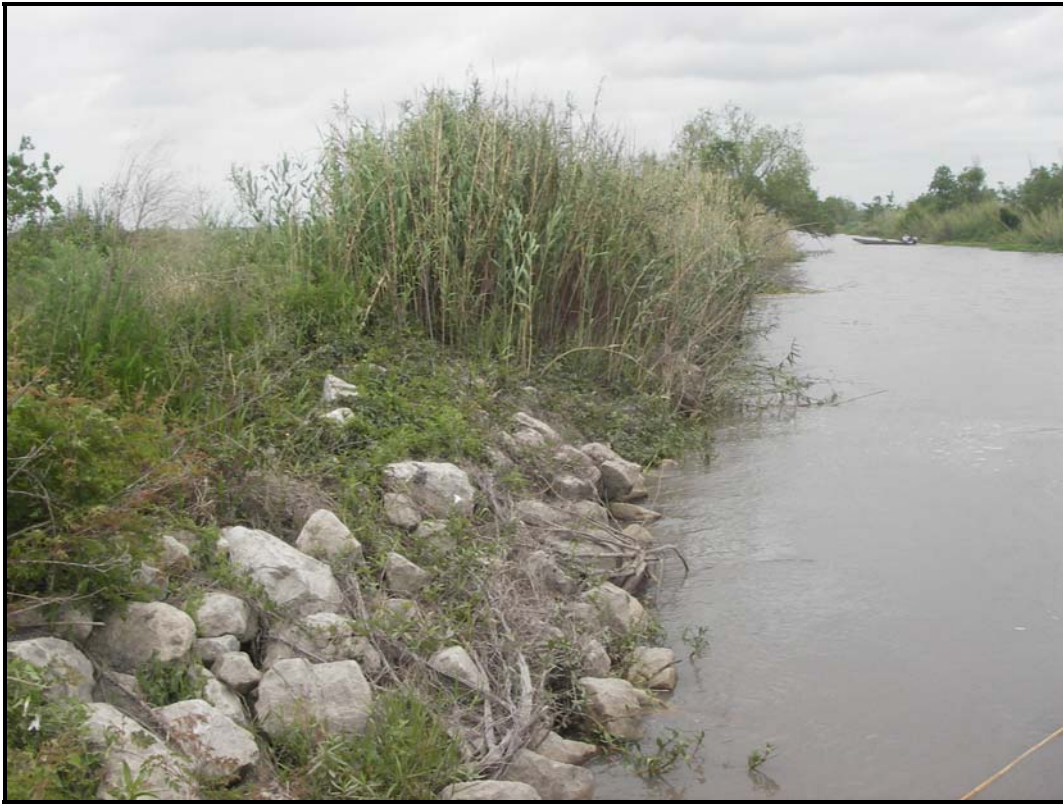
**Photo 3, Tie-in to North Prong Ditch**
