**2009 Annual Inspection Report**

**BRADY CANAL HYDROLOGIC  
RESTORATION PROJECT (TE-28)**

State Project Number TE-28  
Priority Project List 3

June 30, 2009  
Terrebonne Parish

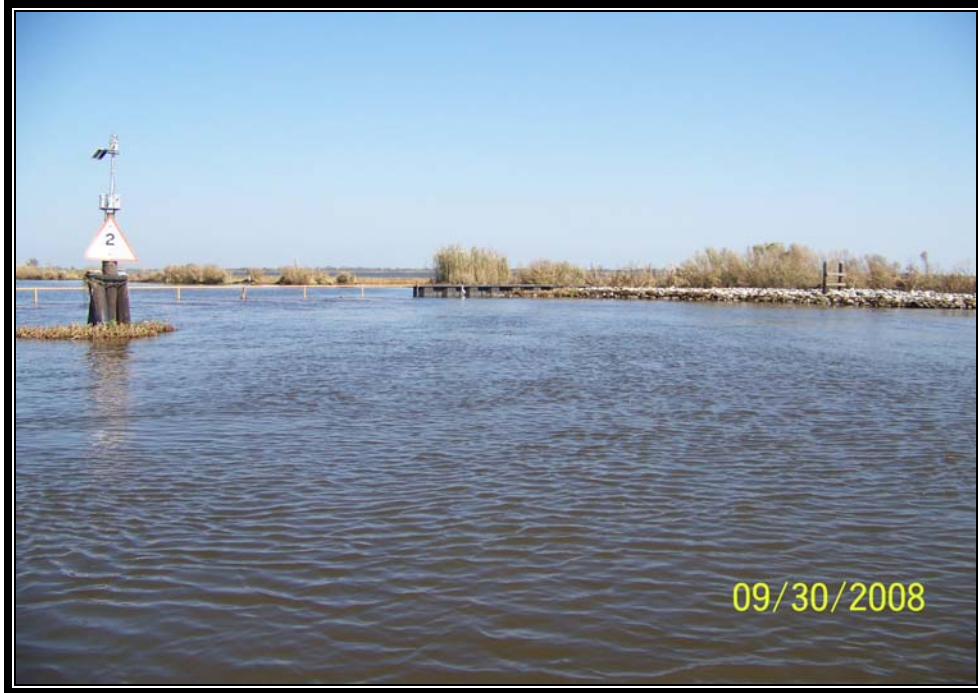
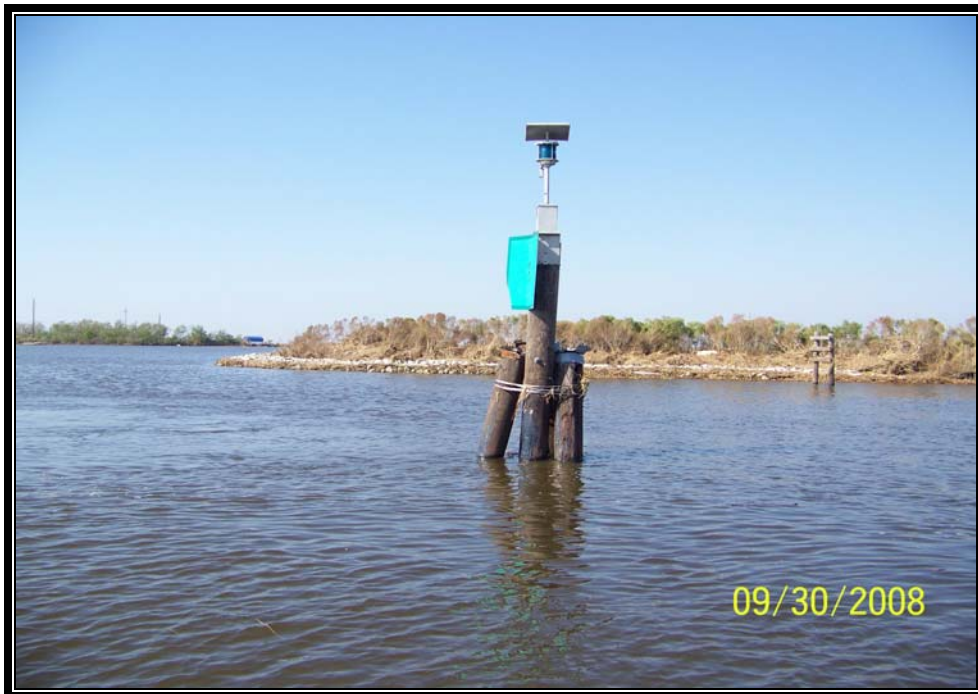
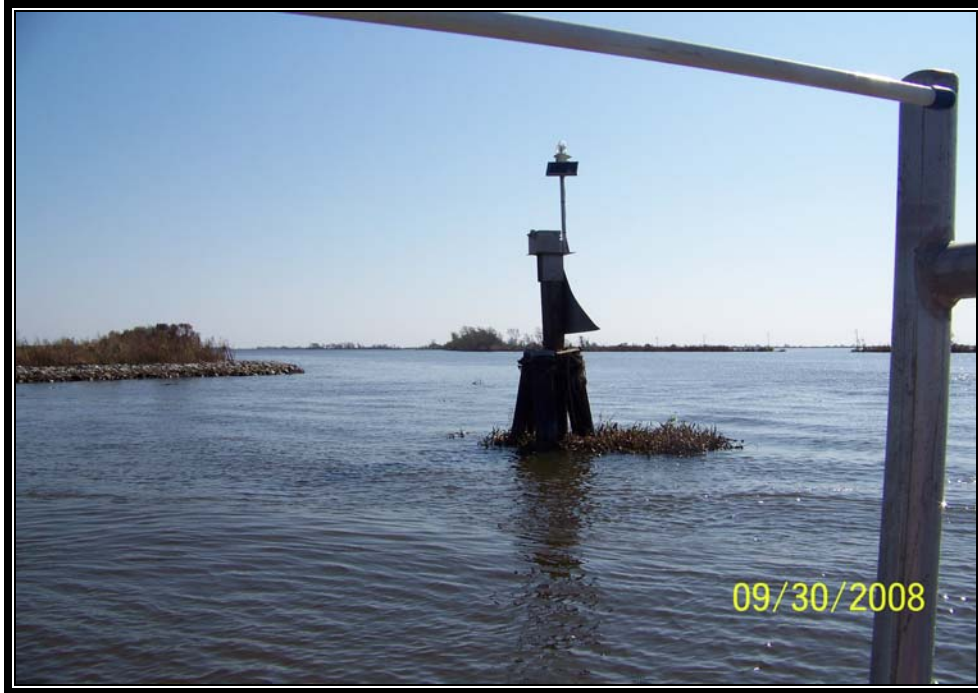
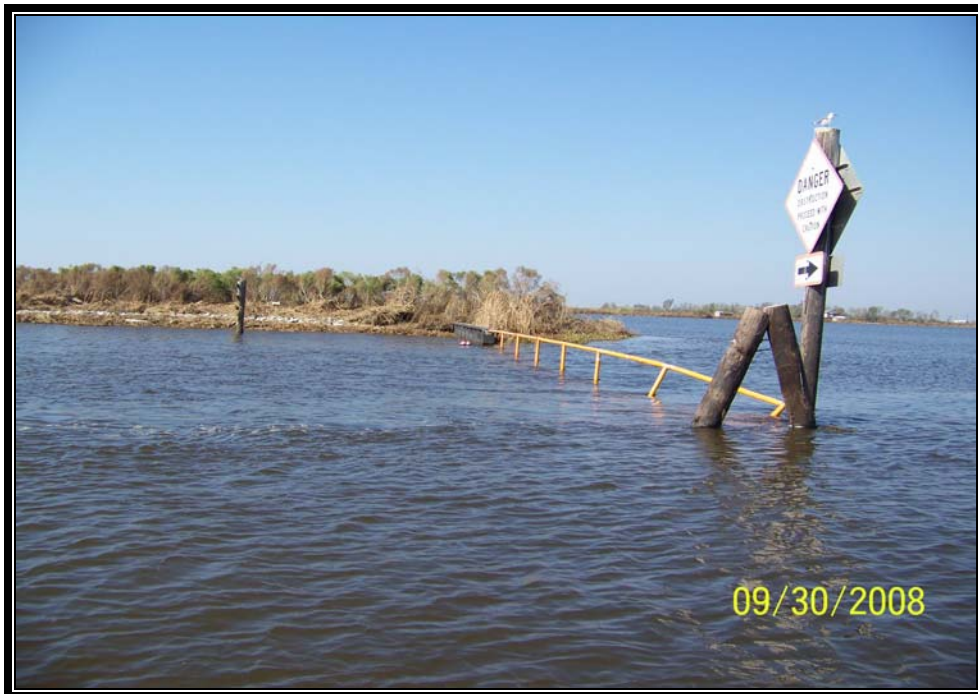
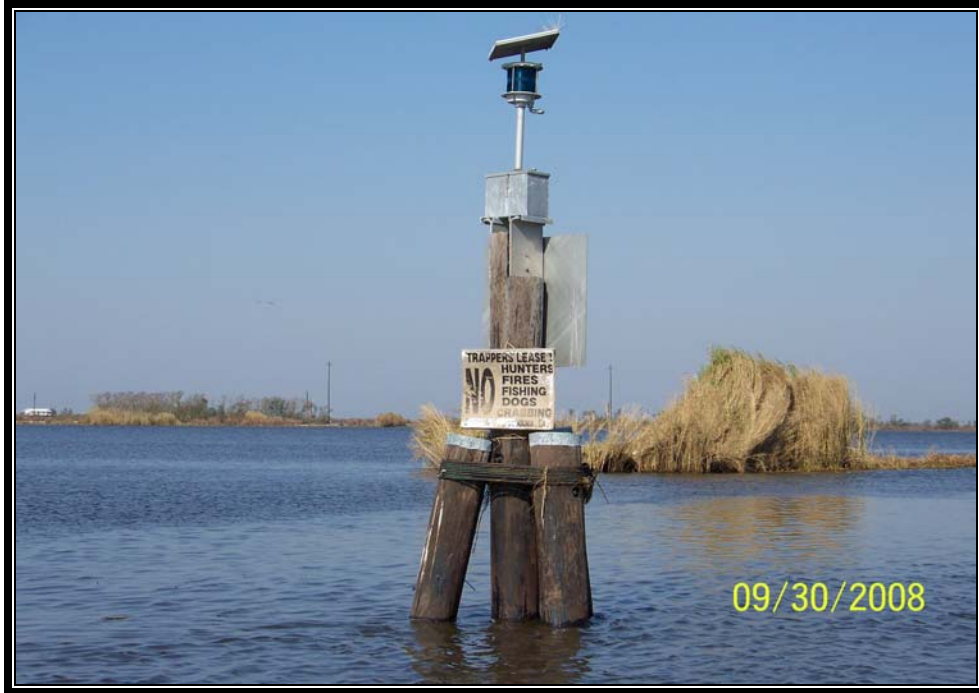
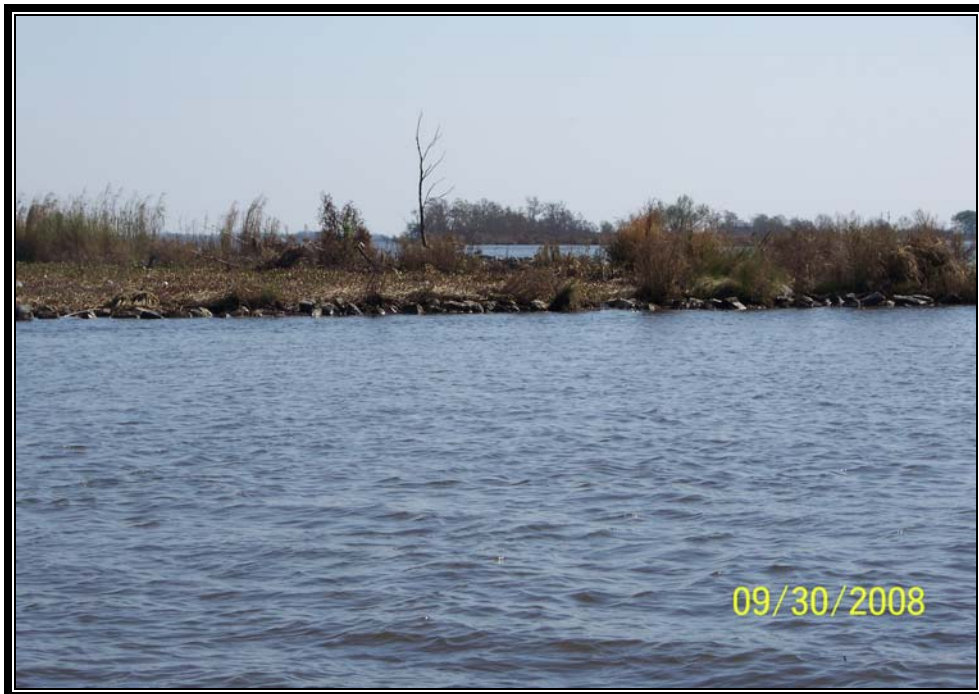
Structure 6 appeared to be in fair condition with severe damage to the steel guard rail attached to the sheetpile wall on the west side of the barge bay entrance and moderate damage to the timber navigational aid pile supports on the southwest side (Bayou Decade) of the structure. The steel guard rail mounted on top of the channel cap of the steel bulkhead was damaged by an oil field service barge while accessing the barge bay opening. Since the September 2008 damage assessment, the oil field service contractor has replaced the timber bumper guards and straightened the guard rail on the west side of the barge bay. Other deficiencies included moderate damage to the two (2) timber batter piles supporting the navigation aid systems on the south side of the structure. The batter piles were off center and split down the middle, and the steel cable wraps around the pile cluster were very loose. Although there is visual damage to both timber pile clusters, it is not anticipated that structural failure is imminent. However, to avoid having to incur additional costs associated with mobilizing equipment in the future to replace the two (2) structures, it is recommended that the timber dolphin system be included in the next maintenance project for the Brady Canal project. It doesn't appear that there is breaching

Photo No. 1 - View of timber navigation aid structure and steel bulkhead on the east side of the barge bay of Structure No.6 along Bayou Decade.

Photo No. 2 – View of the timber navigational aid structure on the southeast side of Structure No.6. The center pile of this structure was replaced in 2003.

Photo No. 3 – View of the timber navigational structure on the southwest side of Structure No.6.

Photo No. 4 – View of the steel bulkhead and timber bumper guards on the west side of the barge bay of Structure No.6. The timber bumper guards were recently replaced by the oilfield service contractor at the request of the landowner.

Photo No.5 – View of the timber navigational aid support and light on the northeast side of Structure No.6

Photo No.6 – view of the north bank of Bayou Decade west of Structure No.6

of the earthen embankment on either side of the structure. Although there are no breaches in this embankment at this time, it is recommended that the spoil bank adjacent to the structure be refurbished with dredged material from Bayou Decade during the next maintenance project. All navigation lights and signage appear to be in working condition. Automatic Power, Inc. of Larose has been maintaining the navigation lights under a maintenance contract with OCPR since February 2007. (Appendix B, Photos 1-6).

The timber cluster pile replacement shall include removal of two (2) existing timber pile structures and replacing them with new treated timber piles, supports and hardware. This work shall also include removal and reinstallation of the navigation aid system.

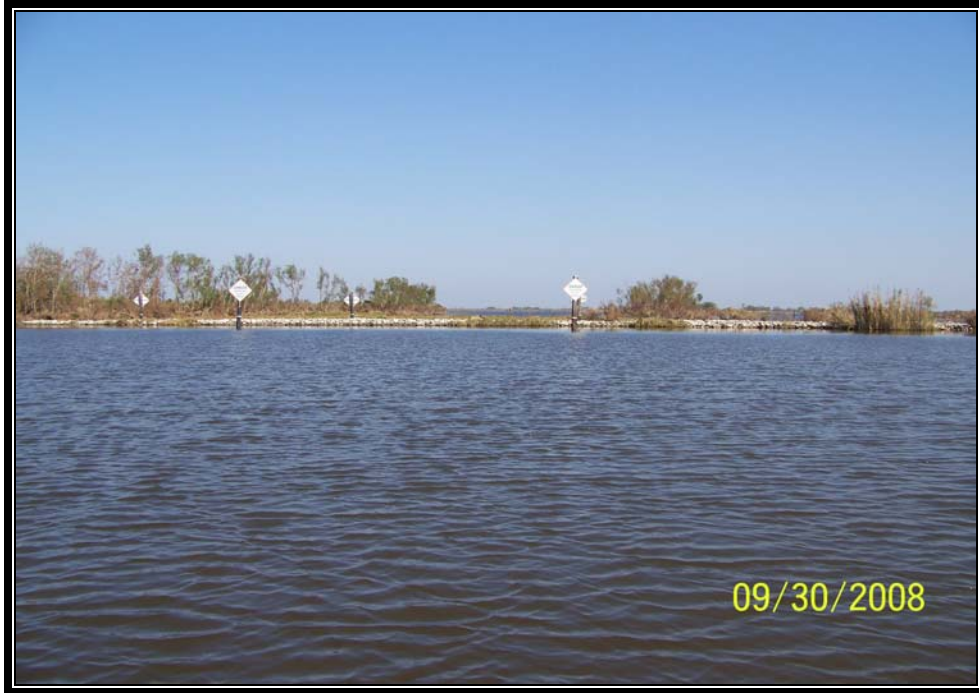
Structure 7 appeared to be in very good condition. There were no indications of erosion around the ends of the structure or rock displacement along the length of the plug. The warning signs and supports were also in very good condition. (Appendix B, Photo 7)

Photo No.7 – An overall view of the rock plug (Structure No.7) on the north bank of Bayou Decade

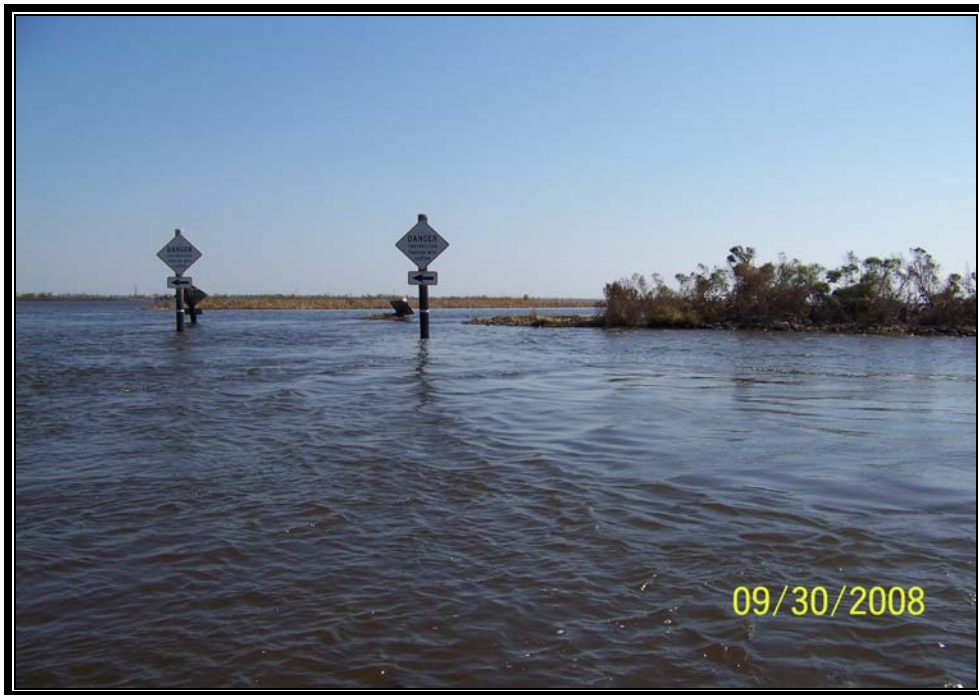
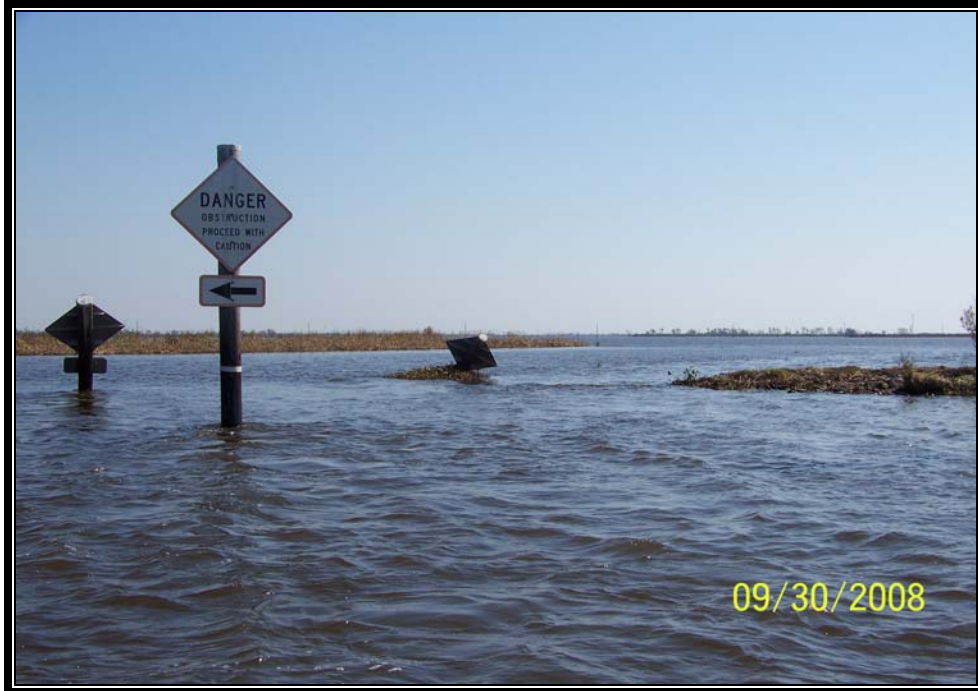
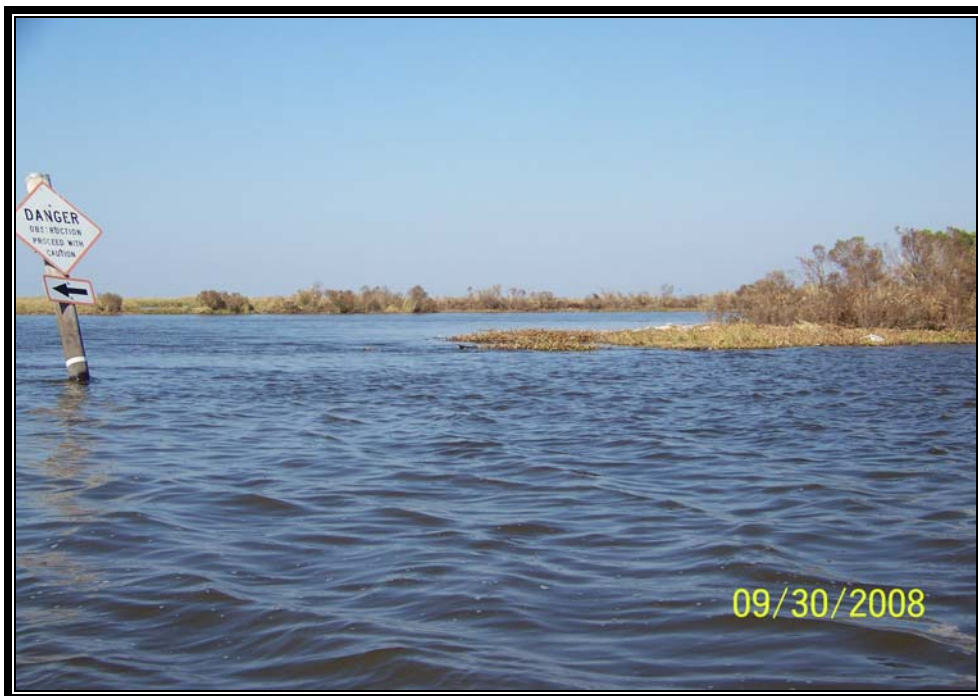
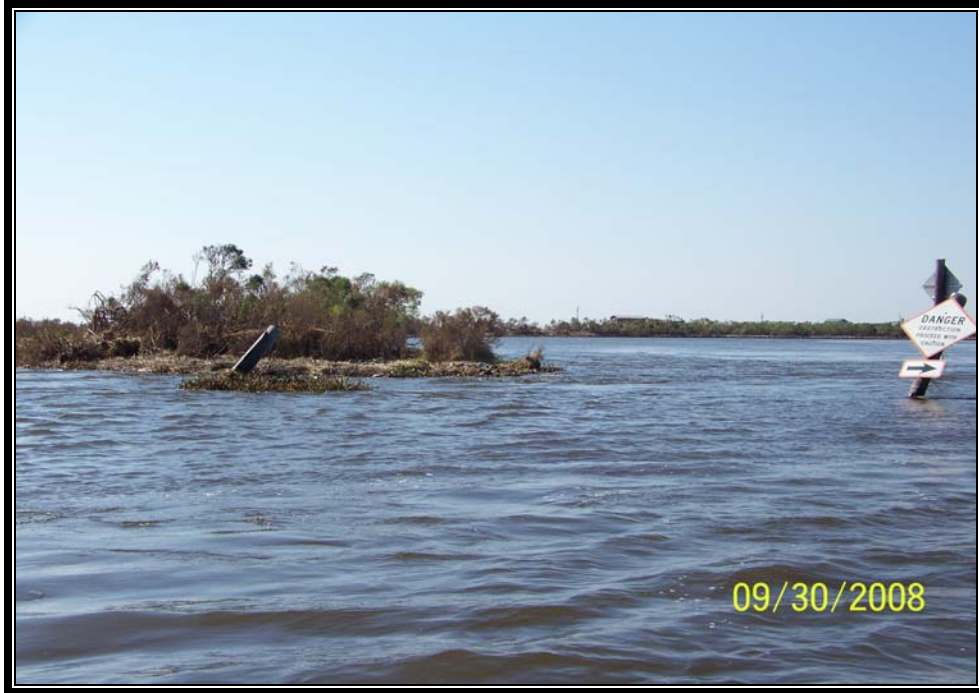
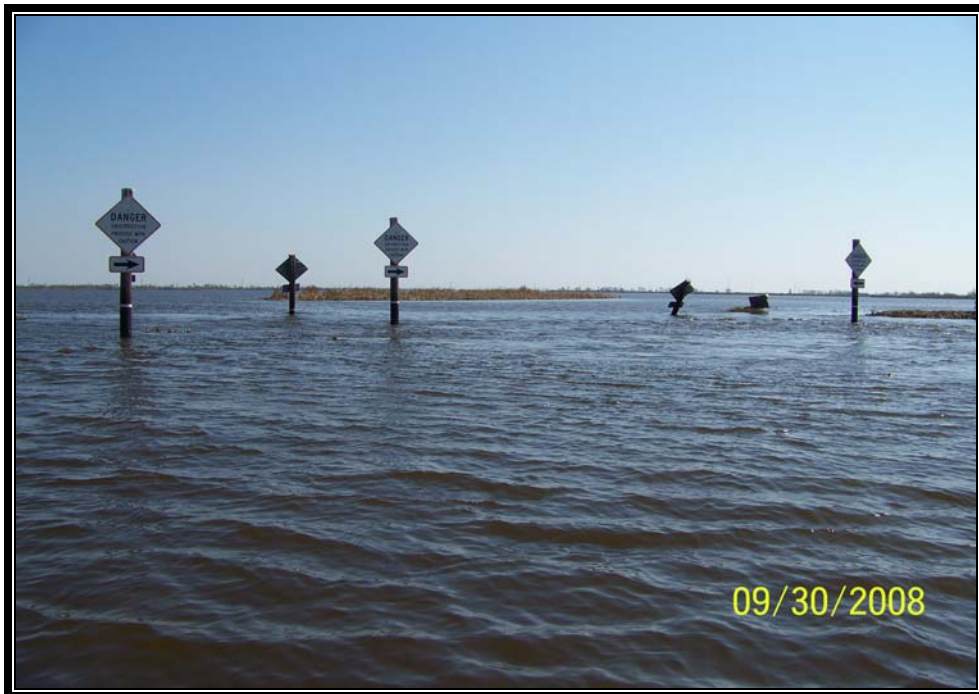
The rock armored channel along Voss Canal appeared to be in good condition with no apparent structural settlement or rock displacement. With most of the structure underwater, it is difficult to determine if the rock structure below the water line has settled. Therefore, it is recommended that a survey profile be performed to assess the condition of the entire rock channel liner structure. The only visible damage to Structure 10 was the three (3) warning signs marking the channel on the interior marsh side of the structure. The warning signs were leaning over to one side. At this time, we do not know if the timber support piles were cracked or sheered below the water line, or if the embedded portion of the pile tips shifted under the intense winds produced by Hurricanes Gustav and Ike. Regardless of the cause, it is recommended that the damaged timber supports be removed and replaced with new timbers and the signs reinstalled. (Appendix B, Photos 8-12).

Photo No.8 – view of the south side of the rock channel liner (Structure No.10) along Voss Canal. The warning signs in the background of the photo are leaning over as a result of strong winds from Hurricanes Gustav and Ike.

Photo No. 9 – A closer view of the damaged warning signs at Structure No.10 shown in the previous photo.

Photo No.10 – The interior warning sign on the north side of the rock channel liner (Structure No.10) along Voss Canal.

Photo No.11 – A closer view from the interior marsh area showing the damaged warning signs on the south side of Structure No.10.

Photo No.12 – An overall view of the rock channel liner (Structure No.10) and existing warning signs.

Replacement of timber piling and warning signs at Structure No.10.

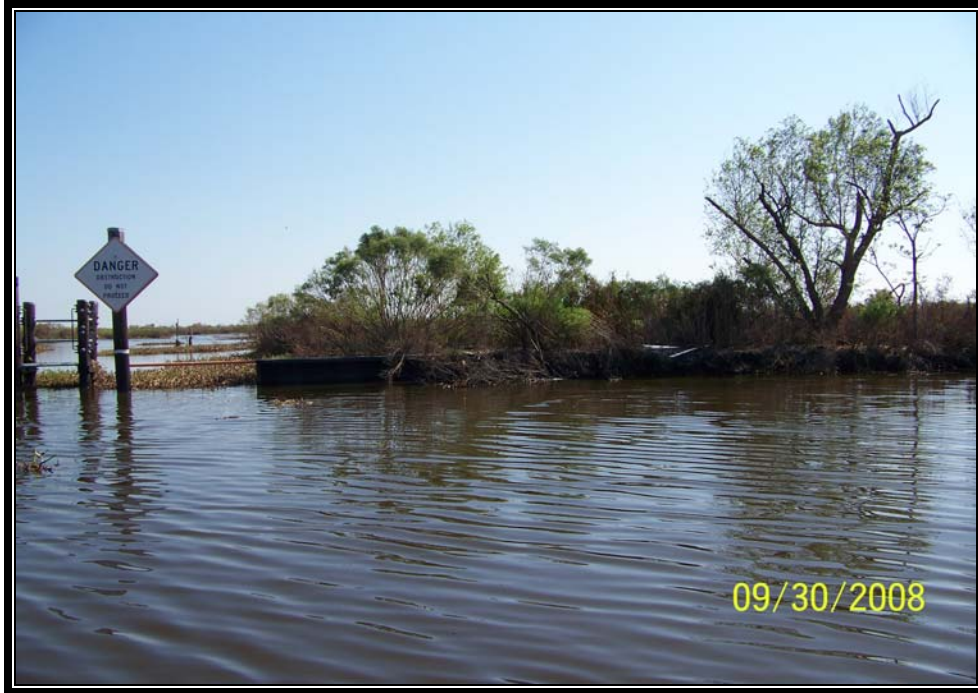
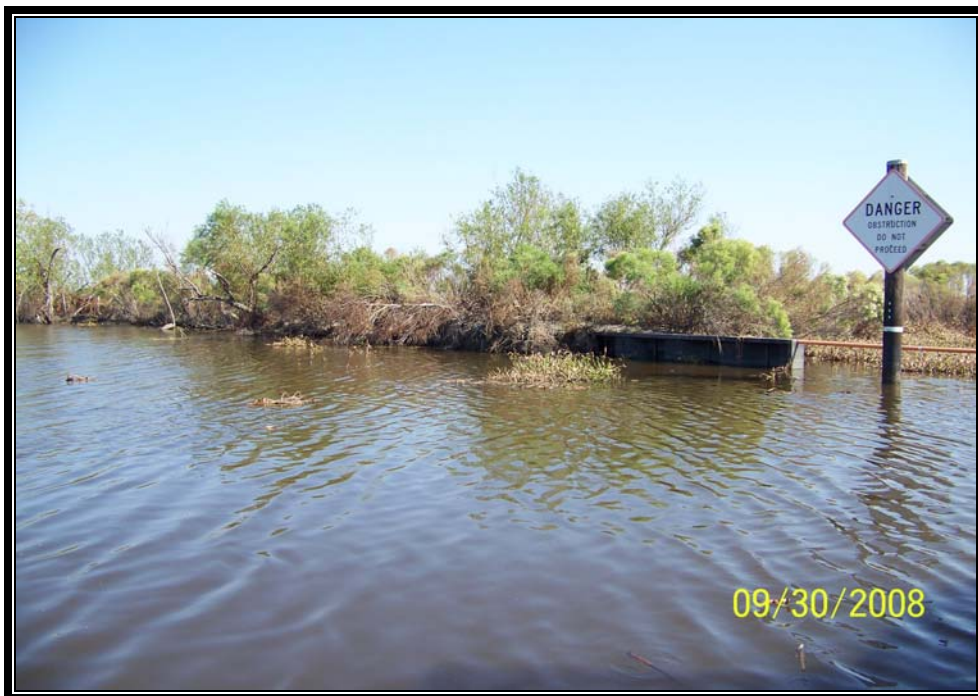
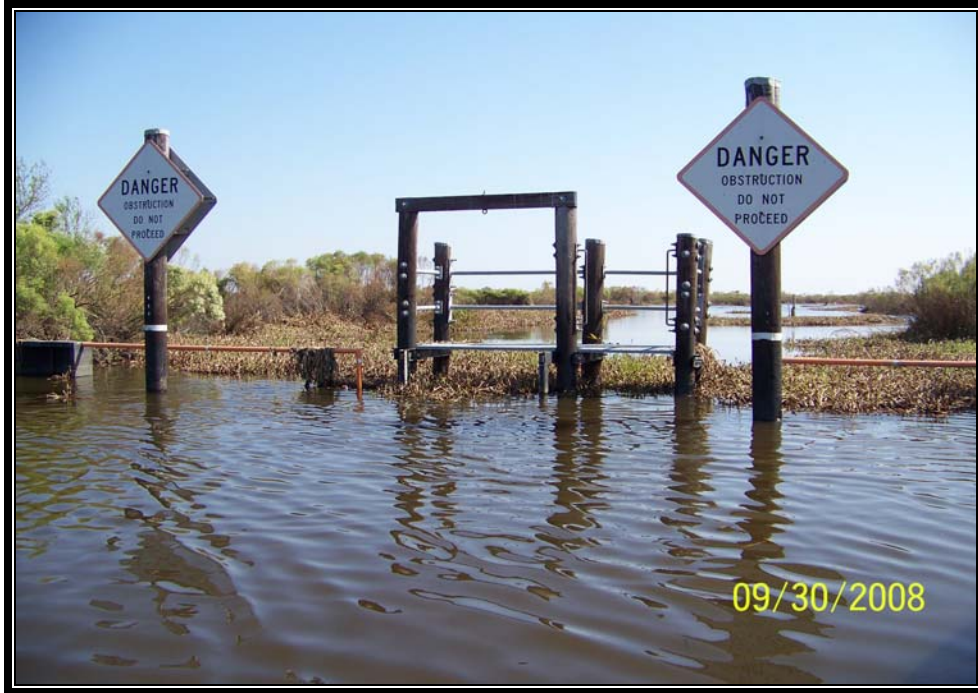
The variable crest weir structure located along the east bank of Bayou Carencro appeared to be in very good condition with only minor erosion noted on both sides near the earthen embankment tie-ins. The signs, timber supports and structural components of Structure 14 were in good condition with no noticeable structural damage or corrosion. All signs and supports were also in good condition (Appendix B, 13-15).

Photo No.13 – view of the steel bulkhead on the south side of the variable crest weir (Structure 14) along Little Carencro Bayou.

Photo No. 14 – View of the steel bulkhead on the north side of the variable crest weir (Structure 14) along Little Carencro Bayou.

Photo No. 15 – View of the variable crested weir section at Structure 14 along Little Carencro Bayou.

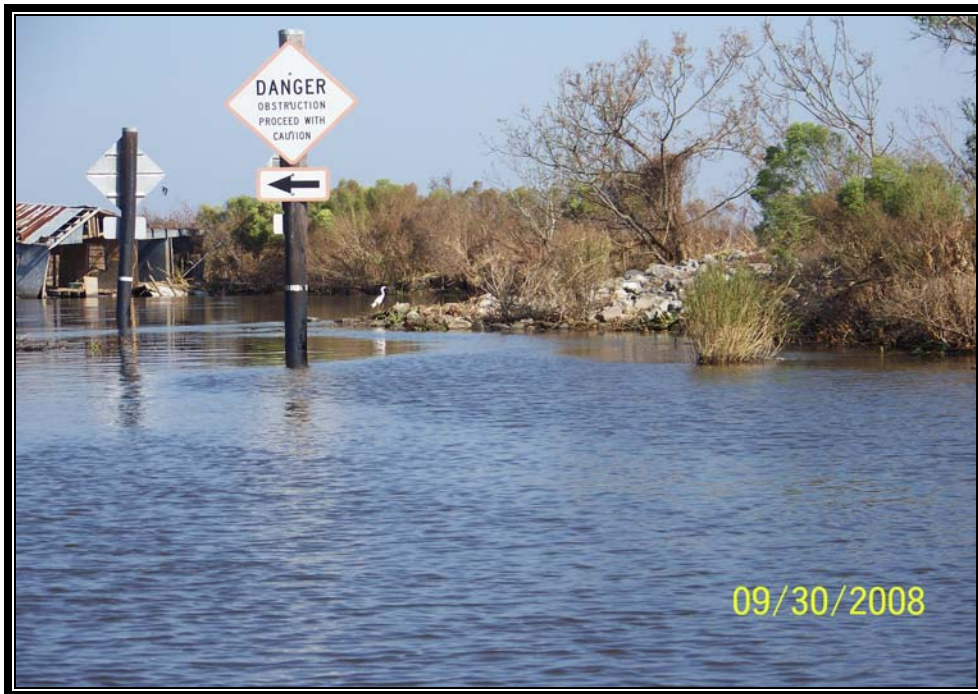
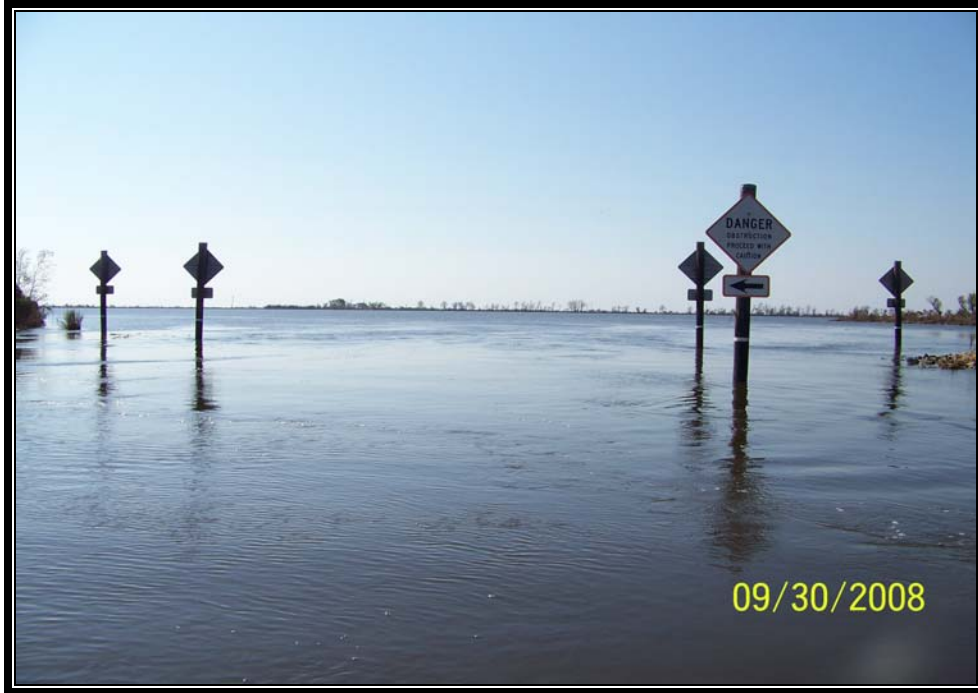
Rock rip-rap channel liner located along the west bank of Jug Lake appeared to be in good condition with no obvious rock settlement or displacement. The warning signs and timber pile supports were also in good condition. As in the case of Structure 10, it is recommended that a survey profile of the rock armored channel be performed to determine if the structure settlement below the water line is of concern, and if maintenance is required. (Appendix B, Photos 16-17).

Photo No. 16 – View of the northern end of the rock channel liner of Structure No.20.

Photo No. 17- An overall view of the rock channel liner (Structure 20) looking southeast towards Jug Lake.

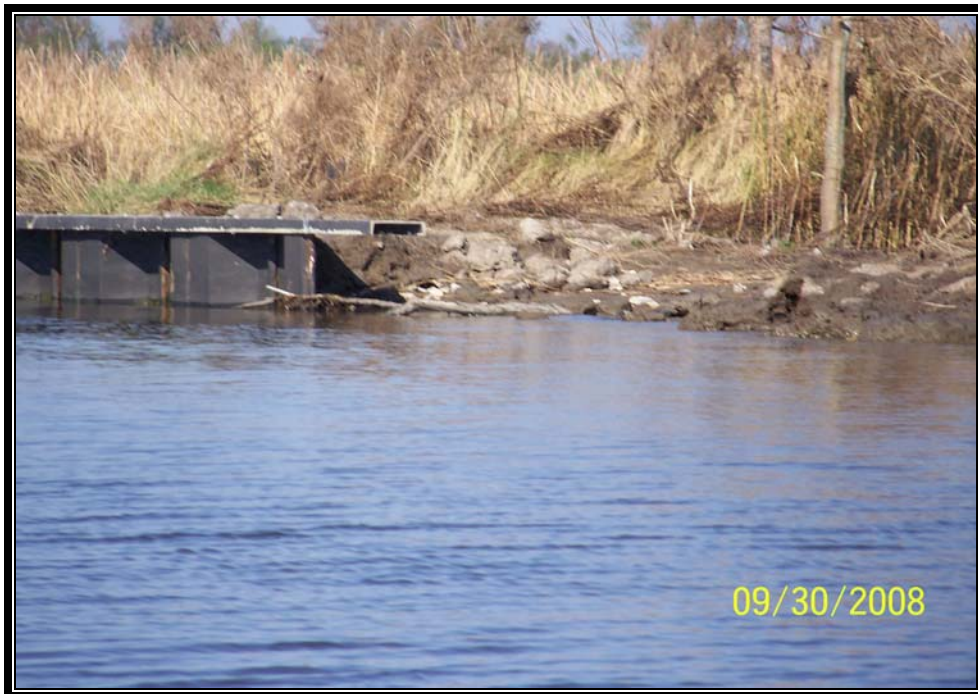
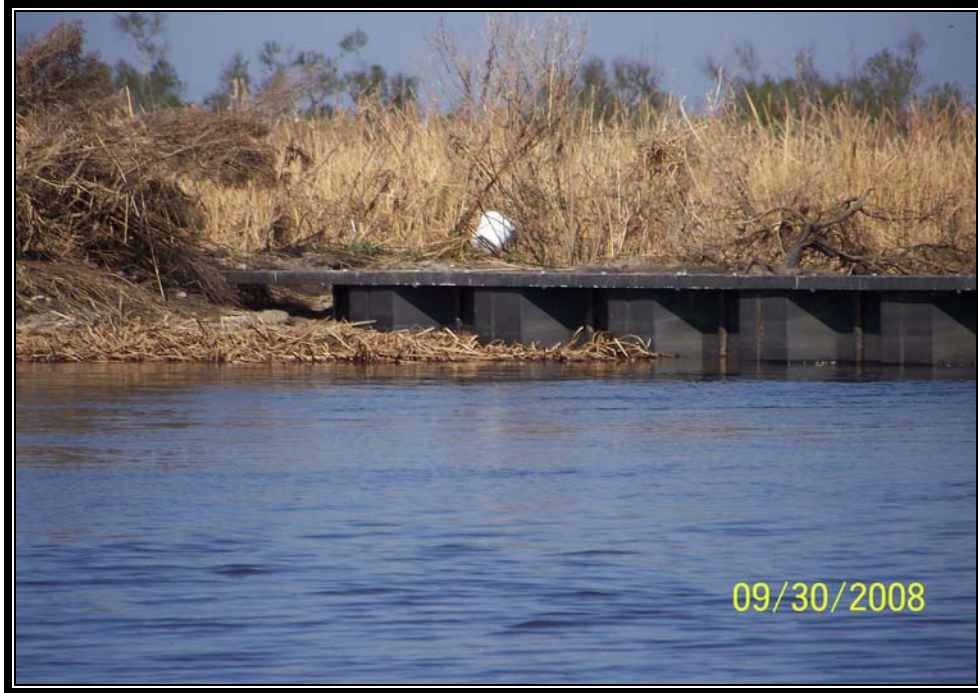
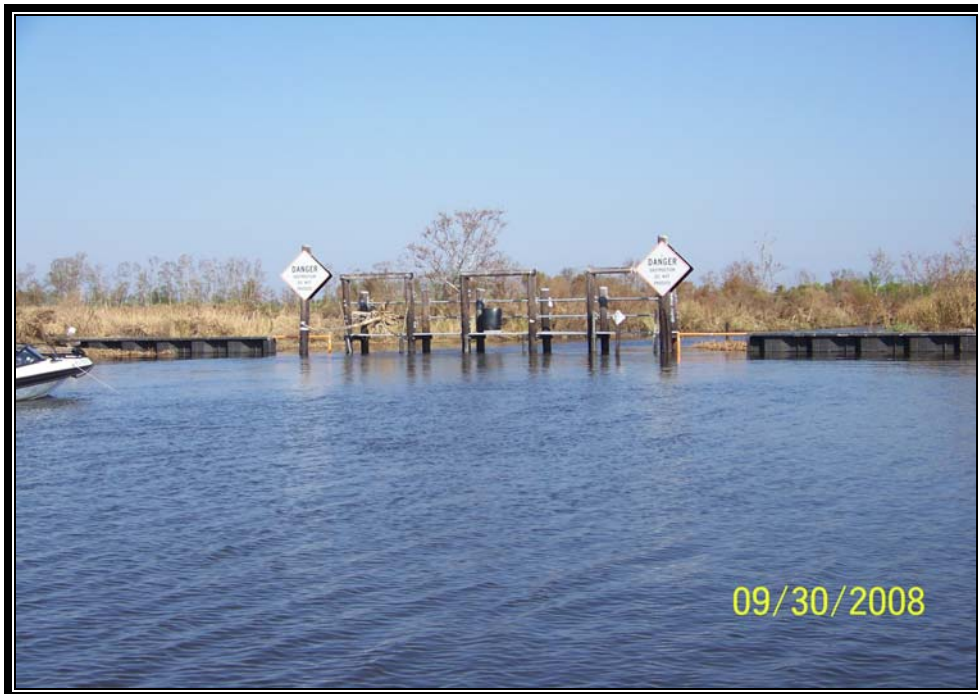
The variable crest weir structure appeared to be in fair condition with no indication of structural damage or corrosion of the structural components. The earthen embankment tie-ins on both sides of the Structure No. 21 have experienced significant erosion, most notable on the north side. The earthen embankments tie-ins were last refurbished by Apache Minerals in July 2007 under their in-kind service agreement with the OCPR. As documented in previous annual inspection reports, the earthen wing walls have required maintenance several times in previous years to avoid breaching around the steel bulkhead. To alleviate the need for continued maintenance of the earthen embankments in the future, it is recommended that the earthen tie-ins be reinforced with stone or rip rap once the embankment is refurbished. A hardened structure in these areas should provide adequate protection from erosion and breaching. (Appendix B, Photos 18-20)

Photo No. 18 – View of the northern end of the steel bulkhead at Structure No.21. Although there was no breach present, the earthen embankment had eroded back beyond the face of the bulkhead exposing the end of the structure.

Photo No.19 – View of the southern end of the steel bulkhead at Structure No. 21. Observed moderate erosion of the earthen embankment exposing the end of the bulkhead.

Photo No.20 – An overall view of the three (3) bay variable crest weir at Structure No.21.

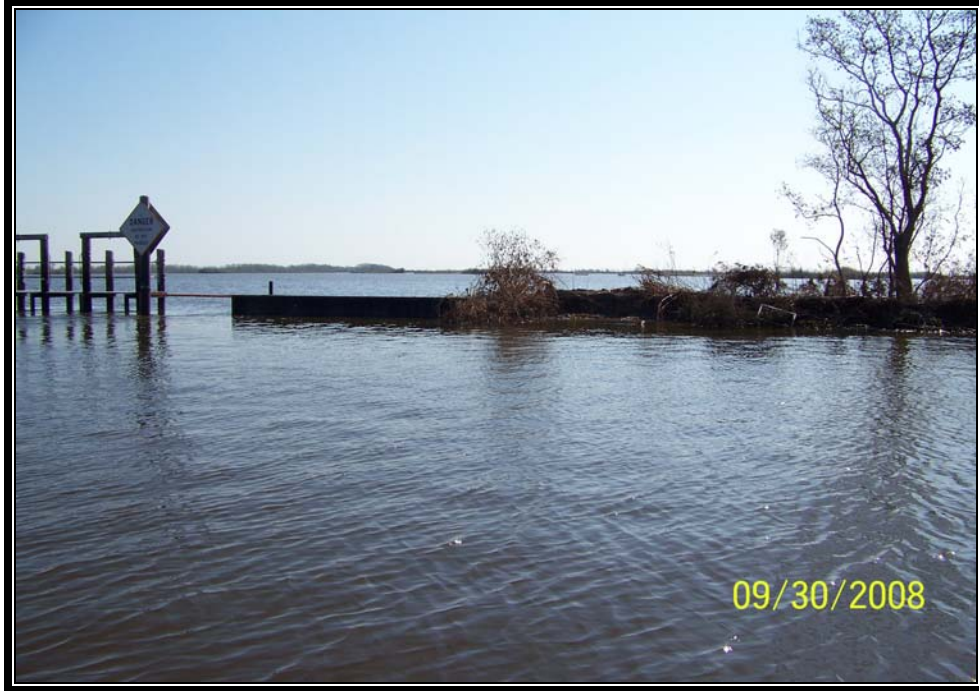
Photo No. 21 - View of the bulkhead tie-in to the earthen embankment on the south side of Structure No. 23.

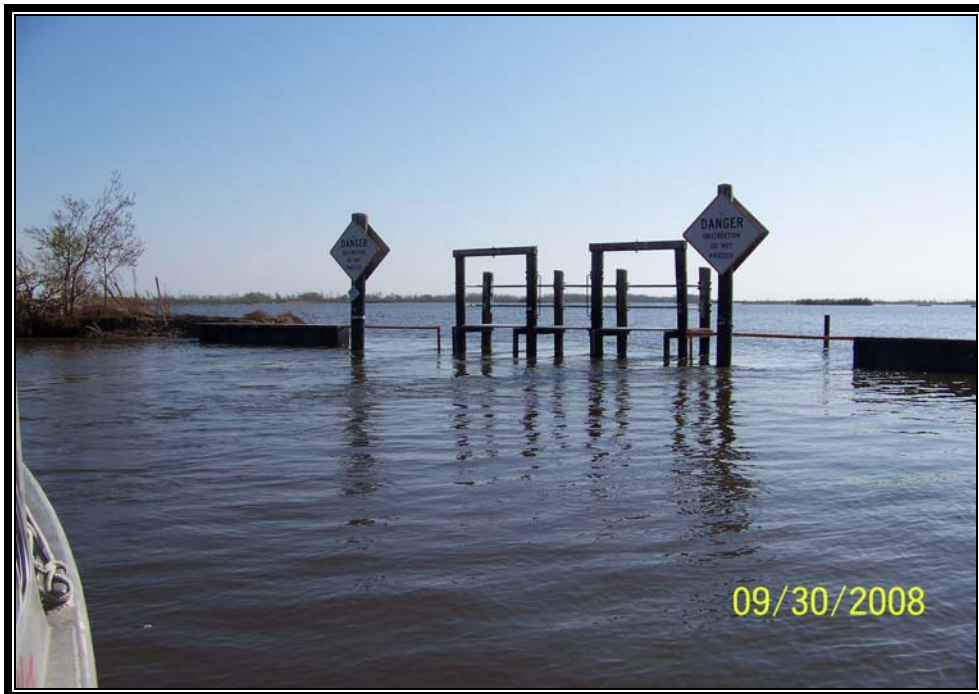
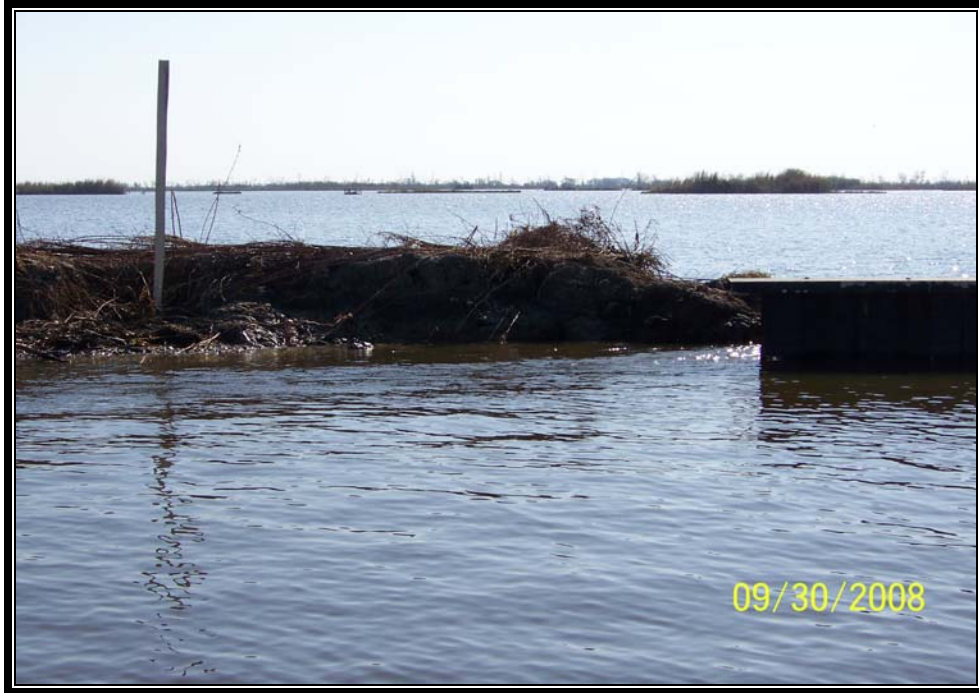
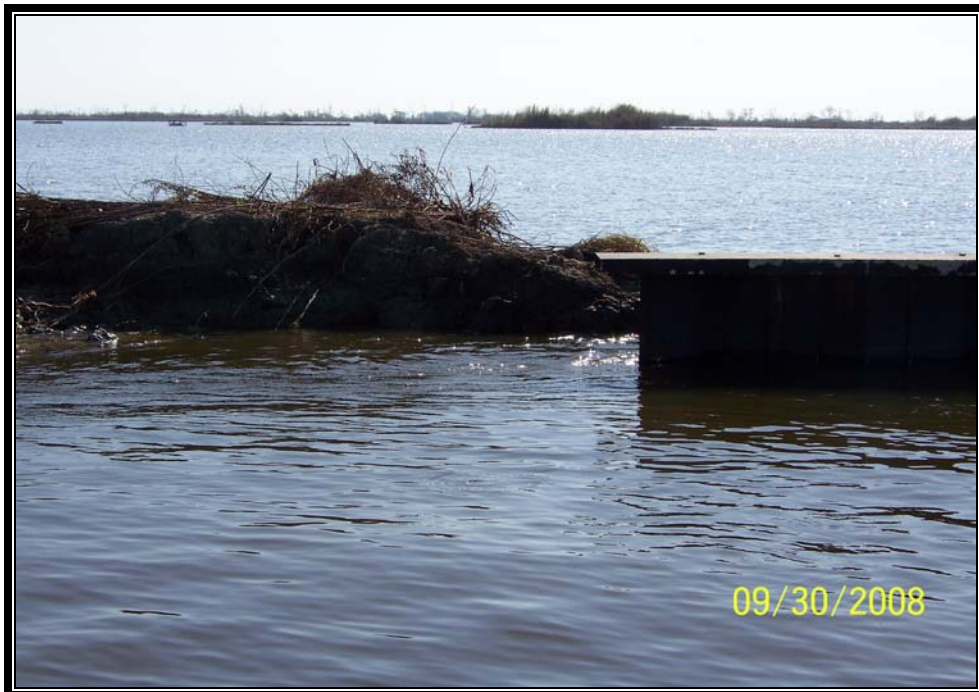
The variable crest weir structure appeared to be in fair condition with no visible damage or corrosion of the structural components. We did observe a breach on the north side of the structure near the earthen embankment tie-ins, exposing the end of the steel sheetpile bulkhead and allowing tidal exchange through the embankment. The earthen tie-ins on both sides of the structure were refurbished by Apache Minerals in July 2007. As noted on previous inspections, the wing-walls adjacent to Structure 23 have been repaired several times over the past few years due to constant erosion of embankment tie-ins. To avoid the need for continued maintenance of the earthen embankments in the future, it is recommended that a rock armor or rip rap pad be constructed along the tie-ins on both sides of the structure to protect these areas from erosion. All signs and timber supports were in good condition. (Appendix B, Photos 22-24)

Photo No.22 – An overall view of the two (2) bay variable crest weir (Structure No.23) looking north.

Photo No.23 – View of the northern end of the bulkhead of Structure No.23. The earthen embankment had eroded around the end of the bulkhead forming a breach.

Photo No.24 – Another view of the breach around the north end of Structure No.23.

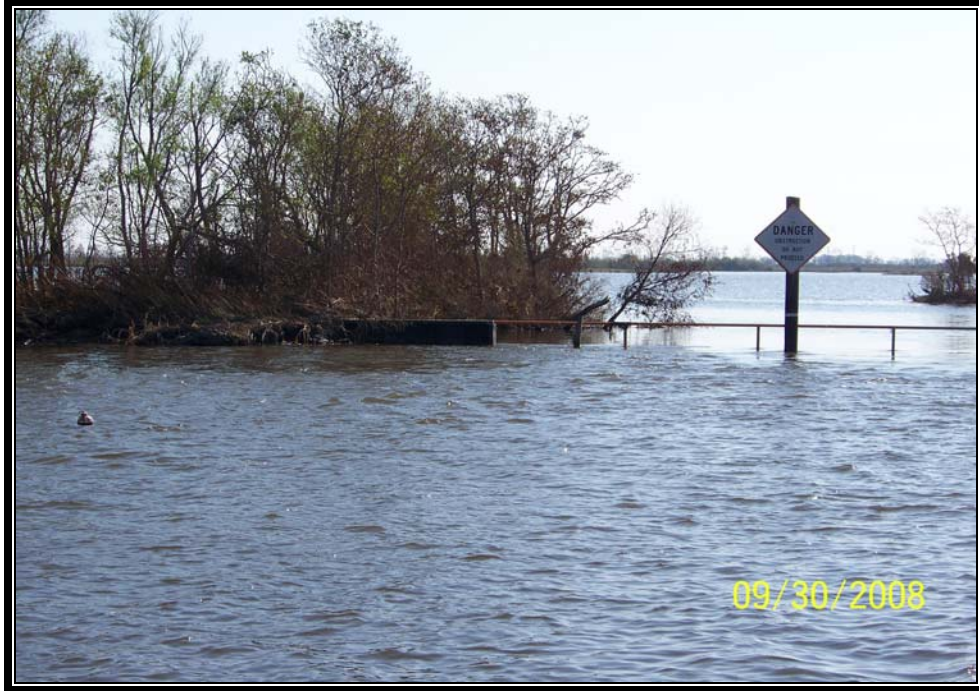
The fixed crest weir located along the southeast bank of Jug Lake appeared to be in very good condition with no visual signs of corrosion of the structural components or erosion of the earthen tie-ins. The earthen tie-ins were refurbished by Apache Minerals, Inc. in July 2007 and are holding up well. All signs and timber supports were also in good condition. (Appendix B, Photo 25)

Photo No.25 – view of the northern tie-in to the earthen embankment at Structure No. 24.
