**2009 Annual Inspection Report**

**BRADY CANAL HYDROLOGIC  
RESTORATION PROJECT (TE-28)**

State Project Number TE-28  
Priority Project List 3

June 30, 2009  
Terrebonne Parish

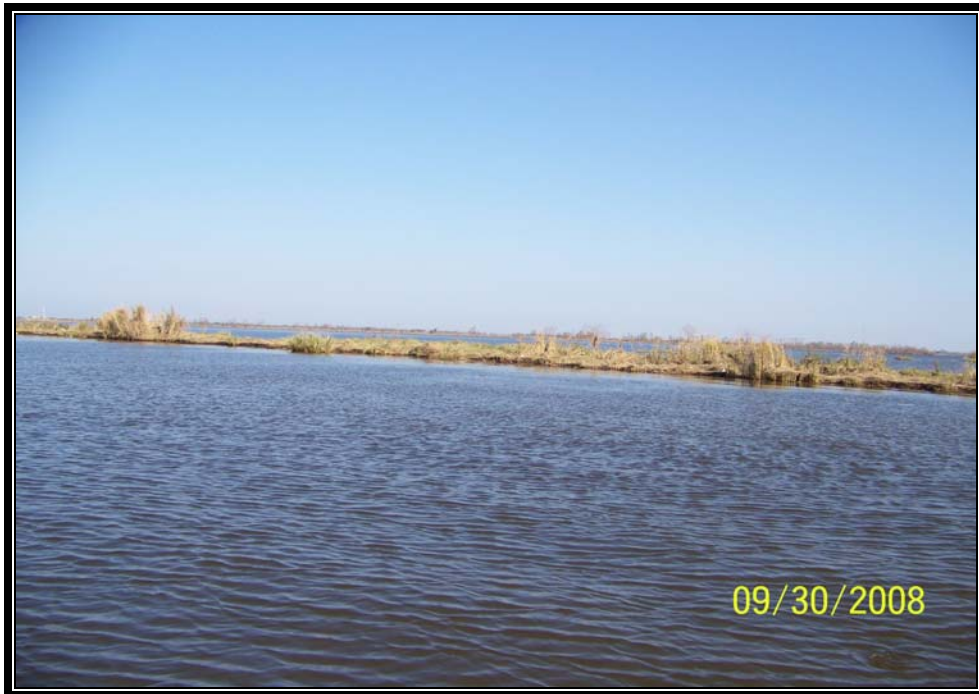
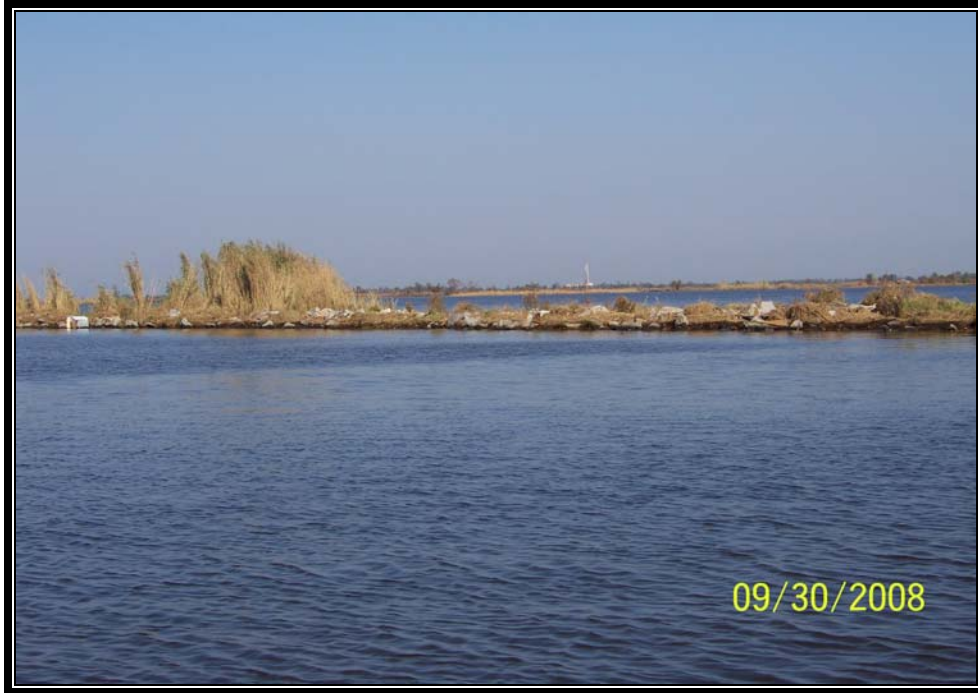
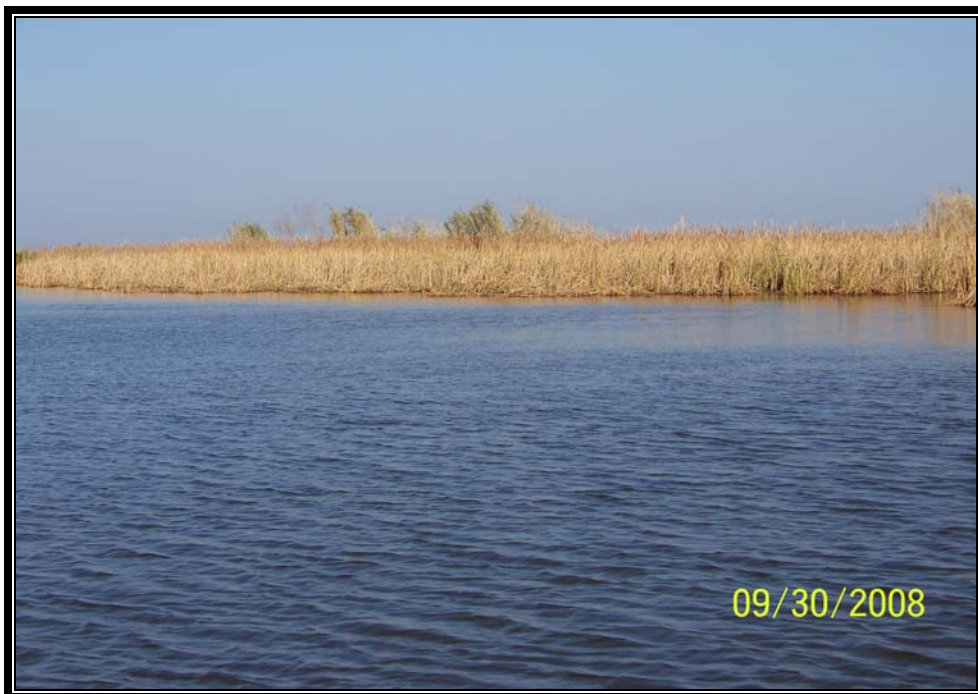
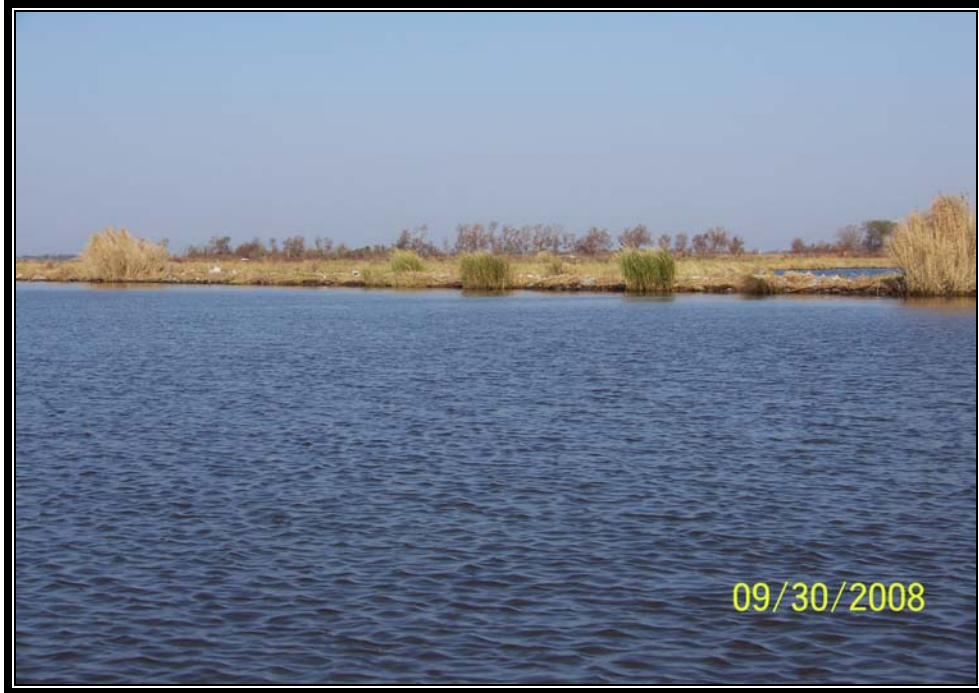
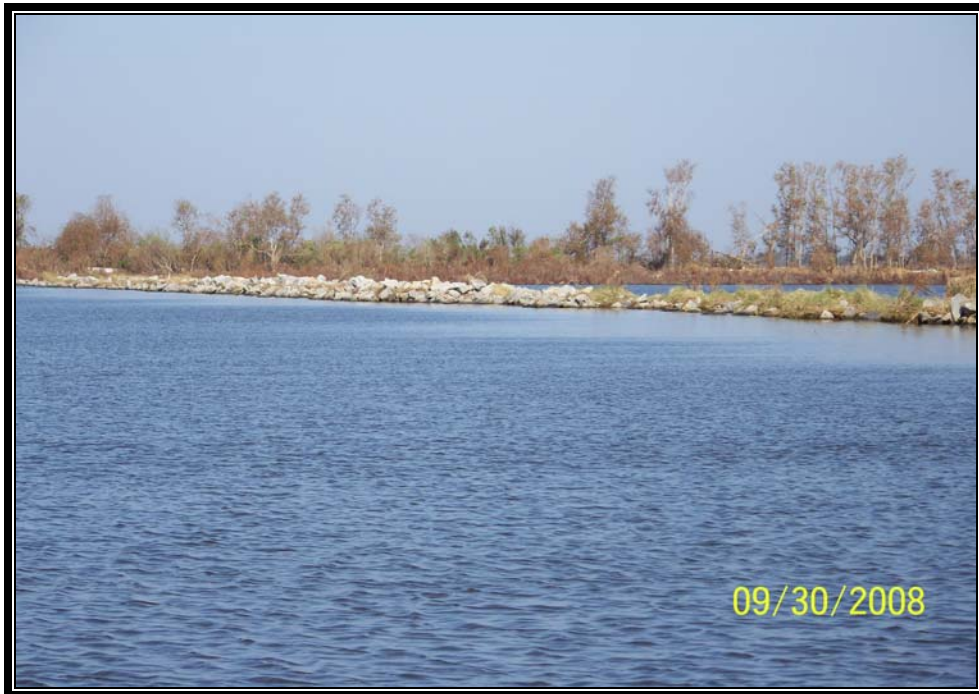
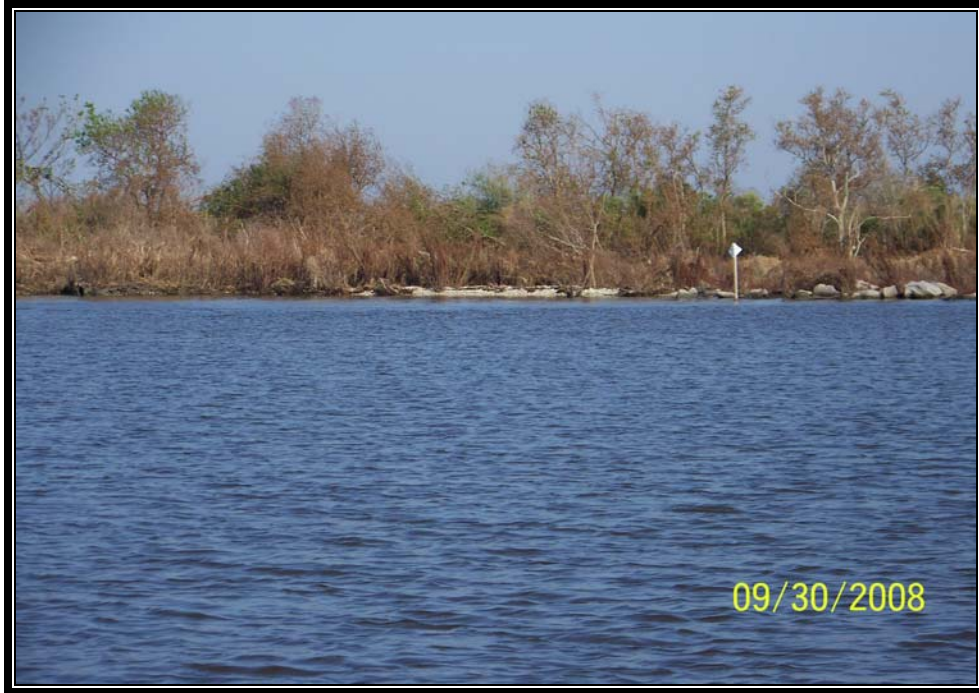
Breach Repair 1 thru 4 – consisted of the construction of a rock dike and breach closures along a low lying ridge on the north bank Bayou Decade from Turtle Bayou to the mouth of Jug Lake. Based on visual observations during the damage assessment following Hurricanes Gustav and Ike, it was apparent that tidal surges and over-wash of the dike during the storms had resulted in moderate displacement of the rock riprap. We have noticed considerable displacement of the rip rap on the dike following the 2005 and 2008 storms causing the constructed section to become irregular and rounded. The displacement of rock material and possible settlement of the structure has also caused a decrease in the crest elevation of the rock dike. Considering the rock displacement that has taken place, the dike remains in fair condition with only isolated locations where settlement was visible. (Appendix B, Photos 26-31)

Photo No.26 – Existing marsh along the north bank of Bayou Decade connecting the east end of the rock dike constructed in 2003 and the existing bank of Turtle Bayou.

Photo No.27 - Rock dike construction in 2003 along the north bank of Bayou Decade between Turtle Bayou and Jug Lake. There appears to be a fair amount of displacement of rock from Hurricanes Katrina, Rita and Ike.

Photo No. 28 – Heavy concentration of cut grass in front of the rock dike along the north bank of Bayou Decade between Jug Lake and Turtle Bayou. This section of dike is concealed by the grass.

Photo No. 29 – View of rock dike along the north bank of Bayou Decade near Jug Lake.

Photo No.30 – View of the rock dike along Bayou Decade near the mouth of Jug Lake.

Photo No.31 – The very end of the rock dike along Bayou Decade near the mouth of Jug Lake.

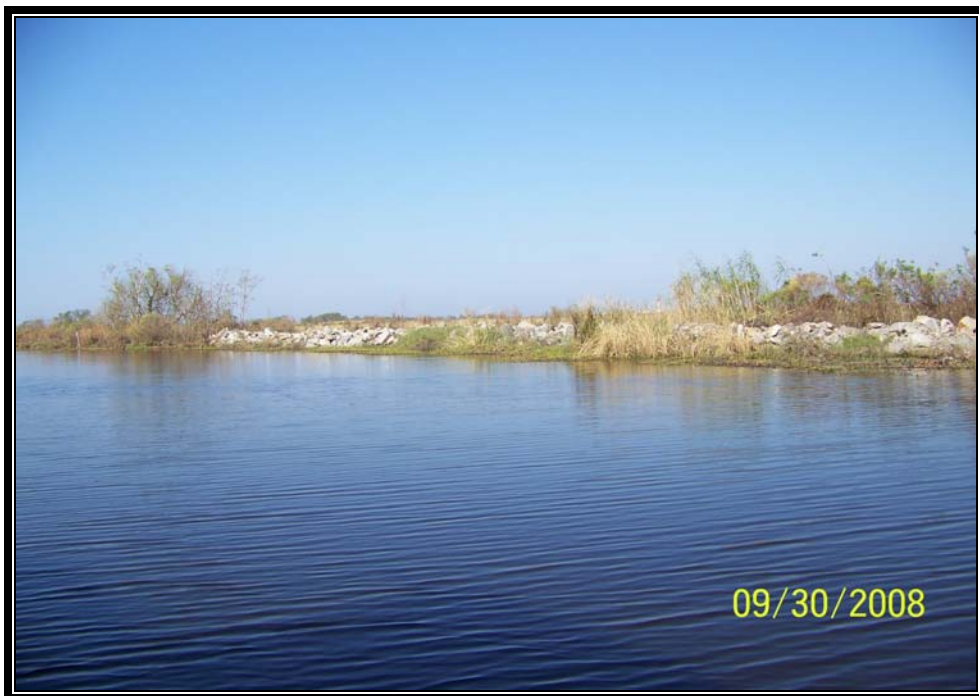
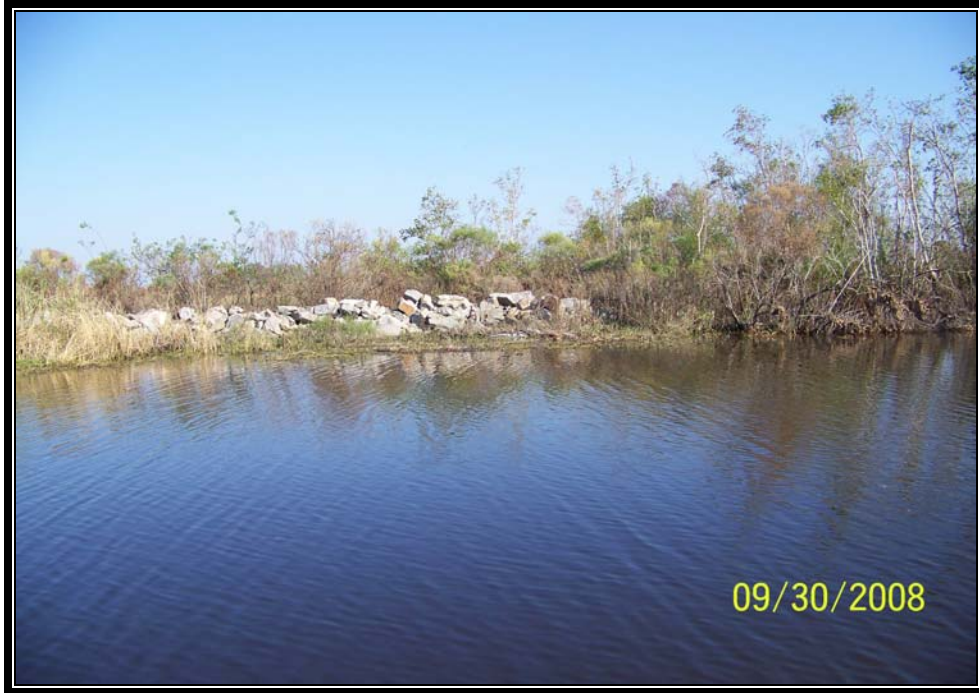
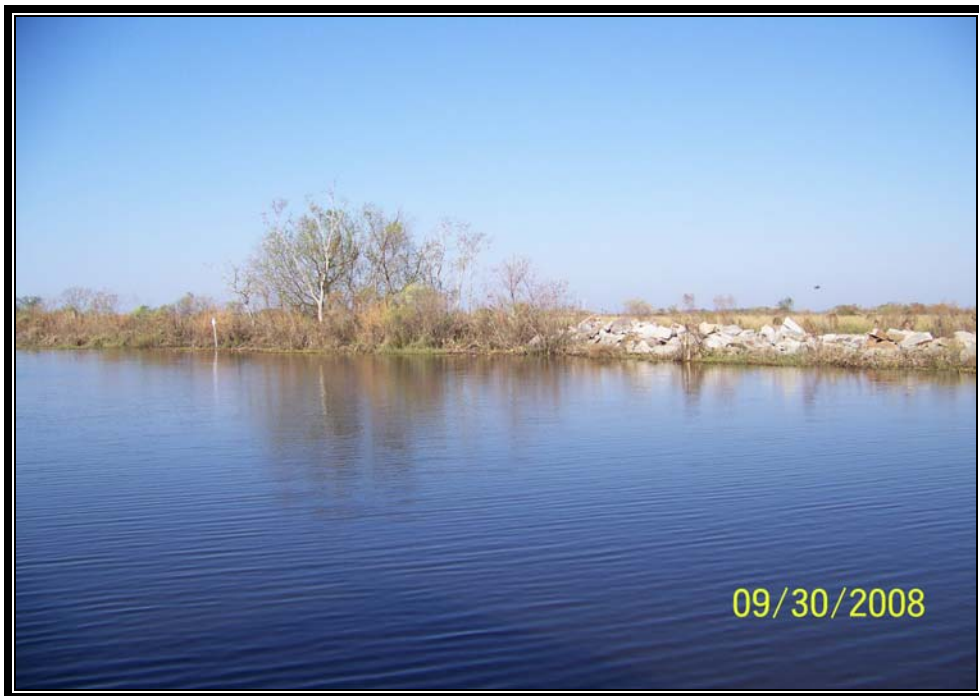
Breach Repair 7 – is located along an existing oilfield canal off of Superior Canal in the northeast section of the project area. Due to the depth of the opening in the earthen embankment, rock rip-rap was used to plug the breach and reinforce the adjacent bank line. The rock riprap breach closure appeared to be in very good condition with no visual signs of settlement or rock displacement. (Appendix B, Photos 32-34)

Photo No. 32 - View of the rock plug constructed in 2003 (Breach 7) along the north bank of an existing oilfield access canal off of Superior Canal.

Photo No. 33 – View of rock plug (Breach 7) to bank tie-in on the northeast side of the structure.

Photo No.34 - View of rock plug (Breach 7) to bank tie-in on the southwest side of the structure.

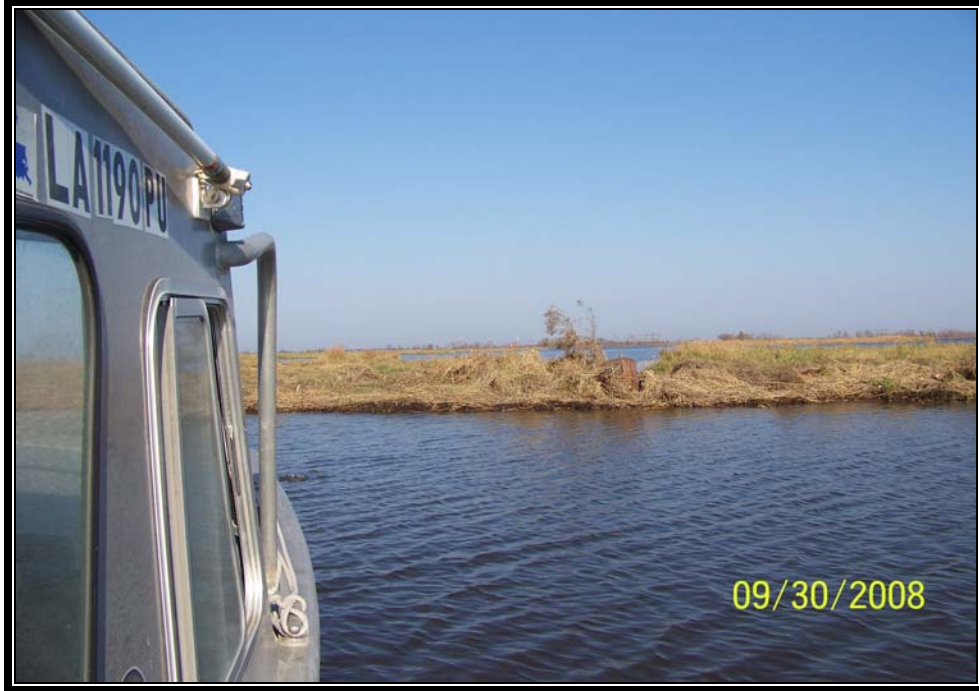
Photo No.35 – Area of the shoreline reconstructed in 2003 along the west bank of Turtle Bayou near the mouth of Superior Canal.

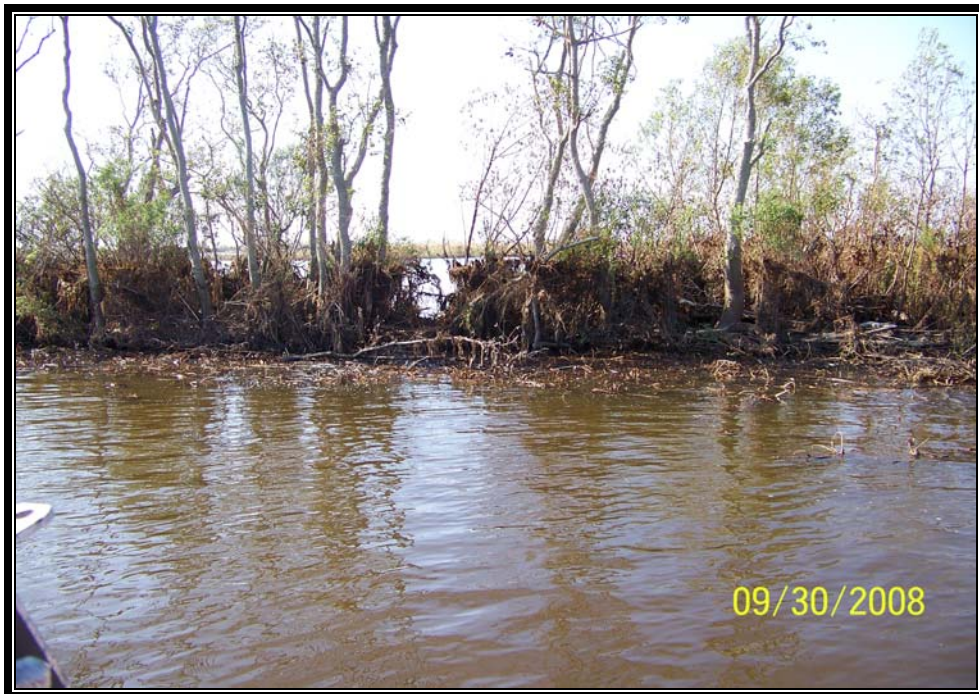
Photo No. 36 – Area along Superior Canal where the existing bank line is narrow and low.

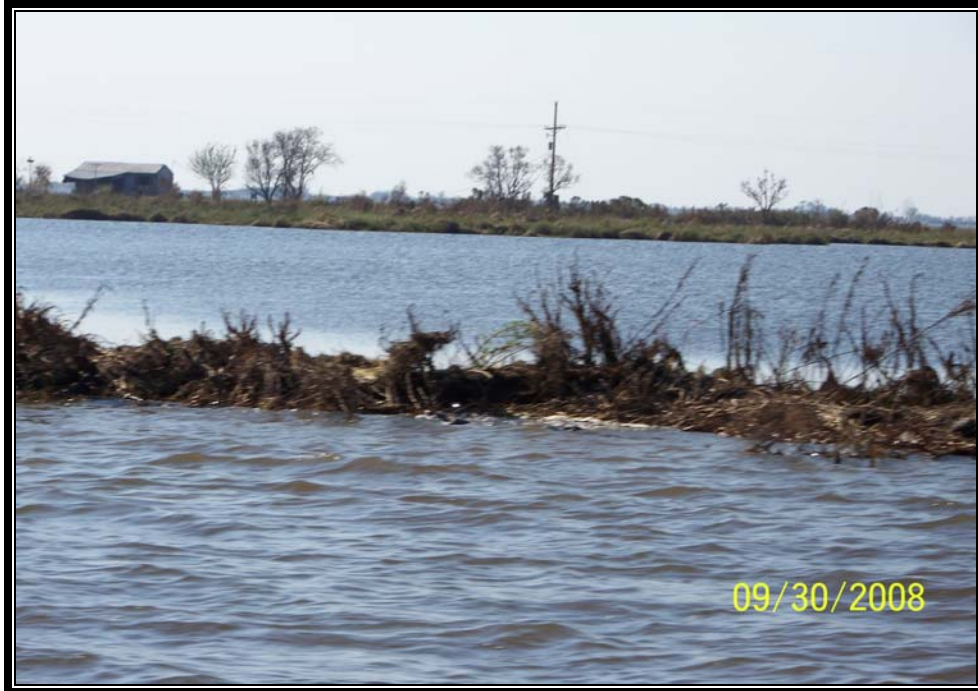
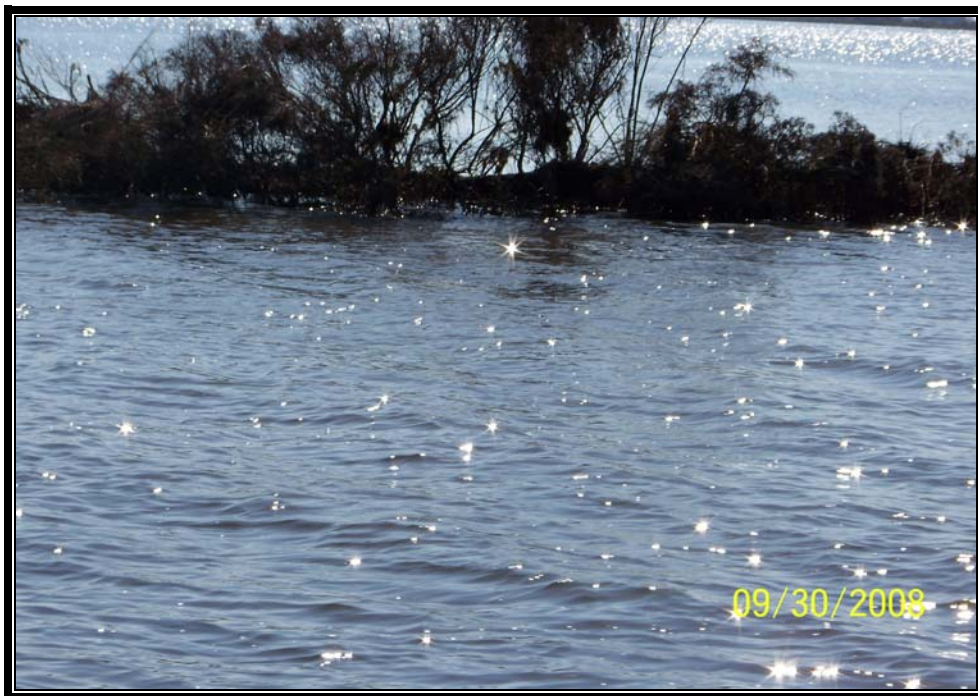
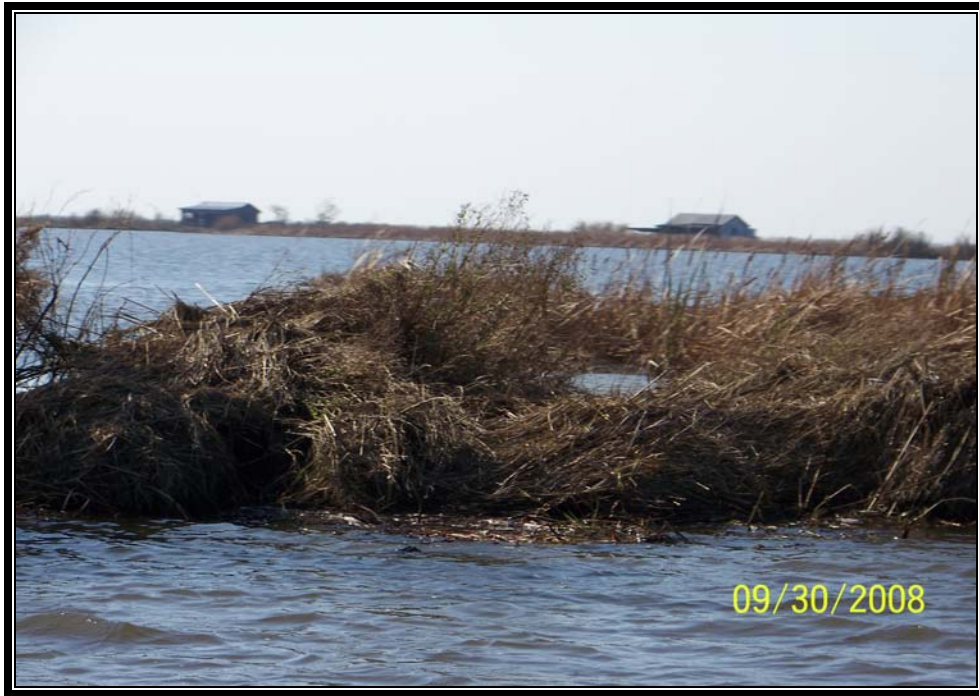
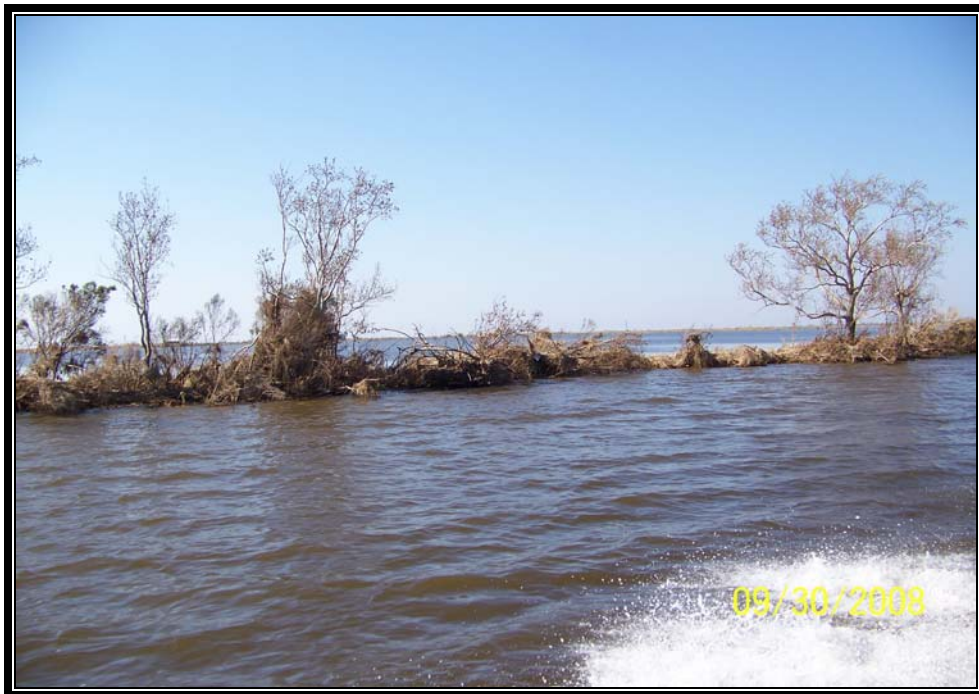
Photo No.37 – View of the existing bank along the southeast shoreline of Jug Lake south of Structure No.24. As evident in the photo, the existing bank line sustained extensive damage from Hurricane Ike. There is very little bank line remaining in this area.

Photo No. 38 – Another photo of the degraded bank line along the southeast shoreline of Jug Lake south of Structure No. 24.

Photo No.39 – View of the southeast shoreline of Jug Lake south of Structure No.24. The bank line from Bayou Decade to Structure No.24 was severely degraded during Hurricane Ike.

Photo No. 40 – Another view of the existing shoreline along the southeast bank of Jug Lake.

As outlined in Section V of this report, it is recommended that approximately 20,000 linear feet of earthen embankment along the perimeter of Jug Lake be refurbished during this maintenance cycle. The method of repair shall include clearing and grubbing trees and brush on the existing embankment and excavating material from the lake bottom to restore the embankment to the original permitted section followed by seeding of the entire crest and slope of the embankment. Once the refurbishment of the earthen embankment of Jug Lake is complete, a 100' wide rock armored blanket shall be installed adjacent to the three (3) water control structures along the crest and slopes of the wing-walls. The locations of the earthen embankment refurbishment and installation of the rock blankets are shown in the 2009/2010 Work Plan under Appendix D.

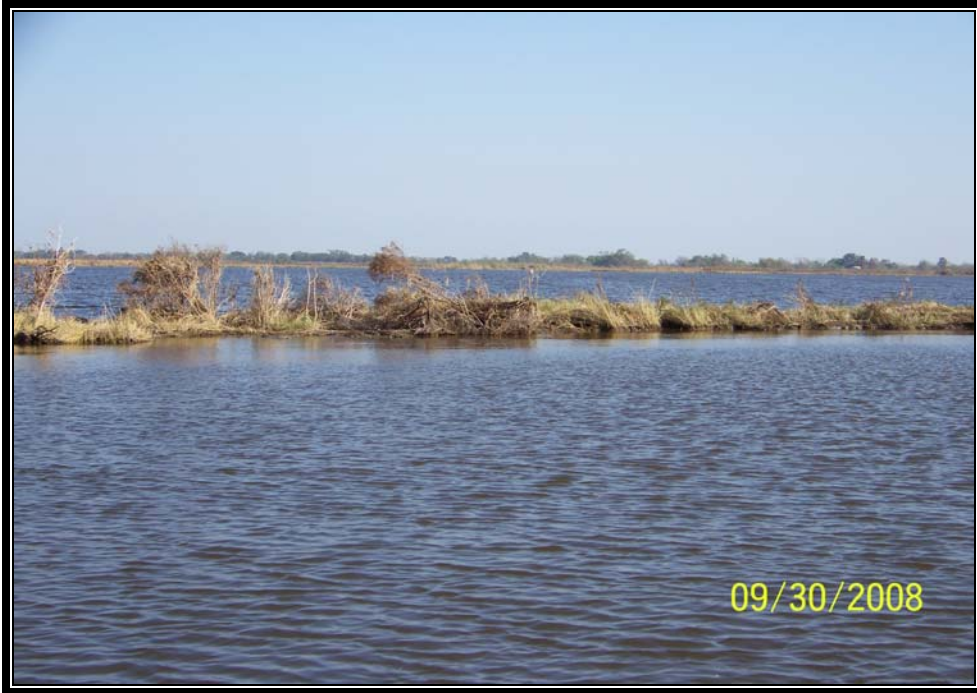
Photo No. 41 – Section of thin bank line along the north bank of Jug Lake between Structures 23 and 21.

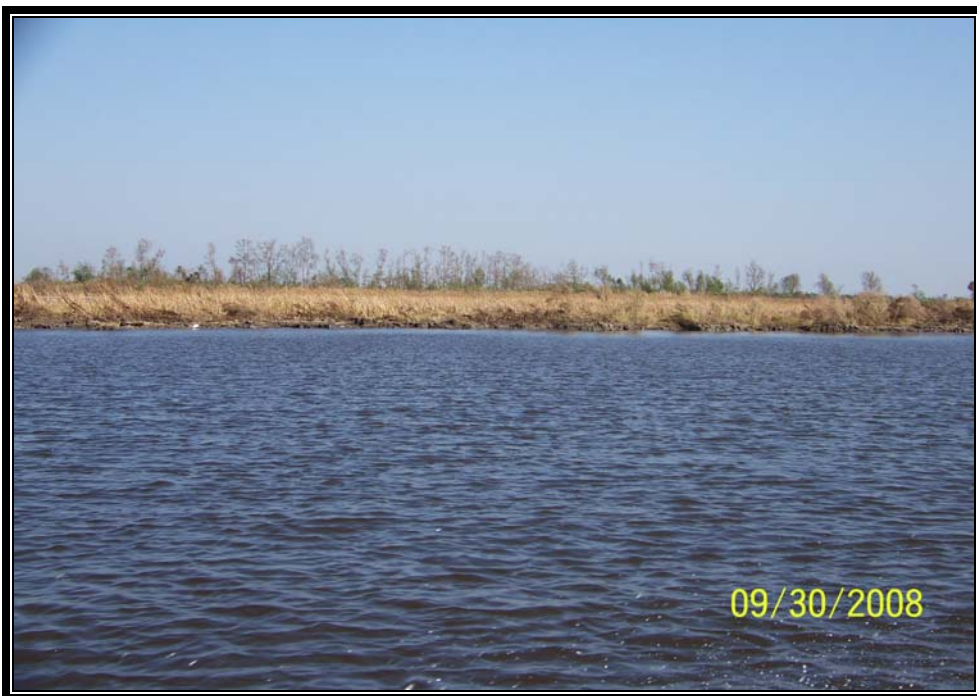
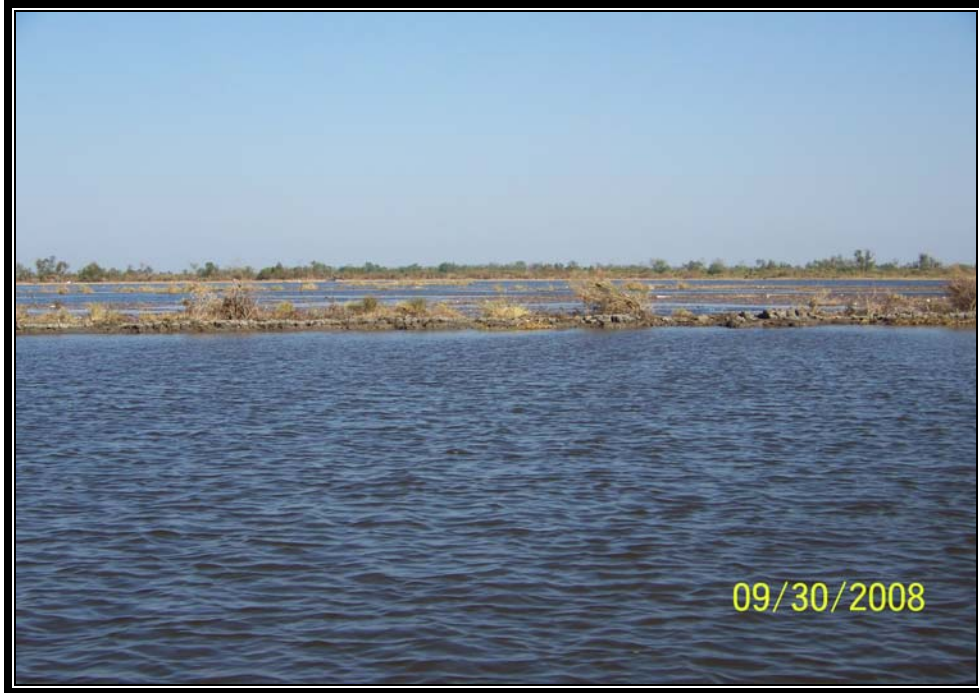
Photo No. 42 – View of shoreline on the west side of Jug Lake between Structures No. 20 and 21.

Photo No. 43 – View of shoreline on the west side of Jug Lake between Structures No. 20 and 21.

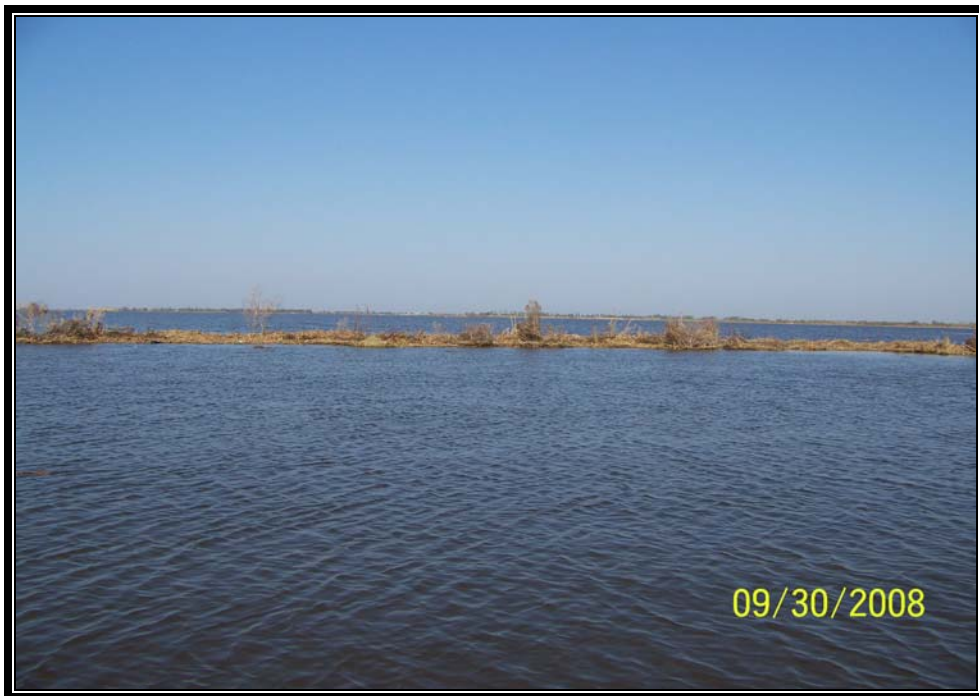
Photo No. 44 – View of thin area along the northern bank of Bayou Decade east of Structure No.6 near the mouth of Jug Lake.
