2009 Annual Inspection Report

Barataria Bay Waterway West Bank Protection

State Project Number BA-23
Priority Project List 4

July 1, 2009
Jefferson Parish

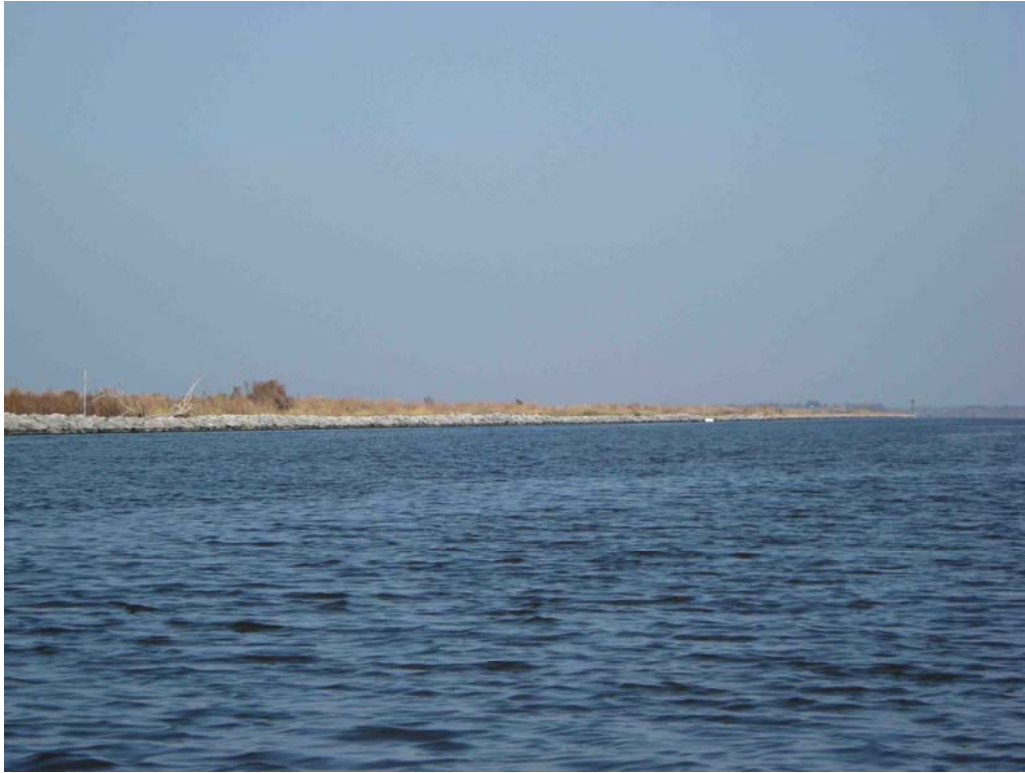
The rock structure appeared to be in good condition at the time of the inspection (Photo #1).

Photo #1 – Shoreline Protection Looking North.

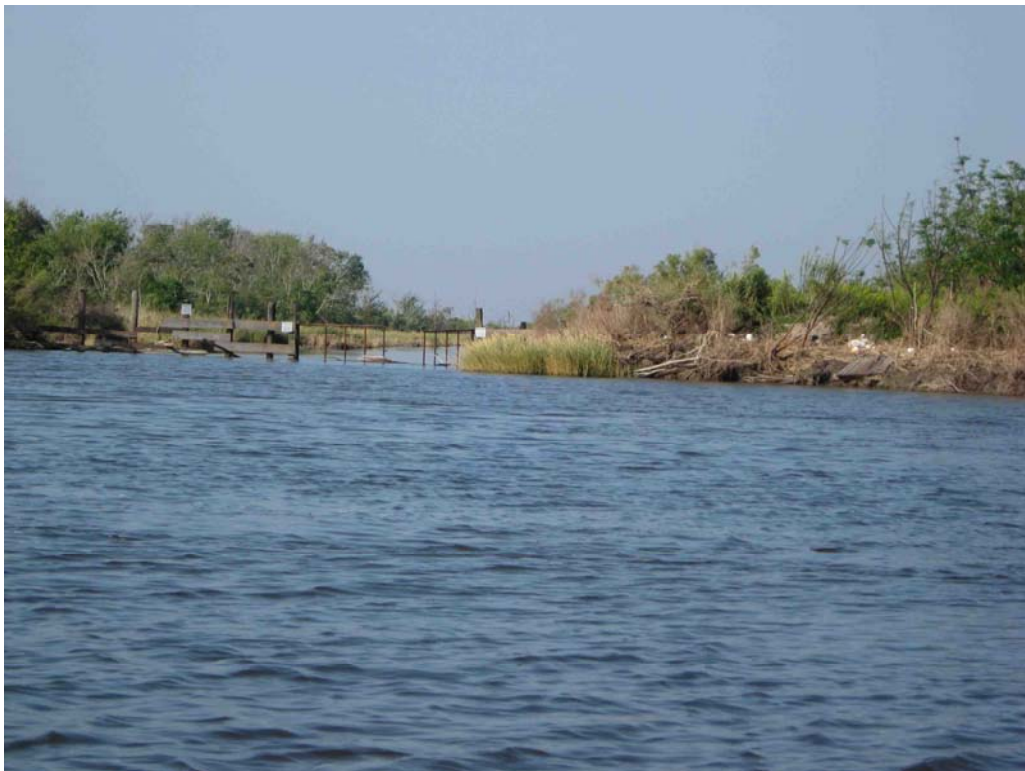
On March 18, 2009, Barry Richard of OCPR removed the stop logs and the structure was in good condition at that time. The water control structure is accessed through an abandoned oil well canal. After Hurricanes Gustav and Ike passed it was noted that some logs and stumps had been deposited in front of the access canal for the water control structure (Photo #2). This canal was dredged recently to improve flow and access to the water control structure. The dredge spoil was placed inside the canal to be used beneficially. This spoil material is showing no sign of sliding back into the dredged channel and is heavily vegetated.

Photo #2 – Access Canal Gate to Water Control Structure.
