## **Coastal Protection and Restoration Authority of Louisiana**

## **2010/2011 Annual Inspection Report**

### **EAST MUD LAKE MARSH MANAGEMENT PROJECT (CS-20)**

State Project Number CS-20  
Priority Project List 2

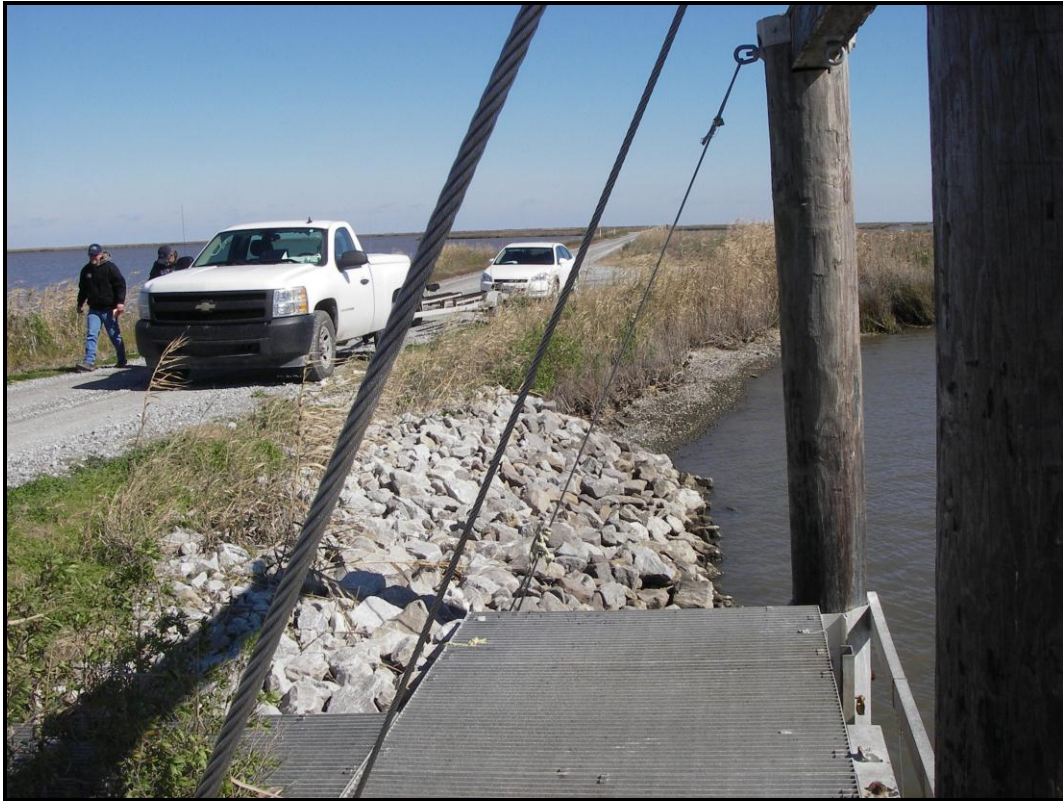
**Photo No.1** Structure No. 6

The overall condition of Structure No. 6 appears to be very good. Water level gauges weren't available near the structure. Water was flowing out of the project at the time of the inspection. The timber piles, stop logs, grating, etc. are in good condition after completion of the recent maintenance event. (Photos: Appendix B, Photo 1).

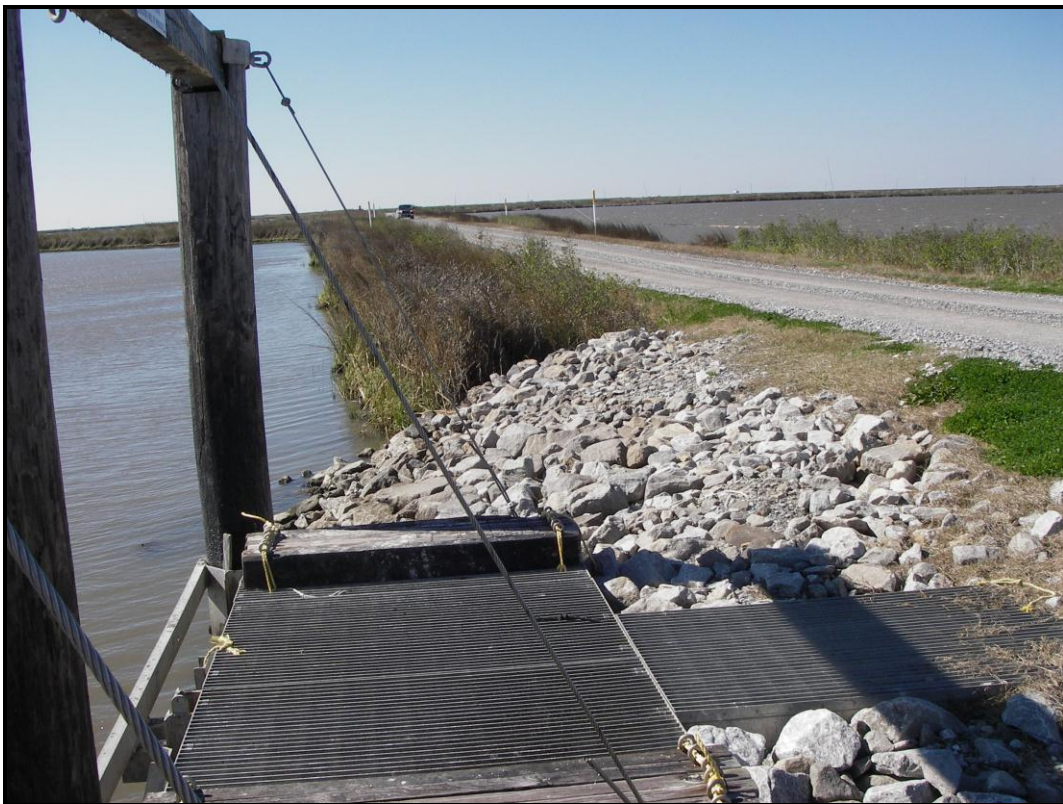
**Photo No. 2** Structure No. 7

Structure No. 7 appears to be in very good condition. Water was flowing out of the project at the time of the inspection. The timber piles, stop logs, grating, etc. are in good condition after completion of the recent maintenance event. (Photos: Appendix B, Photo 2).

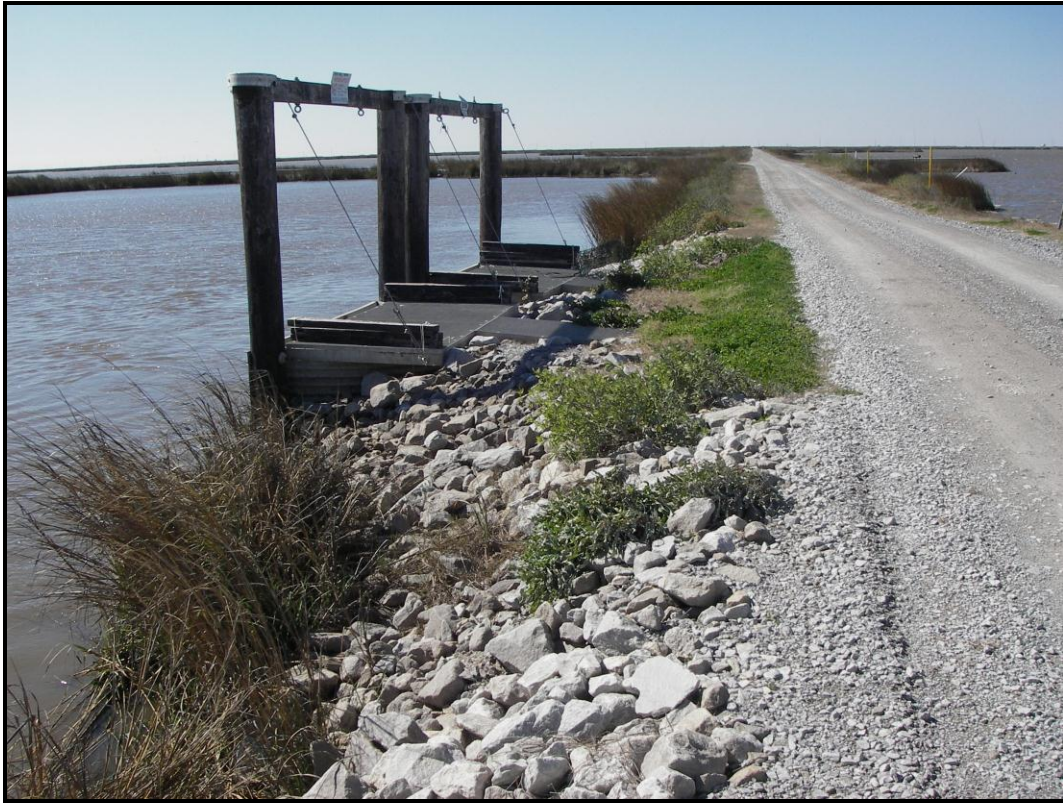
**Photo No. 3, Structure No. 8**

Structure No. 8 appears to be in very good condition. Water level gauges were unavailable. Water was flowing out of the project at the time of the inspection. The timber piles, stop logs, grating, etc. are in good condition after completion of the recent maintenance event. (Photos: Appendix B, Photo 3).

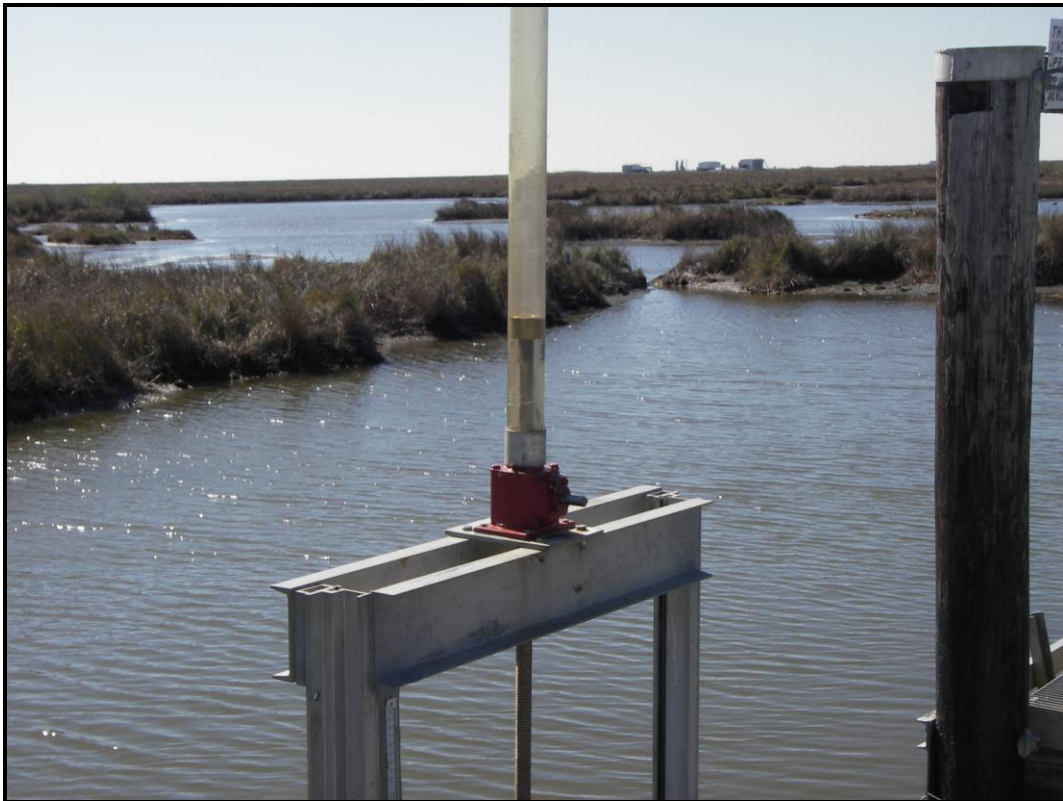
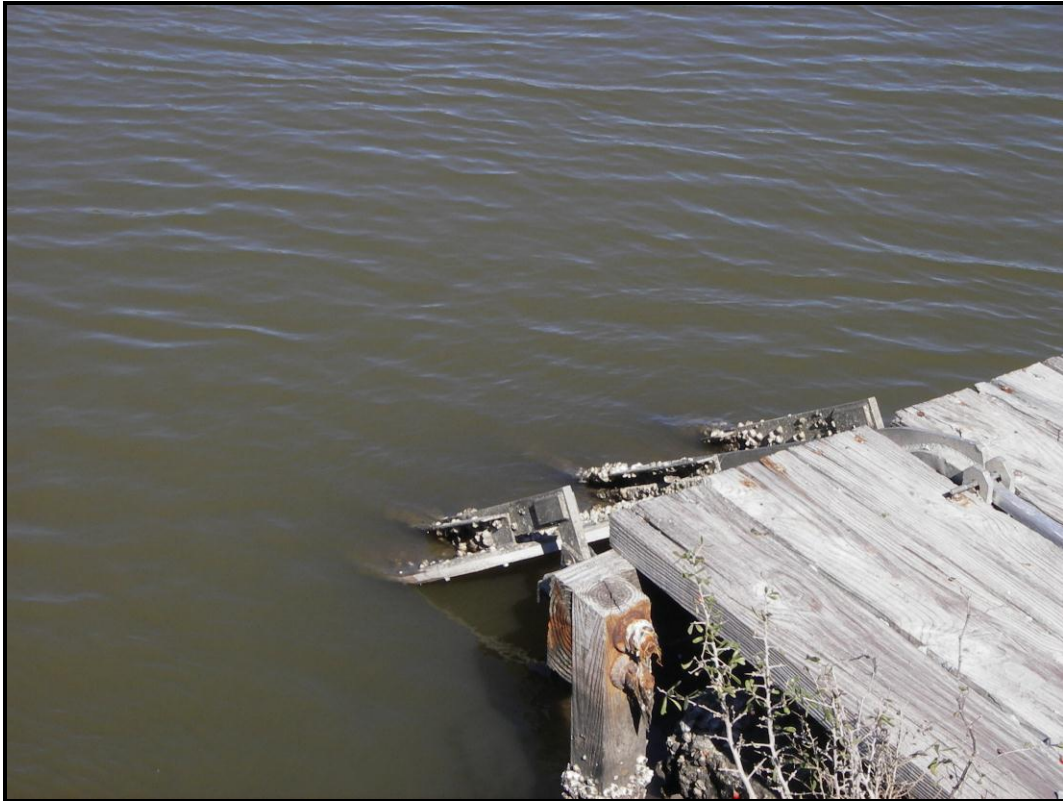
Structure No. 9a is in good condition. All items requiring repair were accomplished through the recent maintenance event. (Photos: Appendix B, Photos 4 & 5).

Structure No. 9b is in good condition. All repairs have been made to the structure during the recent maintenance event. (Photos: Appendix B, Photos 4 & 5).

**Photo No. 4, Structure No. 9a & 9b**

**Photo No. 5, Structure No. 9a & 9b**

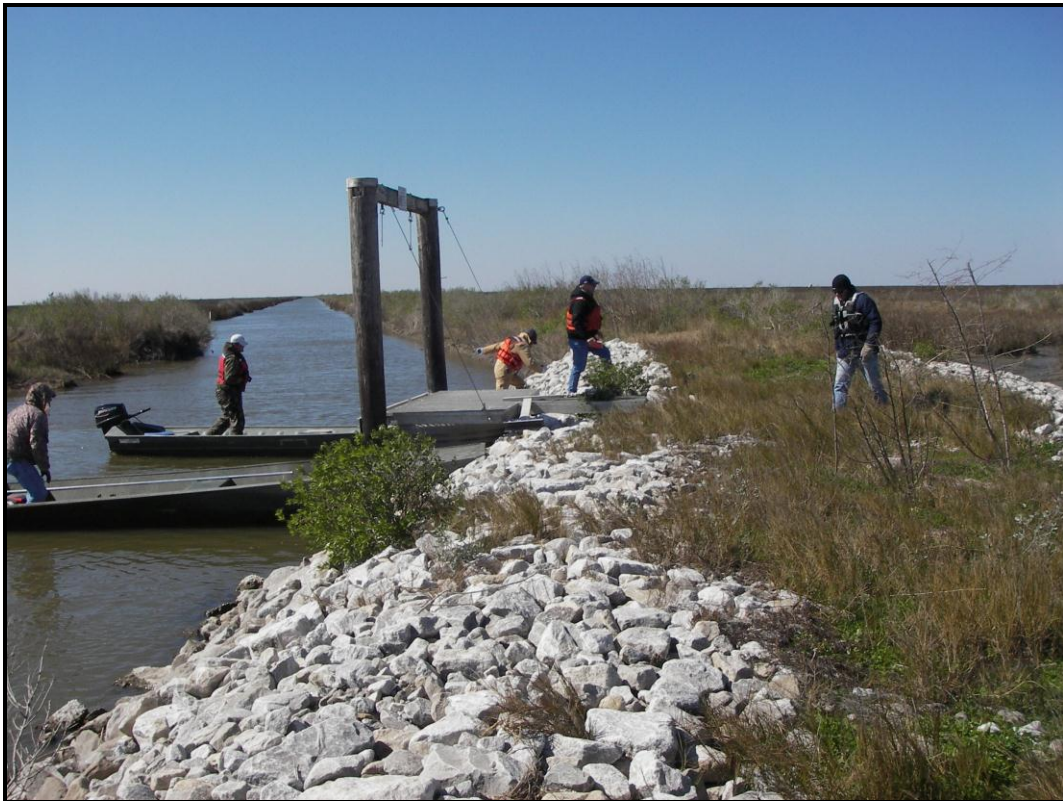
**Photo No. 6, Structure No. 11**

The structure is in good condition. The maintenance event that was just completed rectified all of the items needing repair. (Photos: Appendix B, Photo 6).

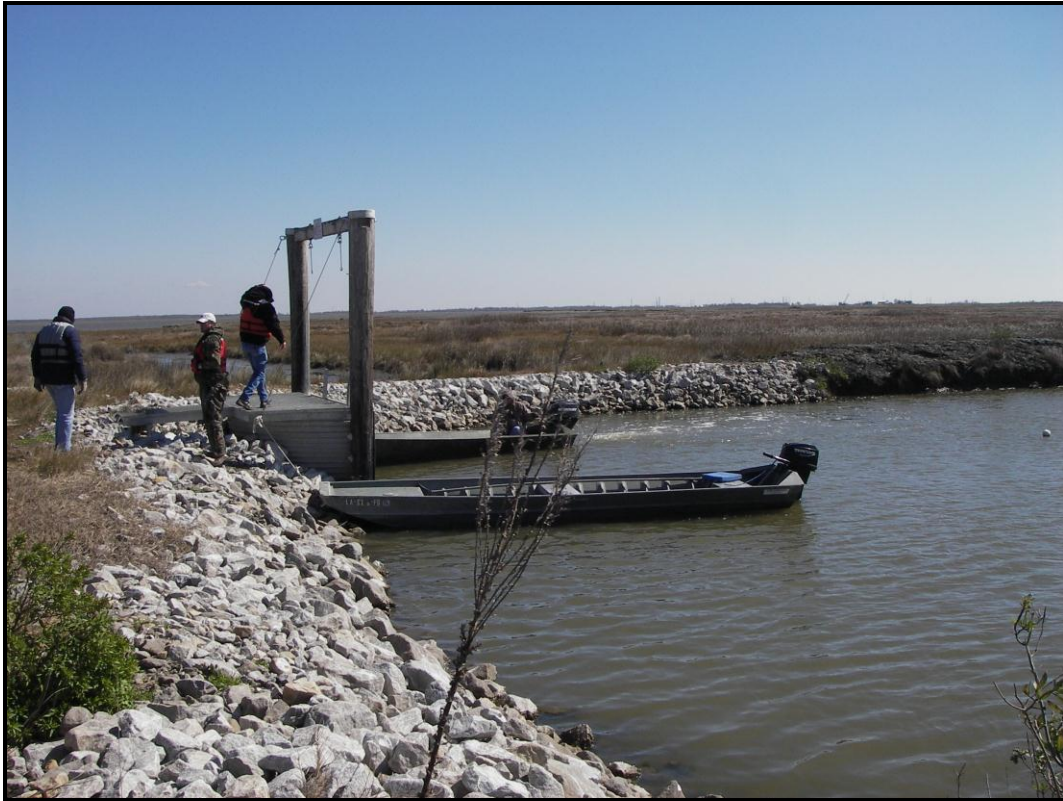
**Photo No. 7, Structure No. 5**

The structure itself is in good condition. All repairs have been made to the structure during the recent maintenance event. (Photos: Appendix B, Photo 7).

The inspection of the earthen levee consisted of a visual inspection of the entire length of levee along the Step Canal. The repaired sections and cleaning of the Step Canal have increased water flow in these areas. (Photos: Appendix B, Photo 7).

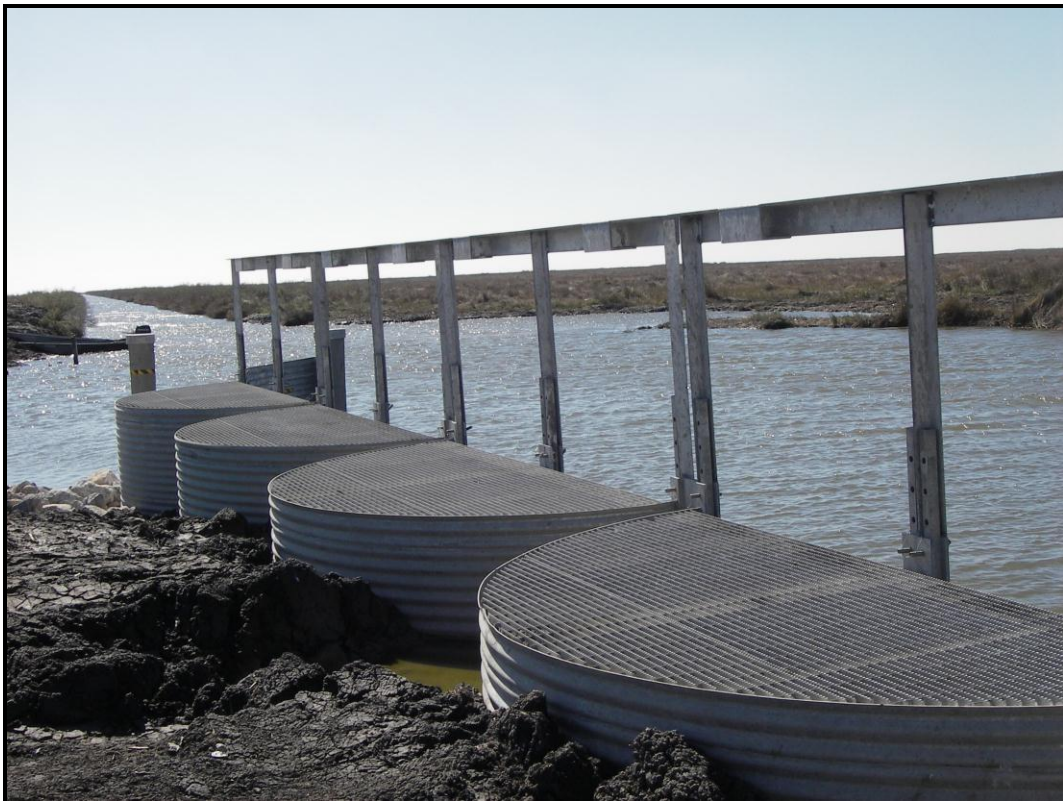
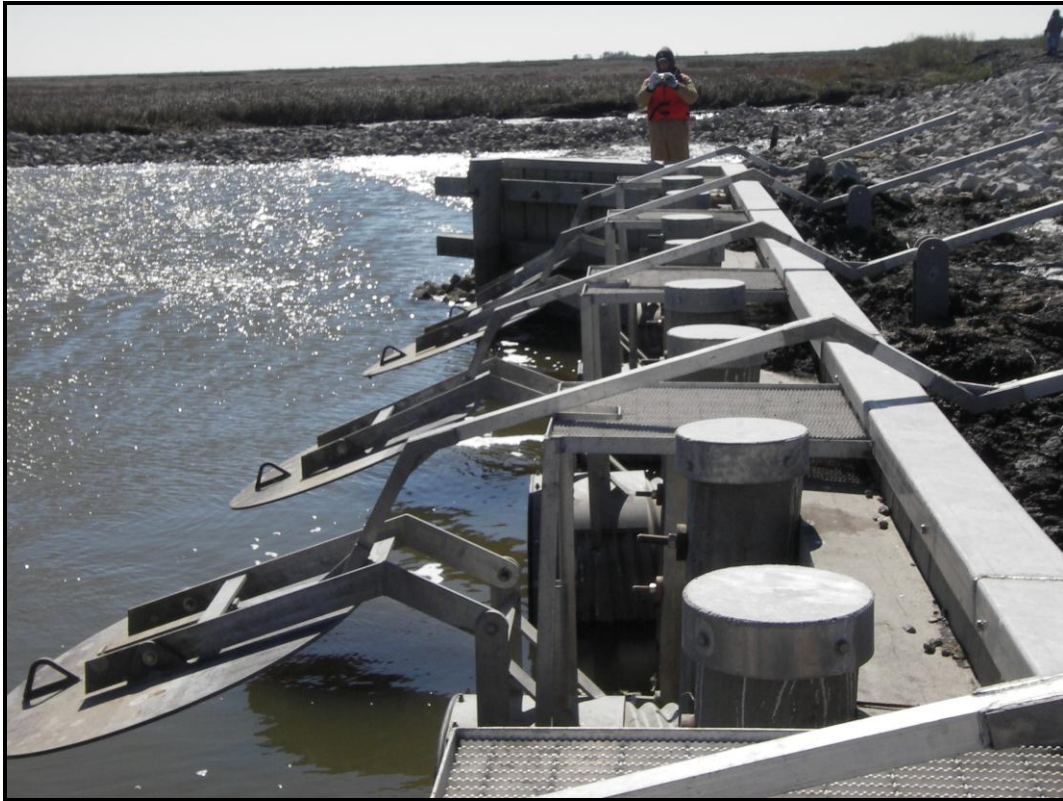
This structure was completely replaced with a new 48 inch diameter five barrel drainage structure, including timber supports, and rock armoring. The pre-existing structure No. 4 was abandoned in place by driving steel sheet piles through the mid-section of the culverts. Staff gauge readings were not available. (Photos: Appendix B, Photos 8 & 9).

**Photo No. 8, Structure No. 4**

**Photo No. 9, Structure No. 4**

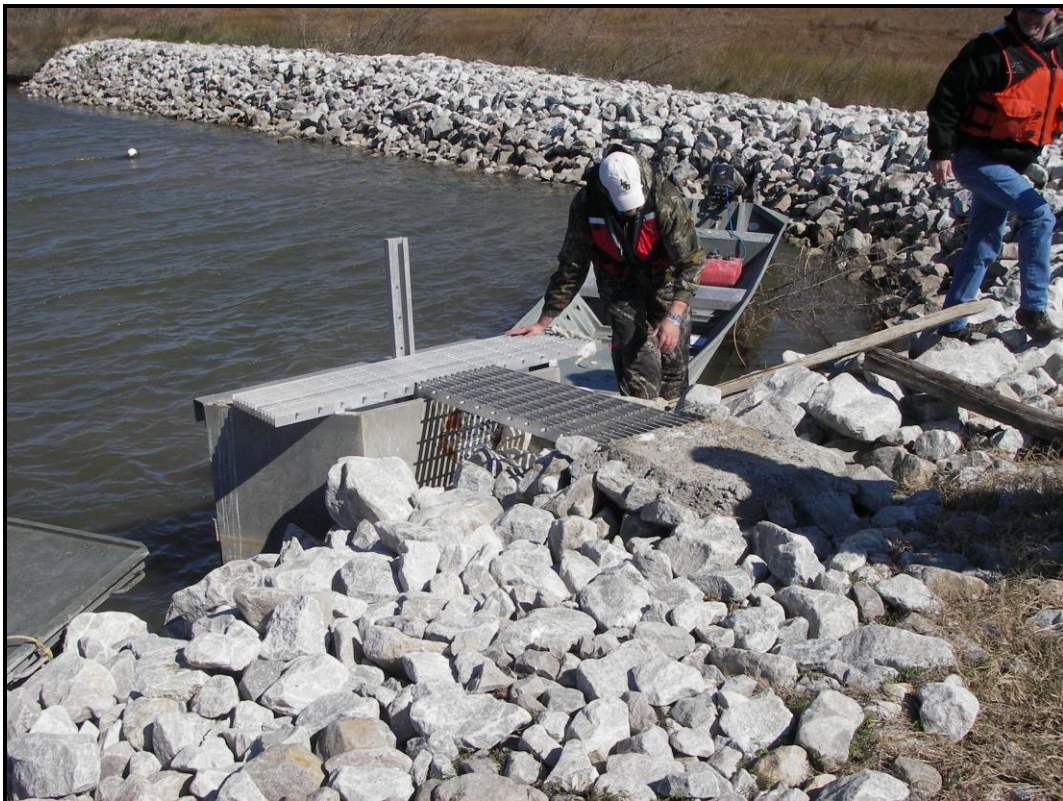
**Photo No. 10, Structure No. 3**

This is also a pre-existing structure that was incorporated into the CS-20 Project. Water was flowing out to the exterior marsh. All of the items requiring repair or replacement were incorporated in the recent maintenance event. The metal grating located at the inlet and outlet channel will be replaced with timber walkways. (Photos: Appendix B, Photo 10).

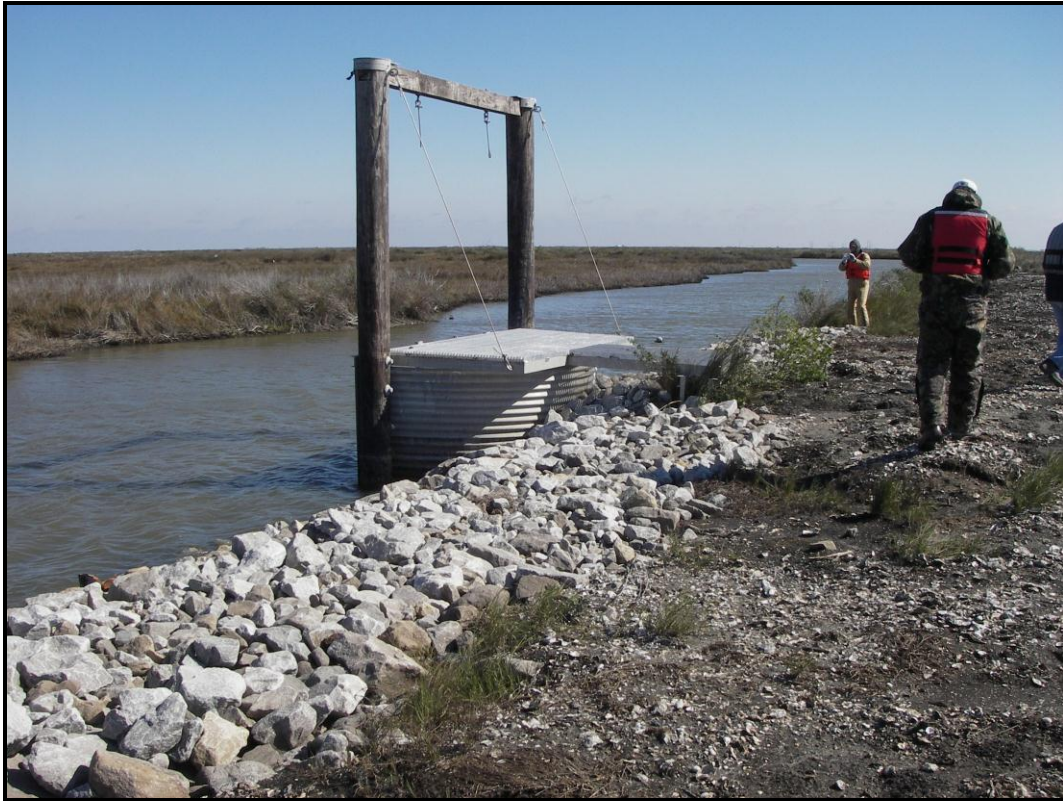
**Photo No. 11, Structure No.1**

This structure is in good condition. All of the items requiring repair or replacement were incorporated in the recent maintenance event. Water was flowing out to the exterior marsh. (Photo: Appendix B, Photo 11).

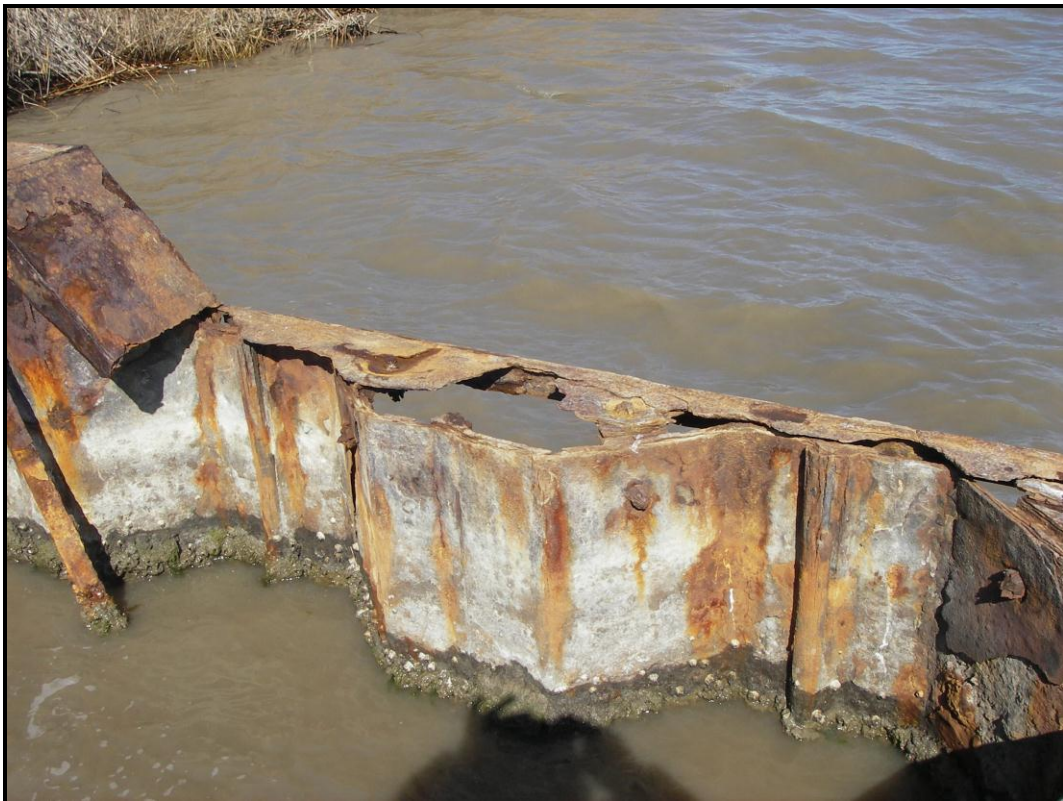
**Photo No. 12, Structure No. 17**

The sheet pile cap is severely rusted out on both sides of the structure. The locking tabs on the landing side of the stop log slots are missing. The warning sign is missing. The padlocks on the stop log locking devices have rusted and cannot be operated. The metal pile cap covers are rusted out. Erosion is also occurring on each end of the sheet pile wall. OCPD and NRCS agree that maintenance work is required to replace sign and pile cap on sheet pile wall, check elevation of staff gages, replace metal pile cap covers, replace padlocks, and replace locking tabs, however due to budget constraints were not undertaken with the maintenance event of 2010. Consideration is also being given to replacing the entire sheet pile wall in the future. (Photos: Appendix B, Photo 12).

Item	Condition	Physical Damage	Corrosion	Photo #	Observations and Remarks
Steel Bulkhead / Caps	Poor		Yes	12	Steel sheet pile and cap show signs of corrosion. Pile cap needs to be replaced.
Steel Grating	Good				
Stop Logs	Fair				The locking tabs on the stop log slots are missing.
Hardware	Poor		Yes		Padlocks corroded and need to be replaced.
Timber Piles	Good				
Timber Wales	Good				
Galv. Pile Caps	Poor				Need to be replaced.
Cables	Good				
Signage / Supports	Poor				Warning sign is missing.
Staff Gages	Good				Check elevation of staff gages.
Rip Rap (fill)	N/A				
Earthen Embankment	Good

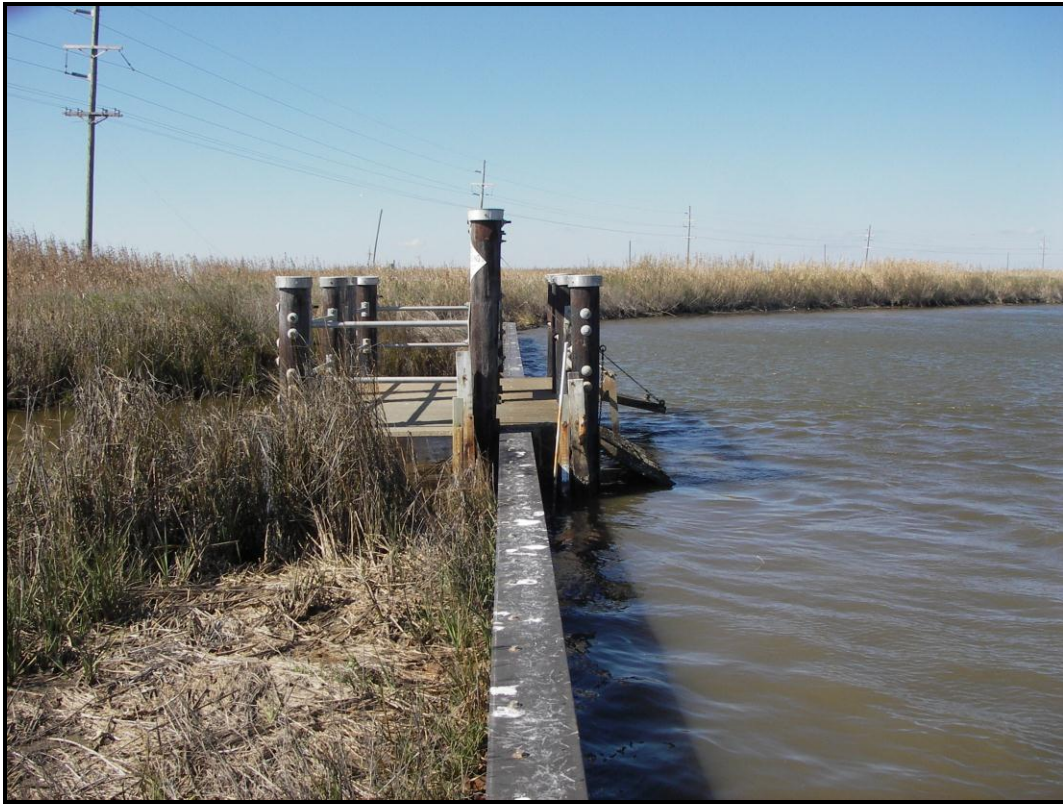
**Photo No. 13, Structure No. 13**

This structure is in good condition after completion of the recent maintenance event. All items requiring repair or replacement have been done. (Photos: Appendix B, Photo 13).
