**2008 Operations, Maintenance,
and Monitoring Report**

**PERRY RIDGE WEST BANK
STABILIZATION**

State Project Number CS-30
Priority Project List 9

April 2009
Calcasieu Parish

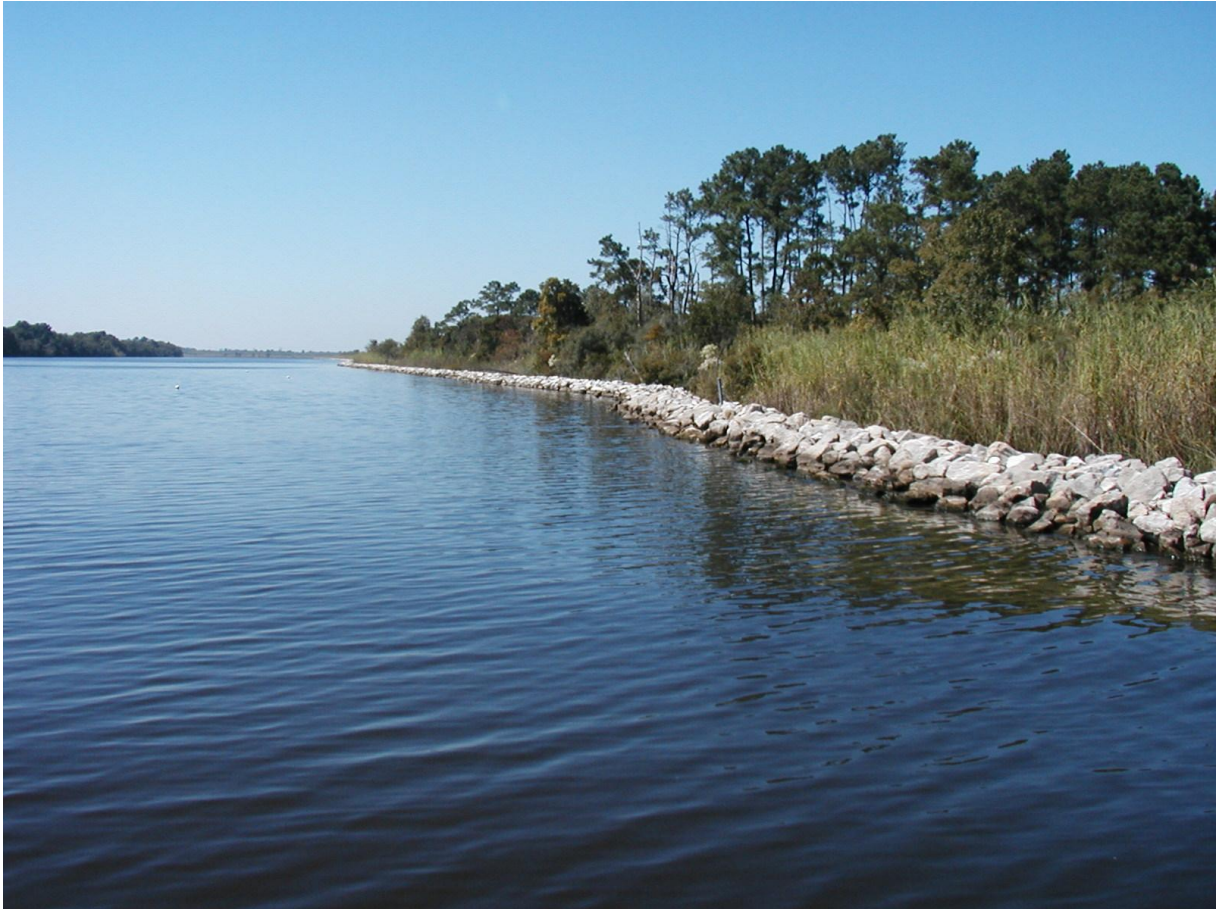
Aerial photography will be used to monitor shoreline movement. Analysis of the 2005 land to water ratio indicates that shoreline erosion appears to have halted since the construction of the rock dike. Visual observations also indicate vertical accretion of the wetland area behind the rock dike at many locations. Direct shoreline measurements on the adjacent CS-24 project, which has similar hydrologic conditions, have shown that the project has been effective in preventing erosion at most project area stations, while the reference area continued to retreat.

Figure 5. View of the Perry Ridge West rock dike taken October 21, 2003. The photograph is facing west.

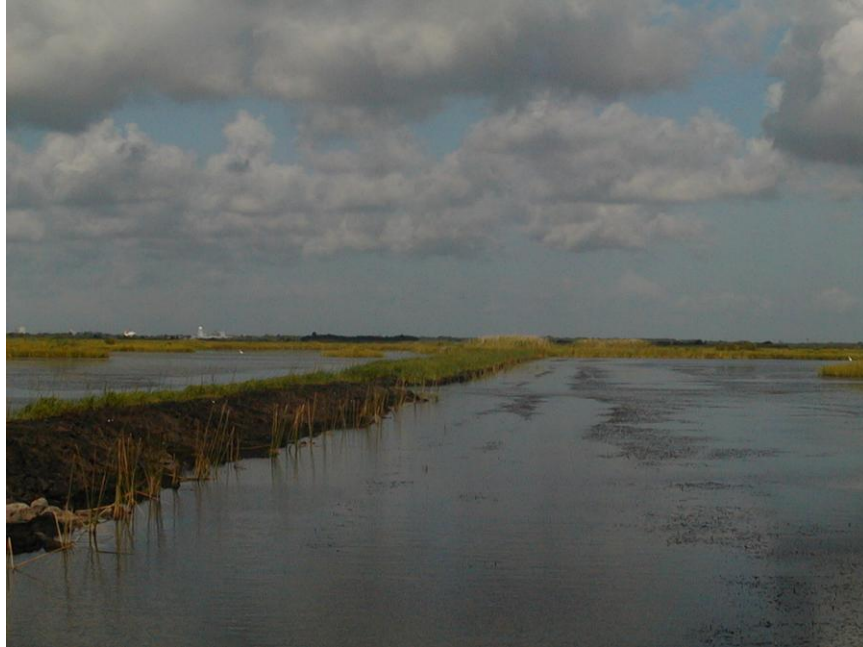
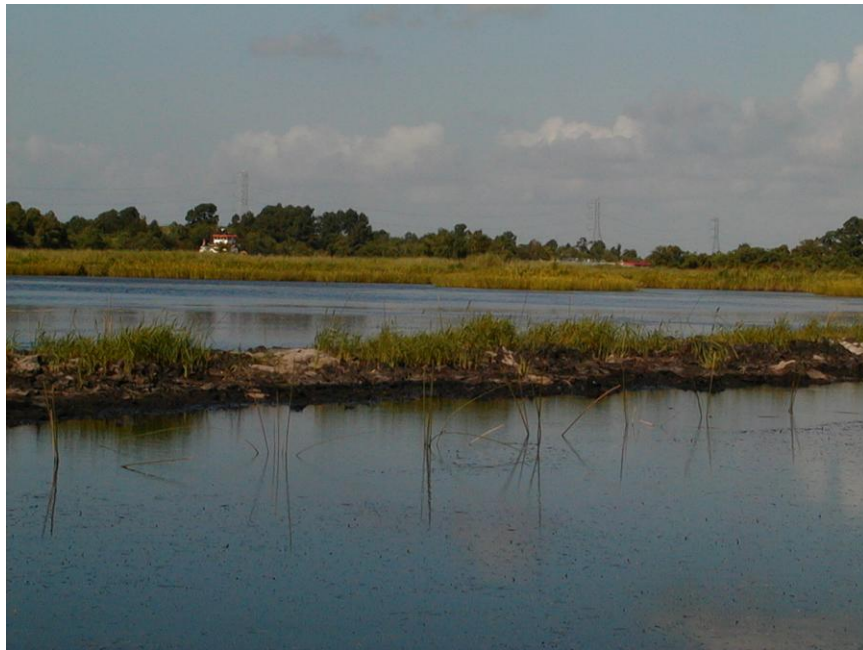
The plantings are in excellent shape at this time. Although the plantings appeared stressed following Hurricane Rita, in 2007, vegetation on the terraces was green and healthy.

Figure 6. Views of the *Schoenoplectus californicus* plantings taken July 2002. The photograph on the top is facing southwest, and on the bottom is facing south. Submerged aquatic vegetation is evident in both photos.

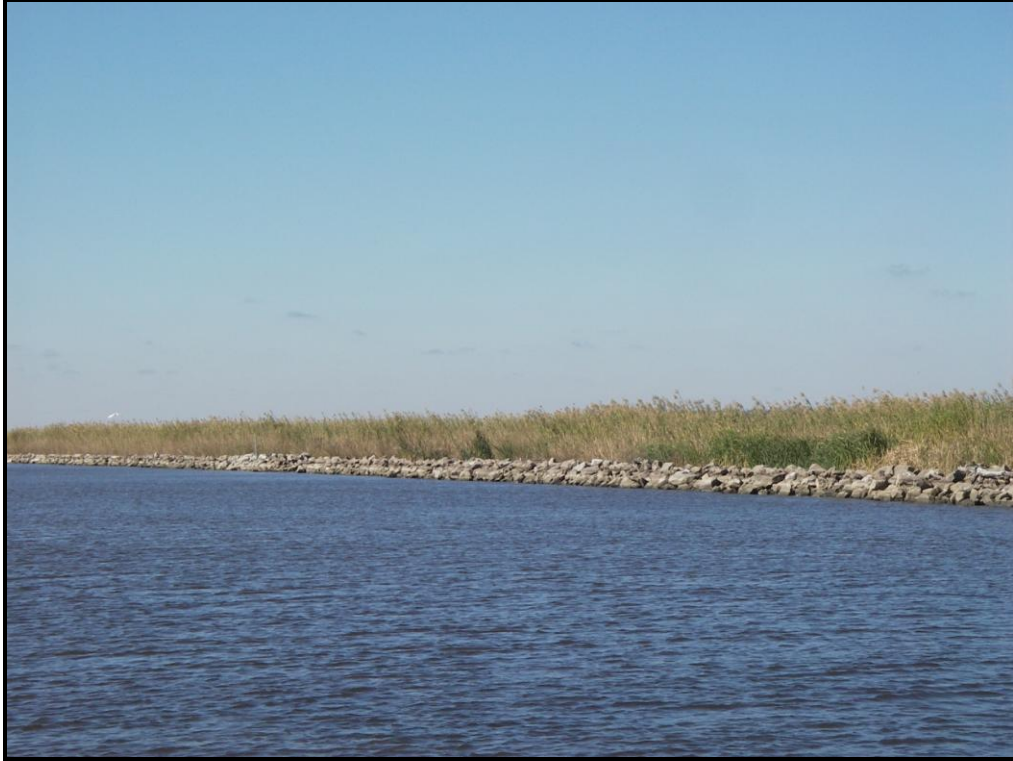
The dike is in very good condition with one small area apparently displaced by a barge noted as being below the constructed height. No maintenance is recommended at this time. (Photos: Appendix A, Photos 1 & 2)

Photo 1, Typical rock dike.

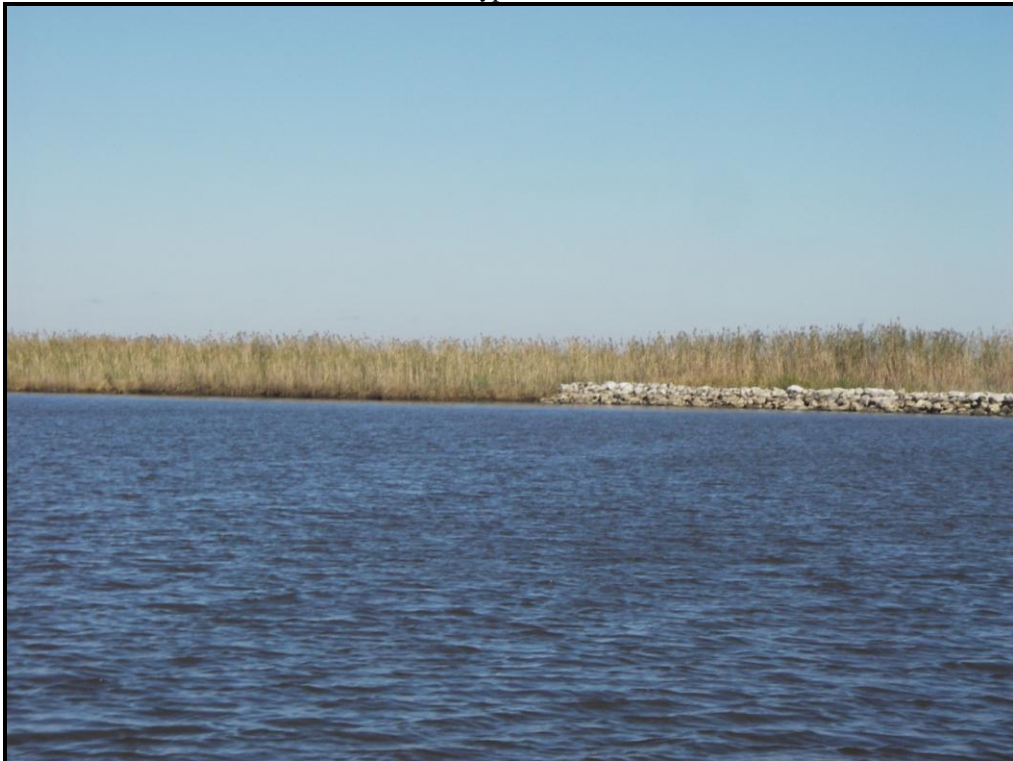
Photo 2, Rock dike, view showing western tie-in to existing marsh.
