Coastal Protection and Restoration Authority of Louisiana

2011 Operations, Maintenance and Monitoring Report

Oaks/Avery Canals Hydrologic Restoration

State Project Number T/V-13a
Priority Project List 6

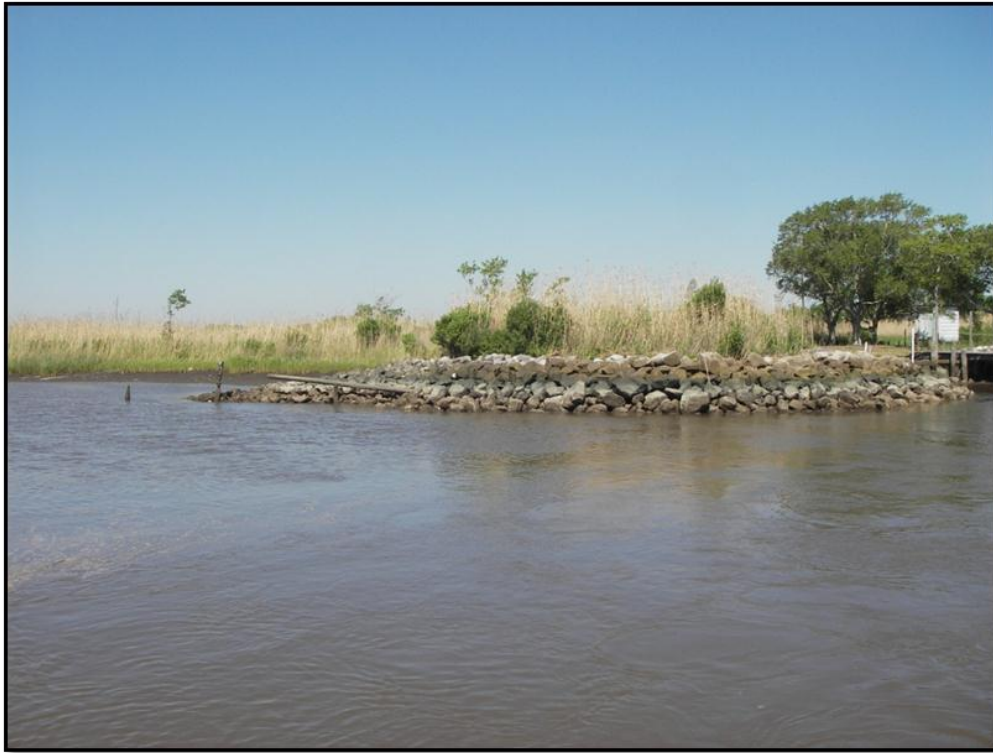
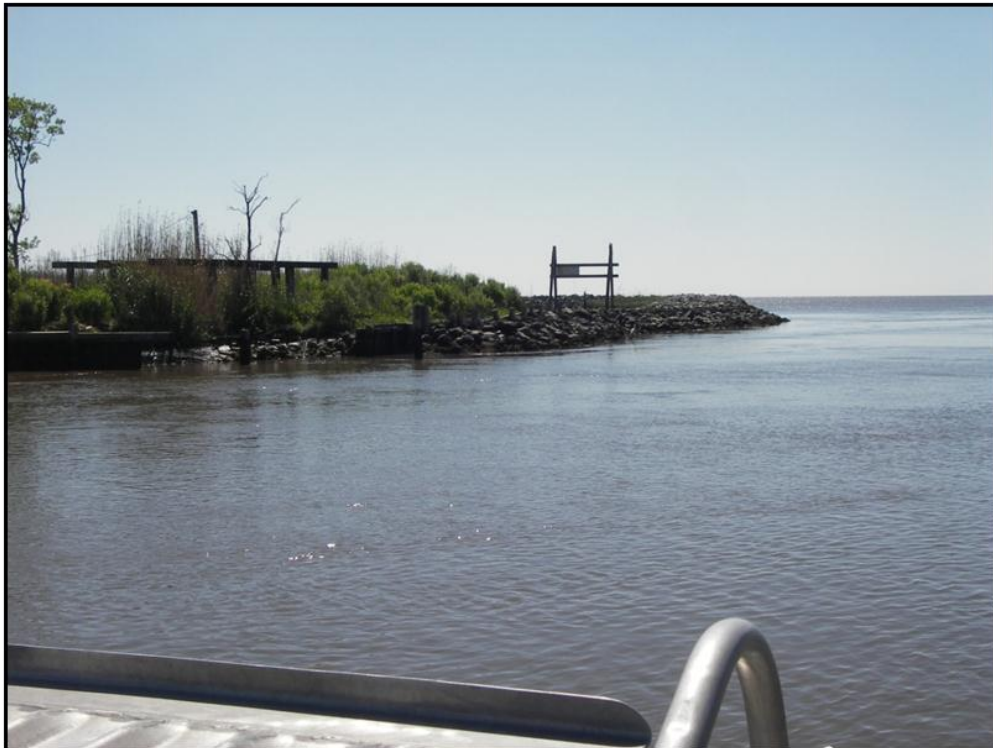
No worsening in this area was evident. The bank between the bay and Bayou Hebert is still only about 6 feet wide and has not gotten any worse. Additional rock has been added to connect the end of the existing rock paving to the rock island protecting two pipelines located on the eastern side of the Oaks Canal. This work was performed by ChevronTexaco Pipeline, LLC-Erath in 2009 through CUP No. 20070581. No immediate maintenance required at this time. (Appendix A; Photos 1-3)

Photo No.1, Rock dike at Oaks Canal, west side

Photo No. 2, Rock dike at Oaks Canal, east side

Item	Condition	Physical Damage	Corrosion	Photo #	Observations and Remarks
Steel Bulkhead / Caps	N/A				
Steel Grating	N/A				
Stop Logs	N/A				
Hardware	N/A				
Timber Piles	N/A				
Timber Wales	N/A				
Galv. Pile Caps	N/A				
Vegetation	N/A				
Signage / Supports	N/A				
Rip Rap (fill)	Excellent			1,2,3	Rock in excellent condition
Eathern Embankment	N/A

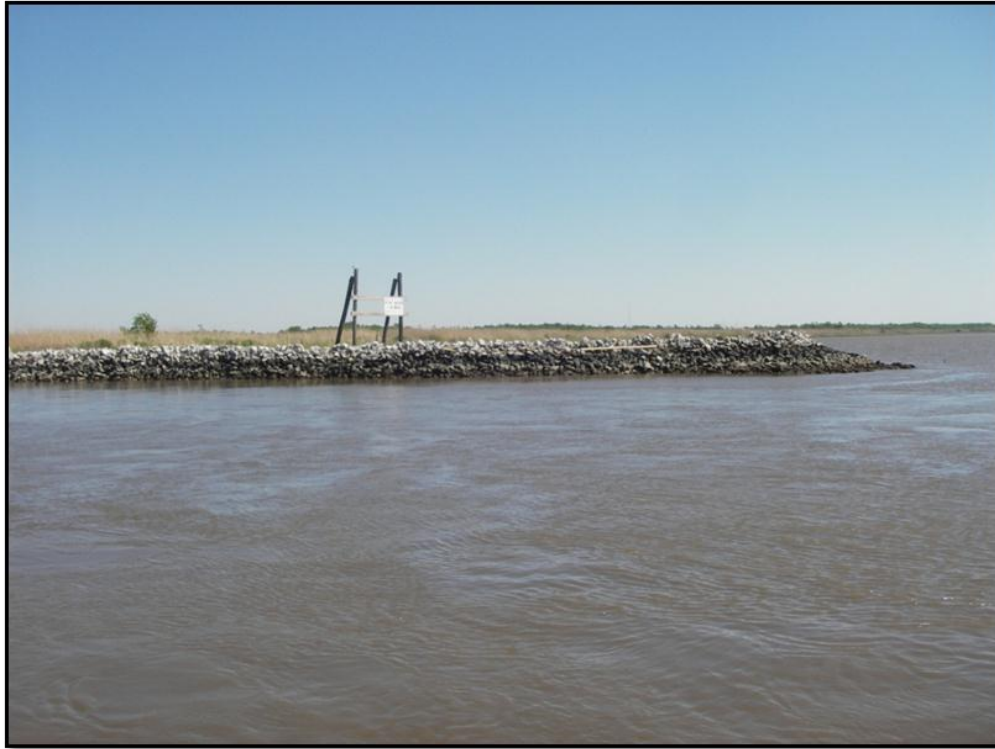
Photo No. 3, Additional rock dike built by ChevronTexaco to protect existing pipelines, located and connected to rock dike on east side of Oaks Canal

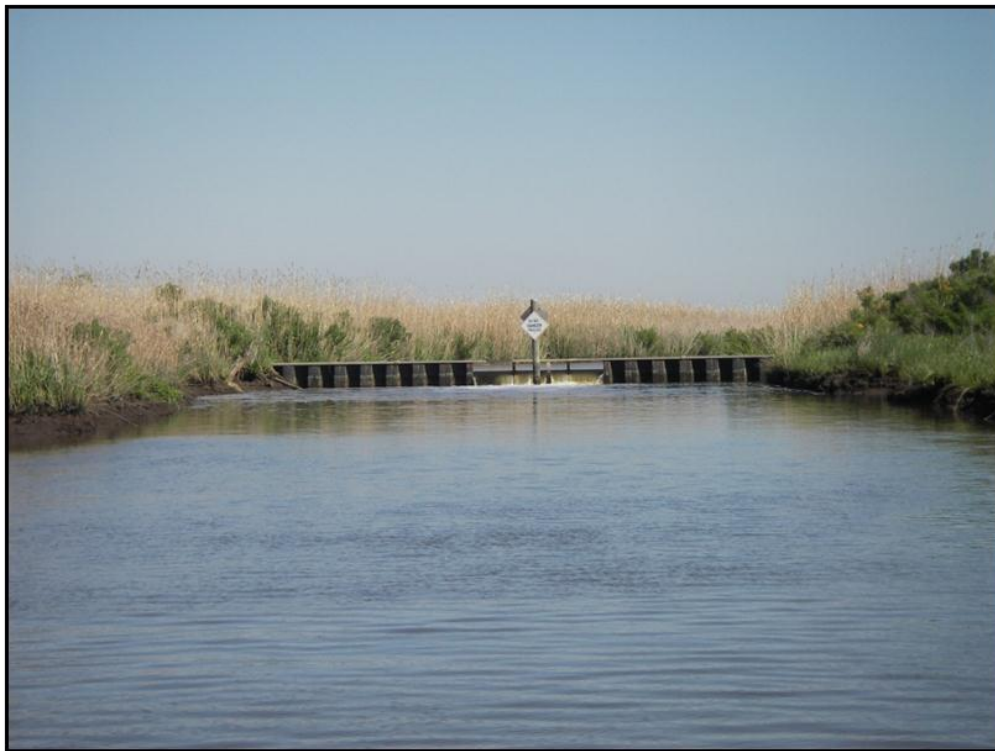
Due to low water conditions, the water control structure could not be inspected. Water could be seen pouring out of structure. The levee on the east side of the structure connecting it to the north bank of the GIWW is stable, in good shape, and well vegetated. (Appendix A; Photo 4)

Photo No. 4, Cow Path Structure

Item	Condition	Physical Damage	Corrosion	Photo #	Observations and Remarks
Steel Bulkhead / Caps	Excellent			4	Could not inspect due to low water.
Steel Grating	N/A				
Stop Logs	N/A				
Hardware	Good			4	Could not inspect due to low water.
Timber Piles	N/A				
Timber Wales	N/A				
Galv. Pile Caps	Excellent				
Vegetation	N/A				
Signage / Supports	Excellent			4	
Rip Rap (fill)	N/A				
Eathern Embankment	Excellent

- Construct earthen plug in lieu of repairing vandalism to the rock plug (site 5) as per landowner's preference.
- Repair low spots on the Oaks Canal where water is seeping through or over the existing levee.
- Add staff gage at Cow Path.

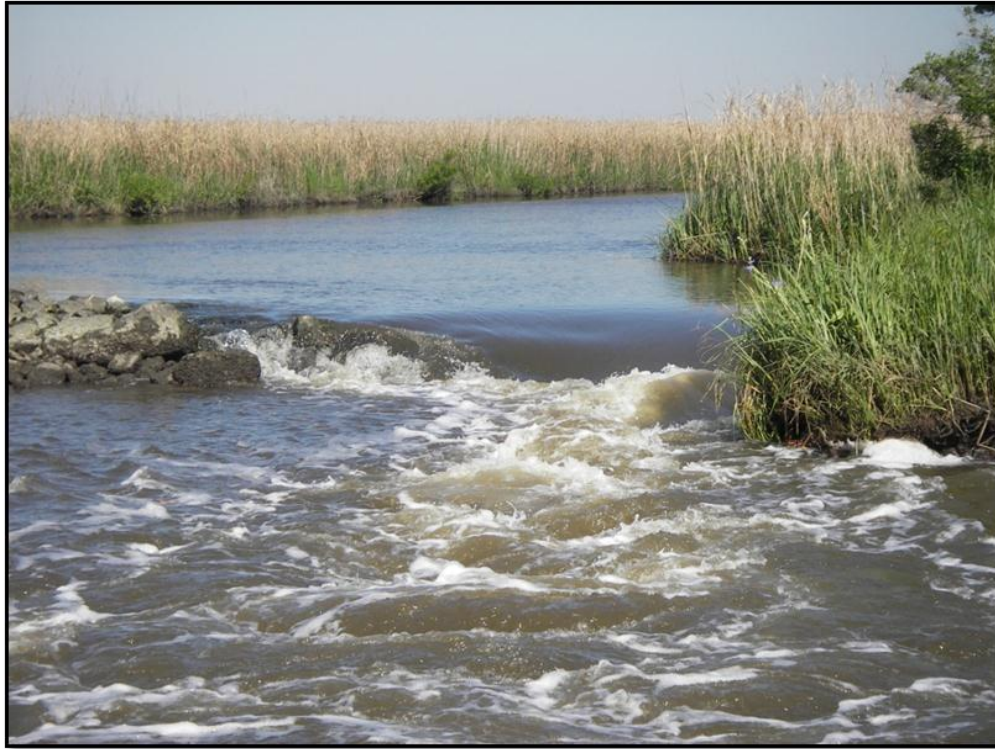
The rock plug is in need of repair. It looks as though more rock has been removed since the last inspection. (Appendix A; Photo 5)

Photo No. 5, The difference in head between the adjacent water bodies forcing water through the breach in the rock plug.

Item	Condition	Physical Damage	Corrosion	Photo #	Observations and Remarks
Steel Bulkhead / Caps	N/A				
Steel Grating	N/A				
Stop Logs	N/A				
Hardware	N/A				
Timber Piles	N/A				
Timber Wales	N/A				
Galv. Pile Caps	N/A				
Vegetation	N/A				
Signage / Supports	N/A				
Rip Rap (fill)	Excellent			5	It looks like more rock has been removed and water was rushing out of the compromised area of the plug.
Eathern Embankment	N/A

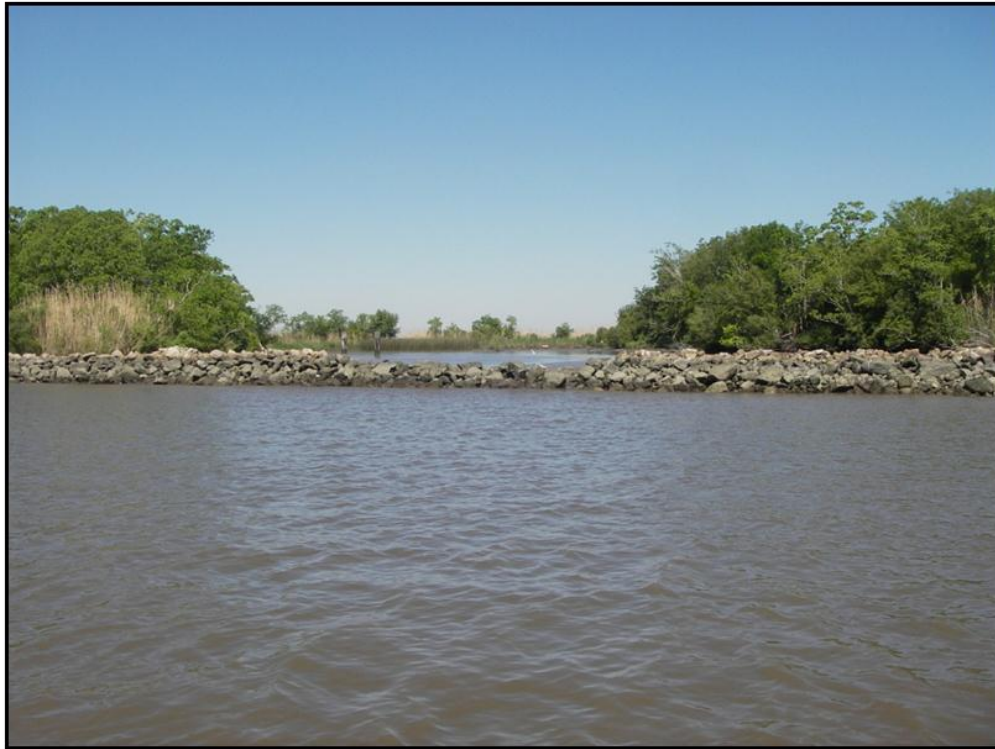
The dike is in excellent condition. Approximately 50 linear feet on the eastern end at a barge slip continues to settle but is in no need of any repairs. This low area is located at N 29° 49' 58.3" and W 91° 59' 25.9". East and west tie-ins are stable, however there is some minor erosion occurring at the east tie-in which will be monitored on future inspections. The water level was low at the time of the inspection so the entire rock dike was visible. (Appendix A; Photo 6)

Photo No. 6, Rock along north bank of GIWW showing low area

Item	Condition	Physical Damage	Corrosion	Photo #	Observations and Remarks
Steel Bulkhead / Caps	N/A				
Steel Grating	N/A				
Stop Logs	N/A				
Hardware	N/A				
Timber Piles	N/A				
Timber Wales	N/A				
Galv. Pile Caps	N/A				
Vegetation	N/A				
Signage /Supports	N/A				
Rip Rap/dike	Excellent			6	Dike is excellent post construction condition. Approx. 50 LF on eastern end hit by barge continues to settle.
Eathern Embankment	N/A

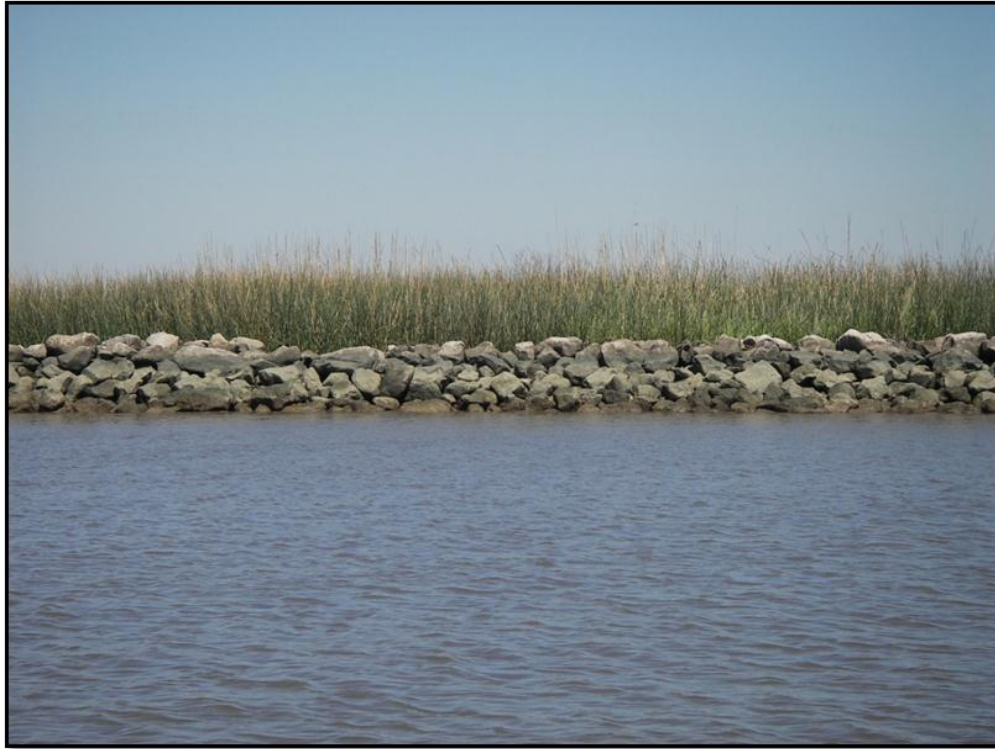
The rock dike is similar to immediate post construction condition and in no need of any repairs. (Appendix A; Photo 7)

Photo No. 7, Rock dike along south bank of GIWW

Item	Condition	Physical Damage	Corrosion	Photo #	Observations and Remarks
Steel Bulkhead / Caps	N/A				
Steel Grating	N/A				
Stop Logs	N/A				
Hardware	N/A				
Timber Piles	N/A				
Timber Wales	N/A				
Galv. Pile Caps	N/A				
Vegetation	N/A				
Signage /Supports	N/A				
Rip Rap (fill)	Excellent			7	Rock dike is in good condition.
Eathern Embankment	N/A

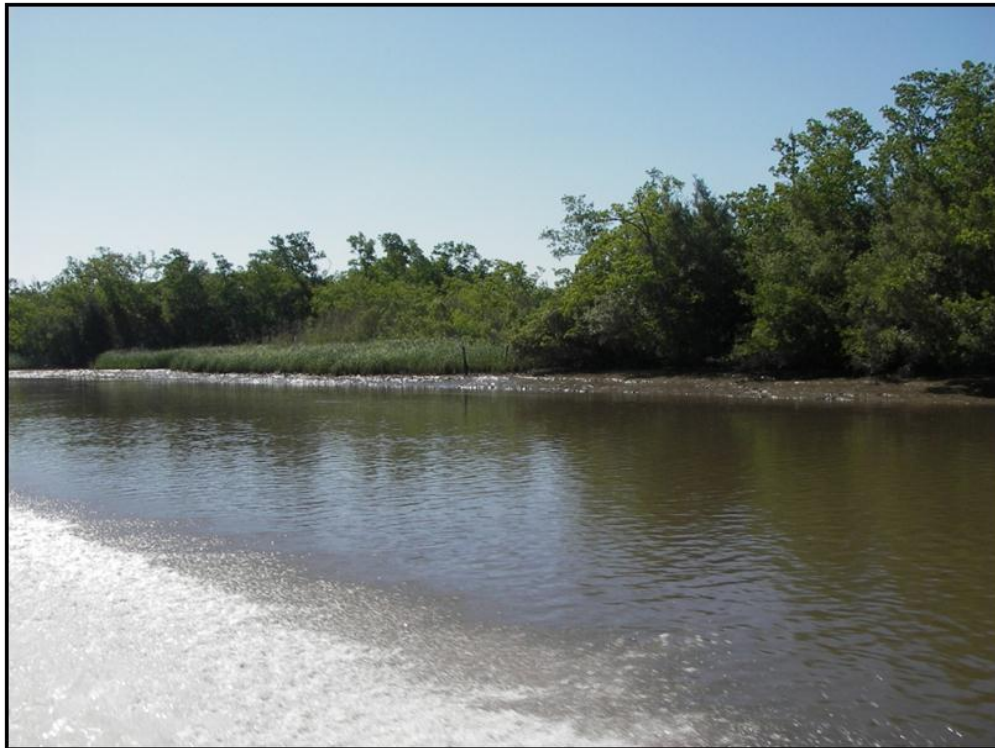
Spoilbank maintenance looks good and is in same condition as last inspection. (Appendix A; Photo 8)

Photo No. 8, Spoilbank Maintenance

Item	Condition	Physical Damage	Corrosion	Photo #	Observations and Remarks
Steel Bulkhead / Caps	N/A				
Steel Grating	N/A				
Stop Logs	N/A				
Hardware	N/A				
Timber Piles	N/A				
Timber Wales	N/A				
Galv. Pile Caps	N/A				
Vegetation	N/A				
Signage /Supports	N/A				
Rip Rap (fill)	N/A				
Eathern Embankment	Excellent			8	Earthen plugs look good.
