**2008 Operations,
Maintenance, and Monitoring
Report**

**Oaks/Avery Canals Hydrologic
Restoration**

State Project Number TV-13a
Priority Project List 6

September 2009
Vermilion Parish

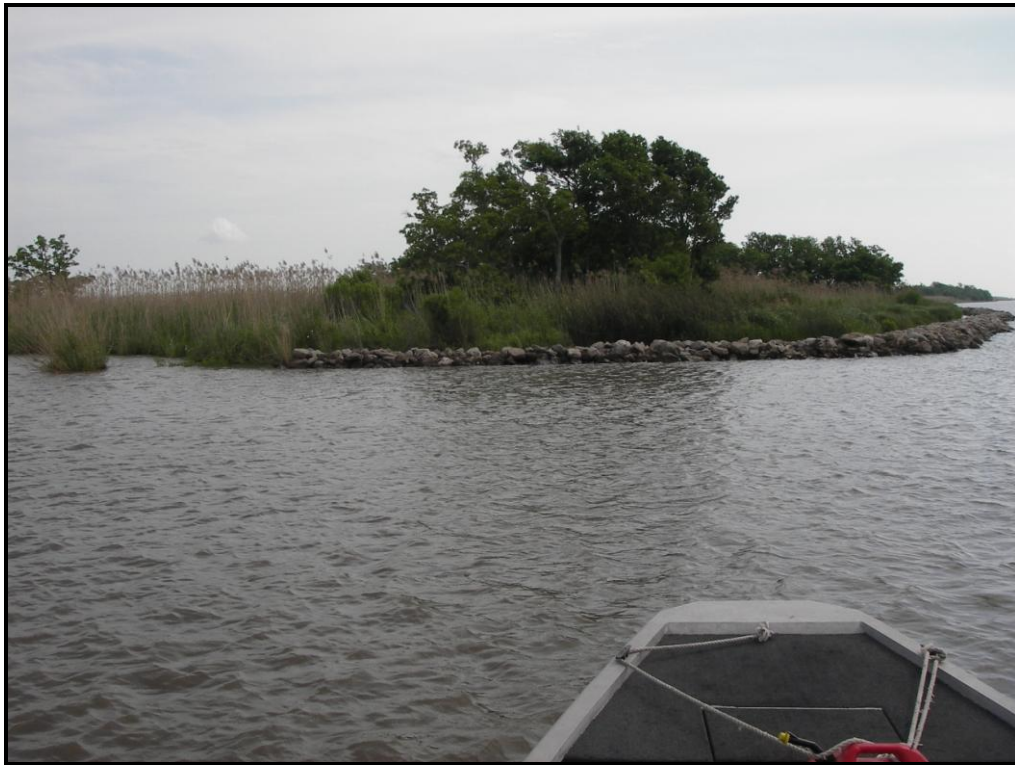
The dike is in excellent condition. Approximately 60 linear feet on the eastern end at a barge slip continues to settle but is in no need of any repairs. East and west tie-ins are stable, however there is some minor erosion occurring at the east tie-in, which will be monitored on future inspections. (Appendix A; photos 1-3)

Photo 1— rock dike on north bank of GIWW; west tie in

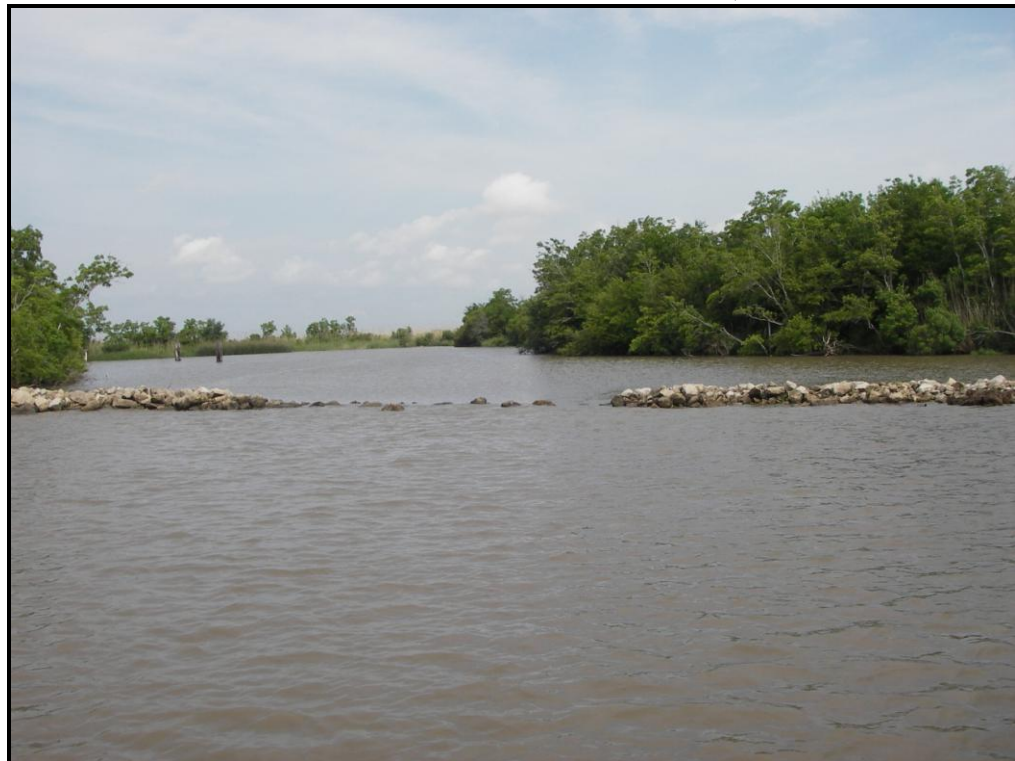
Photo 2—settled rock on north bank of GIWW at barge slip

Item	Condition	Physical Damage	Corrosion	Photo #	Observations and Remarks
Steel Bulkhead / Caps	N/A				
Steel Grating	N/A				
Stop Logs	N/A				
Hardware	N/A				
Timber Piles	N/A				
Timber Wales	N/A				
Galv. Pile Caps	N/A				
Vegetation	N/A				
Signage /Supports	N/A				
Rip Rap/dike	Excellent			1-3	Dike is excellent post construction condition. Approx. 60 LF on eastern end hit by barge continues to settle.
Eathern Embankment	N/A

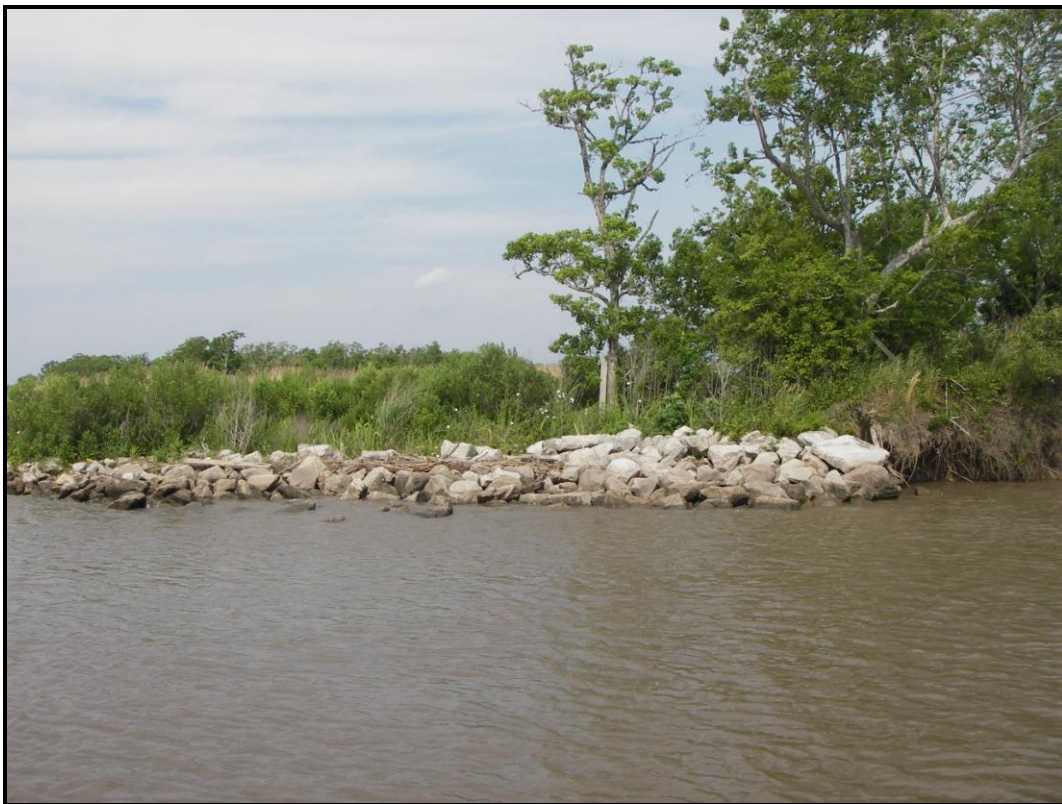
Photo 3-- rock dike on north bank of GIWW; east tie in

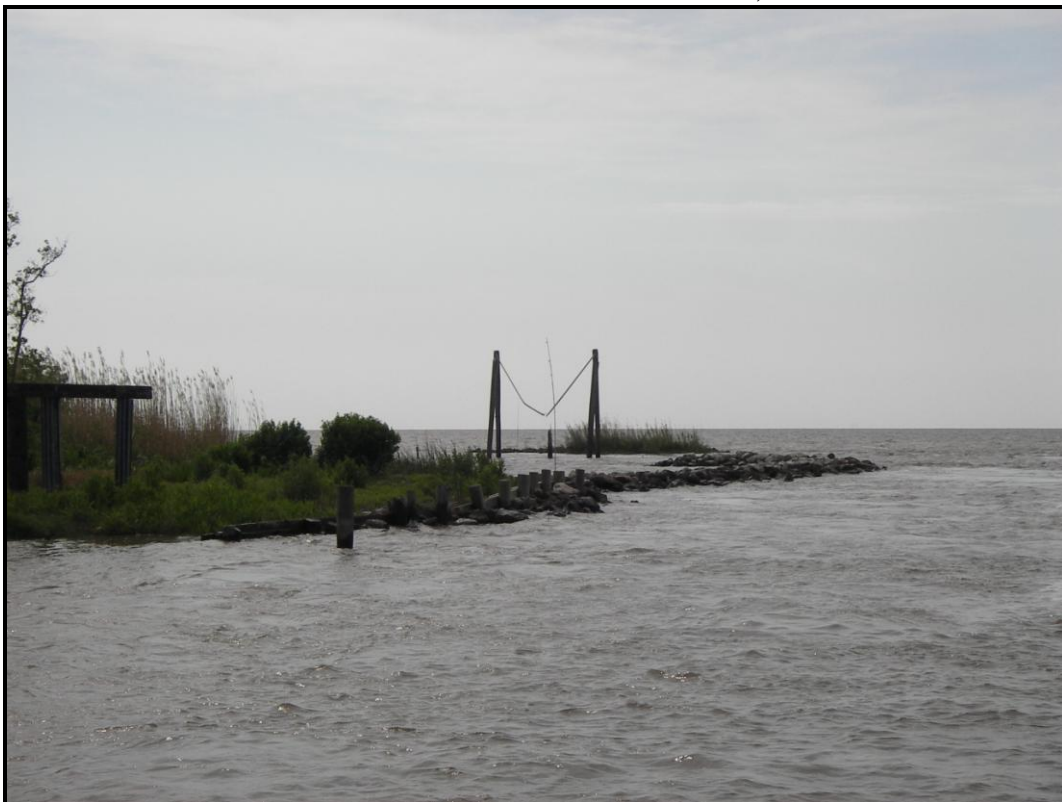
High tides concealed the area along the western bank paving where some rock had apparently slid into the channel. No worsening in this area was evident. The bank between the bay and Bayou Hebert is still only about 6 feet wide and has not gotten any worse. No immediate maintenance required at this time. (Appendix A; photos 4-5)

Photo 4—east bank of Oaks Canal

Item	Condition	Physical Damage	Corrosion	Photo #	Observations and Remarks
Steel Bulkhead / Caps	N/A				
Steel Grating	N/A				
Stop Logs	N/A				
Hardware	N/A				
Timber Piles	N/A				
Timber Wales	N/A				
Galv. Pile Caps	N/A				
Vegetation	N/A				
Signage /Supports	N/A				
Rip Rap (fill)	Excellent			4 & 5	Rock in excellent condition
Eathern Embankment	N/A

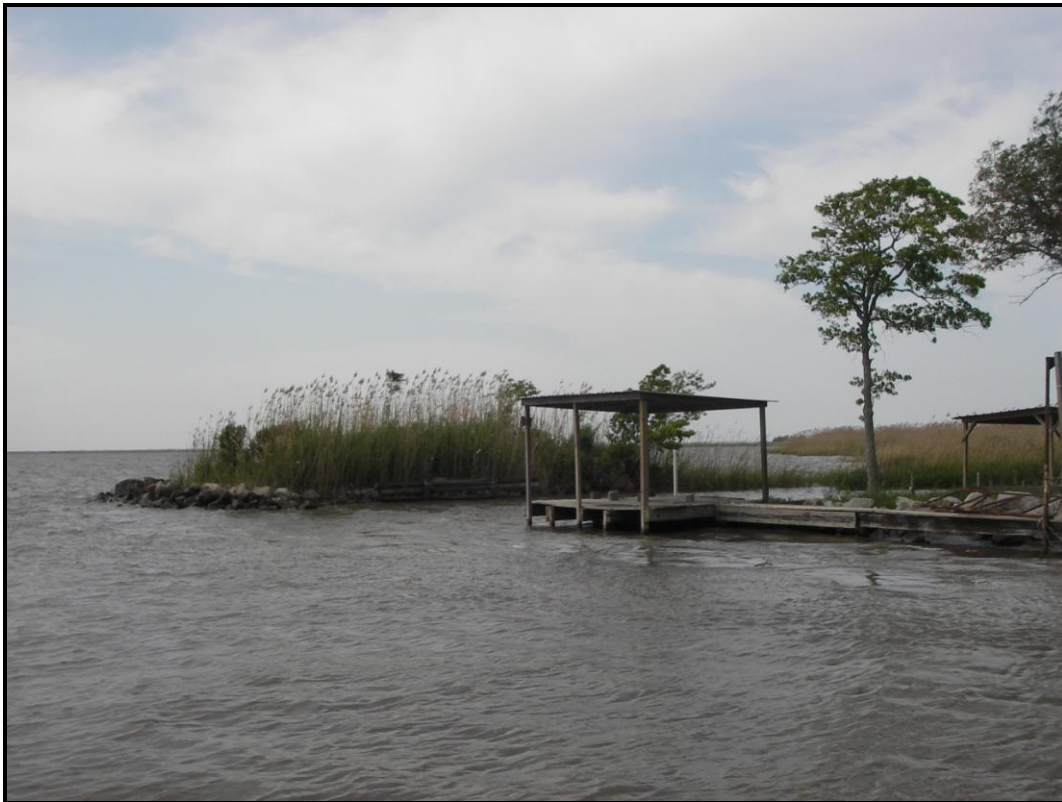
Photo 5—west bank of Oaks Canal

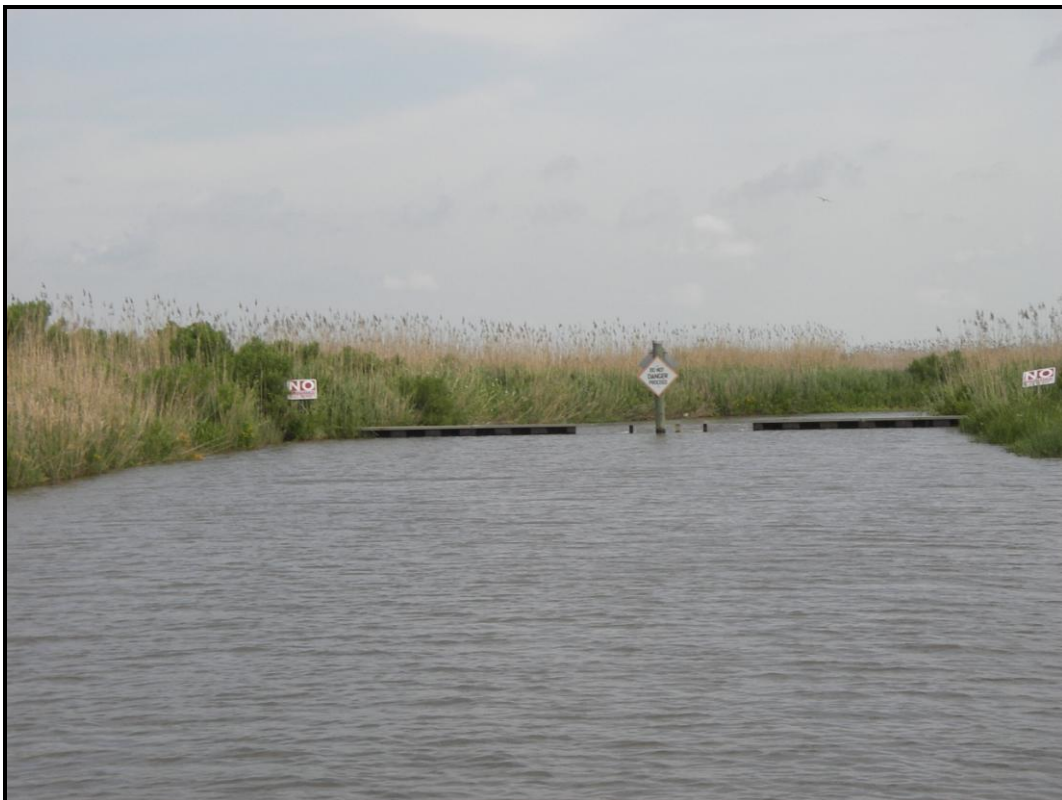
The structure is in excellent shape. Signage is stable. Wingwalls show no signs of any erosion. Three SS bolts are missing from pile cap and will eventually need to be replaced, probably by OCPD personnel. The levee from the east side of the structure to the GIWW is stable. No maintenance required at this time. The boat lifting device installed by the landowners on the western half of the structure has been removed and is on the ground adjacent to the structure. The landowner installed channel iron to accept stoplogs is still on the structure. This will be investigated further by OCPD. (Appendix A; photos 6-8)

Photo 6—cow path structure

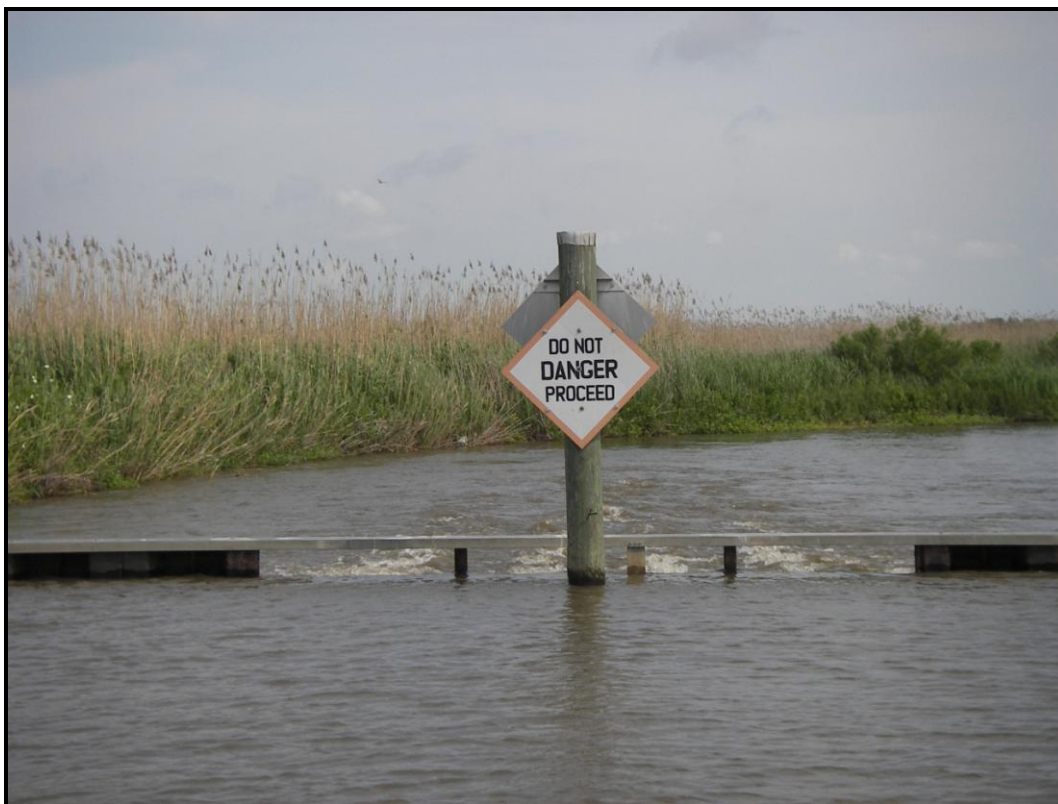
Photo 7—landowner installed channel iron

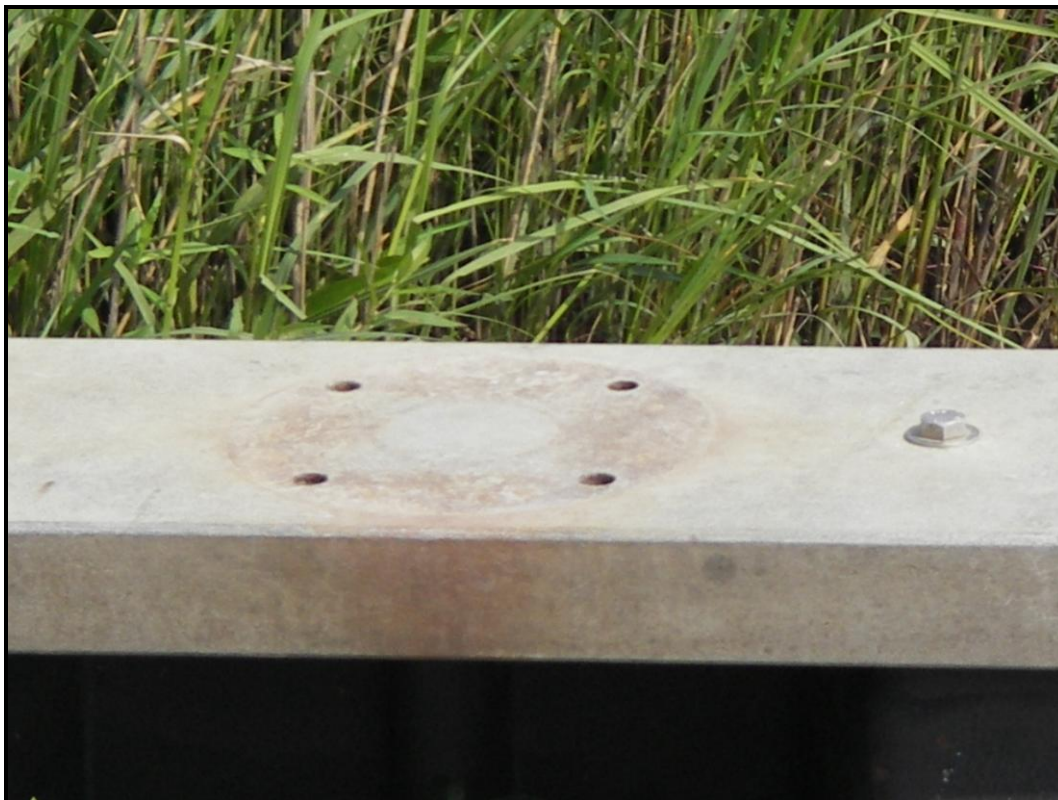
Photo 8—landowner installed boat lifting device has been removed

Item	Condition	Physical Damage	Corrosion	Photo #	Observations and Remarks
Steel Bulkhead / Caps	Excellent			7	
Steel Grating	N/A				
Stop Logs	N/A				
Hardware	Good			8	Three SS bolts missing from pile cap. Not critical. Landowner installed boat lifting device has been removed..
Timber Piles	N/A				
Timber Wales	N/A				
Galv. Pile Caps	Excellent				
Vegetation	N/A				
Signage /Supports	Excellent			6	
Rip Rap (fill)	N/A				
Eathern Embankment	Excellent

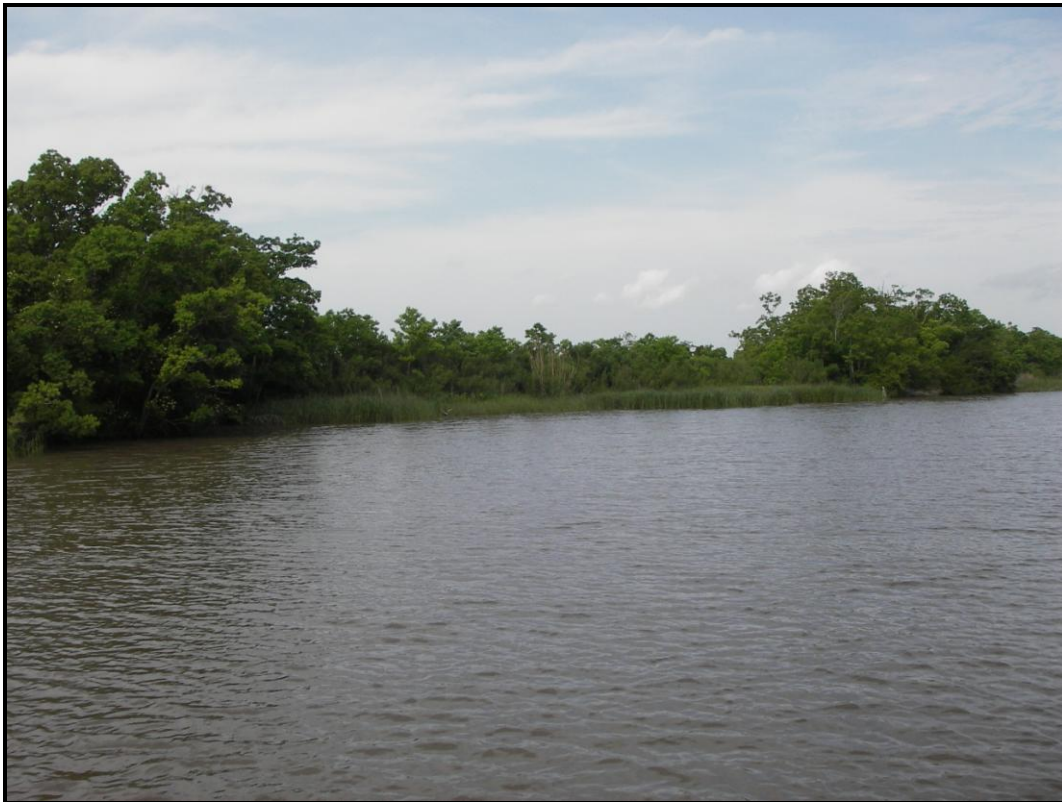
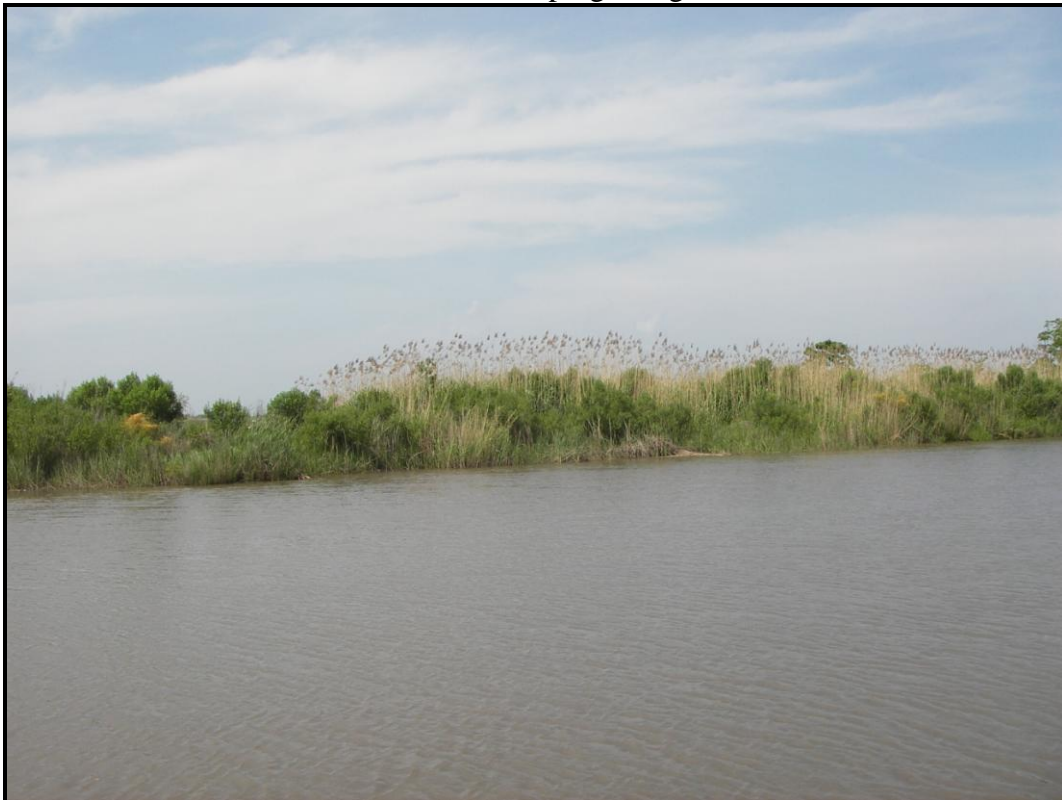
The closures are holding up well. Vegetation has been established. No need for any repairs. (Appendix A; photos 9-10)

Photo 9—earthen plug along levee

Photo 10—earthen plug along levee

Item	Condition	Physical Damage	Corrosion	Photo #	Observations and Remarks
Steel Bulkhead / Caps	N/A				
Steel Grating	N/A				
Stop Logs	N/A				
Hardware	N/A				
Timber Piles	N/A				
Timber Wales	N/A				
Galv. Pile Caps	N/A				
Vegetation	N/A				
Signage /Supports	N/A				
Rip Rap (fill)	N/A				
Eathern Embankment	Excellent			9-10

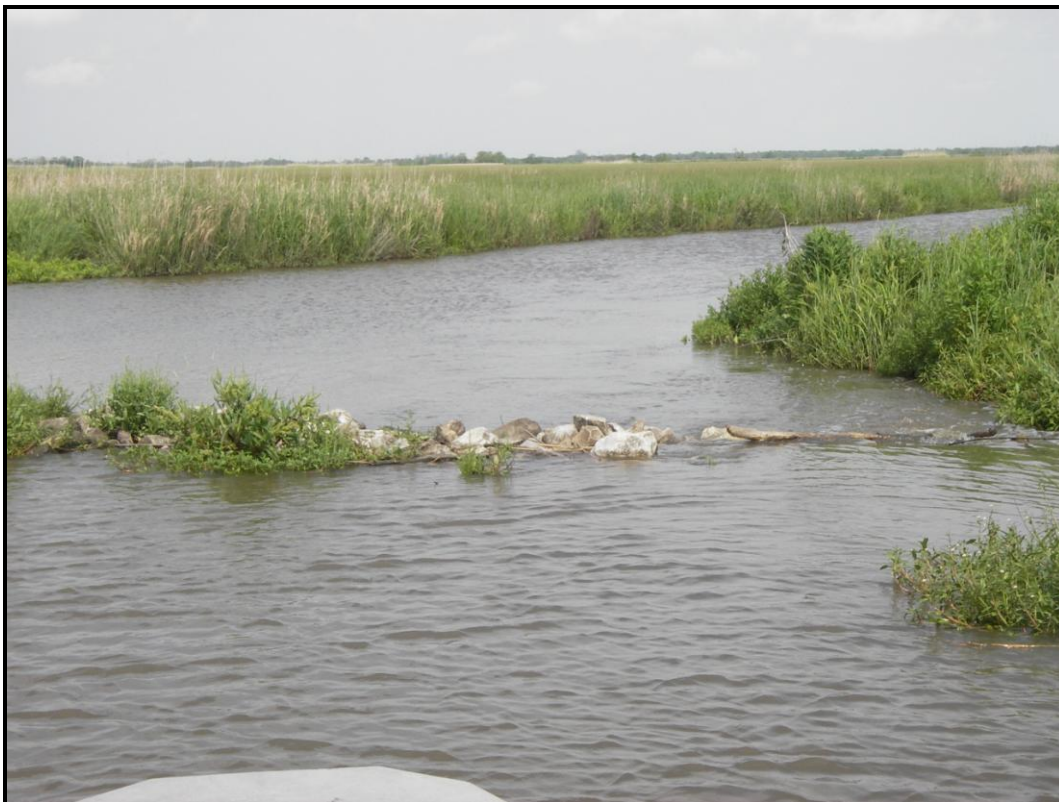
The plug is in good condition. There appears to be some rock moved from the east side of the closure allowing water to go over the rock at high tides. Tie-ins are stable. No need for any repairs. (Appendix A; photo 11)

Photo 11—rock plug

Item	Condition	Physical Damage	Corrosion	Photo #	Observations and Remarks
Steel Bulkhead / Caps	N/A				
Steel Grating	N/A				
Stop Logs	N/A				
Hardware	N/A				
Timber Piles	N/A				
Timber Wales	N/A				
Galv. Pile Caps	N/A				
Vegetation	N/A				
Signage /Supports	N/A				
Rip Rap (fill)	Excellent			11	
Eathern Embankment	N/A

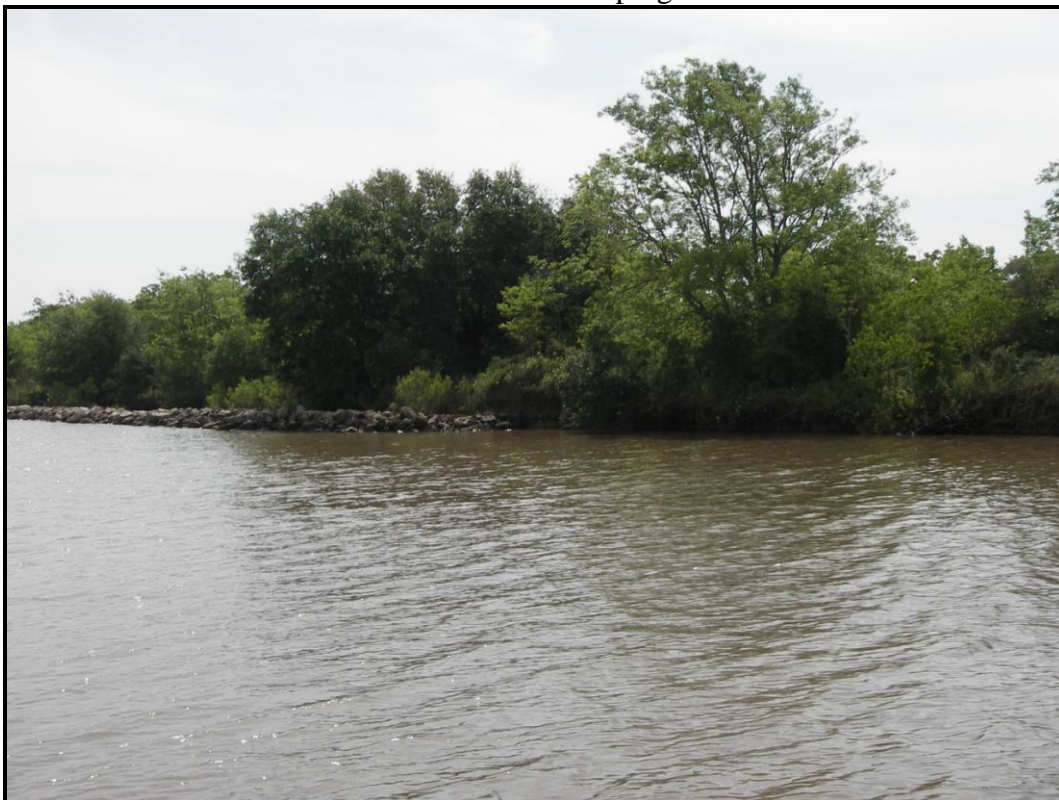
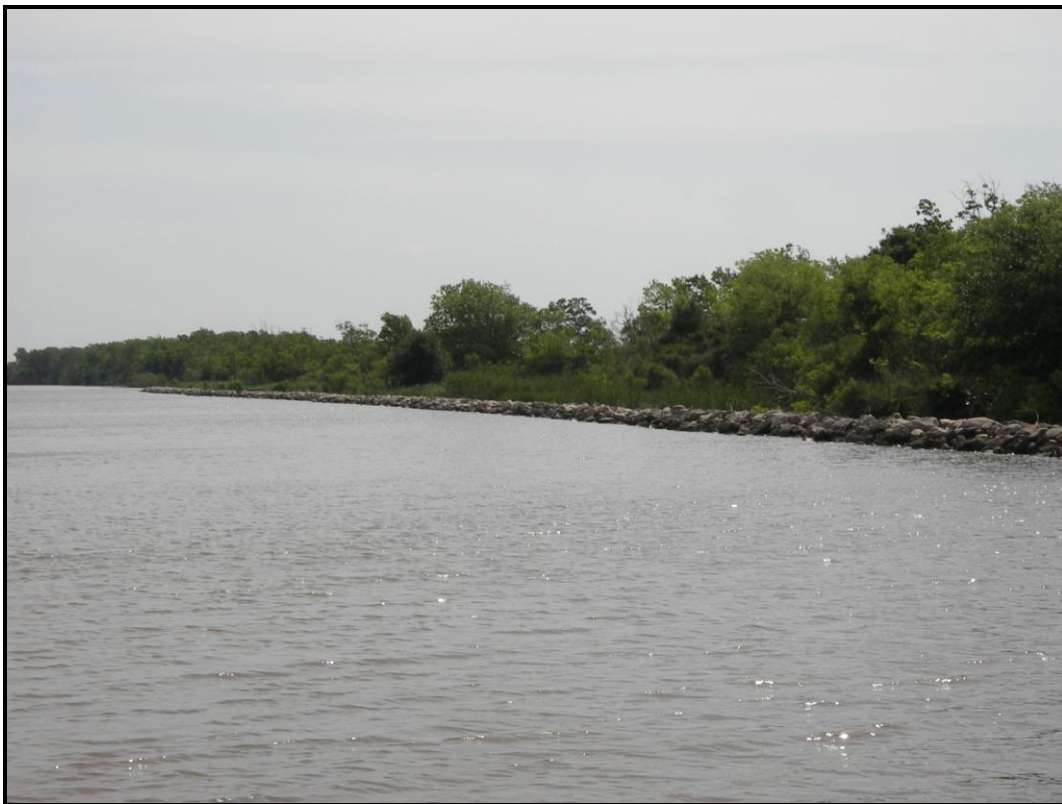
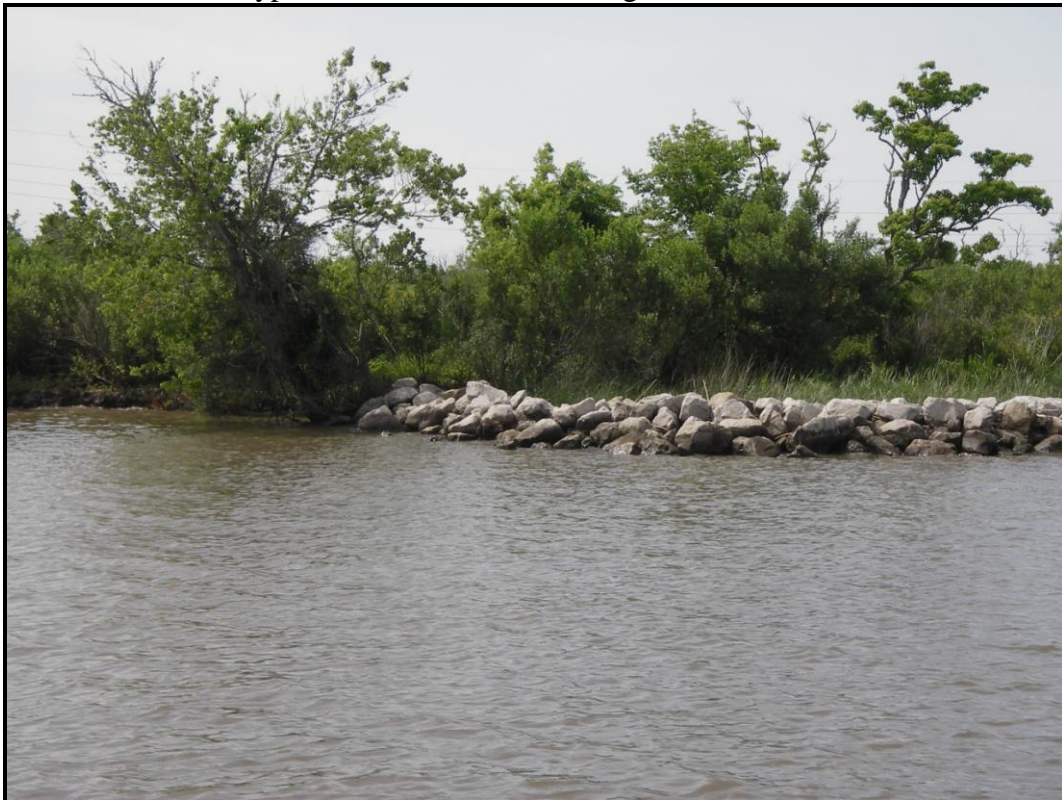
The dike is in immediate post construction condition and in no need of any repairs. (Appendix A; photo 12, 13, & 14)

Photo 12- rock dike on south bank of GIWW, west tie-in

Photo 13- typical rock dike section along southern bank of GIWW

Photo 14- rock dike on south bank of GIWW, east tie-in

Item	Condition	Physical Damage	Corrosion	Photo #	Observations and Remarks
Steel Bulkhead / Caps	N/A				
Steel Grating	N/A				
Stop Logs	N/A				
Hardware	N/A				
Timber Piles	N/A				
Timber Wales	N/A				
Galv. Pile Caps	N/A				
Vegetation	N/A				
Signage /Supports	N/A				
Rip Rap (fill)	Excellent			12, 13, 14	
Eathern Embankment	N/A

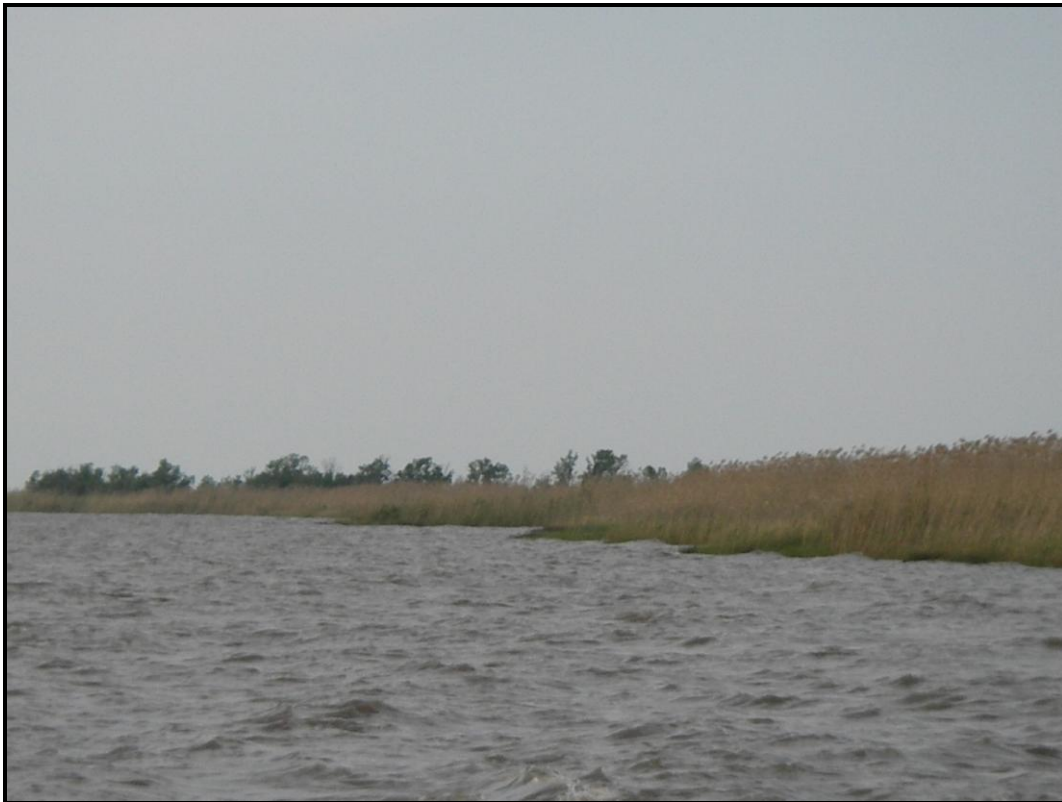
The shoreline plantings were not directly inspected on this trip due to time and wave constraints. They are, however, expected to be in similar condition as previous inspections. All vegetation in the area, including the vegetation behind the rock dikes at the mouth of the Oaks Bayou Canal, is in good condition. (Appendix A; photo 15)

Photo 15- vegetation along shoreline west side of the Oaks Canal

Item	Condition	Physical Damage	Corrosion	Photo #	Observations and Remarks
Steel Bulkhead / Caps	N/A				
Steel Grating	N/A				
Stop Logs	N/A				
Hardware	N/A				
Timber Piles	N/A				
Timber Wales	N/A				
Galv. Pile Caps	N/A				
Vegetation	Good			15	Only vegetation inspected was along either side of the mouth of the Oaks Canal.
Signage /Supports	N/A				
Rip Rap (fill)	N/A				
Earthen Embankment	N/A
