2010 Operations, Maintenance, and Monitoring Report

GIWW (Gulf Intracoastal Waterway) to Clovelly Hydrologic Restoration (BA-02)

State Project Number BA-02
Priority Project List 1

December 2010
Lafourche Parish

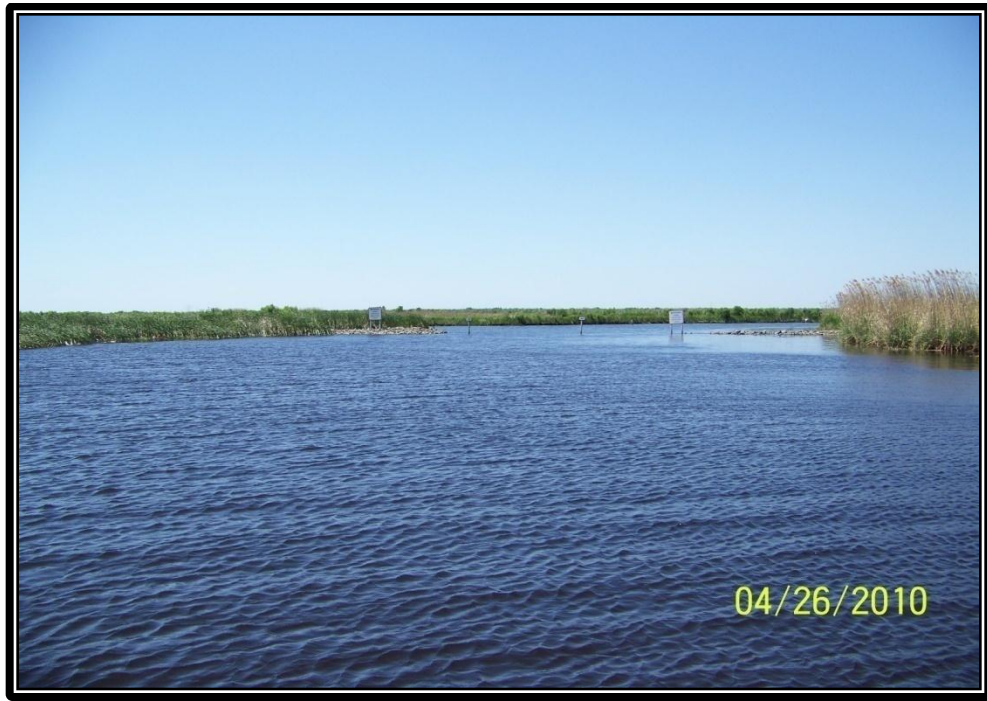
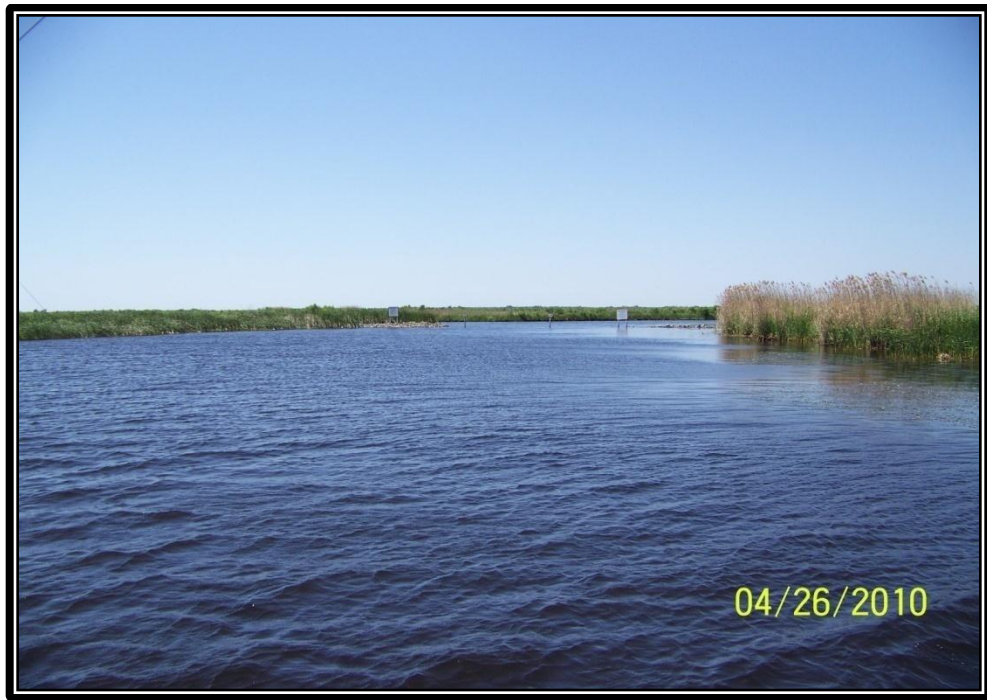
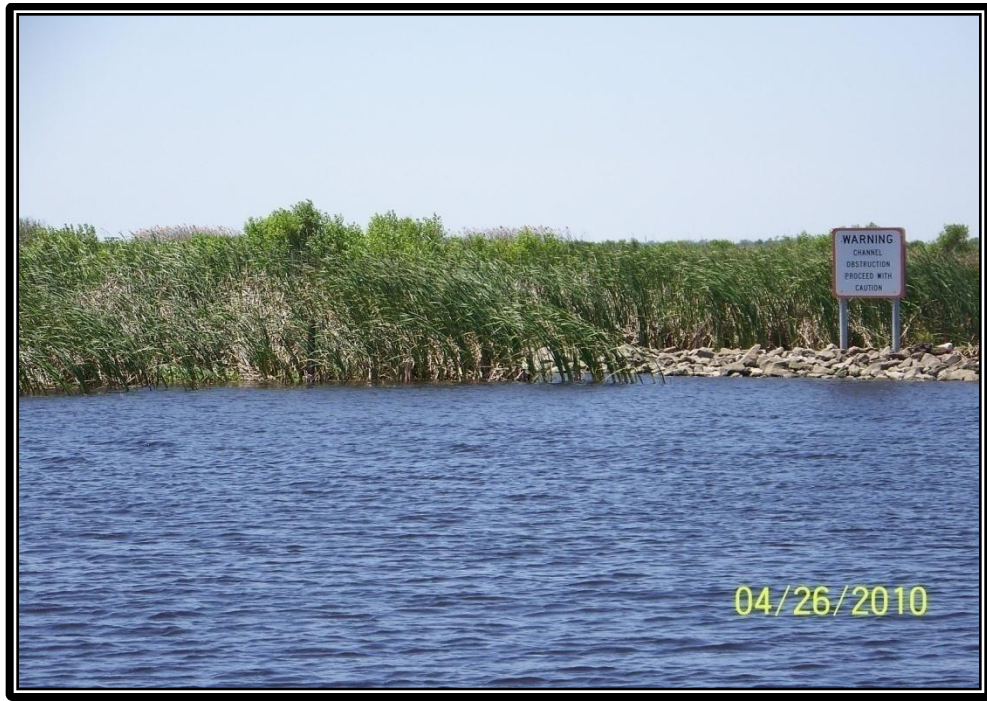
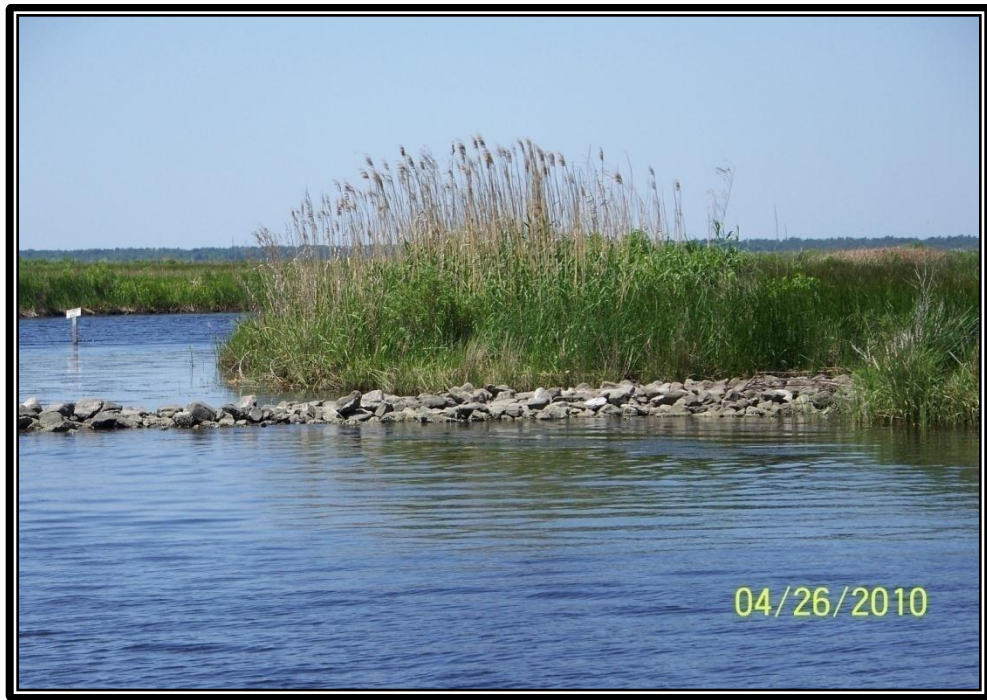
Structure No.2 was constructed using a fixed crest weir consisting of rock riprap material. The as-built drawings indicate that the sill elevation closest to the bank (bank section) on both sides of the structure was constructed to an elevation of +3.9' NAVD. The sill section between the bank section and the boat bay was constructed to an elevation of 2.3' NAVD and the sill of the boat bay section was constructed to an elevation of -5.1' NAVD. As reported on previous inspections and verified through the 2008 profile surveys, moderate settlement was noted between the boat bay and the bank section (ranging from 1.3' to 1.5') and severe settlement within the limits of the boat bay. Based on these observations and supporting survey data, we have included provisions in the 2010 Maintenance Project to refurbish Structure No.2 to the original design elevations. The method of repairs and corrective actions are outlined in the conclusion of this report. The warning signs and supports appeared to be in good condition and will not require repairs (Appendix B, Photos No. 1 through 4).

Photo No.1 – view of rock weir with boat bay (Structure No.2) looking southwest.

Photo No.2 – view of rock weir with boat bay (Structure No.2) looking south.

Photo No.3 – view of southeast bank tie-in of the rock weir (Structure No.2).

Photo No.4 – view of northwest bank tie-in of the rock weir (Structure No.2) looking northwest.

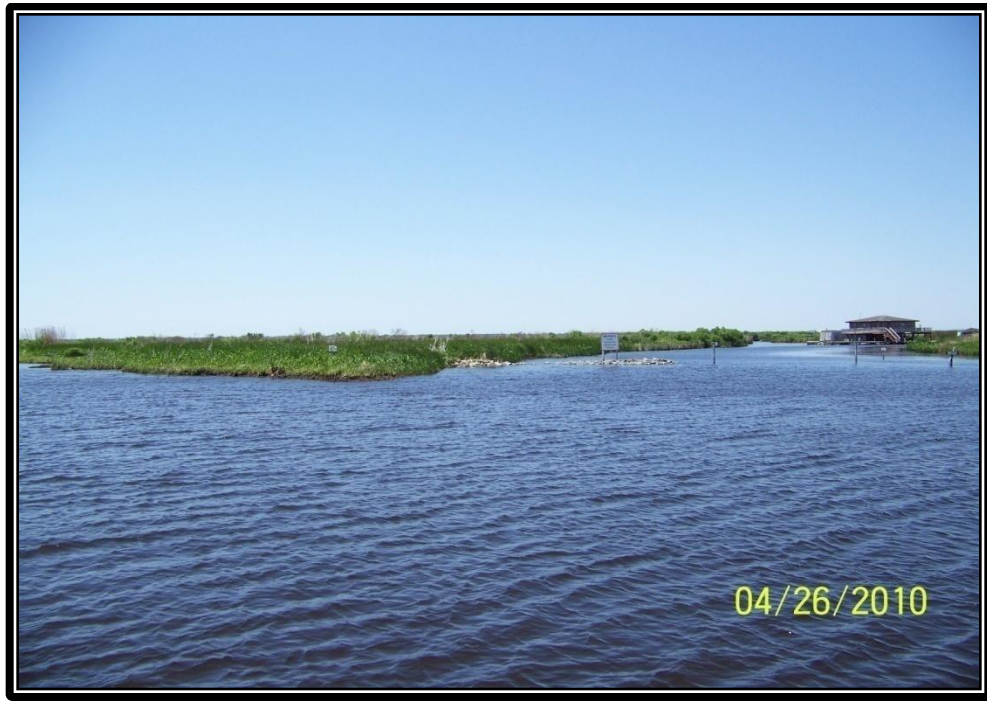
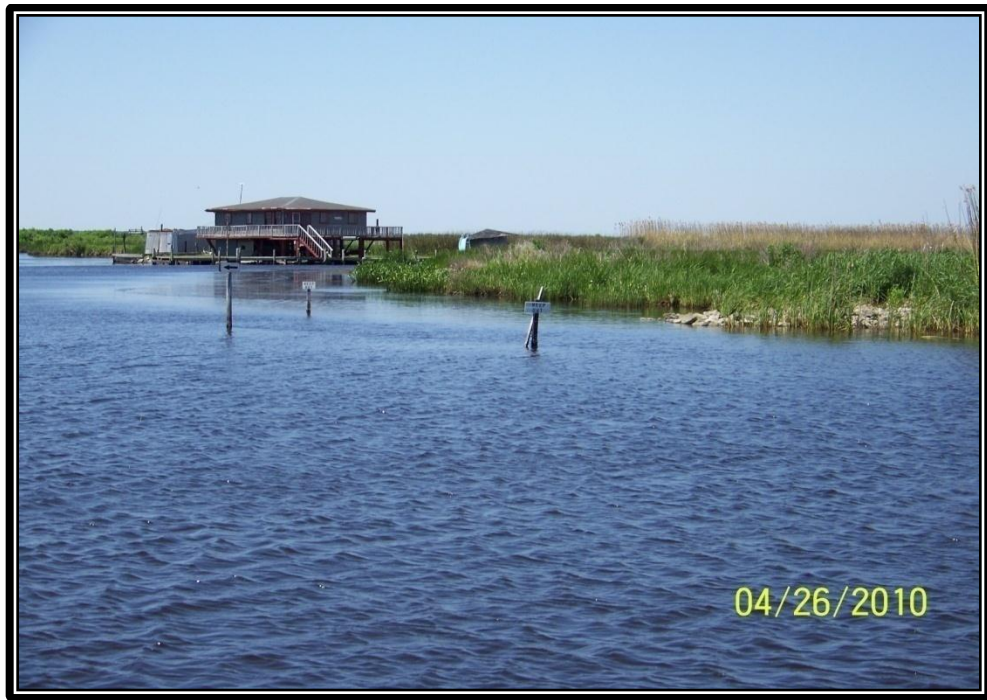
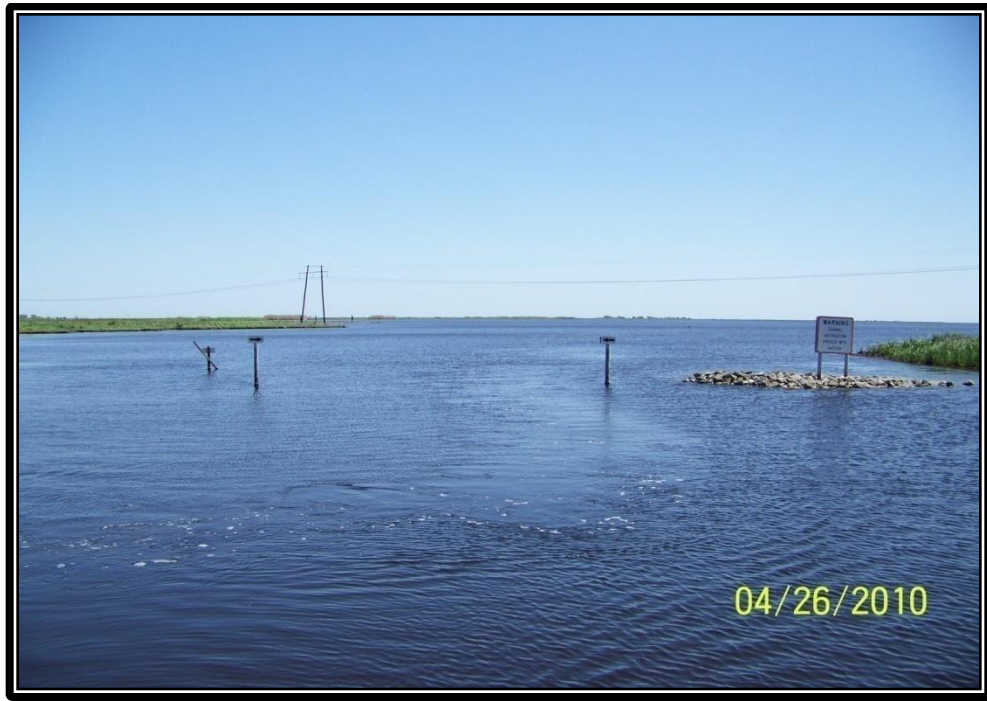
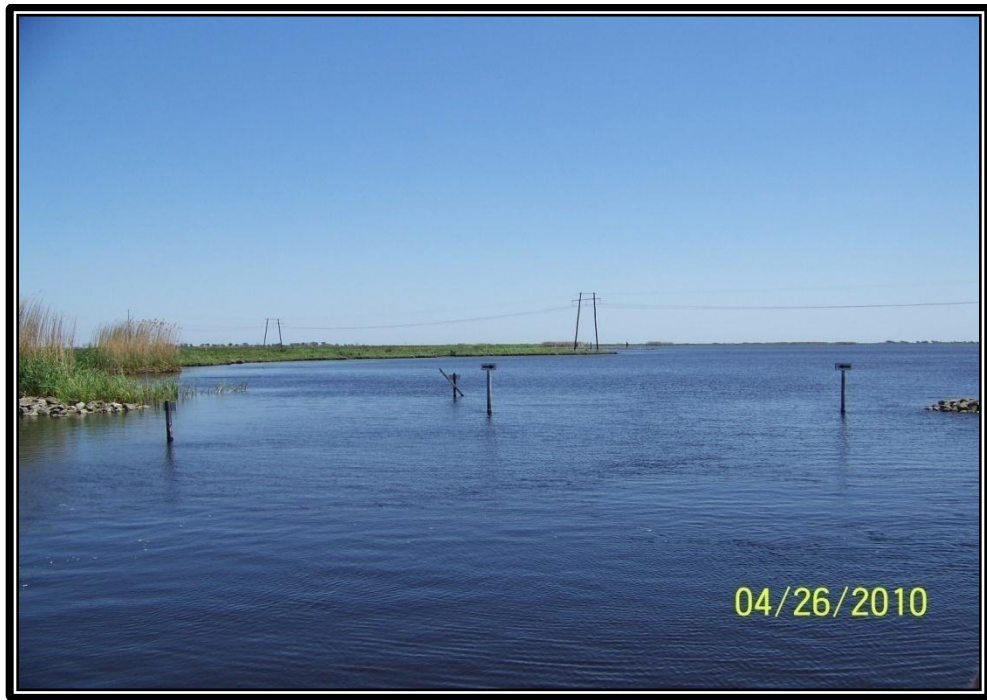
Structure No.4 was also constructed using a three (3) level fixed crest weir consisting of rock riprap material. The rock weir section closest to the bank (bank section) on both sides of the structure was constructed to an elevation of +3.8' NAVD. The intermediate section between the bank section and the boat bay was constructed to an elevation of +2.4' NAVD, and the sill beneath the boat bay was constructed to an elevation of -3.9' NAVD. The condition of Structure 4 appears to be similar to what was observed during the previous 2009 inspection. The most severe settlement was noted on the south side of intermediate crest section with settlement rates as high as 6' to 7'. On the north side of the structure, settlement was moderate with rates ranging

between 1.5' to 2.0'. We also noted that the sign and support on the north side of the structure was missing and recommended for replacement. Based on past and current observations along with supporting the 2008 survey profile data, Structure 4 is also included in the 2010 Maintenance Project for refurbishment. The method of maintenance repairs and corrective actions are outlined in the conclusion of this report. (Appendix B, Photos No.5 through No.8)

Photo No.5 – view of the rock weir with boat bay (Structure No.4) looking west.

Photo No.6 – view of the north side tie-in of the rock weir with boat bay at Structure No.4.

Photo No.7 – view of the rock weir with boat bay (Structure No.4) looking east into Little Lake.

Photo No.8 – view of the rock weir with boat bay (Structure No.4) looking east into Little Lake.

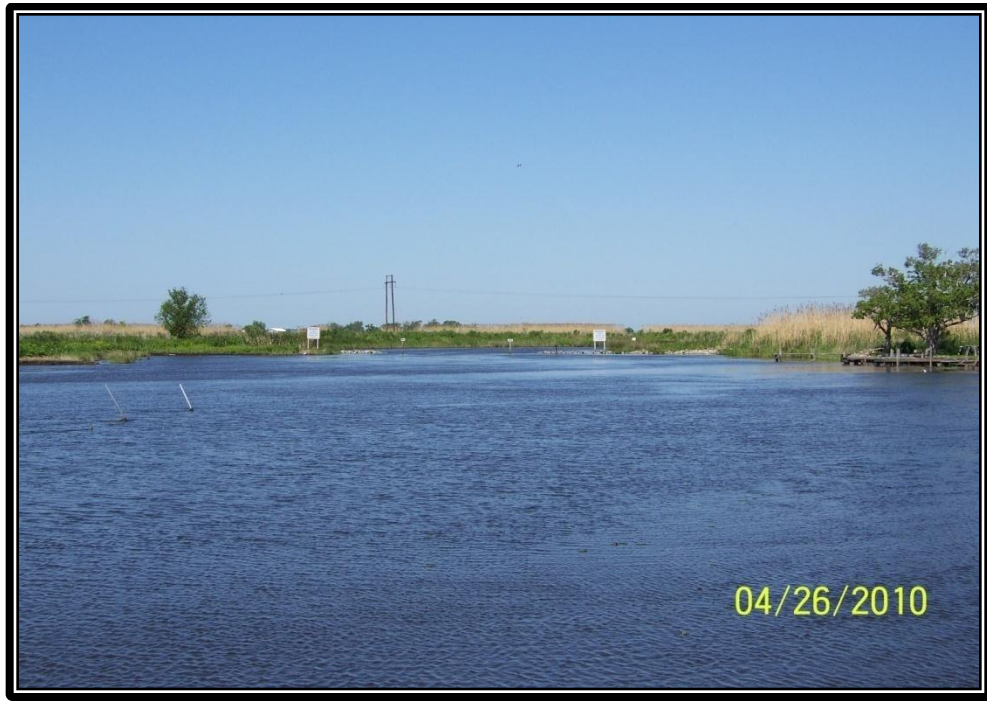
Structure No.7 appeared to be in fair condition with no visual damage to the rock weir or washouts around the ends of the structure. The as-built drawings indicate that the fixed crest rock weir was constructed to elevations of -4.4 NAVD 88 at the boat bay and +2.4' NAVD 88 on the north and south sides between the bank section and the boat bay. Elevation profiles taken in 2008 revealed that the rock weir had subsided uniformly throughout the length of the structure with settlement rates ranging from 1.0' to 1.5'. All signs, supports and earthen embankment tie-ins appear to be in good condition. Considering that the settlement of Structure 7 is uniform and relatively minor, we are not recommending corrective actions at this time. The inspection team will continue to monitor the condition of Structure 7 on future site visits and make recommendations for repairs as needed. (Appendix B: Photos No.9).

Photo No.9 – view of rock weir with boat bay (Structure No.7) from the Little Lake side.

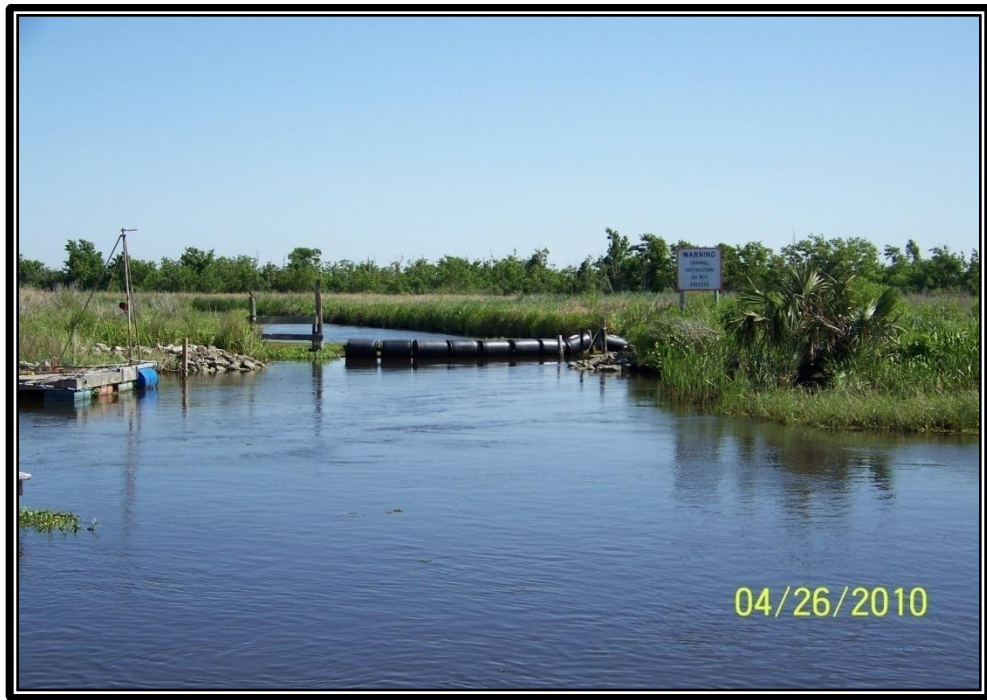
Structure No.8 is a small rock weir with boat bay located on the north side of Structure 7 with a steel gate closure across the weir to prevent access to the existing channel leading to the interior marsh. This structure was not profiled during the most recent survey completed in 2008. From a visual inspection, the rock weir appeared to be in fair condition with no obvious erosion or washouts around the structure. The gate closure constructed across the weir was destroyed during Hurricanes Gustav and Ike and no longer existed as of the 2009 inspection; however, we did notice that the landowner had installed a series of floating barrels strung across the opening to restrict access. At this time, there are no recommendations for recapping the rock weir or replacing the steel gate. (Appendix B: Photos No. 10)

Photo No.10 – view of smaller rock weir (Structure No.8) with boat bay on the north side of Structure No7.

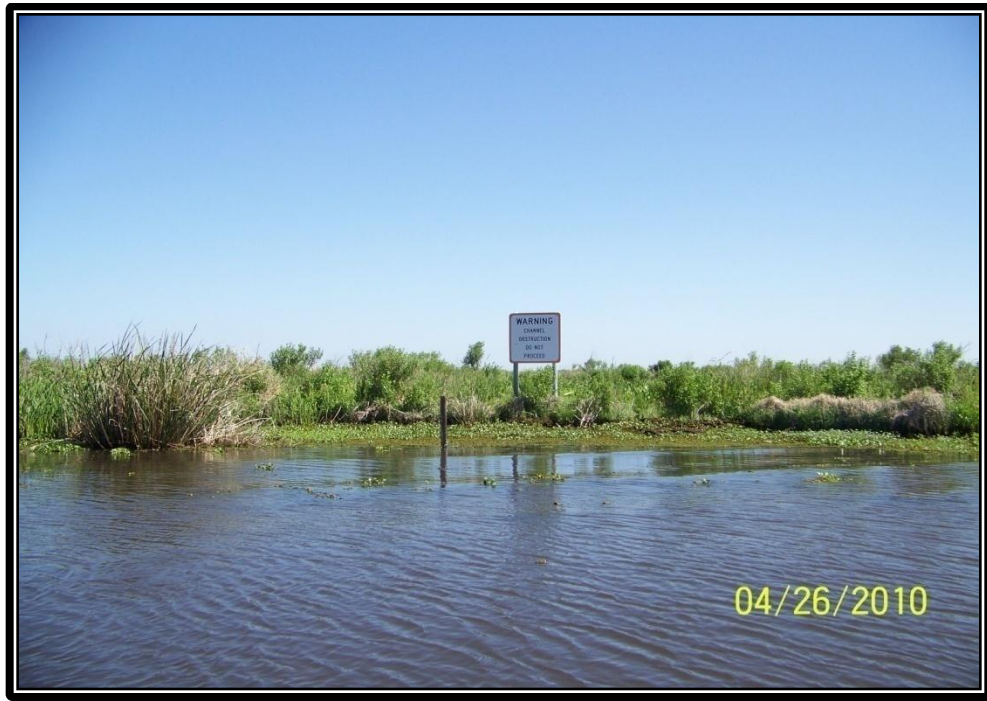
Photo No. 11 – view of rock plug (Structure No. 43) on the interior marsh along Bayou Des Amoureux.

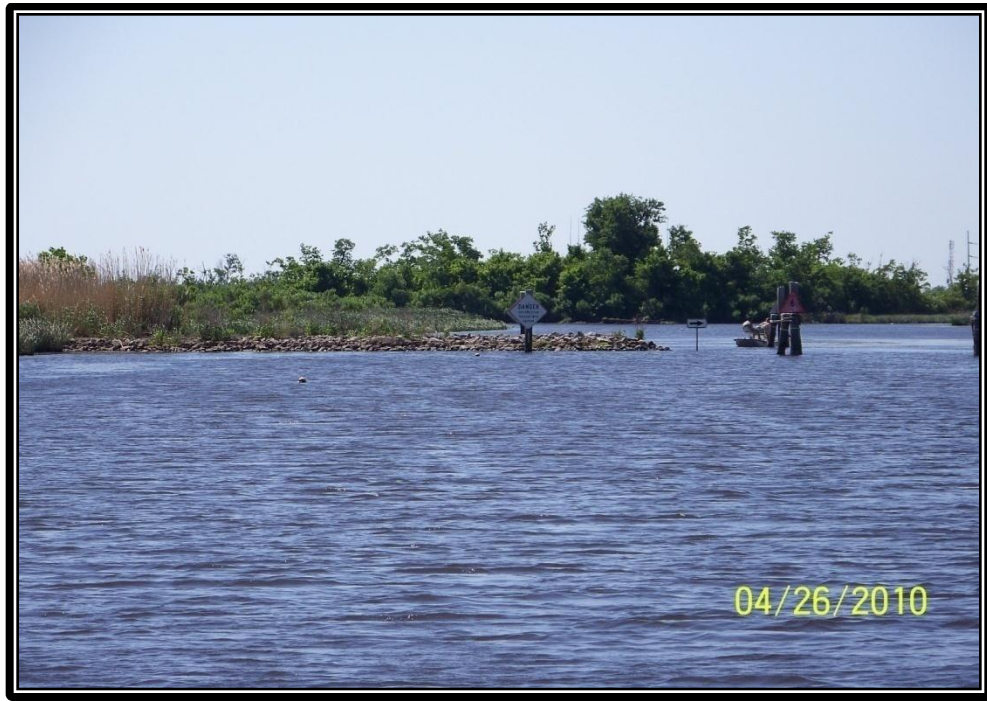
The rock weir with barge bay appeared to be in good condition with no obvious settlement or rock displacement. The weir was constructed to a -6.4' NAVD at the barge bay and +4.0' NAVD along the crest on both sides of the weir between the barge bay and bank line. Staff gauge readings from station BA02-57 just north of the structure indicated that the water elevation at the time of the inspection was 0.9' NAVD and salinity readings were 2.5 ppt. As mentioned in previous inspection reports, there was substantial damage to the four (4) timber pile dolphins at the entrance of the barge bay caused by oilfield service barges accessing the barge opening. In most cases, the vertical timber piles were split, the batter piles were off center and the surface of the piles were worn and scarred. Subsequent to the 2010 inspection, the timber cluster pile on the southwest side of the barge bay was completely destroyed and no longer exists. Considering the poor condition of the remaining three (3) timber dolphins, we have included the replacement of all four (4) dolphin structures in the 2010 Maintenance Project. As a preventative measure, we are also recommending that the new timber dolphin structures be relocated slightly outwards towards the bank to allow for additional clearance for barges moving through the barge bay. (Appendix B: Photos No. 13 through 16)

Photo No.13 – view of the rock dike section and bank tie-in on the east side of Structure No.1 looking south.

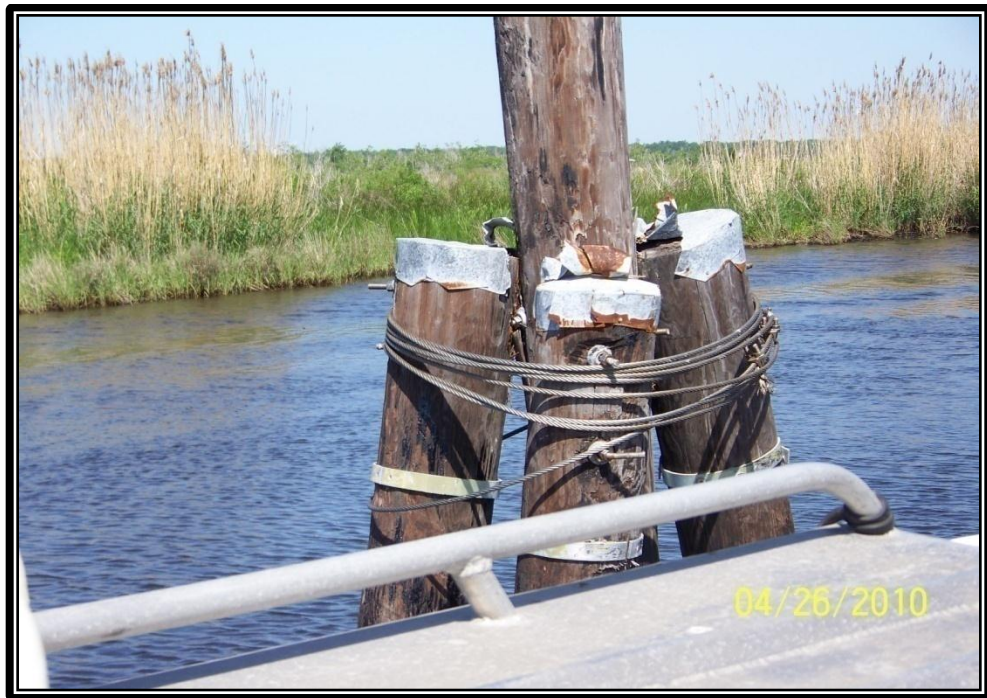
Photo No. 16 – another view of damaged timber dolphin structure at the barge bay entrance of Structure No.1.

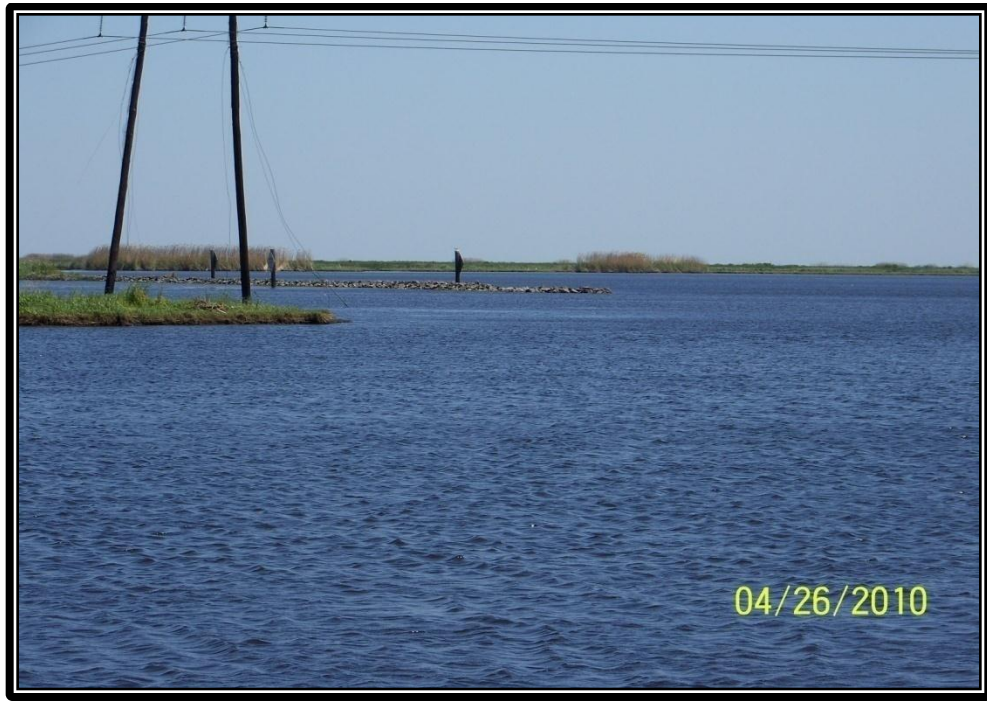
Photo No.17 – view of large open area of eroded marsh between Structures 4 and 4A. The marsh in this area was eroded during Hurricanes Gustave and Ike.

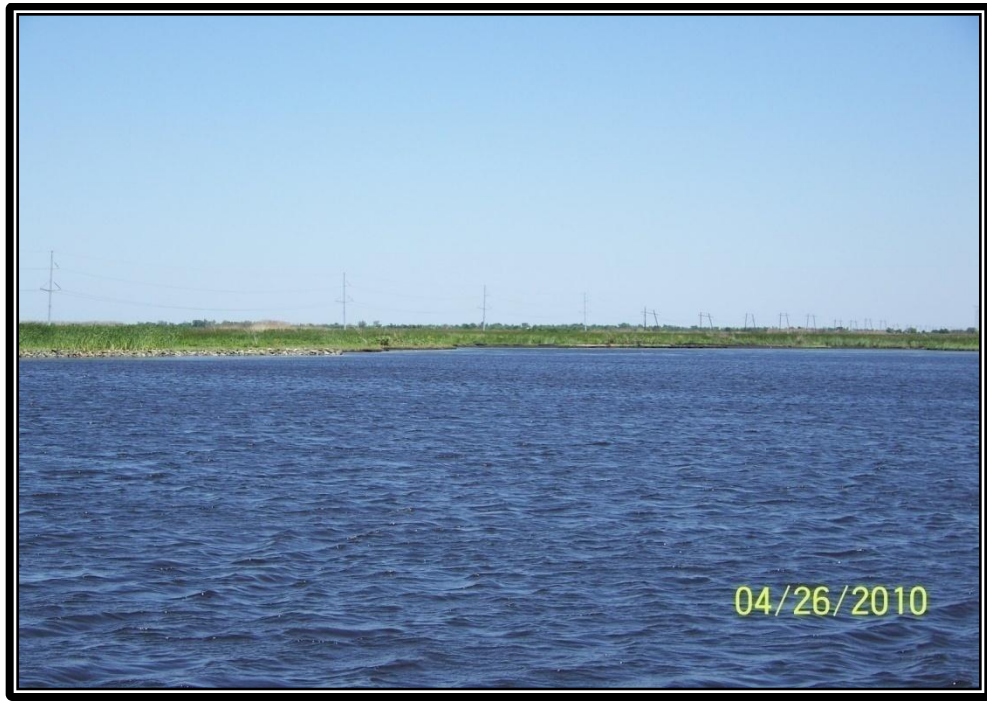
Structures 4A & 4B appeared to be in poor condition with average crest elevations of approximately 1.5' NAVD. As-built data indicates that the original crest elevation of the channel plug was constructed to an elevation of +3.0 NAVD. From visual inspections and survey profile data from 2008, it was estimated that the rock plug has settled between 1.5' and 2.0' across the entire structure.

Photo No.19— view of the north side of the rock plug (Structures 4A & 4B) and the adjacent marsh tie-in.

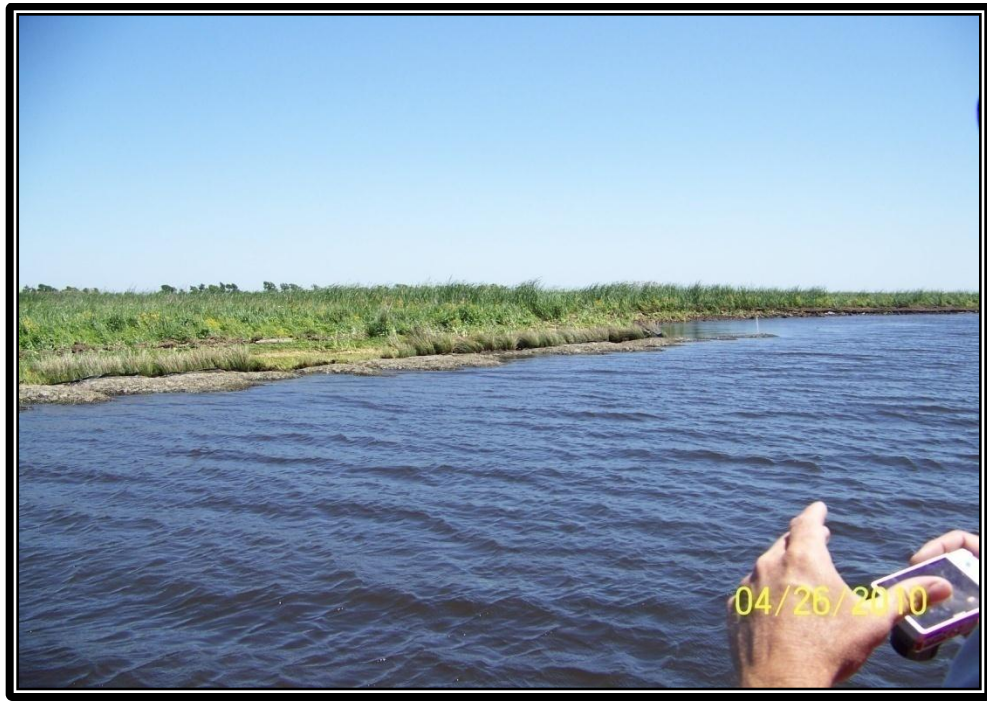
Photo No.21 – view the existing shoreline on the north side of Structures 4A & 4B.

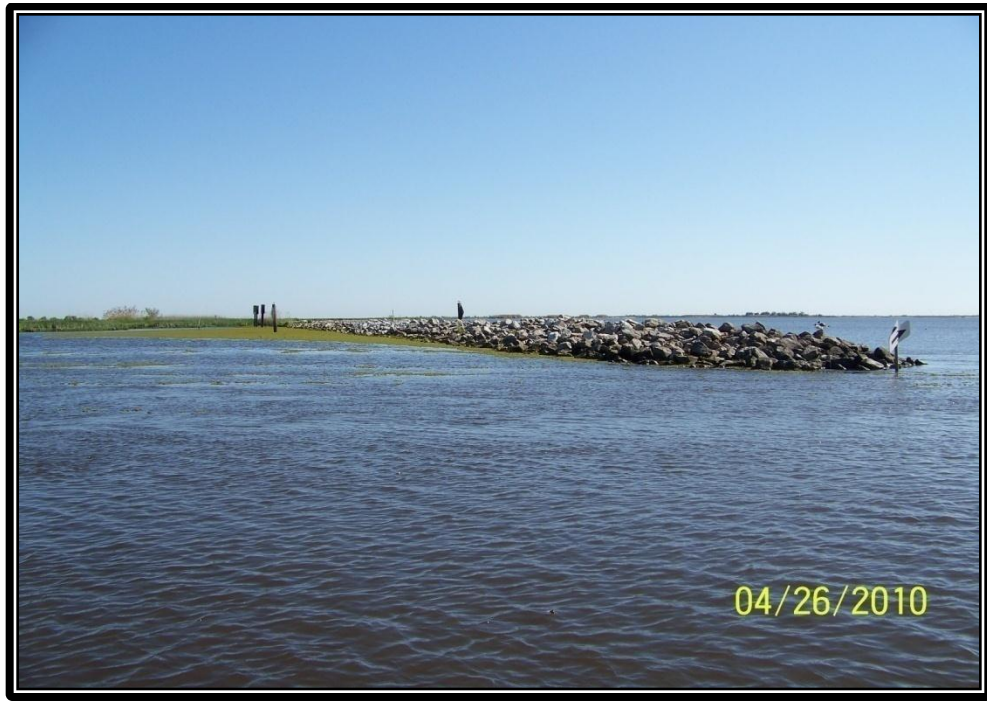
Photo No.23 – view of rock dike section near the barge bay of Structure 14A looking north.

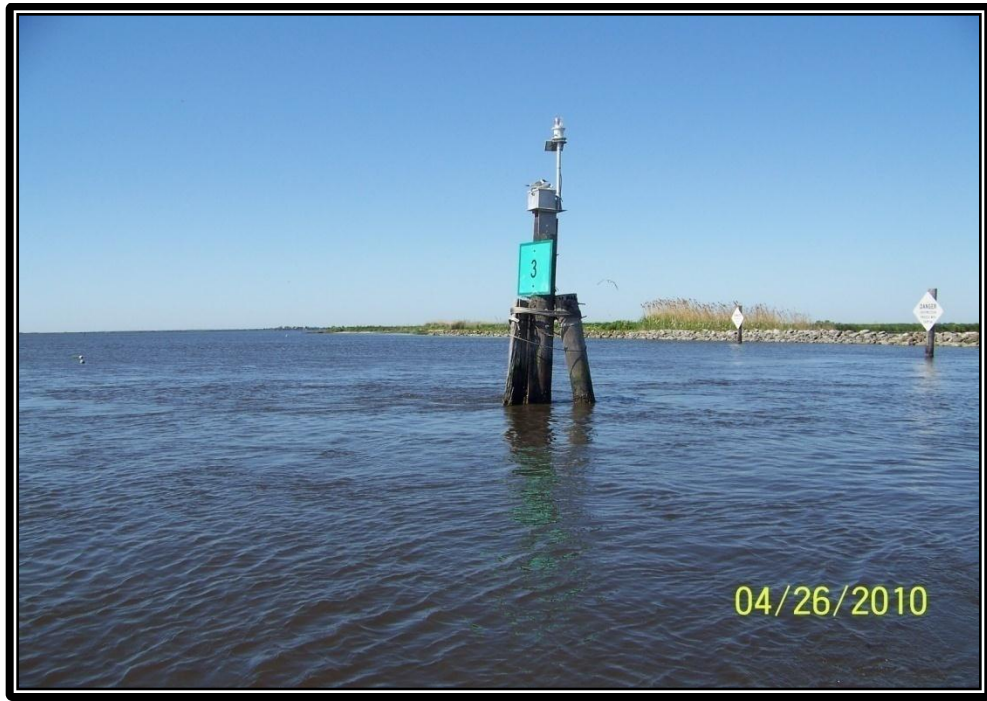
Photo No.25 – view the timber dolphin support and navigational aid on the southeast side of the barge bay at Structure 14A.

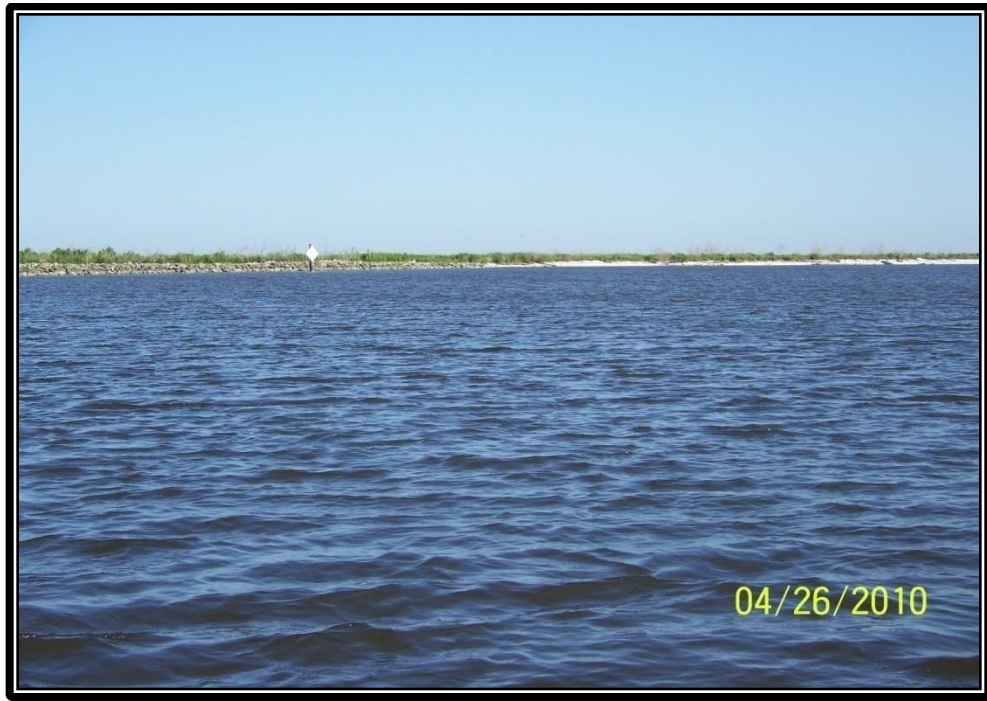
Photo No. 27 – view of rock dike section along the shoreline north of Structure 14A.

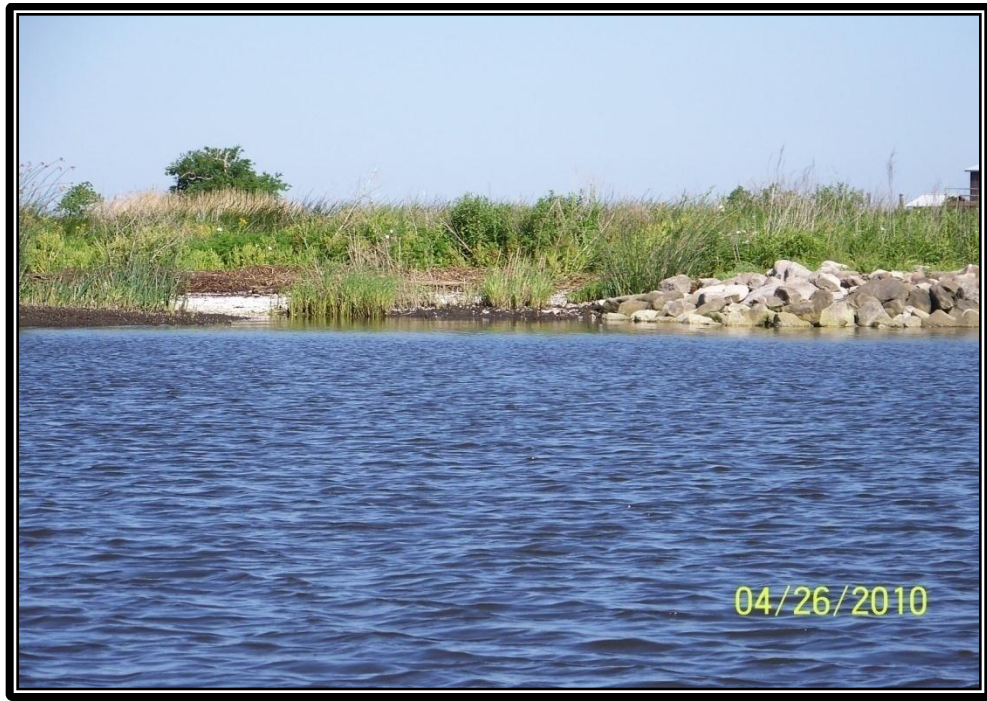
Photo No.29 – view of the rock dike tie-in to the shoreline on the south side of Structure 14A.

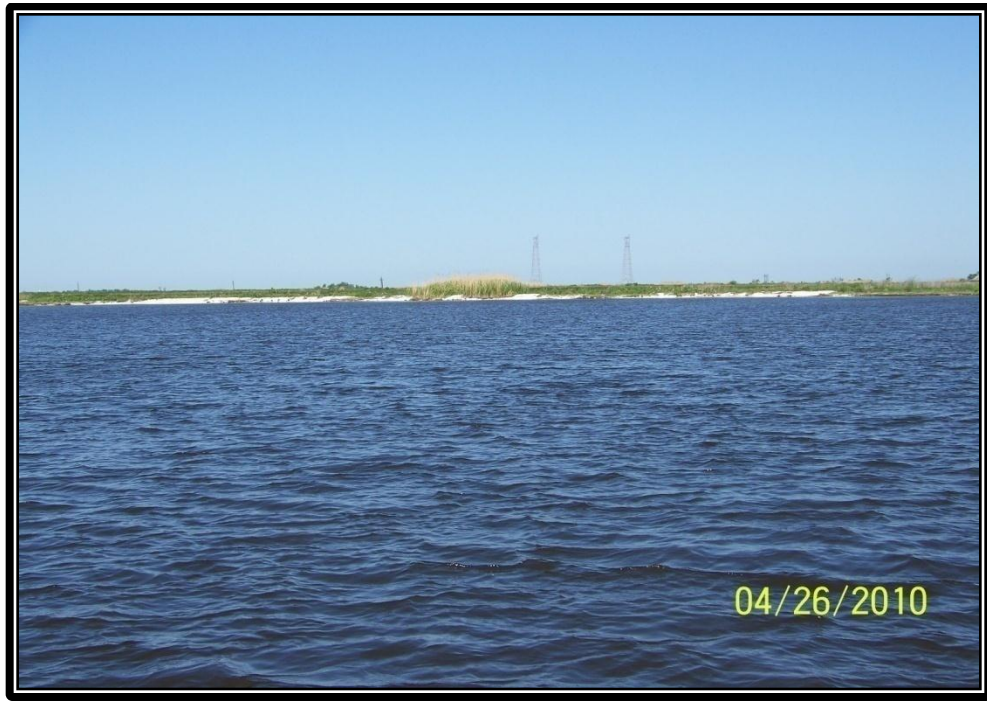
Photo No.31 – view of shell midden along the shoreline of Little Lake south of Structure 14A.

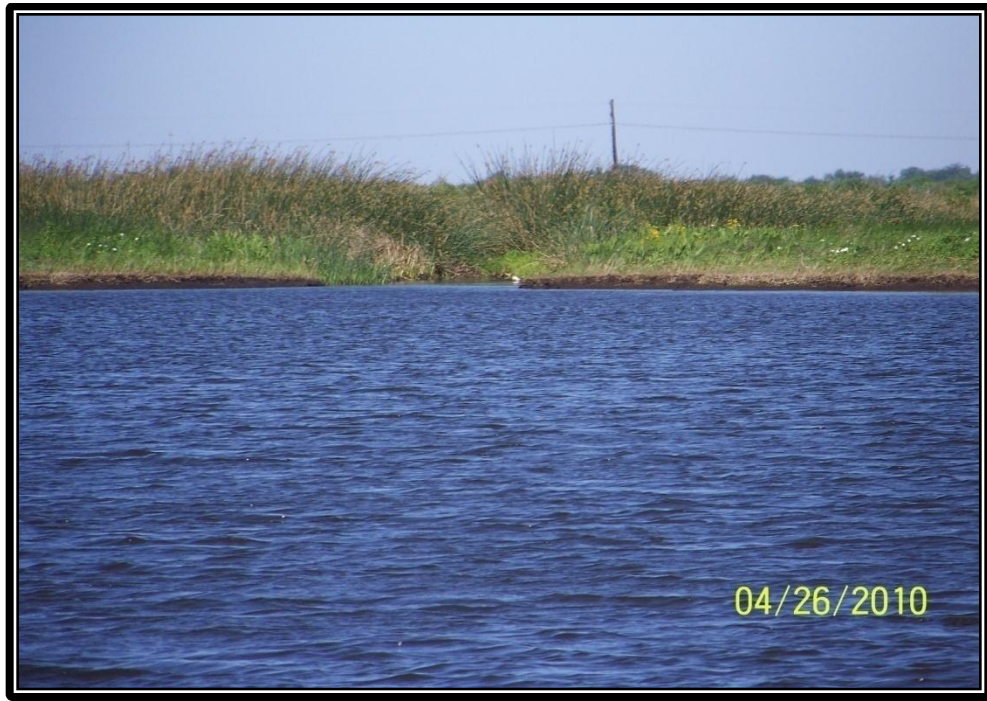
Photo No.33 – view of breach location along the shoreline of Little Lake north of Structure 14A.

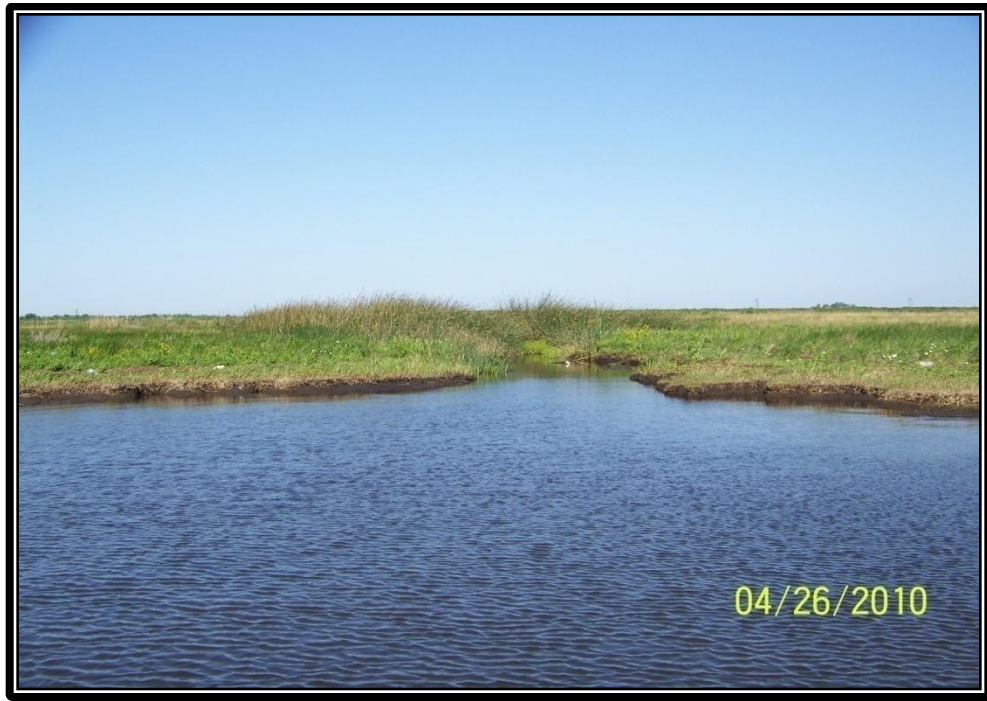
Photo No.35 – view of a second breach in the shoreline of Little Lake south of Structure 14A.

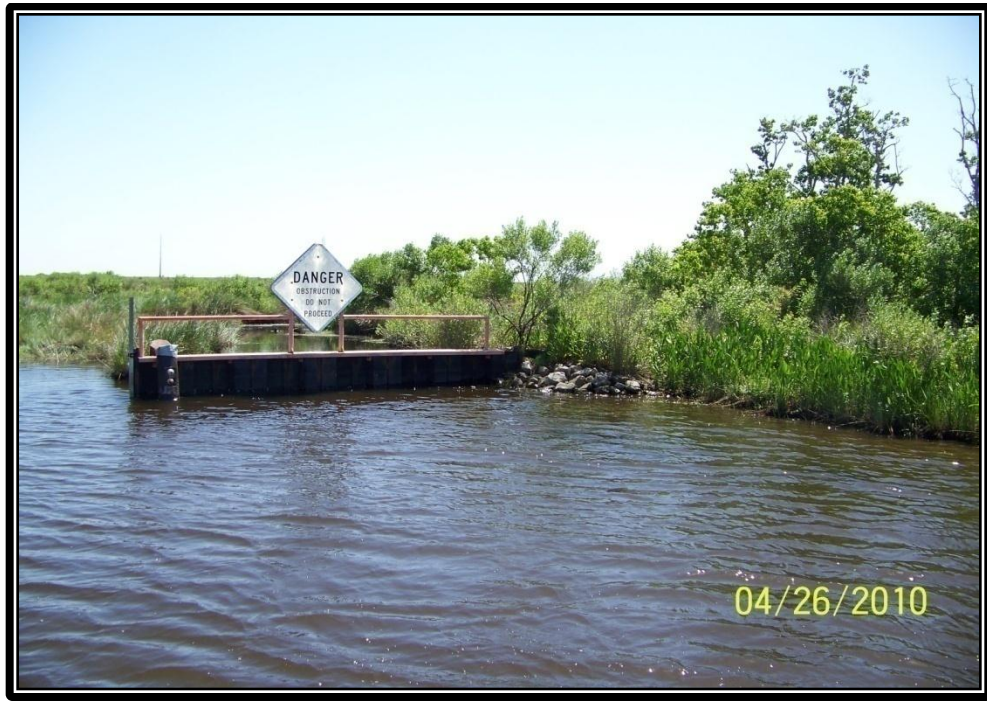
As reported in previous inspections, other than minor corrosion and paint chipping along the channel cap of the bulkhead, handrails and movable boom deck, the structure itself was in good condition. The stop logs, cables, signs, supports and other hardware appear to be operable and in good condition. The conveyance channel from the weir to the interior marsh was open and appeared to be allowing adequate flow through the structure. At this time, we are not recommending any corrective actions to conveyance channel maintenance. (Appendix B: Photos No. 36 through No. 39)

Photo No.37 – view of steel bulkhead and bank tie-in on the south side of Structure No.35.

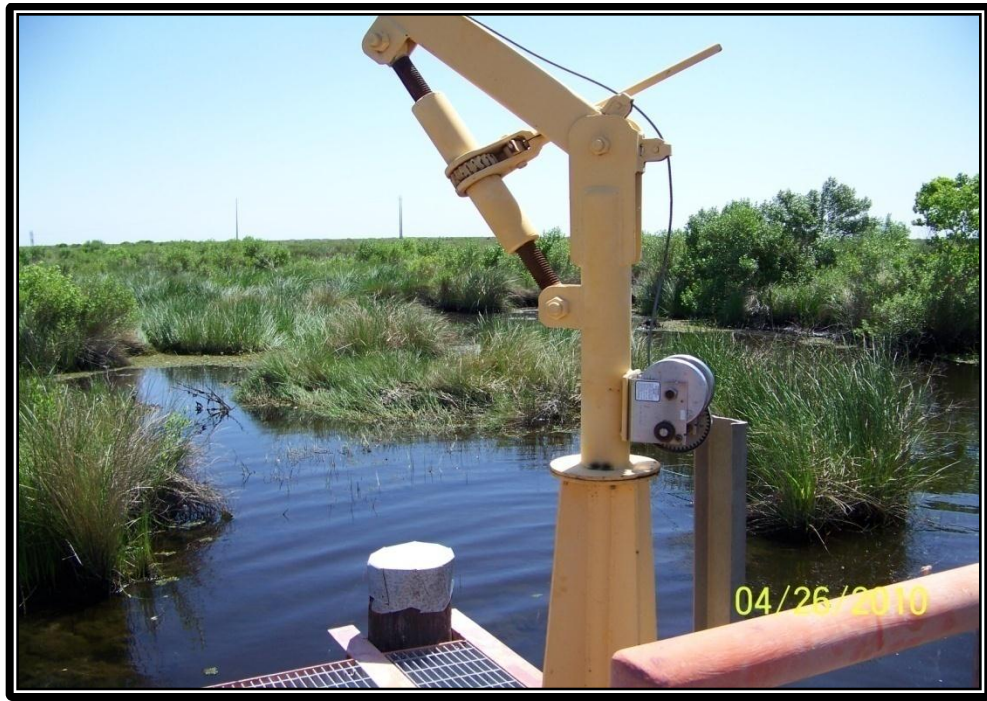
Photo No.39 – view boom structure and interior marsh behind Structure No. 35.

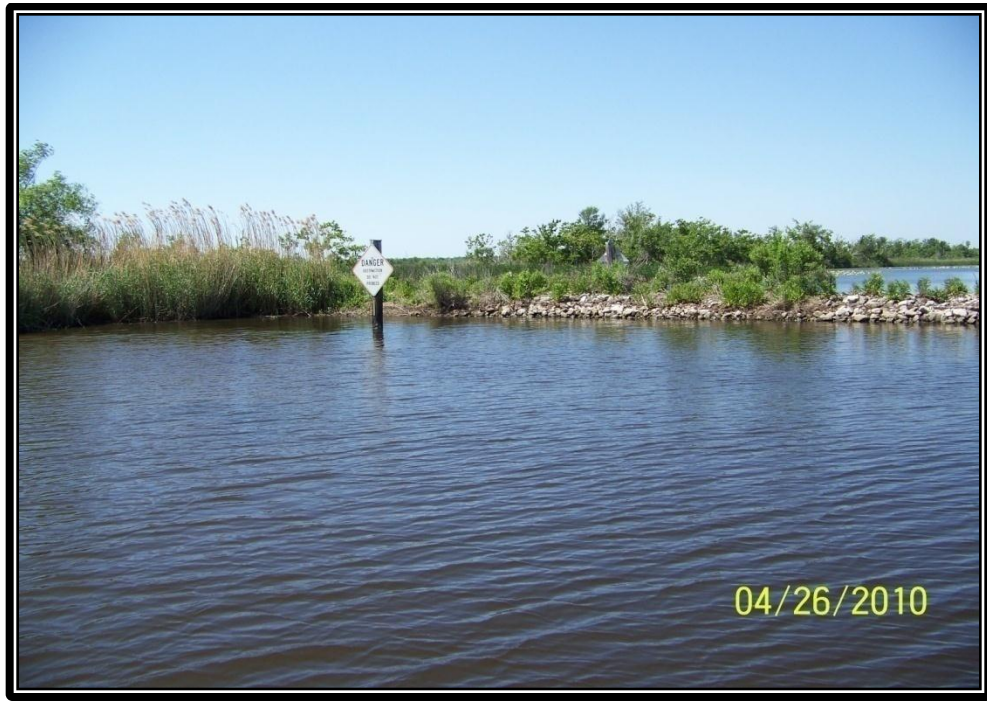
The rock riprap channel plug appeared to be in very good condition with no apparent settlement or erosion around the ends of the structure. The signs and supports were also in good condition. (Appendix B: Photos No.40 and 41)

Photo No.41 – view of rock plug section and bank tie-in on the south side of Structure No.90.

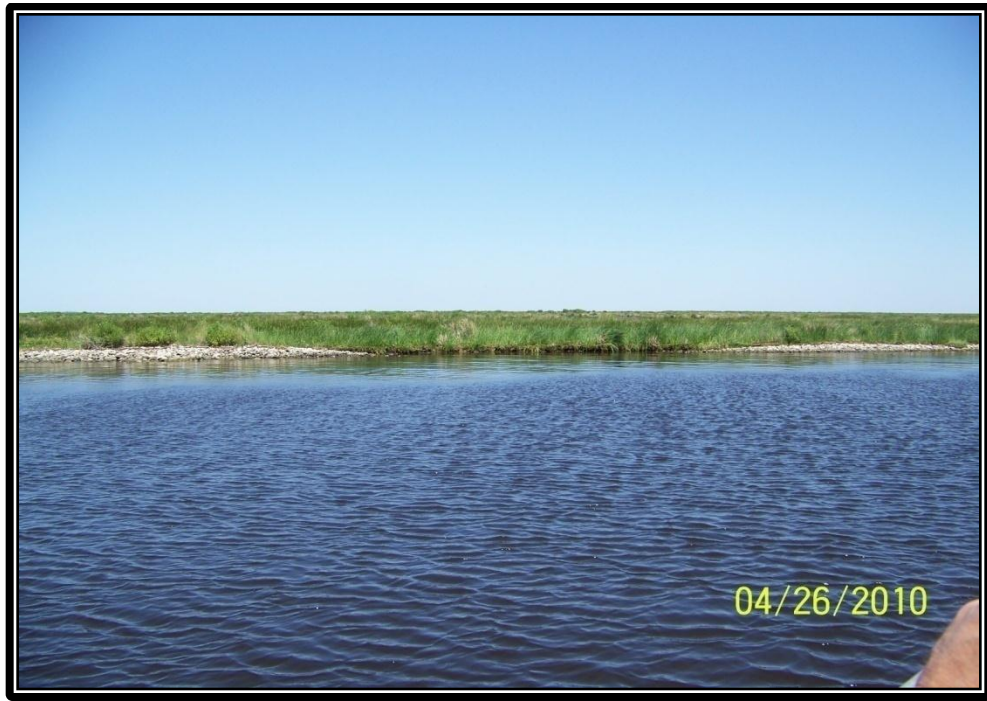
The lake rim structure was constructed between a +2.0' and +3.0' NAVD with six (6) fish dips at various locations along the structure. As indicated on previous inspections and the 2008 survey profiles, the rock dike has displayed minor to moderate settlement along the entire length of the structure. The most notable segments include segments between Stations 7+00 and 13+00, 36+00 and 41+00, and the intersection near the mouth of Breton Canal. During the 2010 field inspections, we observed additional low areas along the north bank of Breton Canal from the mouth of Bay L' Ours proceeding southwest to the first oilfield location canal where Structure 35 is located. Based on the current condition of rock dike, we have included provisions in the 2010 Maintenance Project to recap the entire length of the lake rim to the original design elevation. (Appendix B: Photo No.42 through 52)

Photo No.43 – view of rock shoreline along the north bank of Breton Canal.

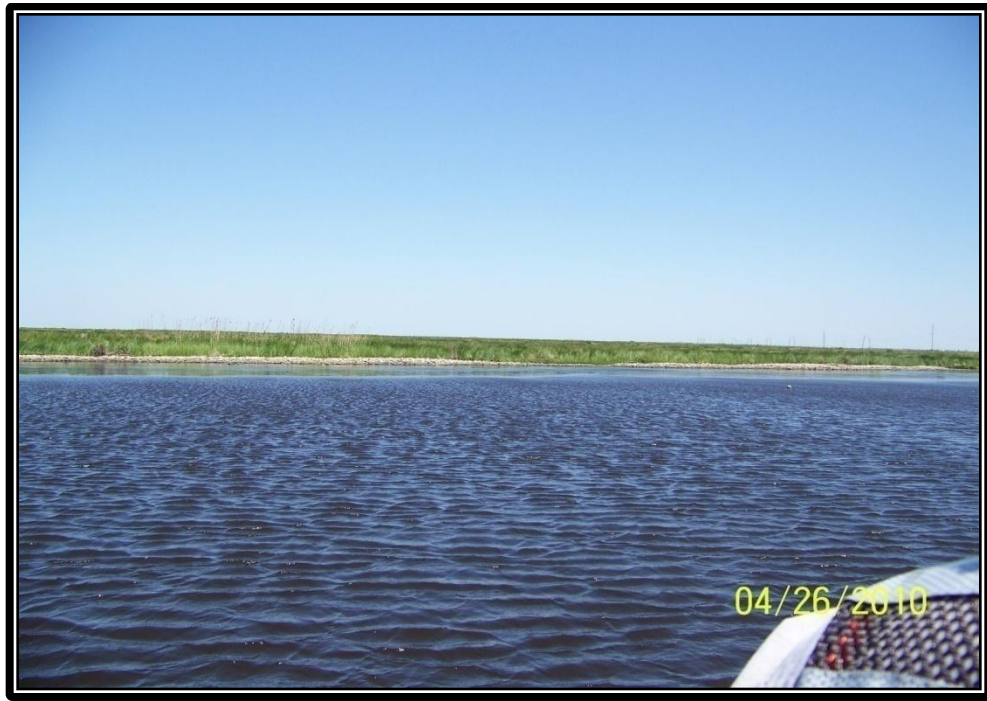
Photo No.45 – view of rock shoreline along the north bank of Breton Canal.
