2010 Operations, Maintenance, and Monitoring Report

GIWW (Gulf Intracoastal Waterway) to Clovelly Hydrologic Restoration (BA-02)

State Project Number BA-02
Priority Project List 1

December 2010
Lafourche Parish

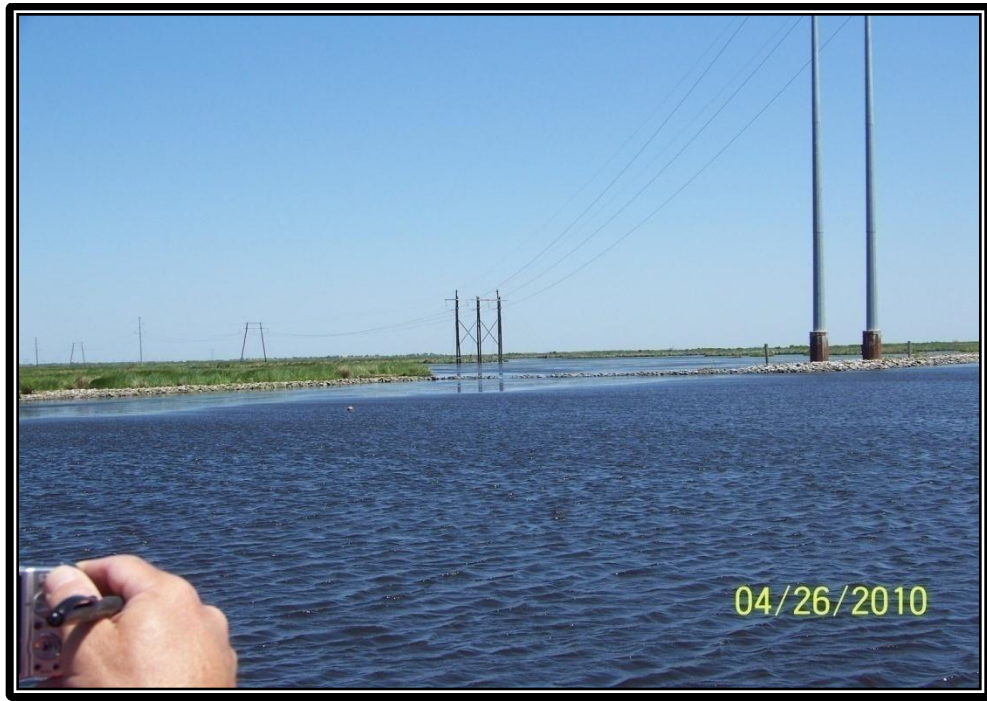
The lake rim structure was constructed between a +2.0' and +3.0' NAVD with six (6) fish dips at various locations along the structure. As indicated on previous inspections and the 2008 survey profiles, the rock dike has displayed minor to moderate settlement along the entire length of the structure. The most notable segments include segments between Stations 7+00 and 13+00, 36+00 and 41+00, and the intersection near the mouth of Breton Canal. During the 2010 field inspections, we observed additional low areas along the north bank of Breton Canal from the mouth of Bay L' Ours proceeding southwest to the first oilfield location canal where Structure 35 is located. Based on the current condition of rock dike, we have included provisions in the 2010 Maintenance Project to recap the entire length of the lake rim to the original design elevation. (Appendix B: Photo No.42 through 52)

Photo No.47 – view of rock shoreline along the north bank of Breton Canal.

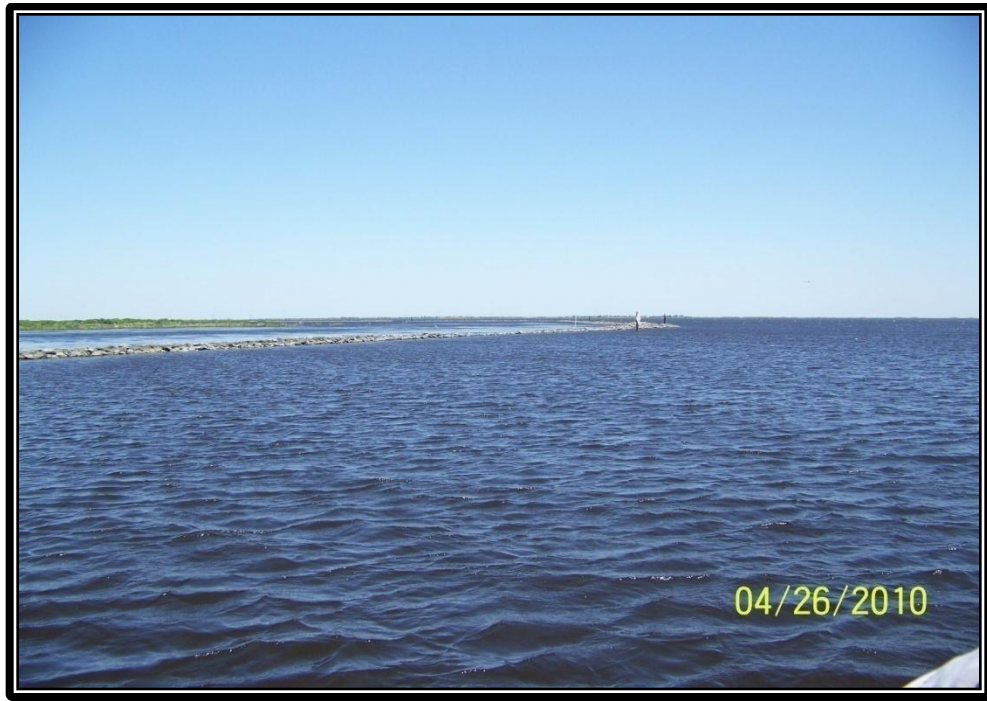
Photo No.49 – view of rock dike along the north bank of Breton Canal looking into Little Lake.

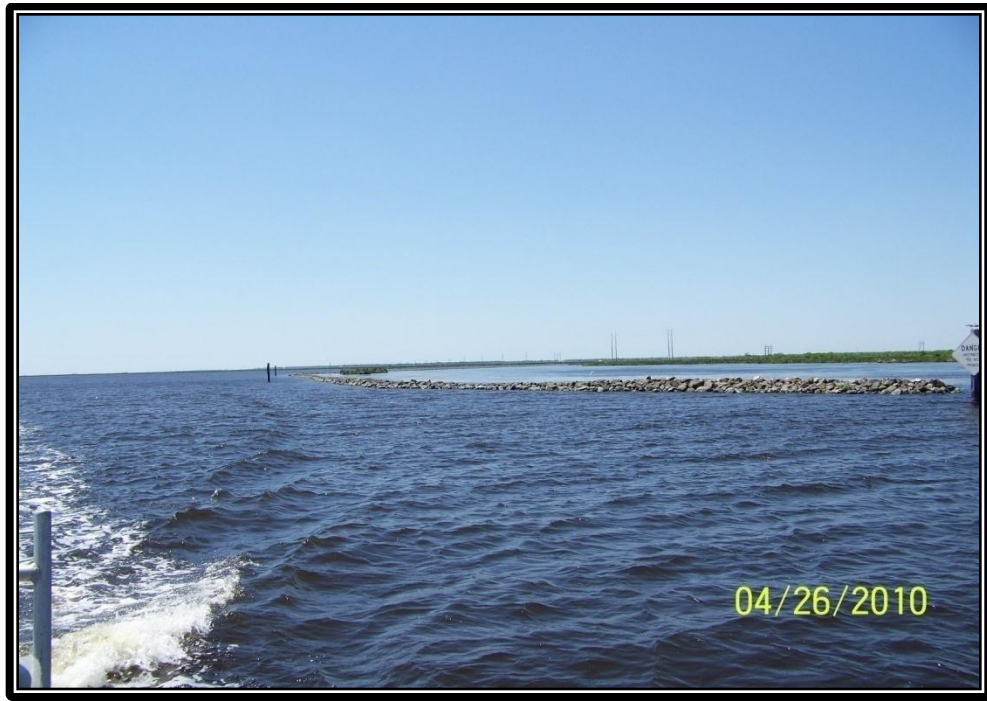
Photo No.51 – view of the rock dike along the lake rim of Little Lake.

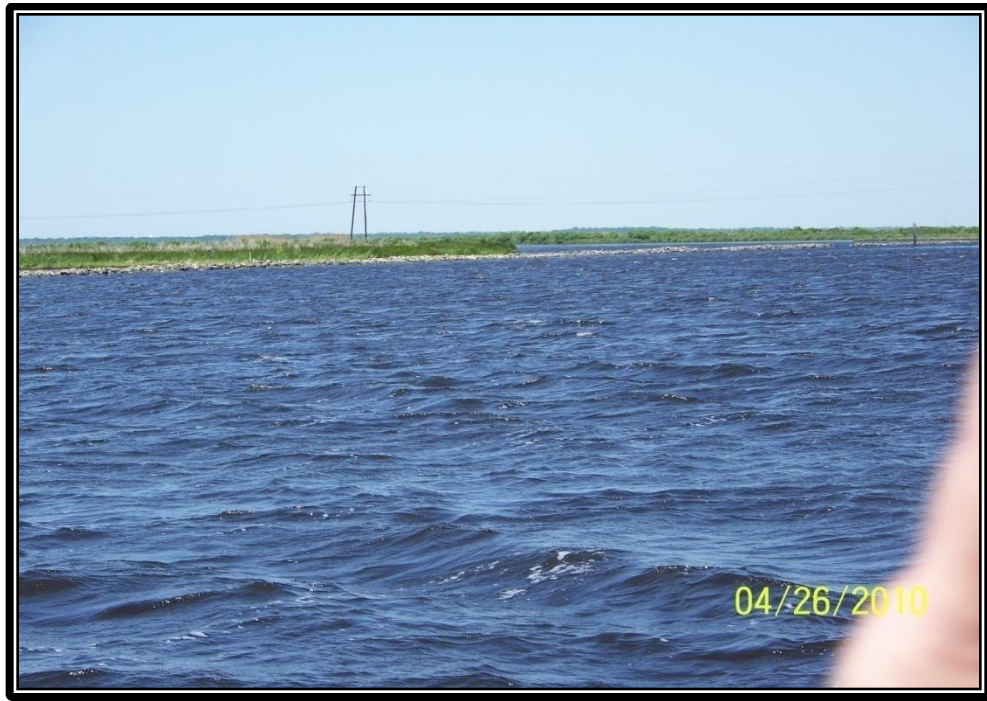
Photo No.53 – view of the rock dike along the lake rim of Little Lake looking west.

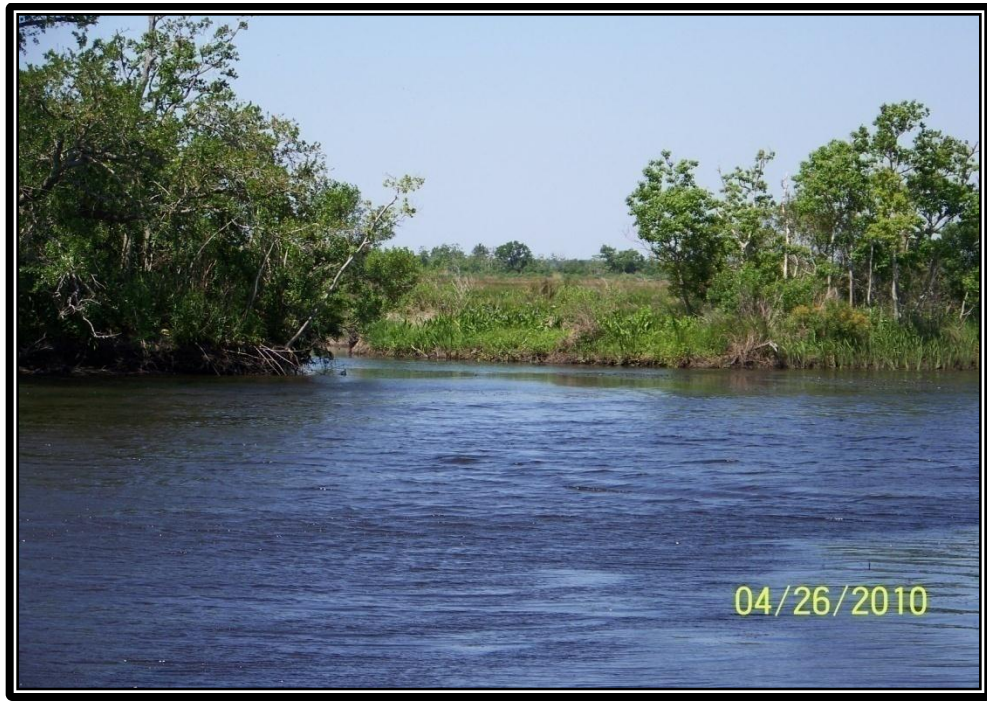
There are five (5) breaches identified for repairs and/or refurbishment to be included in the 2009/2010 Work Plan. Breach 1 is located along the north bank of Breton Canal just southwest of the first location canal from Bay L' Ours and is approximately 20' wide. Breach 2 is located along the northeast bank of the second location canal north of Breton Canal and is approximately 10' wide. Breach 3 is located on the south bank of the same location canal as Breach 2 and is approximately 25' wide. Breach 4 is located on the west bank of a location canal that intersects Superior Canal east of Structure No. 1 and is approximately 30' wide. Another breach, designated as Breach 5, was discovered at the end of a dead end oil field slip south of Breach 4. It is recommended that all five (5) breaches be closed using in situ material from adjacent canals to reconstruct the bank line. (Appendix B, Photos (Photos No.53 through 53).

Photo No.55 – Breach No.2 located along the north bank of the first oilfield location canal along Brenton Canal across from Breach 3.

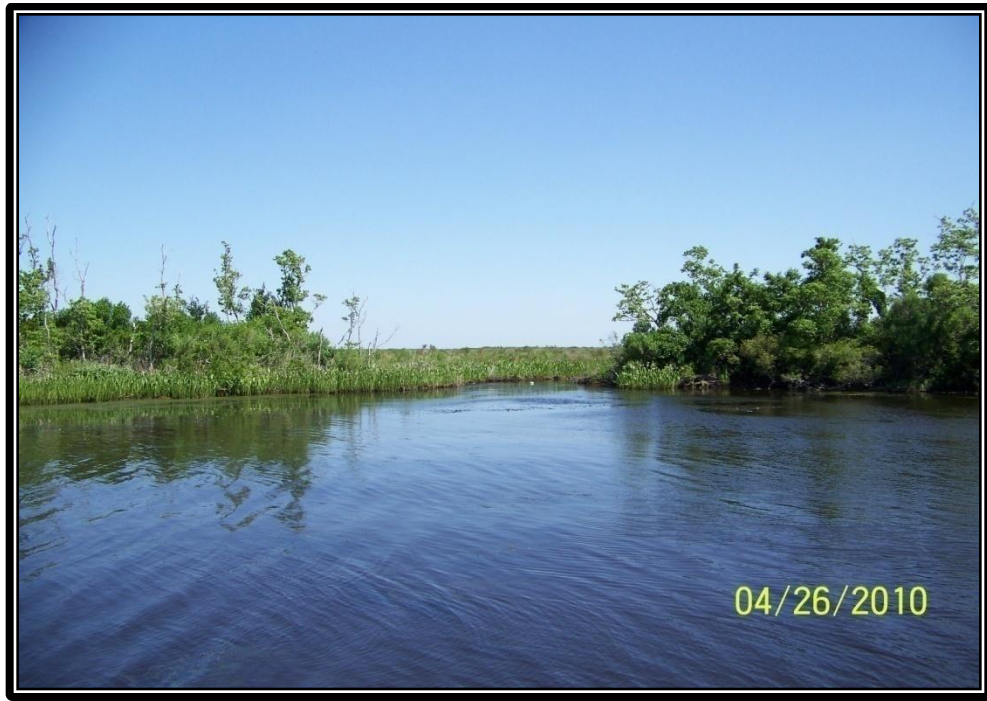
Photo No.57 – Breach No.3 located along the south bank of first oilfield location canal along Breton Canal.

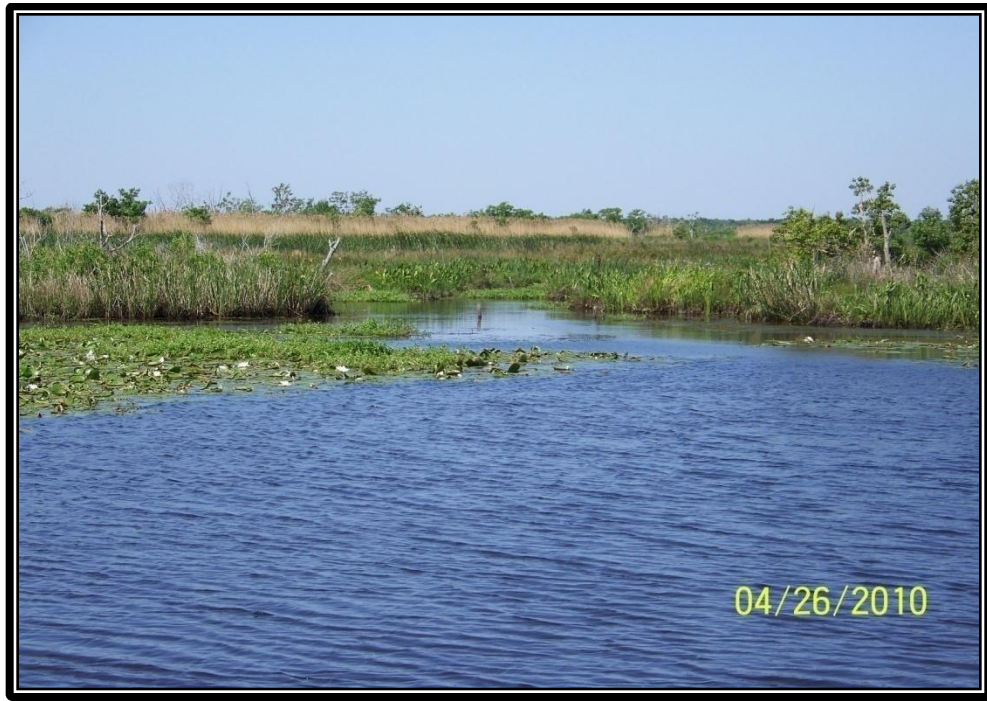
Photo No.59– Breach No. 6 located at the end of an existing pipeline slip just southwest of Breach 4.
