**State of Louisiana  
Coastal Protection and Restoration  
Authority**

**2011 Operations, Maintenance,  
and Monitoring Report**

**Caernarvon Diversion Outfall  
Management (BS-03a)**

State Project Number BS-03a  
Priority Project List 2

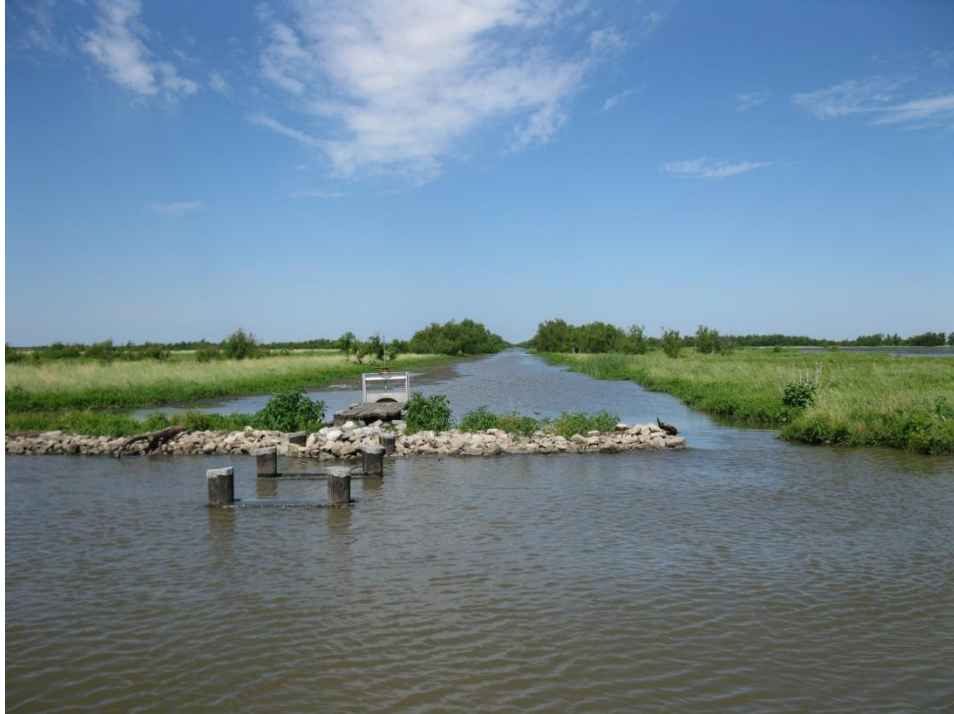
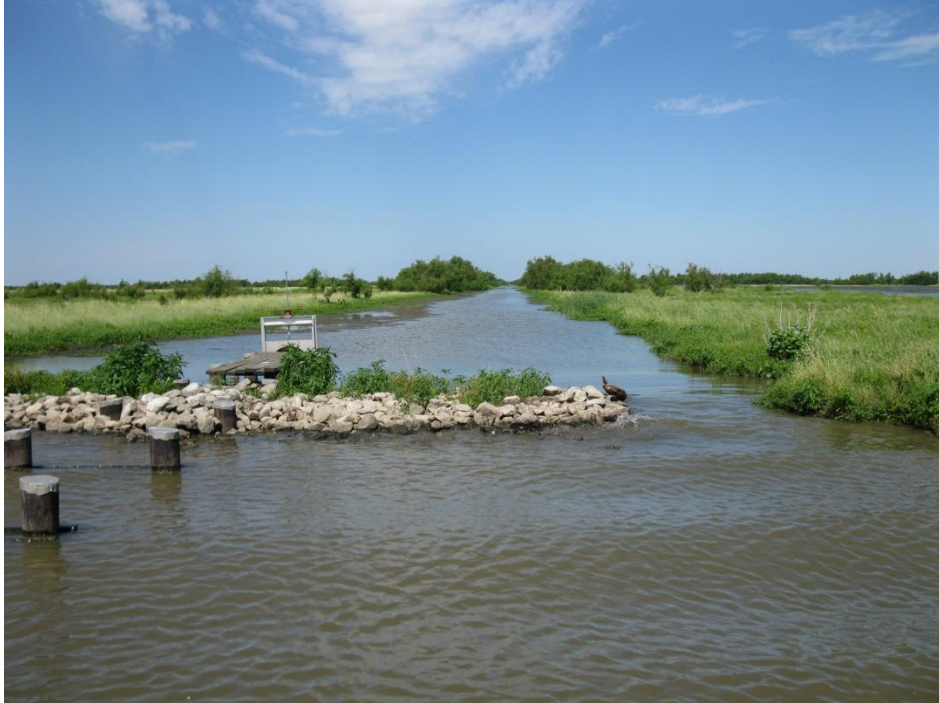
**Photo No. 7, Site 50**

movement was noticed through the structure to the interior marsh. The timber walkway remains bowed. The next maintenance contract for the Caernarvon Outfall will include a work item for repair of this breach. (Photos 7 & 8)

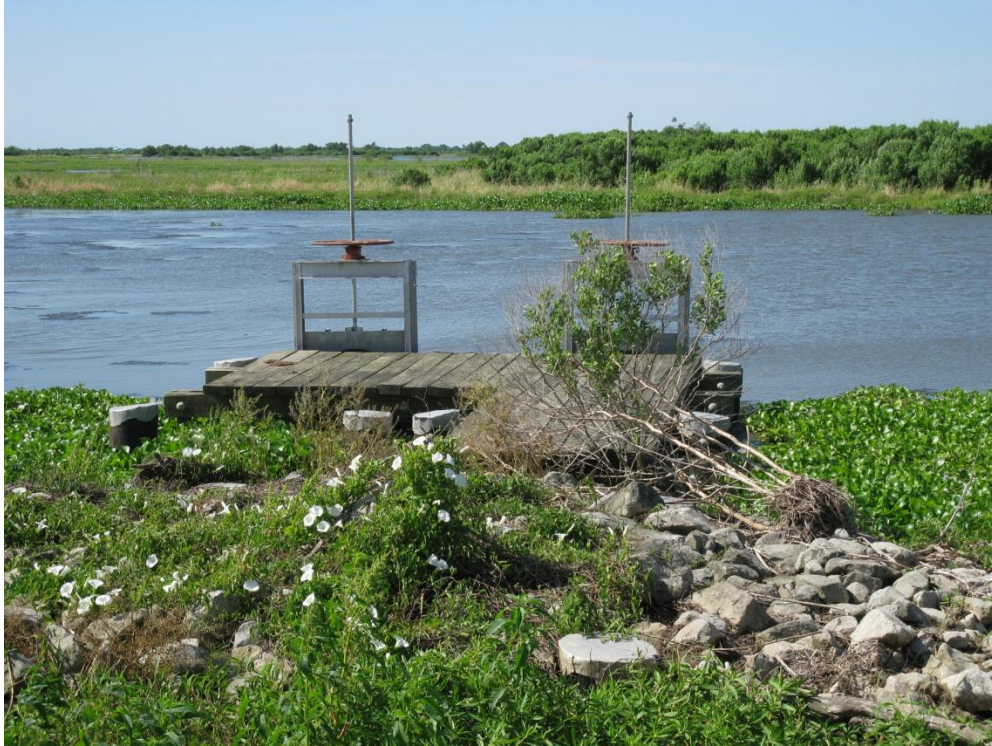
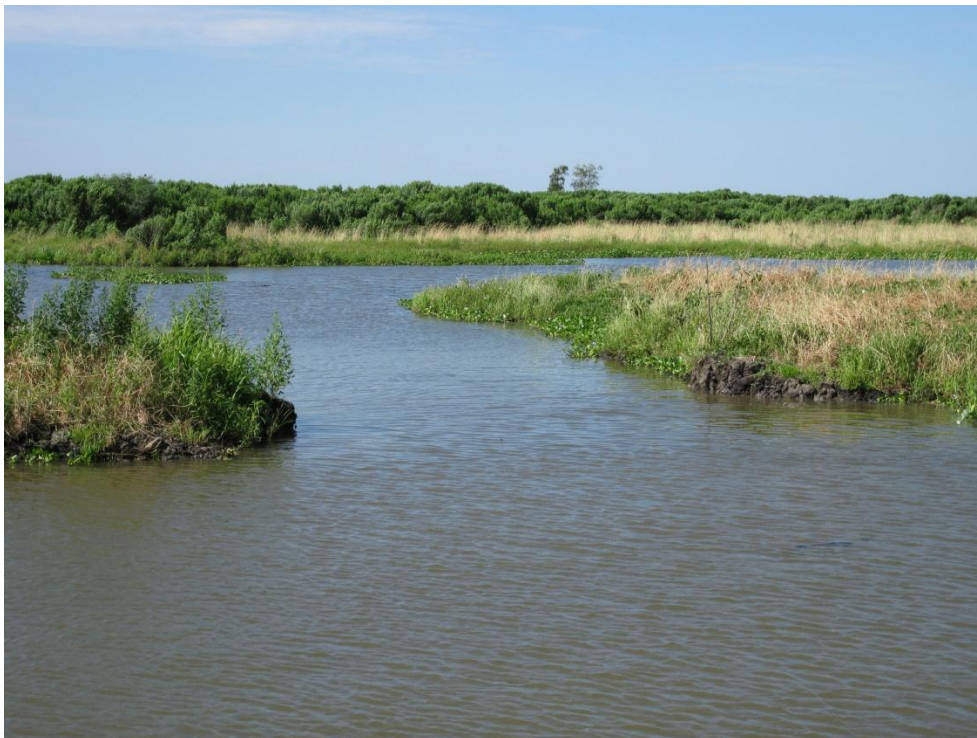
**Photo No. 9, Site 52**

- G. Site/Structure #51** – This plug is heavily vegetated. Maintenance is not required for this structure.
- H. Site/Structure #52** – The two combination gates were in the up/open position. The combination gates will be closed to allow the flap gates to function as designed. A 10-15 foot wide breach was plugged in June 2011 by the Delacroix Canal dredging contractor. The photo in the appendix shows the breach prior to the repair. (Photos 9 & 10)

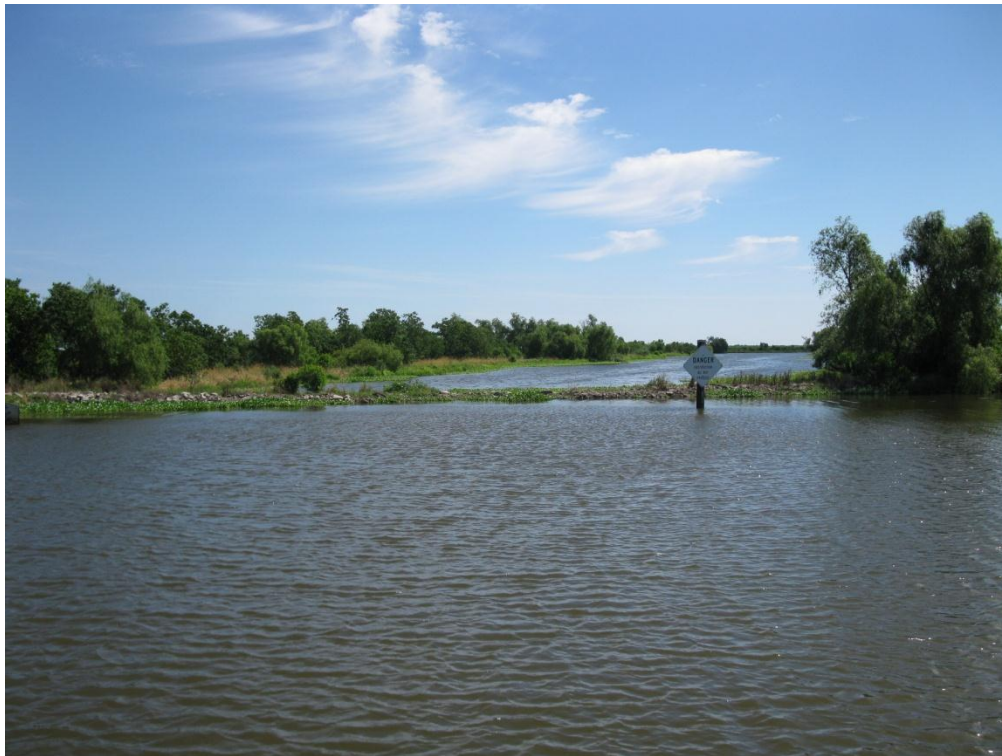
**Photo No. 12, Site 56**

- J. Site/ Structure #56** – No additional subsidence was noted in this rock structure since the last inspection. Small amounts of vegetation remain on the entire rock closure. Soon after construction, the middle section of the plug subsided approximately 0.5 feet more than the sides. The warning signs that were damaged during the storm were previously reset; however, one of the signs is leaning and partially submerged (Photo 12).
