2010 Operations, Maintenance, and Monitoring Plan

Highway 384 Hydrologic Restoration (CS-21)

State Project Number CS-21
Priority Project List 2

December 2011
Cameron Parish

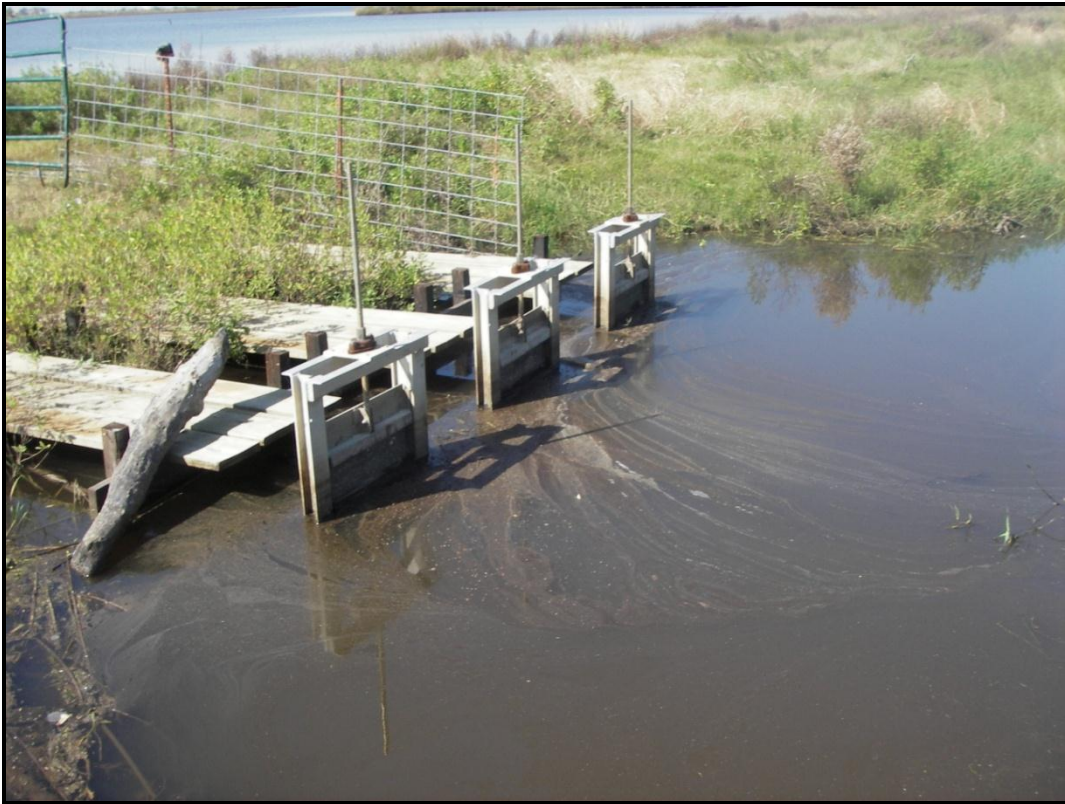
The structure is in good condition. Water level on the outside was elevation +1.65 NAVD88 and the level inside could not be determined because the staff gage was not readable. The inside staff gage will need to be replaced. Rock placed on the bank during the maintenance event of June 2002 is stable and in no need of repair. Two of the outlet flapgates were locked open with small nails. The operations contractor was contacted to unlock the flaps. The hyacinth fence is in good condition; however there is trash accumulating on the outside of the fence which needs to be removed. (Photos: Appendix A, Photos 1-3). The road/levee leading up to the structure is in good condition since it was repaired in June 2006. The recently installed Portable Multi-Parameter Water Quality Troll 9500 – 29r operation sonde was not functioning and the operations contractor was also contacted to trouble shoot the problem. The solar panel should be cleaned and bird excluder devices installed.

Photo No. 1, Structure No.1, inlet side.

Install bird excluder device on the solar panel and replace the staff gage at Structure No. 1. Replace the metal pile cap covers and install bird excluder device on the solar panel at Structure No. 12. Replace inside and outside staff gauges at Structure No. 8.

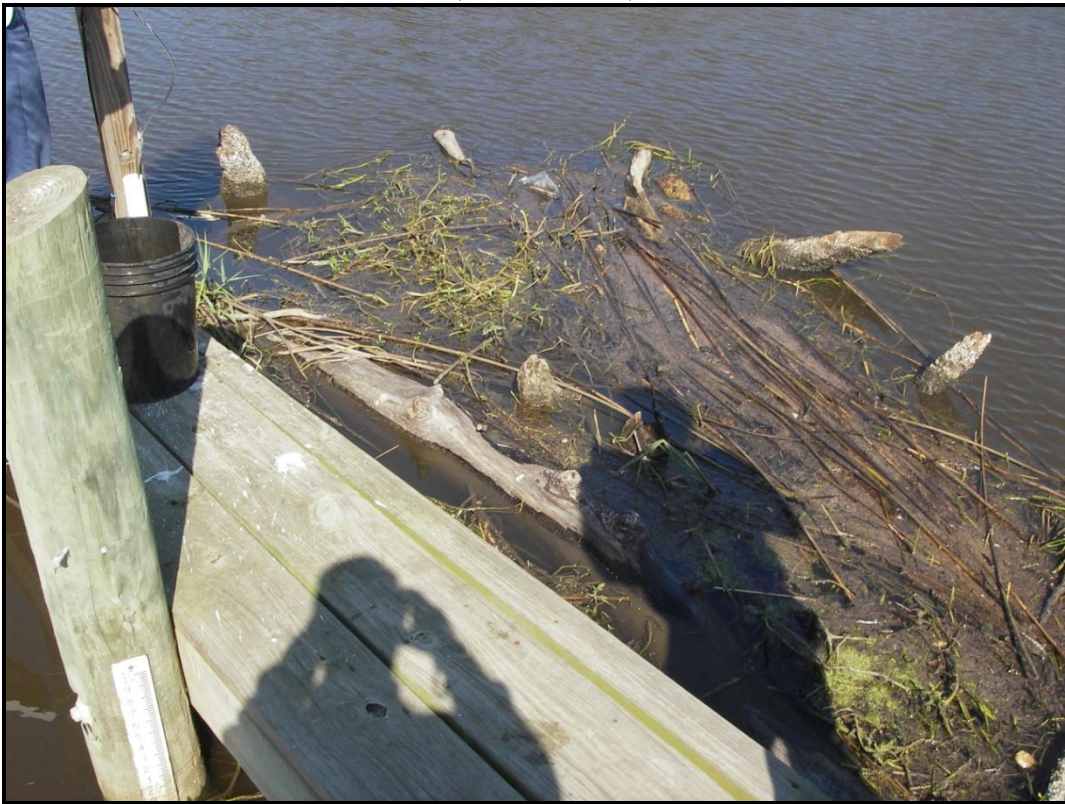
Photo No. 2, Structure No.1, trash along fence.

- Structure No. 1 – install bird excluder device on solar panel, replace staff gage, and remove trash from outside of the hyacinth fence.
- Structure No. 12 – replace metal pile cap covers, install bird excluder device on solar panel.
- Structure No. 8 (Rock Plug) – install staff gauges both lake and marsh sides.

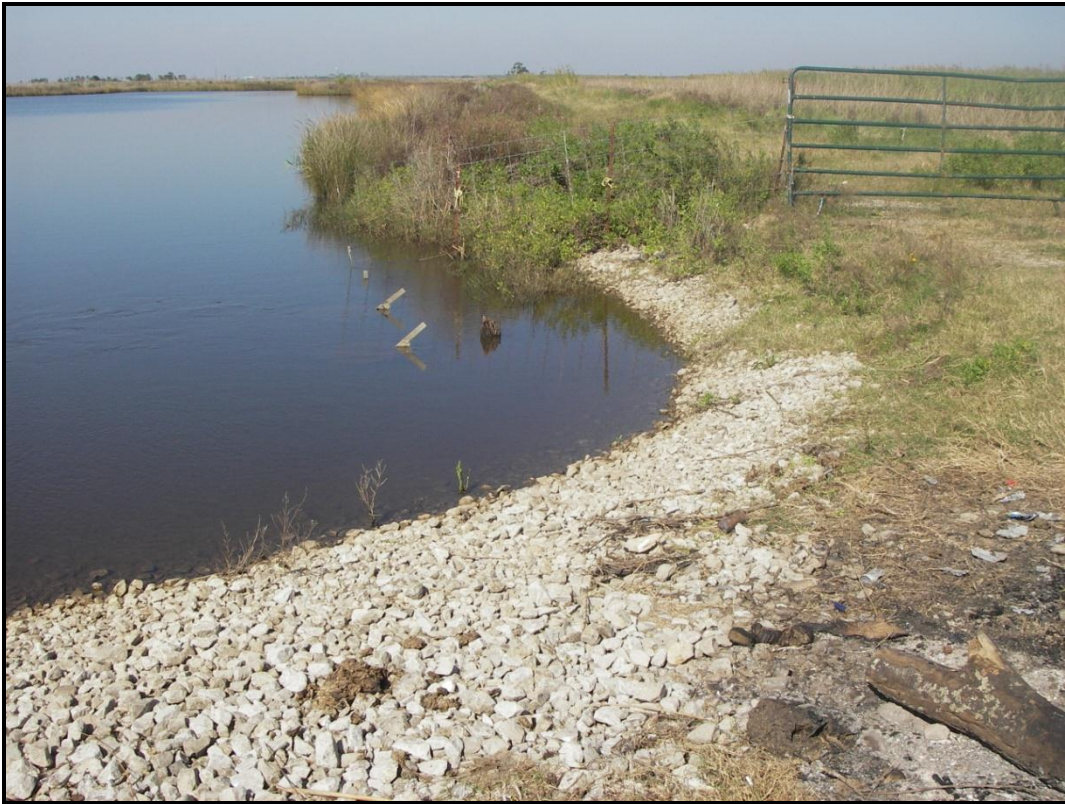
Photo No.3, Structure No.1, outlet side.

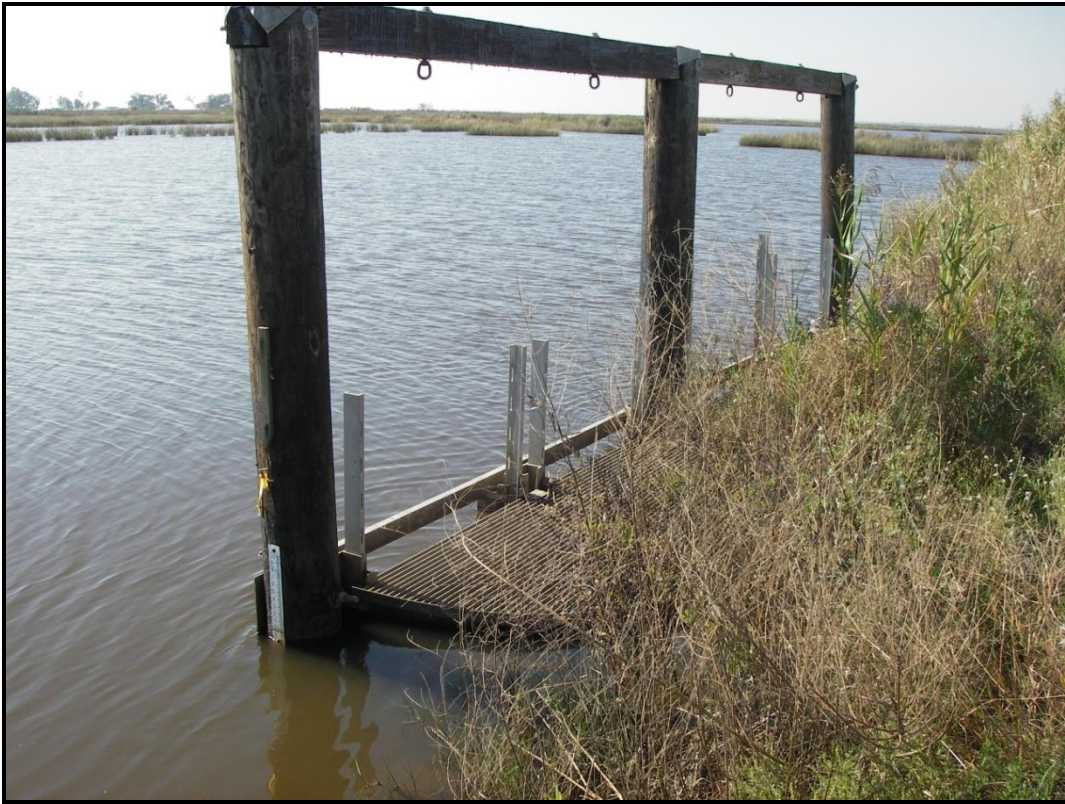
The structure is in good shape and the inlet and outlet sides appear undamaged. Water level on the outside was elevation +1.8 NAVD88 and the level inside was +1.6 NAVD88. Pile caps on the outlet side and the padlocks on the stop log locking devices have rusted and will eventually need to be replaced. Rock that was placed during the maintenance of Nov. 2000 is stable. The road/levee leading up to the structure is in good condition since it was repaired in June 2006. (Photos: Appendix A, Photos 4-5).

Photo No. 4, Structure No. 12, inlet side.

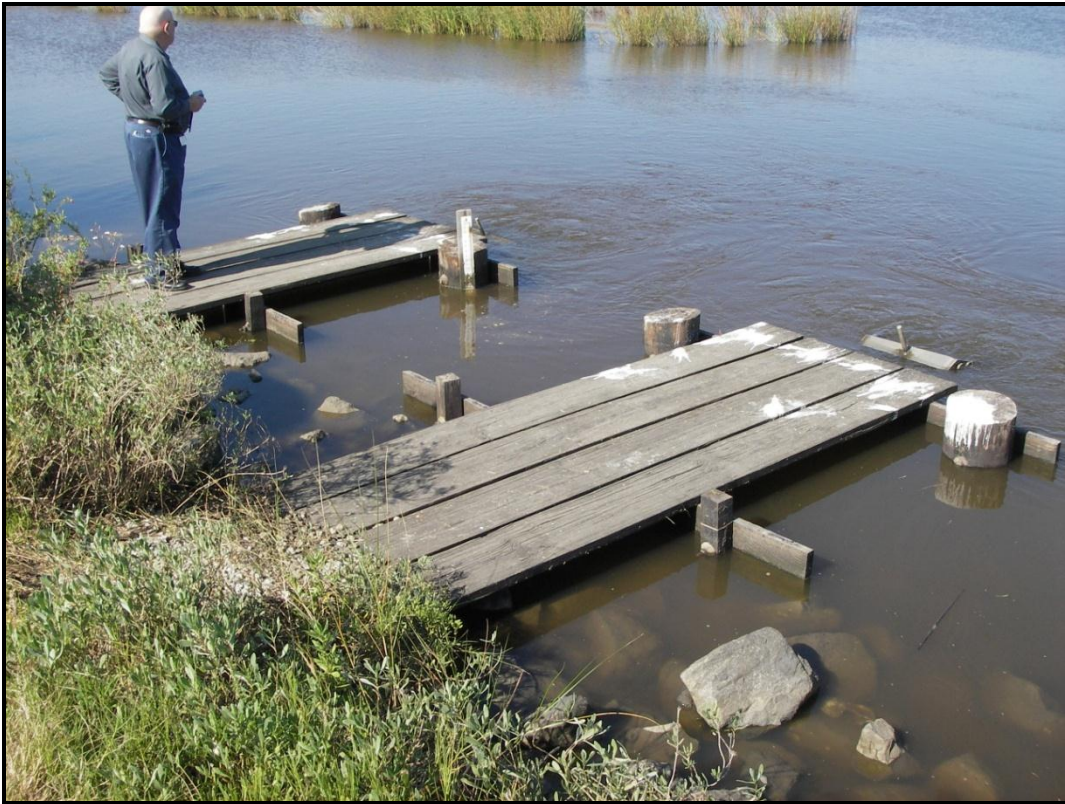
Photo No. 5, Structure No. 12, outlet side.

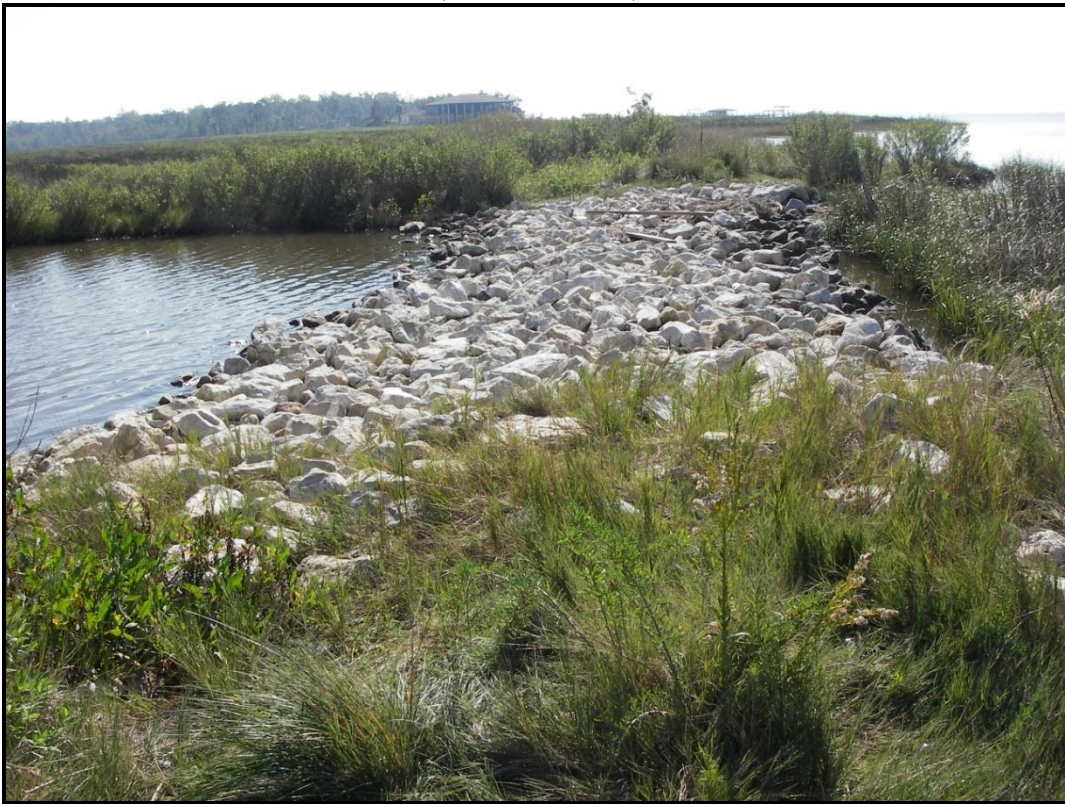
The rock plug is in good condition. Water levels could not be determined because the outside staff gage is missing and the inside staff gage was leaning and not readable. Both staff gages will need to be replaced. The earthen levee that was built as part of the May 2002 maintenance is in excellent condition and vegetation exists beyond the channel limits. Maintenance work completed in May 2005 to repair the plug from vandalism held up well under the high storm surge waters. The lakeside of the rock plug has accretion building and also has vegetation growing towards the lakeside. (Photos: Appendix A, Photo 6).

Photo No. 6, Structure No. 8, rock plug showing accretion occurring on lake side.
