2011 Operations, Maintenance, and Monitoring Report

Brady Canal Hydrologic Restoration (TE-28)

State Project Number TE-28
Priority Project List 3

December 2011
Terrebonne Parish

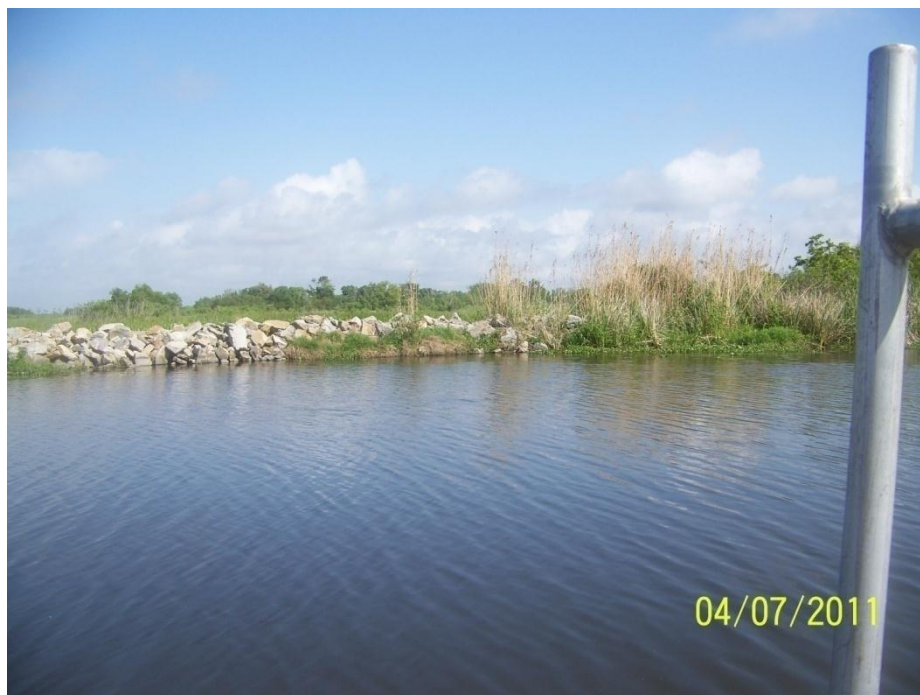
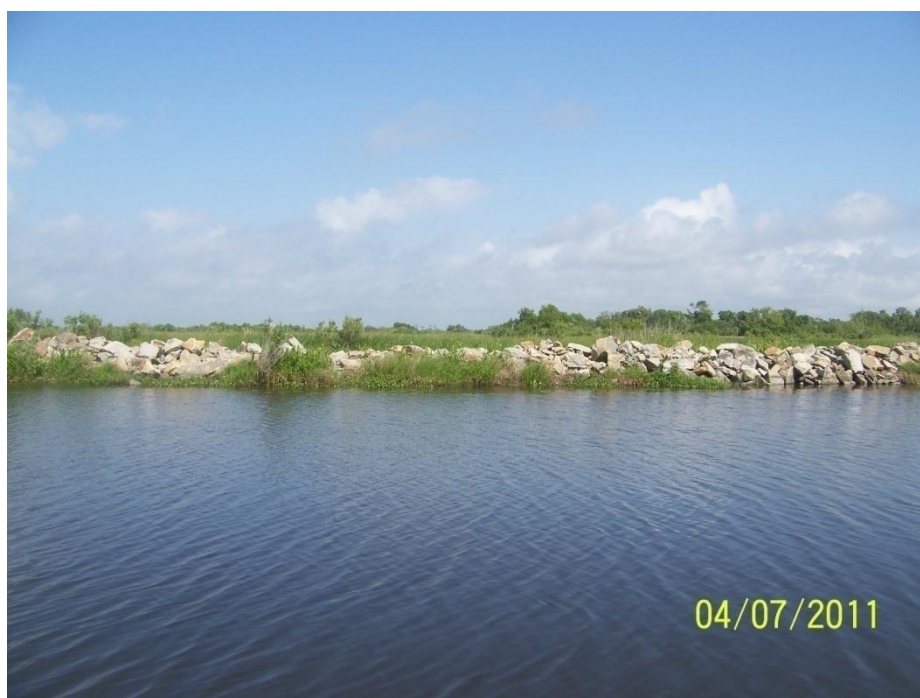
The rock armored repair located along the oil field access canal connecting to Superior canal is in good overall condition. There is no observed settlement along the length of the embankment and no erosion or washouts around the embankment tie-ins. There are no recommendations for corrective action at this time, but will continue to be monitored on future inspections (see Appendix A, Photos 1-2).

Photo 1: Armored breach repair located in oil field access off Superior Canal, looking northeast

Photo 2: Armored breach repair located in oil field access off Superior Canal, looking northeast

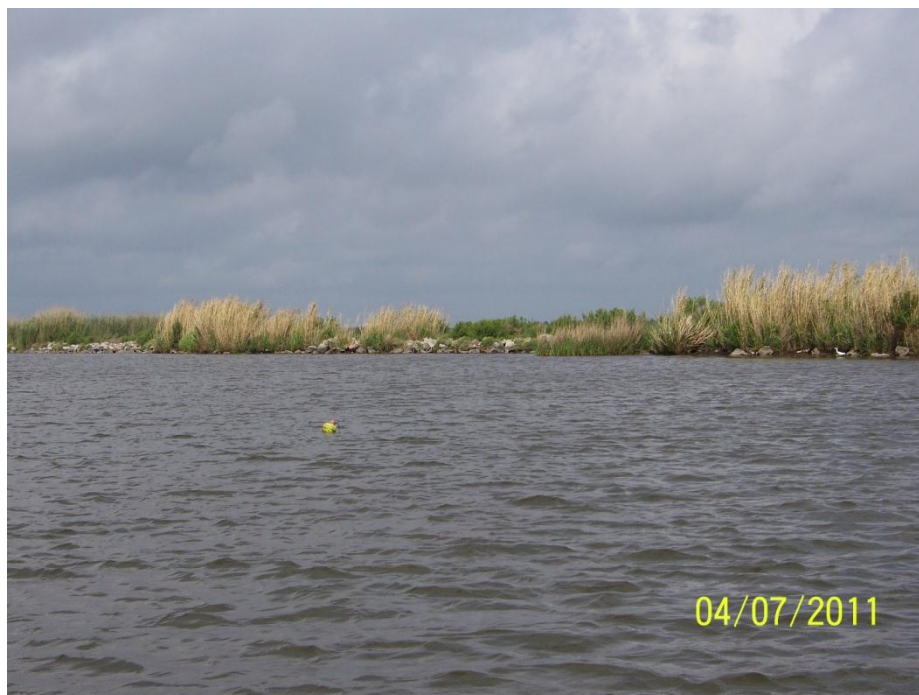
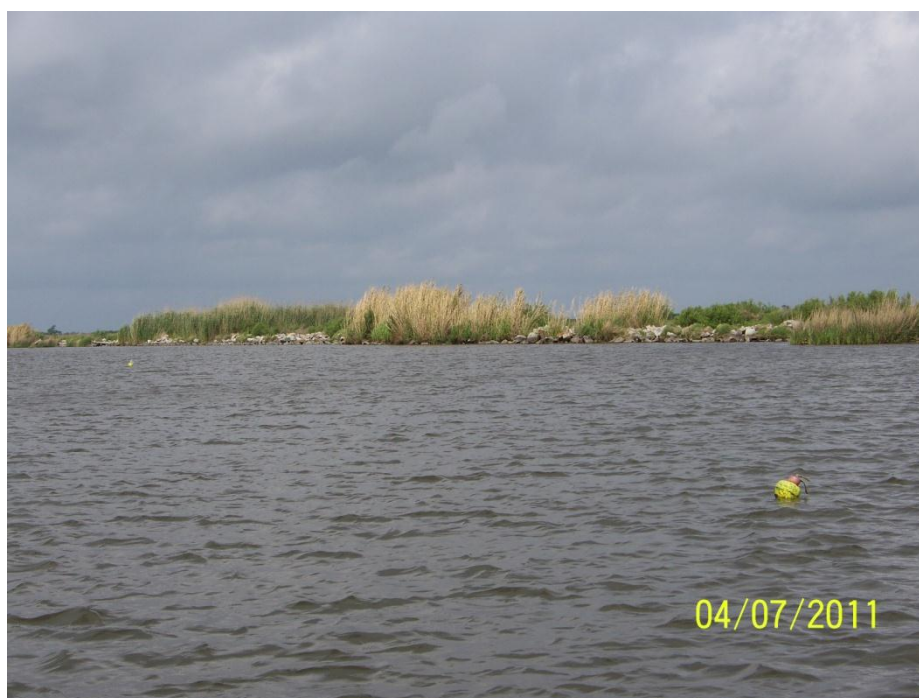
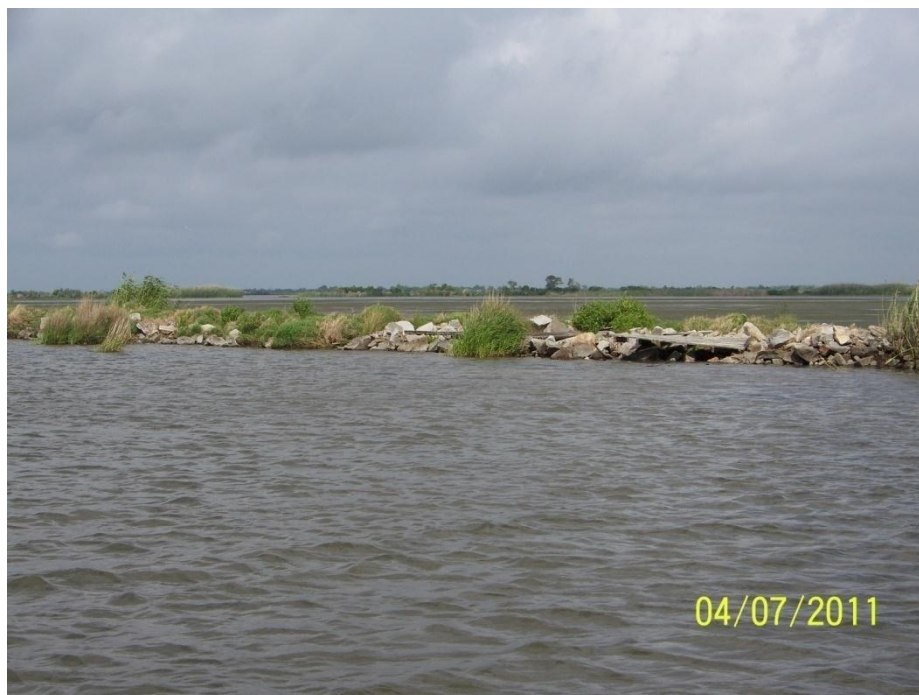
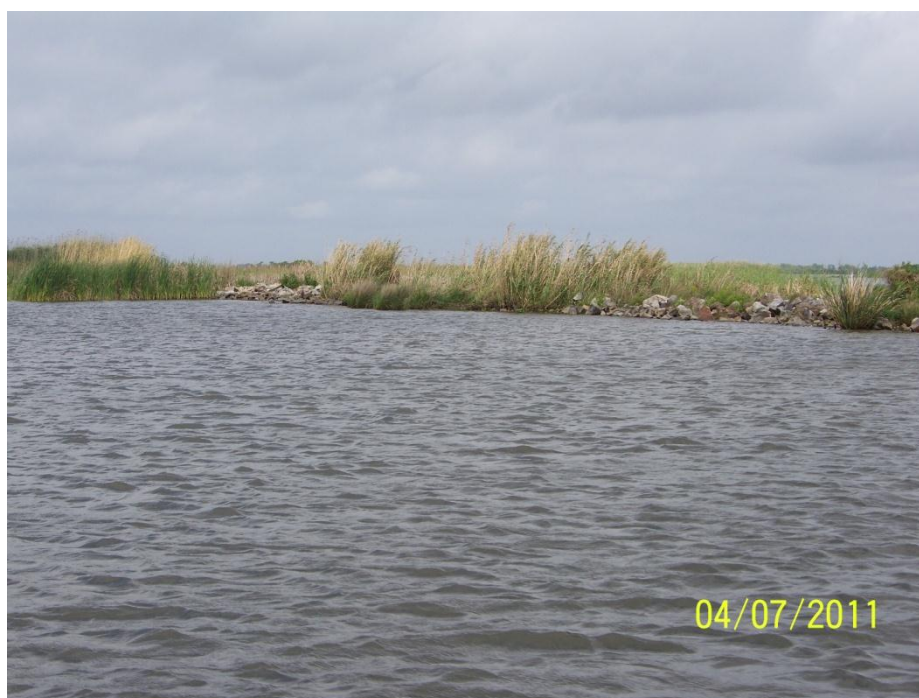
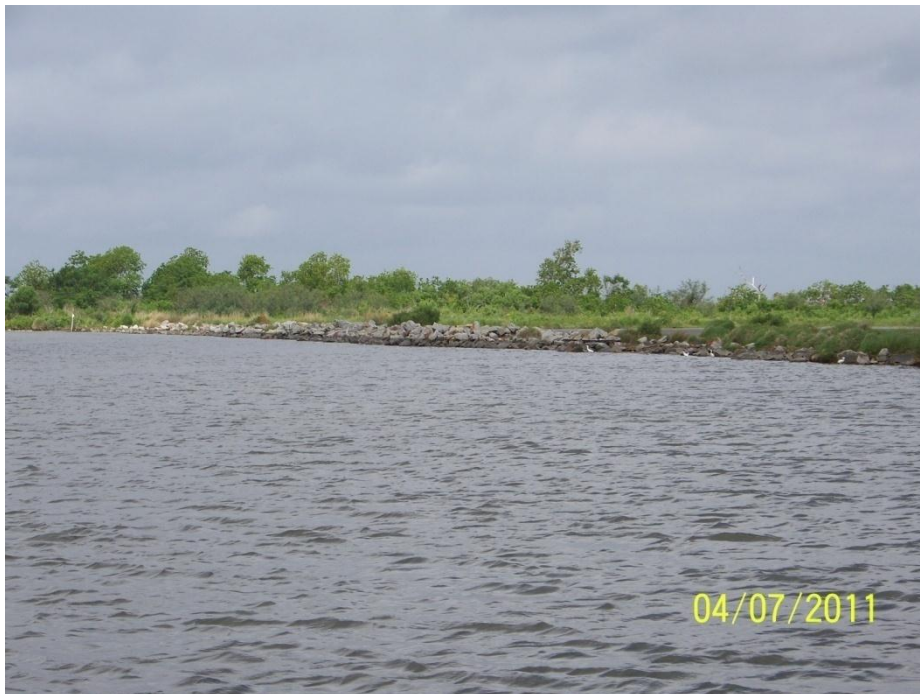
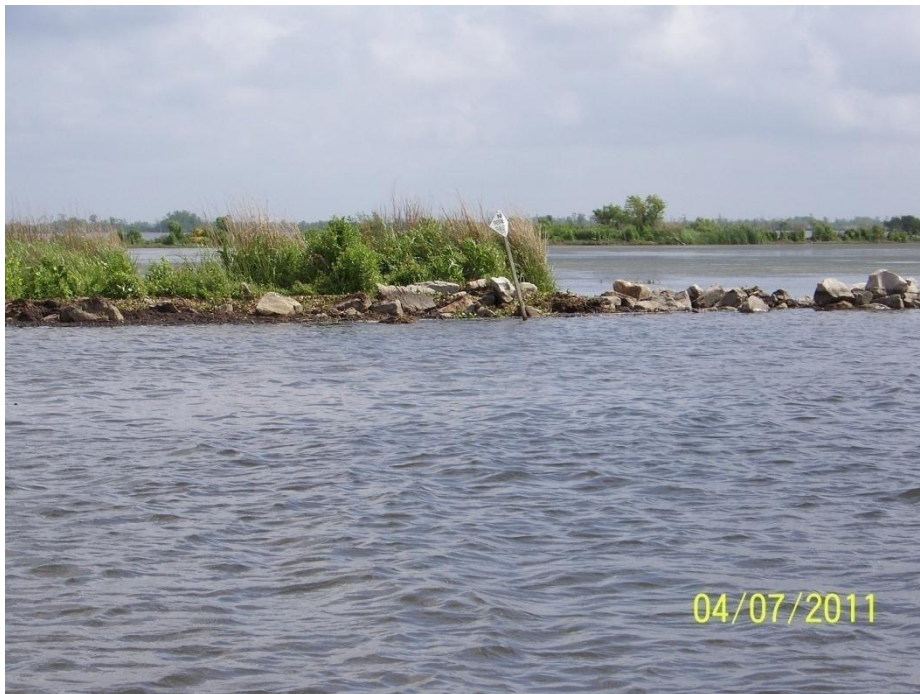
The rock armored embankments found along the north bank of Bayou DeCade and Voss Canal are in good overall condition. The earthen embankment with rock revetment beginning at the intersection of Bayou Decade and Voss Canal to Structure 10 along the east bank of Voss Canal appears to have some settlement since its initial construction, but no significant change since the last annual inspection and no breaching or severe rock displacement. OCPR will continue to monitor the condition

of rock dike structure on future field investigations. The earthen embankment with rock revetment along Bayou Decade between Structure 6 and 7 and just west of Structure 7 appear to be in very good condition with no apparent settlement or rock displacement. The rock dike along the north bank of Bayou Decade between Turtle Bayou and Jug Lake constructed under the 2003 Maintenance Project appeared to be in fair condition with isolated low areas and moderate displacement. Despite the minor deficiencies, there is no evidence the structure is not performing as intended, therefore there are no repair recommendations at this time (see Appendix A, Photos 3-10, 49-53 and 57-60).

Photo 3: Bayou DeCade Rock Dike and breach closure constructed in 2003, looking north

Photo 4: Bayou DeCade Rock Dike and breach closure constructed in 2003, looking north

Photo 5: Bayou DeCade Rock Dike and breach closure constructed in 2003, looking north

Photo 6: Bayou DeCade Rock Dike and breach closure constructed in 2003, looking north

Photo 8: Bayou DeCade Rock Dike and breach closure constructed in 2003, looking north

Photo 10: Bayou DeCade Rock Dike and breach closure constructed in 2003, looking north

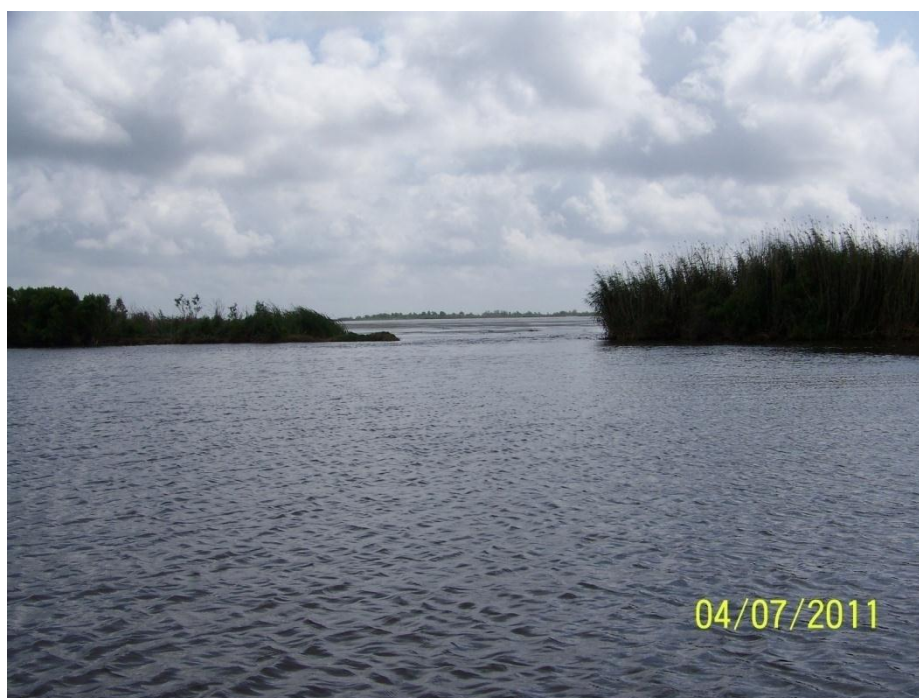
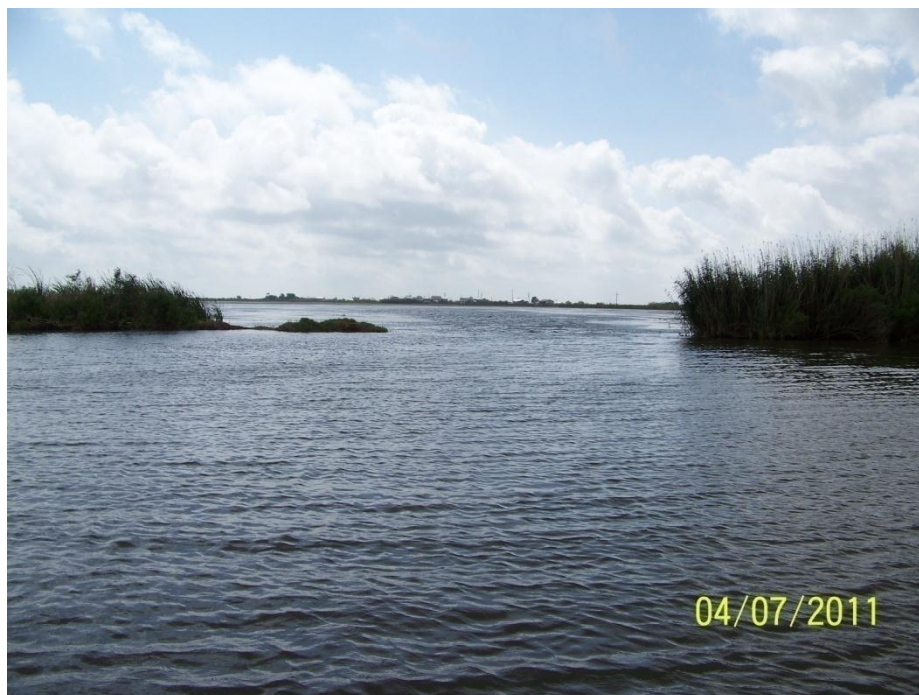
The edge of Jug Lake is the area of most concern throughout the entire Brady Canal Project. This boundary is approximately 20,000 ft. in length and is oriented in a northeasterly to southwesterly direction. Over the past several years, with the help of Hurricanes Katrina and Rita, the earthen rim along the perimeter of Jug Lake has deteriorated to thin and narrow embankments with multiple breaches. There is very little marsh left inside of the project area, therefore the rim is exposed to high wave energies from both the lake and open water in the project area. The complete degradation of the lake rim would have extremely negative impacts to the project area as it would render three (3) water control structures ineffective and allow large quantities of high saline water into project areas that are mainly brackish. Taking into consideration the negative impacts related to the failure of the Jug Lake earthen embankment, OCPR has implemented the 2011 Maintenance Project to refurbish the entire 20,000 linear foot perimeter of Jug Lake. The repairs will include using borrow material from the lake to reconstruct the earthen rim around Jug Lake, and to further combat erosion, a 100 linear foot rock revetment will be installed above the earthen rim on both sides of the water control structures to protect the tie-ins. These repairs are scheduled to be completed later this year.

Photo 12: Large breach along southeast bank of Jug Lake, location N 29° 22' 14.2" W 90° 56' 40.8"

Photo 13: Large breach along southeast bank of Jug Lake, location N 29° 22' 14.2" W 90° 56' 40.8"

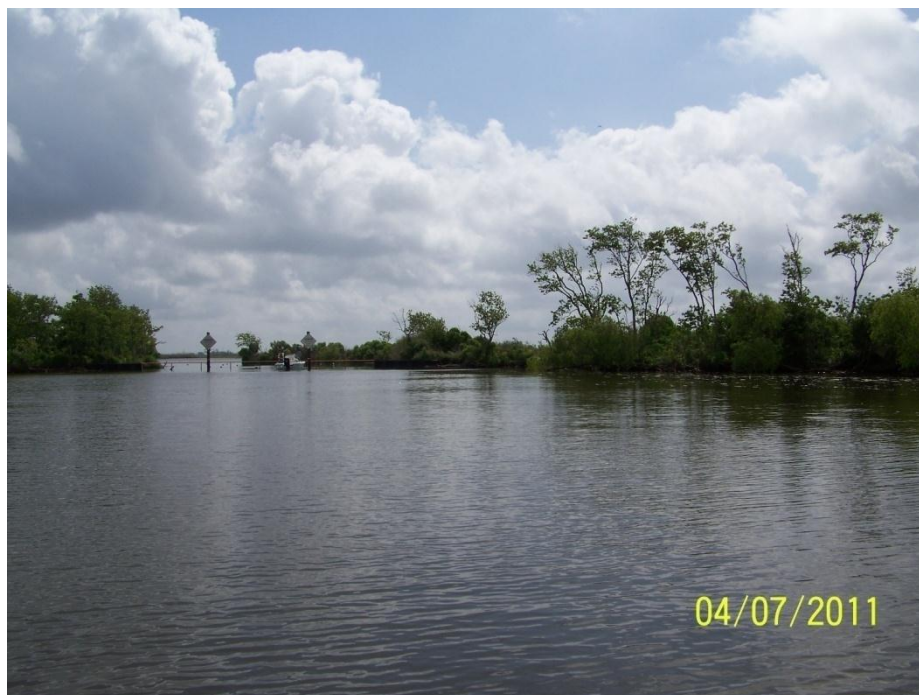
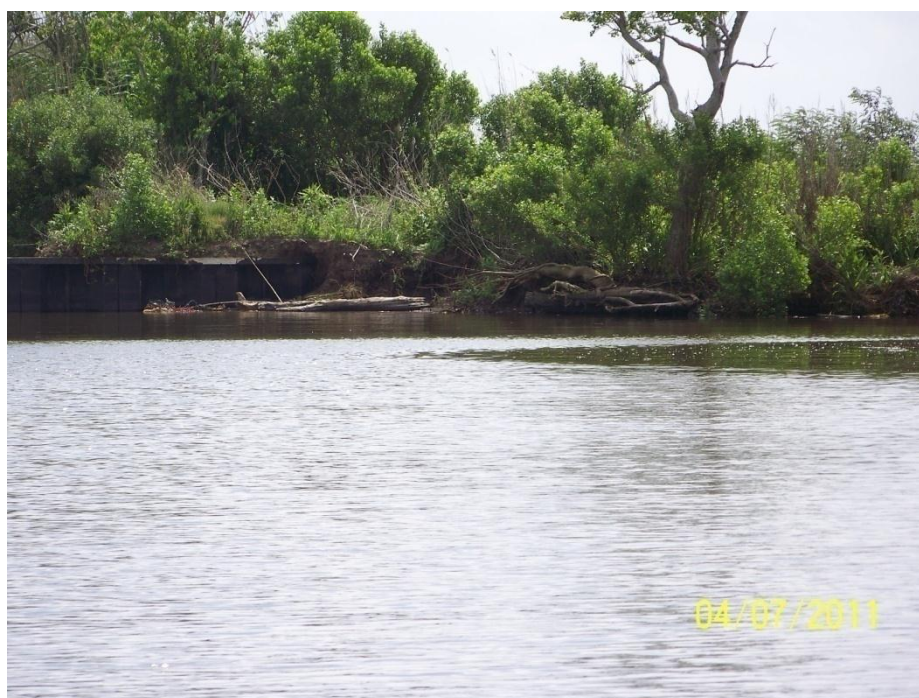
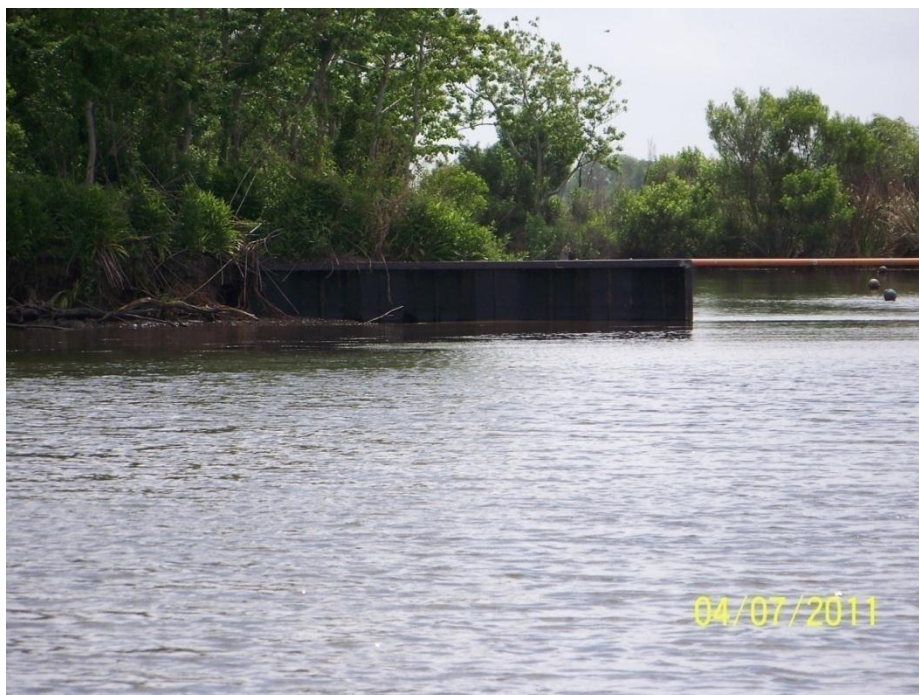
This structure appears to be in good condition. All structural components are undamaged with no signs of corrosion. The warning signs and their timber piles are visible and upright. The earthen tie-ins, refurbished by Apache Minerals Inc. in July 2007, are still intact and holding well. Although no repairs are needed at this time, there are some provisions in the 2011 Maintenance Project to protect the tie-ins which are usually susceptible to erosion. This includes the reconstruction of the tie-ins with borrow material from the lake and then reinforcing approximately 100 linear feet on both sides of the structure with rock riprap. These upgrades are scheduled to begin later this year (see Appendix A, Photo 17 through 19).

Photo 17: Structure 24 along Jug Lake shoreline, looking east

Photo 18: Embankment tie-in south of Structure 24, looking east

Photo 19: Embankment tie-in north of Structure 24, looking east

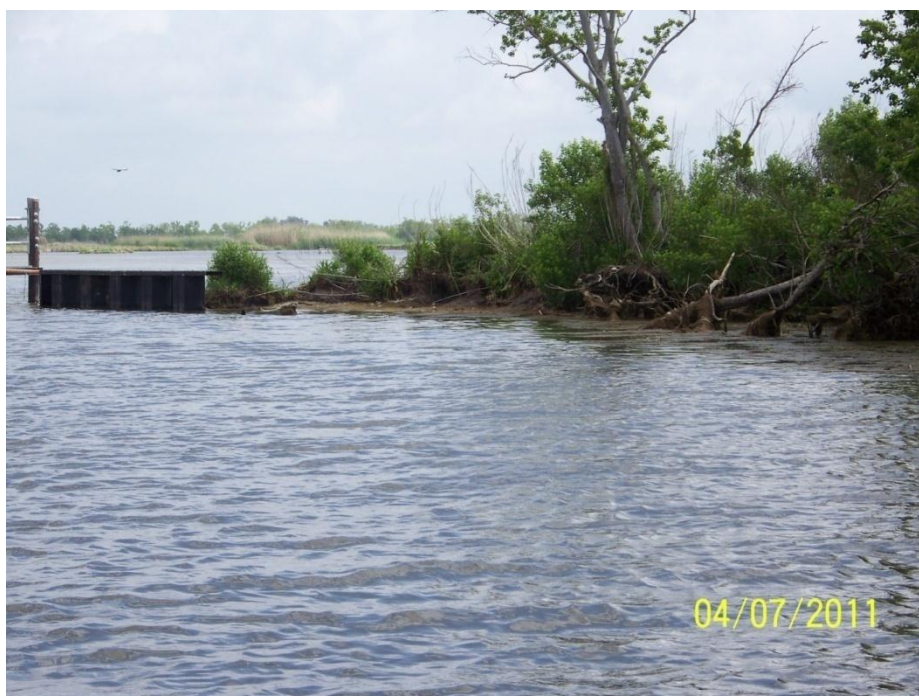
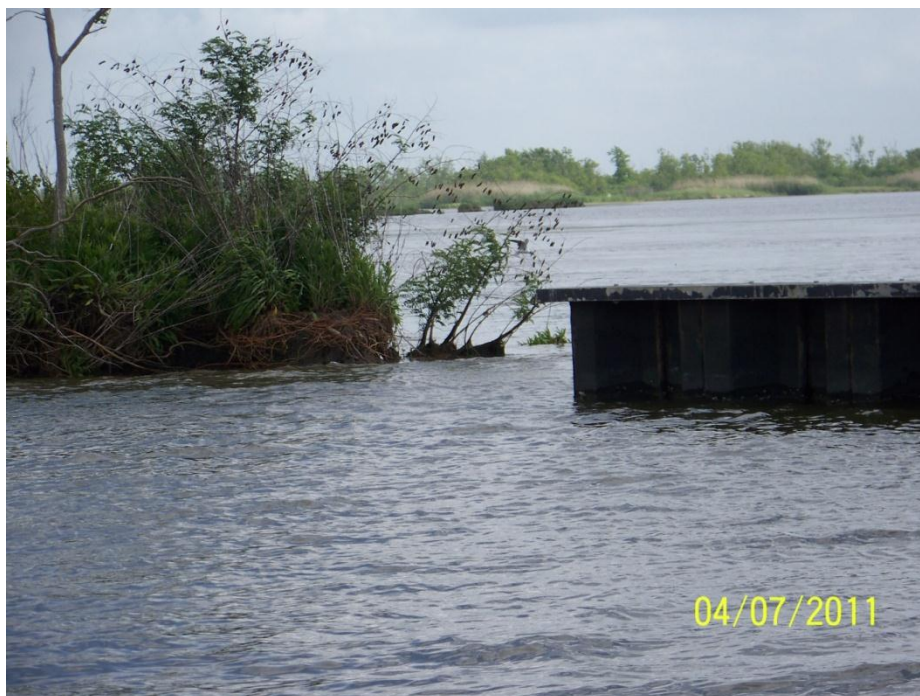
This structure is in overall good condition as there is no visual damage to the steel bulkhead, railings, decking, warning signs or timbers. However, both of the structures earthen tie-ins have now been breached due to erosion. The north tie-in has been repaired several times in the past, but to prevent further erosion of the embankment, both sides require refurbishment and more robust tie-ins. These improvements are part of the 2011 Maintenance Project and include the reconstruction of the tie-ins with borrow material from the lake and then reinforcing approximately 100 linear feet on both sides of the structure with rock riprap. The upgrades are scheduled to be completed later this year (see Appendix A, Photos 20 through 22).

Photo 20: Embankment tie-in south of Structure 23 Tie-In Erosion, looking east

Photo 22: Structure 23 Tie-In Breach on north side of structure, looking east

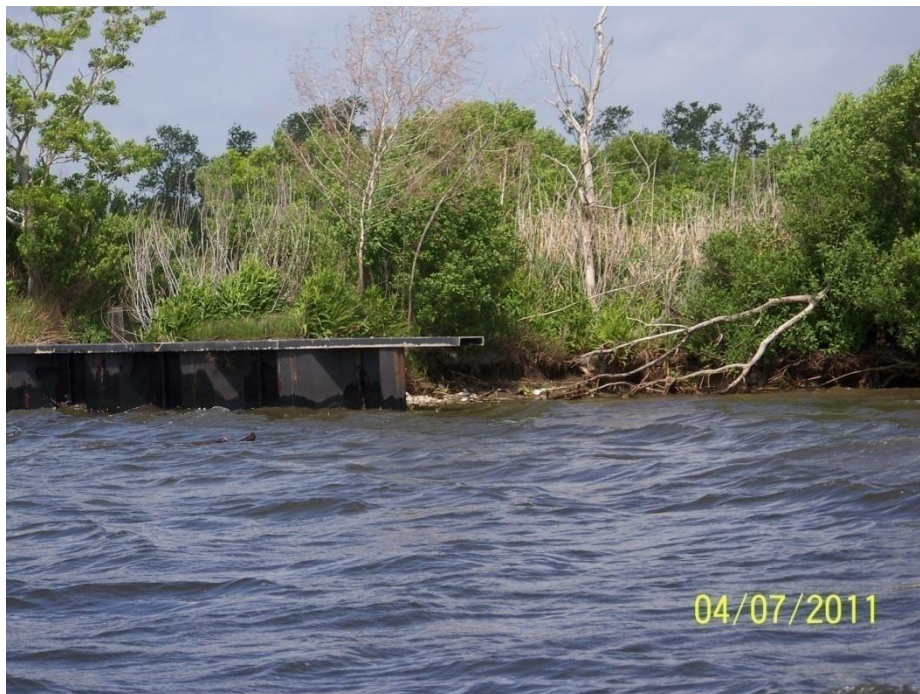
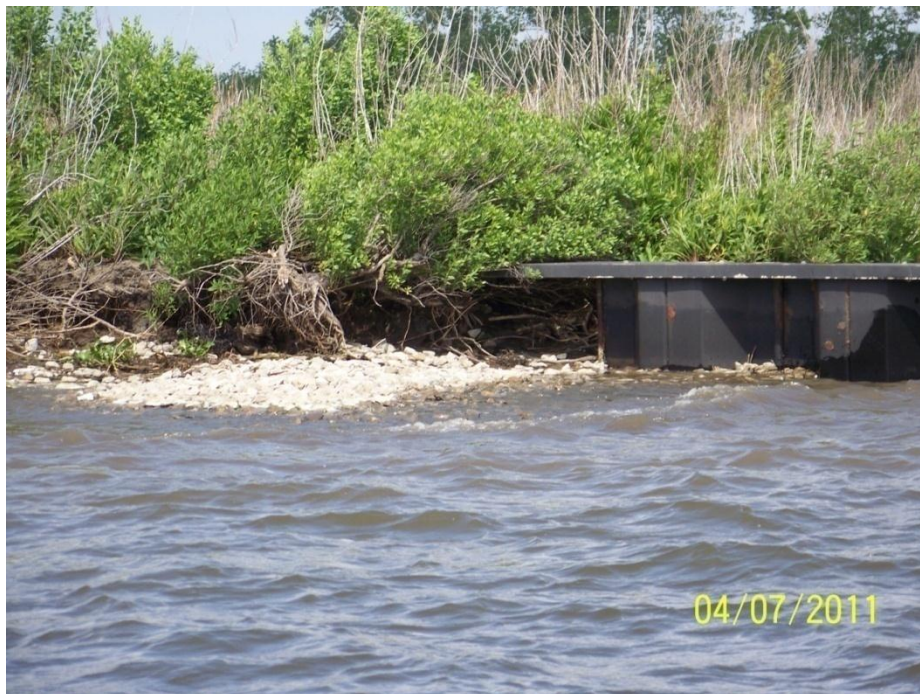
This structure is in overall good condition as there is no visual damage to the steel bulkhead, railings, decking, warning signs or timbers. There is substantial erosion of the earthen tie-ins, exposing the end of the steel bulkhead on both sides of the structure, and causing a breach on the east side of the structure. To prevent further erosion of the embankment, both sides require refurbishment and more robust tie-ins. These improvements are part of the 2011 Maintenance Project and include the reconstruction of the tie-ins with borrow material from the lake and then reinforcing approximately 100 linear feet on both sides of the structure with rock riprap. The upgrades are scheduled to be completed later this year (see Appendix A, Photos 27 through 28).

Photo 26: Tie-in erosion on northeast side of Structure 21 causing exposed bulkhead

Photo 28: Tie-in erosion on southwest side of Structure 21 causing exposed bulkhead

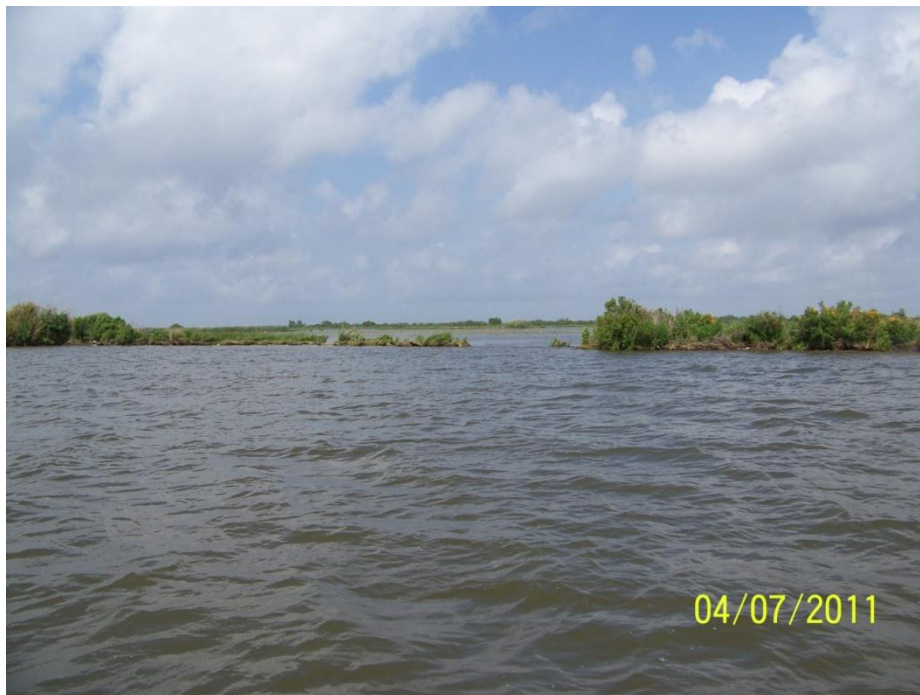
Photo 32: Small breach along the northwest shoreline of Jug Lake located between Structure 20 and Structure 21

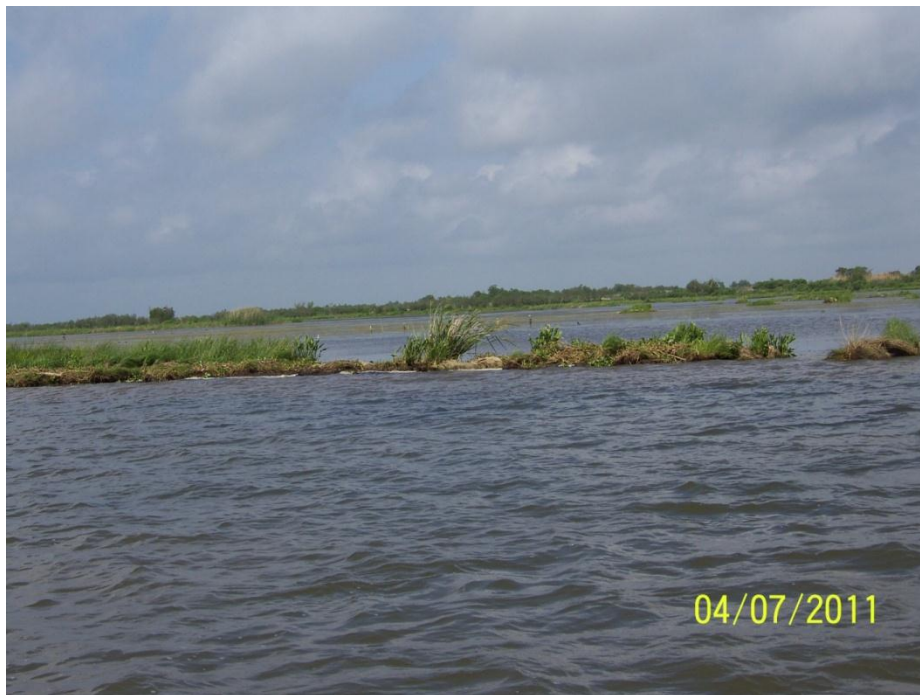
Photo 34: Jug Lake Shoreline to be repaired in 2011 Maintenance Project, looking northwest

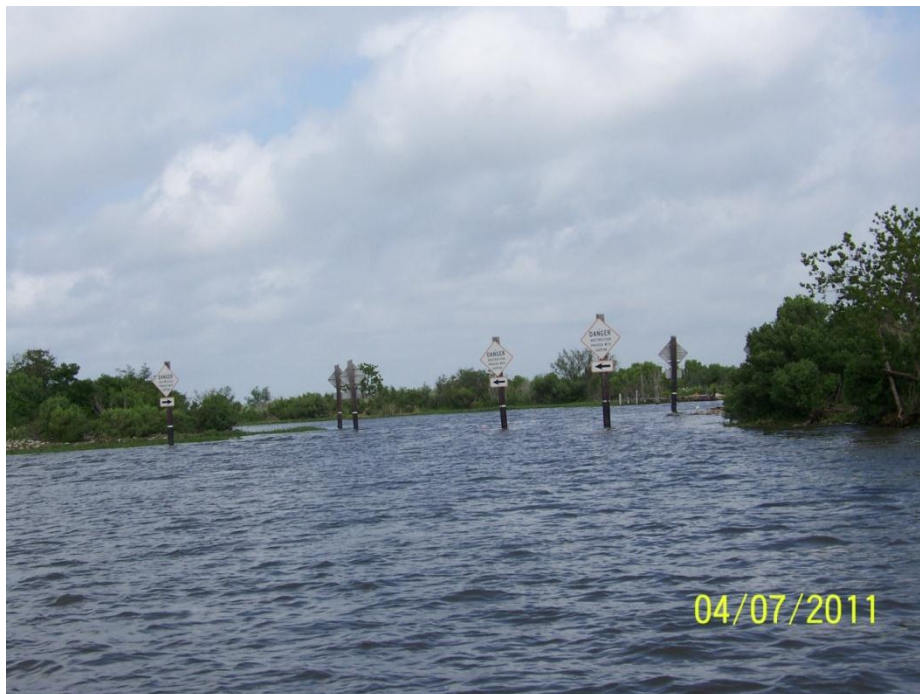
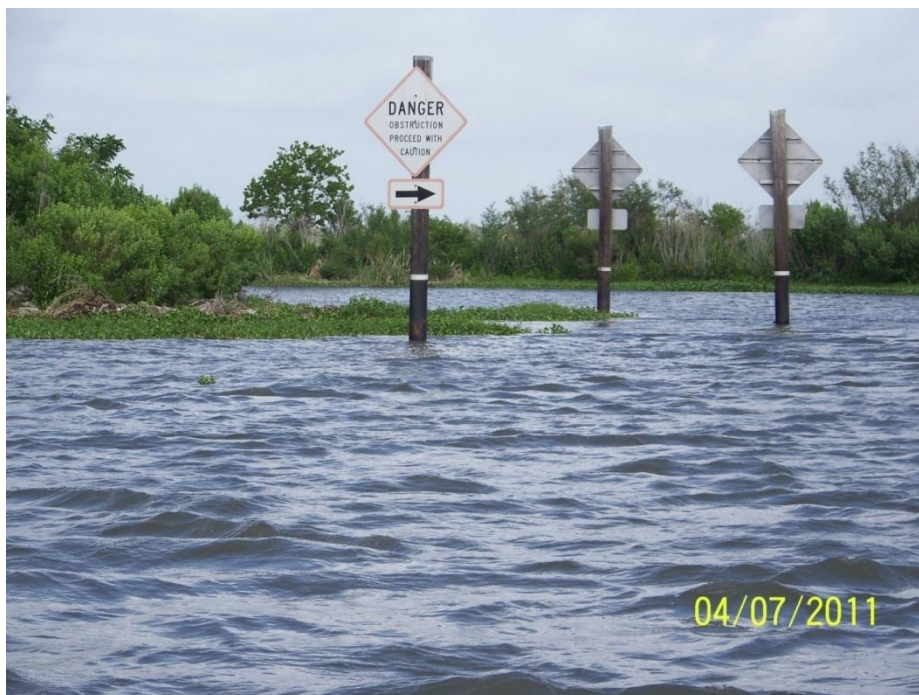
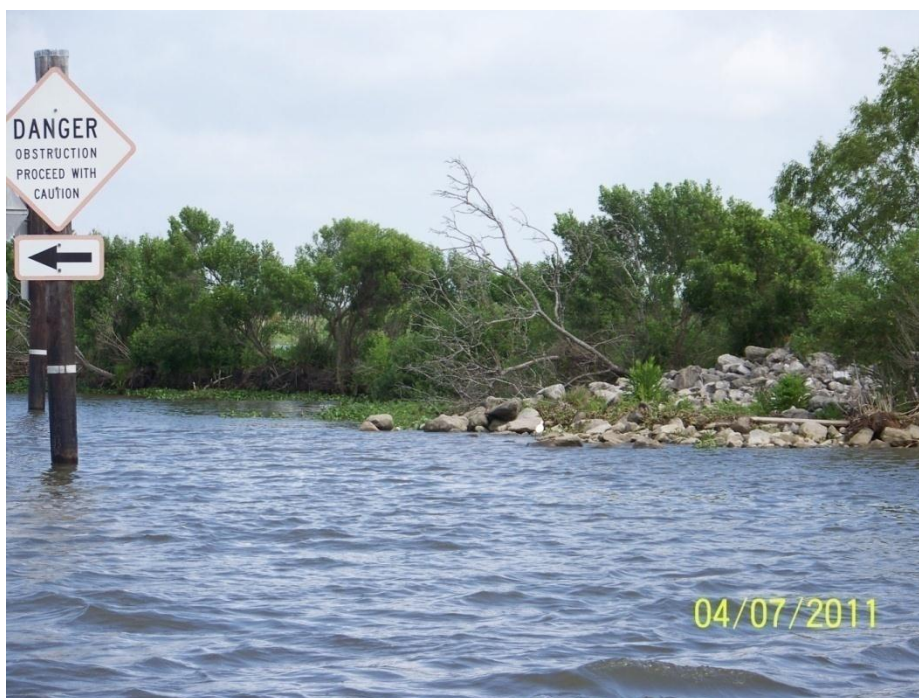
This structure appears to be in fair condition as some settlement of the rock riprap can be observed on both exposed sides of the structure as well as the submerged crest. Using a handheld depth sounder in the center of the boat bay, the water depth above the rock crest was recorded as 7.0' below the water line. With a water level reading of +1.2' NAVD observed at the CRMS station near structure 6, the current crest of structure 20 is approximately -5.8' NAVD. According to the as-built drawings, the center of the rock crest was constructed to an elevation of -4.75' NAVD, therefore it has settled approximately 1.05'. It is recommended that a survey profile across the structure be conducted to confirm the field measurement before we proceed with any

corrective action. All other warning signs and timber piles are in good condition (see Appendix A, Photos 36 through 38).

Photo 36: Rock armored channel liner of Structure 20, looking north

Photo 37: Structure 20 channel liner bank tie-in on west side, looking north

Photo 38: Structure 20 channel liner bank tie-in on east side, looking north

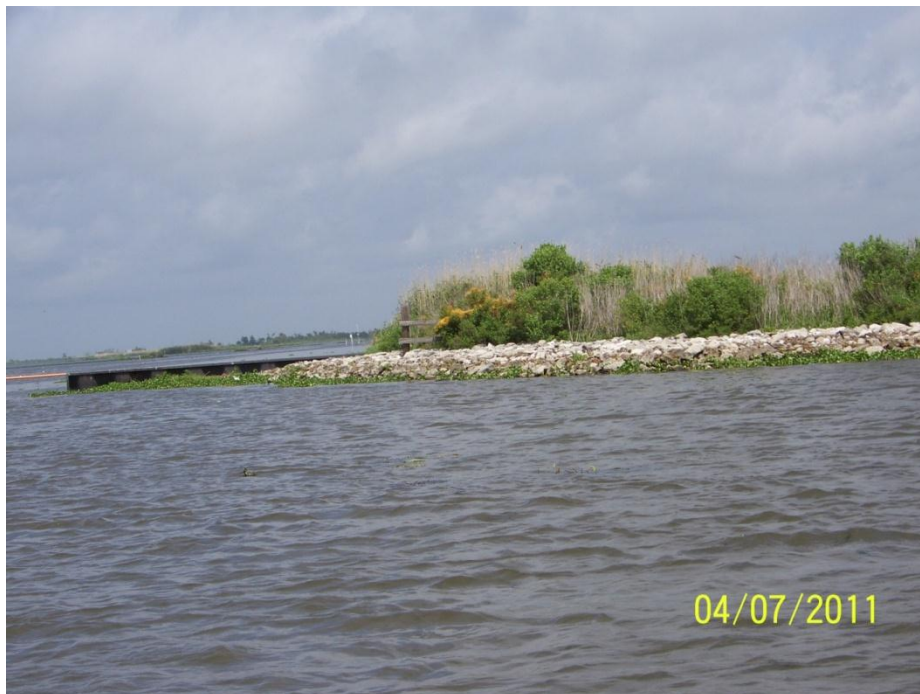
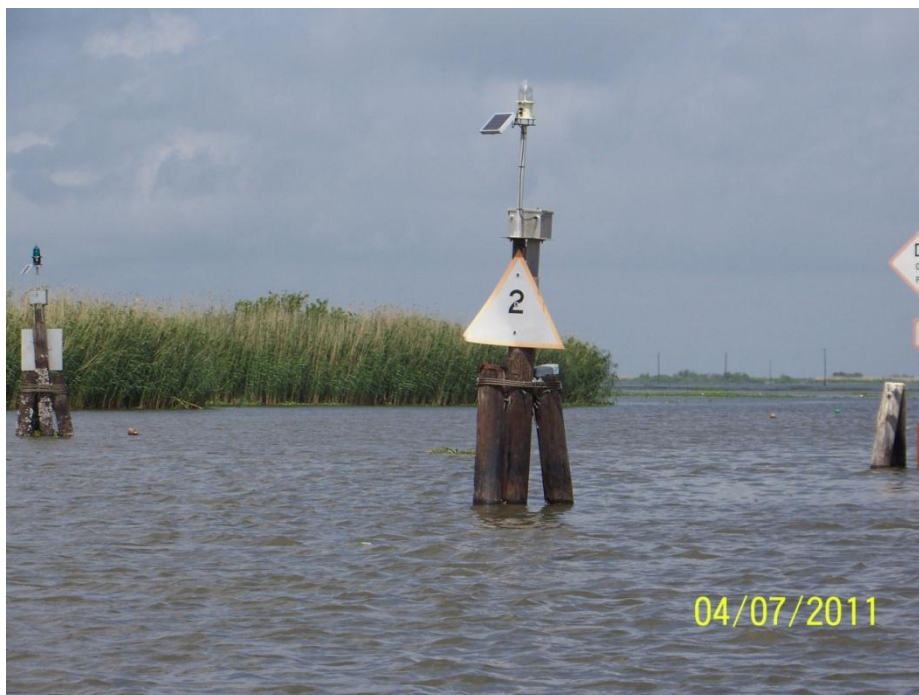
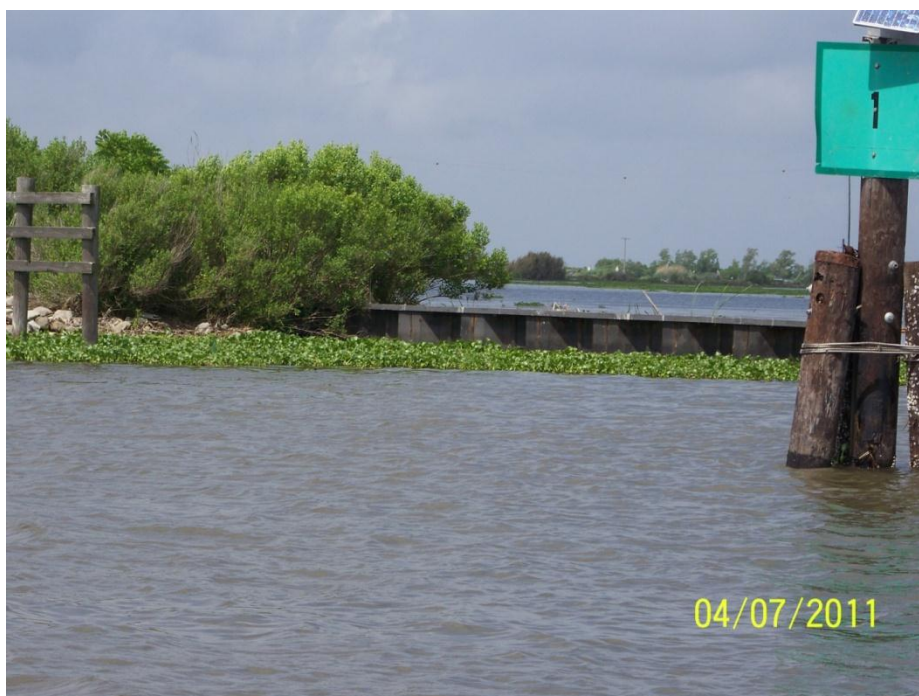
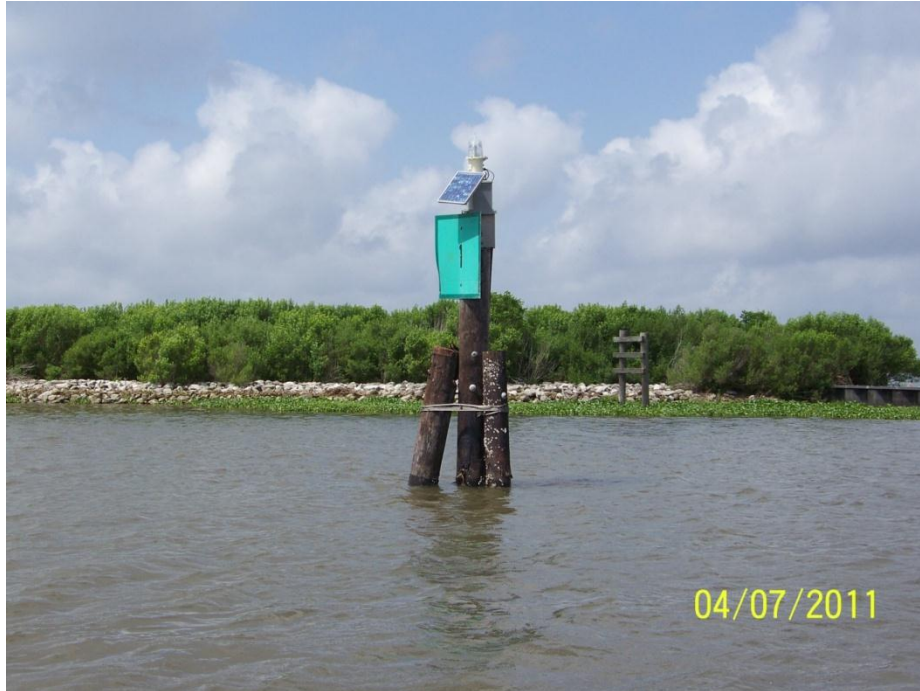
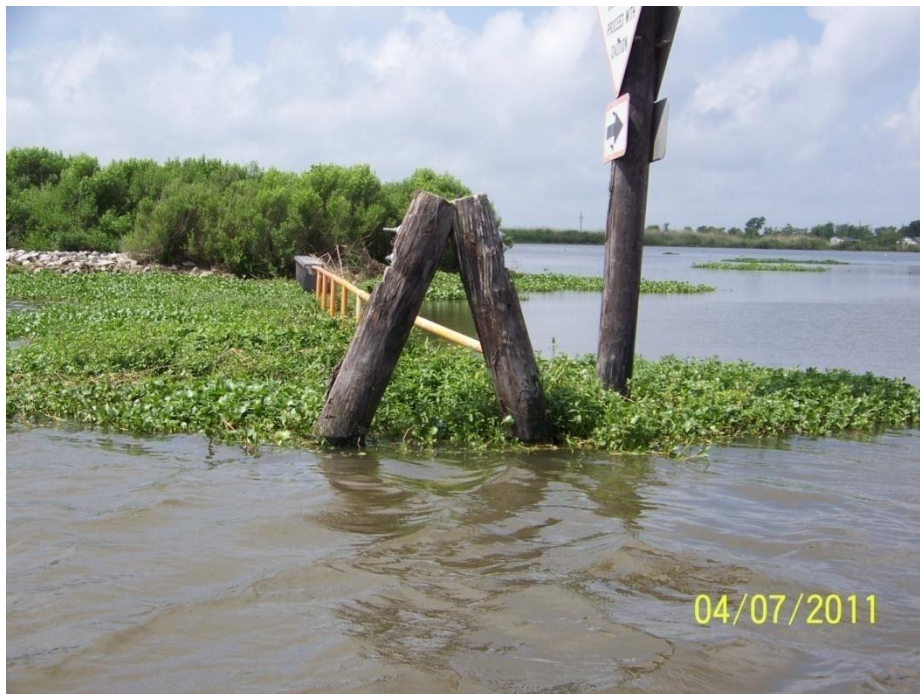
This structure looks to be in overall good condition. There are no apparent deficiencies in the steel bulkhead or its tie-ins to the earthen embankment. All navigational lights appear to be operational and navigational signs are visible with some minor degradation due to exposure. The only damage to the structure observed during the inspection was the two timber pile dolphins on the south side of the structure. These piles are both cracked and displaced from center. It is assumed the oilfield service barges are using these piles as assistance to navigate through the barge bay, due to the sharp 90 degree turn from Bayou Decade, causing excessive wear and

tear on the timber. The damage to the timber pile support dolphin on the south side of the structure was observed during the 2010 annual inspection, and is recommended for replacement under the 2011 Maintenance Project. In addition to the new timber navigational aid structure, all existing navigation signs will be replaced. These recommended upgrades are scheduled to be completed later this year in the 2011 Maintenance Project (see Appendix A, Photos 42 through 48).

Photo 42: Fixed crest weir tie-in on east side of Structure 6, looking north

Photo 43: Navigational sign on east side of Structure 6, to be replaced in 2011 Maintenance Project

Photo 44: Fixed crest weir tie-in on west side of Structure 6, looking north

Photo 45: Navigational sign on west side of Structure 6, to be replaced in 2011 Maintenance Project

Photo 46: Steel sheetpile weir and timber bumper guards on the west side of the barge bay of Structure No. 6

Structure 6 – Timber Cluster Pile Replacement

The timber cluster pile replacement shall include removal of two (2) existing timber pile structures on the south side of Structure 6 and replacing them with new treated timber piles, supports, cables and hardware. It is also recommended that the new structure be more rigid with additional lateral support. This could be accomplished by

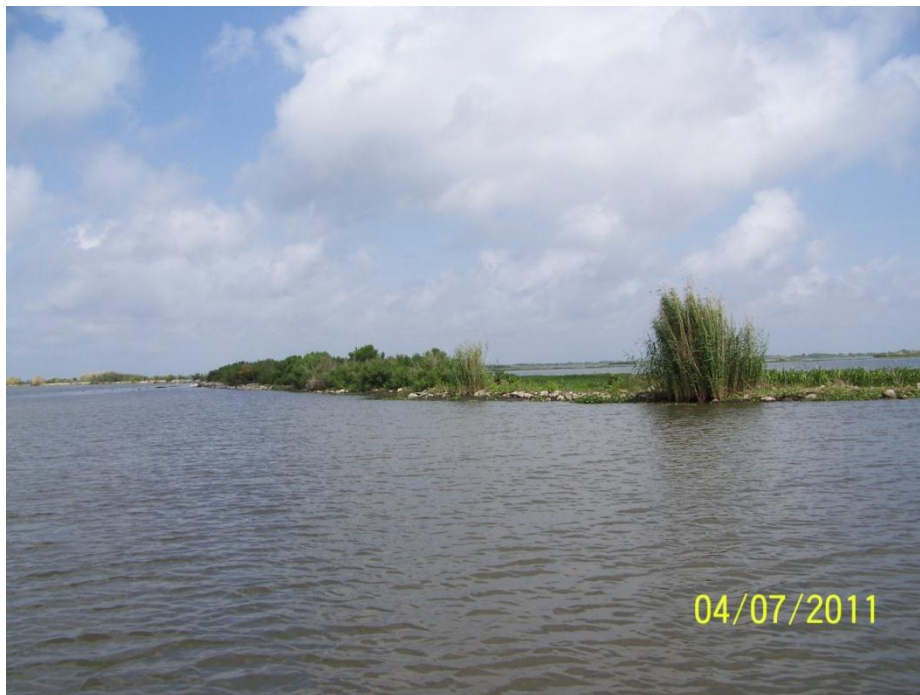
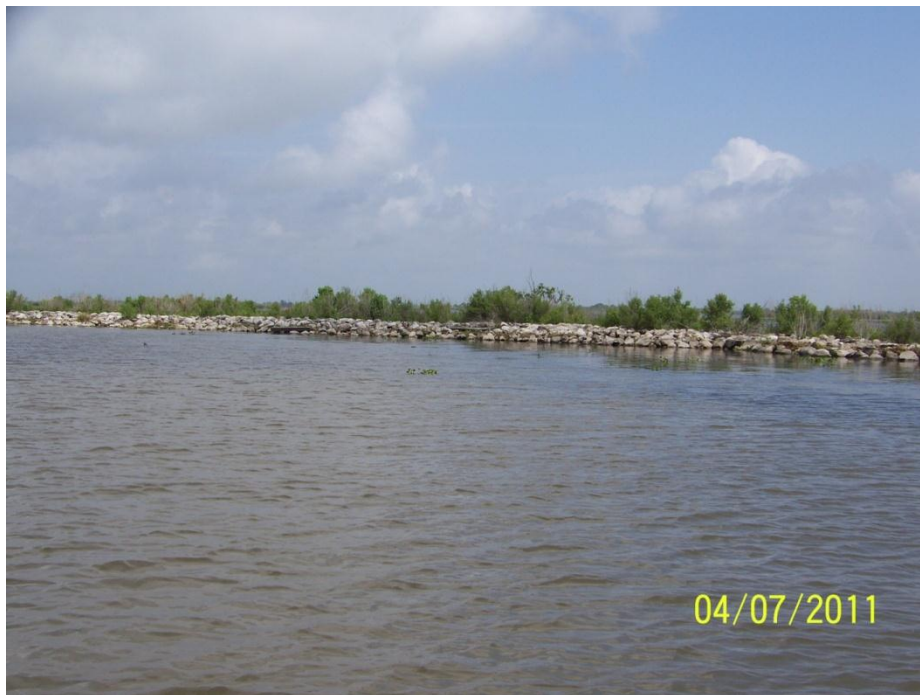
Photo 50: Low area of rock dike along Bayou DeCade north shoreline, located between Structure 6 and 7

Photo 52: Embankment with rock along Bayou DeCade north shoreline located between Structure 6 and 7

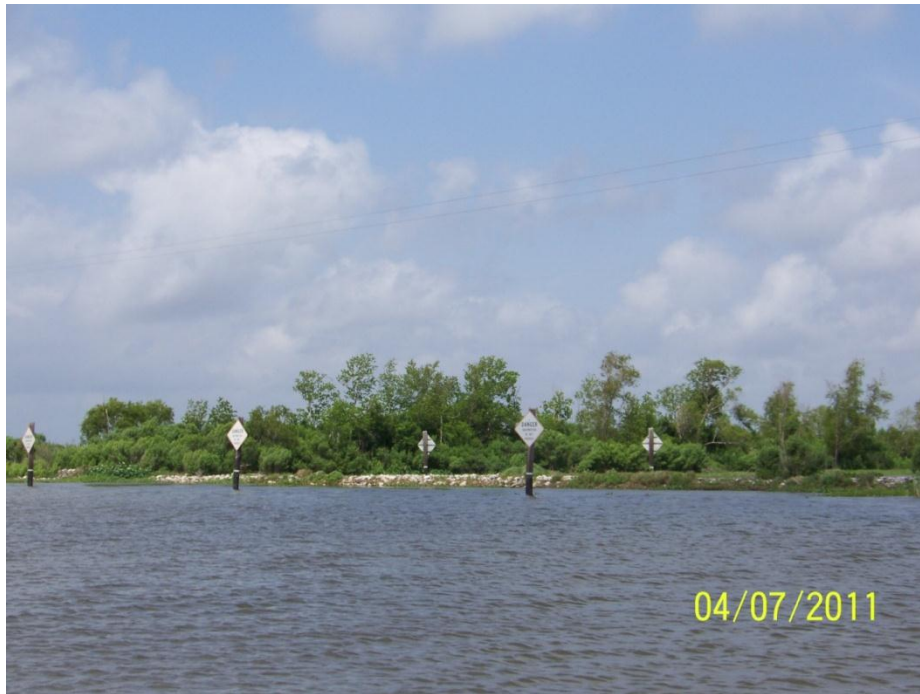
Structure 7 is in overall good condition with no observed settlement of the rock plug or signs of erosion around the tie-ins to the earthen embankment. This structure does not require maintenance at this time therefore there are no recommendations for repair (see Appendix A, Photos 54 and 55).

Photo 54: Structure 7 rock plug located on north bank of Bayou DeCade, looking north
