2011 Operations, Maintenance, and Monitoring Report

Brady Canal Hydrologic Restoration (TE-28)

State Project Number TE-28
Priority Project List 3

December 2011
Terrebonne Parish

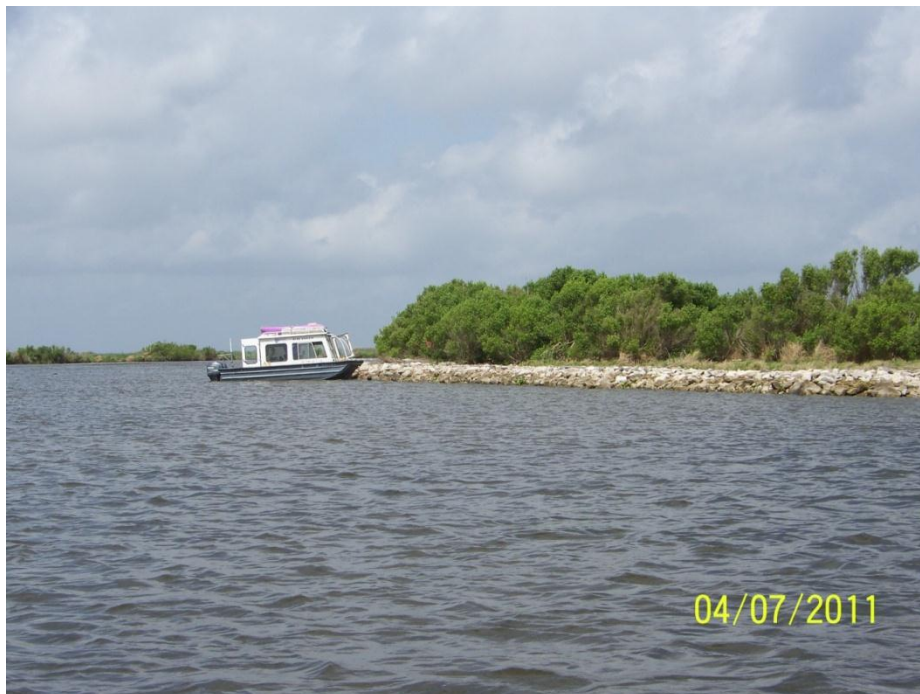
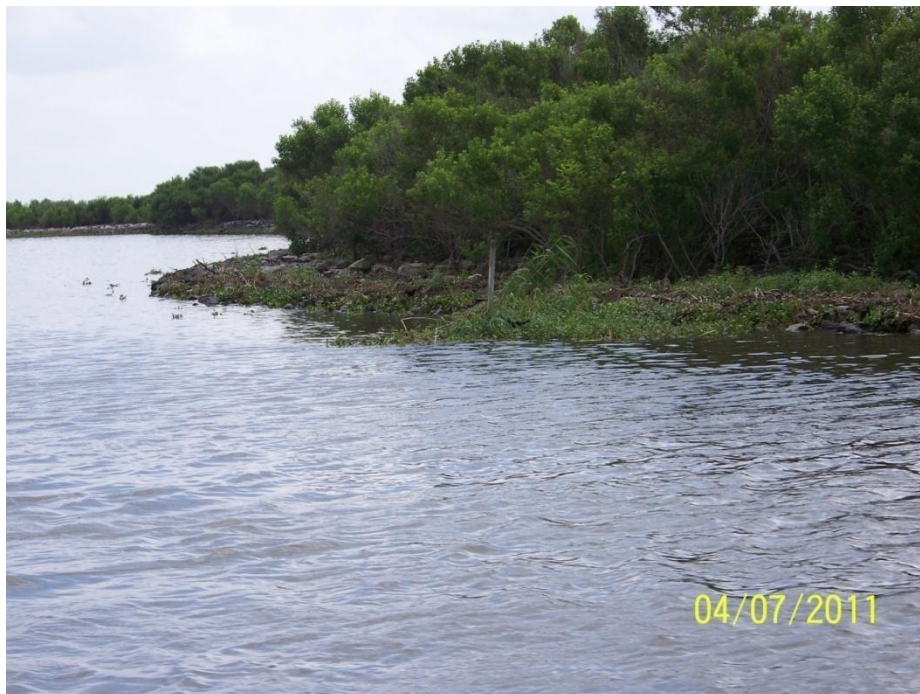
Photo 58: Bayou DeCade and Voss Canal intersection, earthen embankment with rock

Photo 60: Embankment with rock on east side of Voss Canal

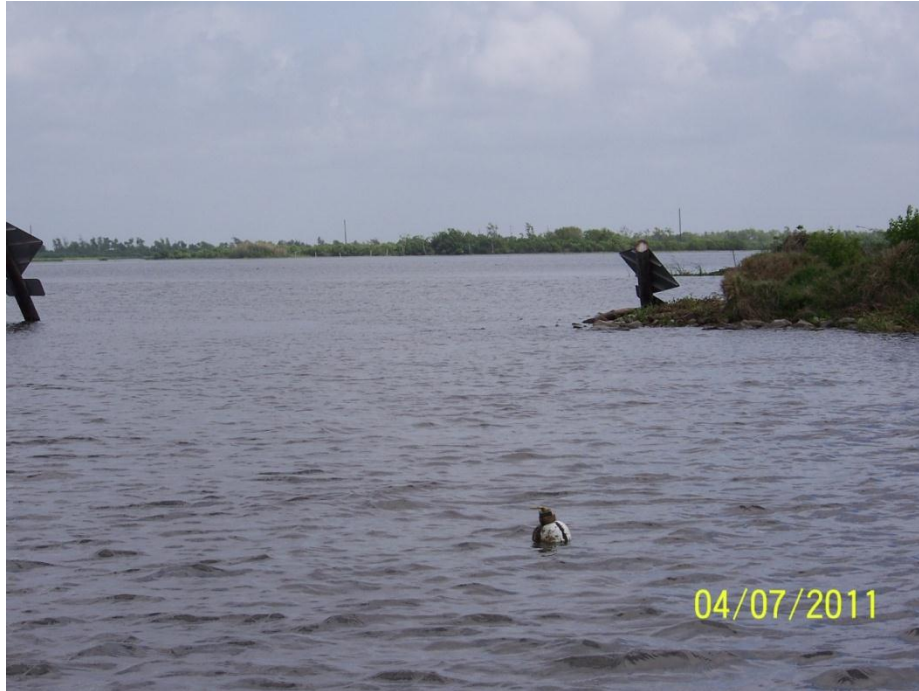
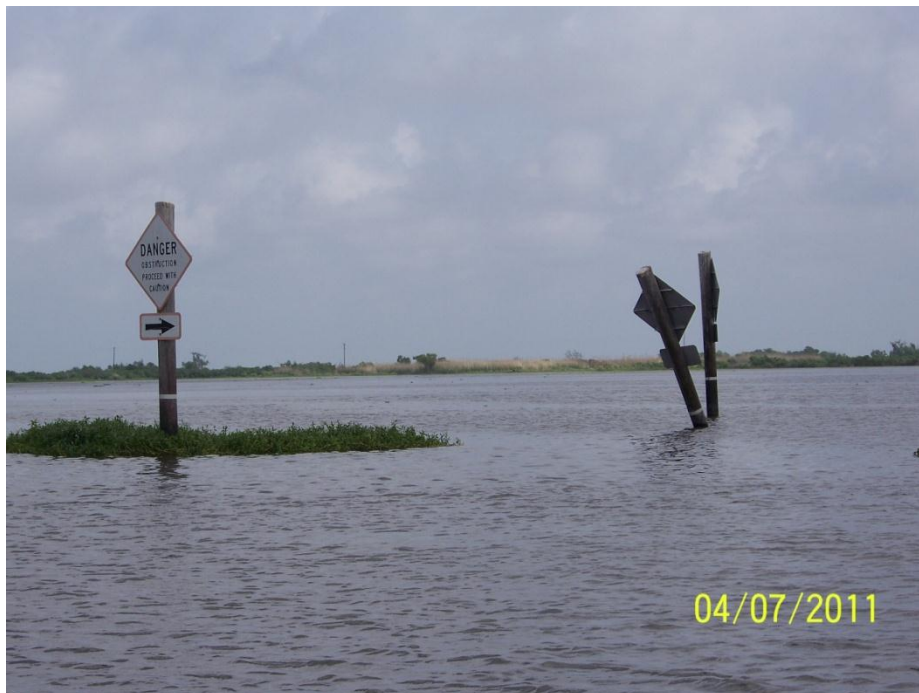
This structure along Voss Canal seems to be in good condition. There is no structural damage and no additional settlement or displacement of the rock from previous inspections. A handheld depth sounder was used to obtain the water depth in the boat bay, and depth above the rock crest was recorded as 6.0' below the water line. With a water level reading of +1.2' NAVD observed at the CRMS station near structure 6, the current crest of structure 10 is approximately -4.8' NAVD. As previously reported in the 2009 annual inspection report, the timber piles holding the warning signs on the northeast side of the structure are leaning and no longer vertical. It is recommended that the existing timber piles and signs be replaced, and this corrective action is included in the 2011 Maintenance Project and should be completed later this year (see Appendix A, Photos 61 through 63).

Photo 61: Structure 10 warning signs are down, to be replaced in 2011 Maintenance Project, looking east

Photo 62: Structure 10 rock armored channel liner along Voss Canal, looking west

Structure 10 – Warning Sign Replacement

Warning sign replacement shall include the removal of four (4) existing timber piles and signage and replacement with new material including timber piles, hardware and warning signs.

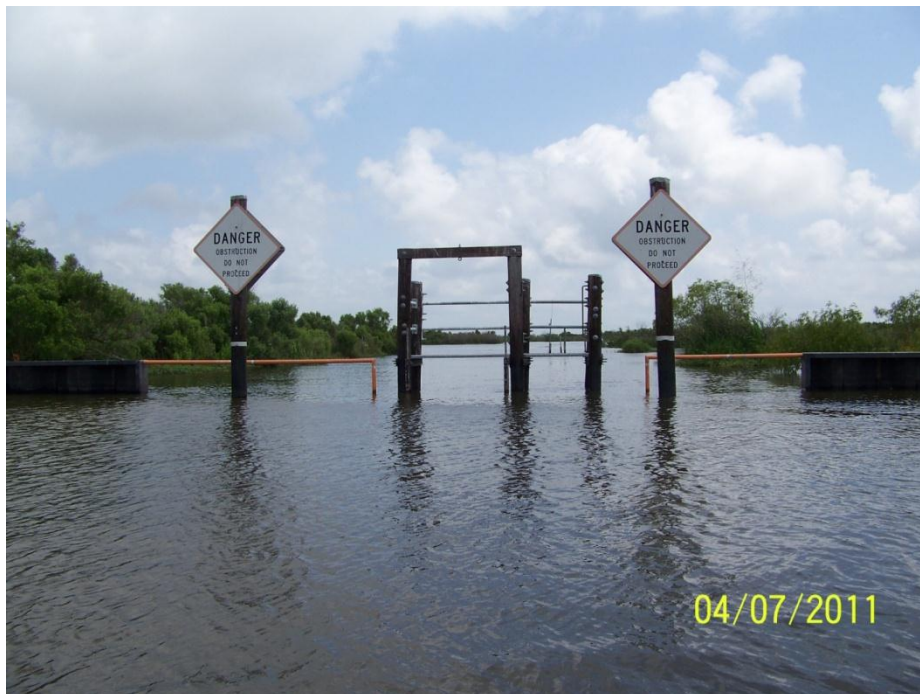
This structure appears to be in overall good condition. There is no apparent damage to the steel bulkhead, railings, platform, or warning signs and their timbers. There is some noticeable erosion around the tie-ins on the west side of the structure, but no more than was noticed in the 2010 annual inspection. Because there was no significant change, there will be no recommendations to restore the tie-ins at this time, but they will continue to be monitored for further erosion on future visits (see Appendix A, Photos 67 through 69).

Photo 68: Structure 14 fixed crest weir with variable crest section, looking east
