**2013 Operations, Maintenance,
and Monitoring Report**

**BARATARIA BASIN LANDBRIDGE
SHORELINE PROTECTION
PROJECT (PHASES 1&2, 3, and 4)**

State Project Number BA-27
Phases 1 & 2, Priority Project List 7
Phase 3, Priority Project List 9
Phase 4, Priority Project List 11

July 2, 2013
Lafourche & Jefferson Parishes

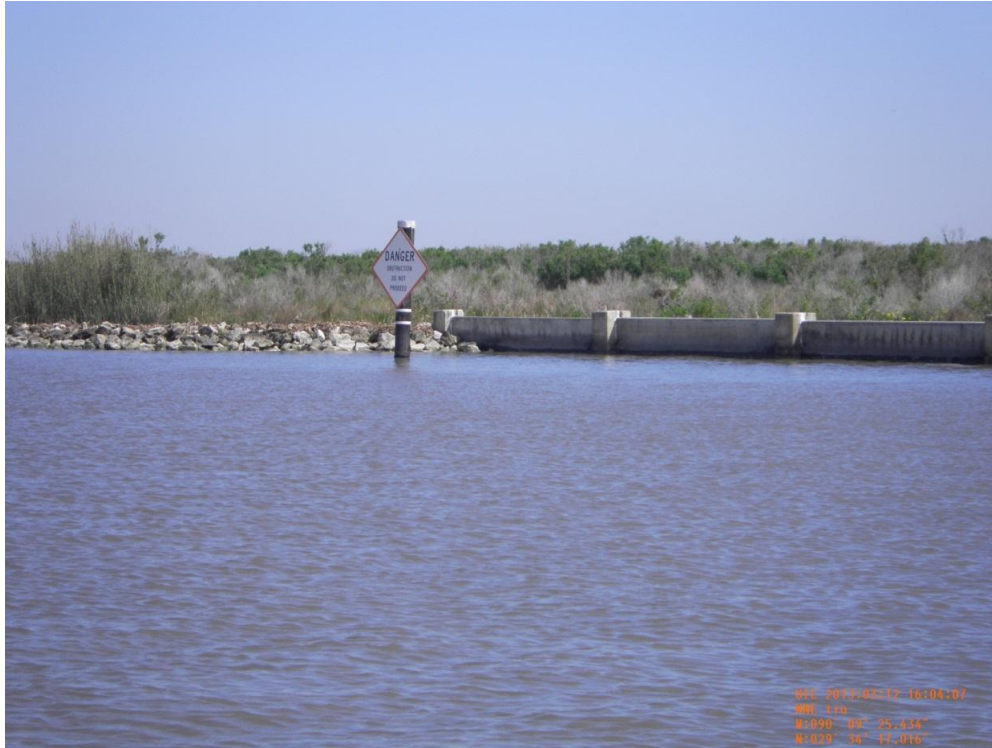
CU 2 appeared to be in good overall condition. The inspection of CU 2 began at the west end near Sta. 0+42 and proceeded to the east end of the reach near Sta. 36+83. As previously reported, a low area of the rock dike approximately 200 feet wide exists from Sta. 31+50 to Sta. 29+50. In comparison to the photos taken last year, there appeared to be no further settlement of the rock dike in this section. Directly behind this low area is a containment dike and newly created marsh constructed under the Dedicated Dredging on the Barataria Basin Landbridge (BA-36) project. Satellite images of this containment dike shows this area is not degrading or eroding due to the low area of the rock dike. Also previously reported was a slight dip in the rock dike above the Exxon/Humble pipeline right-of-way located near Sta. 12+33. Again, comparison with images taken in previous years shows no indication of further settlement of the rock dike or deterioration of the containment dike directly behind it. Due to the lack of marsh degradation and high construction cost associated with repairing small sections of dike, we are not recommending any corrective actions at this time, but these areas will continue to be monitored should their conditions change. (Appendix B, Photos #1-7)

Reach 1. All of the transitions from rock riprap to concrete wall were in good condition. The rock riprap embankment tie-ins were also in good condition. A warning sign and its support marking the concrete pile on the west side of the oilfield canal in Reach 3 were missing. It is recommended this sign and its support should be replaced. Also, a timber piling was resting on the concrete wall on the east bank of Harvey Cutoff in Reach 1. This timber piling did not appear to be damaging the concrete wall, but it is recommended that it should be removed. There are no other recommendations for maintenance at this time. (Appendix B, Photos #1 & #15-32)

Photo 1: View of transition from CU#4 concrete wall to CU#2 rock dike

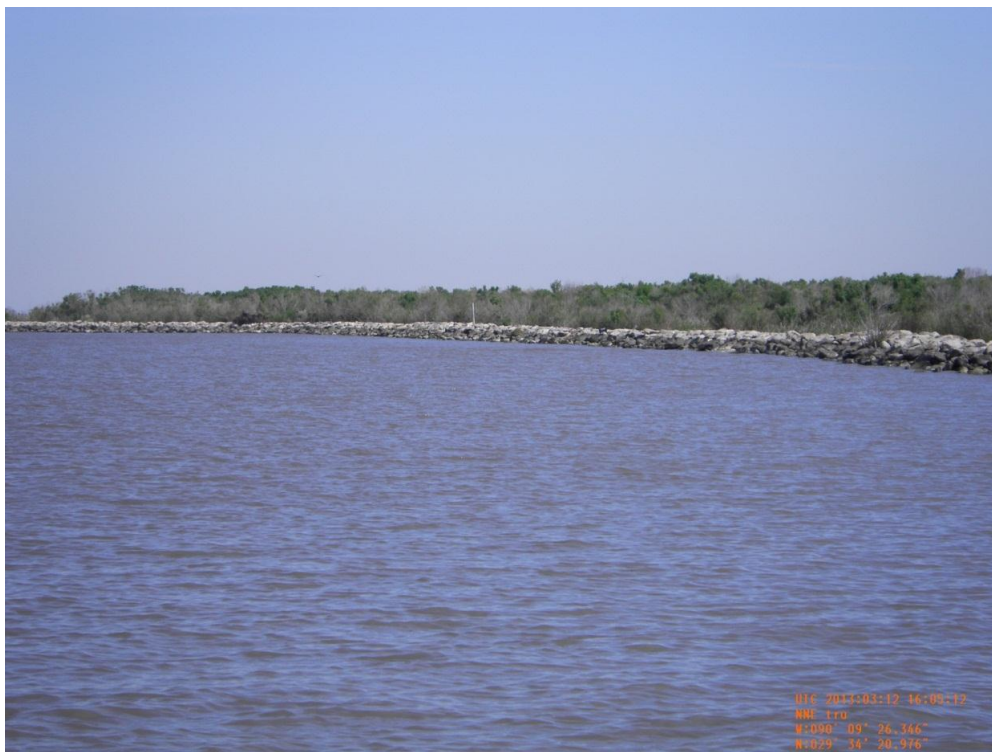
Photo 2: View of CU#2 rock dike along the southern end of Bayou Perot looking east

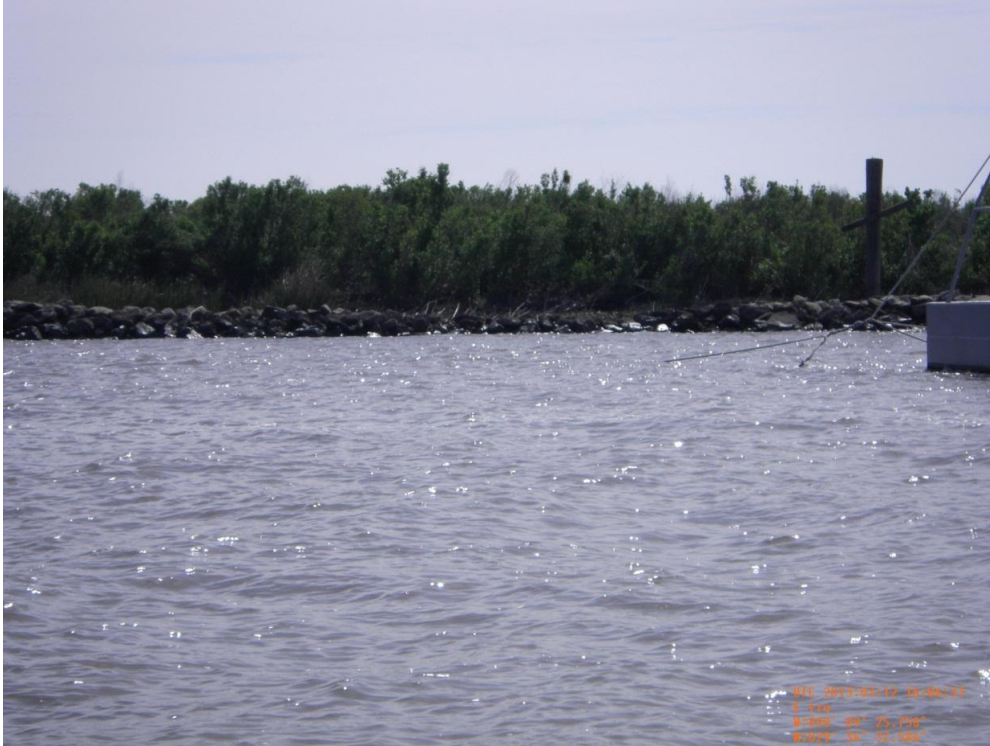
Photo 3: View of a low section of the CU#2 rock dike along the southern end of Bayou Perot

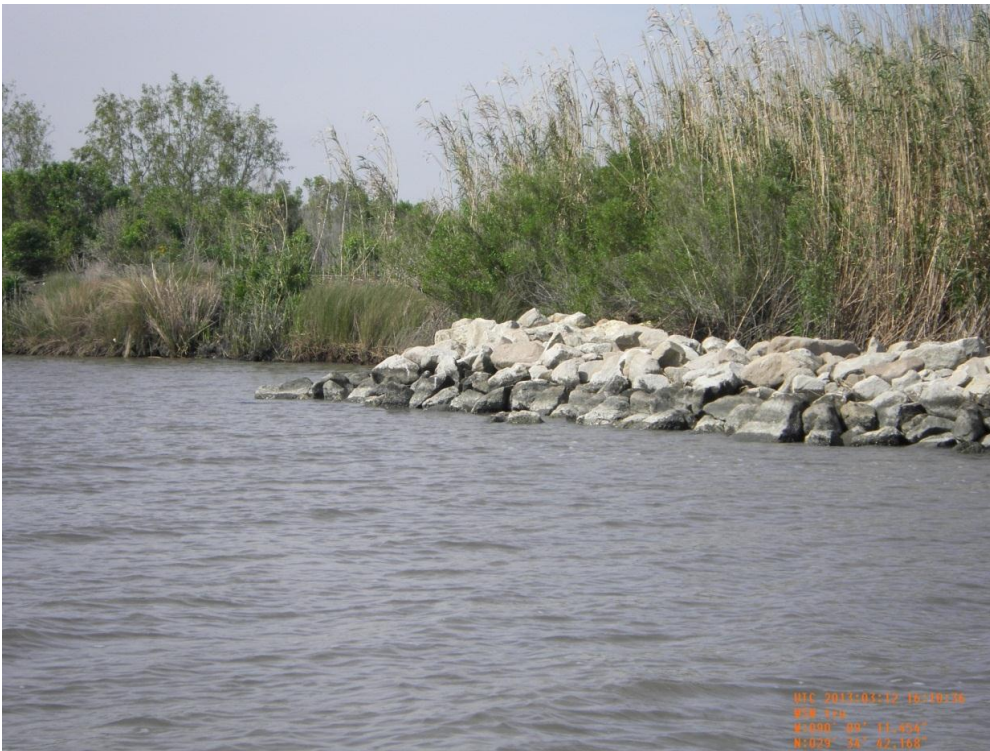
Photo 4: View of CU#2 embankment tie-in on west side of oilfield canal

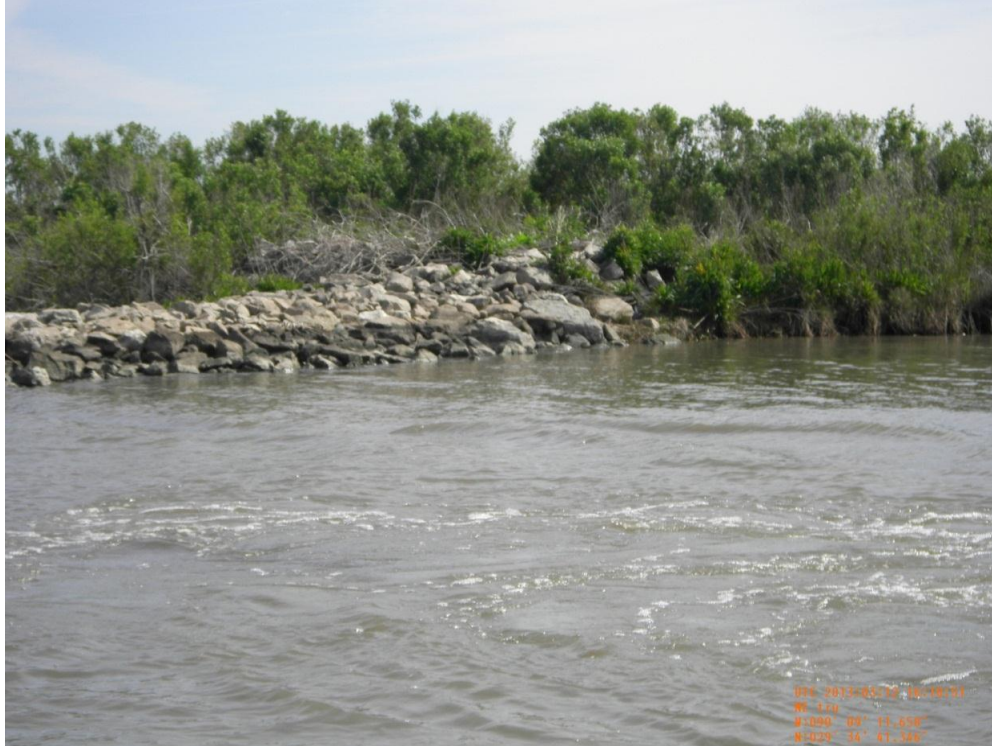
Photo 5: View of CU#2 embankment tie-in on east side of oilfield canal

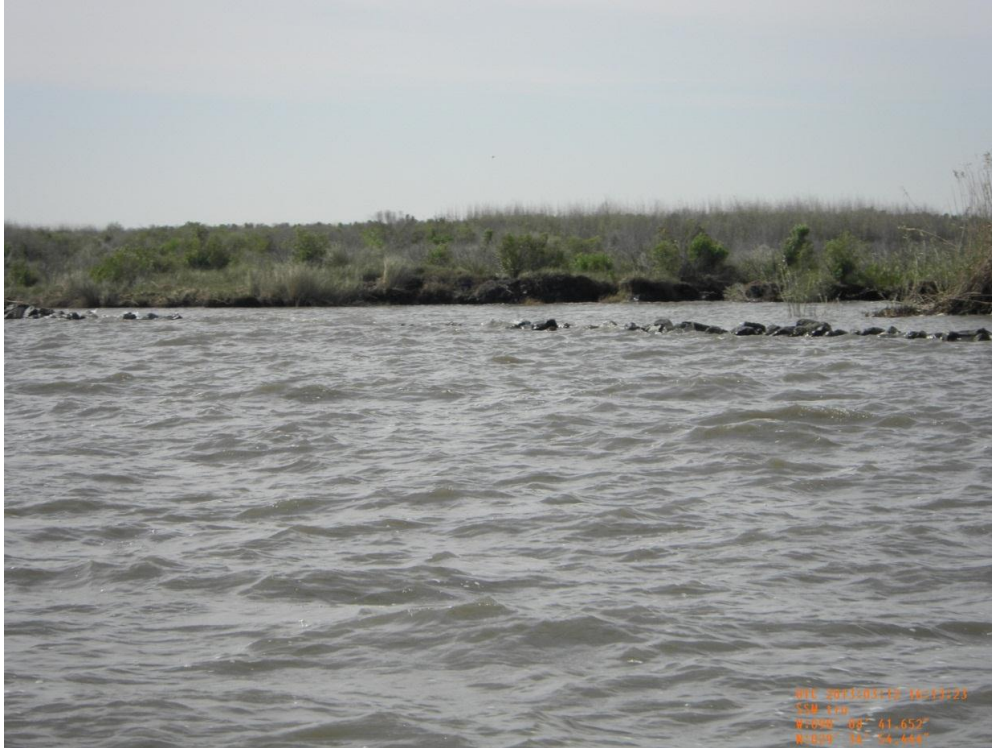
Photo 7: View of a low section along the CU#2 rock dike near the Harvey Cutoff canal

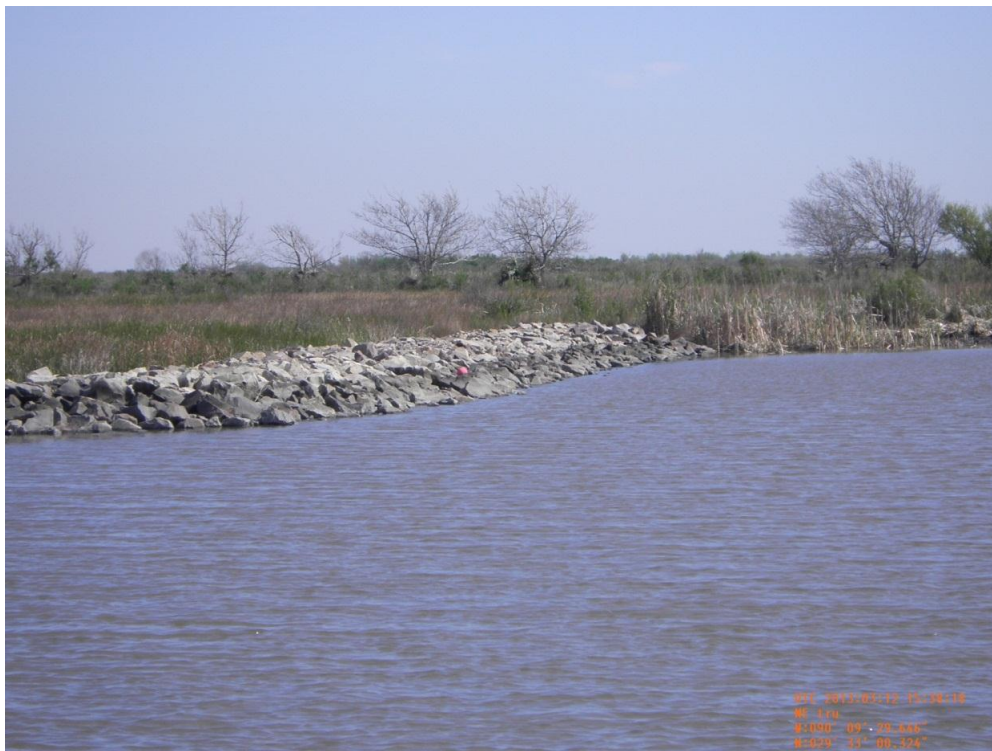
CU 3 was in good overall condition. The inspection of CU 3 began on the east bank of Little Lake at Sta. 108+65 and progressed along the northeast bank of Little Lake to the mouth of Bayou Perot at Sta. 0+00. A visual inspection of this unit revealed the rock dike in good overall condition with minor settlement near the BP pipeline crossing at Sta. 67+00. Despite the settlement, the structure appeared to provide adequate shoreline protection and does not require maintenance at this time. The embankment tie-ins were in overall good condition with no visible erosion or wash-outs on both ends. (Appendix B, Photos #8-14)

Photo 8: View of the southern embankment tie-in of CU#3 along the eastern edge of Little Lake

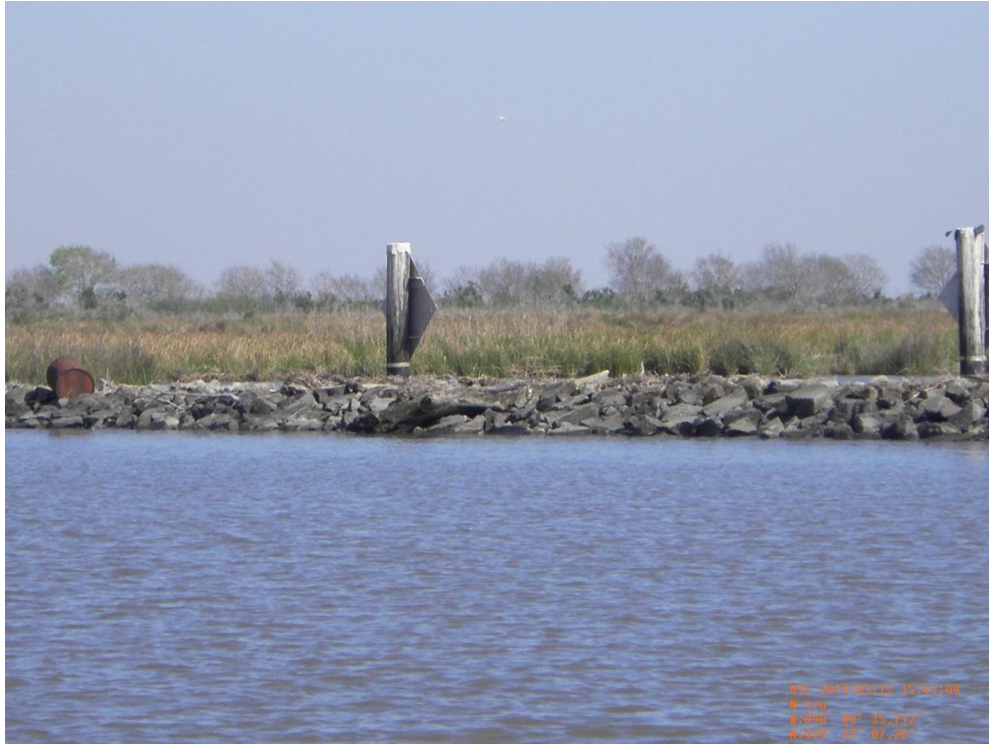
Photo 9: View of CU#3 rock dike and warning signs on the eastern edge of Little Lake

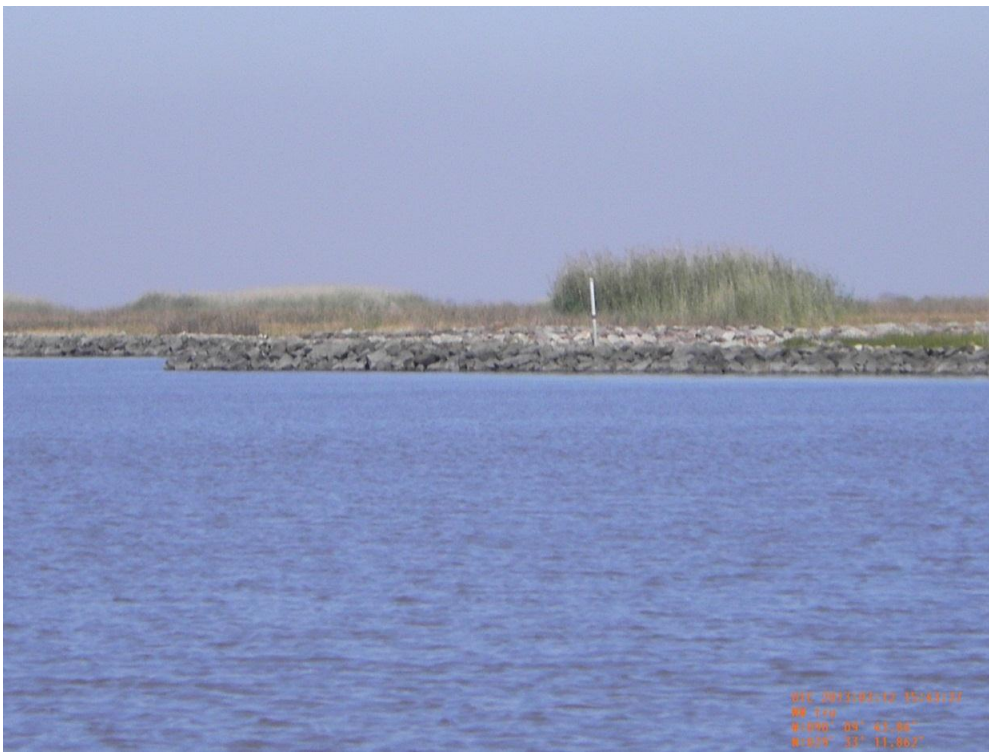
Photo 10: View of CU#3 rock dike on the eastern edge of Little Lake looking north

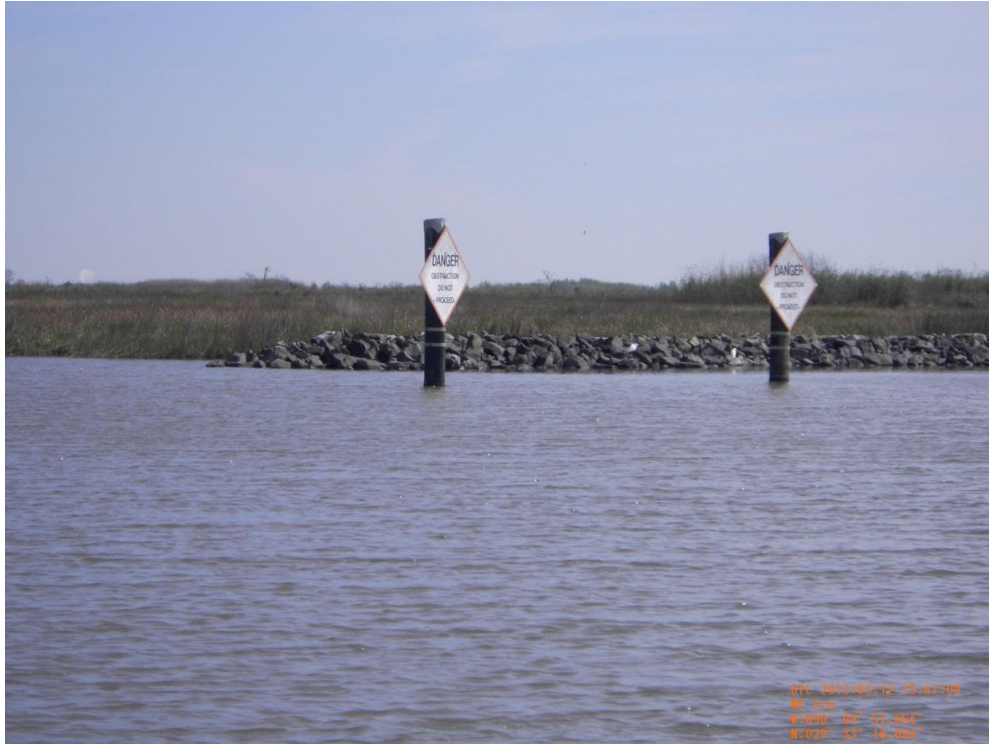
Photo 11: View of a rock dike opening and warning signs along CU#3

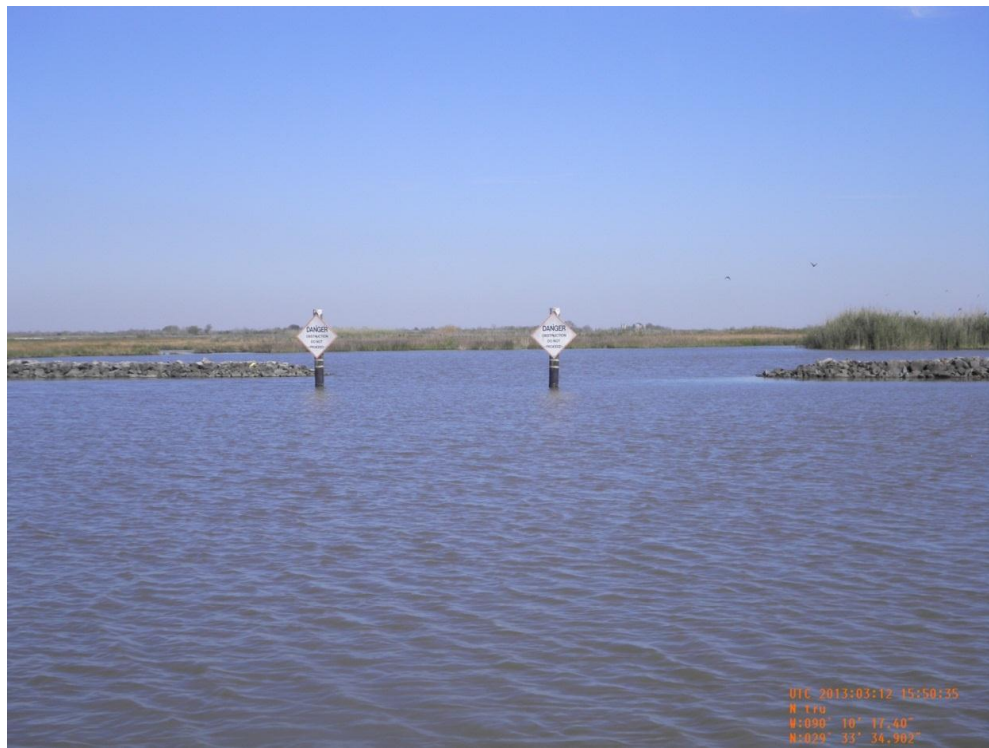
Photo 12: View of a rock dike opening and warning signs along CU#3

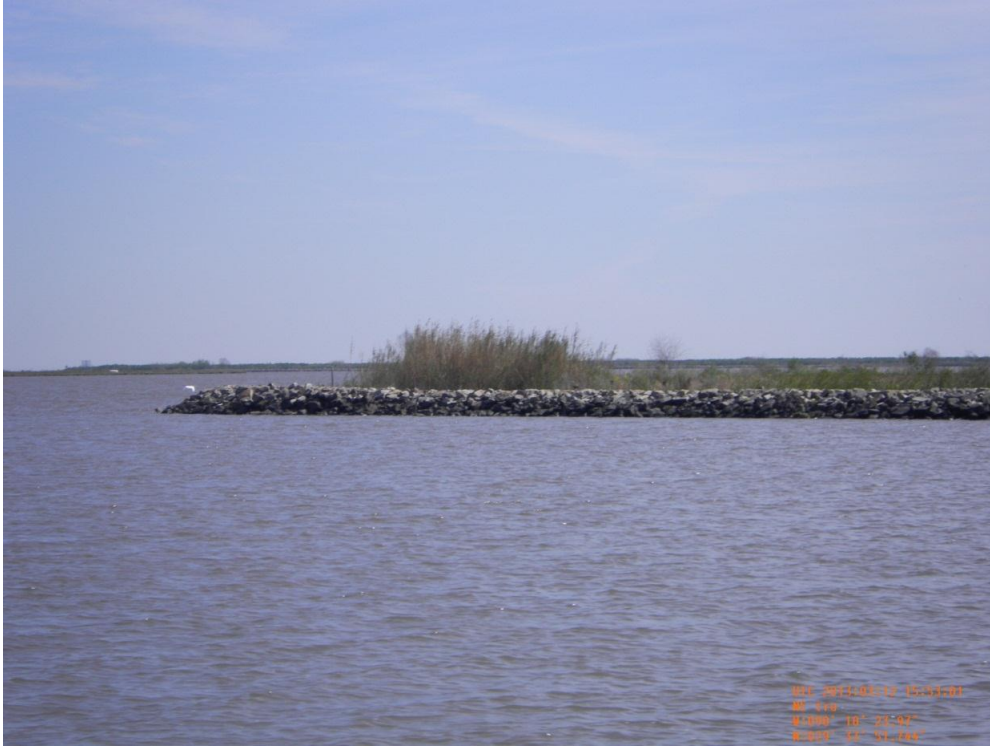
Photo 13: View of the CU#3 rock dike along the southern end of Bayou Perot

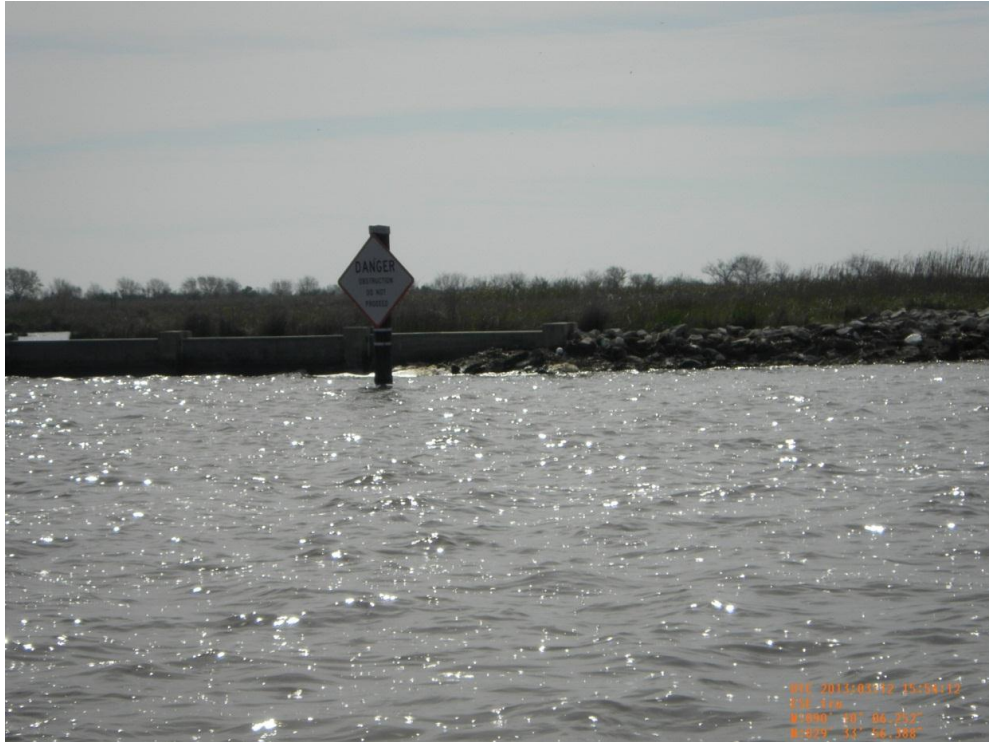
Photo 15: View of rock revetment tie-in on the western end of CU#4

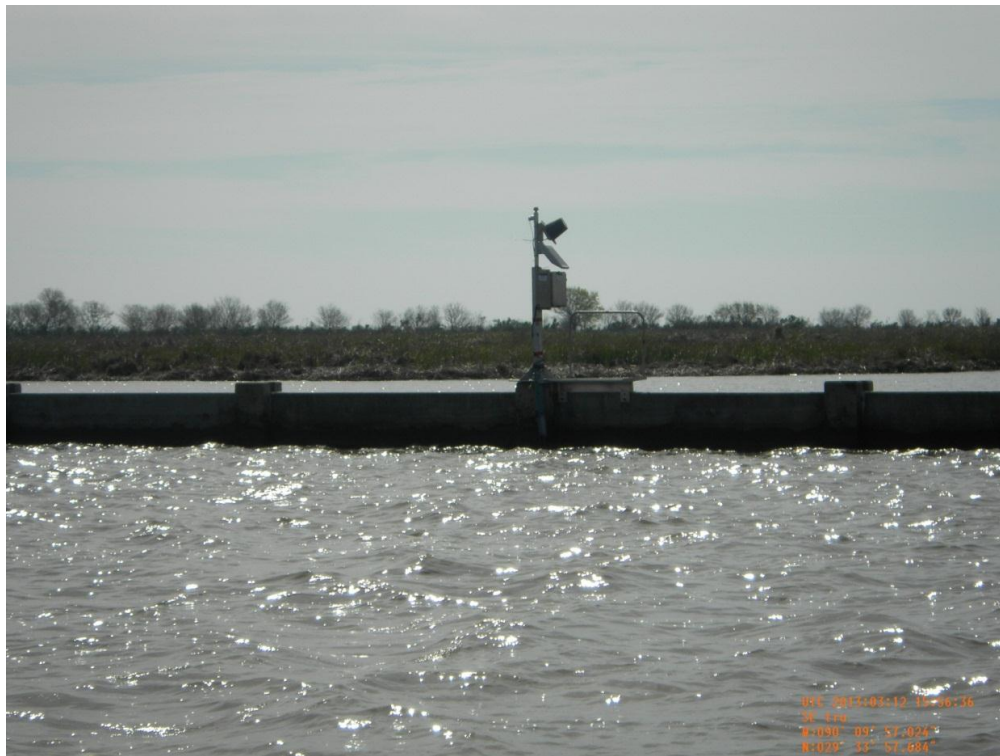
Photo 16: View of data station illicitly installed on the CU#4 concrete wall

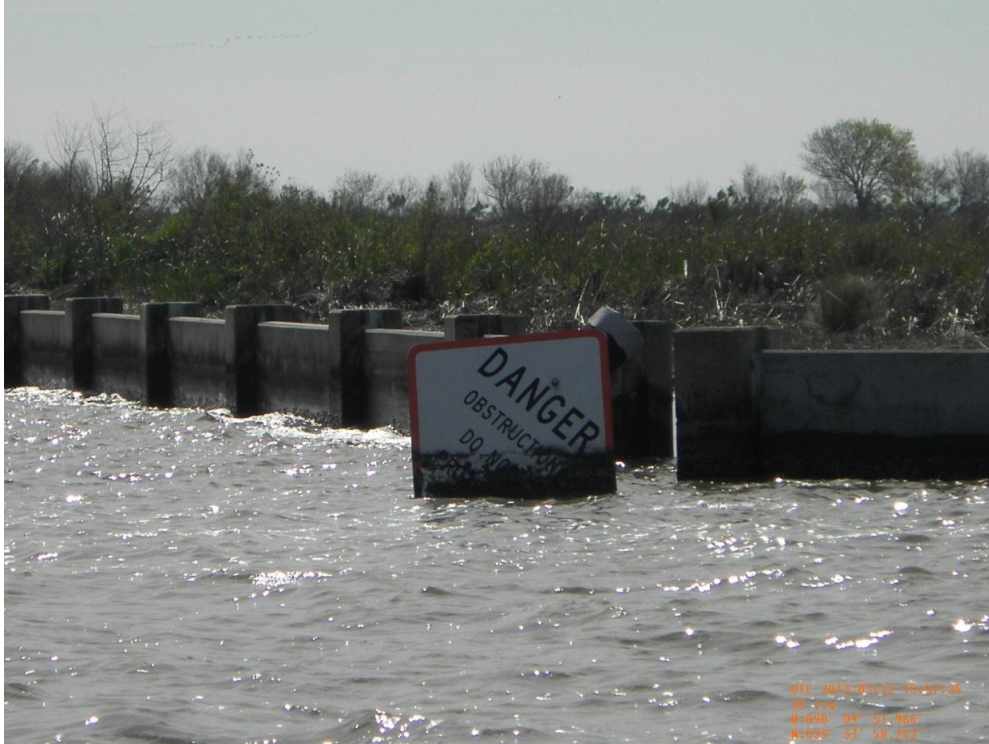
Photo 17: View of damaged warning sign along CU#4 concrete wall near an oilfield canal

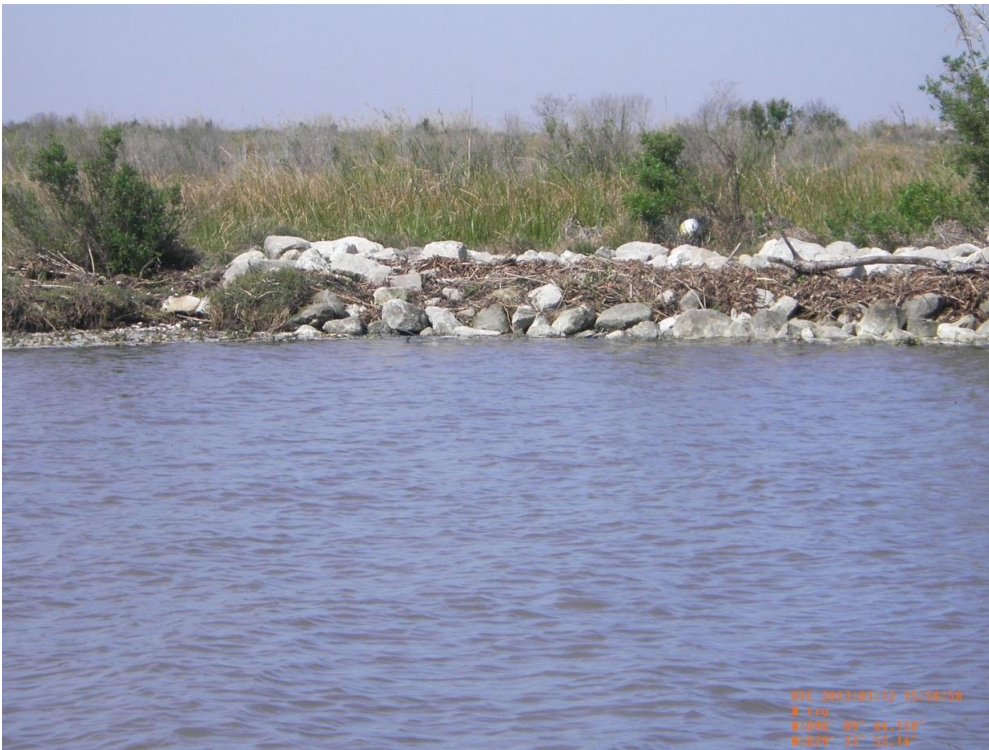
Photo 18: View of CU#4 rock tie-in on south side of oilfield canal

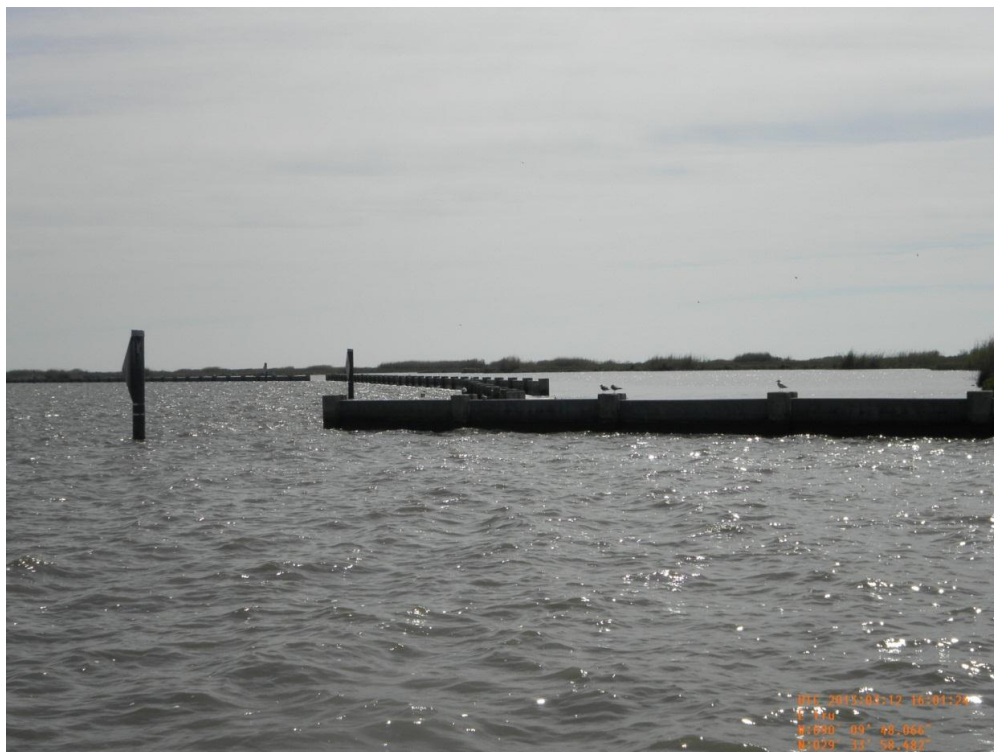
Photo 20: View of CU#4 concrete wall along southern end of Bayou Perot looking east

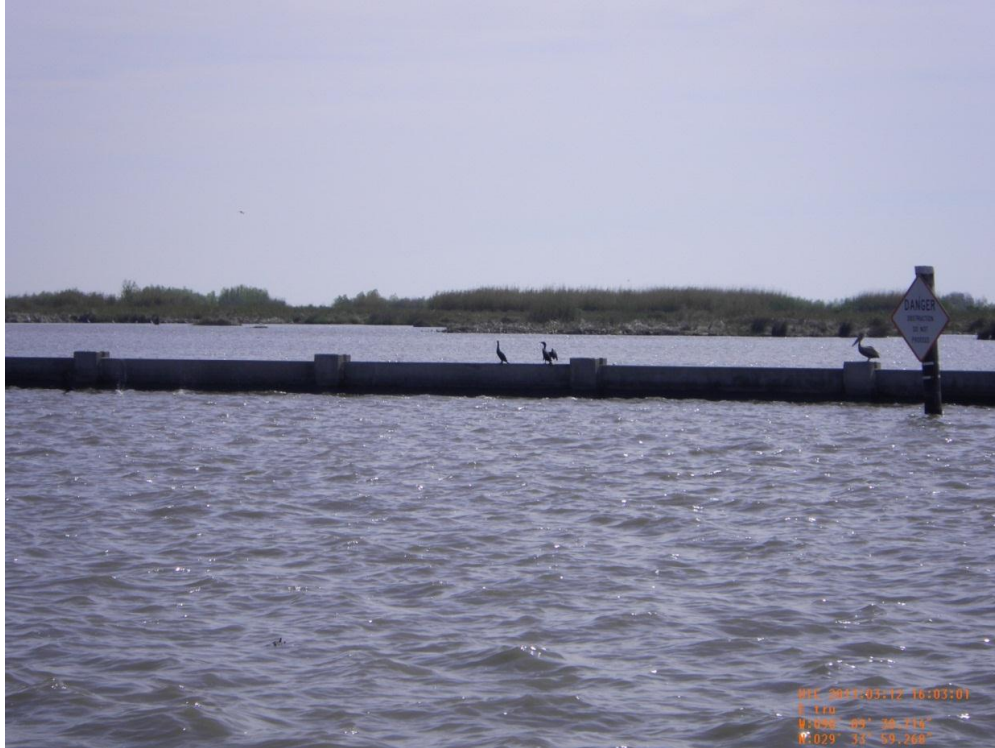
Photo 21: View of CU#4 concrete wall along southern end of Bayou Perot looking south

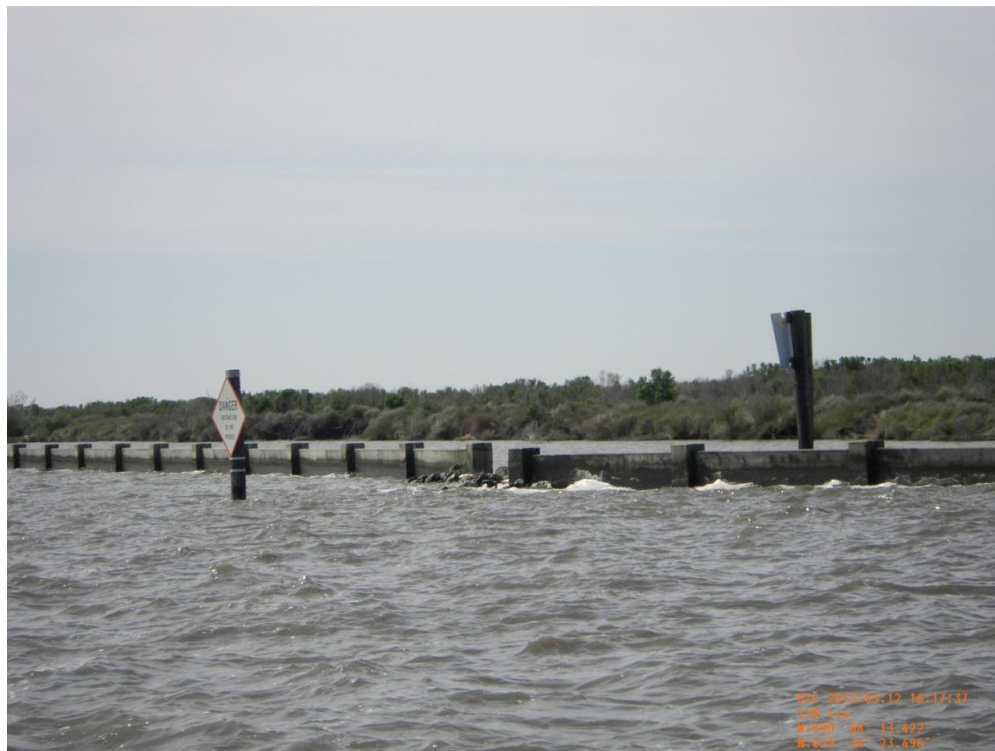
Photo 22: View of the CU#4 concrete wall near the Harvey Cutoff canal

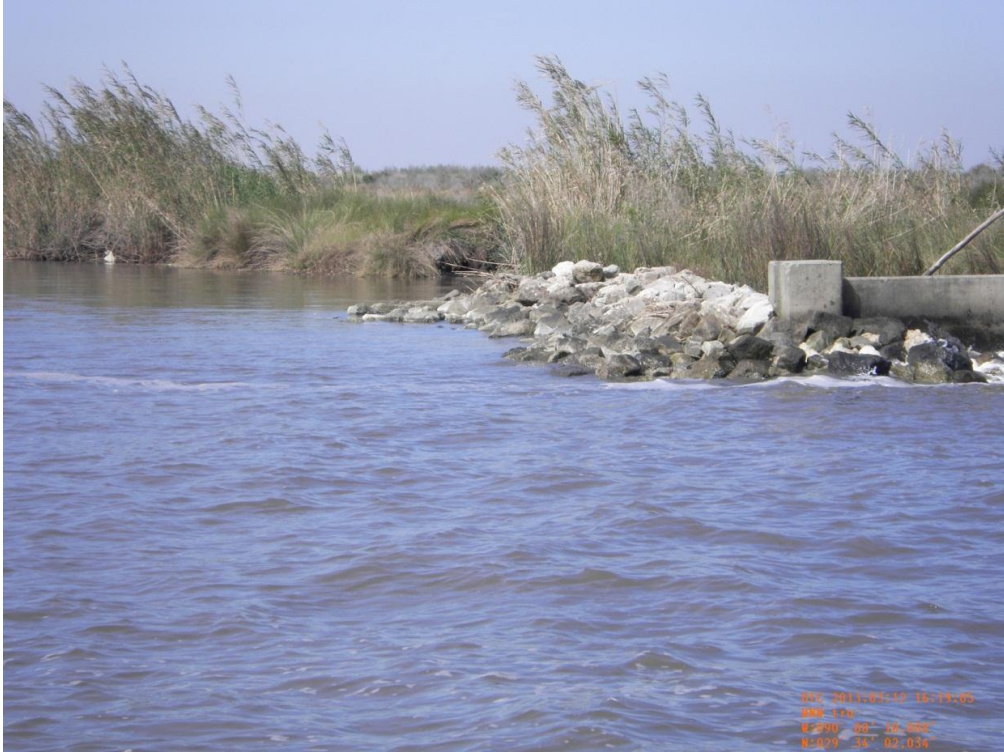
Photo 23: View of the CU#4 rock tie-in on the west side of Harvey Cutoff canal

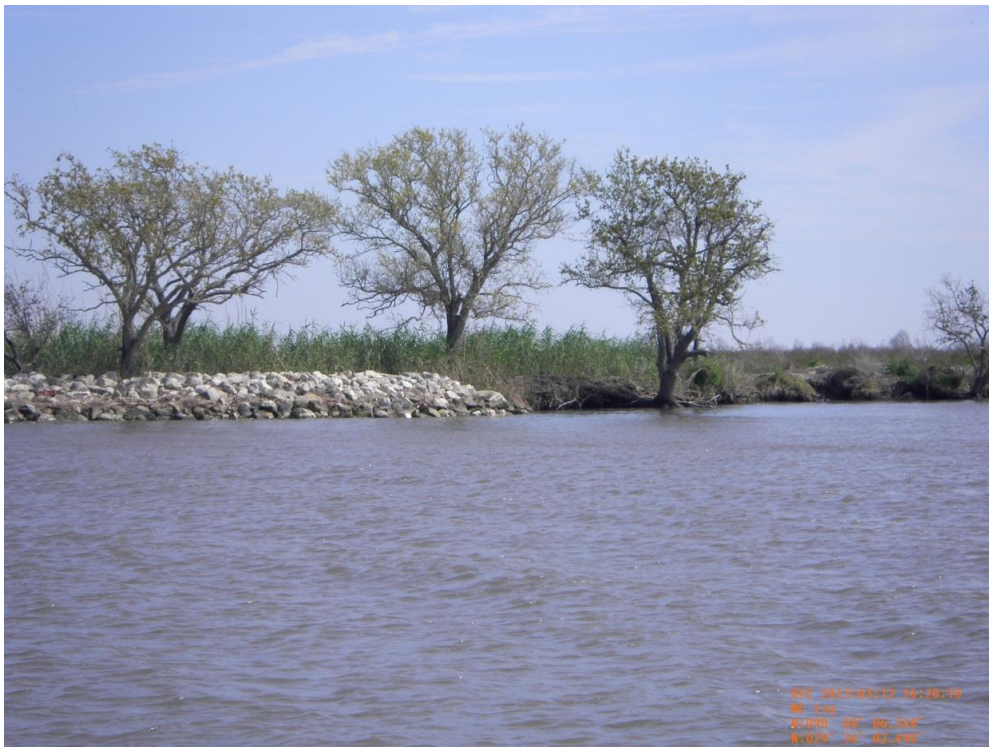
Photo 24: View of the CU#4 rock tie-in on the east side of Harvey Cutoff canal

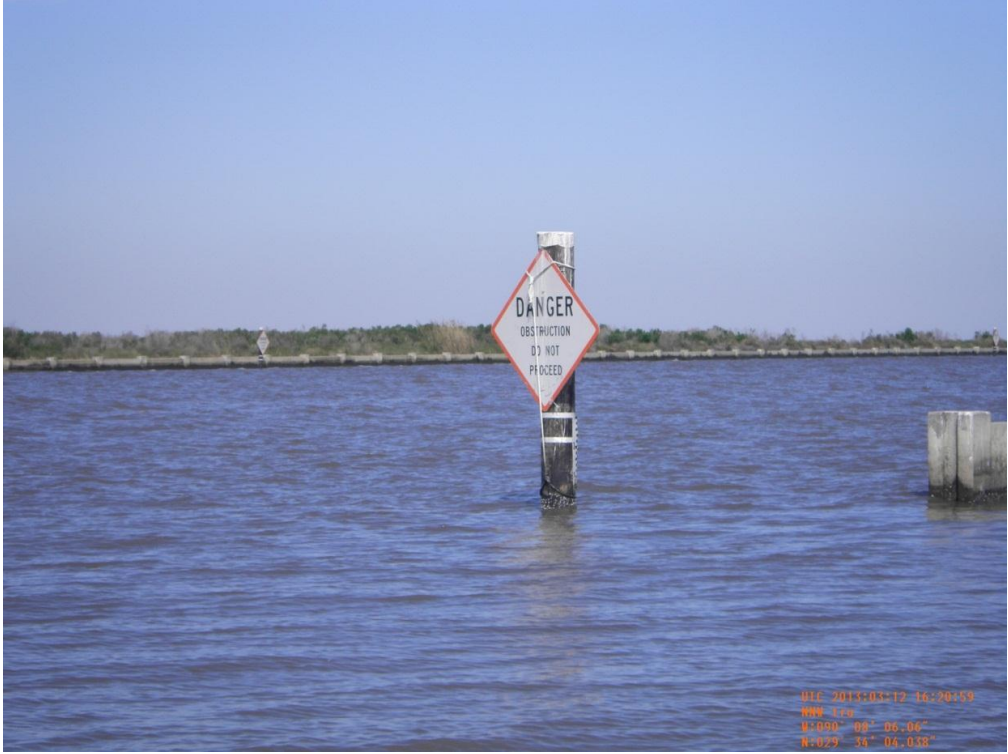
Photo 25: View of rope hanging off of warning sign in the Harvey Cutoff canal

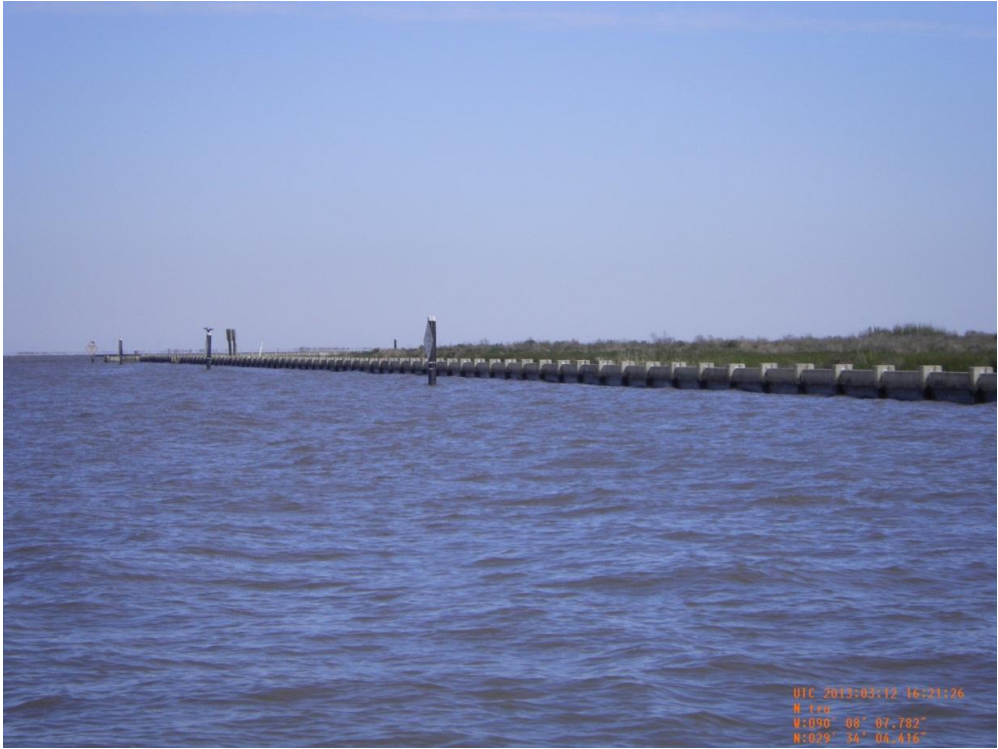
Photo 26: View of the CU#4 concrete wall along the east side of Harvey Cutoff canal

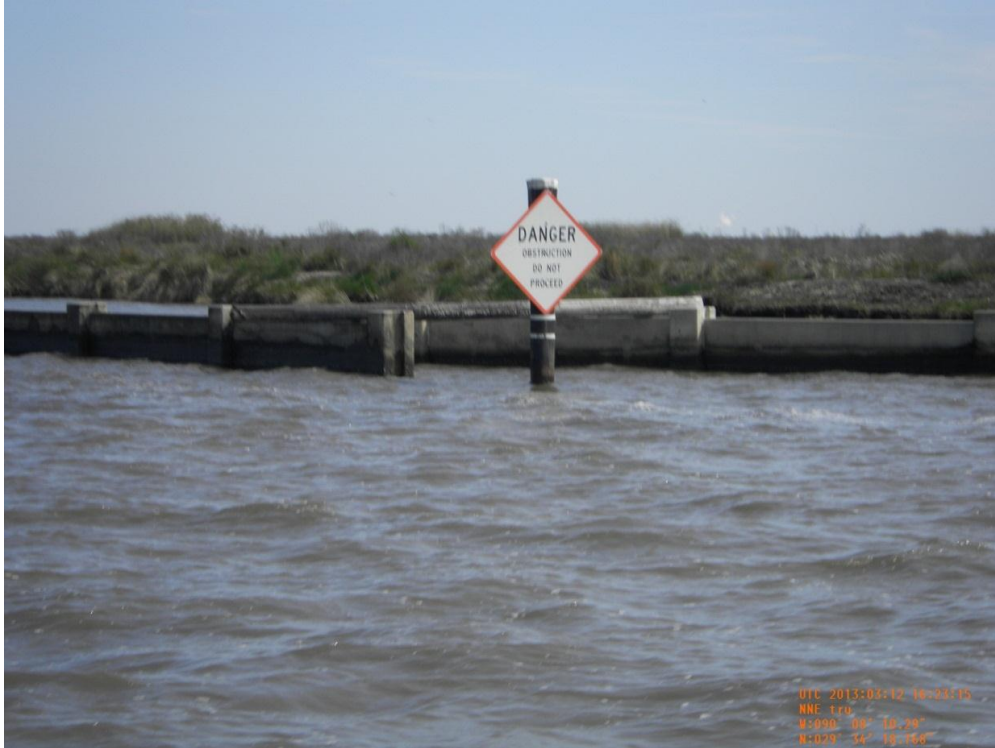
Photo 27: View of timber piling resting on top of the CU#4 concrete wall near Harvey Cutoff canal

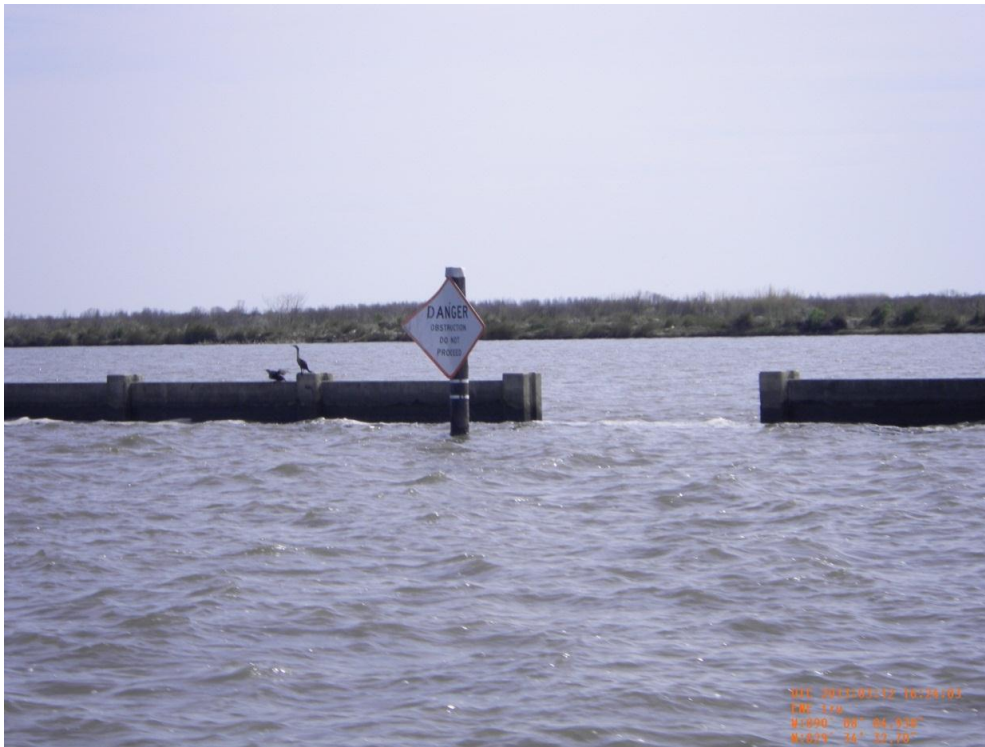
Photo 28: View of a bent warning sign along CU#4 concrete wall near Harvey Cutoff canal

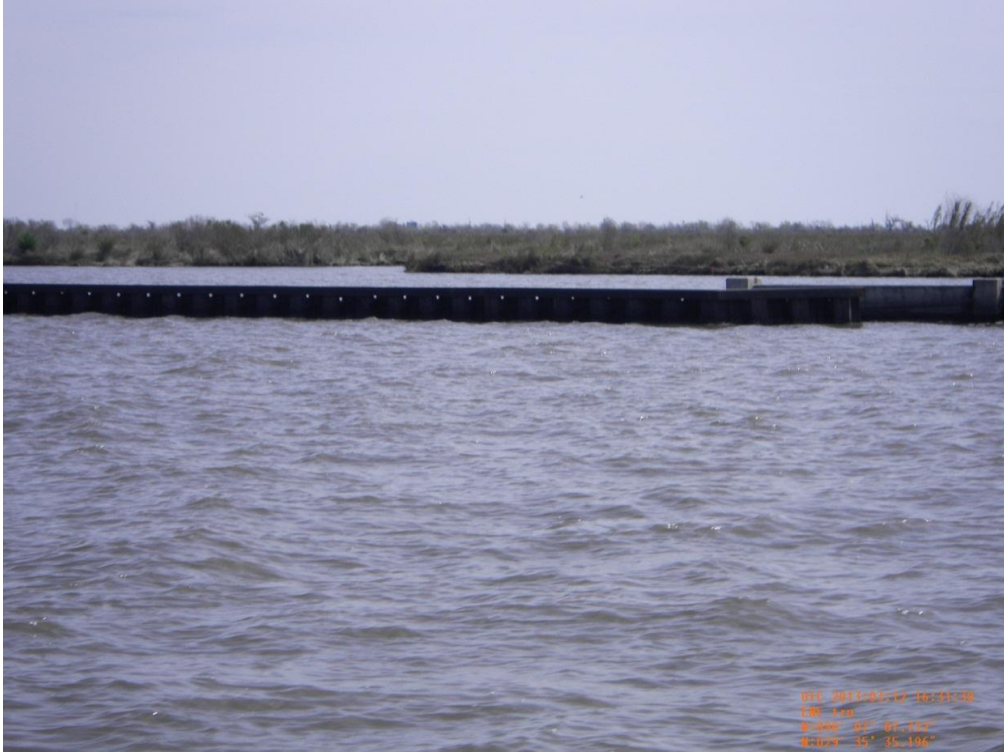
Photo 29: View of steel bulkhead placed to close gap left in CU#4 concrete wall

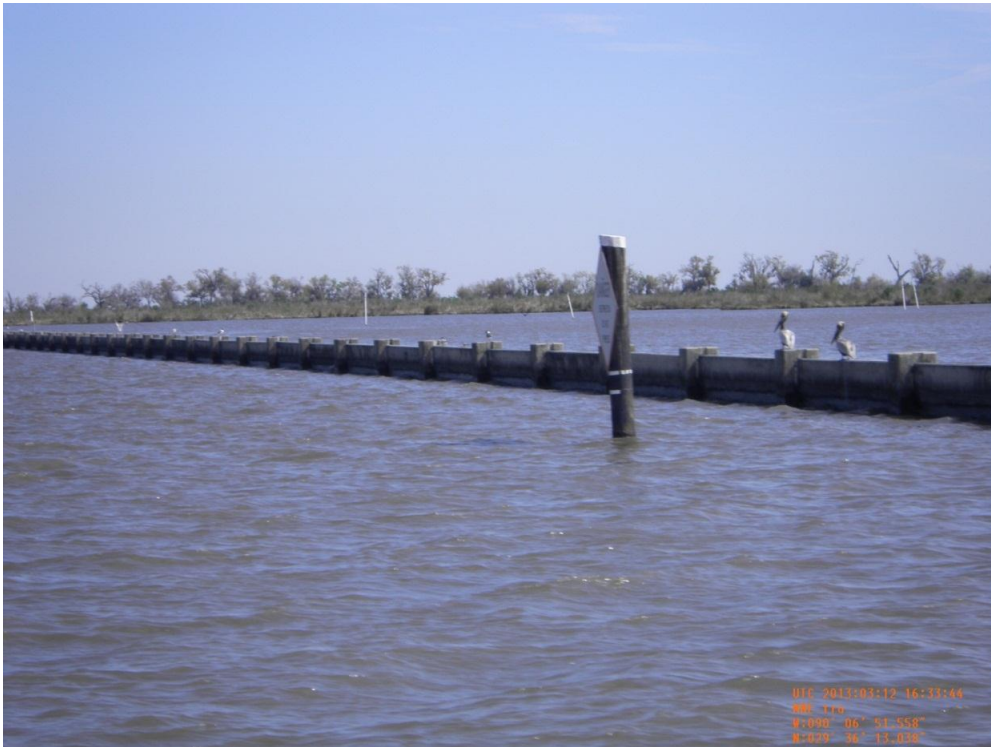
Photo 30: View of CU#4 concrete wall along the eastern side of Bayou Rigolettes

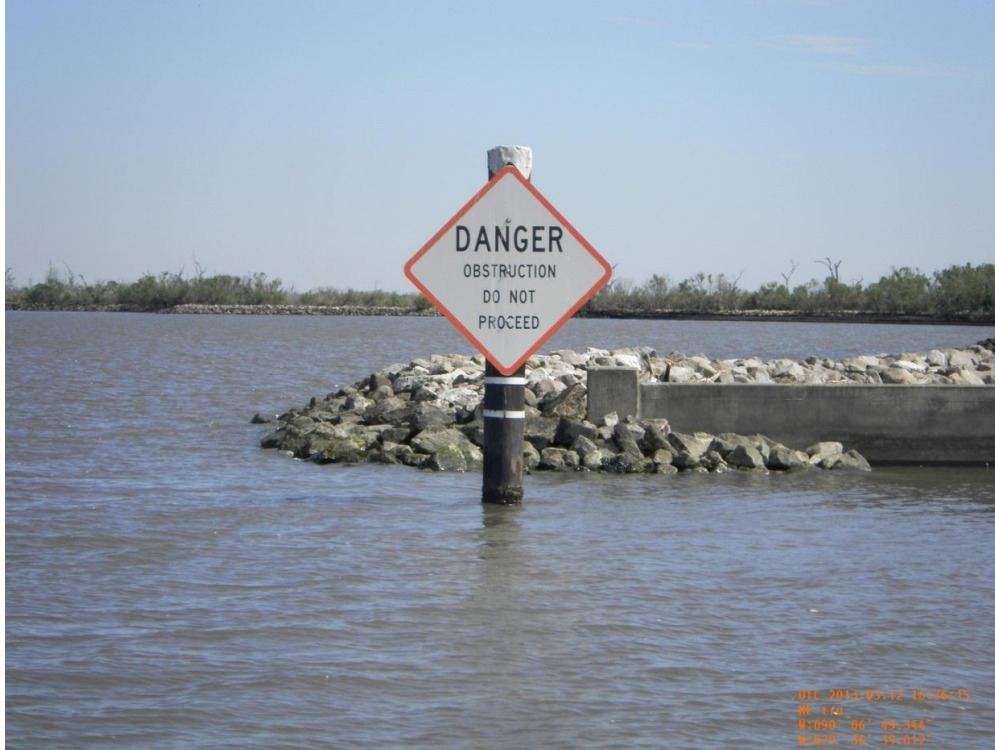
Photo 31: View of warning sign and CU#4 concrete wall transition to rock revetment tie-in

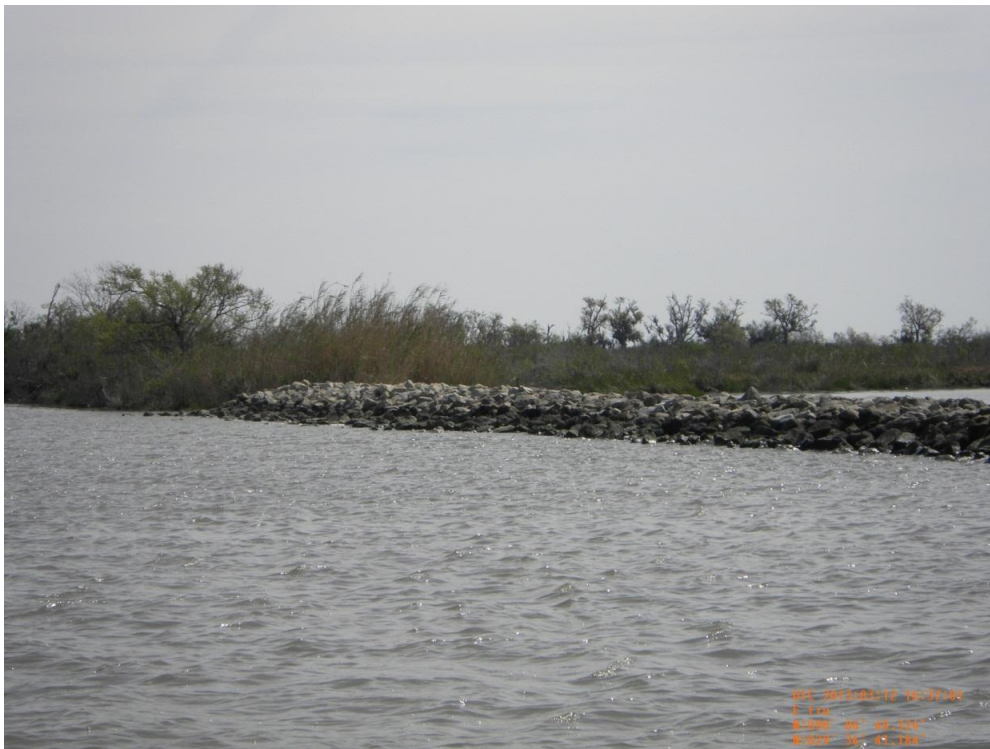
Photo 32: View of CU#4 rock embankment tie-in on south side of oilfield canal
