**2013 Operations, Maintenance,
and Monitoring Report**

**BARATARIA BASIN LANDBRIDGE
SHORELINE PROTECTION
PROJECT (PHASES 1&2, 3, and 4)**

State Project Number BA-27
Phases 1 & 2, Priority Project List 7
Phase 3, Priority Project List 9
Phase 4, Priority Project List 11

July 2, 2013
Lafourche & Jefferson Parishes

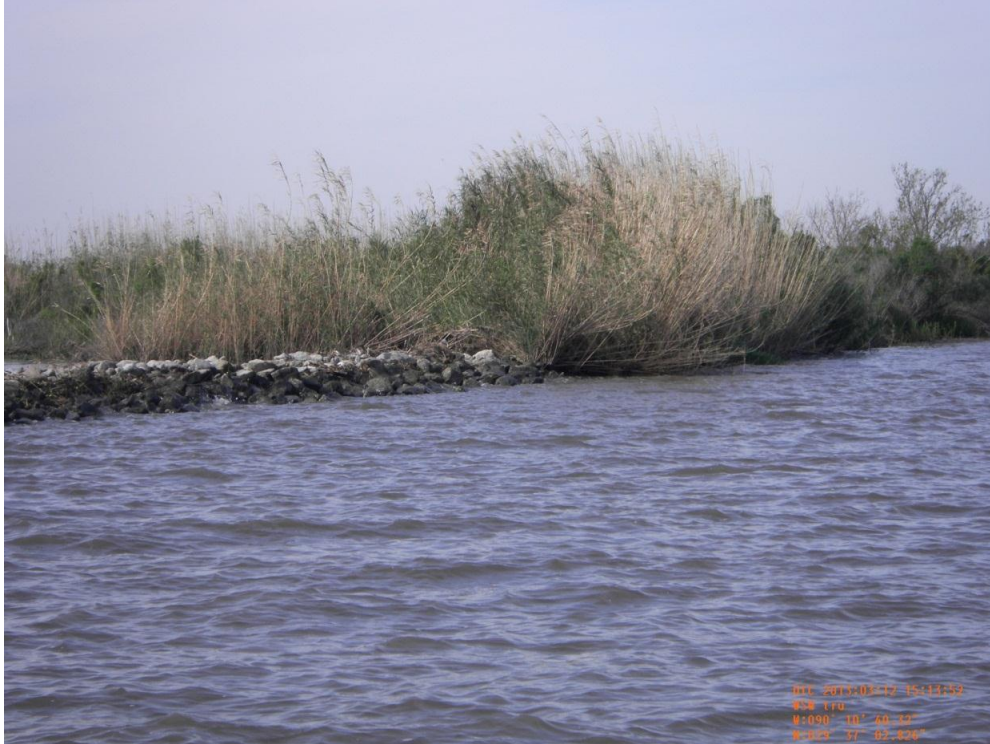
CU 5 was also constructed in early 2009 and appeared to be in good condition with no displacement or cracked panels. The inspection began at the northernmost point of CU 5 on the west bank of Bayou Perot near the Enbridge Pipeline Canal and progressed southward along the shoreline to the southernmost point of CU 5 at an existing location canal. The rock tie-ins were also in very good condition with no obvious washouts or erosion. There are no recommendations for maintenance of CU 5 at this time. (Appendix B, Photos #33-37)

Photo 33: View of rock revetment embankment tie-in on the north end of CU#5

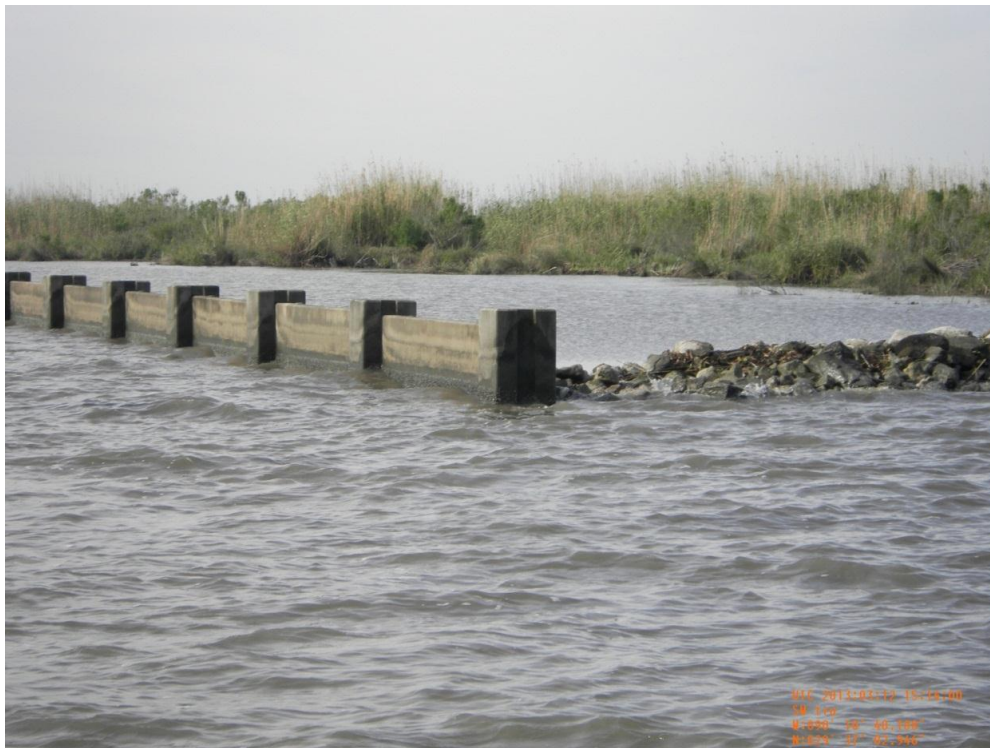
Photo 34: View of transition between rock revetment and concrete wall on north end of CU#5

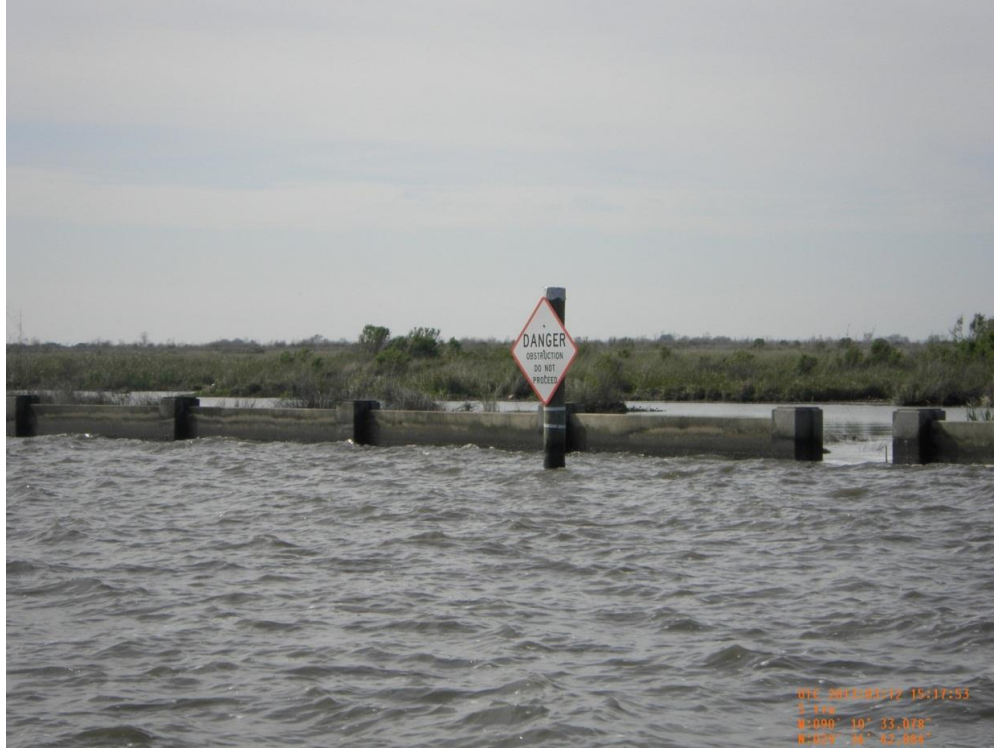
Photo 35: View of concrete wall and warning sign along CU#5

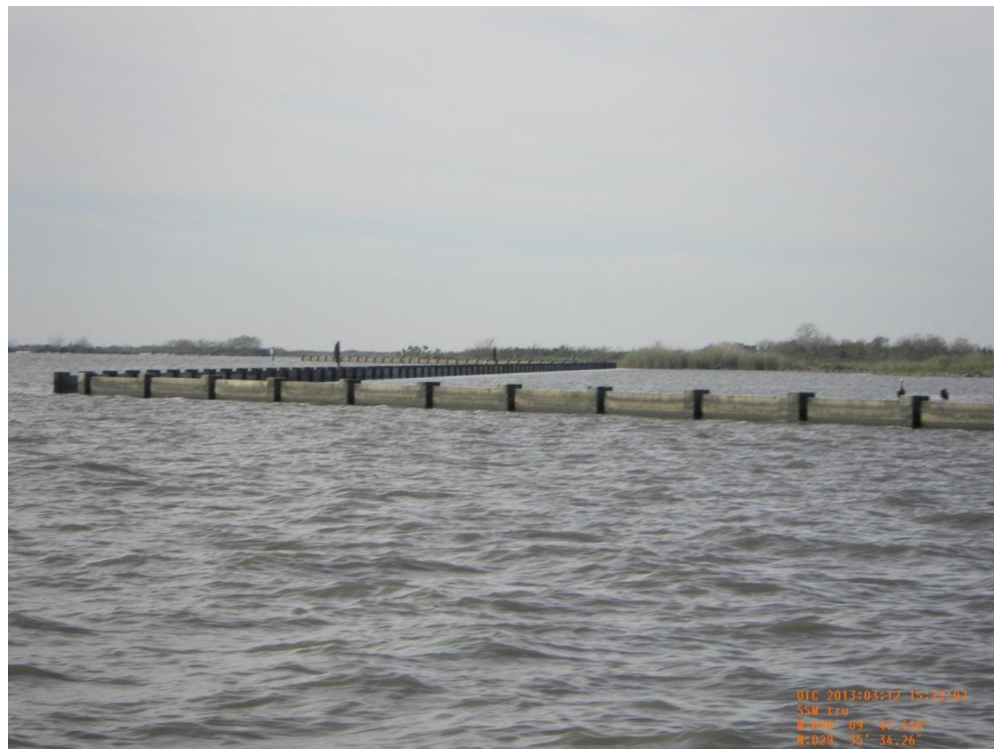
Photo 36: View of concrete wall of CU#5 along Bayou Perot looking south

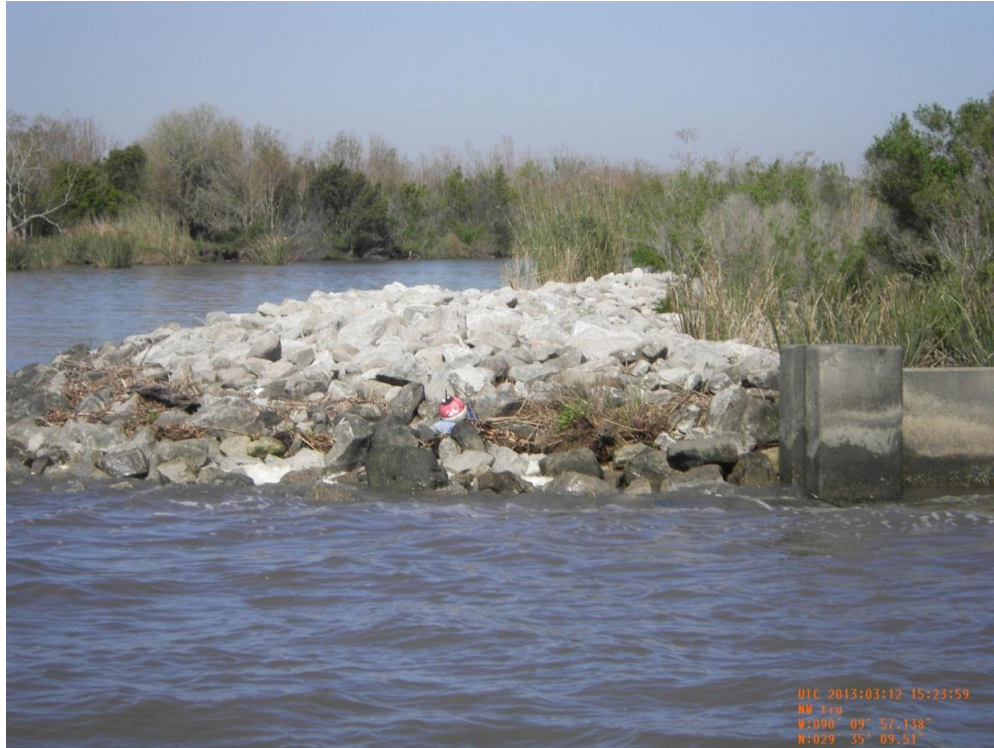
Photo 37: View of rock revetment embankment tie-in on the south end of CU#5

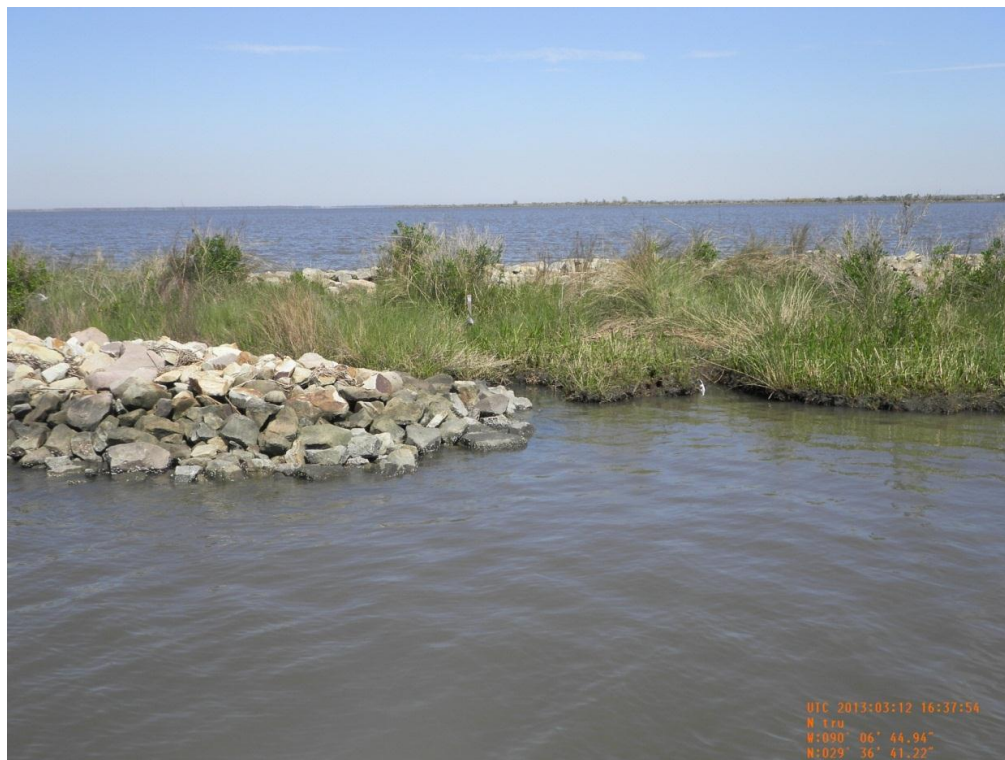
The rock dike appeared to be in good overall condition with no visual displacement or settlement of rock material. The inspection of CU 6 began at Sta. 0+00 near an existing oilfield access canal and proceeded along the east bank of Bayou Rigolettes to Sta. 307+78 near the Barataria Waterway. All signs and supports at the fish dip locations were also in good condition. We are not recommending any corrective actions at this time. (Appendix B, Photos # 38-48)

Photo 38: View of CU#6 rock embankment tie-in on north side of oilfield canal

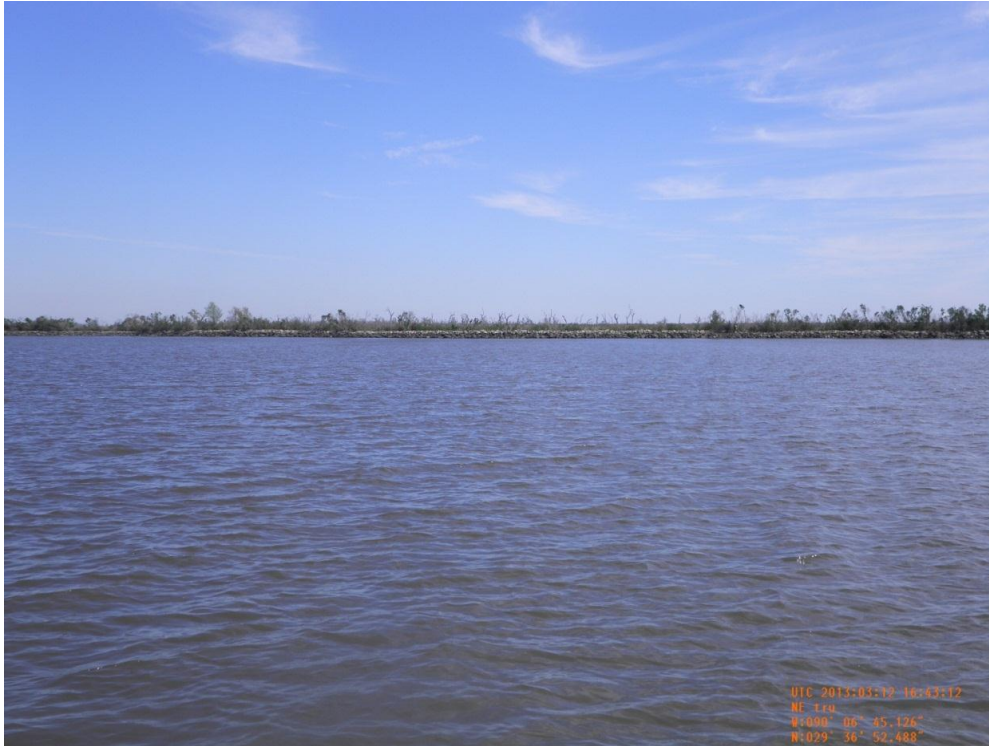
Photo 39: View of CU#6 rock dike along the eastern side of Bayou Rigolettes

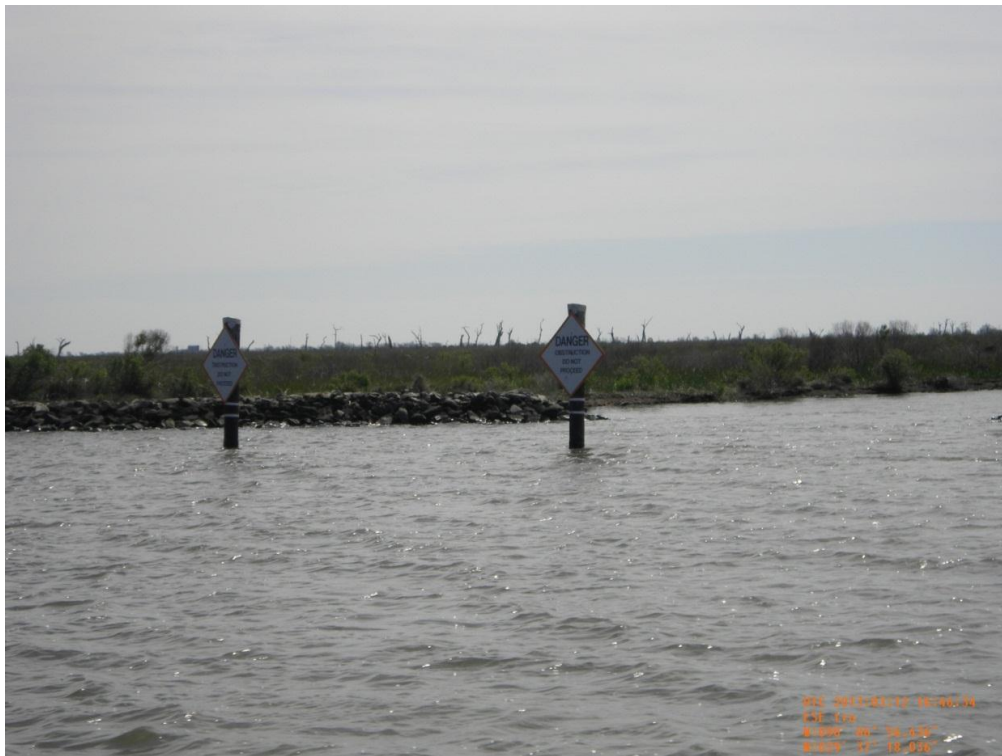
Photo 40: View of warning signs and CU#6 rock dike along eastern side of Bayou Rigolettes

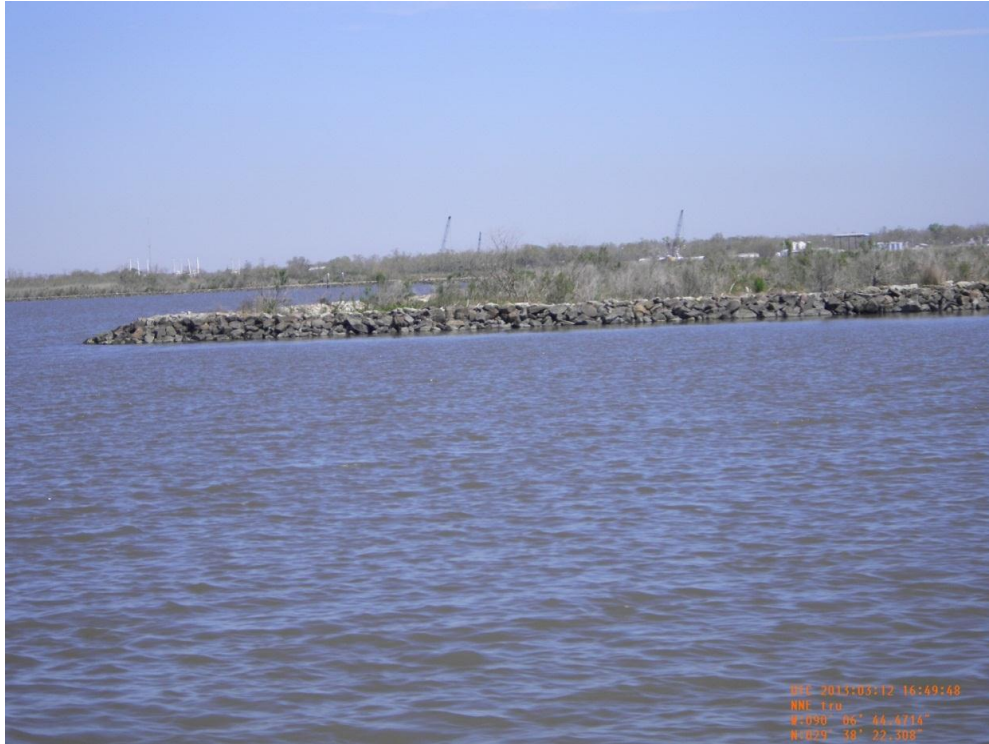
Photo 41: View of CU#6 rock dike from Bayou Rigolettes looking northeast

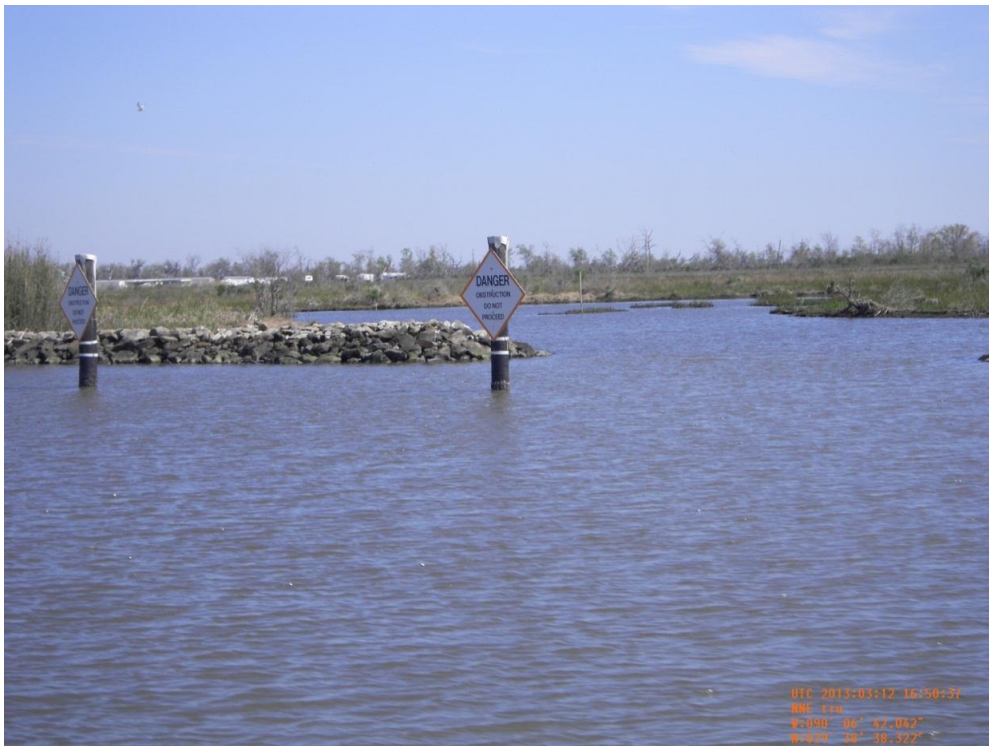
Photo 42: View of warning signs and CU#6 rock dike along eastern side of Bayou Rigolettes

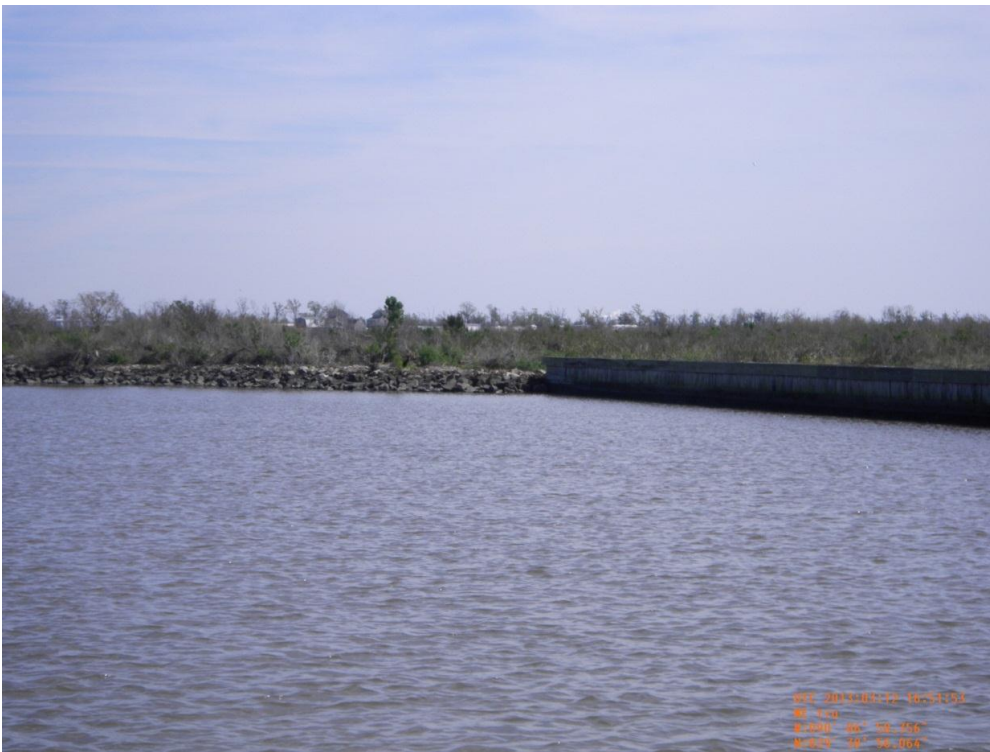
Photo 44: View of intersection of CU#6 rock dike and pipeline timber bulkhead looking east

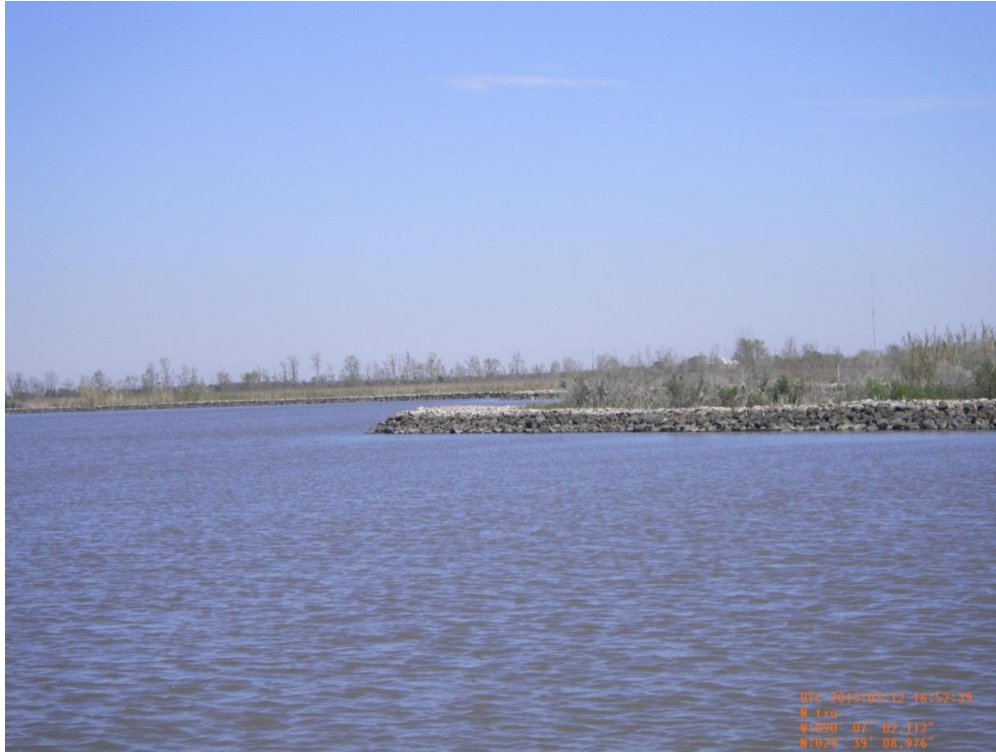
Photo 45: View of CU#6 rock dike from Bayou Rigolettes looking north

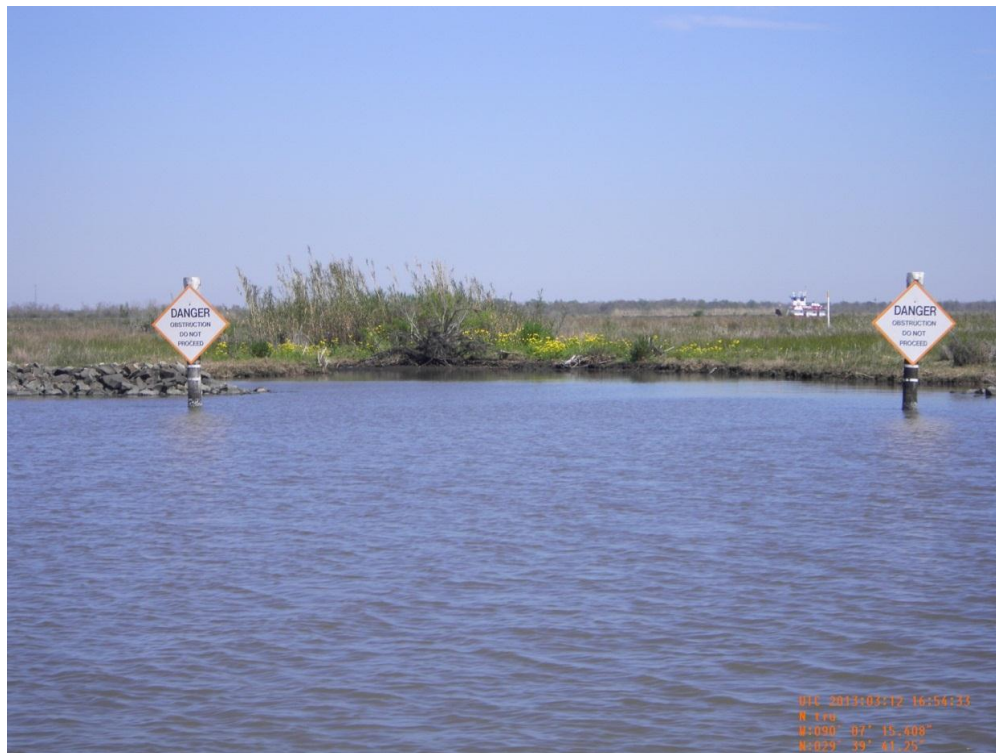
Photo 46: View of warning signs and CU#6 rock dike along eastern side of Bayou Rigolettes

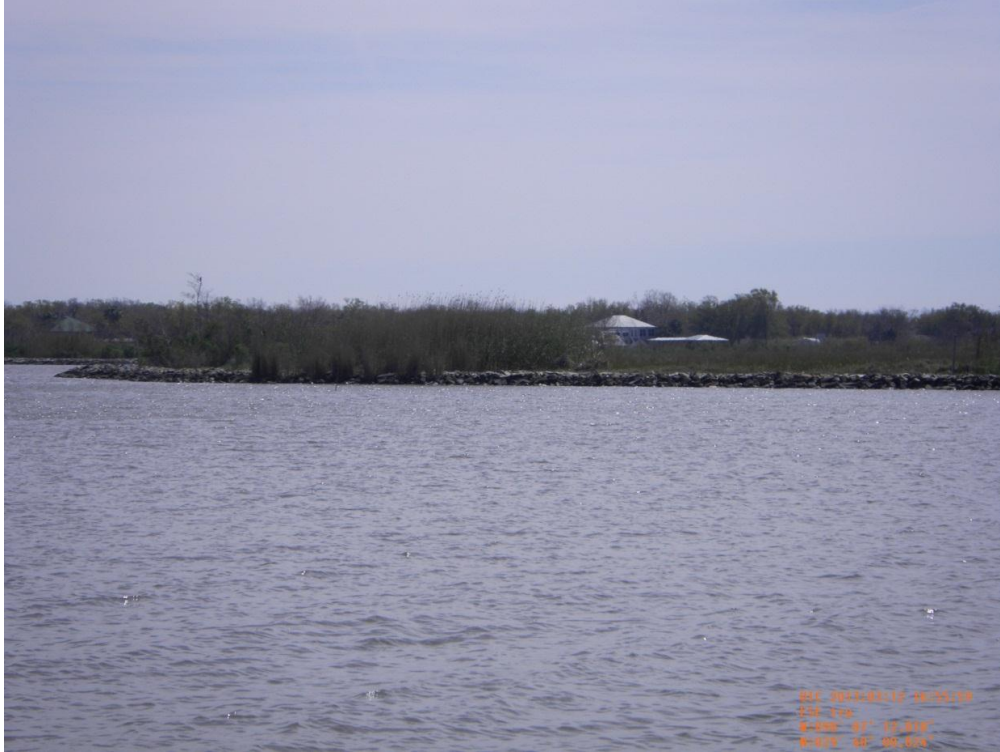
Photo 47: View of CU#6 rock dike from Bayou Rigolettes looking east

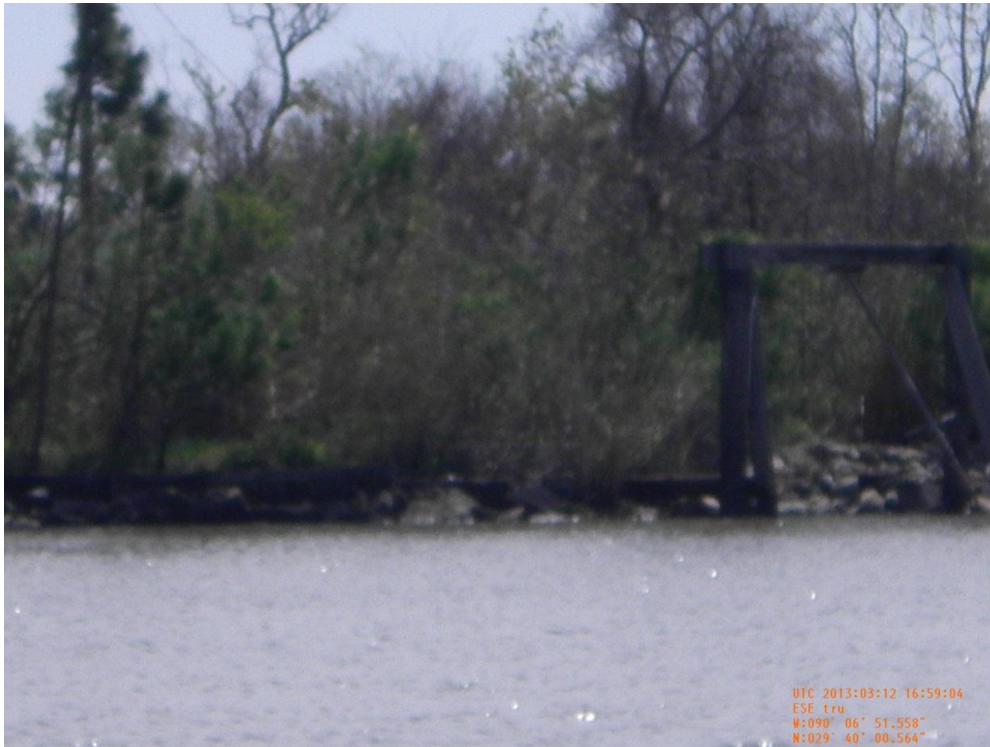
Photo 48: View of northern CU#6 rock dike embankment tie-in near Laffite
