# 2013 Operations, Maintenance, and Monitoring Report

## East Marsh Island Marsh Creation

State Project Number TV-21  
Priority Project List 14

June 2013  
Iberia Parish

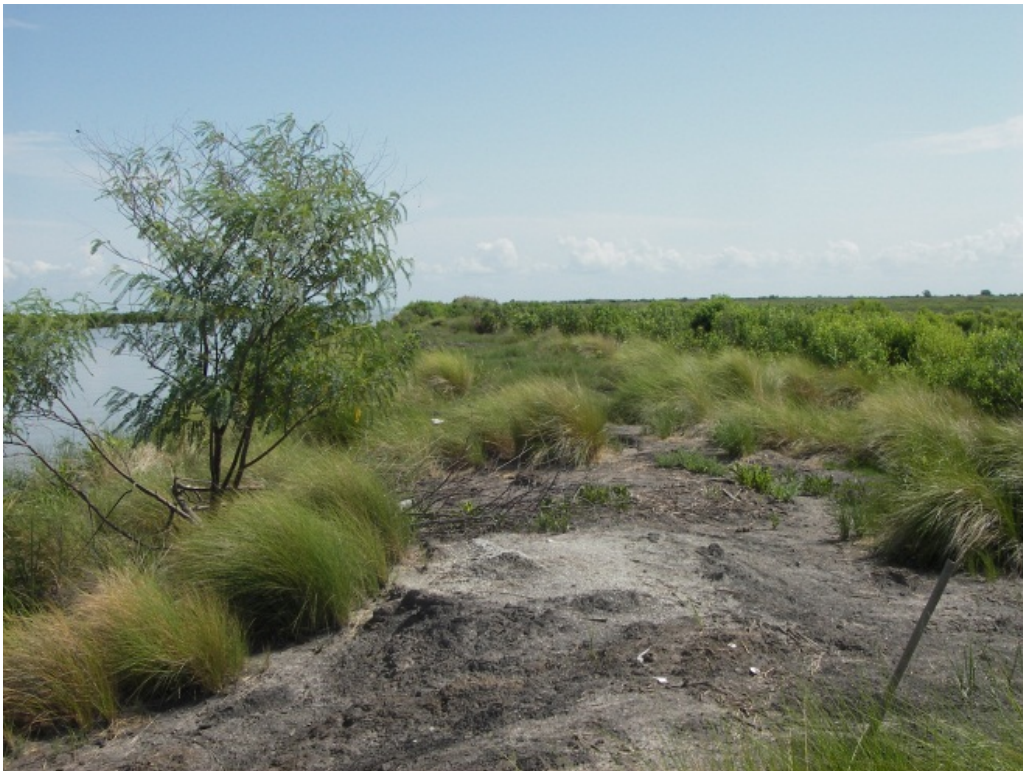
The two marsh creation cells are in good condition since the project was completed in 2010. (Photos: Appendix B, Photo 1, 4, 5 & 7) It is estimated that there is seventy per cent (70%) natural vegetation cover despite the large nutria population. The one year post construction surveys completed by T. Baker Smith in December 2011 indicated

NRCS prepared plans and specifications to install 55,000 vegetative plants (five different species) which was bid in December 2010, awarded in January 2011, and mobilization to the project site on July 2011; however, only 3,257 plants were actually installed before the contractor defaulted on the project. No further planting project was pursued within the two Marsh Creation Cells No. 1 & 2 such that the natural vegetation was flourishing. NRCS is currently looking at planting a woody species on the remnant containment dike. (Photos: Appendix B, Photo 1 &4)

**Photo No. 1,** Containment Dike and Marsh Creation Cell No.1 (Looking North)

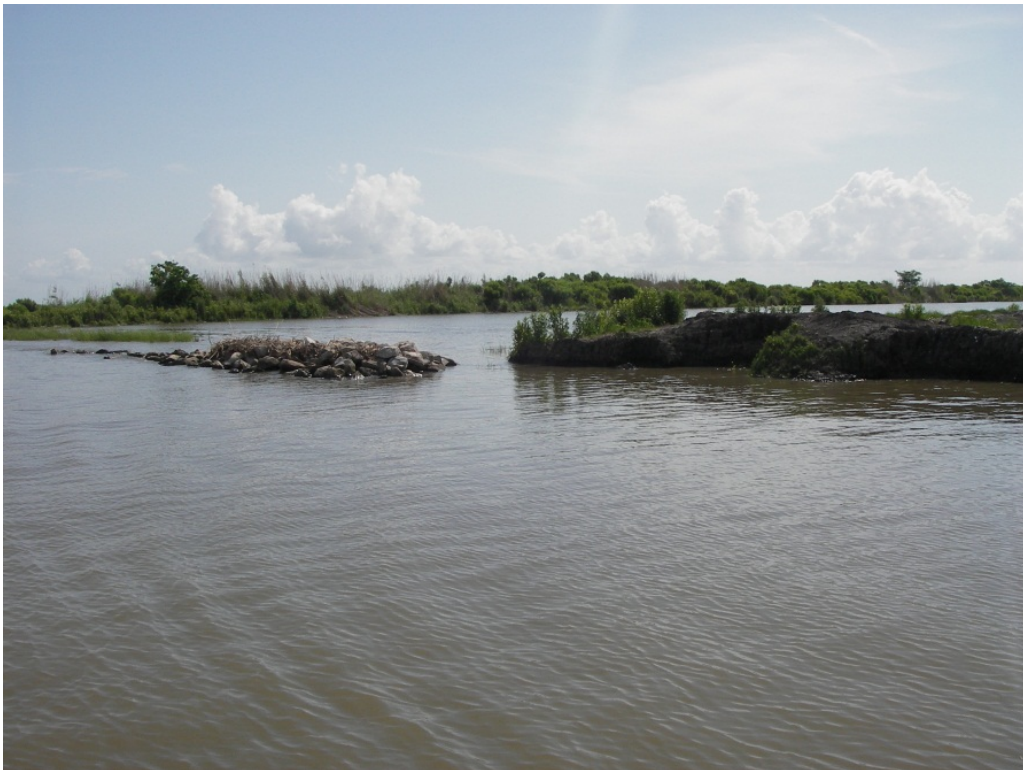
that the marsh platform is settling as expected and is near the target healthy marsh elevation of +1.7 NAVD88 on average. The northern end of the Marsh Creation Cell No. 1 appears to be settling at a greater pace than the remainder of the cell. The majority of the containment dikes are stable and the natural vegetation continues to expand. However, there are two areas of concern which are in need of repair. They are identified by orange ovals in Appendix B, Photo No. 7. One location is along the North-South Canal at its intersection with the East-West Canal adjacent to the rock plug. The second is on the Gulf ward shoreline near the East-West Canal. These areas are experiencing erosion at a fairly rapid rate. (Photos: Appendix B, Photo 2-3 & 7-9)

**Photo No.2,** Containment Dike along North-South Canal at Rock Plug

Repair and armor the two areas of erosion at each end of the East-West Canal located on the North boundary of Marsh Creation Cell No. 1. These breaches

in the containment dike will allow the exchange of gulf water into an interior oilfield canal making the northeast corner of the project vulnerable to deterioration.

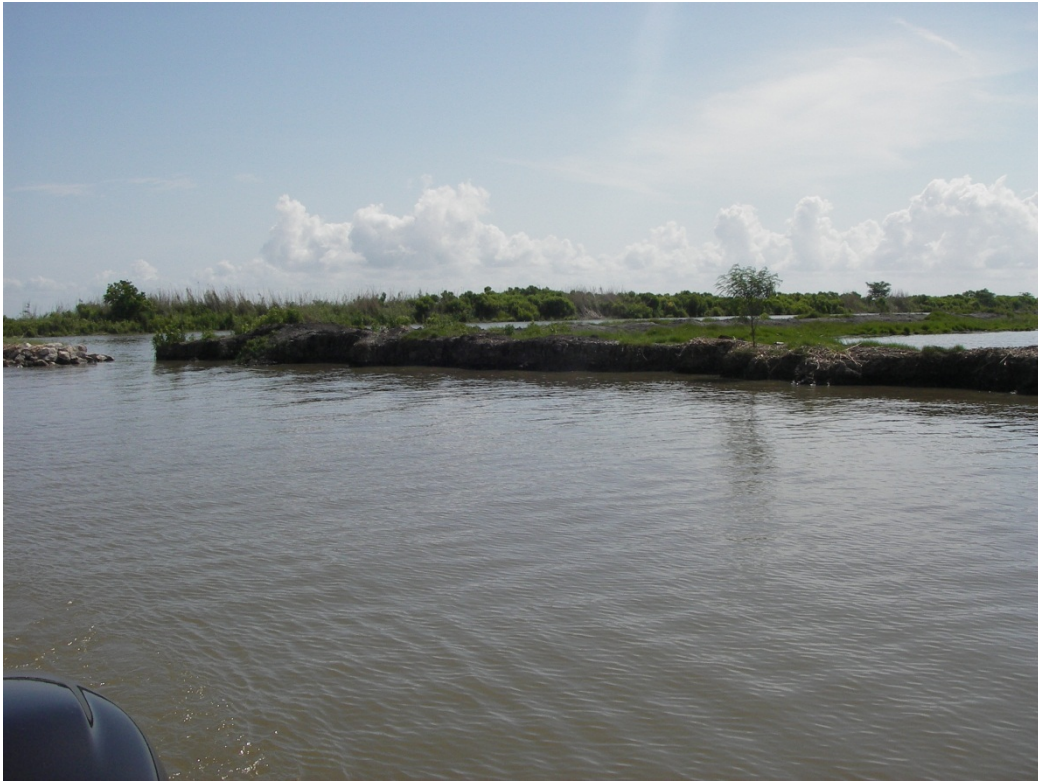
**Photo No. 3, Containment Dike along North-South Canal near Rock Plug**

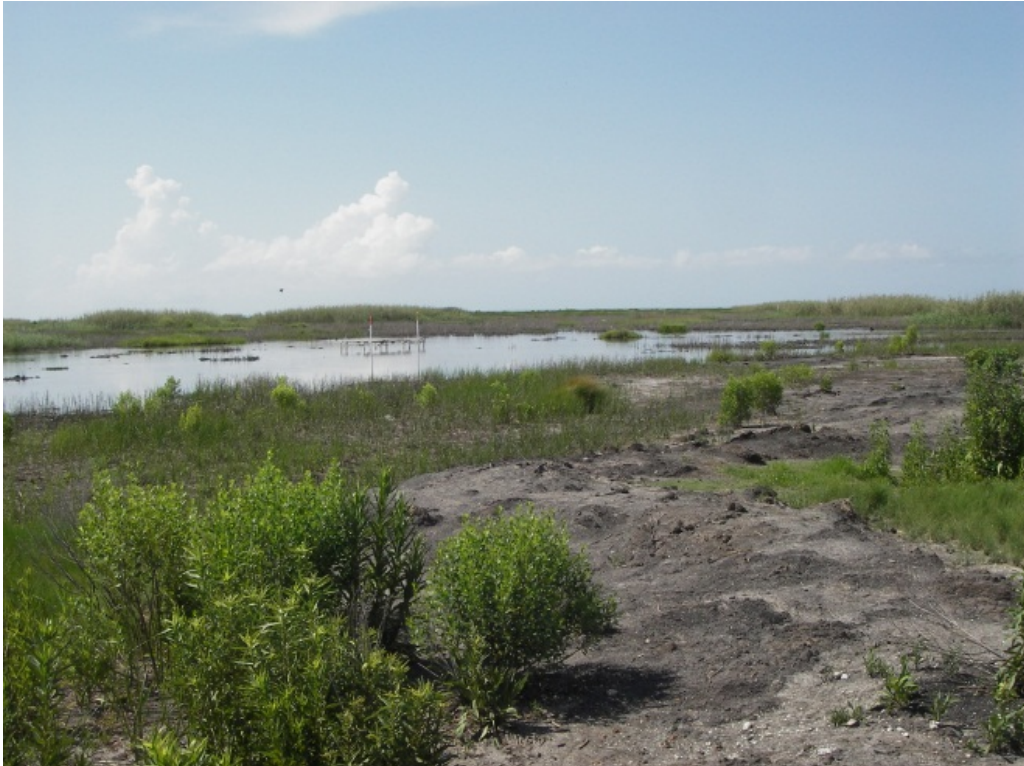
**Photo No. 4, Marsh Creation Cell No.2 (Looking South)**

- Perform the planned gap degrading at the Timber Mat location and Gap “N” in the Marsh Creation cell No. 2 containment dike to allow tidal exchange into that cell.
- Degrade four existing plugs left by the contractor in the interior marsh of Nourishment Area No. 1 and Nourishment Area No. 2 to allow drainage and prevent stagnation.
- NRCS will re-evaluate the vegetation on the containment dikes for a potential Spring 2015 planting (woody species) for those reaches which are bare.

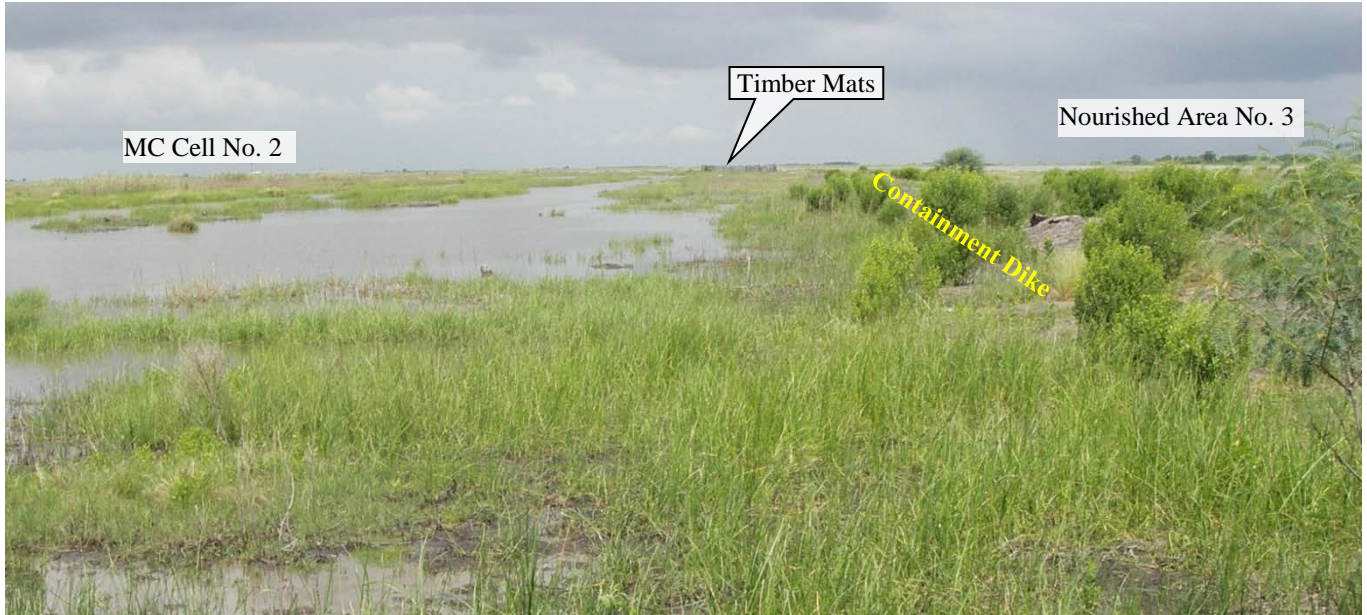
The vegetation in Nourished Areas No. 3 & 4 appears to be in good condition. (Photos: Appendix B, Photo 5) Nourished Areas No. 1 & 2 were not visited during this inspection. However, site visits performed by CPRA monitoring staff indicate that the vegetation in Nourished Area No 2. has been drastically affected by nutria damage.

**Photo No. 5**, Marsh Creation Cell No. 2, Borrow Channel, Containment Dike, Timber Mats, and Nourished Area No. 3 (Looking West)

- Lower an existing gap labeled “Gap N” in the Marsh Creation Cell No. 2 containment dike.
- Remove the timber mats used during the original project construction to repair a containment dike breach and create an additional gap at this location at Hawkins Lake (mats will be removed and disposed of off-site).

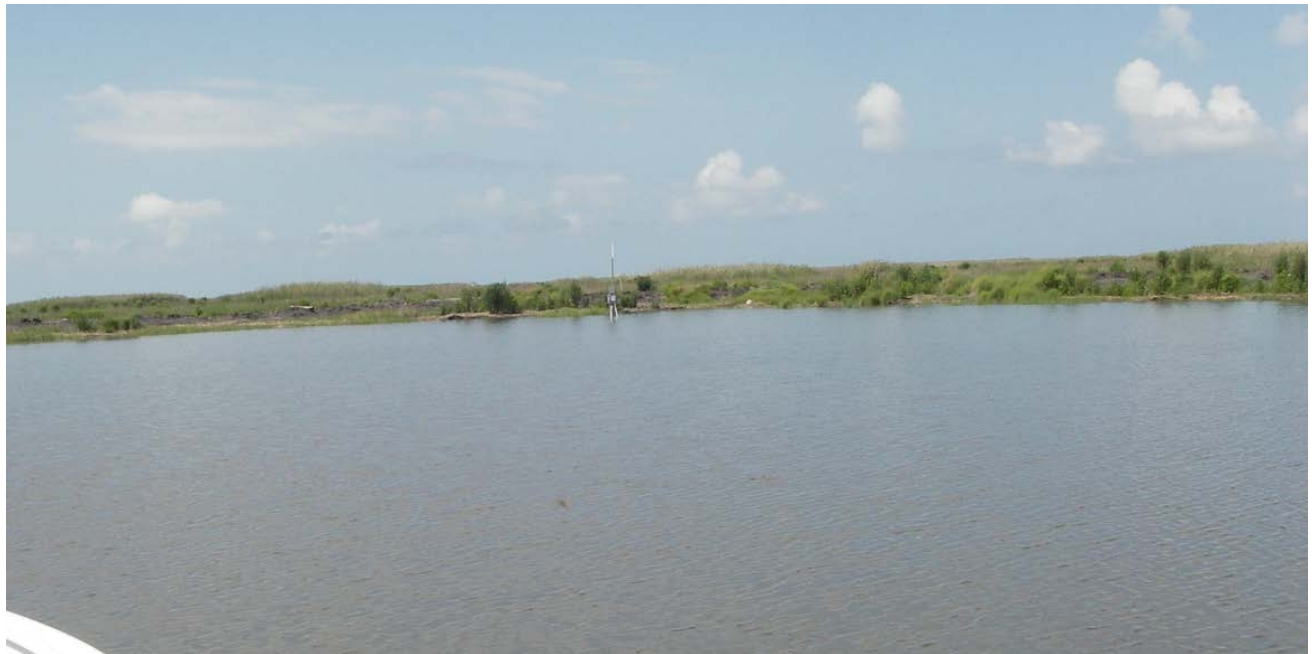
The earthen plug at the end of the North-South Pipeline Canal is holding up well with no differential settlement taking place. There are some bare spots remaining where vegetation has not taken hold. (Photos: Appendix B, Photo 6)

**Photo No. 6**, Earthen Plug at End of North-South Pipeline Canal

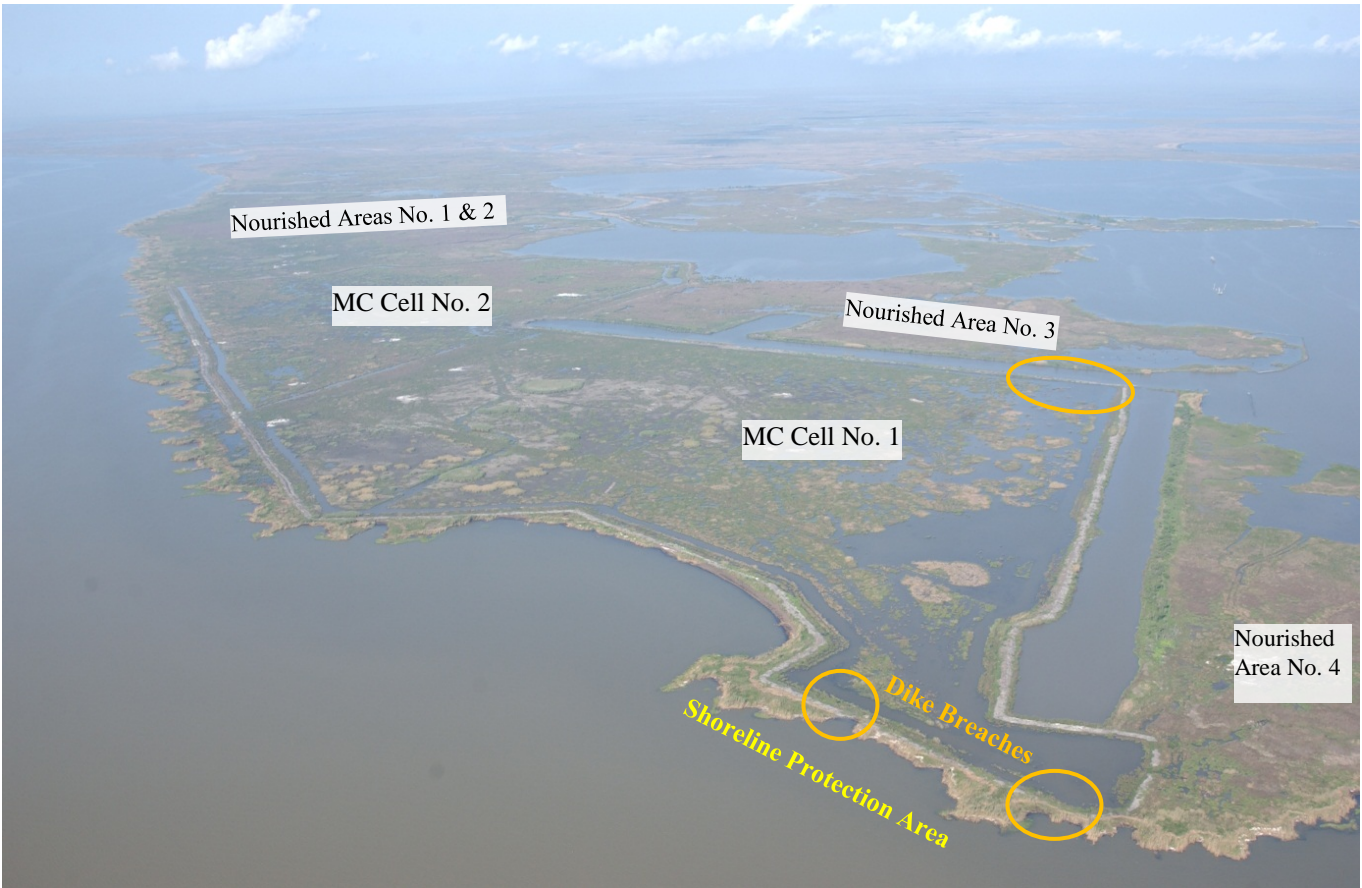
**Photo No. 7**, Aerial view (March 2012), Looking Southwest at Project Area

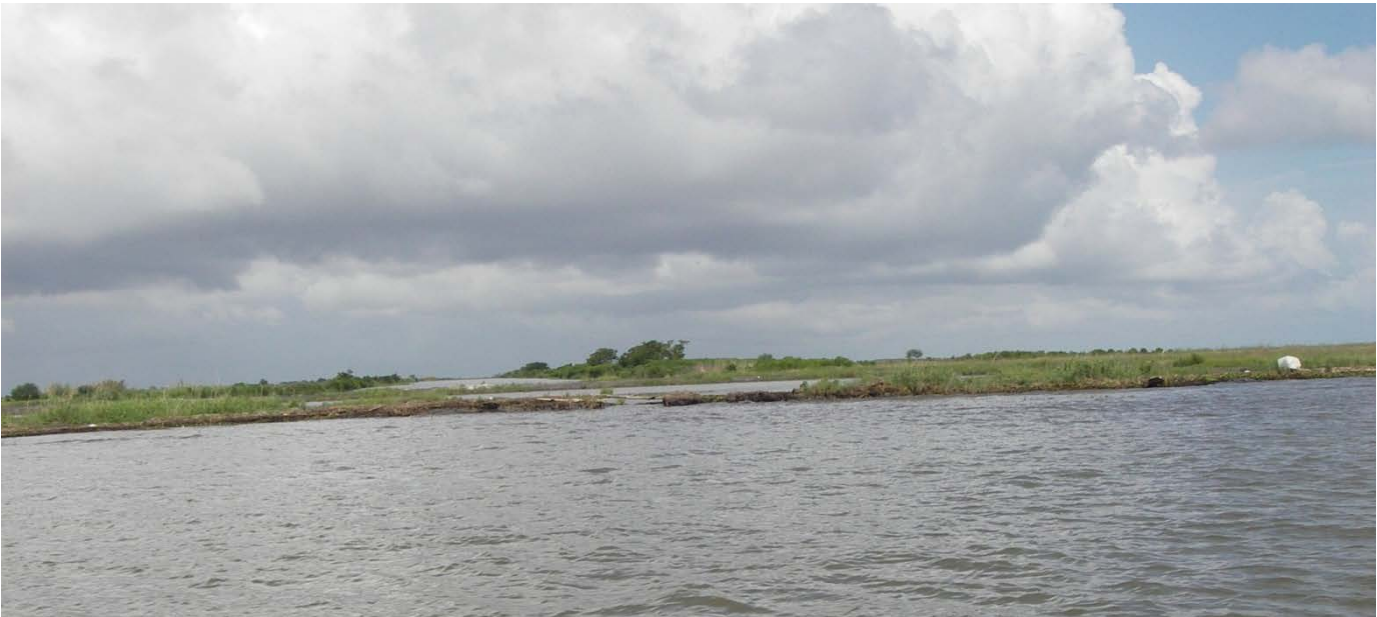
**Photo No. 8**, Containment Dike along Gulfward Shoreline at NE Corner of MC Cell No. 1 (Northern Most Section of Intended Armor Area)

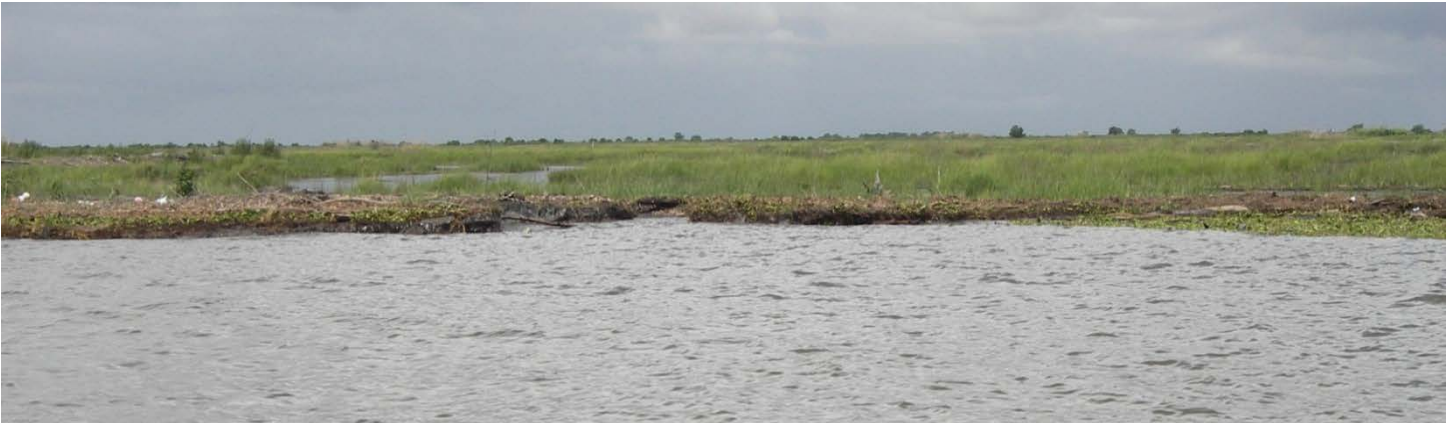
**Photo No. 9**, Containment Dike along Gulfward Shoreline at NE Corner of MC Cell No. 1  
(Original Breach near Southern Section of Intended Armor Area)

What are the conditions of the existing levees?  
 Are there any noticeable breaches? There are three breaches in the containment dike at critical areas which could allow exposure of the interior of the northeast tip of the island to the East Cote Blanche Bay and the gulf.
