**State of Louisiana  
Office of Coastal Protection and  
Restoration**

**2015 Annual Inspection Report**

**GIWW/ CLOVELLY HYDROLOGIC  
RESTORATION**

State Project Number BA-02  
Priority Project List 1

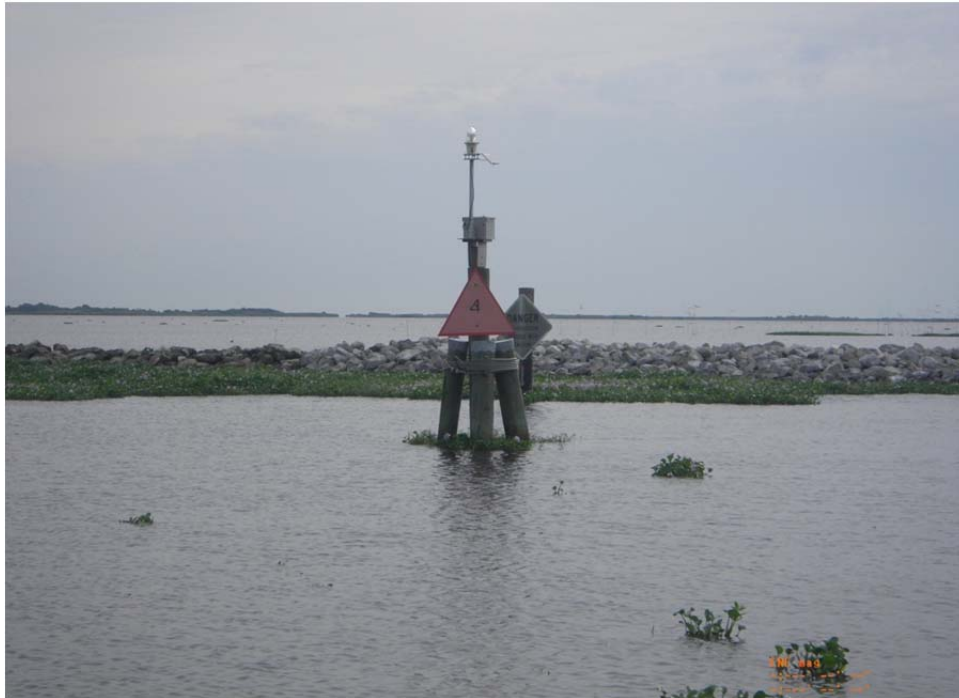
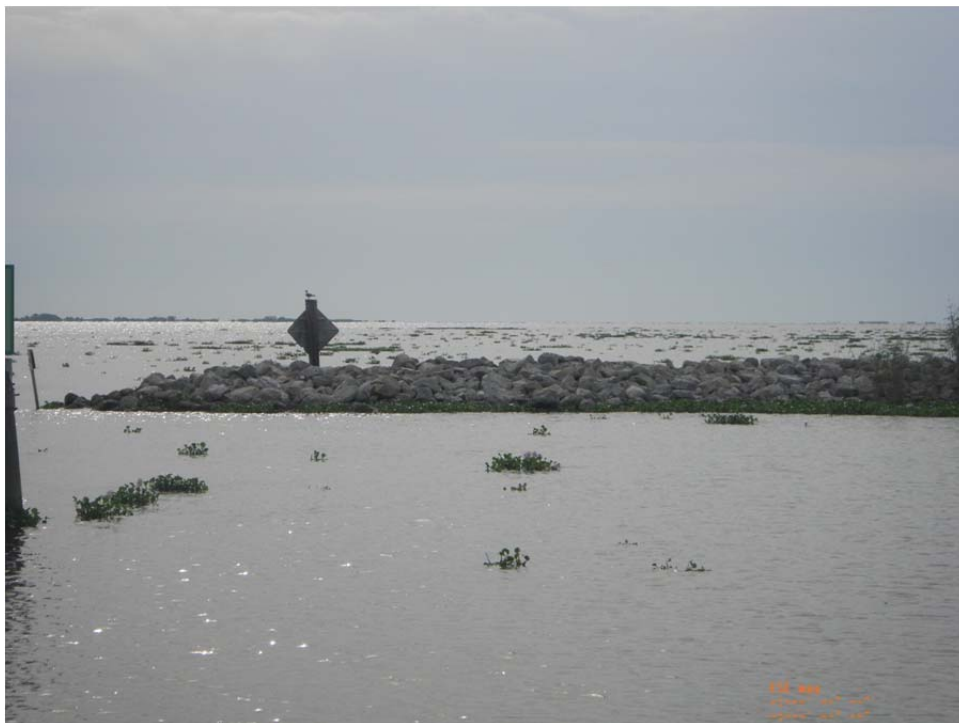
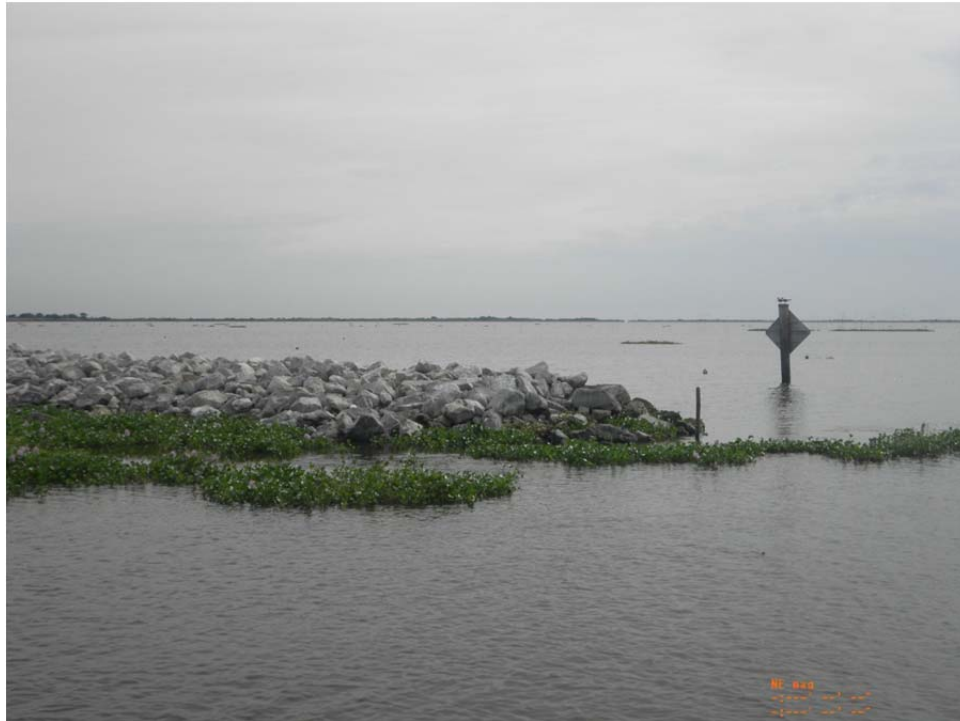
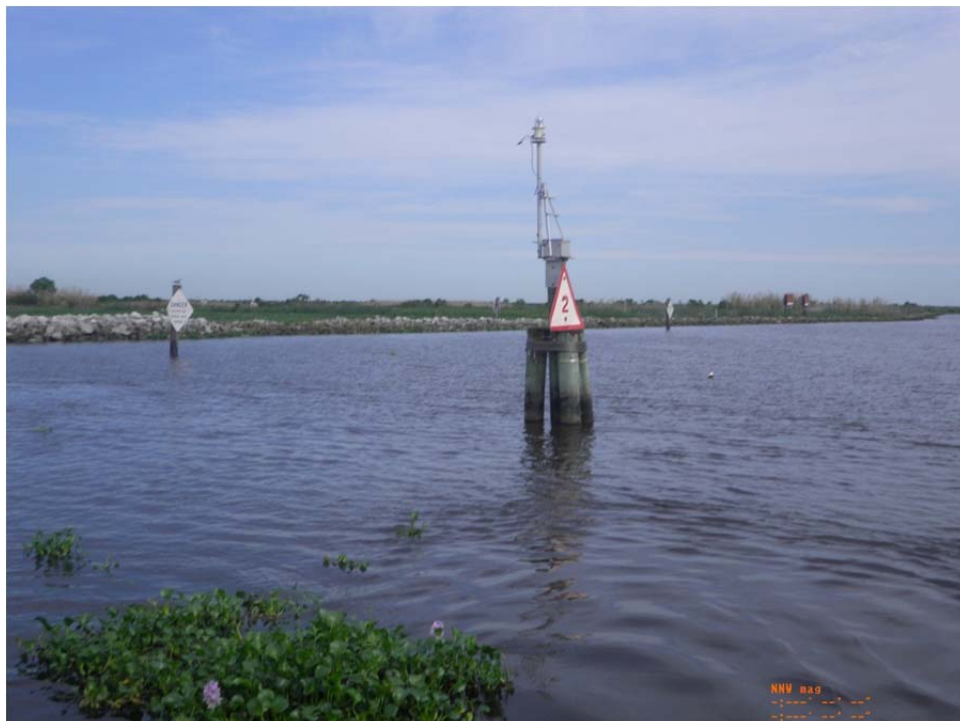
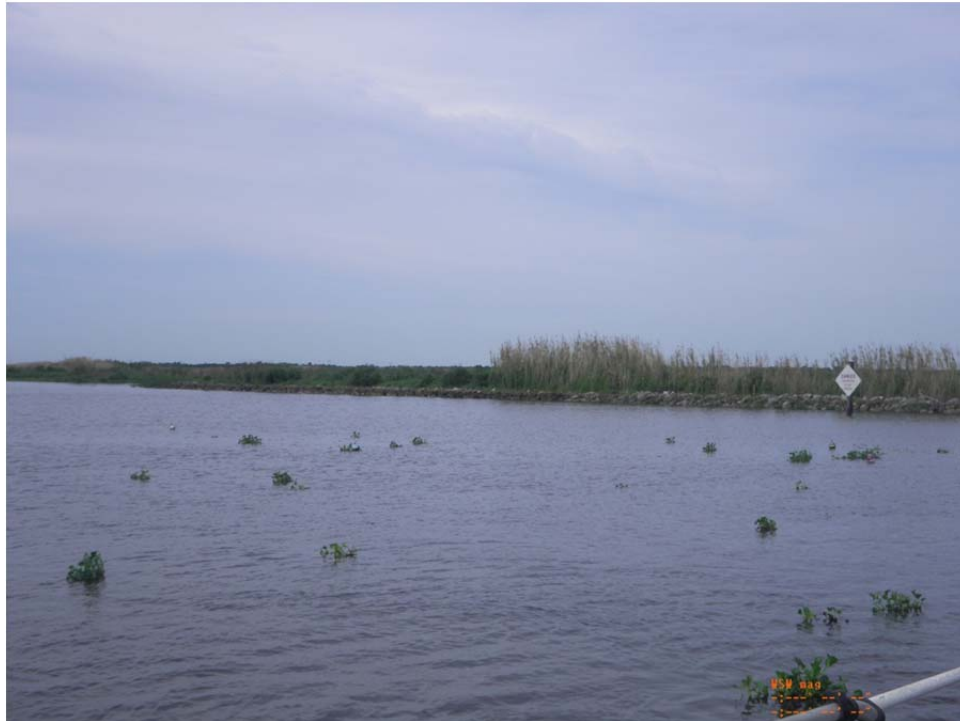
Structure 14A was also rehabilitated during the 2012 Maintenance Project. The structure was recapped with a heavier 250# class rock riprap to the original design elevation of -6.5' NAVD 88 at the barge bay to prevent further scouring of the channel bottom, and +4.0' NAVD88 along the crest of the weir. Depth soundings were taken along the center of the barge bay which indicated that the average depths ranged from 7.5' on the north side to 8.3' on the south side. Based on these depths, the average bottom sill elevation of the barge bay ranged between -6.1' to -6.9 NAVD 88. Based on our observations, the structure appears to be in good condition, as there is no visible settlement of the rock since the end of construction. Also, three (3) of the navigation aid timber pile supports and daymark signs were replaced under the 2012 Maintenance Project. The rock weir and navigation aid structures are in good condition and there are no recommendations for maintenance at this time. (See Appendix B, Photos 1 through 5)

Photo 1: View of navigational aid on SW side of Structure 14 A and rock weir in background.

Photo 2: View of rock weir on the south side of the barge bay on Structure 14A.

Photo 3: View of rock Weir at the barge bay on the north side of Structure 14A.

Photo 4: View of navigation aid lights on the NE side of Structure 14a and rock weir in background.

Photo 5: view of the rock weir on the south side of Structure No. 14A.

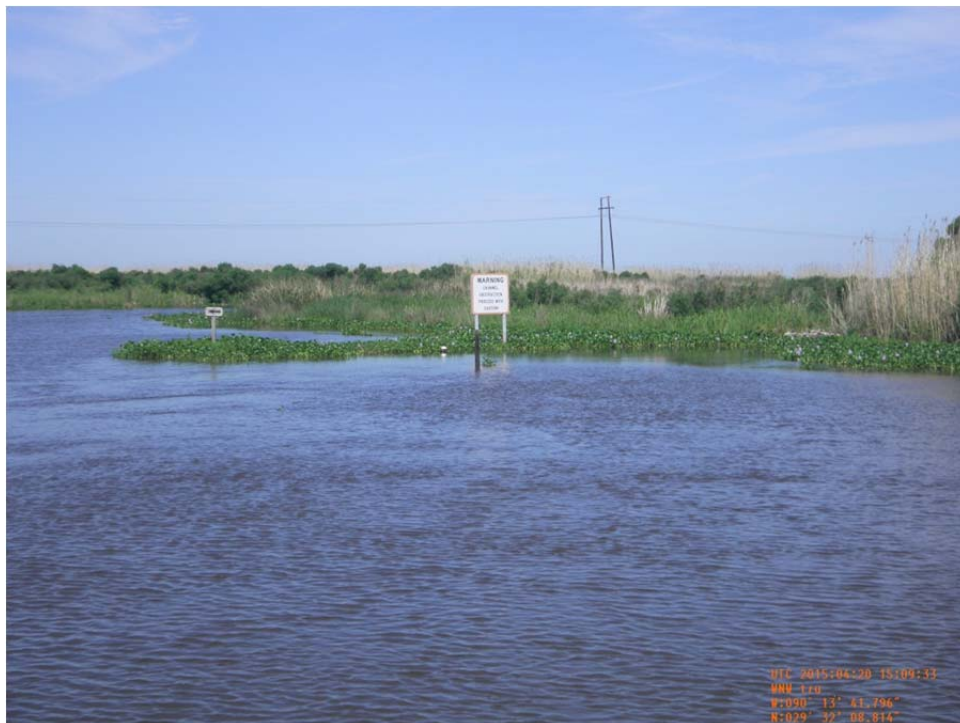
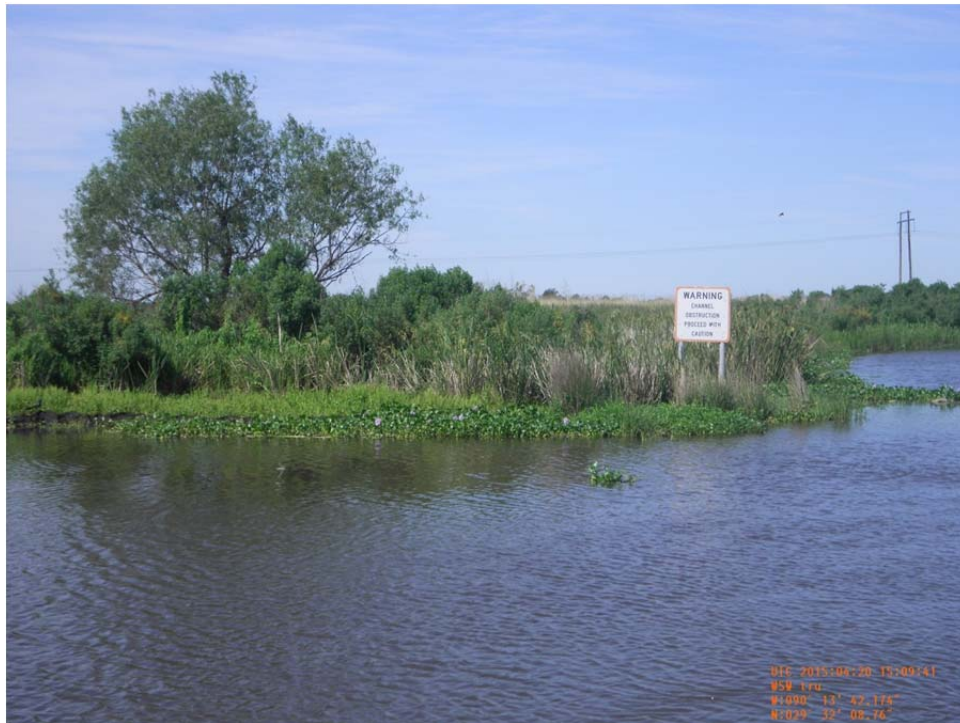
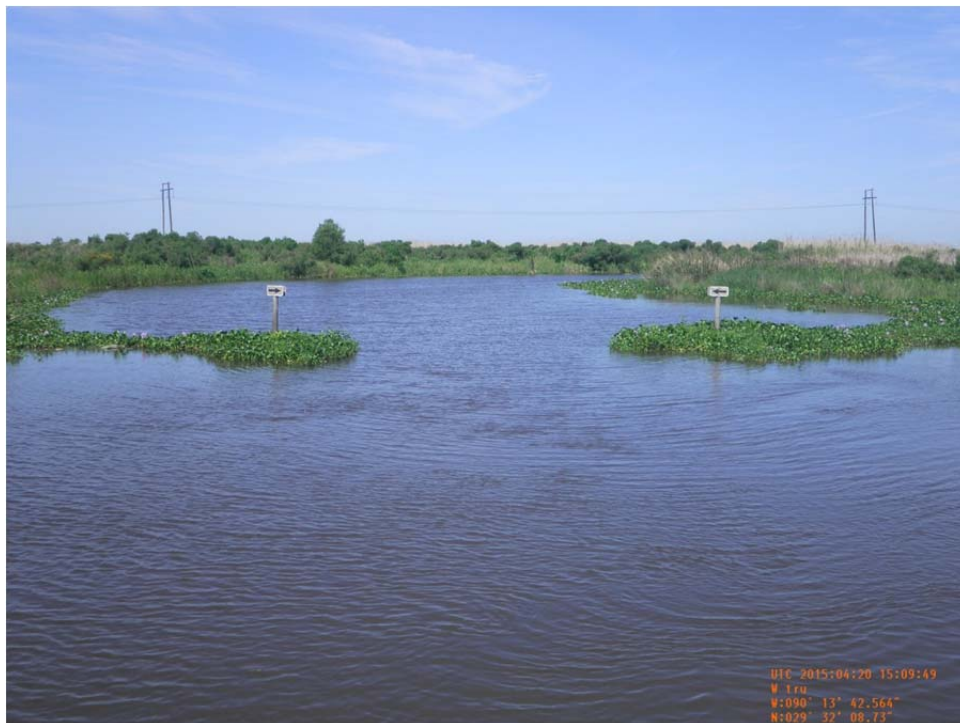
Structure 7 appeared to be in fair condition with some settlement of the rock riprap material but no visual damage to the weir or erosion around the embankment tie-ins. The settlement of Structure 7 has been uniform with no breaches of the bank tie-ins. We are not recommending maintenance of Structure 7 at this time. All warning signs and their supports appear to be in good condition. (See Appendix B, Photos 6 through 8)

Photo 6: View of the rock weir on the north side of the boat bay on Structure No. 7.

Photo 7: View of rock weir on the south side of boat bay on Structure No.7.

Photo 8: Overall view of the rock weir with boat bay of Structure No.7.

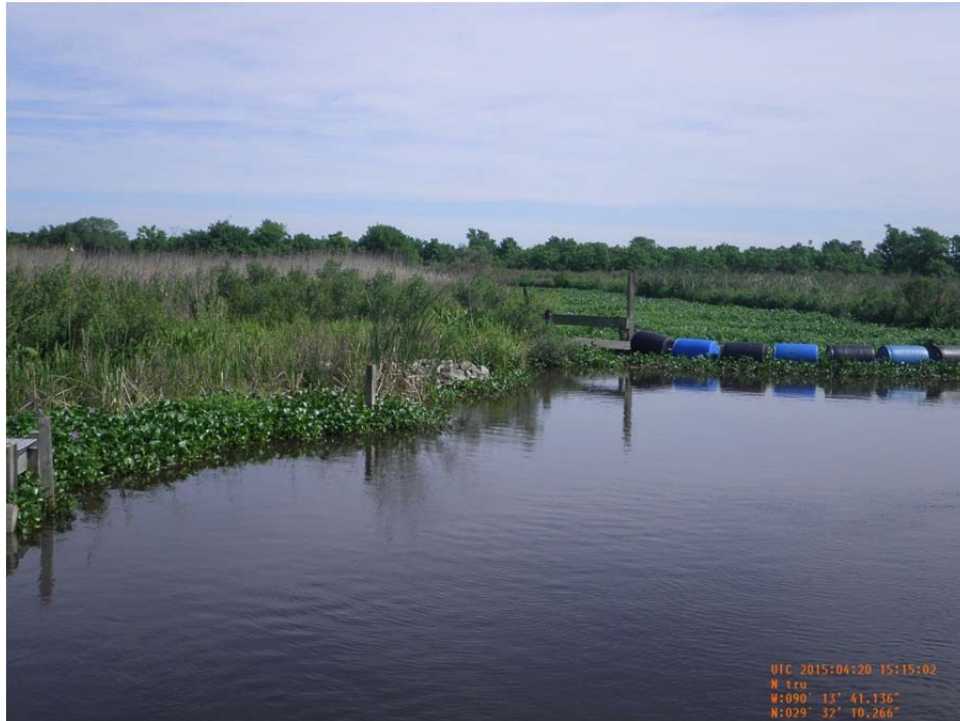
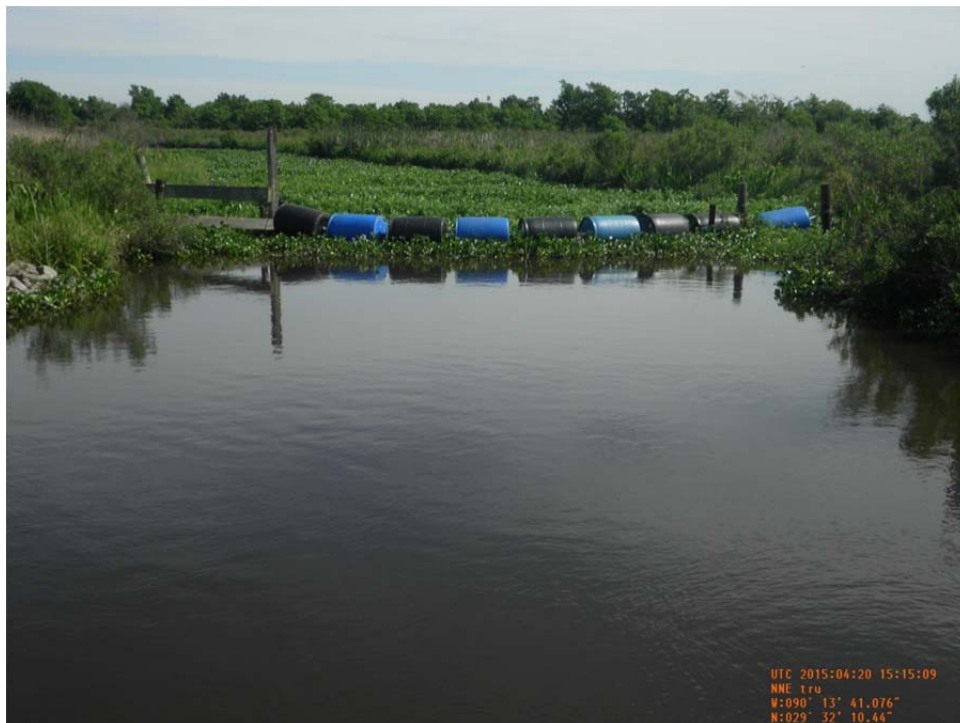
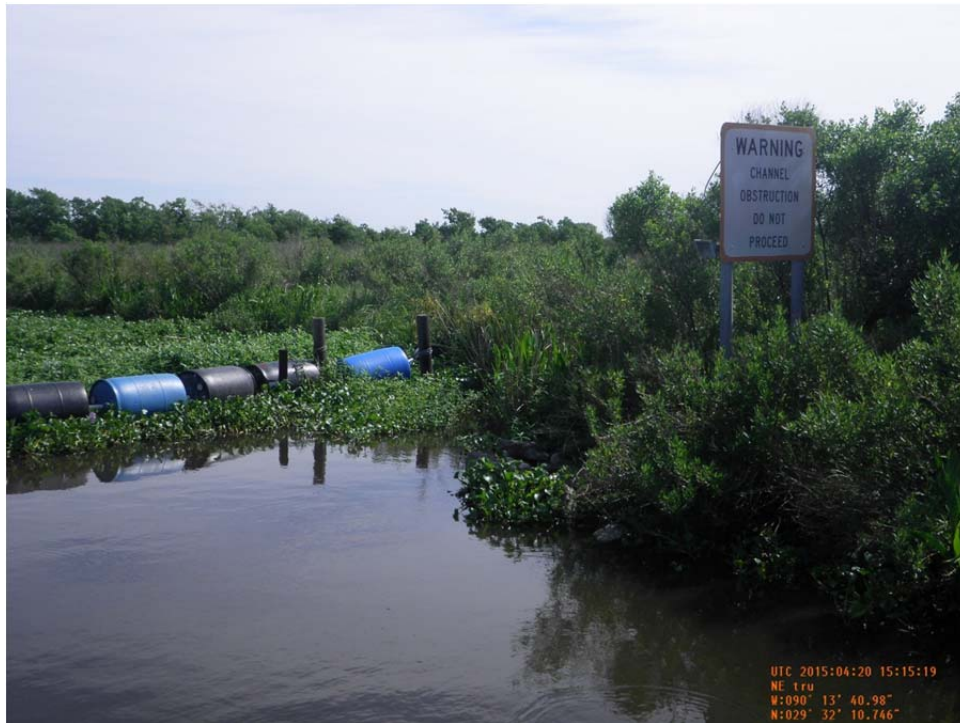
Structure 8 is a small rock weir with a boat bay located just north of Structure 7. This structure appears to be in fair condition with minimal settlement of the riprap material and no erosion or washouts around the bank tie-ins. This structure was originally constructed with a steel gate to prevent access into the interior marsh, but this gate was destroyed during Hurricanes Gustav and Ike. Since the gate was destroyed, the landowner has installed a series of floating barrels to restrict access, thus there is no need to replace the gate at this time. (See Appendix B, Photos 9 through 11)

Photo 9: View of rock weir and floating barrel gate at Structure No. 8.

Photo 10: View of rock weir and floating barrel gate at Structure No.8.

Photo 11: Viwe of the east side of rock weir and floating barrel gate closure of Structure No.8.

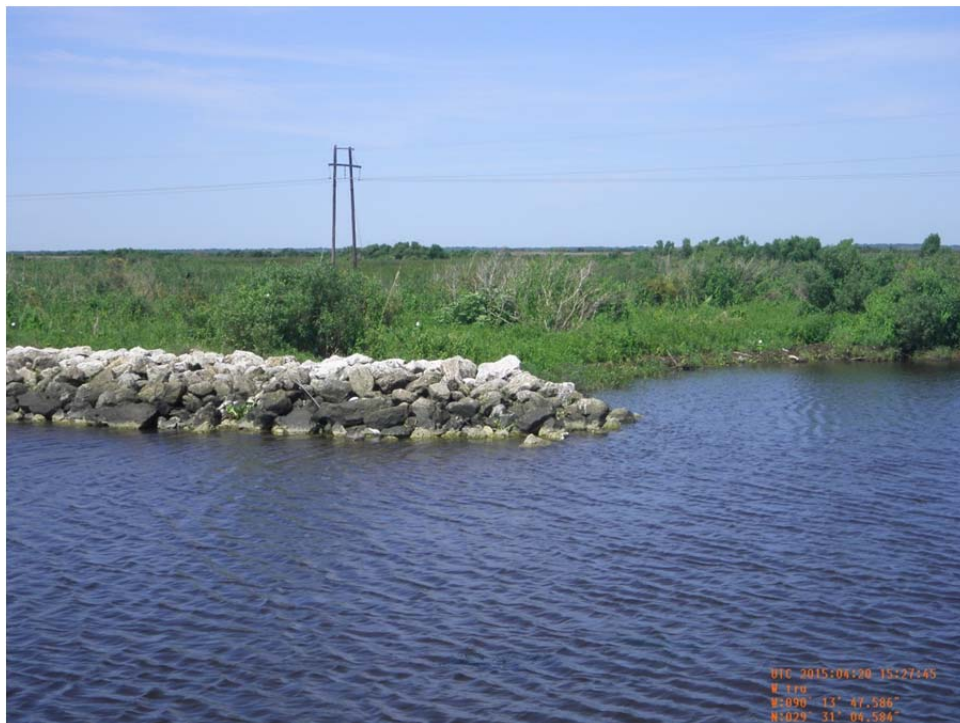
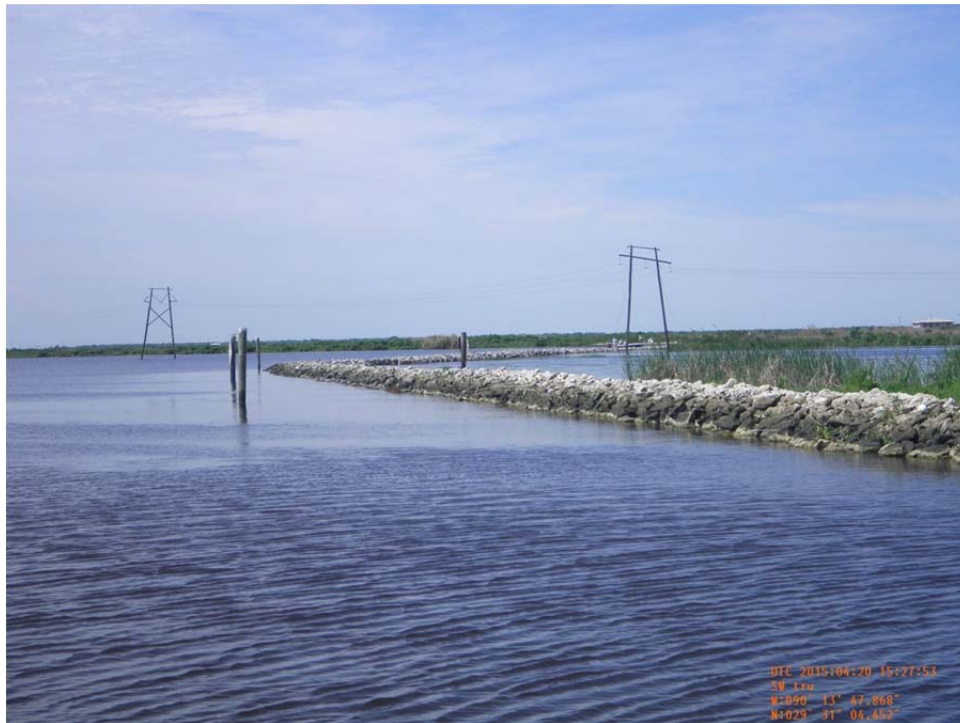
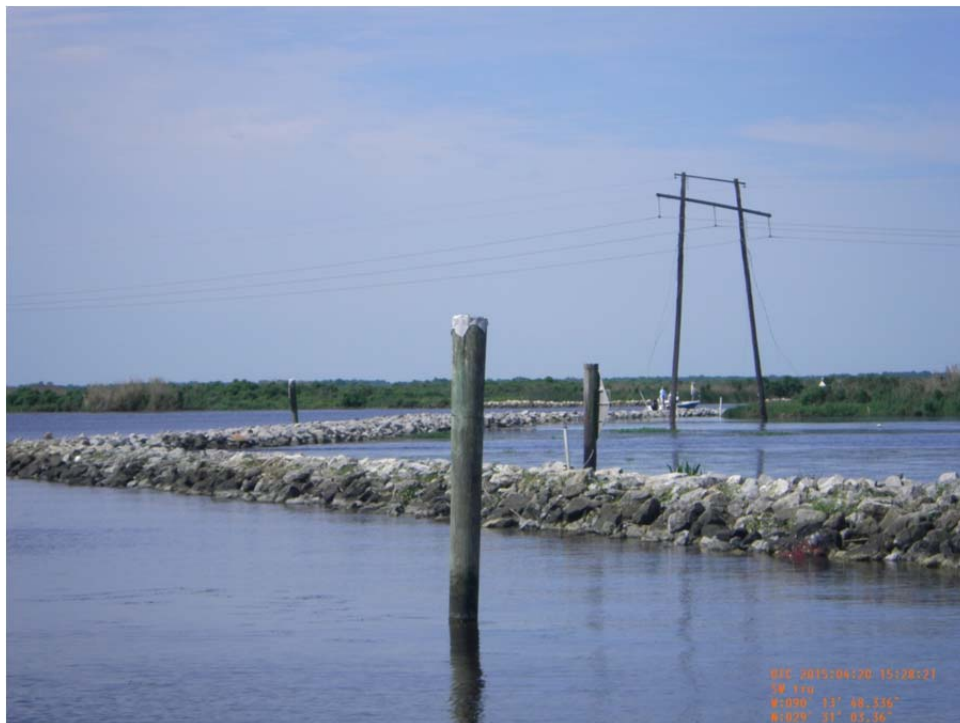
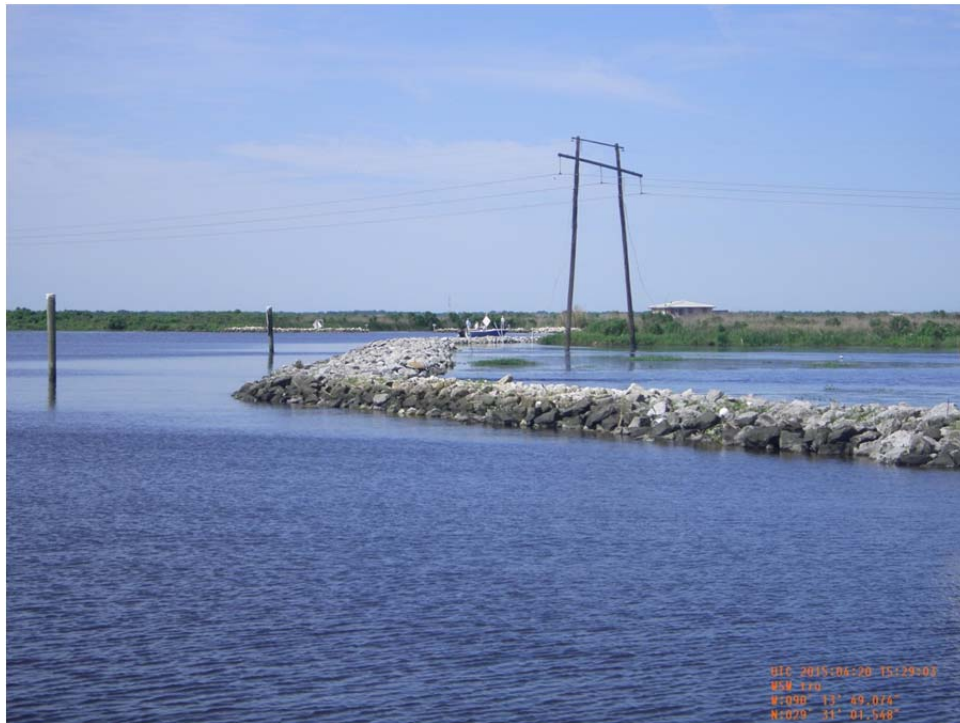
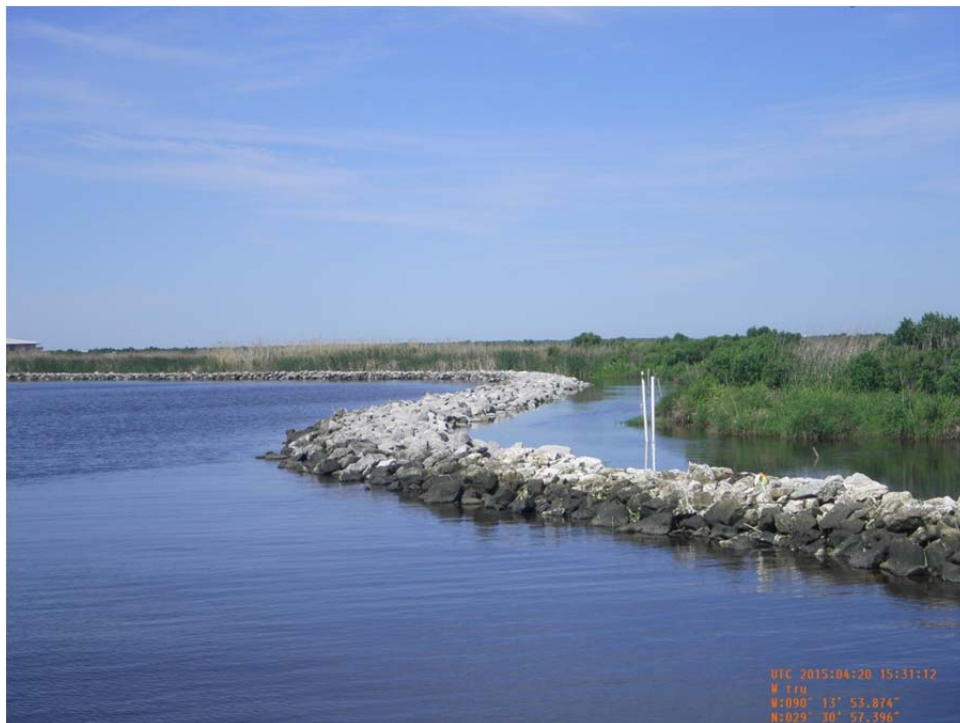
As part of the 2012 Maintenance Project, Structure 4, 4A & 4B was recapped to its original design elevation and rock dike closure was extended to Structure 4. The existing structures and 1,000 linear feet dike closure were built to an elevation of +3.5' NAVD88 using 130# class rock riprap. Structures 4 and 4A/4B, and the dike closure appear to be in very good condition with no noticeable settlement or degradation of riprap material. During construction of the dike closure, a change order was issued to the contractor to install two warning signs with timber supports in the location of the fish dips. At the time of the inspection, we did notice that several of the wooden signs install along the structure were missing or in poor shape. Under the 2015 Maintenance Project schedule to begin this fall, we have included provisions for the replacing all wood signs with aluminum signs. There are no recommendations for maintenance at this time. (See Appendix B, Photos 12 through 17)

Photo 12: View of the north end of rock plug tie-in at Structures 4A and 4B.

Photo 13: rock plug (Structure 4A & 4B) and rock dike extension to Structure 4 construction in 2012.

Photo 14: View of rock dike closure between Structure No.4B and Structure No.4 constructed in 2012.

Photo 15: View of rock dike closure between Structure 4B and Structure 4 constructed in 2012.

Photo 16: View of rock dike closure between Structure 4B and Structure 4 constructed in 2012.

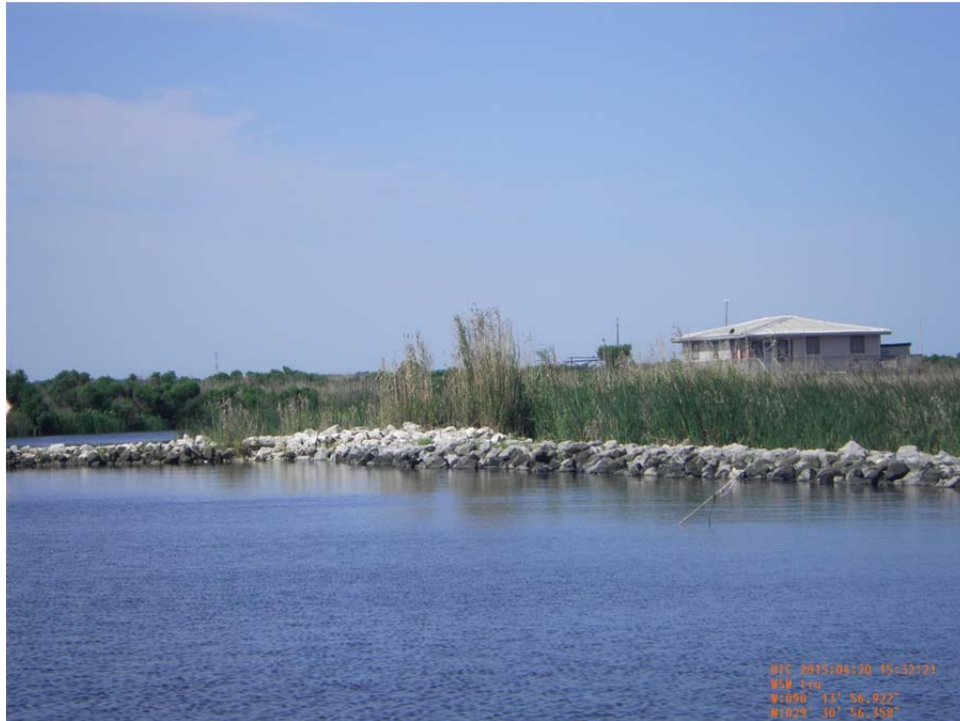
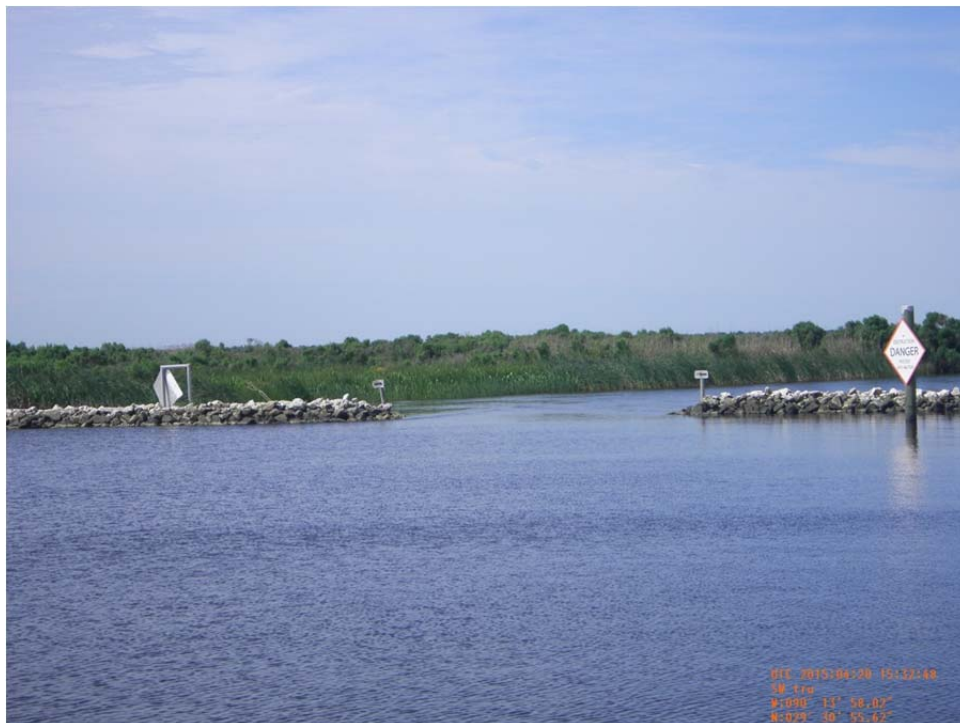
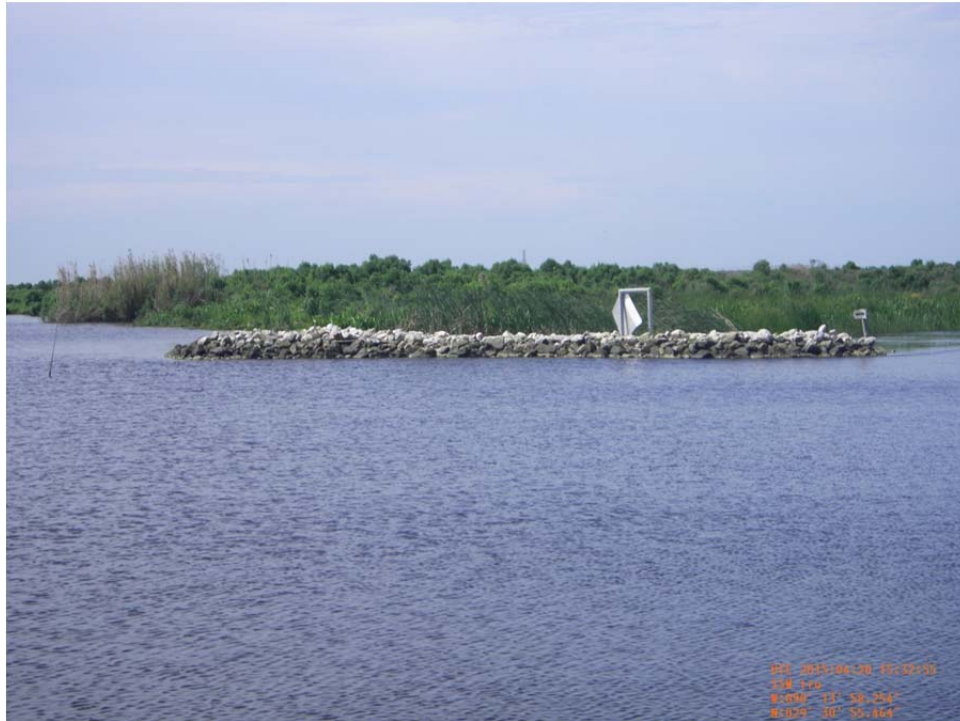
Structure 4 is also a three (3) level fixed crest weir constructed of rock riprap material. The structure was recapped with 130# class rip-rap to its original design elevation as part of the 2012 Maintenance Project. Sounding taken during the inspection revealed an average depth of 6.1' at the center boat bay of the structure. Based on the elevation of the staff gauge located in Superior Canal, the calculated elevation of the boat bay was -4.7' NAVD. The as-built drawings from the 2012 Maintenance Project show a center elevation of -5.5' NAVD. From our calculations, the sounding elevations are higher than the documented as-built elevations from the 2012 Maintenance Project. We are not confident that our soundings are correct and will take additional soundings on the next inspection to try to identify the discrepancy. We did note that the marsh on the southern tie-in continues to erode and has detached from the rock

Photo 17: View of rock dike closure tie-in to the north side of Structure No.4 constructed in 2012.

Photo 18: Overall view of rock weir with boat bay at Structure No.4.

Photo 19: View of the rock weir on the south side of the boat bay of Structure No.4.

weir. We recently completed the plans and specification and have submitted them for bidding to extend the rock dike from the southern end of Structure 2 to the north end of Structure 4. Once completed, the shoreline will be protected and erosion should be halted. The sign on the south side of the structure has come loose from the its supports and is hanging on one side. As part of the 2015 Maintenance Project, we will replace this sign and other signs installed during the 2012 maintenance event with new aluminum signs. Overall, the structure is in good condition with exception of the breach on the south side and the damaged sign. These deficiencies will be repaired during the upcoming 2015 Maintenance Project. (See Appendix B, Photos 17 through 19)

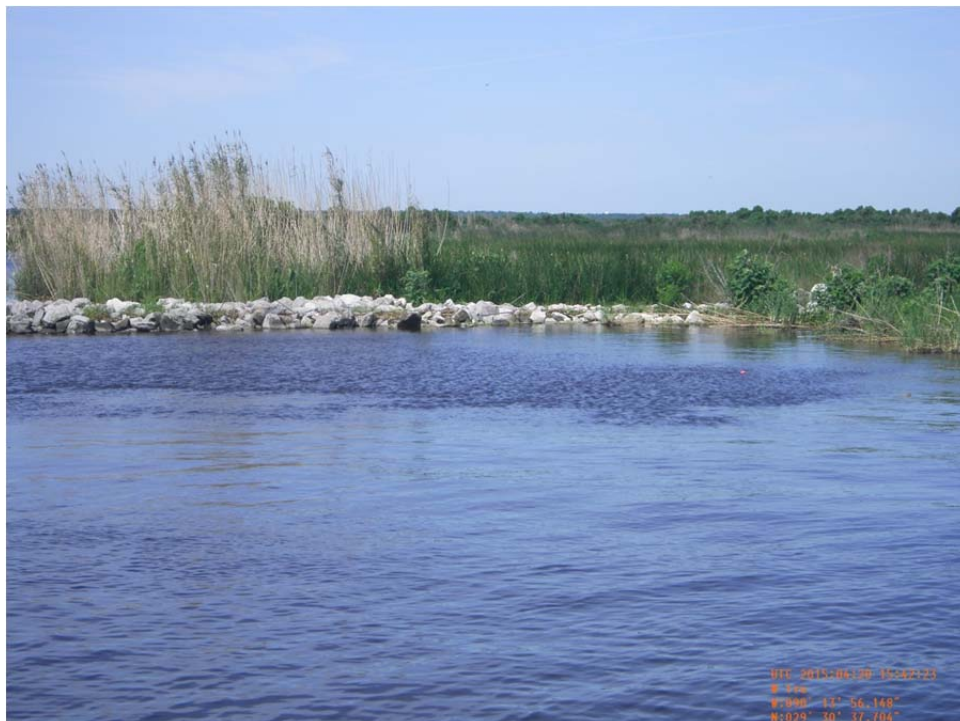
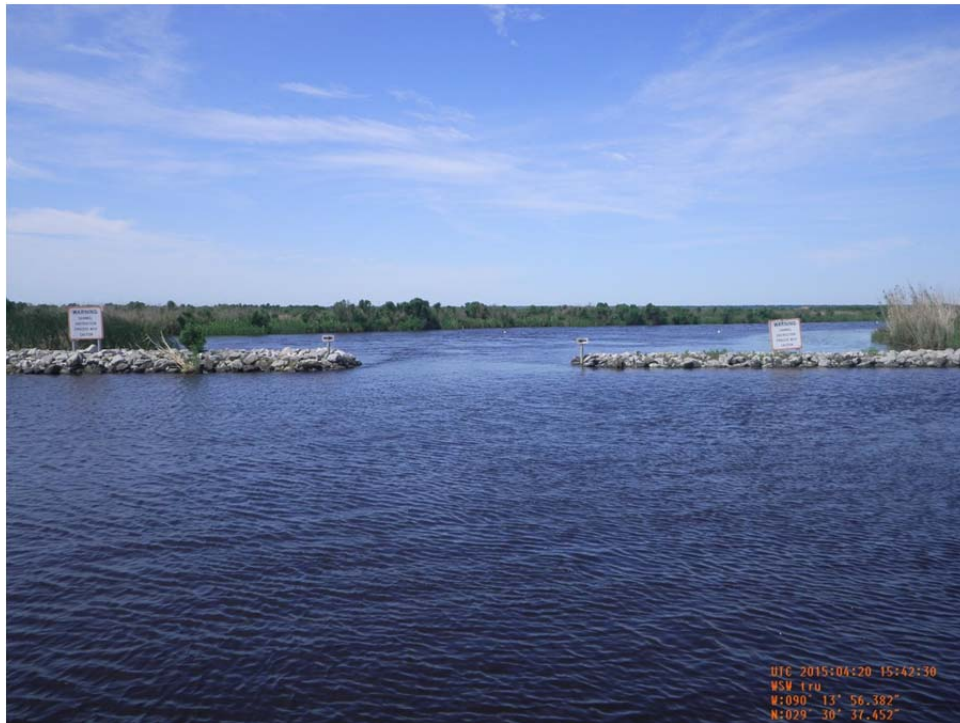
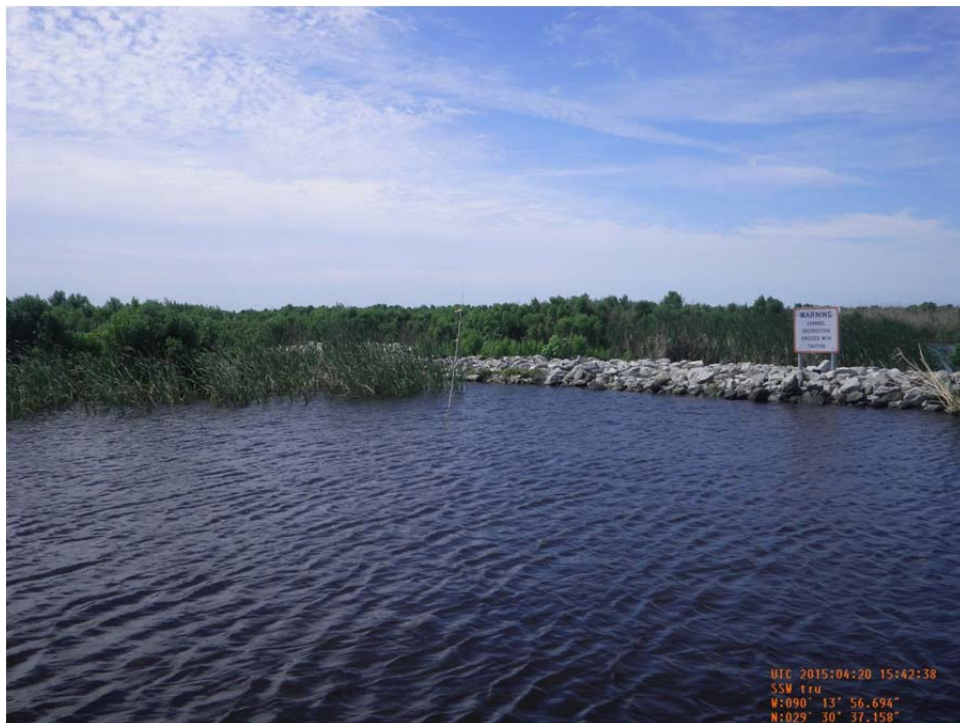
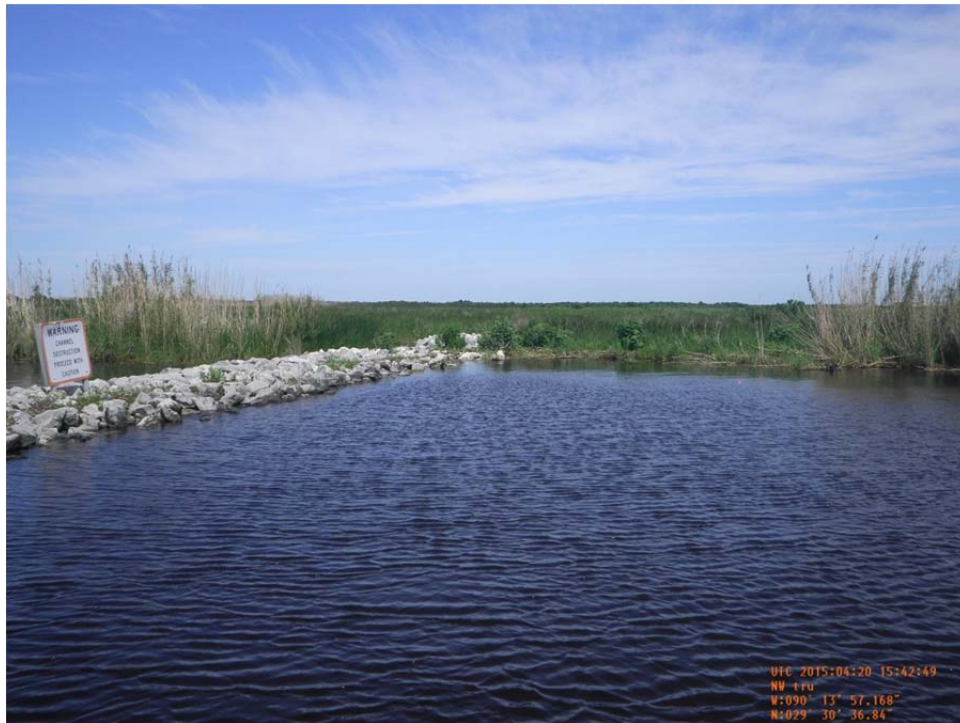
Structure 2 is a three (3) level Fixed Crest Weir constructed of rock riprap material. This structure was recapped with 130# class riprap to its original design elevation as part of the 2012 Maintenance Project. Soundings taken during the inspection along the center section of weir averaged 7.1'. Based on the staff gauge reading in Superior Canal, the estimated elevation of the center section was calculated to be approximately -5.7' NAVD. The as-built drawings show a final constructed elevation of -5.0' NAVD, which would indicate the center section had settled nearly 0.7' since completion of the 2012 Maintenance Project. The sections located closest to the banks on each side of the structure appeared to be stable and no obvious settlement was observed. The warning signs on Structure 2 are in good condition and do not require replacement. The overall structure was in good condition and no maintenance will be required at this time. (See Appendix B, Photos 20 through 23)

Photo 20: View of the rock weir on the north side of the boat bay of Structure No.2.

Photo 21: Overall view of the rock weir with boat bay at Structure No.2

Photo 22: View of the south side of the rock weir at Structure No.2

Photo 23: View of north side of rock weir at Structure No.2.
