**State of Louisiana  
Office of Coastal Protection and  
Restoration**

**2015 Annual Inspection Report**

**GIWW/ CLOVELLY HYDROLOGIC  
RESTORATION**

State Project Number BA-02  
Priority Project List 1

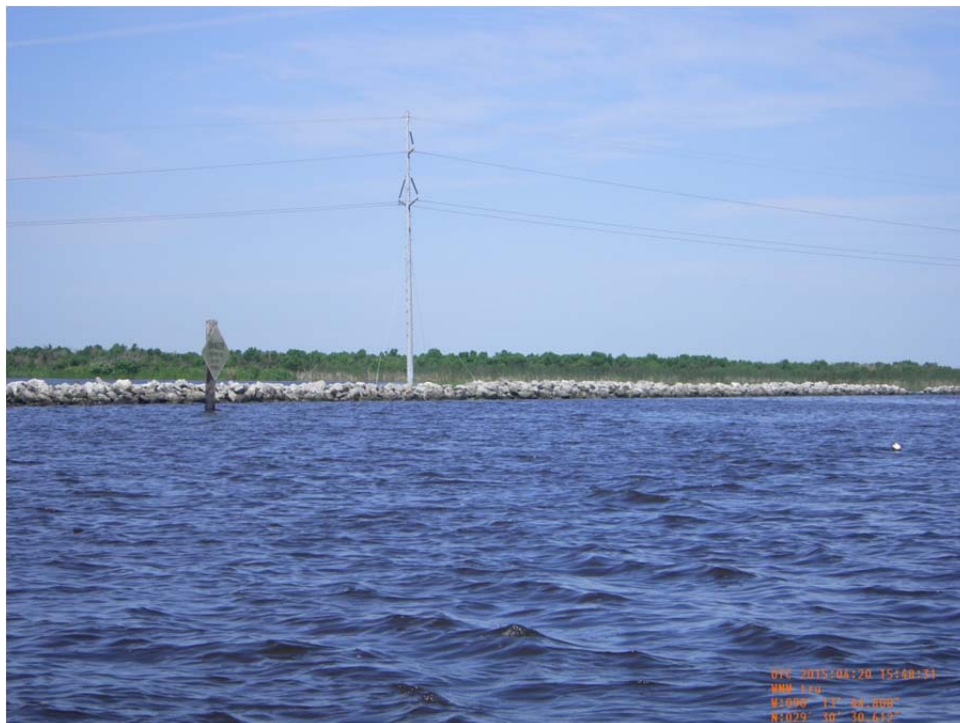
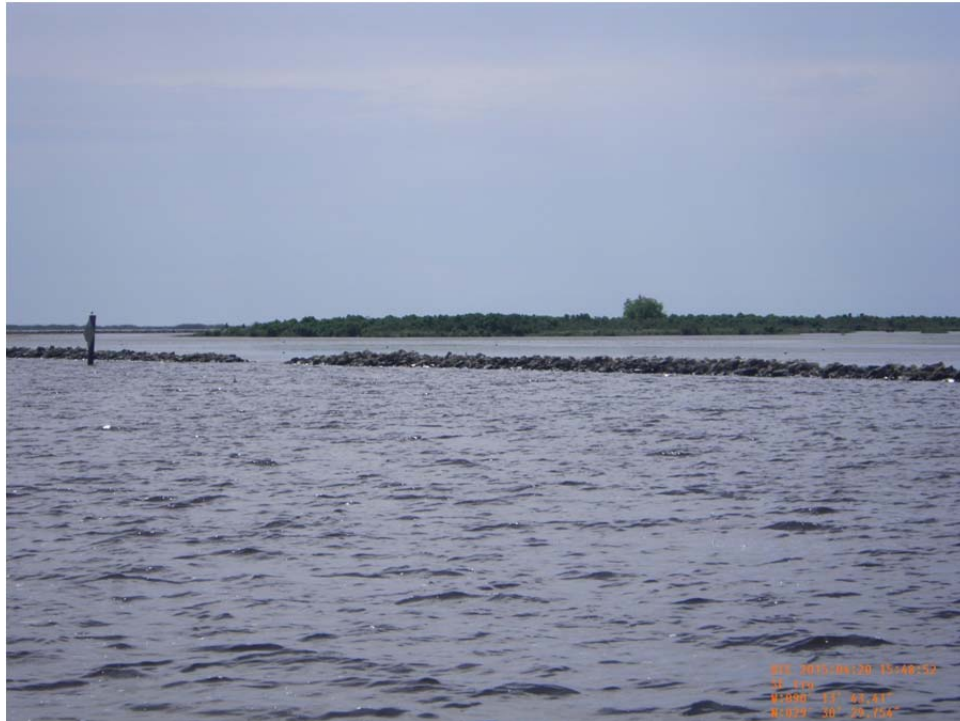
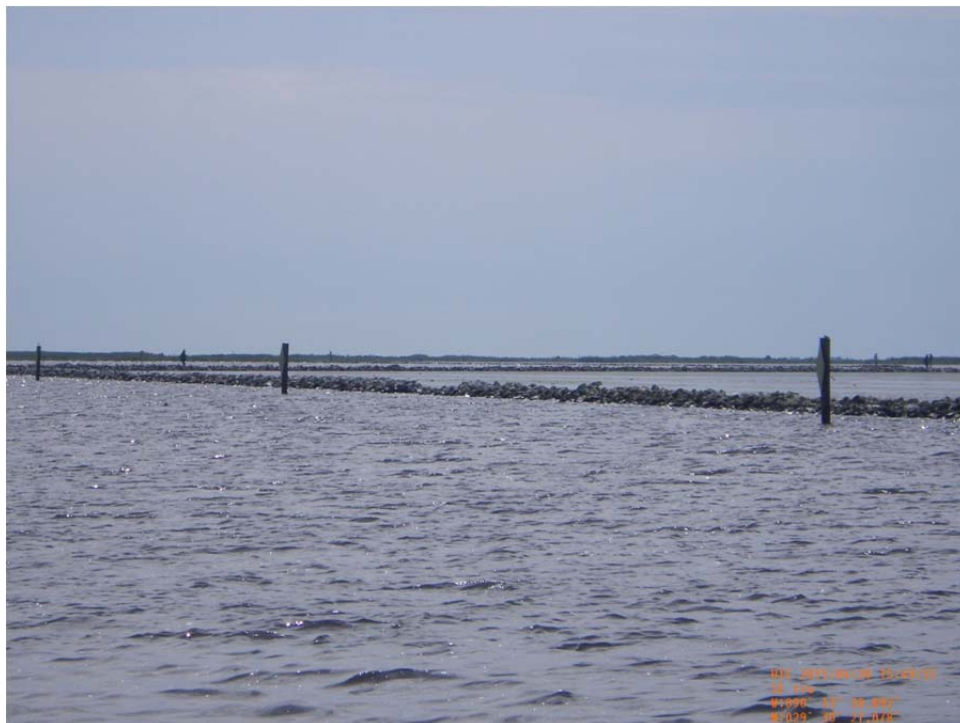
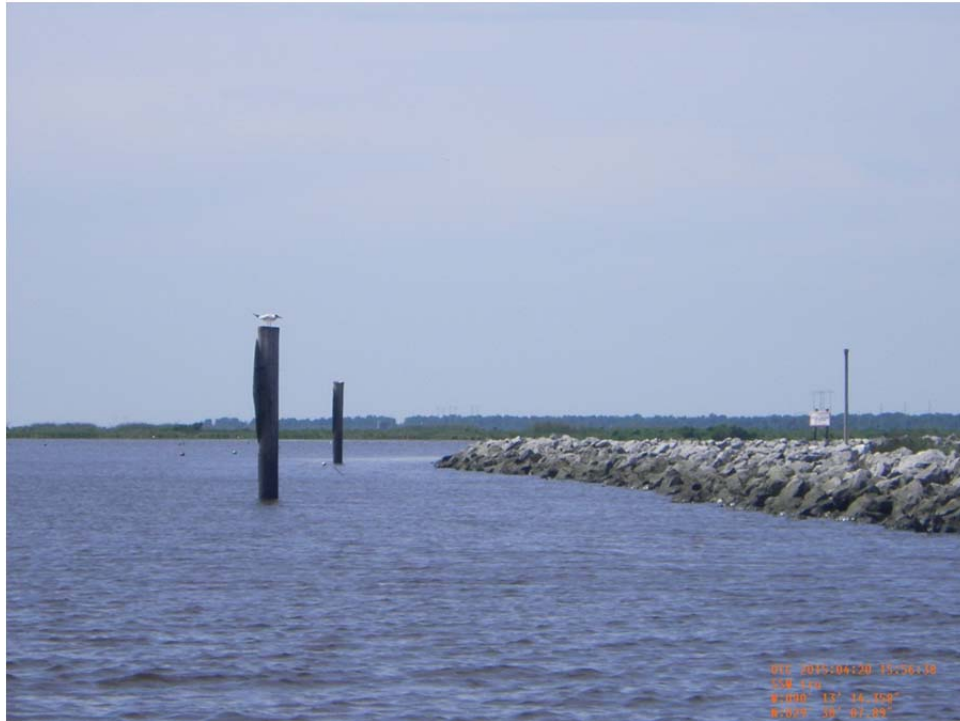
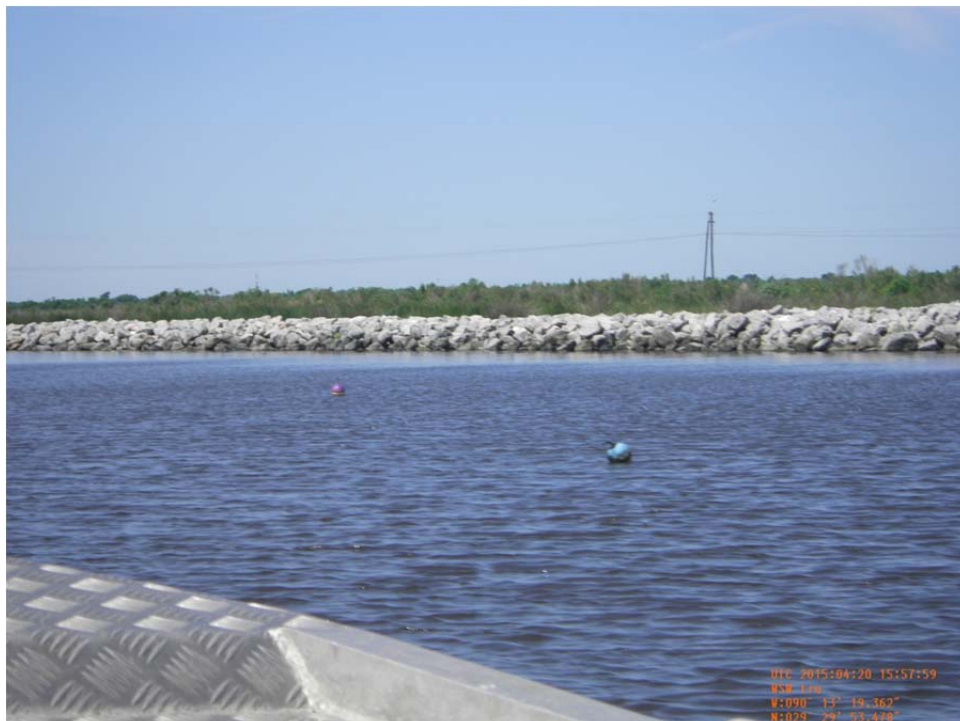
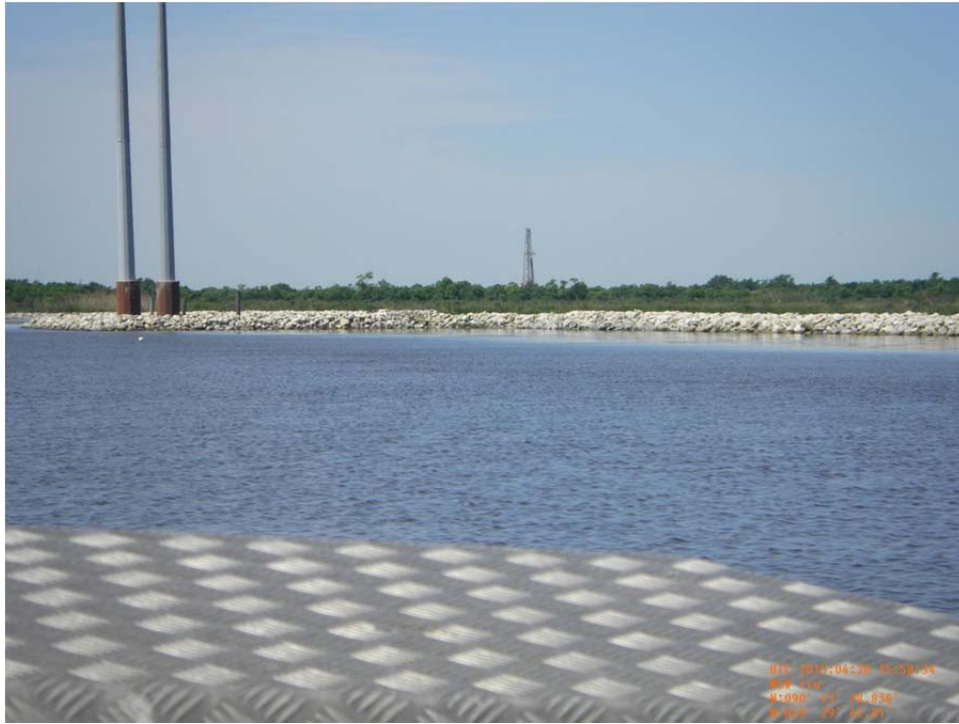
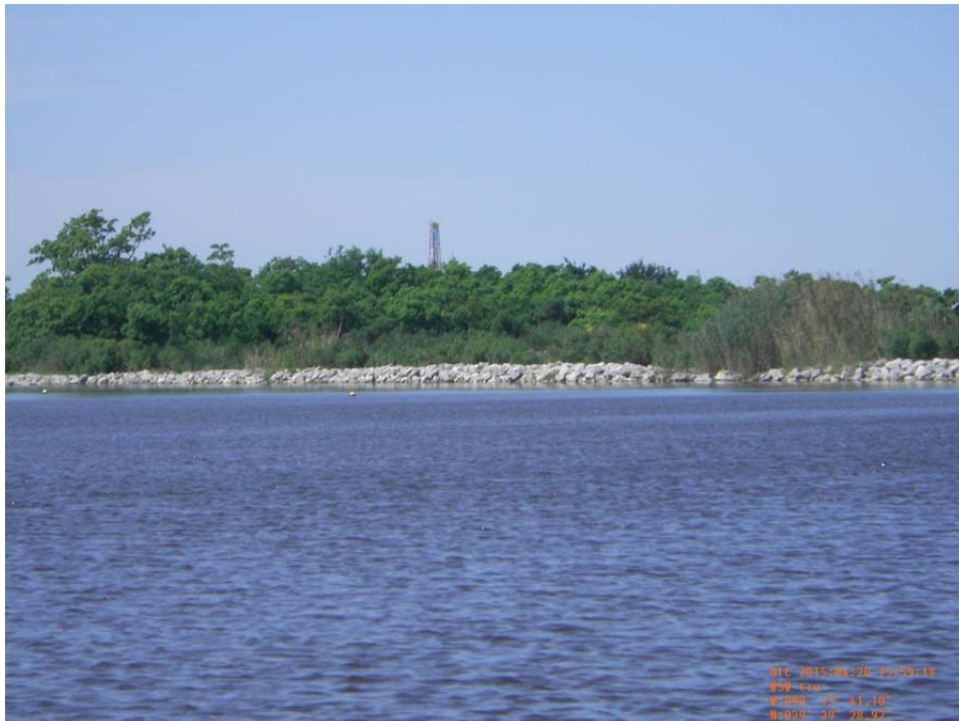
The Lake Rim structure was recapped as part of the 2012 Maintenance Project. The project included the recapping of the entire lake rim with 130# class rock riprap to its original design elevation of +3.0' NAVD88 from the north bank along Breton Canal to southern embankment tie-in of Structure 2. During construction, the Lake Rim structure did not settle from the weight of the extra rock as much as anticipated, which left the contractor with an excess bid quantity of rock riprap. This additional rock was used to place a second lift of rock along the north bank of Breton Canal, Structure 4, and the Lake Rim structure. The 2012 Maintenance Project as-built drawings show the constructed elevation of the Lake Rim structure to be approximately +3.5' NAVD88 to +4.0' NAVD88 after the second lift. At the time of the inspection, there appeared to be no further settlement of the structure since the end of 2012 maintenance project. There are no recommendations for maintenance at this time. (See Appendix B, Photos 24 through 30)

Photo 24: View of the rock dike lake rim along the south shoreline of Bay L' Ours.

Photo 25: View of rock dike lake rip along the south shoreline of Bay L' Ours.

Photo 26: View of the rock dike lake rim along the south shoreline of Bay L' Ours.

Photo 27: View of the rock dike lake rim along the south shoreline of Bay L' Ours.

Photo 28: View of the rock dike along the north bank of Breton Canal.

Photo 29: View of the rock dike along the north bank of Breton Canal near transmission power line.

Photo 30: View of rock dike along the north bank of Breton Canal near the first location canal.

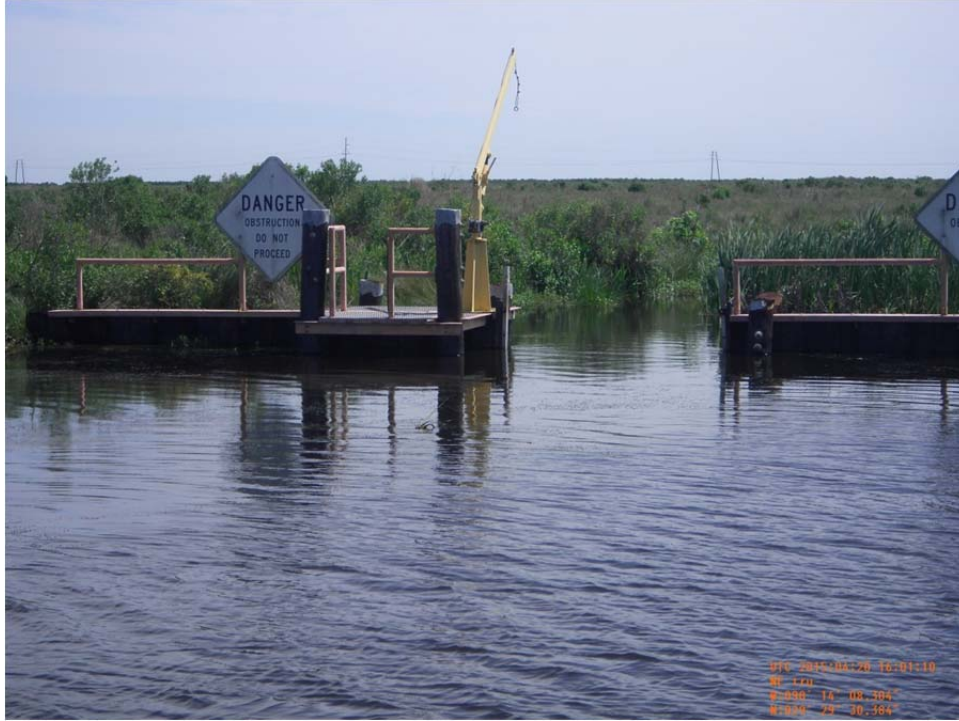
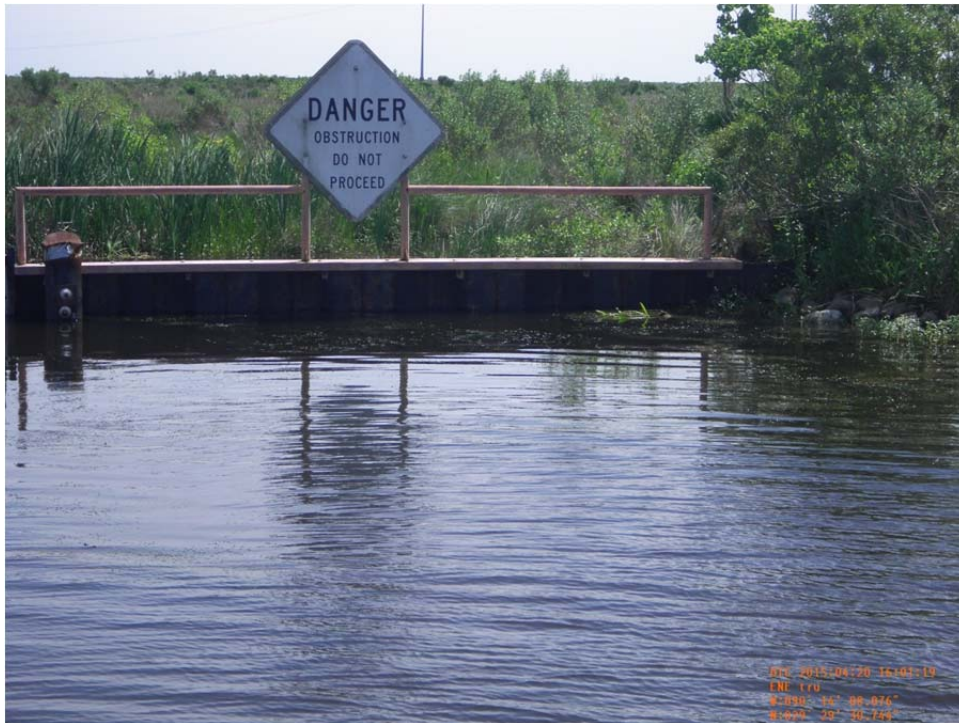
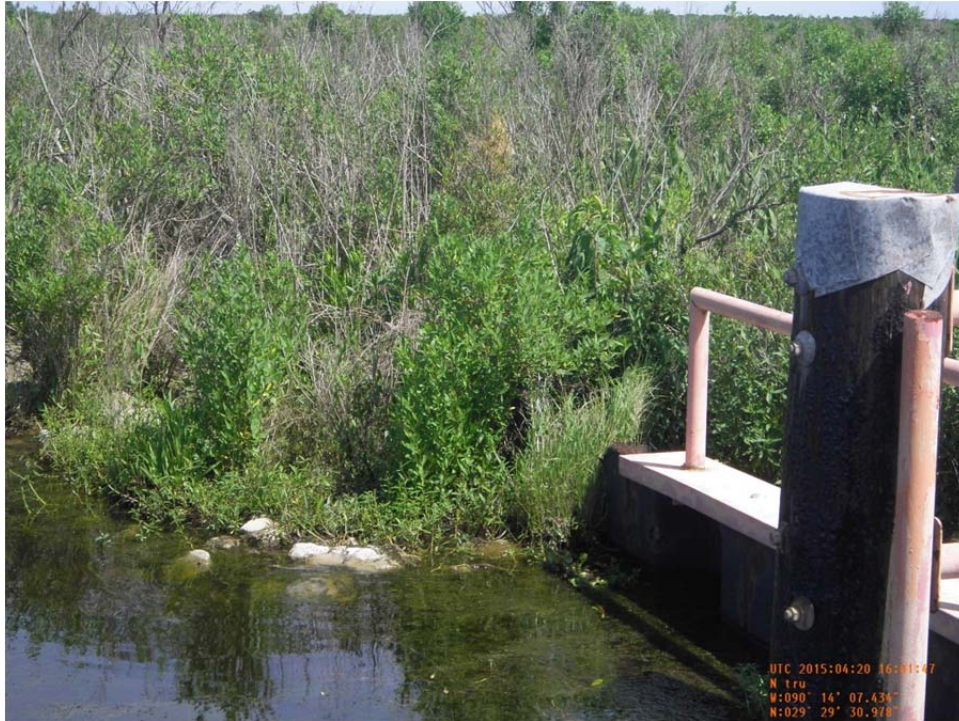
Overall, Structure 35 is in good condition with some signs of minor corrosion on the bulkhead cap, handrails and deck. The stop logs, cables, signs and supports appear to be in good condition and operable. At the time of inspection the channel from the weir to the interior marsh was open and there appeared to be adequate flow through the interior marsh and structure. The embankment tie-ins also appear to be in good condition with no erosion or

Photo 31: View of variable crest weir Structure No.35 on north bank of location canal off of Breton Canal.

Photo 32: view of sheet pile weir and bank tie-in on the SW side of Structure No.35.

Photo 33: View of steel sheet pile weir and bank tie-in on the NE side of Structure No.35.

washouts. We are not recommending any repairs or corrective actions at this time. (See Appendix B, Photos 31 through 33)

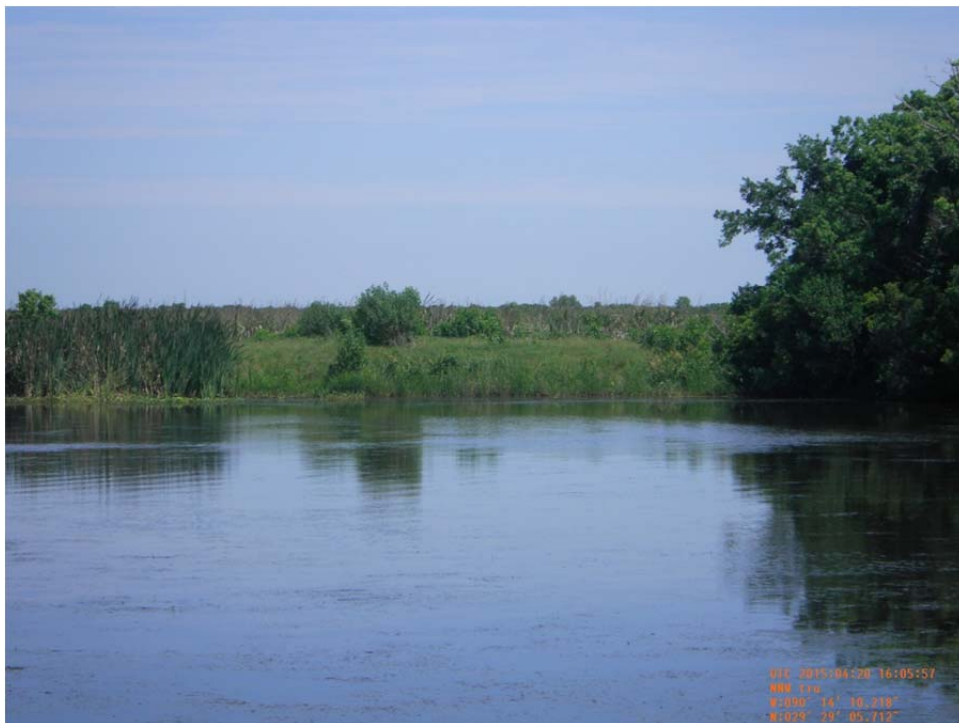
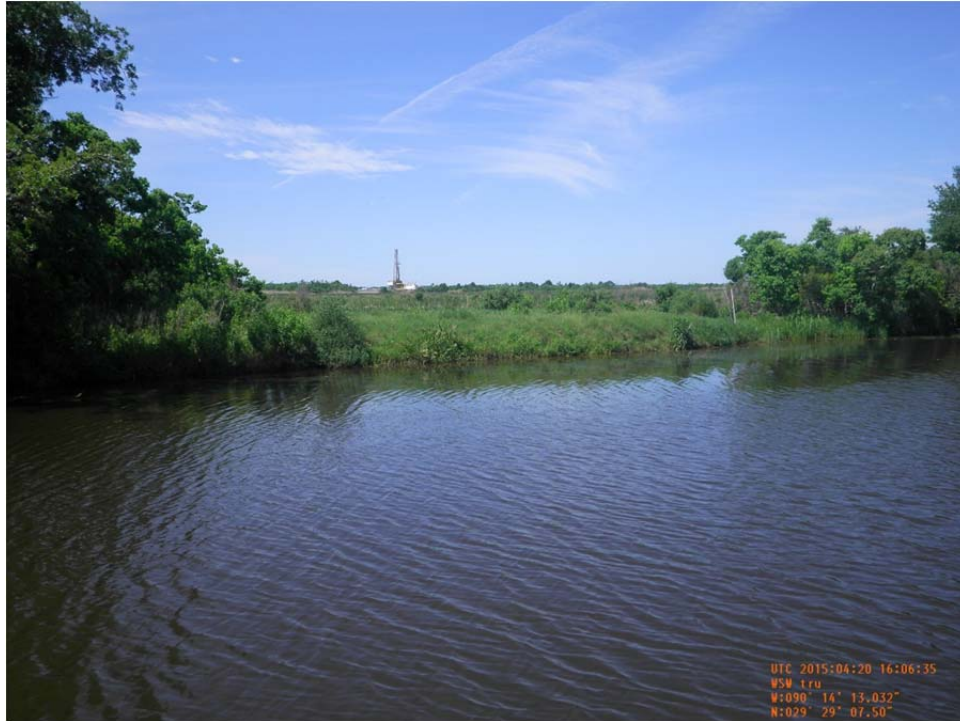
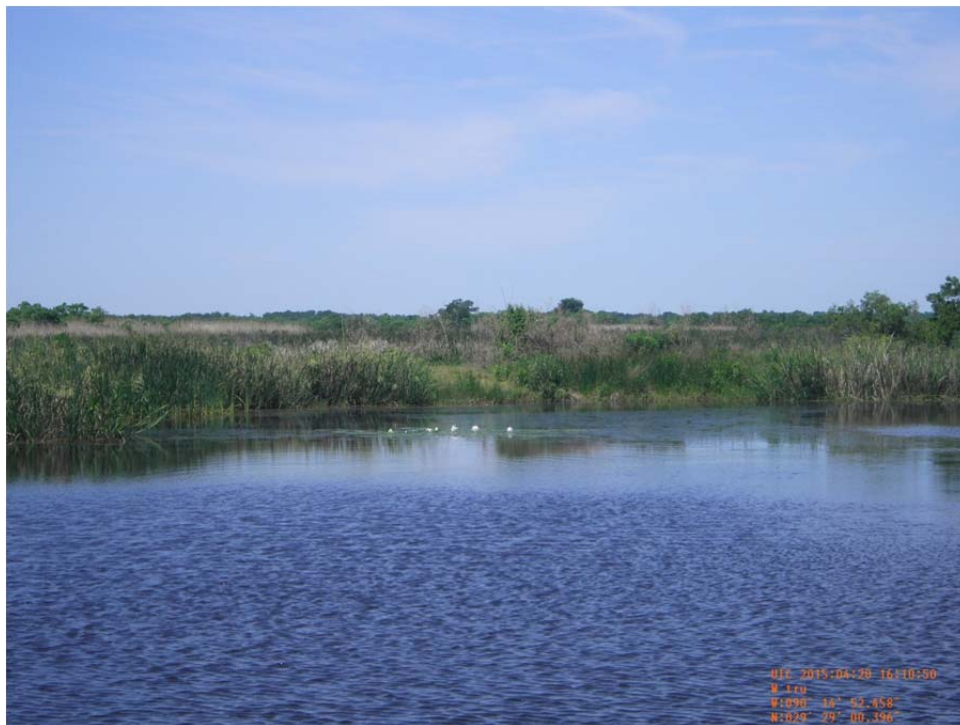
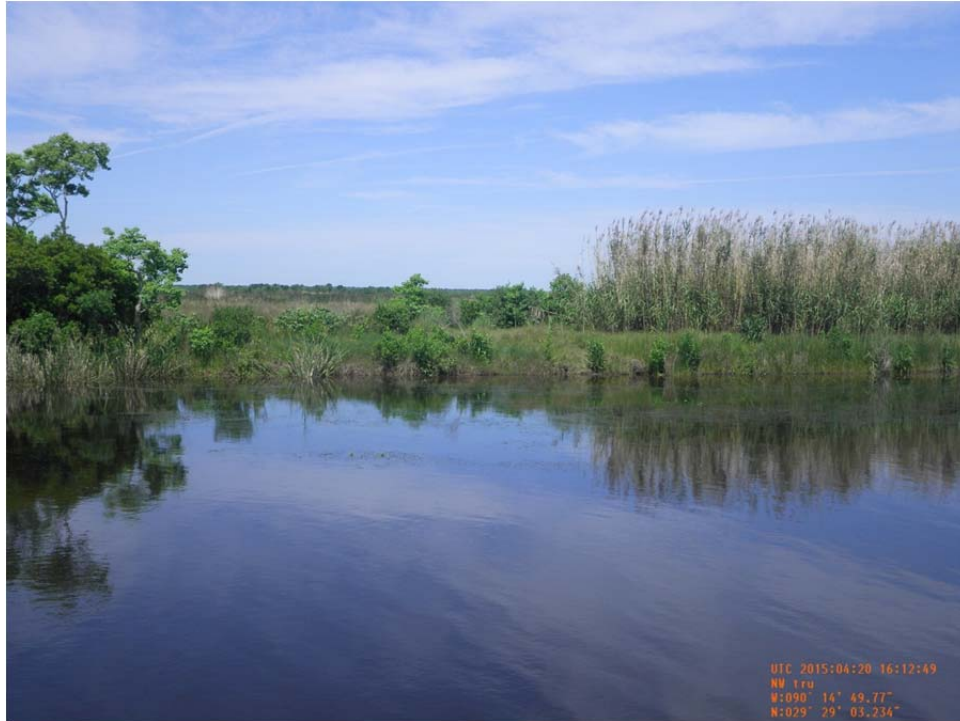
There were five (5) breaches repaired during the 2012 Maintenance Project. Breach 1 was located along the north bank of Breton Canal just southwest of the first location canal from Bay L' Ours and is approximately 20' wide. Breach 2 was located along the northeast bank of the second location canal north of Breton Canal and was approximately 10' wide. Breach 3 was located on the south bank of the same location canal as Breach 2 and was approximately 25' wide. Breach 4 was located on the west bank of an oilfield canal that intersects Breton Canal east of Structure No. 1 and was approximately 30' wide. Another breach, designated as Breach 5, was discovered at the end of a dead end oilfield slip south of Breach 4. The breaches were closed by using material from the adjacent canal bottoms to reconstruct the earthen dike. The material was allowed to dry before it was shaped, seeded, and fertilized. At the time of the inspection, all of the breach repairs appeared to be in good condition with full vegetation and no signs of settlement. Breach 1 did show some signs of erosion on its northeast side facing Breton Canal. Due to the minor erosion, not affecting the overall stability of the breach repair, there are no recommendations for maintenance at this time; however this location will continue to be monitored on future inspections. (See Appendix B, Photos 34 through 37)

Photo 34: Breach location (Identified in as-built drawings as Breach 2) repaired in 2012 along the second location canal from Bay L' Ours via Breton Canal.

Photo 35: Breach repaired in 2012 (identified as Breach 3) off of third location along Breton Canal from By L' Ours.

Photo 36: Breach repaired in 2012 (labeled Breach 4) off of third location along Breton Canal from Bay L' Ours.

Photo 37: - Breach repaired in 2012 (labeled Breach 5) off of third location along Breton Canal from Bay L' Ours.

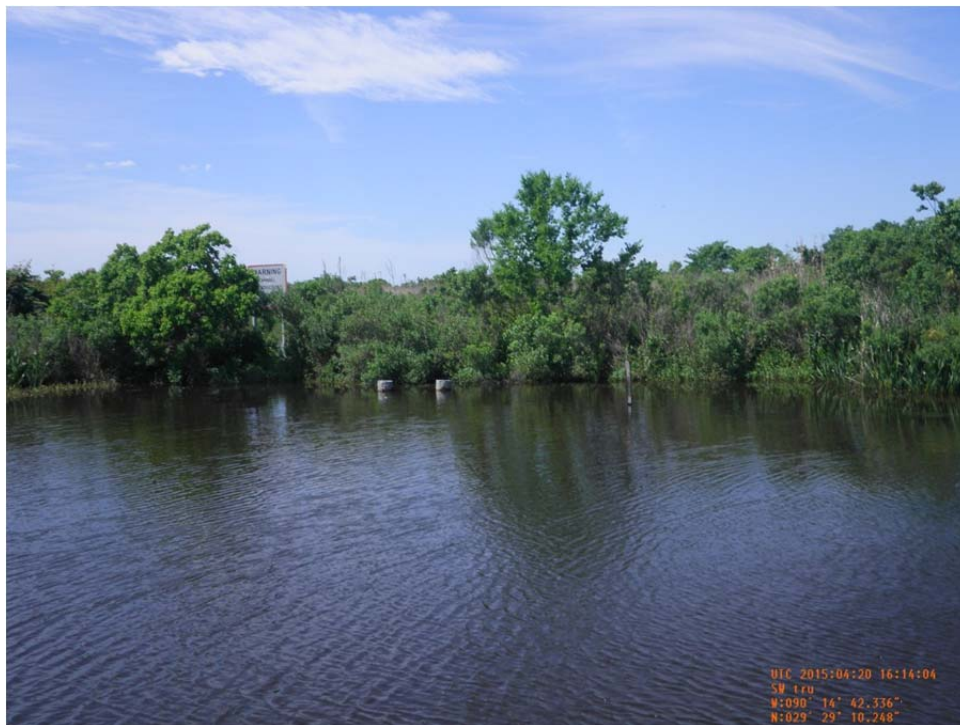
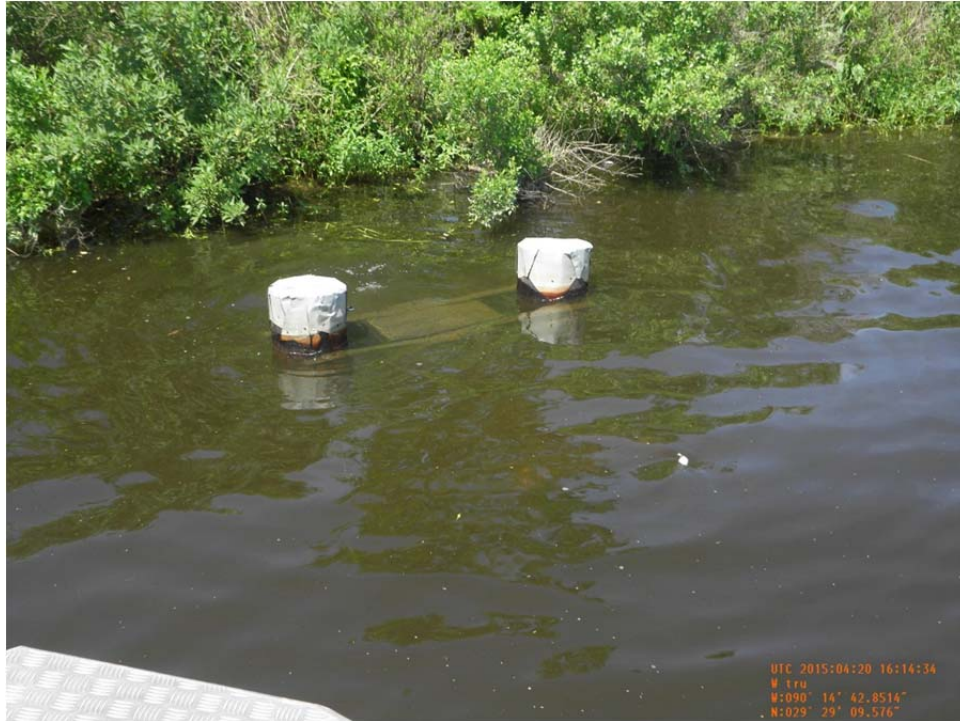
Structure 91 rock plug appeared to be in good overall condition. It was also difficult to inspect this structure due to the thick woody vegetation covering the entire structure. From what we were able to view, it appears that the structure was in good condition with no obvious settlement or breaches around the structure. The timber piles supporting the corrugated metal pipe and flap gate was in good condition as well. New galvanized timber pile caps were installed as part of the 2012 Maintenance project to protect the head of the piling. Also, the warning sign for the structure has been damaged by vandals as it appears the sign has endured several shots from a shotgun. Because the sign is still legible, there are no recommendations

Photo 38: View of rock weir (Structure 91) with corrugated metal pile and flap gate through embankment.

Photo 39: View of corrugated metal pipe support and flap gate at Structure No.91.

for replacement at this time, but it will continue to be monitored on future inspections for further damage. (See Appendix B, Photos 38 and 39)

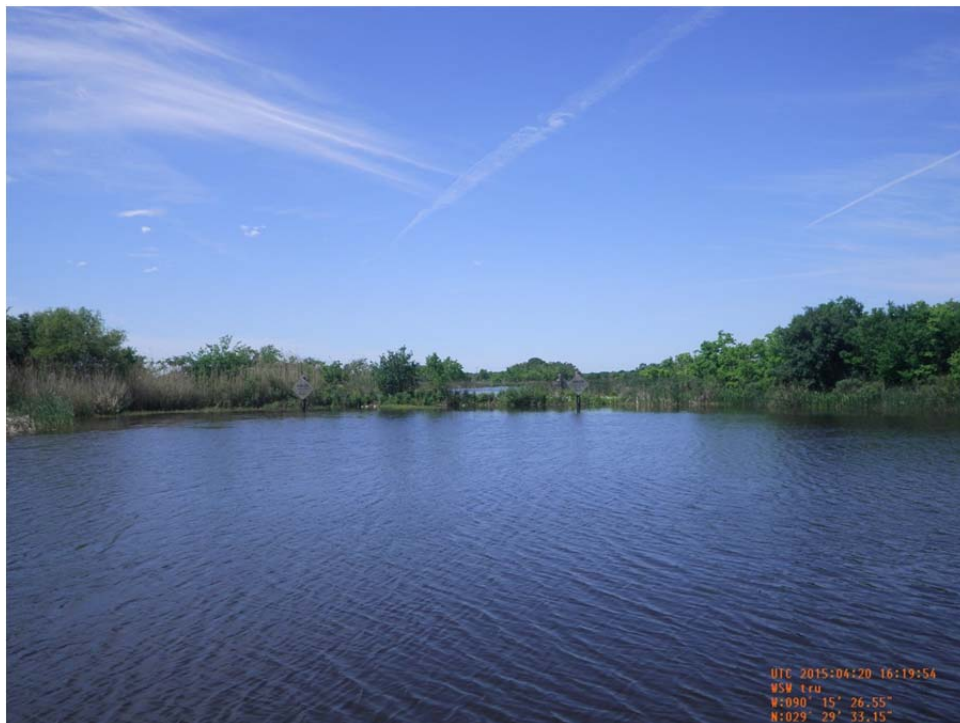
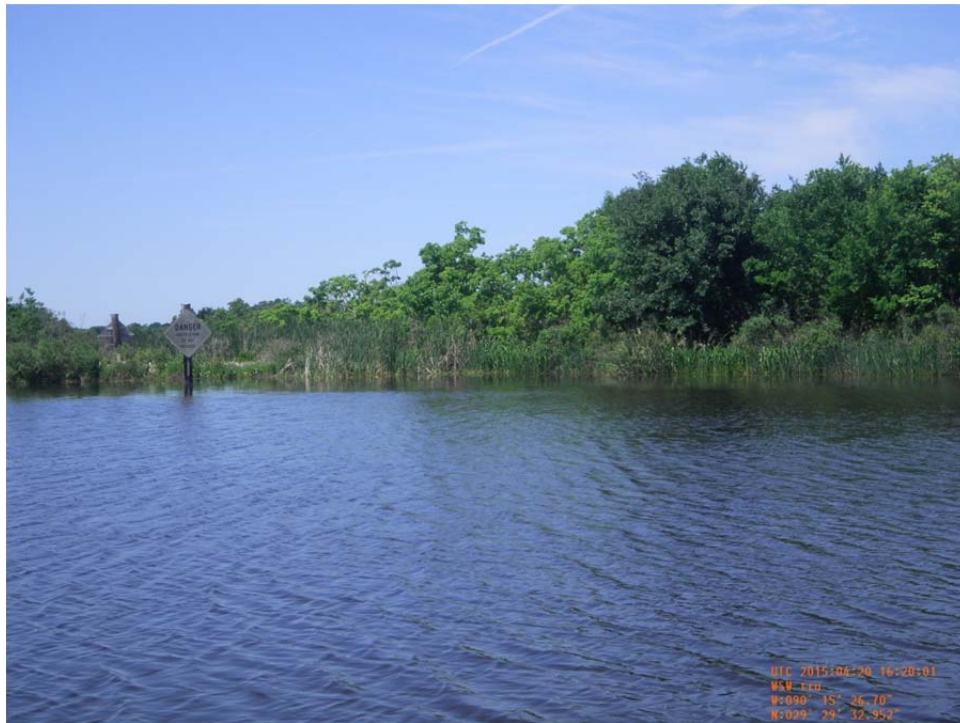
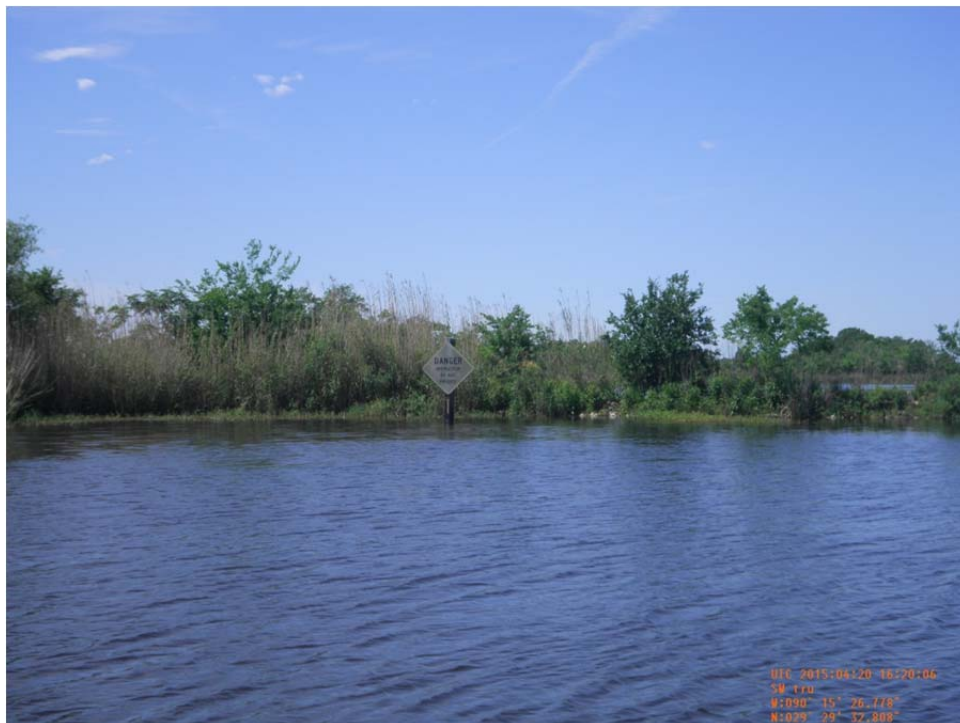
Structure 90 appears to be in good condition with no obvious rock settlement/ displacement or erosion around the embankment tie-ins. All warning signs and supports are in good condition also. There are no recommended corrective actions at this time. (See Appendix B, Photos 40 through 42)

Photo 40: Overall View of Structure 90, a rock rip rap channel plug located in the second location canal on the east bank of Superior Canal from the Hurricane Protection Levee.

Photo 41: View of rock dike plug and warning signs at Structure No.90.

Photo 42: View of rock dike plug and warning signs at Structure No.90.

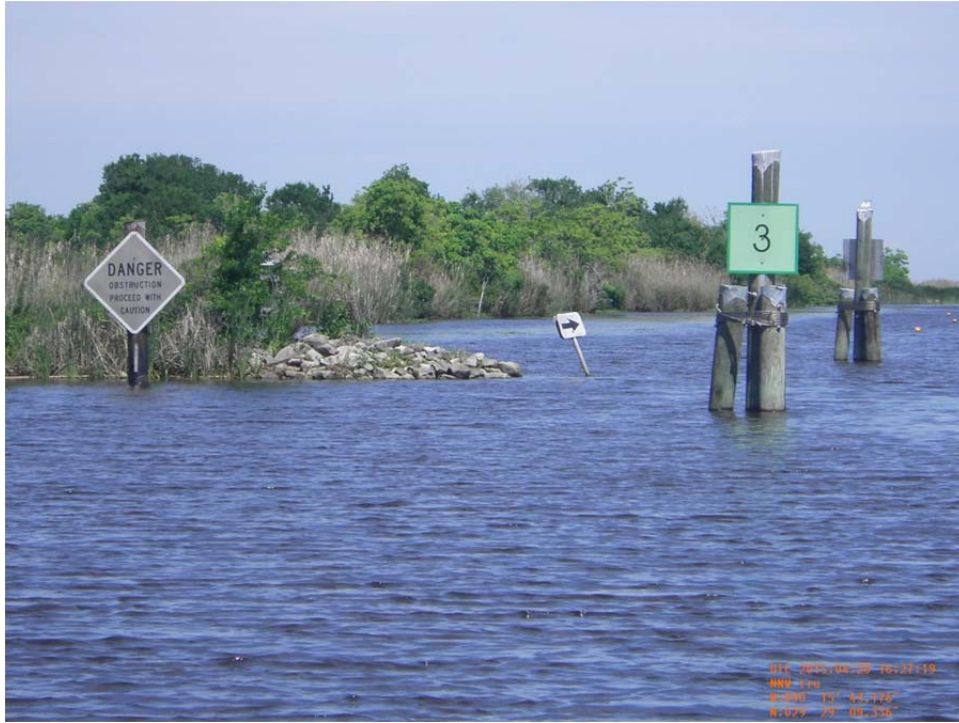
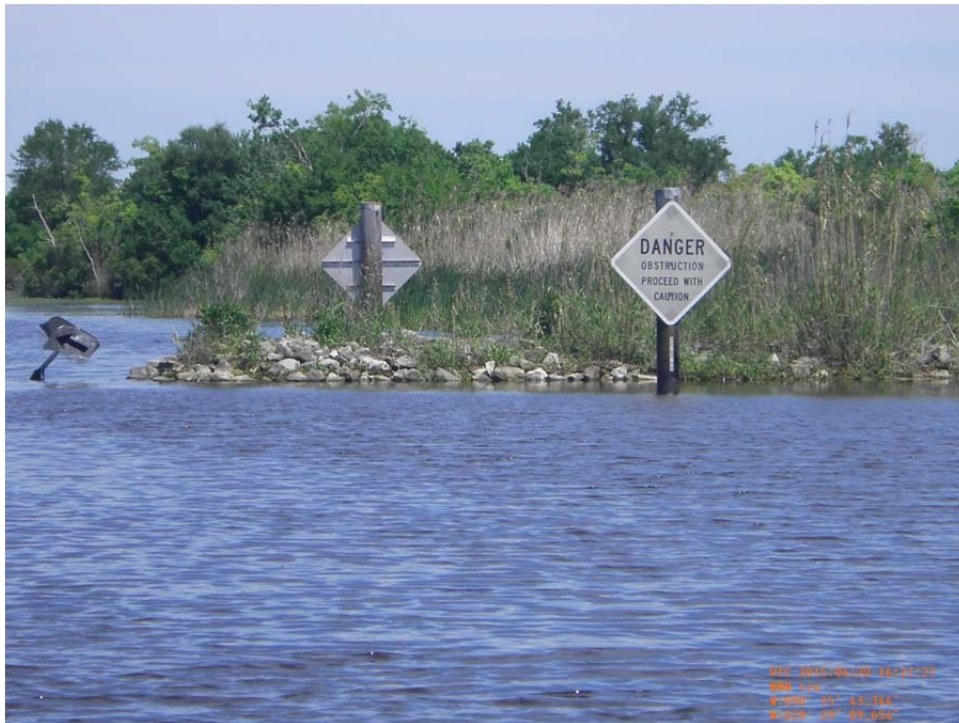
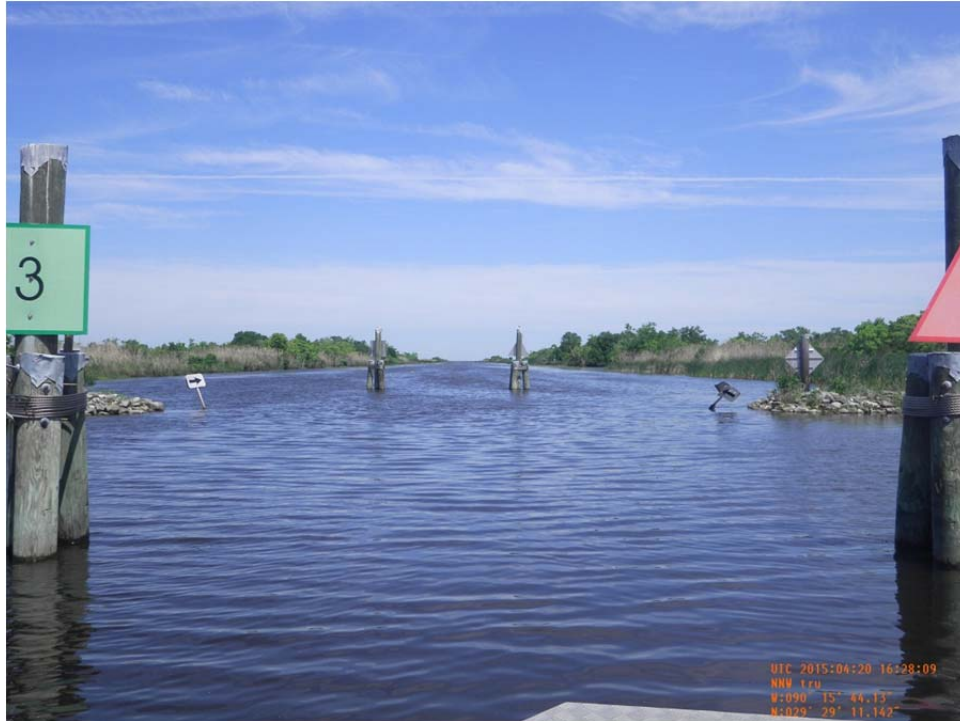
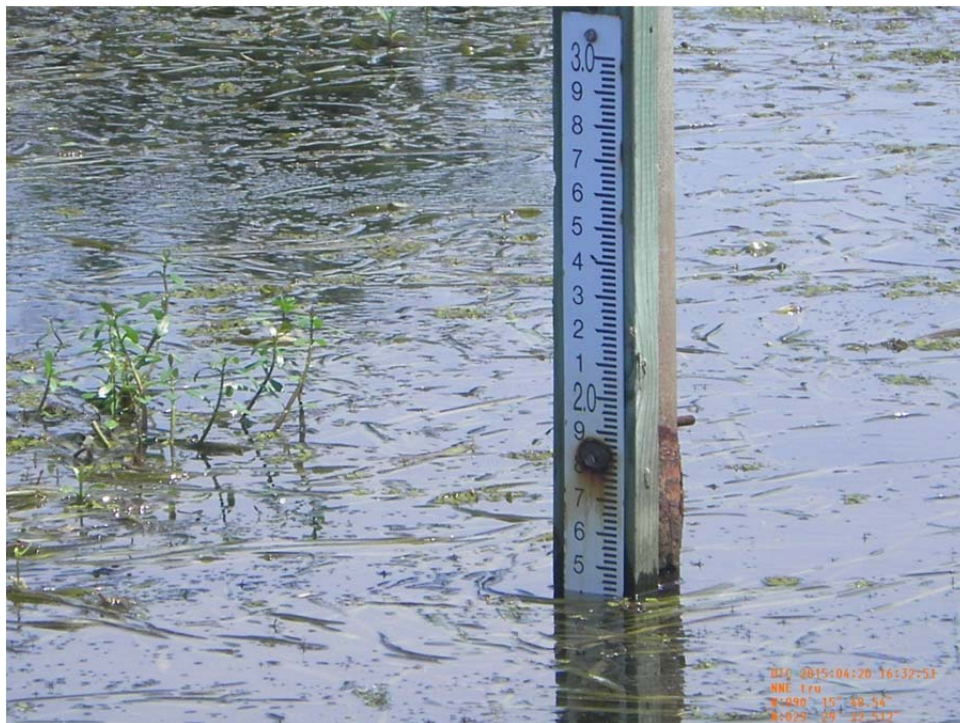
Structure 1 appeared to be in good overall condition with no obvious settlement or displacement of the rock riprap material or erosion along the bank tie-ins of the structure. The four (4) timber dolphin structures and daymark signs at the entrance of the barge bay opening were replaced during the 2012 Maintenance Event and are currently in good condition. Structure 1 is in good condition and there are no recommendations for maintenance at this time. (See Appendix B, Photos 43 through 46)

Photo 43: View of rock weir on the west side, warning signs and barge bay opening at Structure No.1 located along Superior Canal.

Photo 44: view of the rock weir on the east side of Structure No.1 and warning signs.

Photo 45: View of barge bay opening and timber warning signs at Structure No.1.

Photo 46: View of CRMS Station BA-02-57 staff gauge located north of Structure No.1

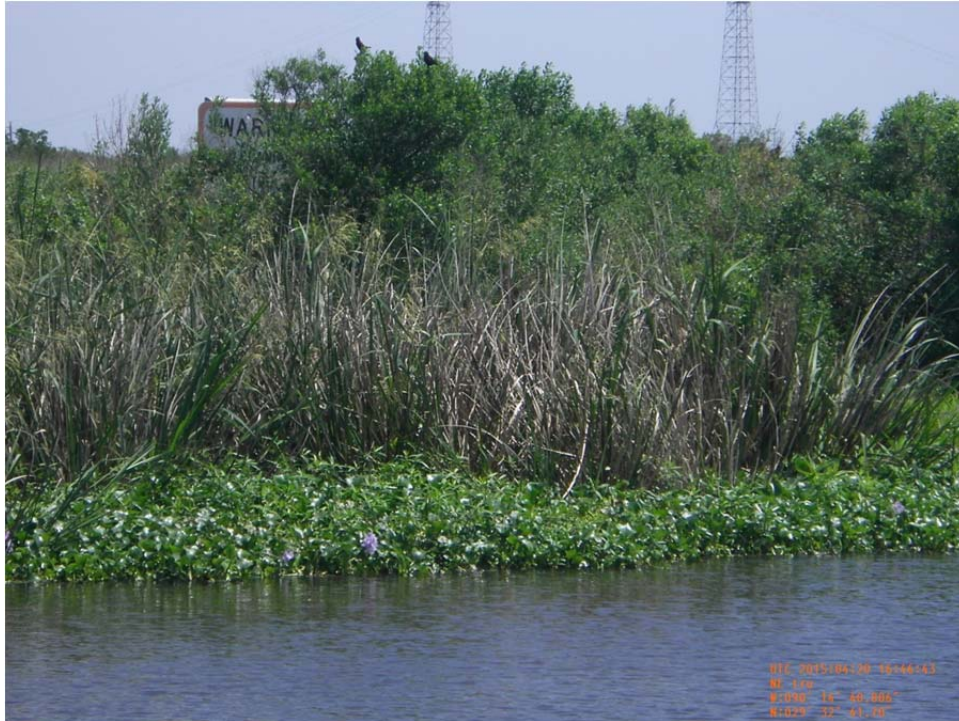
We were unable to visually inspect Structure 43 due to the woody vegetation and floating water hyacinth blocking access and the visibility of the structure. During prior inspections, there was a small breach identified on the eastern end of the rock plug which allowed water to flow around the structure. Currently, we did not notice the breach or water bypassing the structure. It's possible that the vegetation has plugged the breach, thereby reducing the flow of water around the structure. Since the breach has been identified on previous inspections, we will continue to look for water flow around the structure on future inspections. All warning signs and support structures appear to be in good condition, and at this time, there are no recommendations for maintenance. (See Appendix B, Photo 47)

Photo 47: View rock rip rap channel plug (Structure 43) located along Bayou Des Amoreaux.
