**State of Louisiana
Coastal Protection and Restoration Authority**

2016 Annual Inspection Report

Barataria Bay Waterway East Shoreline Protection

State Project Number BA-26
Priority Project List 6

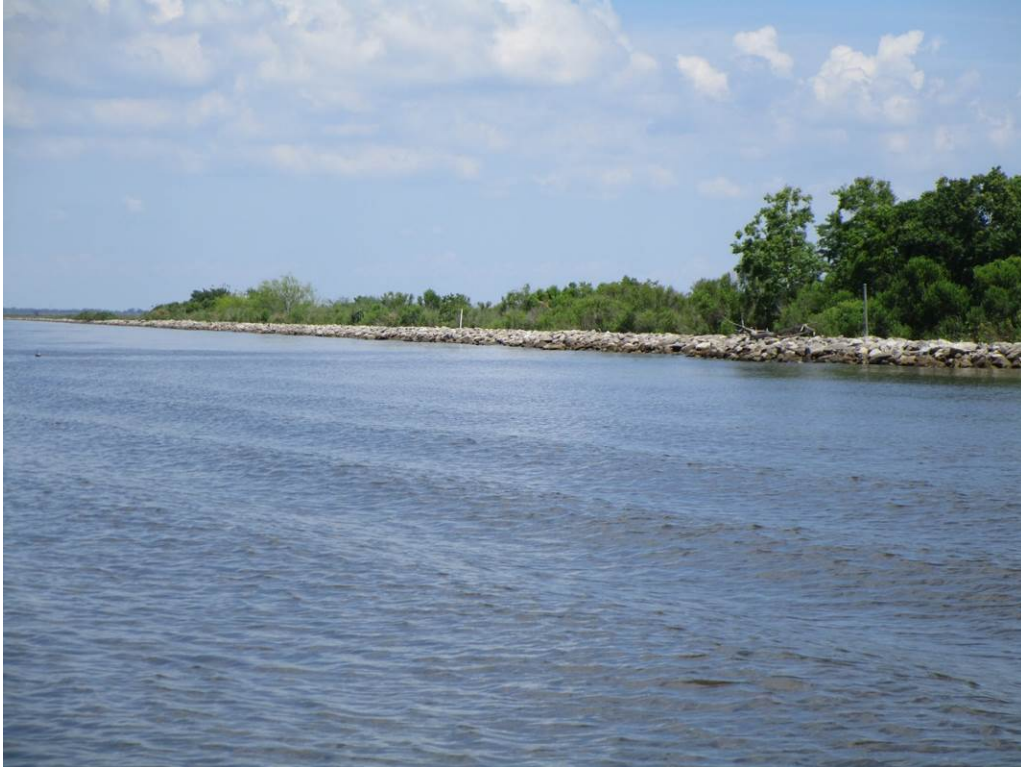
The overall condition of the rock shoreline protection structure was good (Photo #1). Some portions of the rock structure adjacent to and south of the BA-41 marsh creation area have experienced settlement (Photos #2 & #3). Accretion and vegetation were observed behind the rock structure at the northern end of the project (Photo #4).

Photo #1 – Shoreline protection rock structure

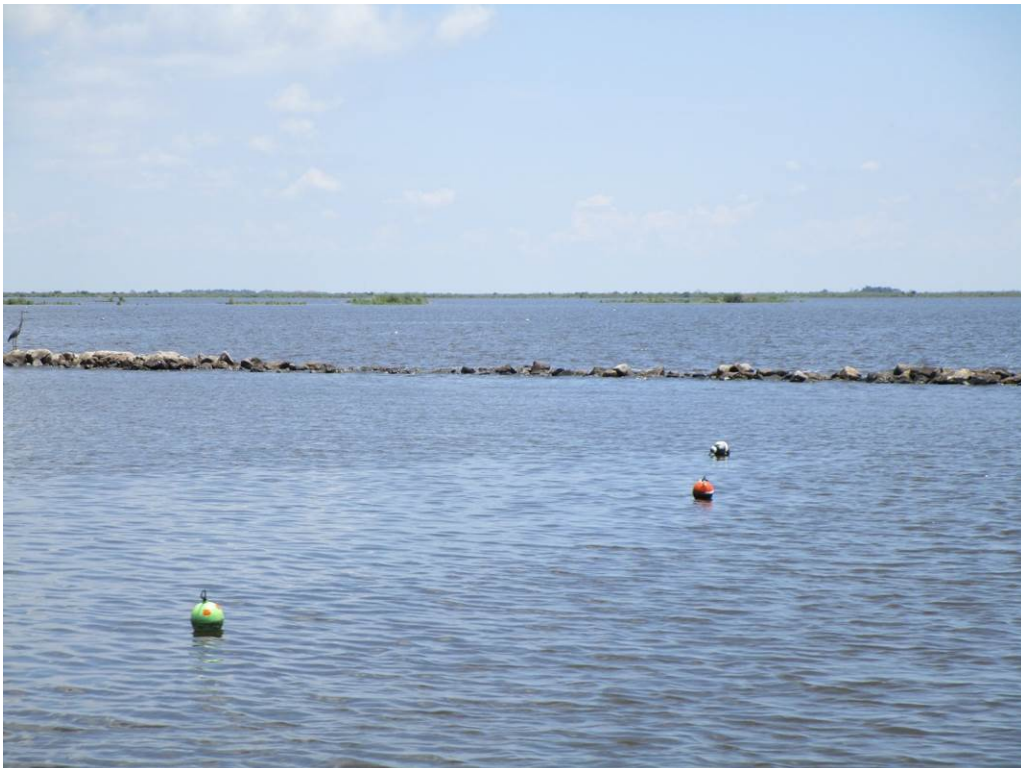
The Barataria Bay Waterway East Protection Project (BA-26) is performing adequately. The rock dike is protecting the existing marsh as designed. Settlement has been noted in some areas which may require corrective action in the near future.

Photo # 2 – Settlement noted in open water area

To determine if a maintenance rock lift is warranted, CPRA recommends performing a one-day reconnaissance survey effort to assess and document the top-of-rock elevations in the areas which appear to be experiencing settlement. Additional recommendations will be presented to NRCS following the collection and assessment of survey data.

- CPRA will perform a survey check of the low rock areas.

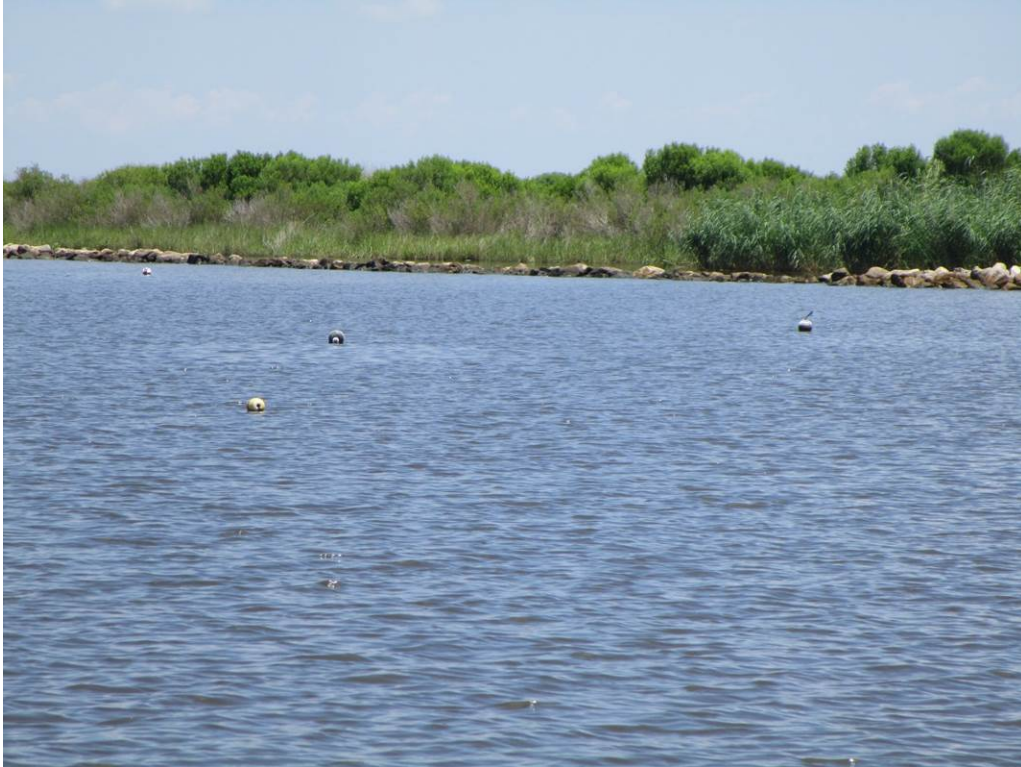
Photo # 3 – Settlement noted west of BA-41 marsh creation area

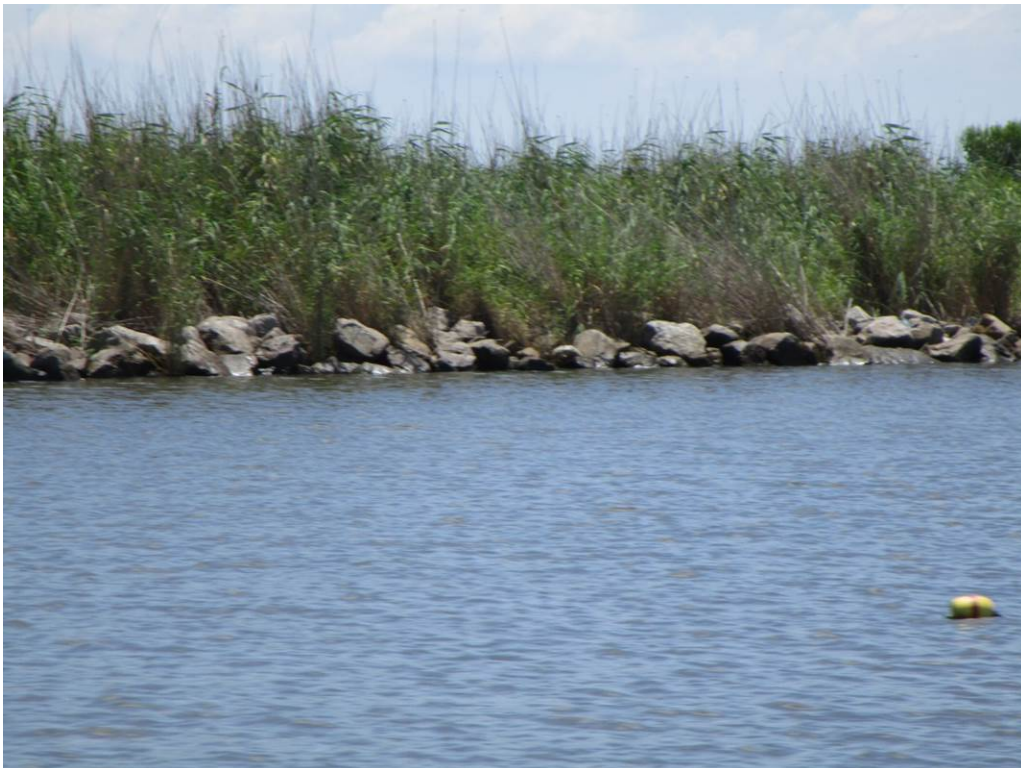
Photo # 4 – Accretion & vegetation behind the rock structure
