**Coastal Protection and Restoration Authority
of Louisiana (CPRA)**

**2015 Operations, Maintenance, and
Monitoring Report**

**East Mud Lake Marsh Management
(CS-20)**

State Project Number CS-20
Priority Project List 2

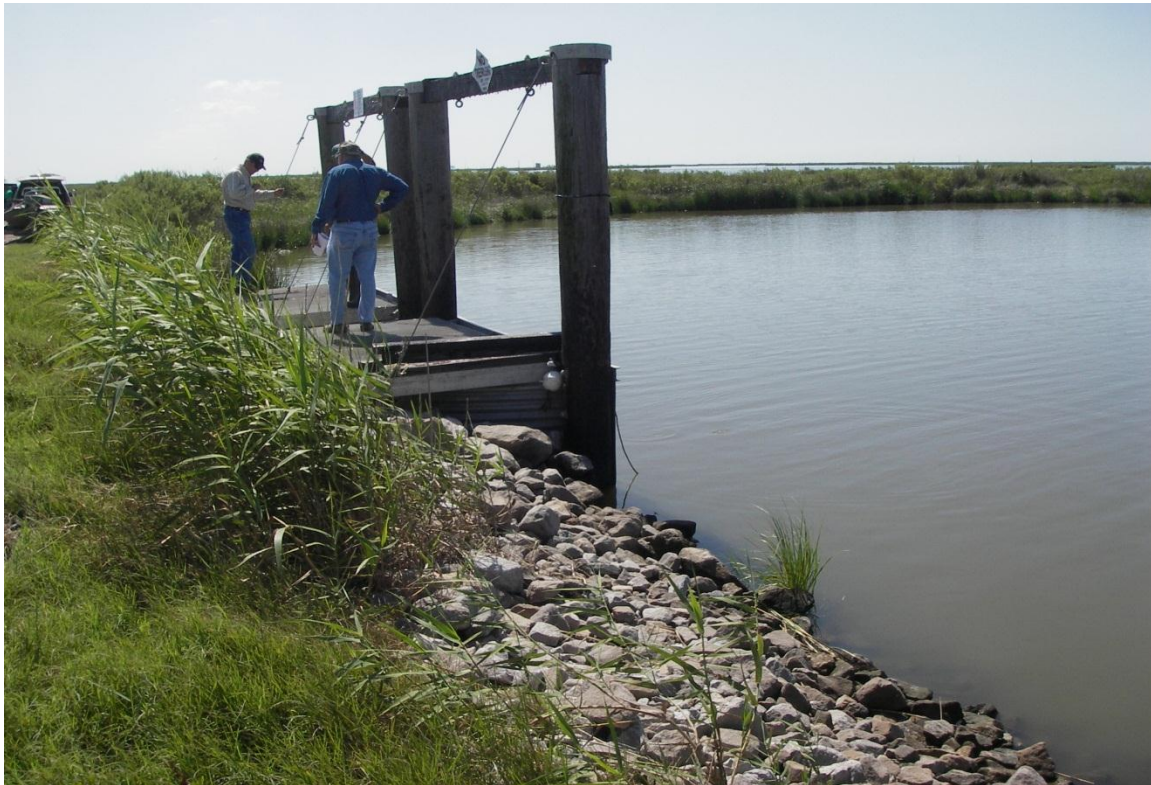
Photo No.1 Structure No. 6

Structure No. 6 remains in very good condition. The timber piles, stop logs, grating, etc. are in good condition. (Photos: Appendix A, Photo 1).

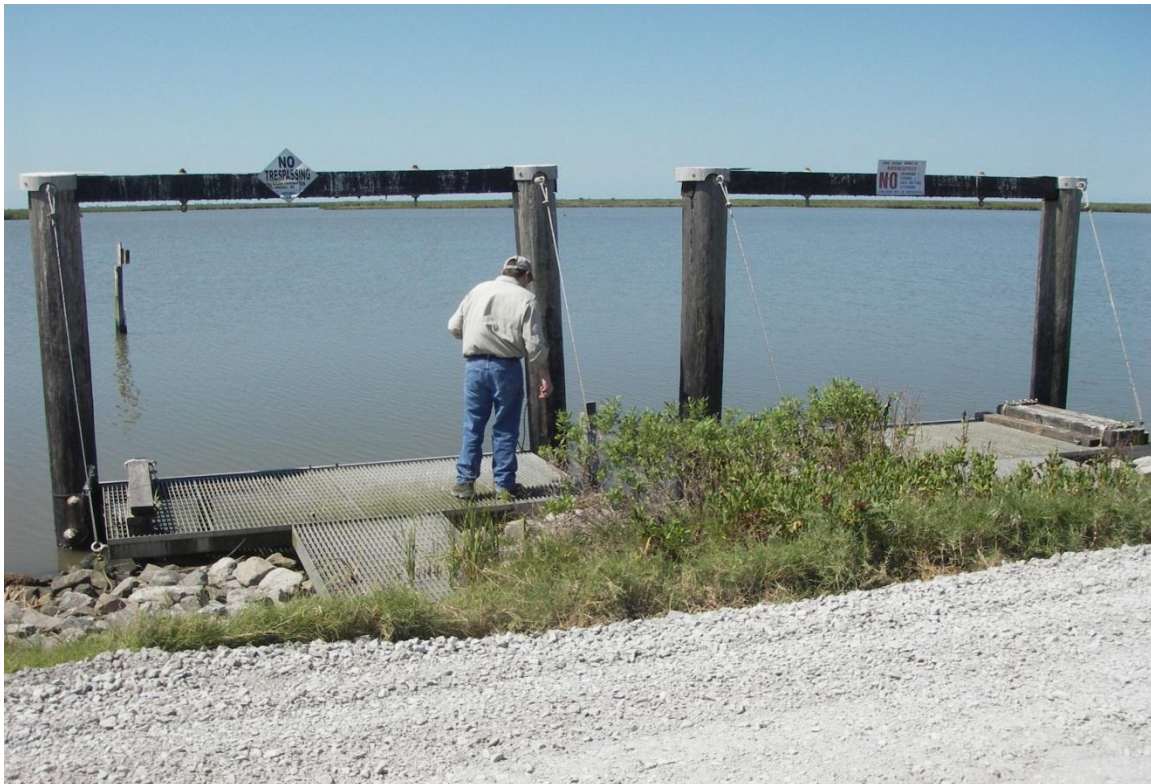
Photo No. 2 Structure No. 7

Structure No. 7 is also in very good condition. The timber piles, stop logs, grating, etc. are in good condition. Water levels at this structure were +1.4 on the outside and +1.5 on the inside. (Photos: Appendix A, Photo 2).

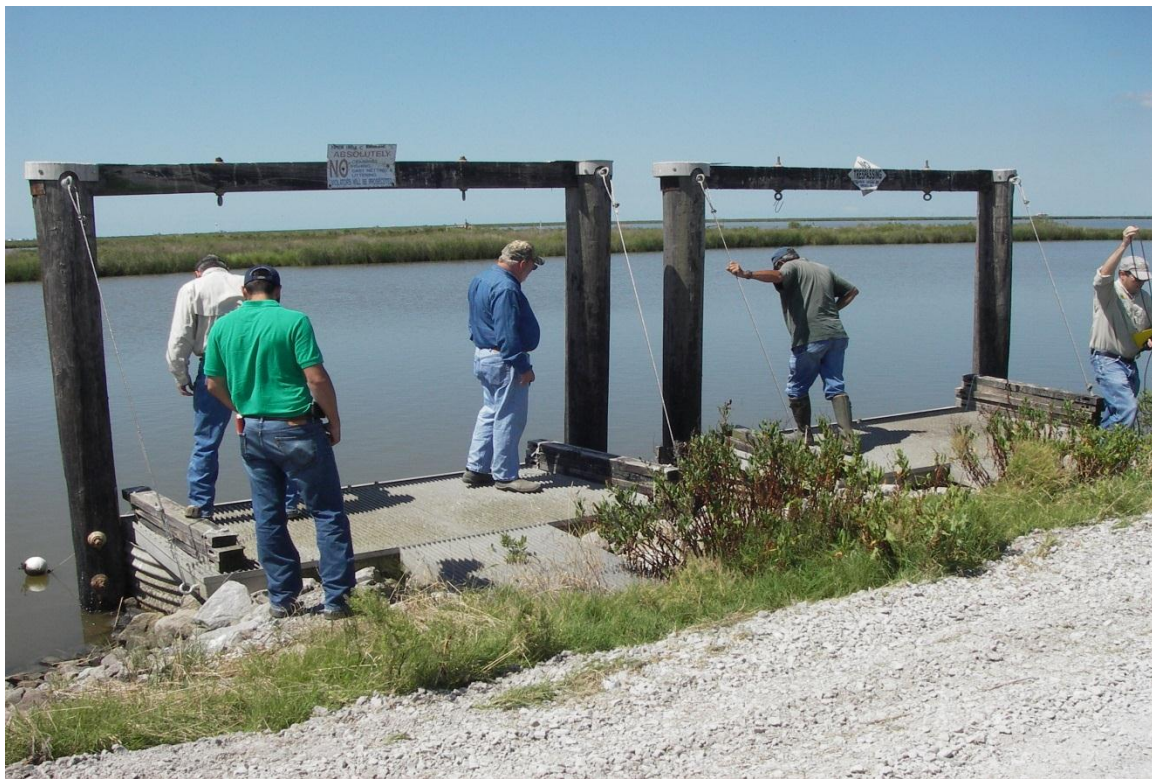
Photo No. 3, Structure No. 8

Structure No. 8 is in very good condition. The timber piles, stop logs, grating, etc. are in good condition. (Photos: Appendix A, Photo 3).

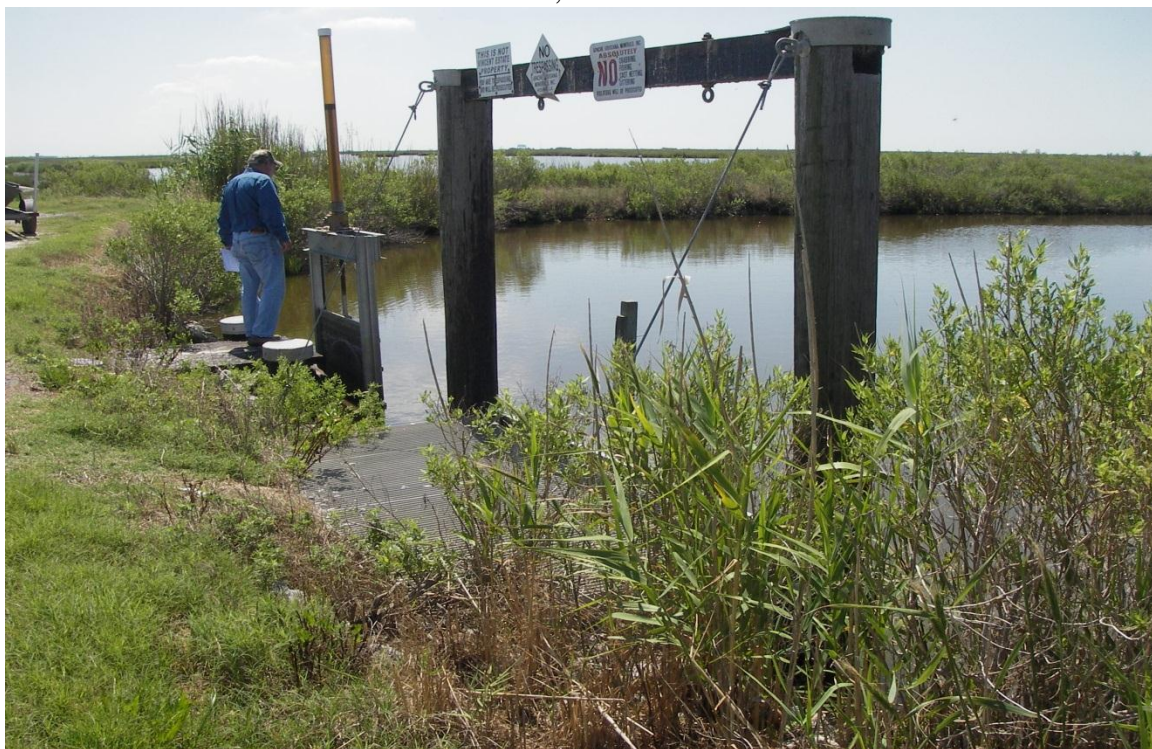
Photo No. 4, Structure No. 9a

Structure No. 9a is in good condition and functioning as intended. (Photos: Appendix A, Photos 4 & 6).

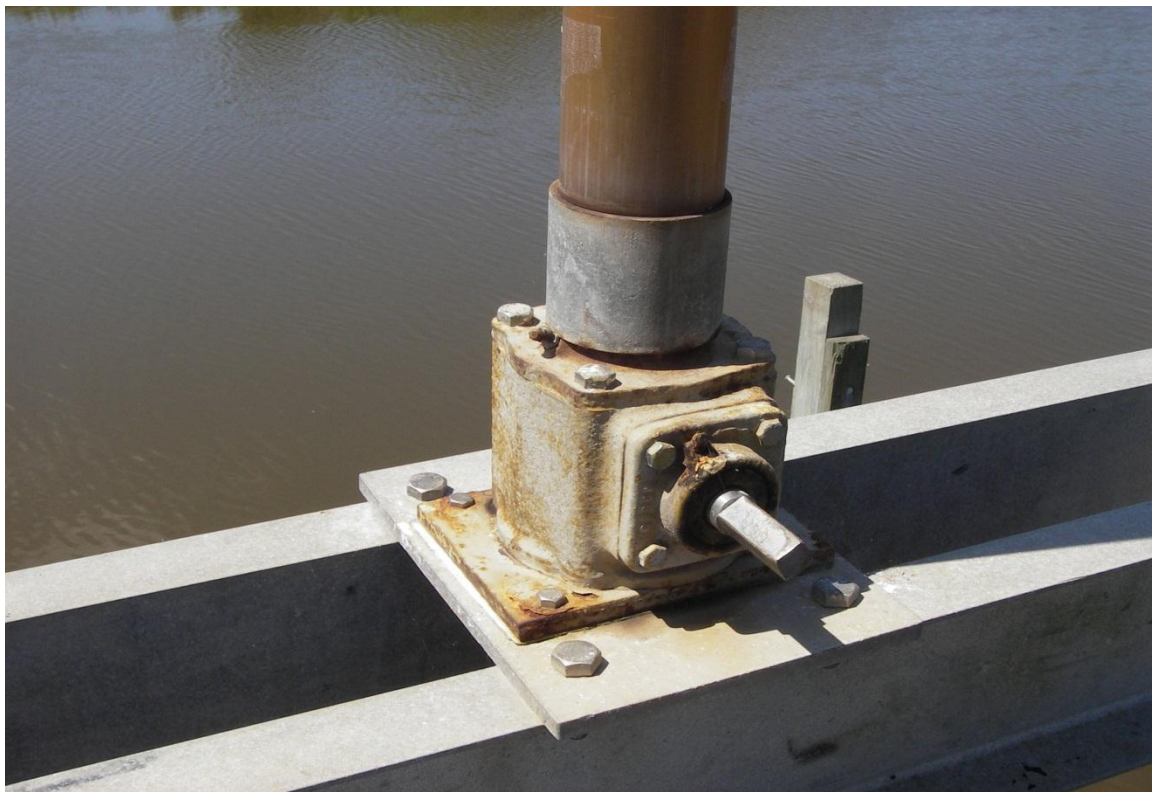
Structure No. 9b is in good condition. Vandals have broken the flapgate lifting arm. This will be one of the items addressed with the proposed maintenance event. Apache has filed a police report. The structure is still functional and all other components are in good shape. Water levels were ~+1.47 on the inside and ~ =1.49 on the outside however water was flowing out. These staff gauges will need to be verified. (Photos: Appendix A, Photos 5 & 6).

Photo No. 5, sluice gate gear box on Structure 9b

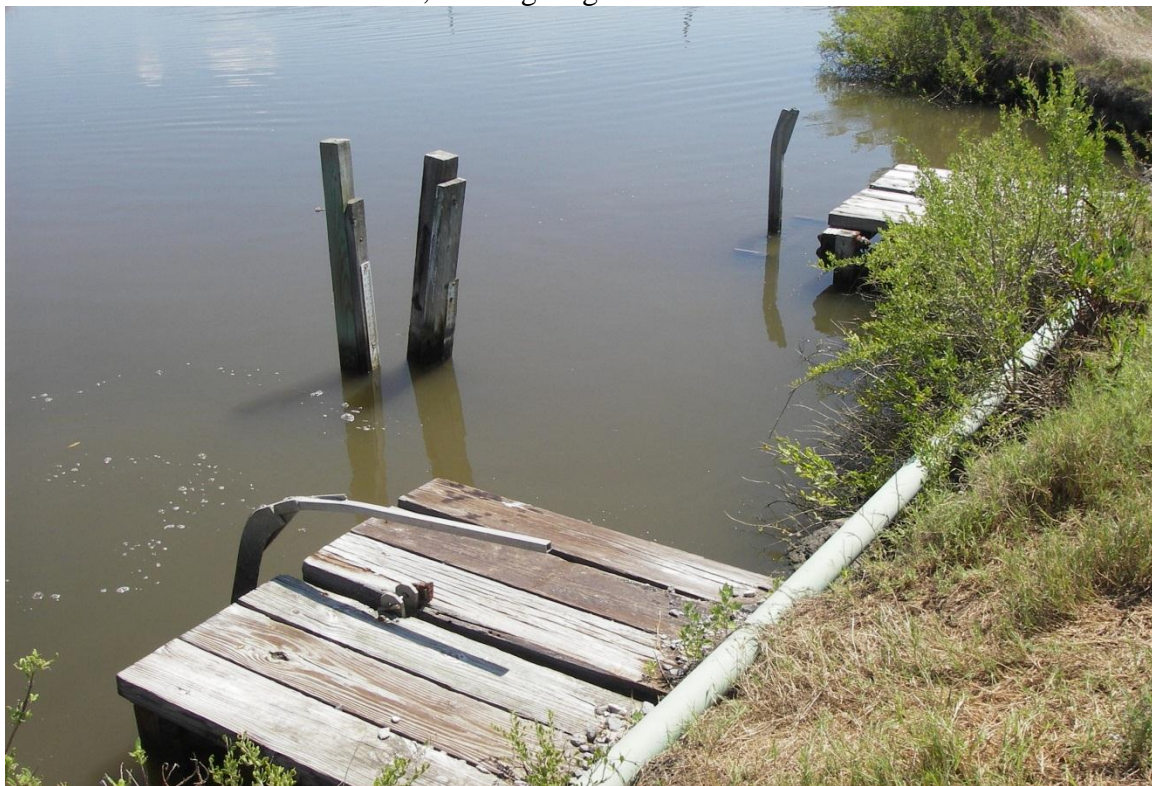
Photo No. 6, flapgates on Structures 9a & 9b

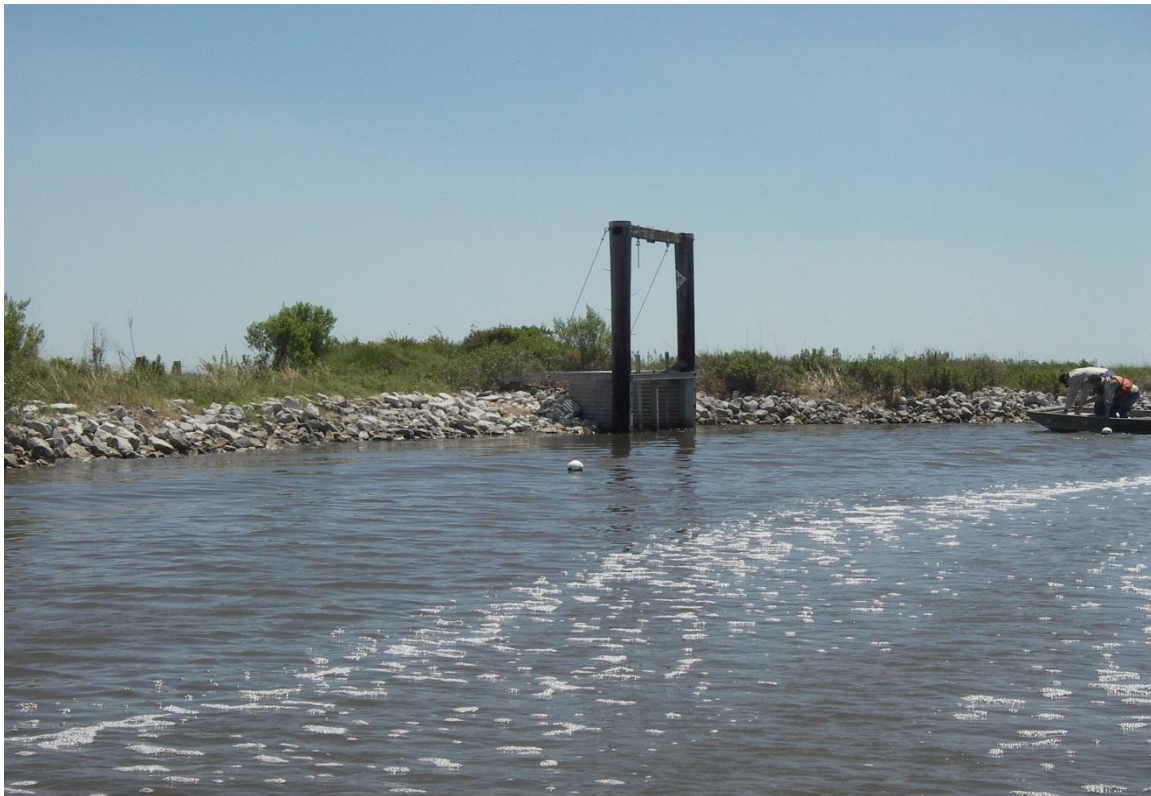
Photo No. 9, Structure No. 5

The structure itself is in good condition. Rock placed here continues to work very well. (Photos: Appendix A, Photo 9 & 10).

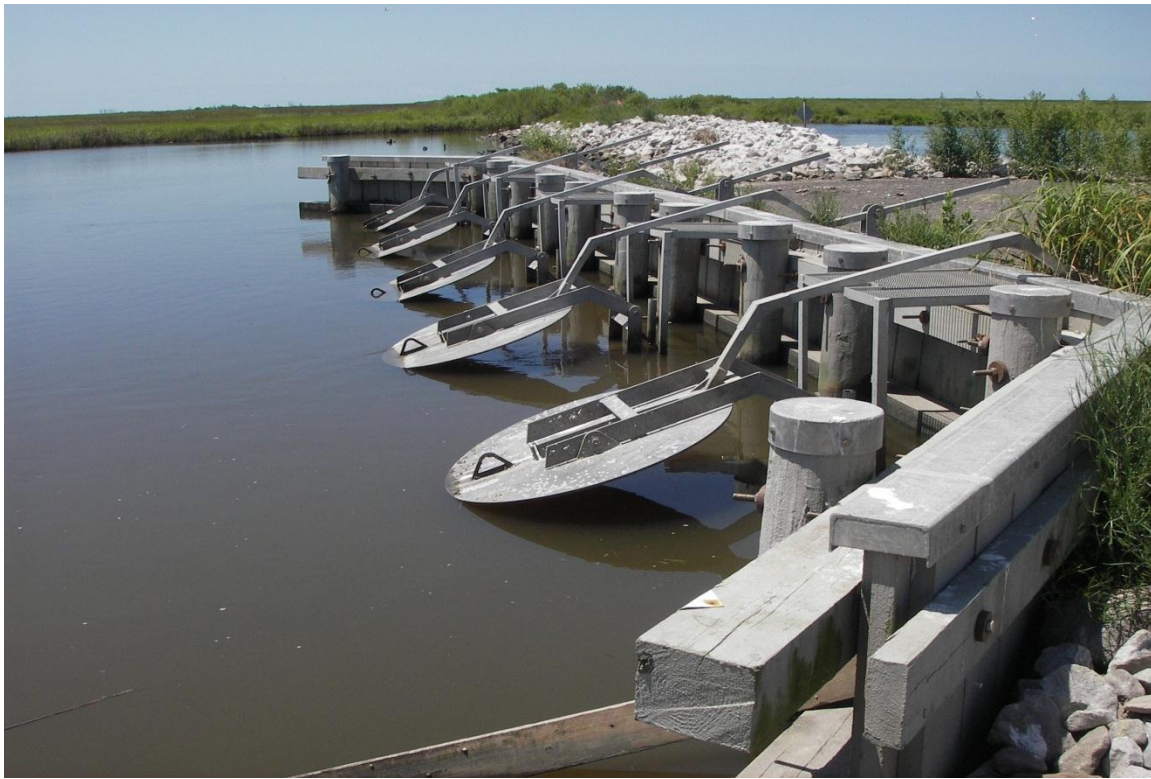
Photo No. 11, flap side, Structure No.4

This structure was completely replaced with a new 48 inch diameter five barrel drainage structure, including timber supports, and rock armoring. The pre-existing structure No. 4 was abandoned in place by driving steel sheet piles through the mid-section of the culverts. The dirt placed on top of the new structure has continued to settle. The sinkholes that developed on the stoplog side of the structure and have worsened, but the anti-seep collar is still in place and functioning. They will continue to be monitored. Two of the locks were missing from the stoplog locking devices but the stoplogs were still in place. The four large stoplogs that were stolen previously will need to be replaced. Timber is still missing from the boat barrier and will also need to be replaced. (Photos: Appendix A, Photos 11 - 14).

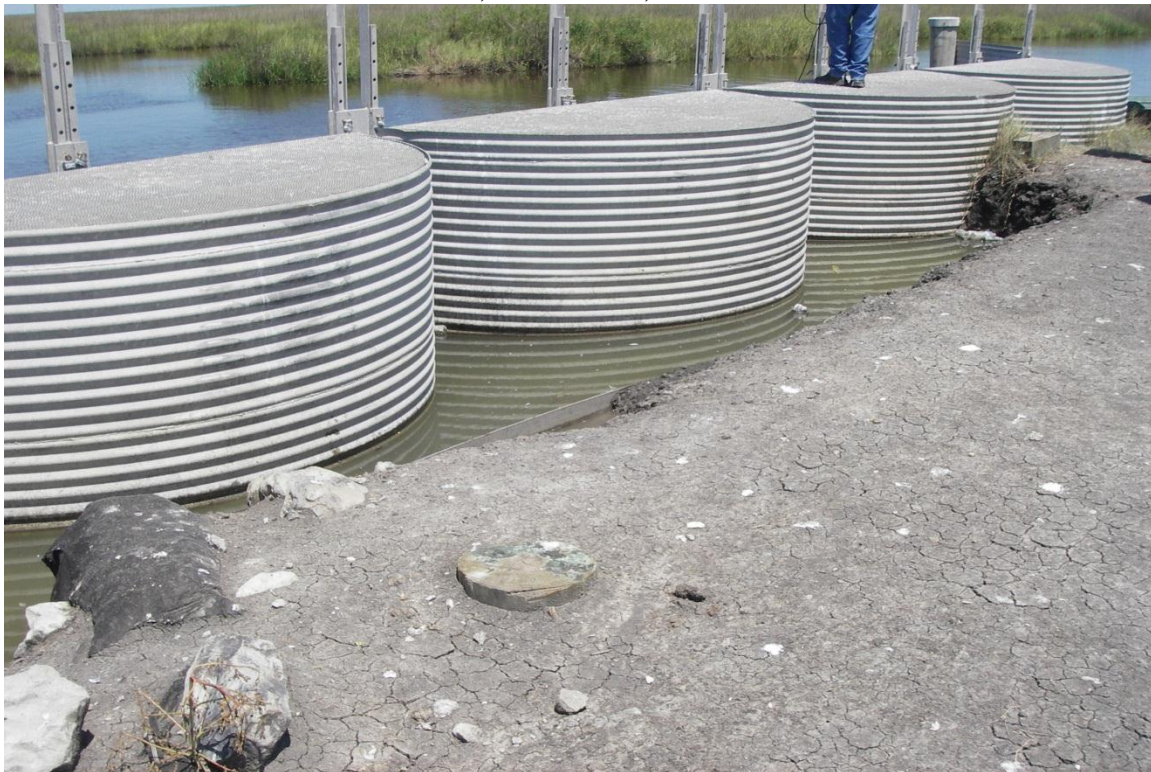
Photo 14, sinkholes developing behind Structure 4 stoplog bays

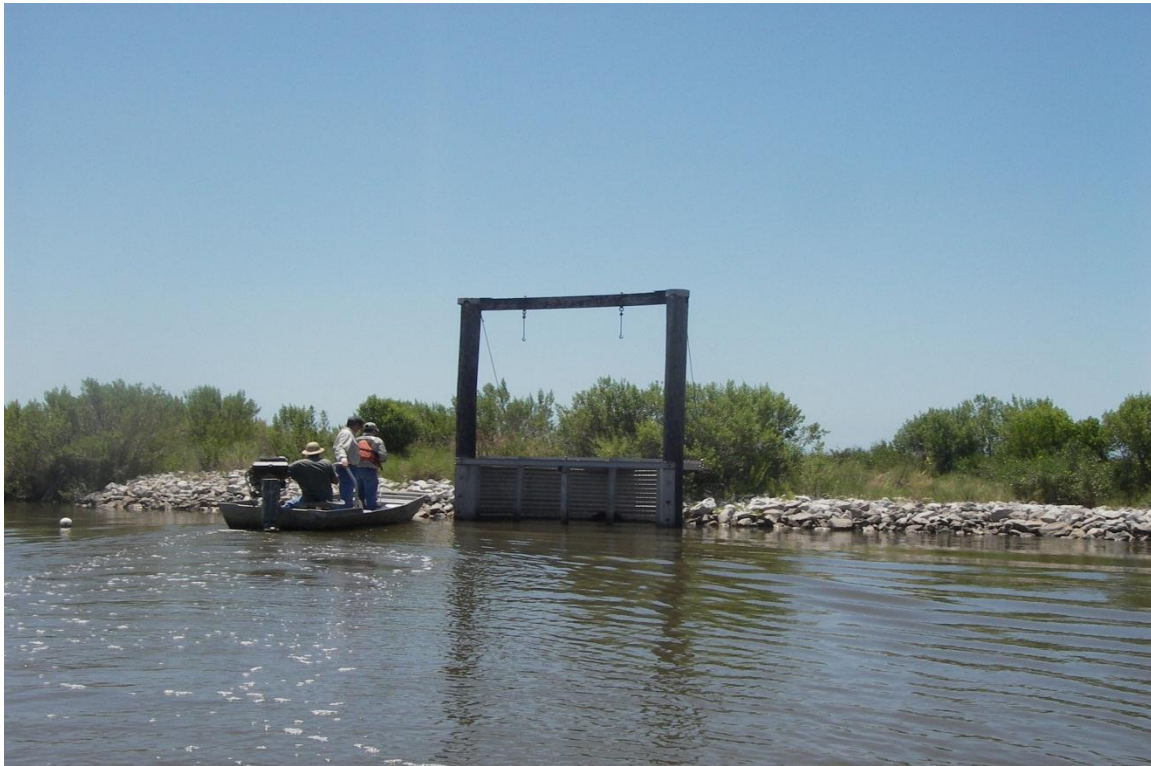
Photo 17, Structure 1

This structure is in good condition. Walkways have been tacked into place. No vandalism at this structure. Rock has stabilized the banks. (Photo: Appendix A, Photos 17 & 18).

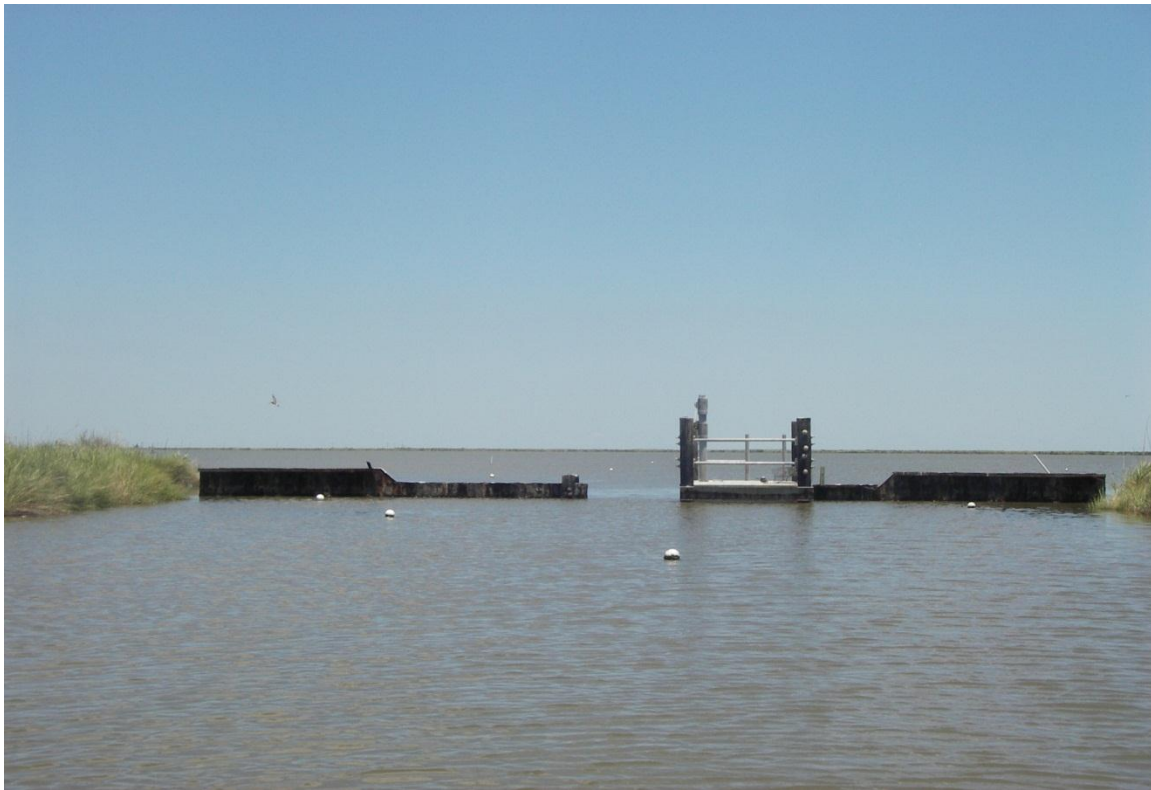
Photo 19, Structure 17

Erosion around both sides of this structure has continued. There is water exchange on both sides. The sheet pile cap rust is extensive. The hardware for lifting the stoplogs is still in place and in fairly good shape. In order to be able to perform any other drawdowns in the future, significant maintenance will be required on this structure. (Photo: Appendix A, Photos 19 & 20)

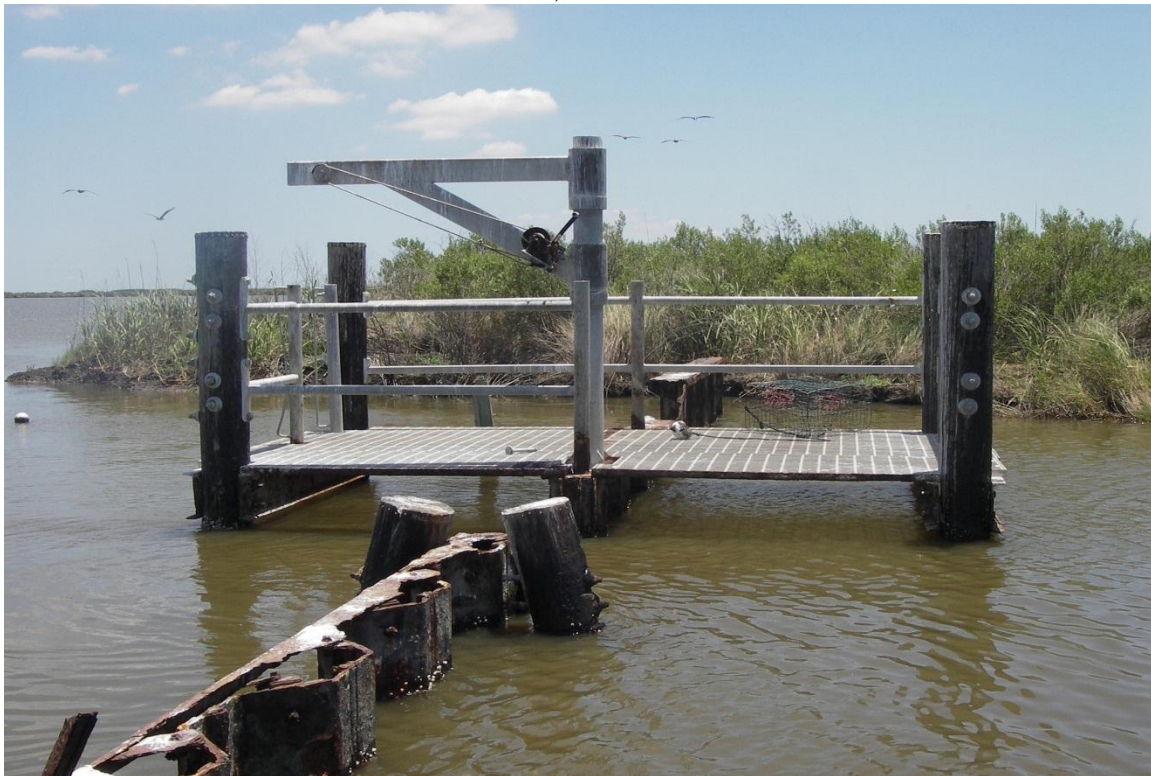
Photo 20, sheet pile, cap and lifting hardware at Structure 17

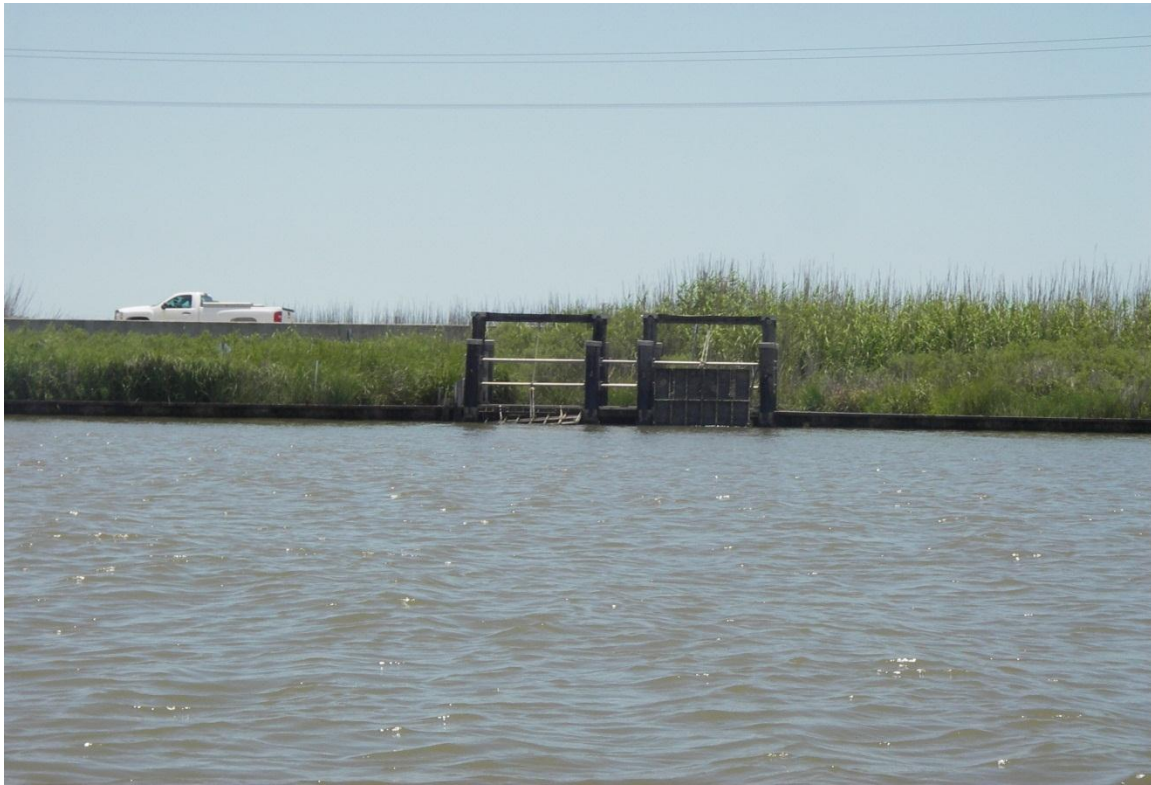
Photo 21—Structure 13

The flaps are broken on both bays of this structure and were tied in place by Apache. The rest of the structure, sheet piles, caps, signs, etc. are in very good condition. Maintenance will be required to repair the flaps. (Photos: Appendix A, Photos 21 - 24).

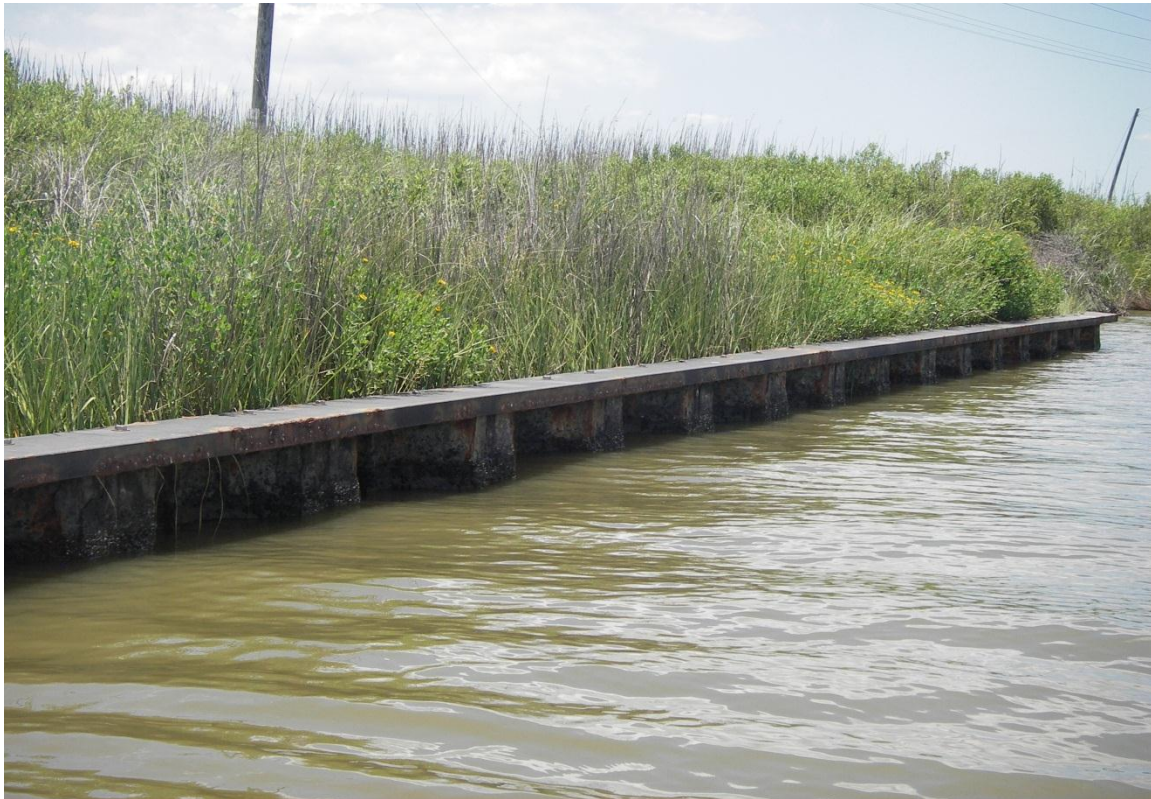
Photo 22—sheet pile wall and cap at Structure 13

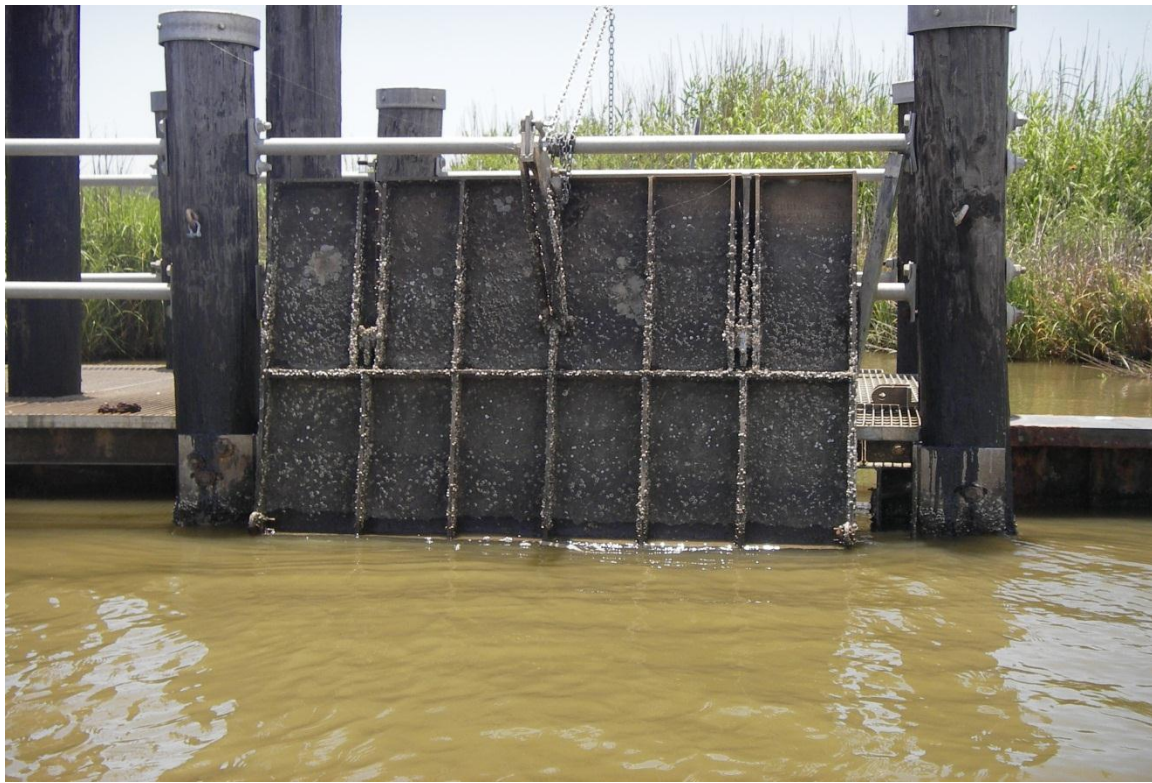
Photo 23—disconnected flap on Structure 13

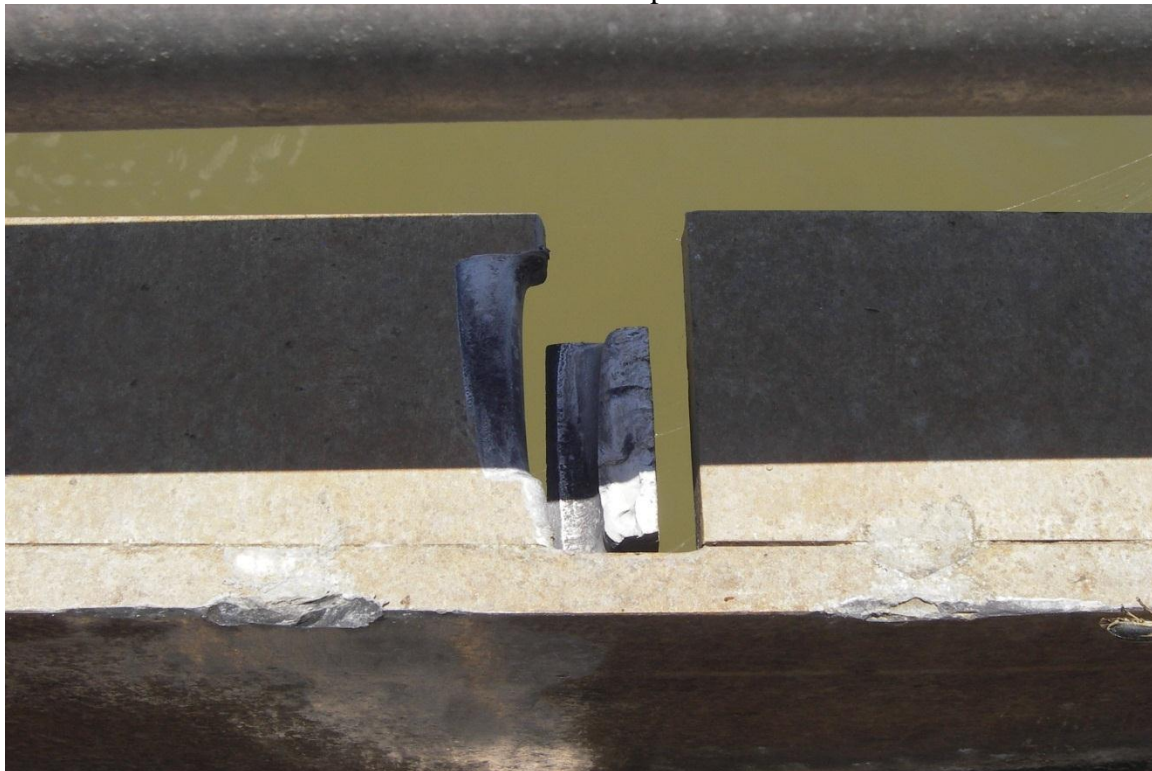
Photo 24—broken pivot point on Structure 13 flap
