**State of Louisiana  
Coastal Protection and Restoration Authority**

**2015 Annual Inspection Report**

**GOOSE POINT / POINT PLATTE  
MARSH CREATION PROJECT**

State Project Number PO-33

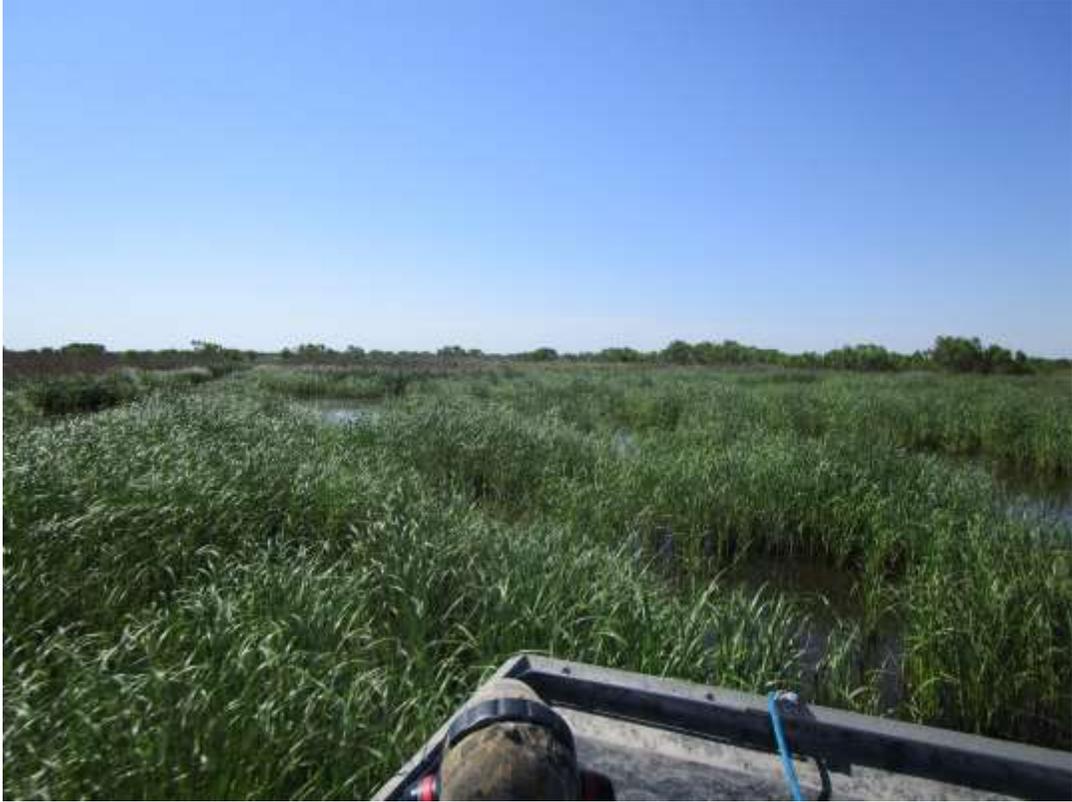
**Area A** – Marsh grass plantings with vegetated fill area beyond

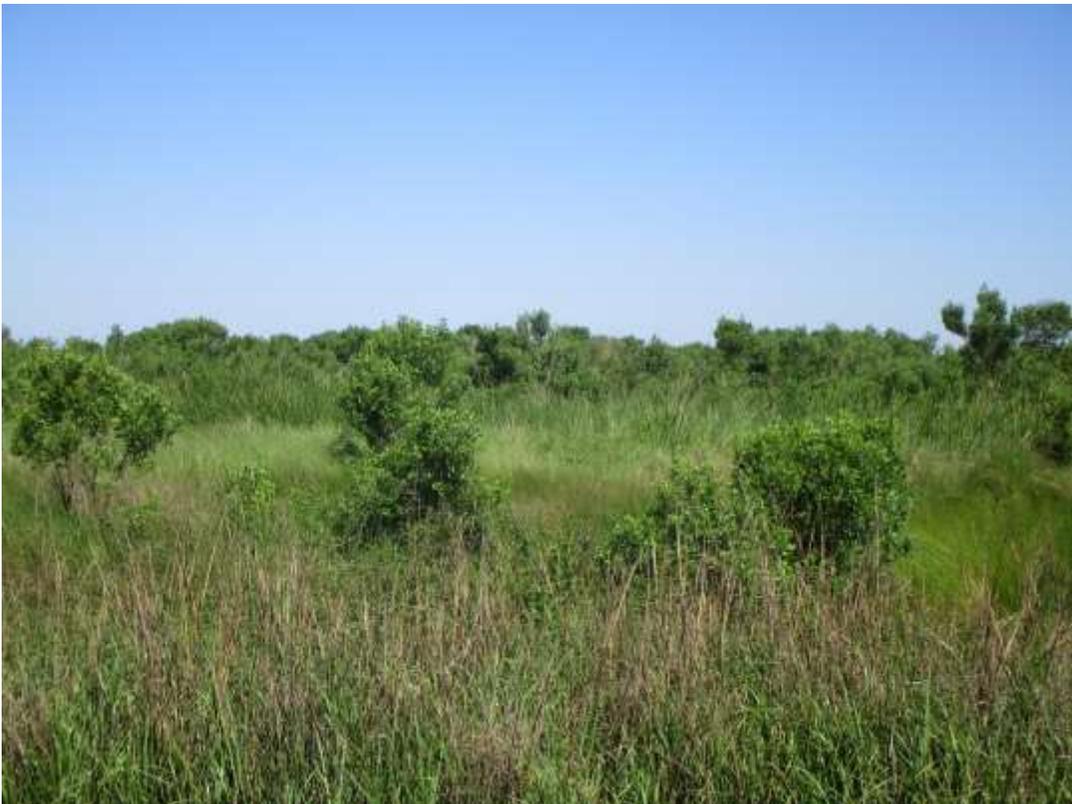
**Area A** – Shrubs observed within the fill area and along the containment rim

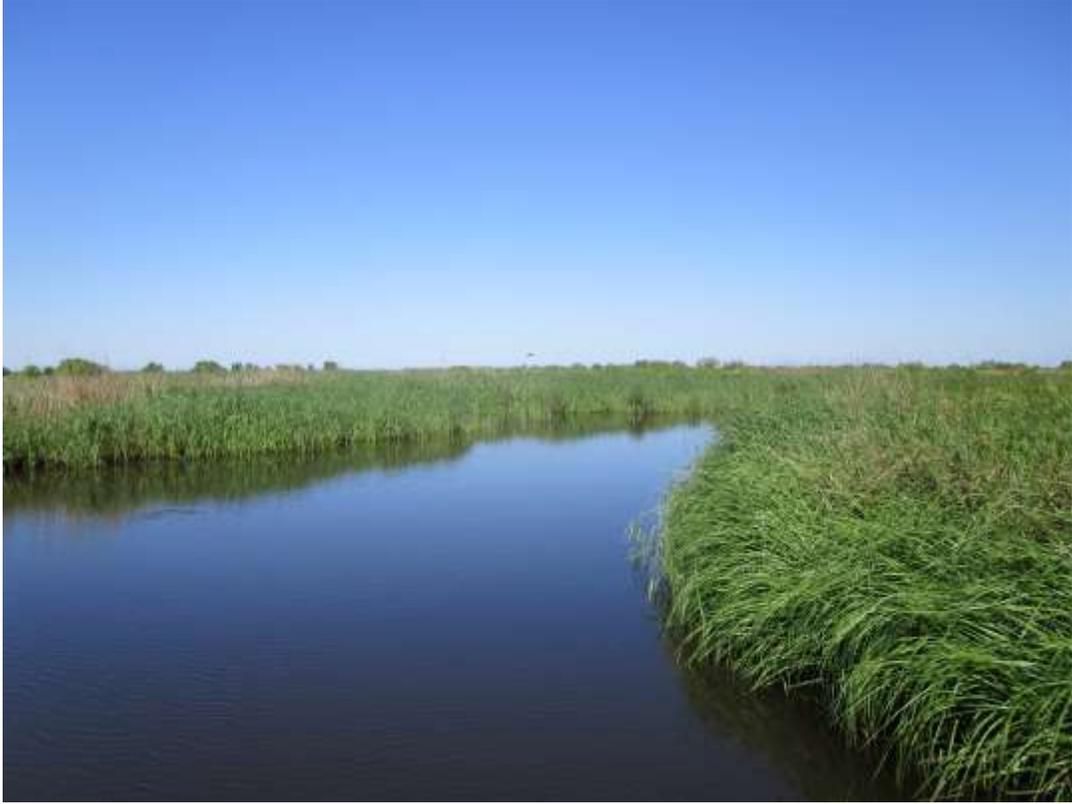
**Area B** – Shallow water in containment borrow area with healthy marsh beyond

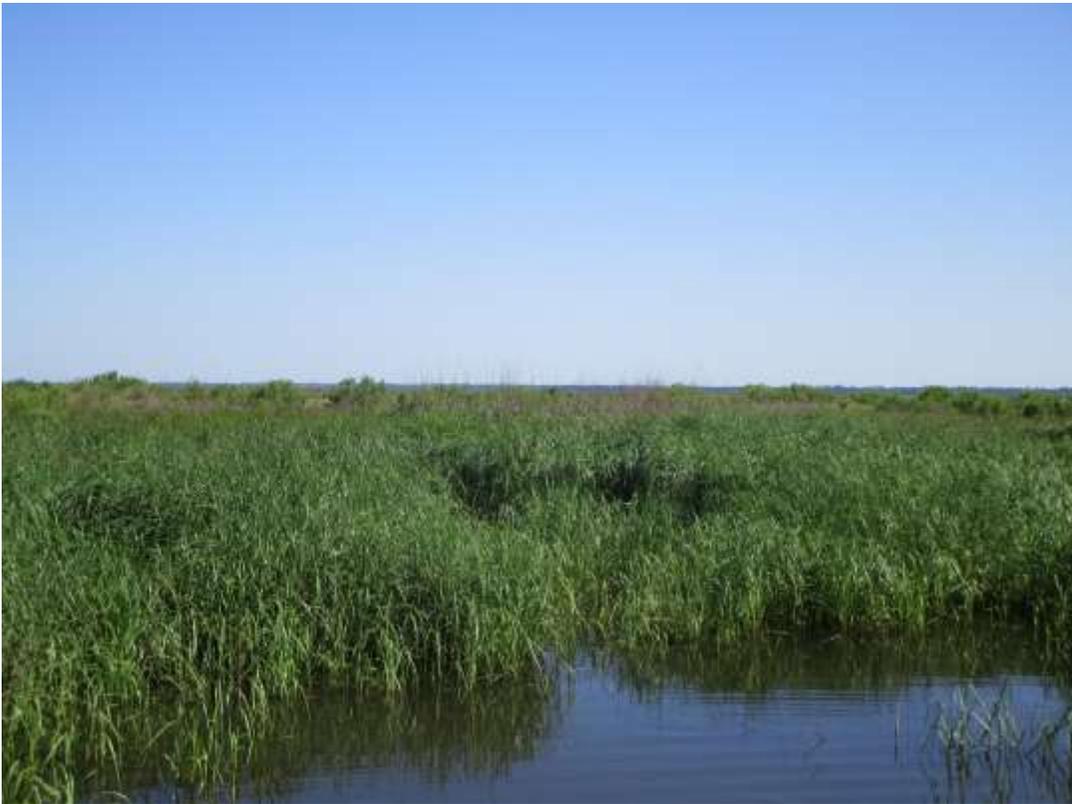
**Area B** – Grass plantings after one full growing season

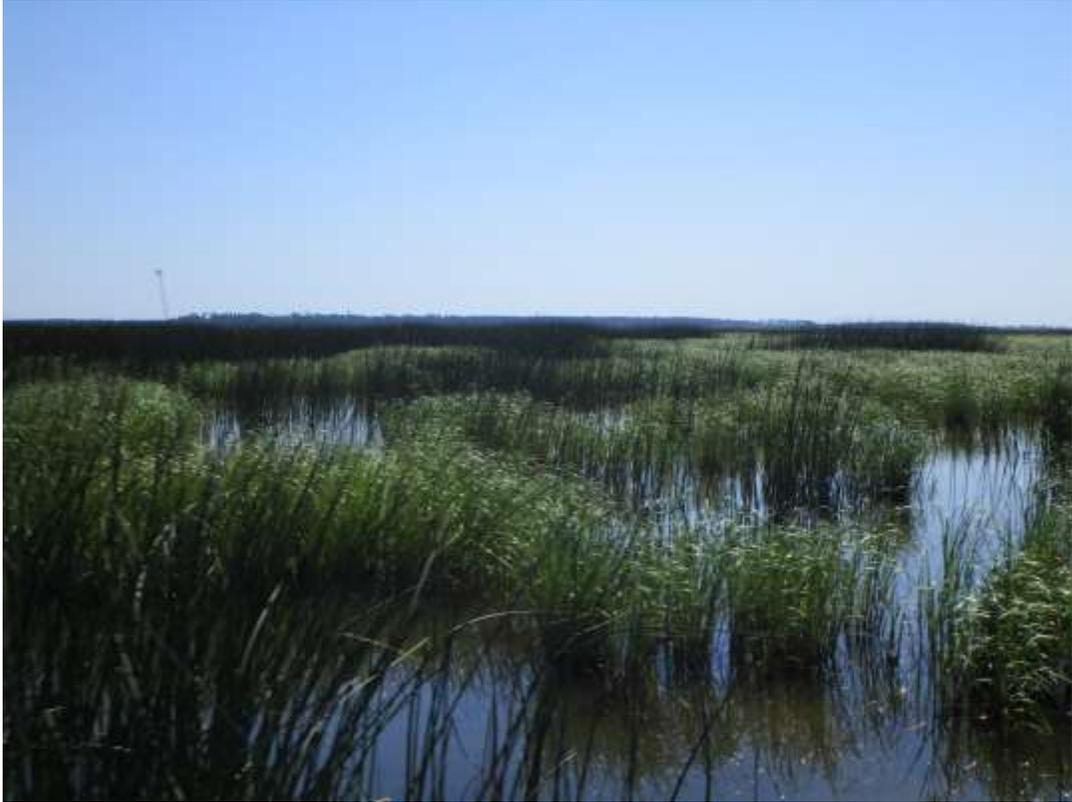
**Area B Nourishment** – This area was mostly shallow mud flats one year ago

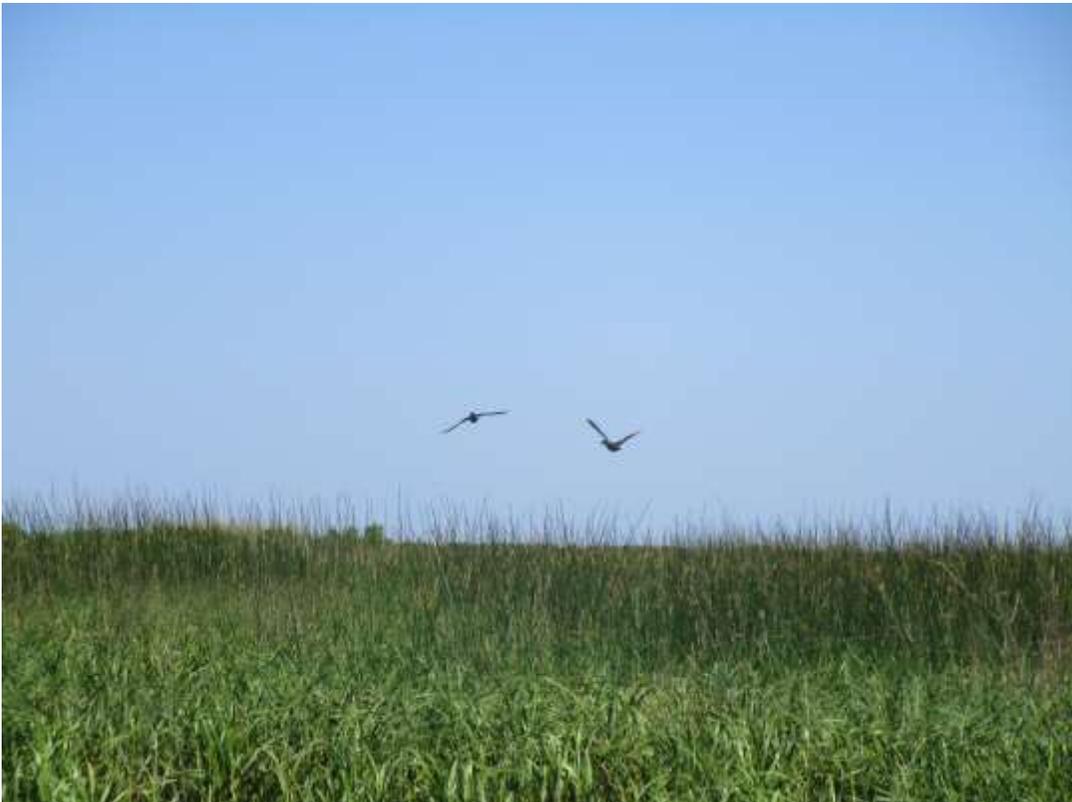
**Area B Nourishment** – Active wildlife observed throughout project area

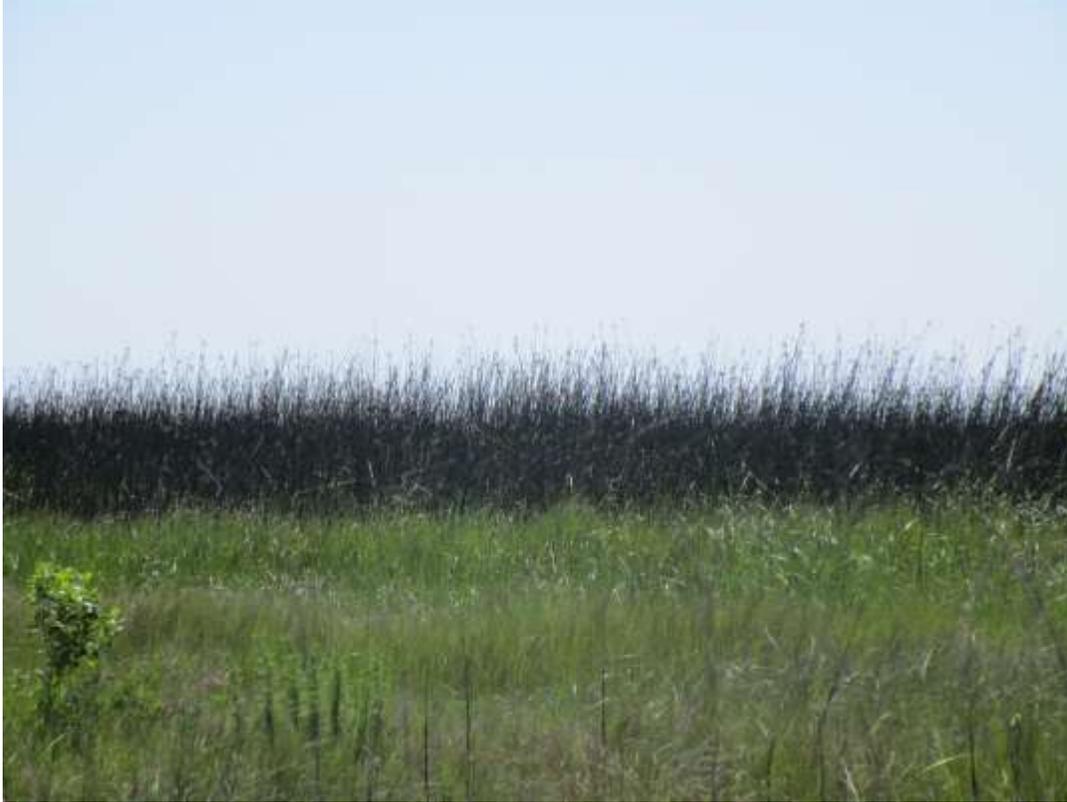
**Area C** – North containment berm with marsh creation area in background

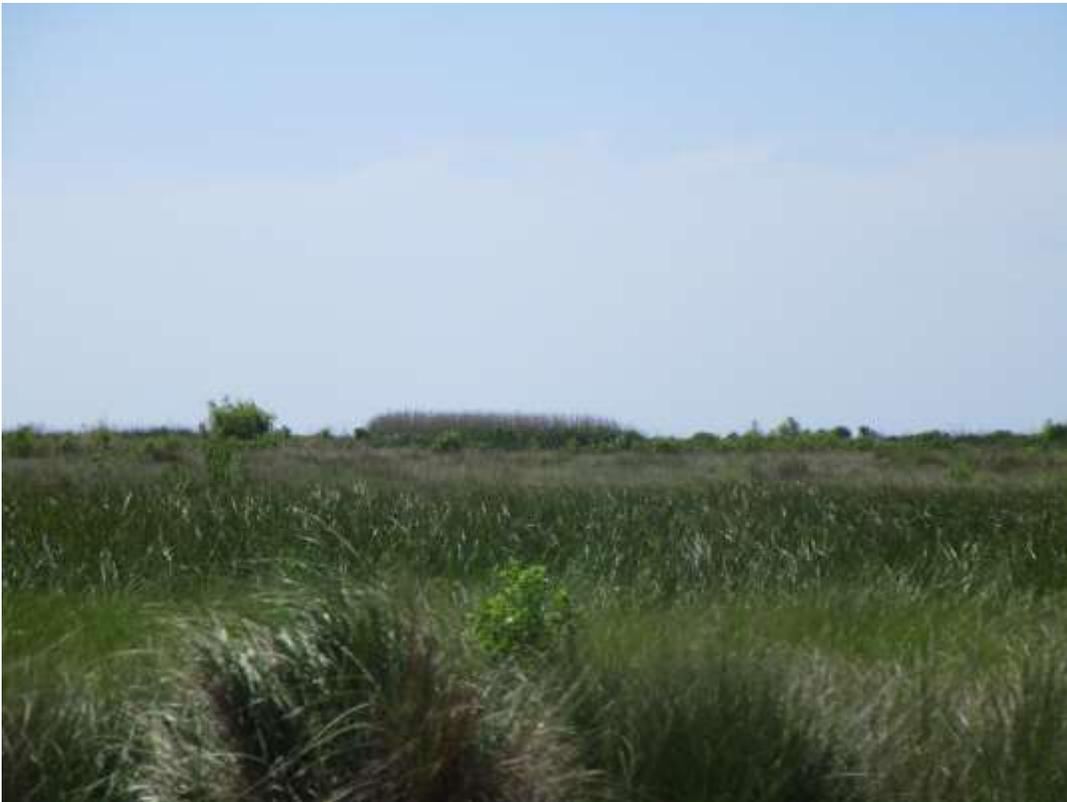
**Area C** – Interior of marsh creation area viewed from north containment rim

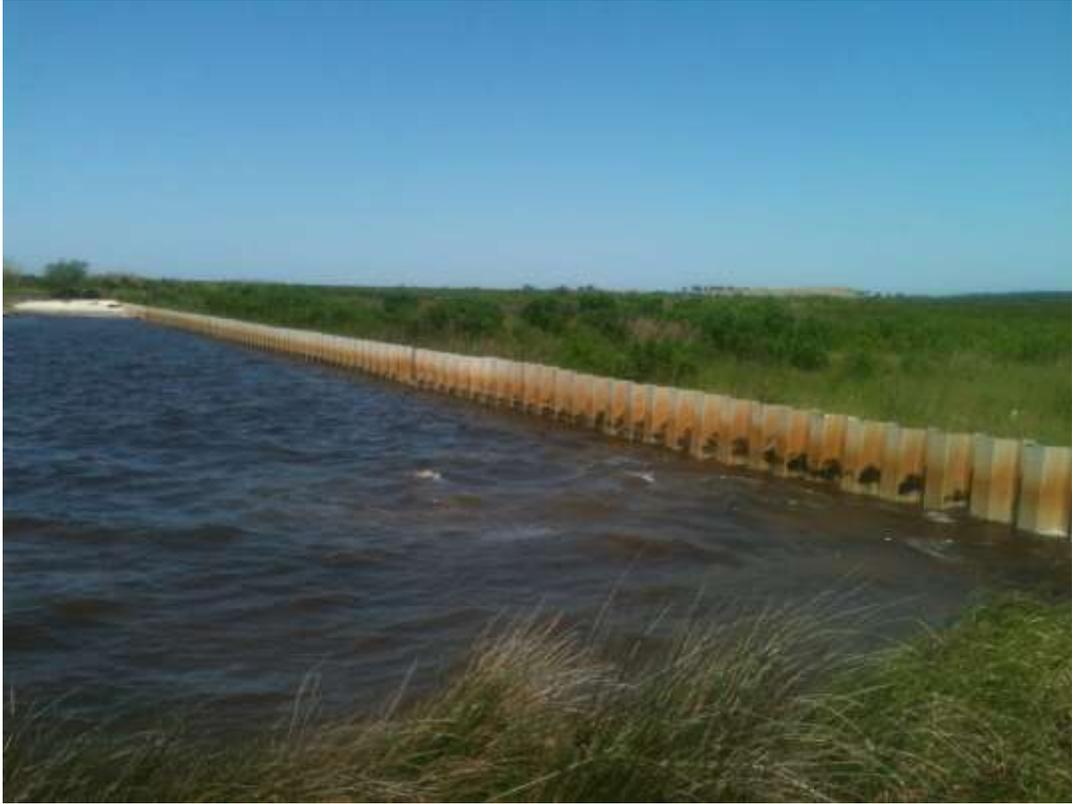
**Area D** – Vinyl sheet pile wall at Lake Pontchartrain shoreline

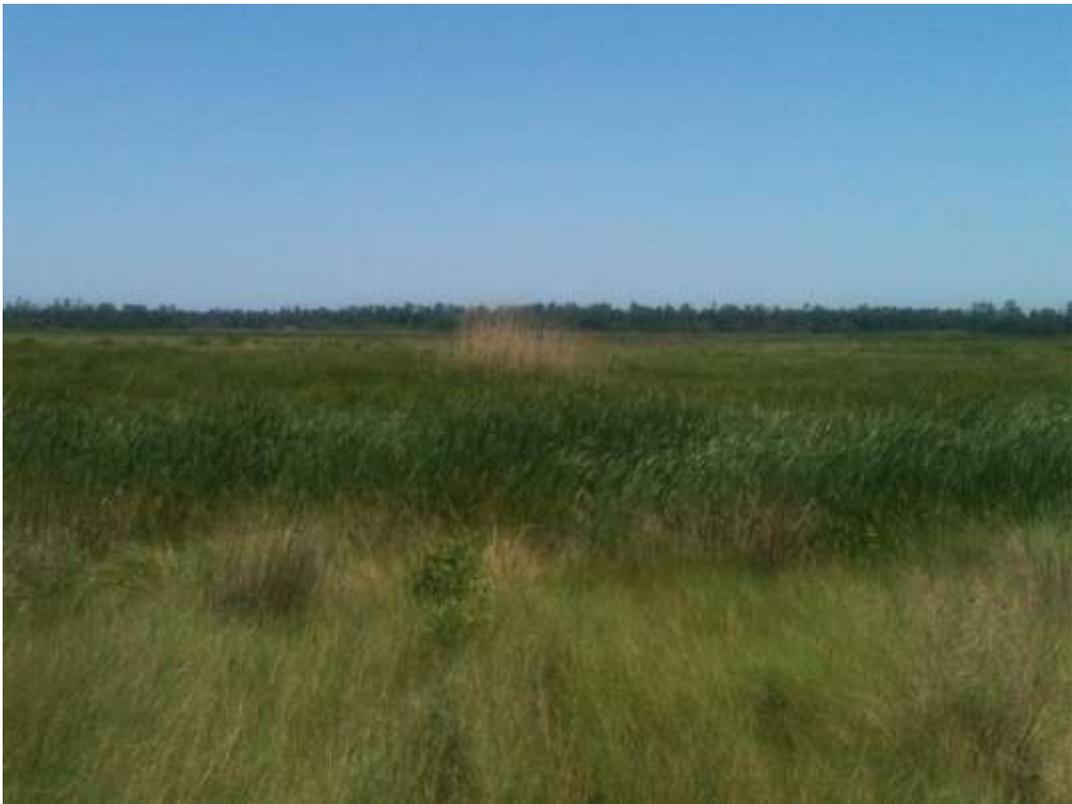
**Area D** – Interior of marsh creation area as viewed from lake shore containment

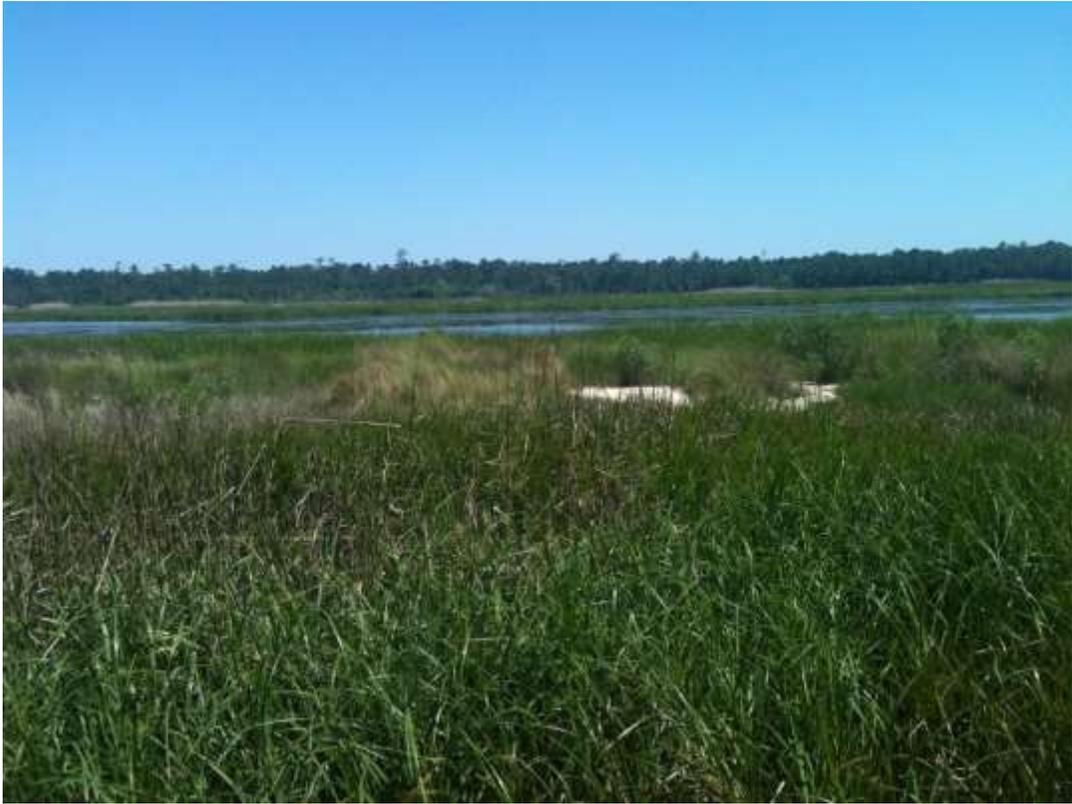
**Area E** – Vegetated containment berm at north side of fill cell

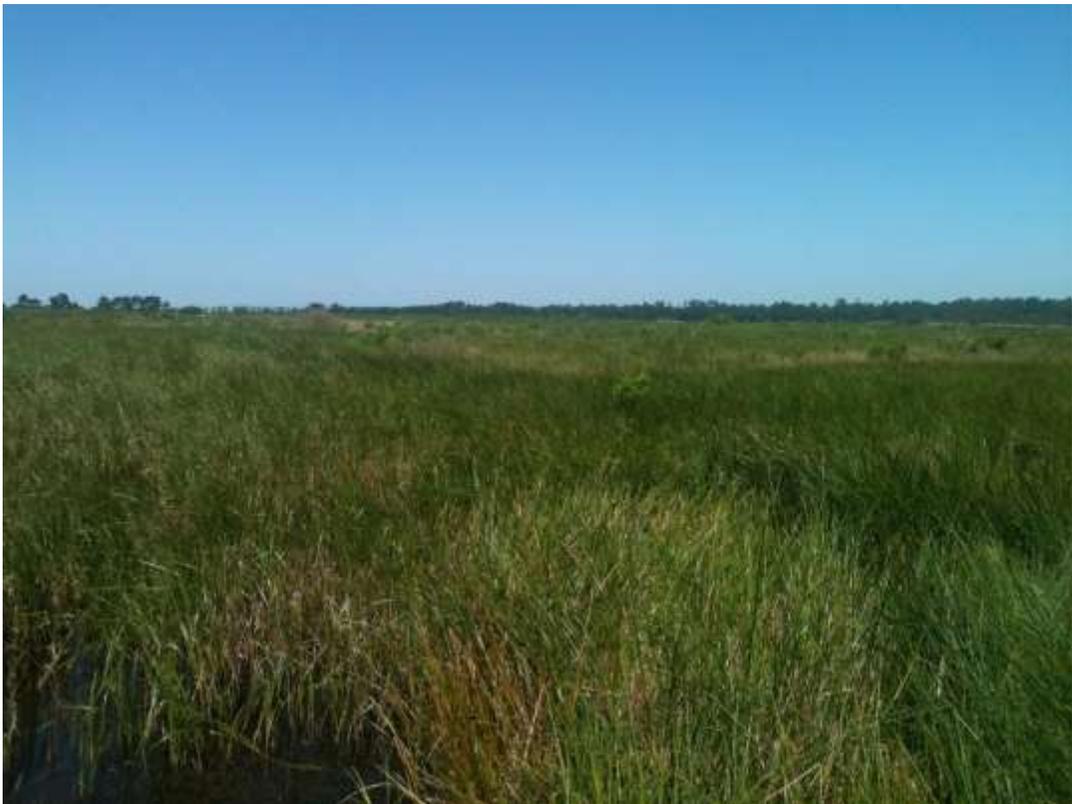
**Area E** – Interior of marsh creation area showing healthy vegetation
