**State of Louisiana
Coastal Protection and Restoration Authority**

2016 Annual Inspection Report

**GOOSE POINT / POINT PLATTE
MARSH CREATION PROJECT**

State Project Number PO-33
Priority Project List PPL-13

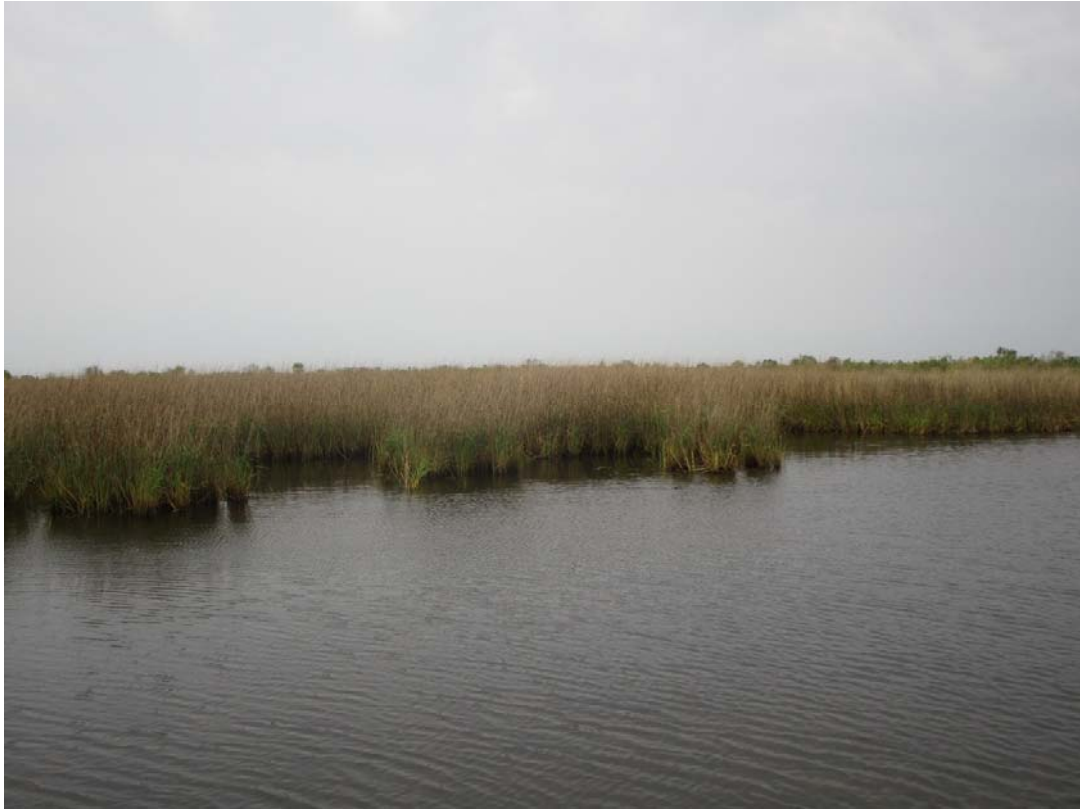
Area A – Marsh grass plantings with vegetated fill area beyond

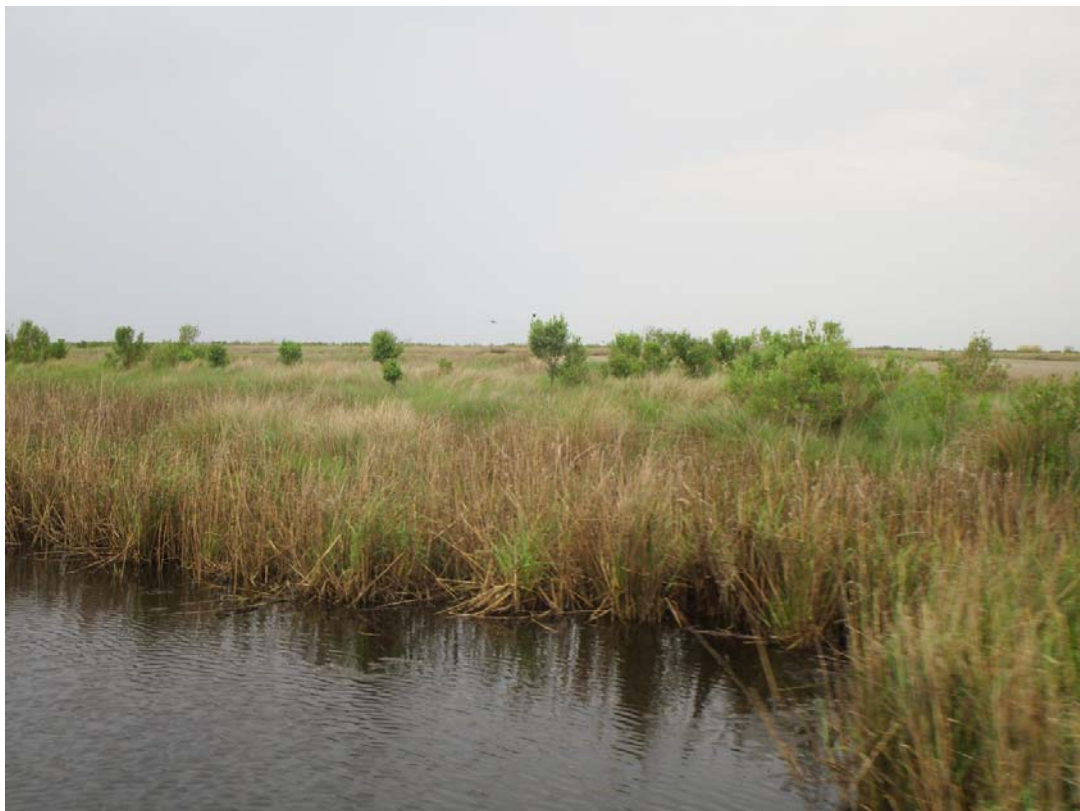
Area A – Shrubs observed within the fill area and along the containment rim

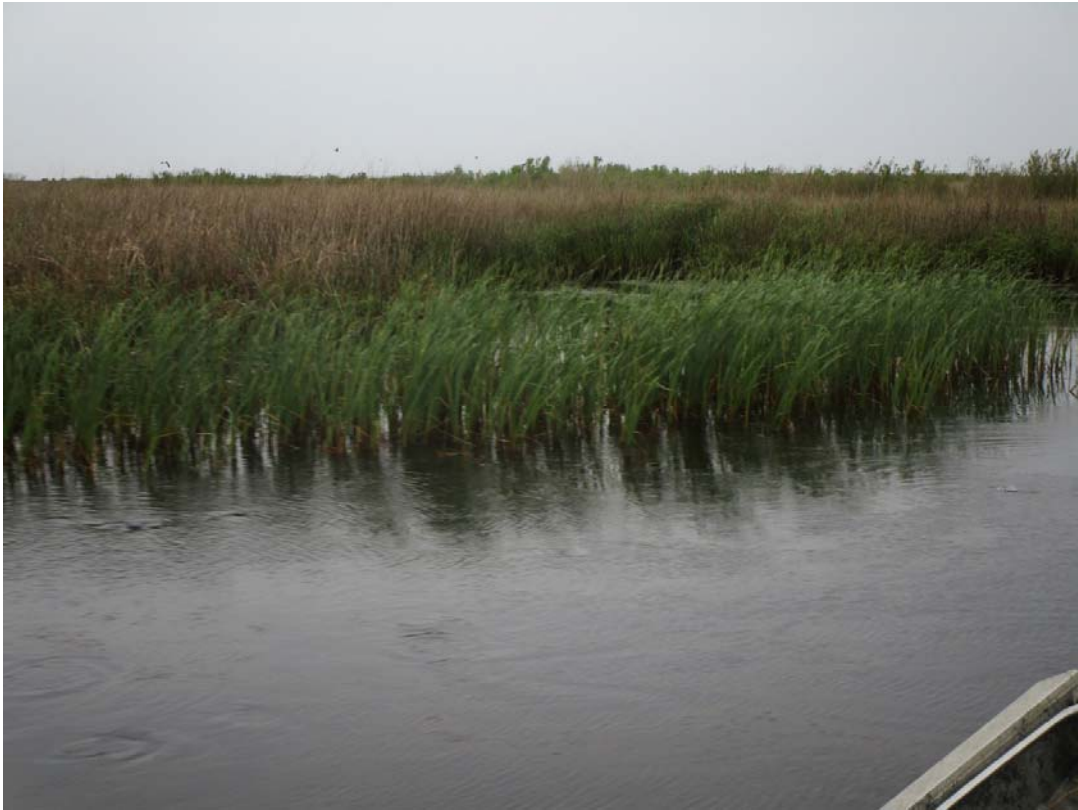
Area B – Shallow water in containment borrow area with healthy marsh beyond

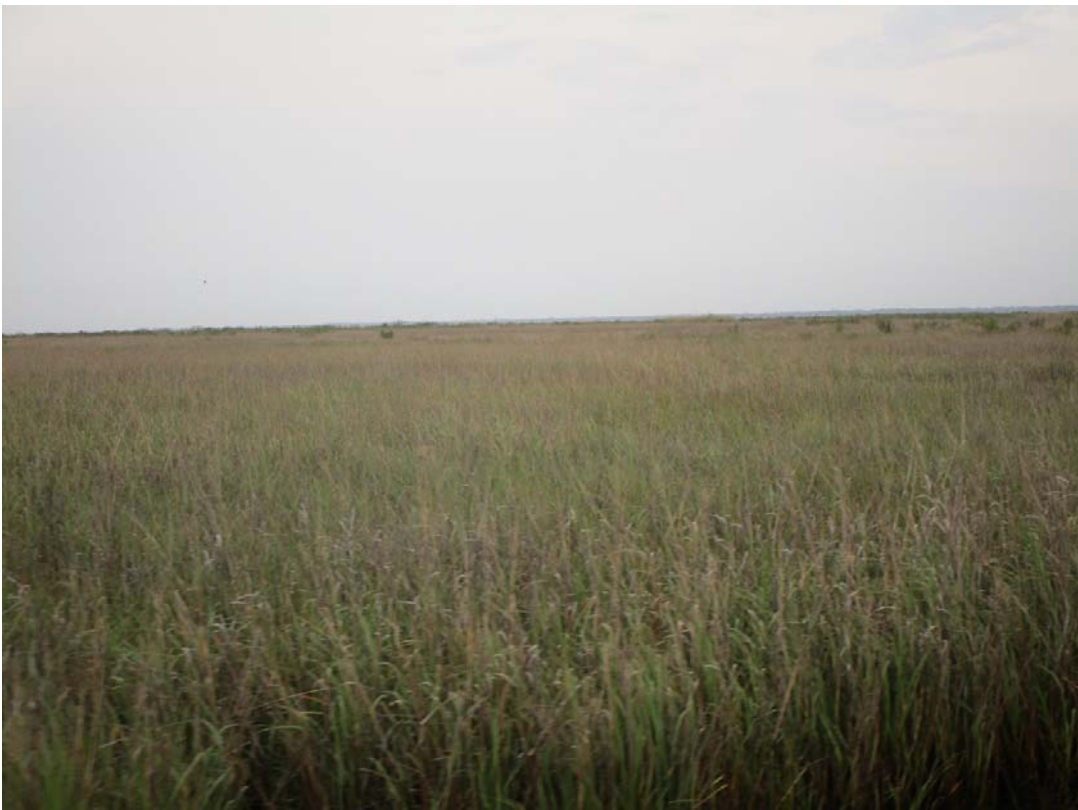
Area B – Interior of fill cell is well-vegetated

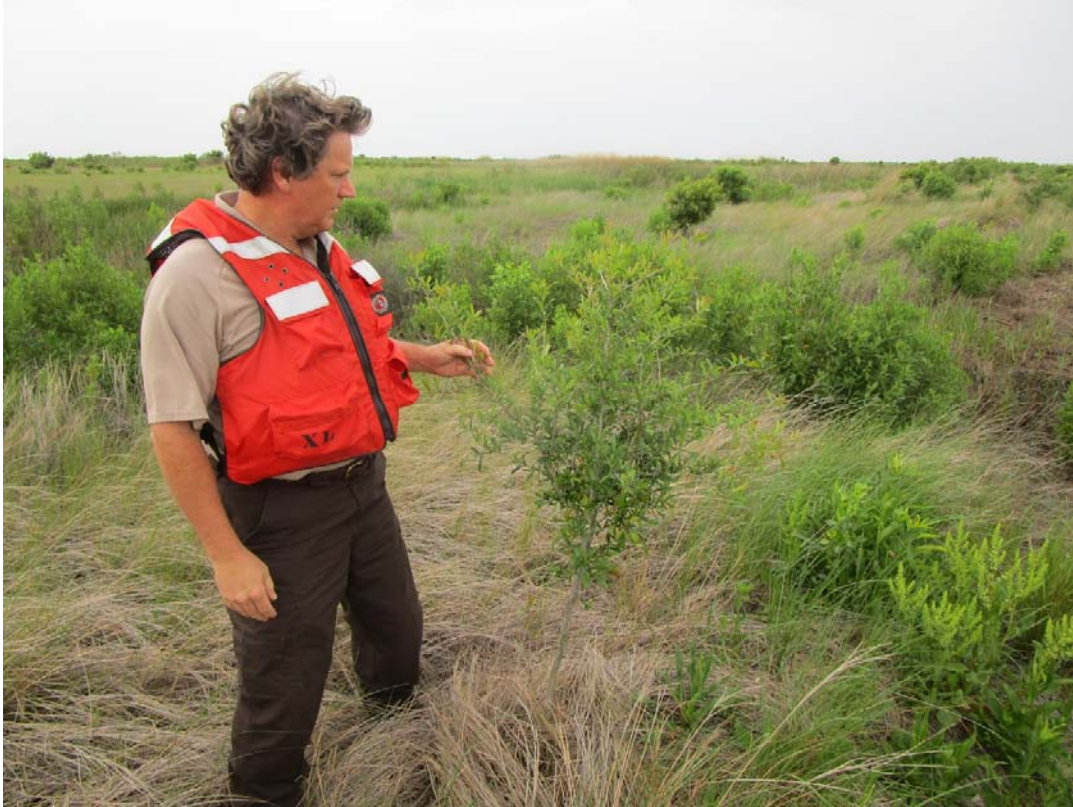
Area C – Oak tree growing on northern containment berm

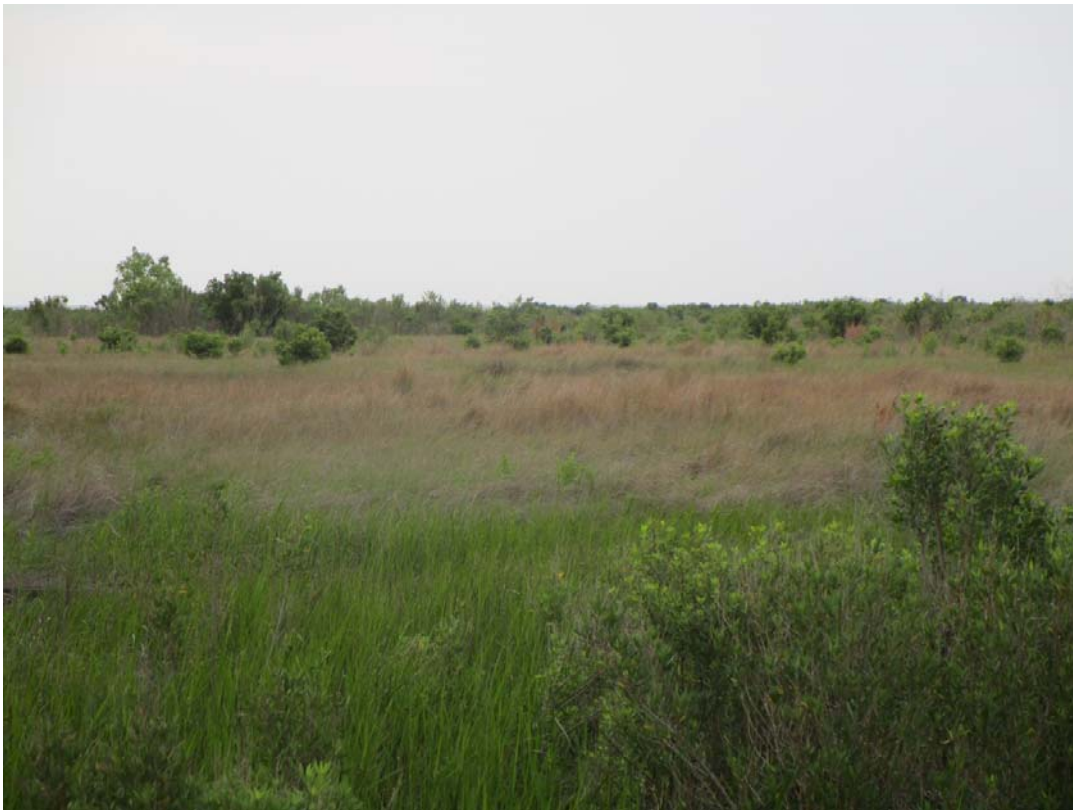
Area C – Interior of marsh creation area viewed from north containment rim

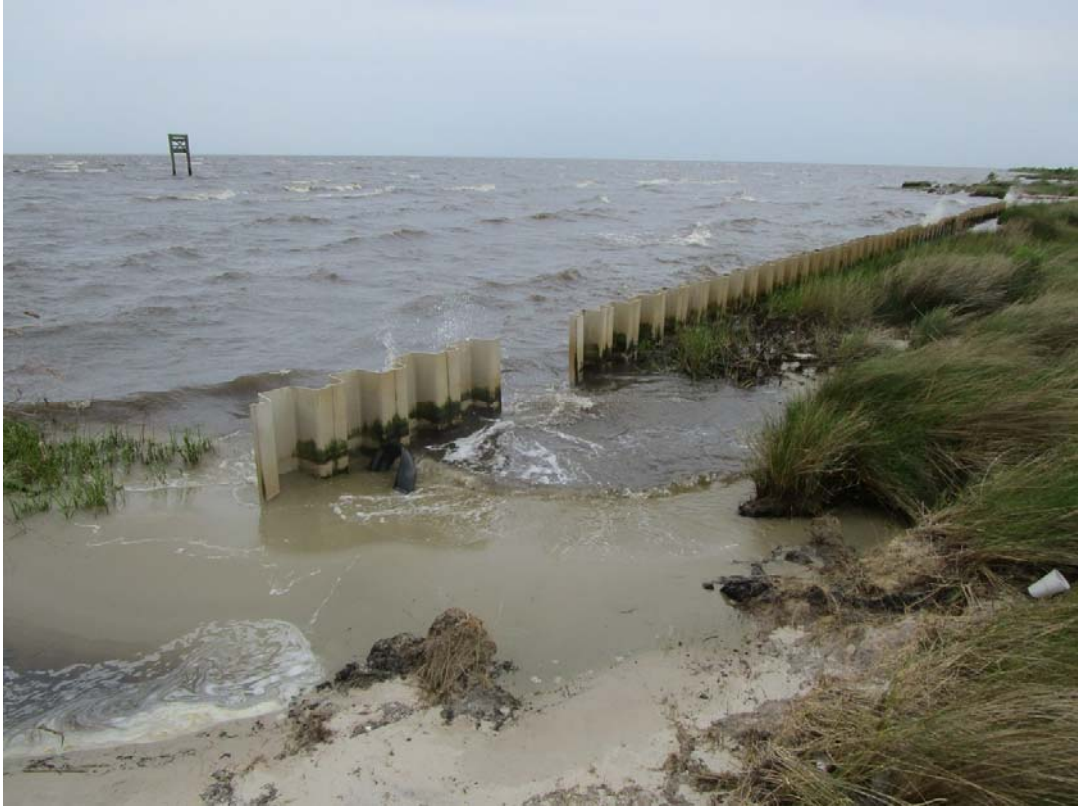
Area D –Vinyl sheet pile wall at Lake Pontchartrain shoreline

<u>Fill Area "D"</u> Vinyl Sheet Pile 504 ft.	Good	See Remarks	Very Good	Very Good	Vinyl sheet piles along the lake shore have experienced some additional minor damage/deterioration; however the condition of the marsh behind the sheet pile wall was very good.
<u>Fill Area "E"</u> Vinyl Sheet Pile 110 ft.	Very Good	None	Very Good	Very Good	Similar to Areas A & B, much of the containment borrow area remains shallow open water. However, the containment berm and the fill cell appeared to be well-vegetated with marsh grass and shrub species.

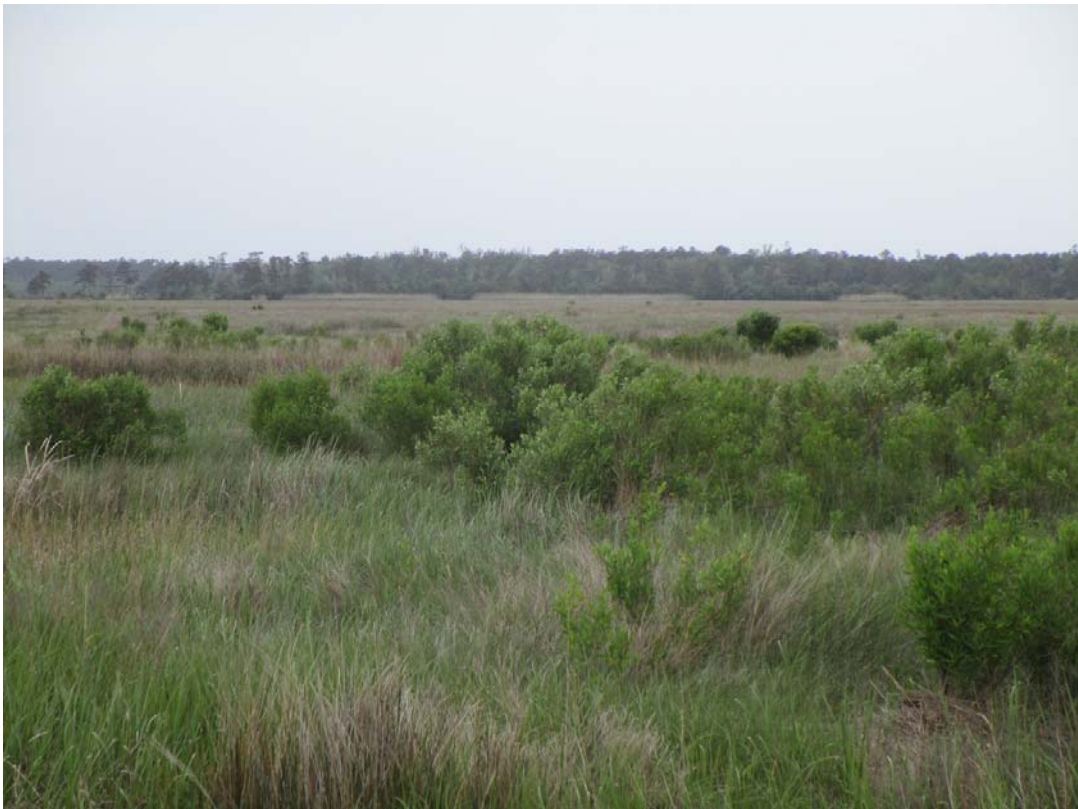
Area D – Interior of marsh creation area as viewed from lake shore containment

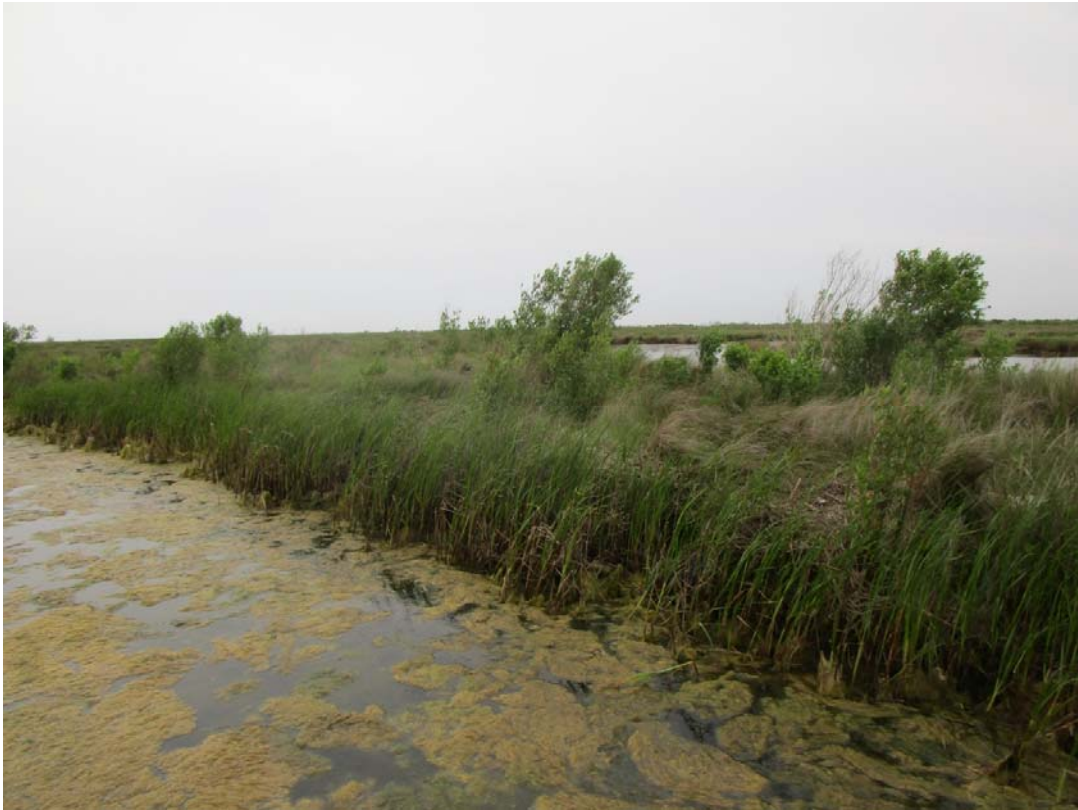
Area E – Vegetated containment berm at north side of fill cell

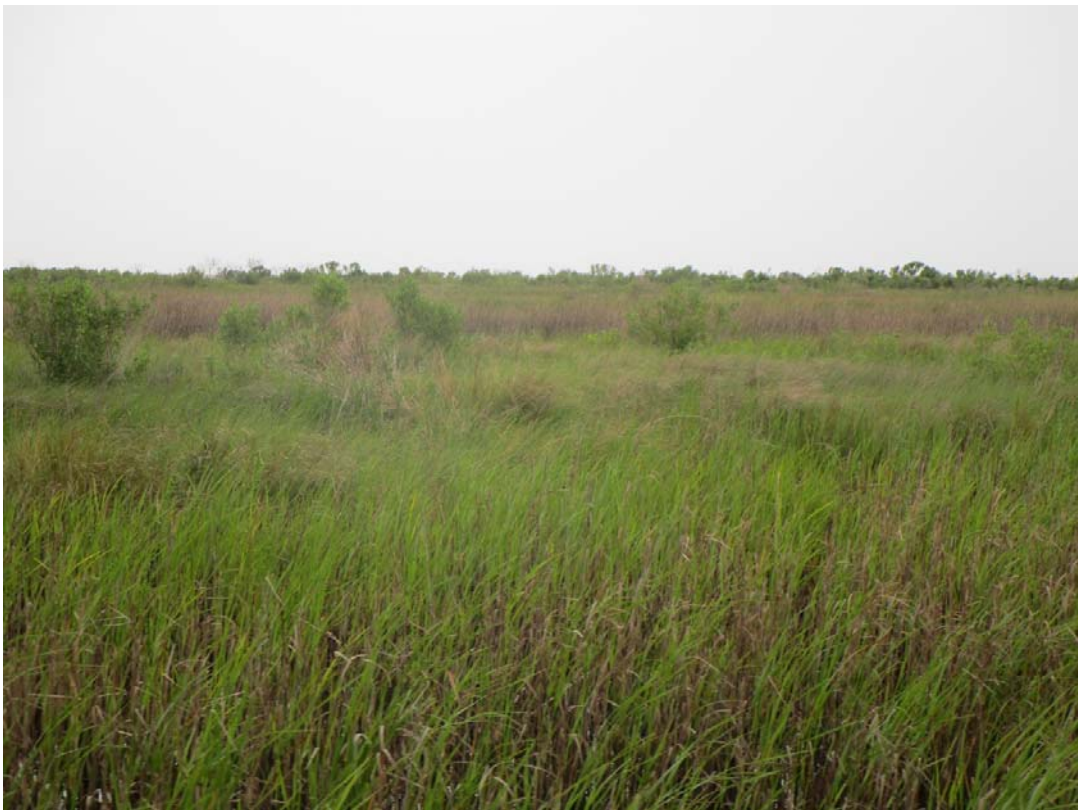
Area E – Interior of marsh creation area showing healthy vegetation
