**State of Louisiana
Coastal Protection and Restoration
Authority**

2015 Annual Inspection Report

**GIWW Bank Restoration Project –
Segment 4 (TE-43)**

State Project Number TE-43
Priority Project List 10

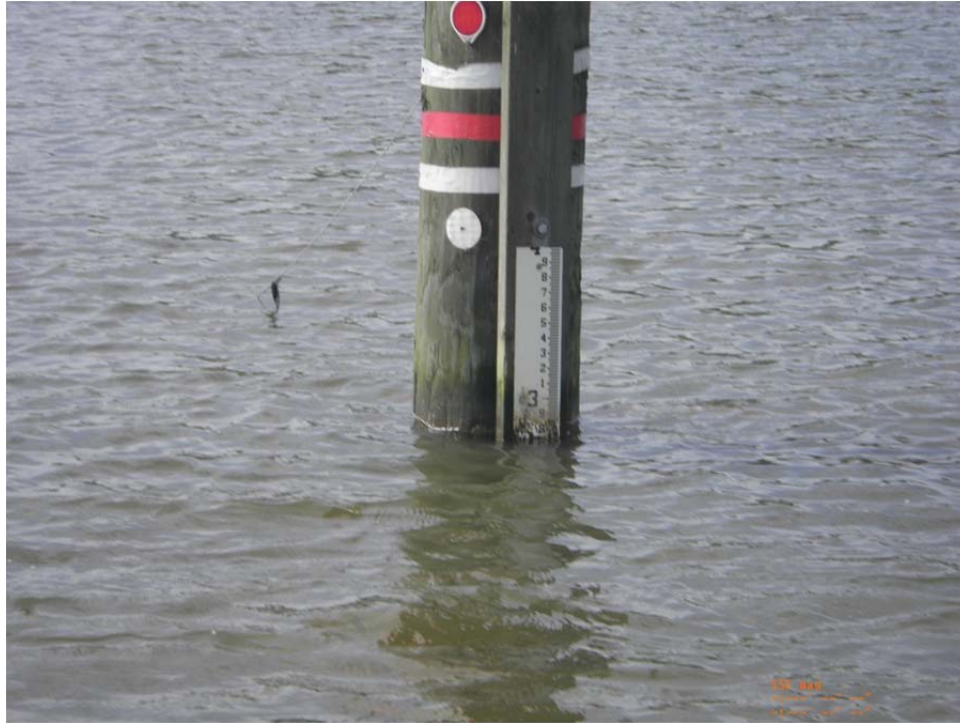
The inspection began by traveling to Segment 1 of the rock dike constructed under the Coastal Impact Assistance Program (CIAP) completed in 2012 to obtain a staff gauge reading of the water level at the time of the inspection. The gauge reading indicated an elevation of 2.8' NAVD at 8:45 a.m. This water level reading was used to estimate the crest elevations of the rock dike constructed under Segment 4.

Photo 1: View of the staff gauge on the west end of Segment No.1 of the GIWW CIAP project.

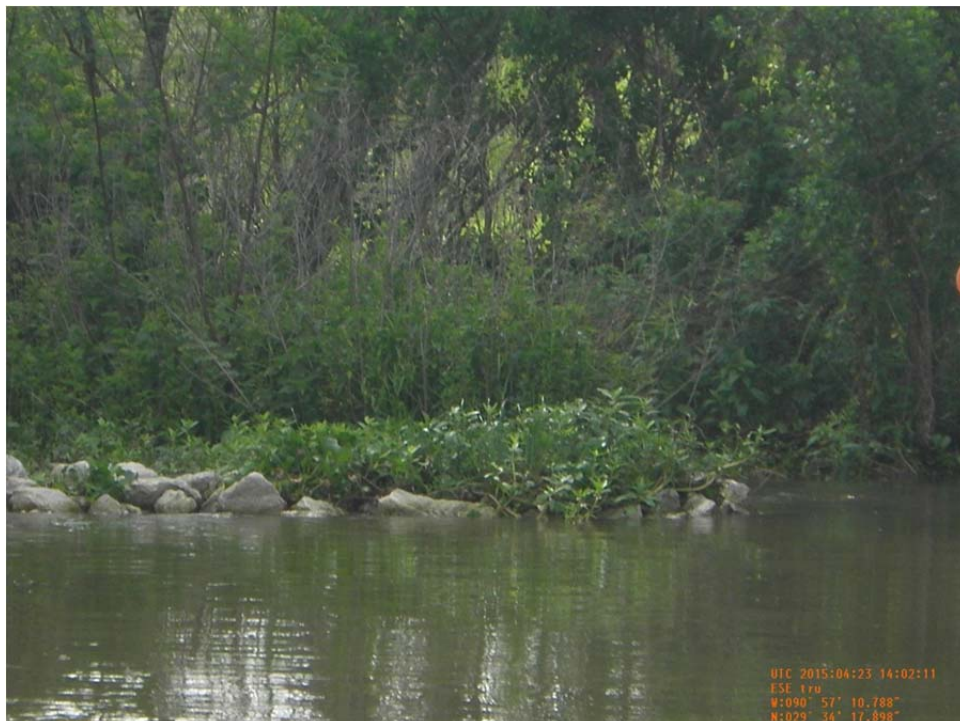
The inspection began at the mouth of Bayou Copasaw near the bank tie-in which appeared to be in good condition with no noticeable breaching or erosion. Proceeding eastward along the rock dike from Sta. 00+06 to Sta. 2+50, the rock dike crest was approximately 0.5' above the estimated water elevation of +2.8'. From Sta. 2+50 to Sta. 100+00, the crest was at or well below the estimated water level of 2.8' NAVD. Beyond Sta. 100+00 to the end of the project (Sta. 105+78), the crest of the rock dike

Photo 2: View of the rock dike tie-in on the west end of the GIWW Breach Closure Project (CWPPRA) at the entrance of the Copasaw Canal.

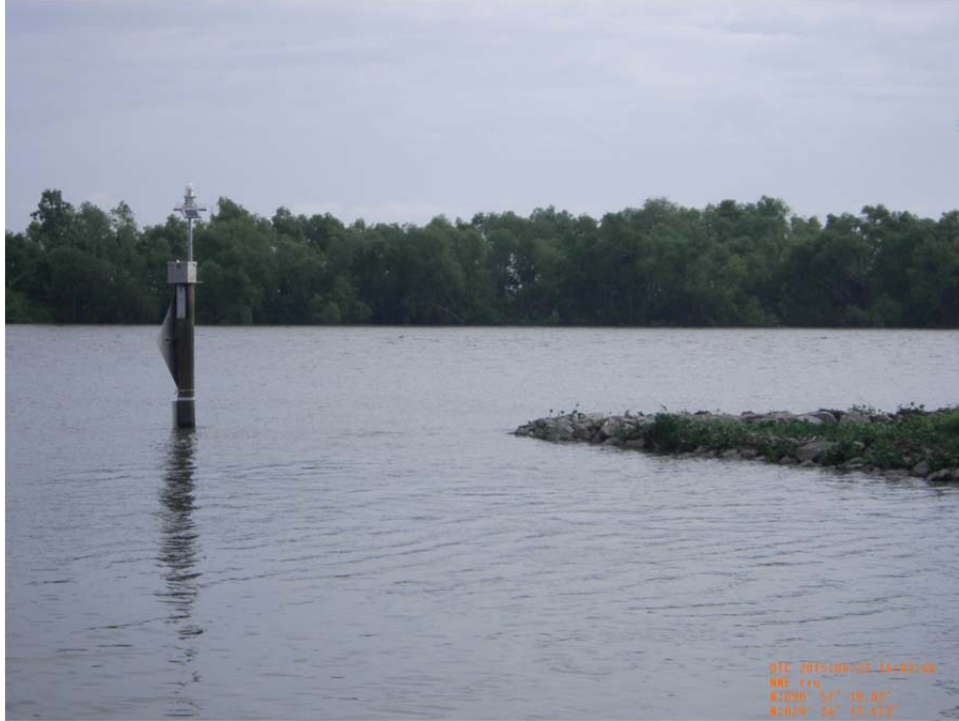
Photo 3: View of permanent warning sign (PS-2) and navigational aid light at the west end of the Breach Closure (TE-43) project.

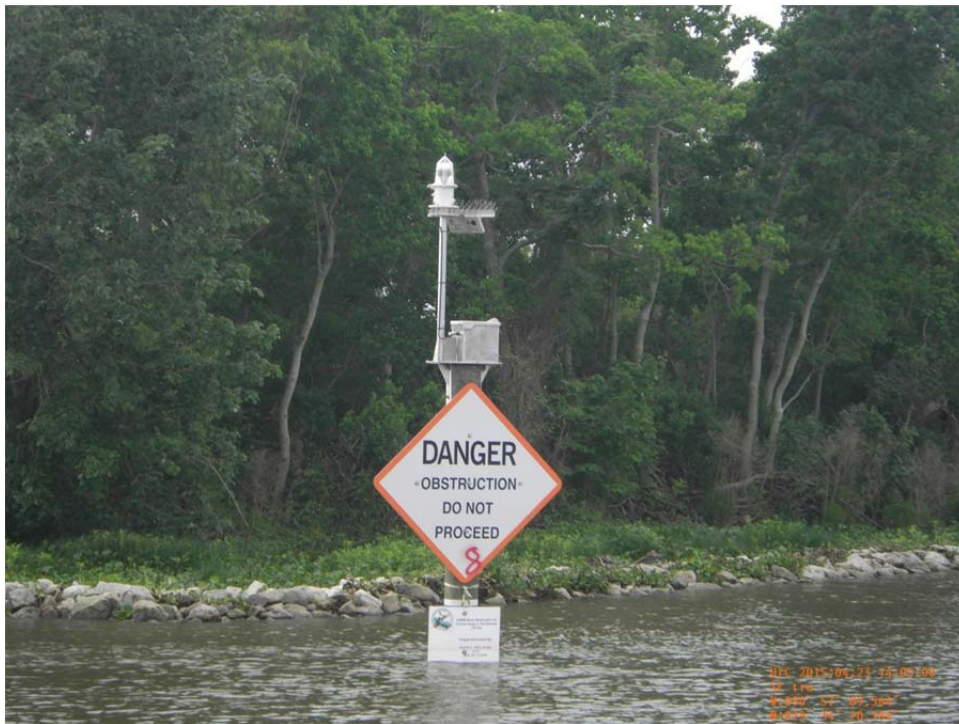
Photo 4: View of the warning sign (PS-2) and navigational aid light at west end of project near Sta. 2+00.

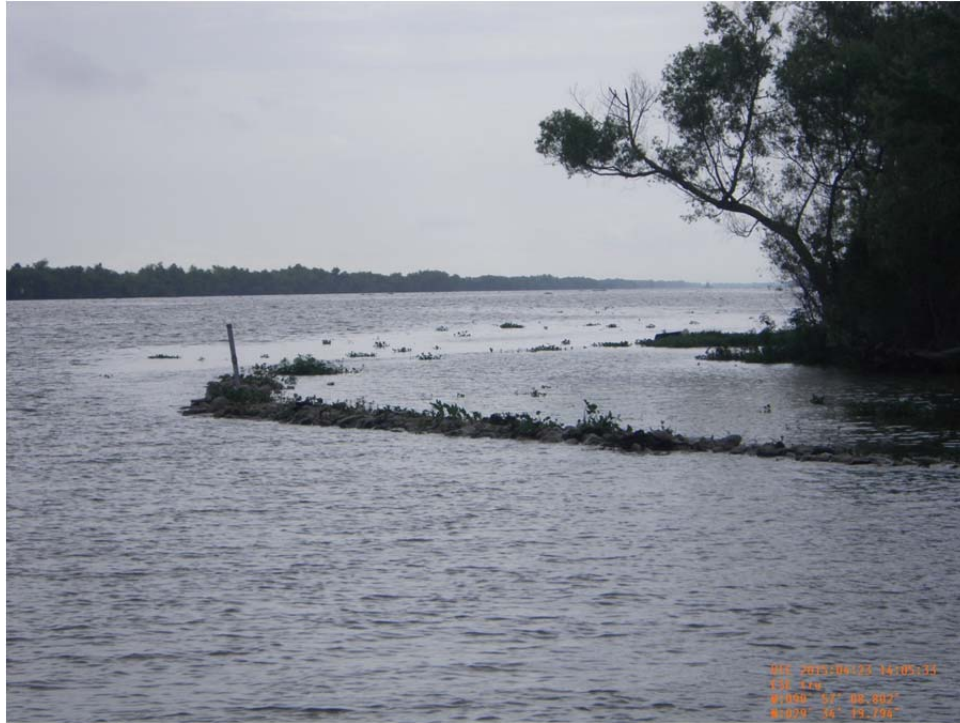
Photo 5: View of rock dike near Sta. 2+00 looking eastward.

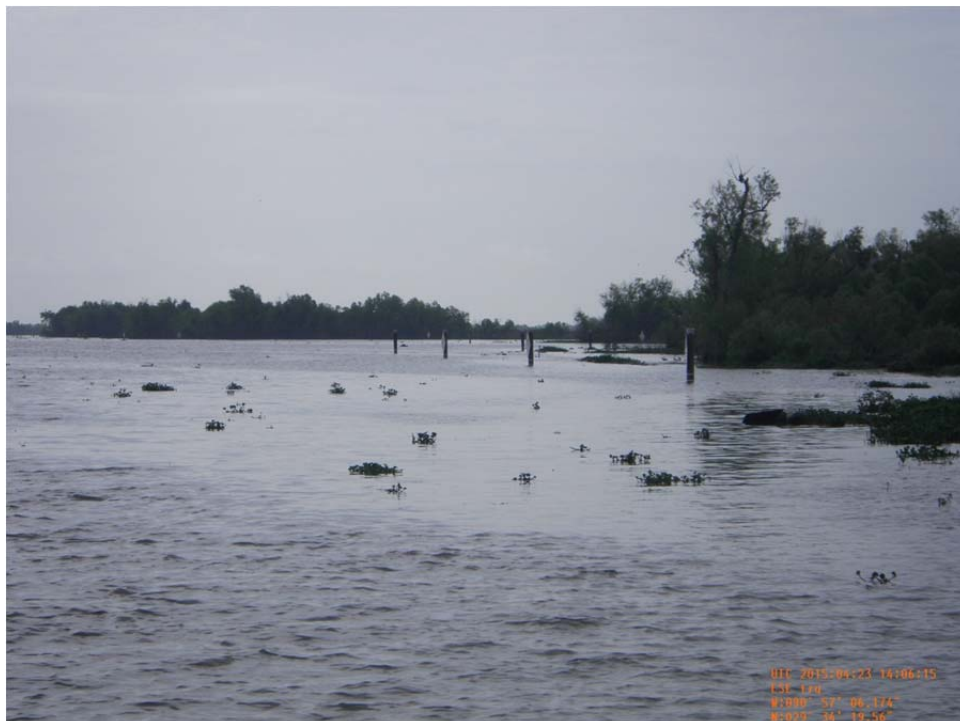
Photo 6: View of the submerged rock dike and warning signs near Sta. 5+00 looking southeast.

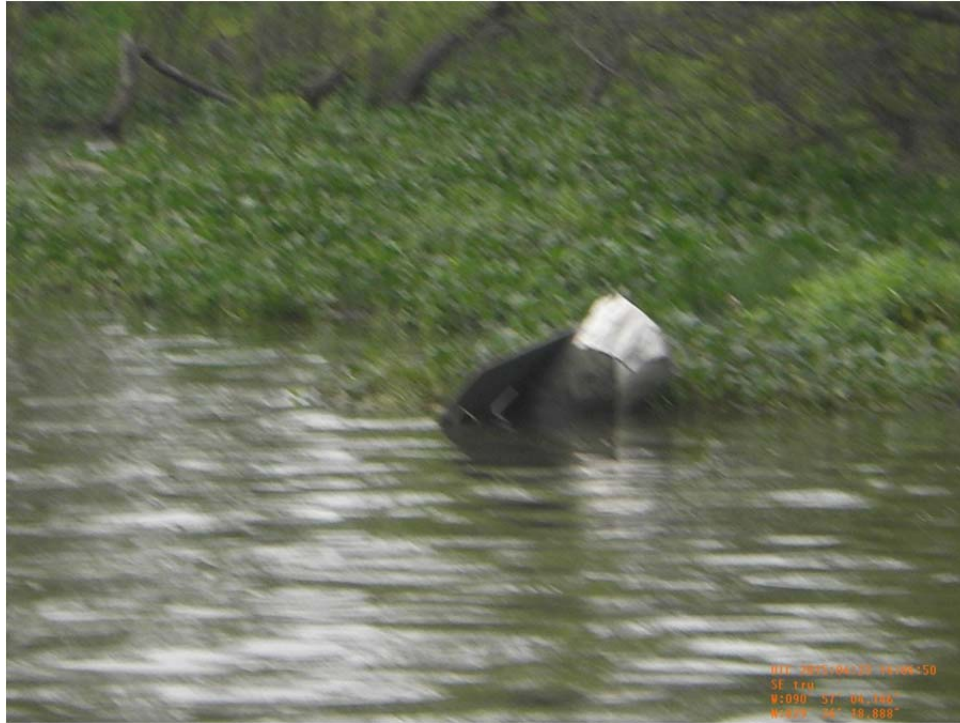
Photo 7: View of damaged warning sign near Sta. 7+00.

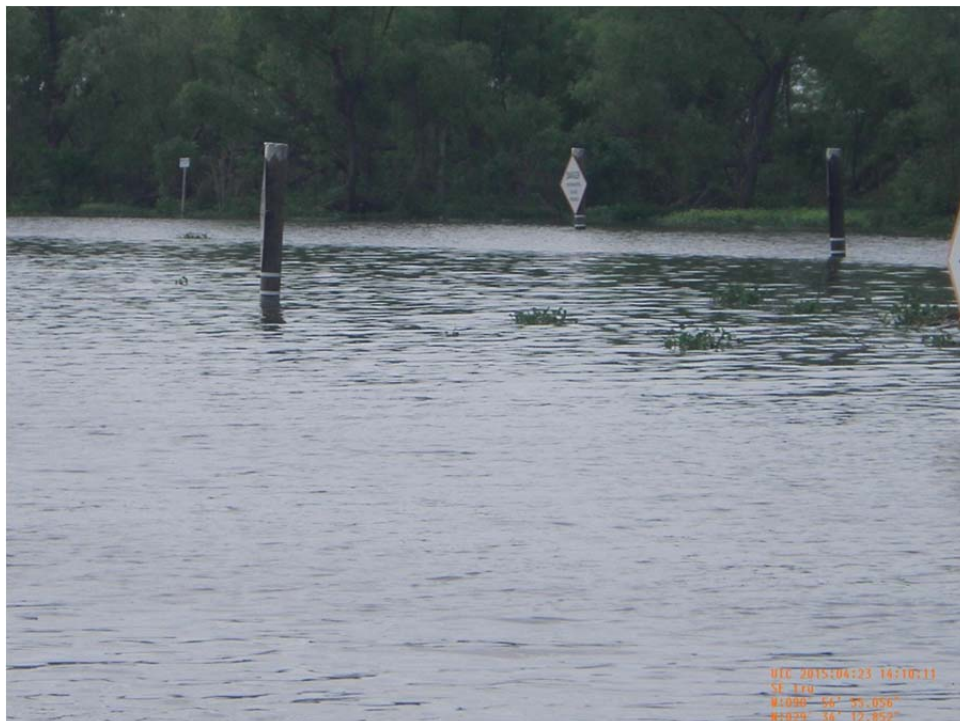
Photo 8: View of the submerged rock dike and warning signs near cove in the bank line (Sta. 16+00).

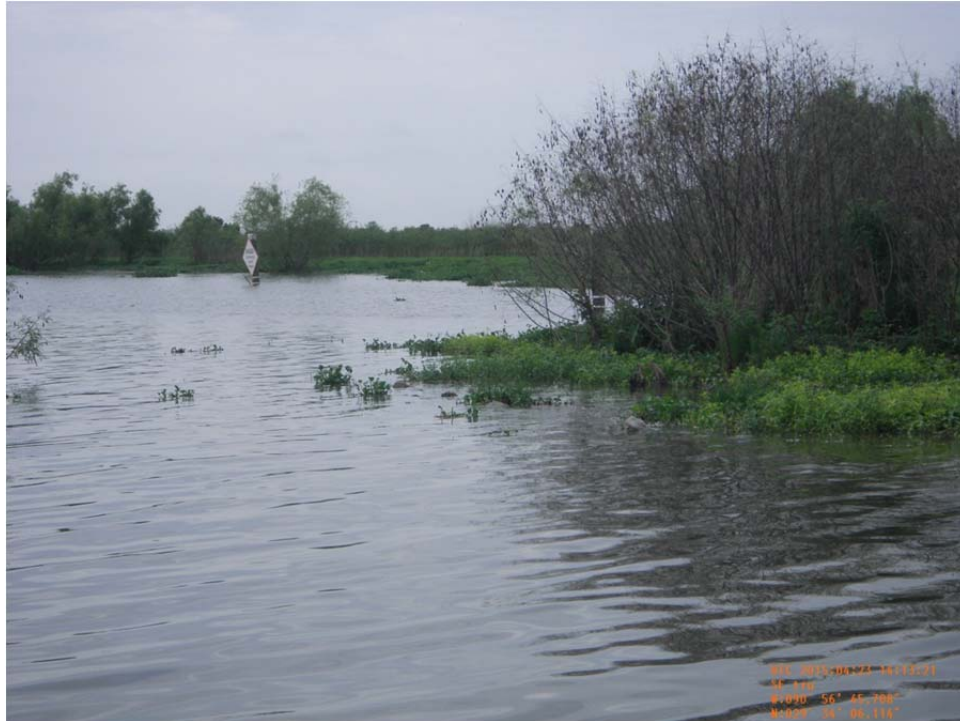
Photo 9: View of the submerged rock dike and warning sign near Sta. 29+00.

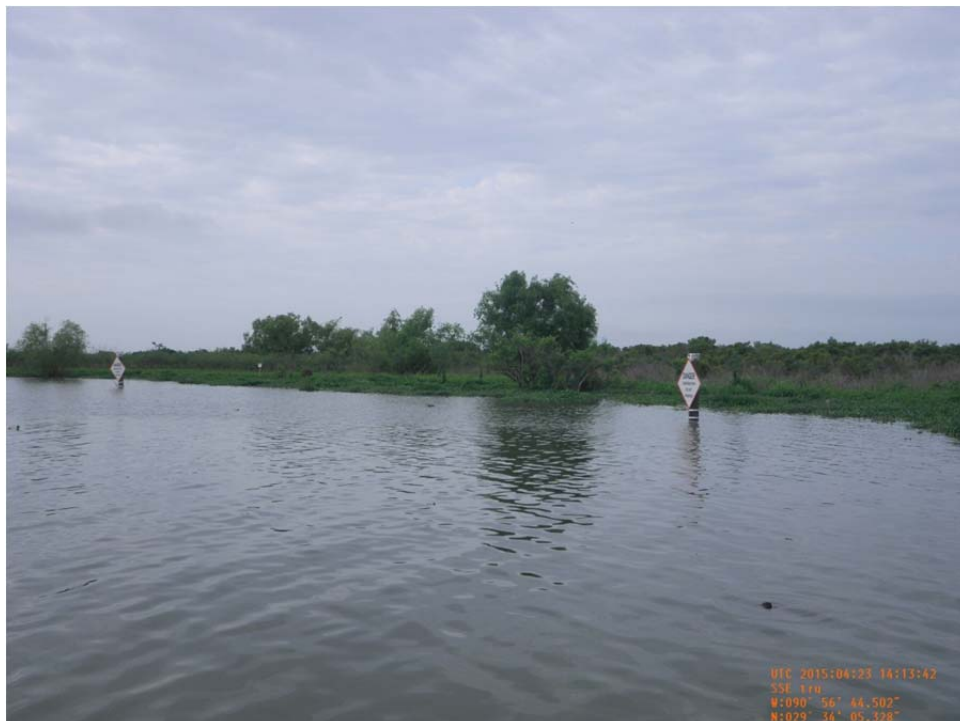
Photo 10: View of the submerged rock dike and warning signs near Sta. 30+00 looking southeast.

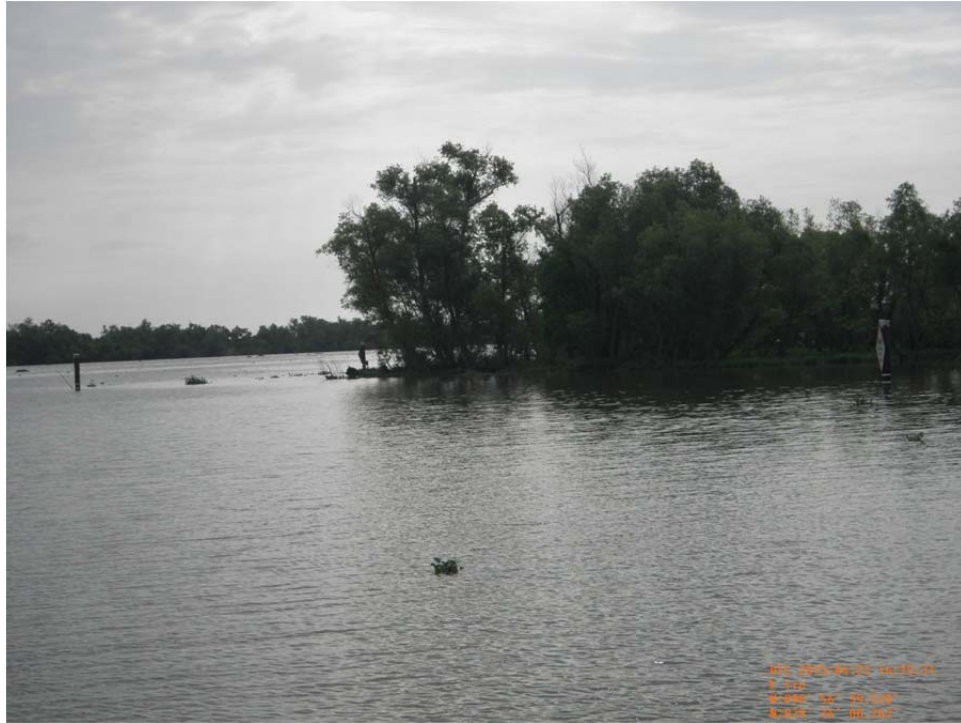
Photo 11: View of the submerged rock dike and bank line near Sta. 37+00 looking northeast.

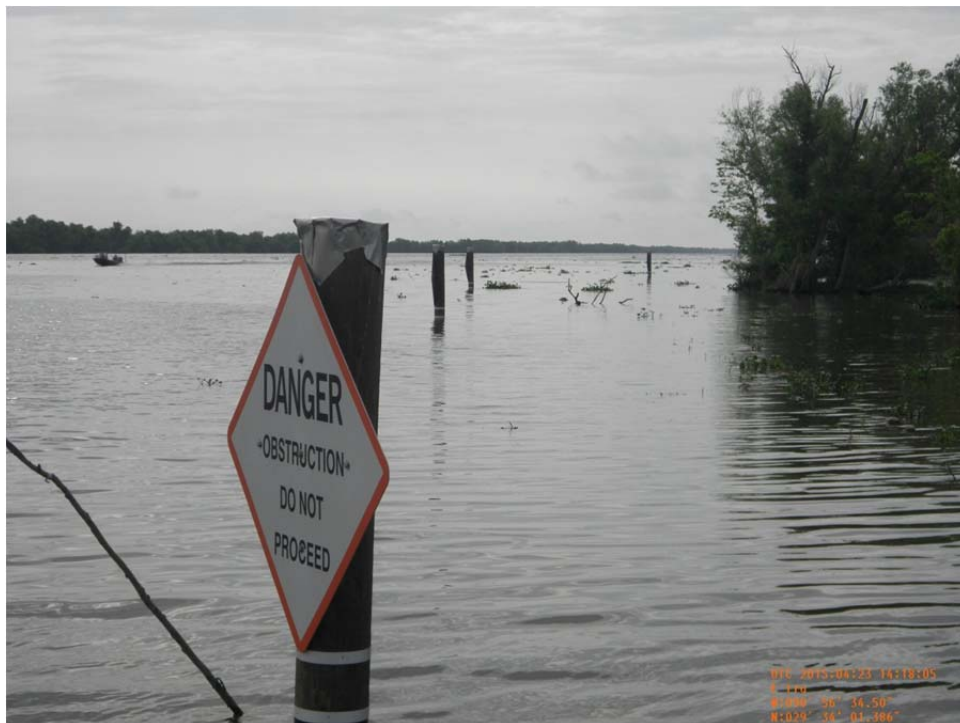
Photo 12: View of warning signs and the submerged rock dike near Sta. 42+00 looking southeast.

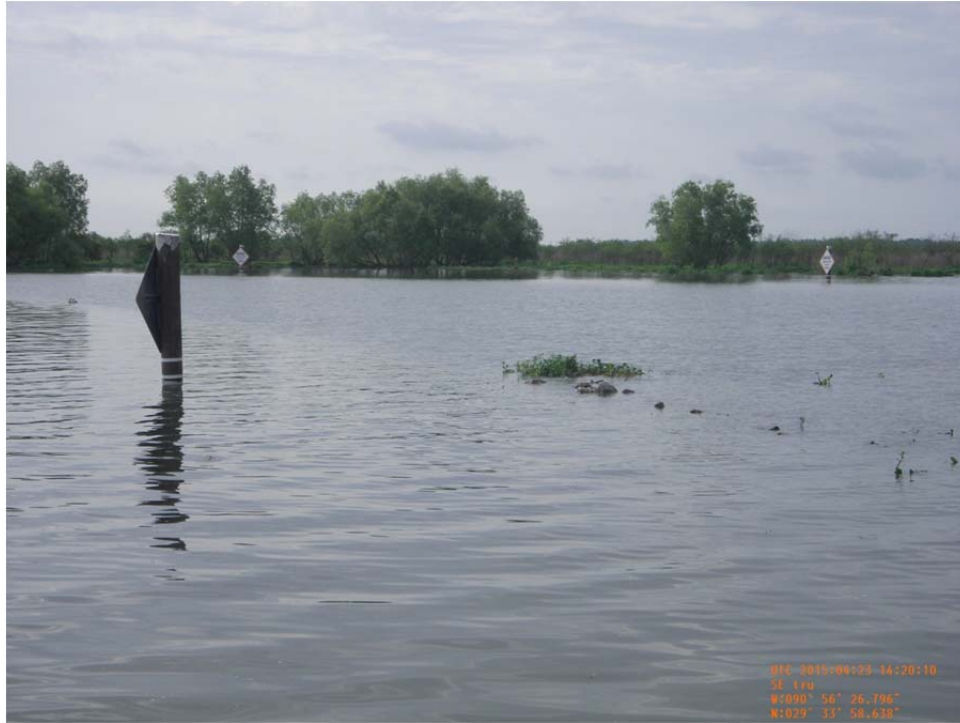
Photo 13: View of submerged rock dike and warnings signs near cove in bank line near Sta. 47+00.

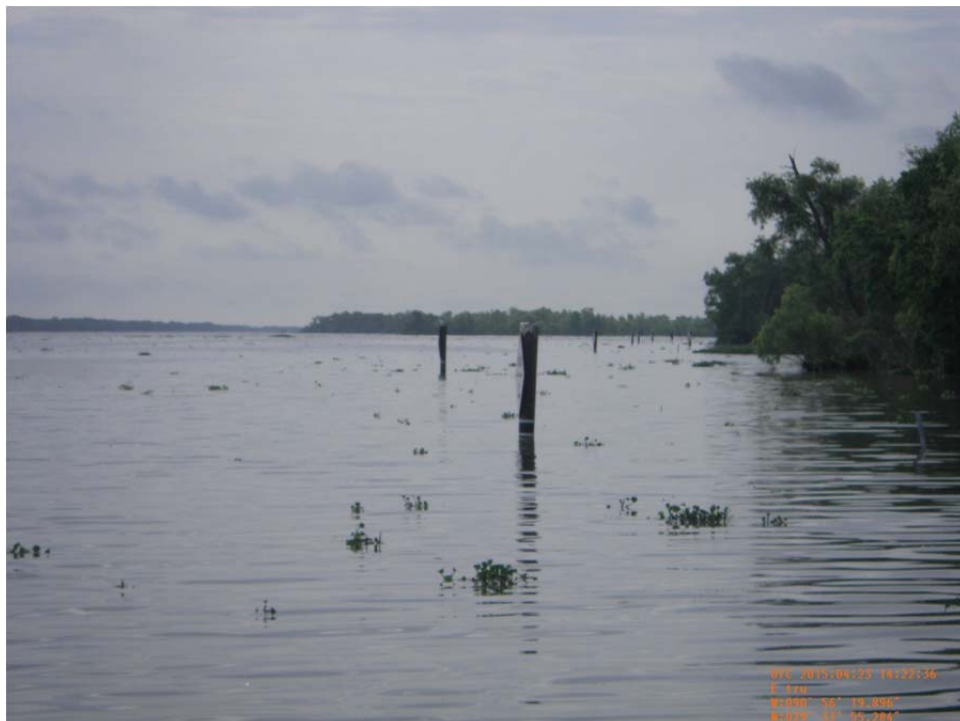
Photo 14: View of the submerged rock dike and warnings signs near Sta. 59+00 looking southeast.

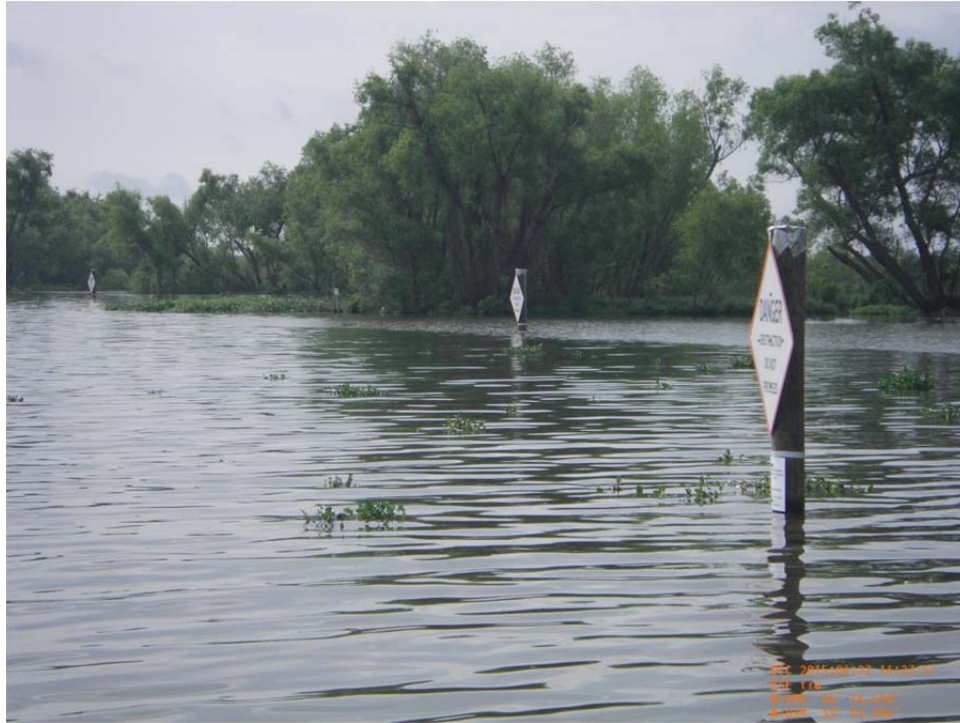
Photo 15: View of warning signs and submerged rock dike near Sta. 65+00 looking southeast.

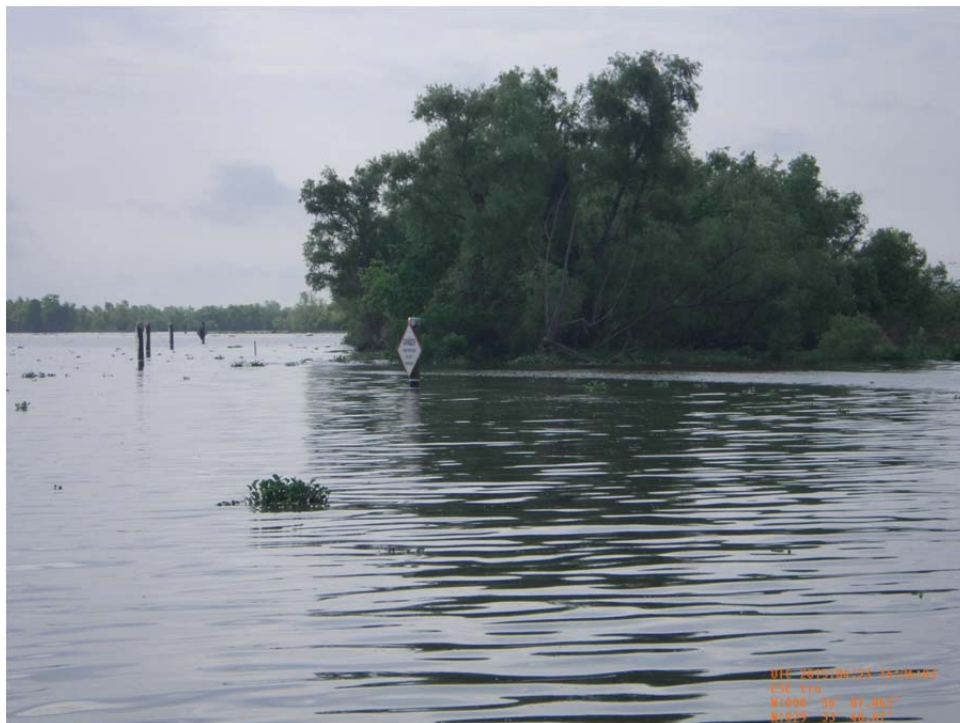
Photo 16: View of warning signs and submerged rock near Sta. 72+00 looking northeast.

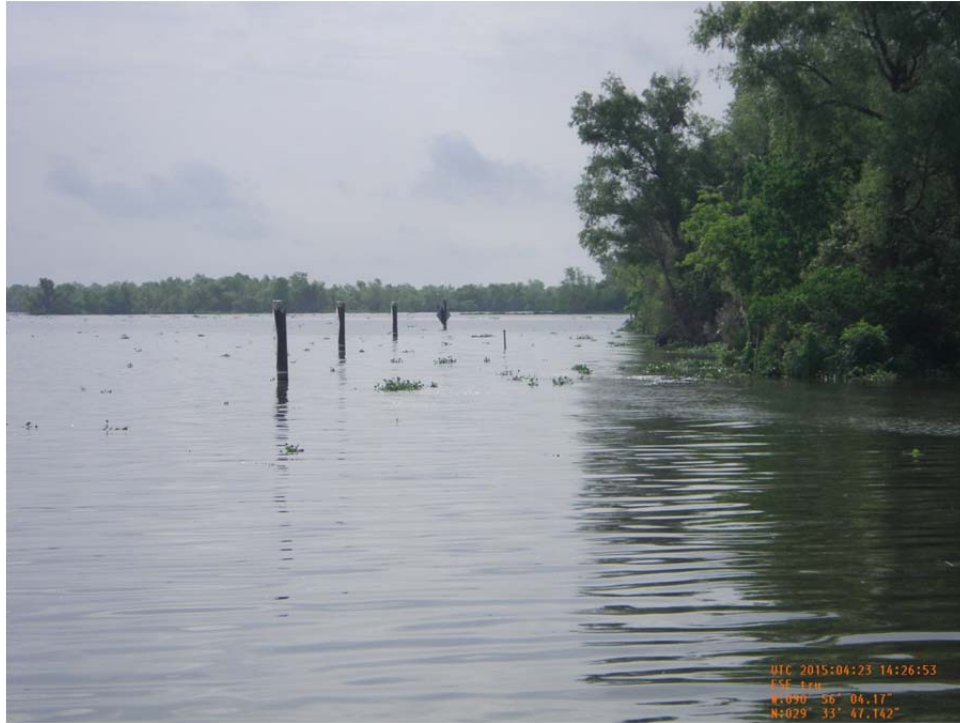
Photo 17: View of warning signs and submerged rock dike near Sta. 77+00 looking east.

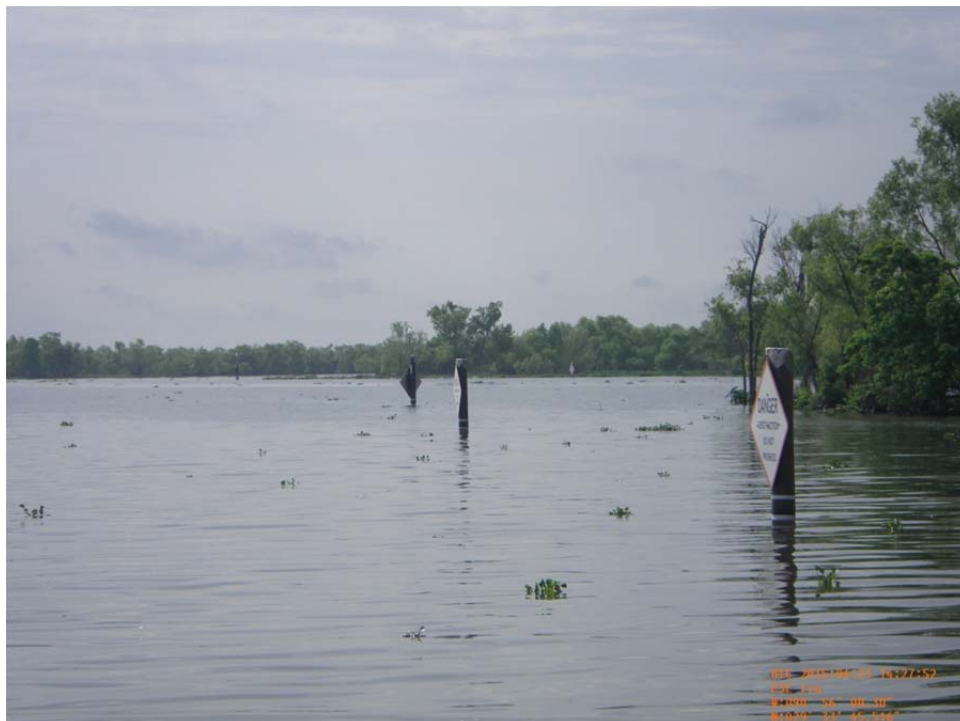
Photo 18: View of warning signs and submerged rock dike near Sta. 80+00 looking east.

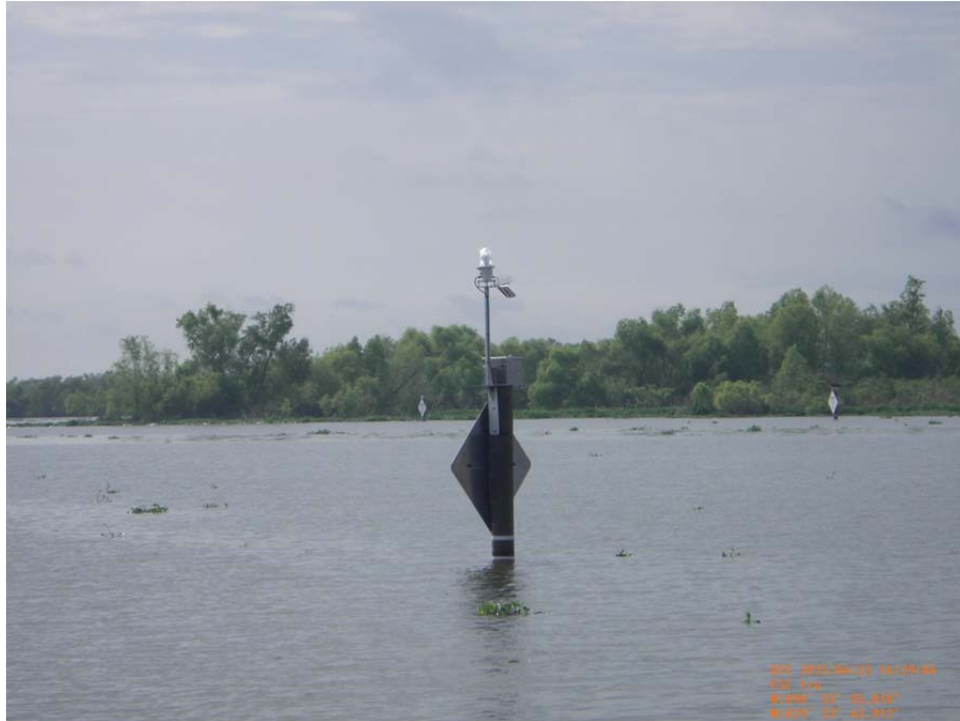
Photo 19: View warning sign and navigational aid lights (PS-20) near Sta. 85+00 looking southeast.

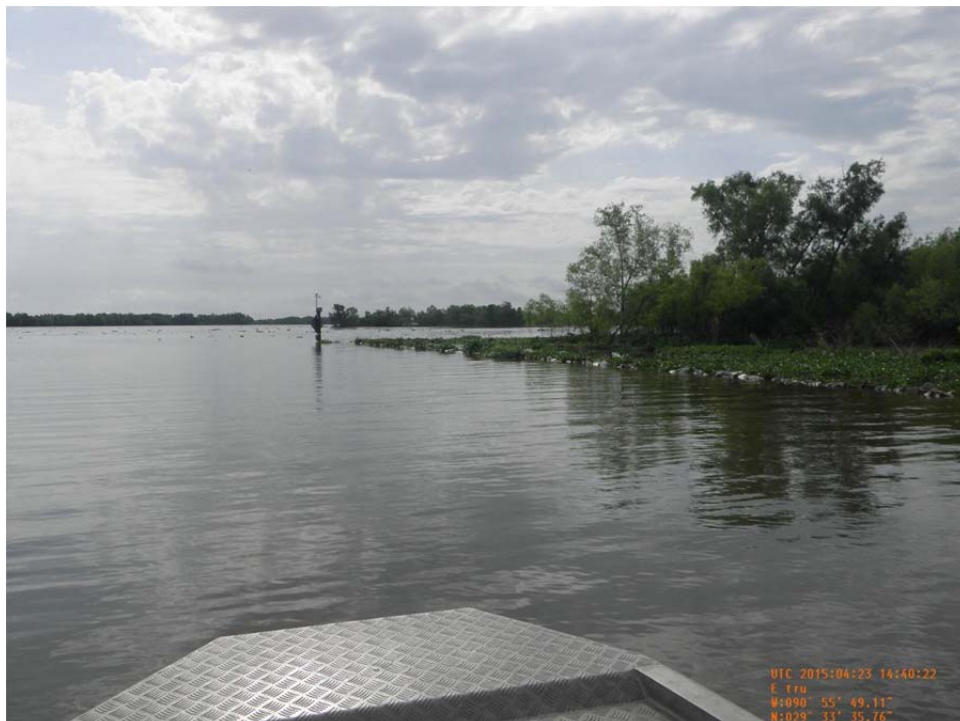
Photo 20: View of rock dike just above water line, warning sign and navigational aid light at the corner of Bayou Copasaw (Sta. 104+50).

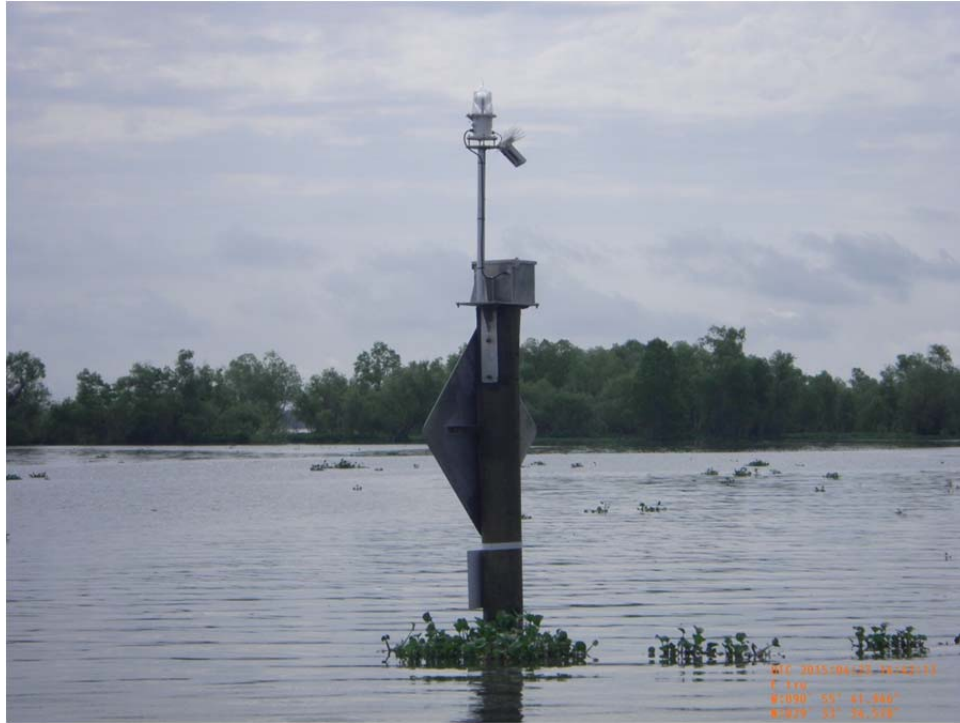
Photo 21: View of warning sign and navigational aid lights (PS-24) near the entrance of Bayou Copasaw on the east end of the project.

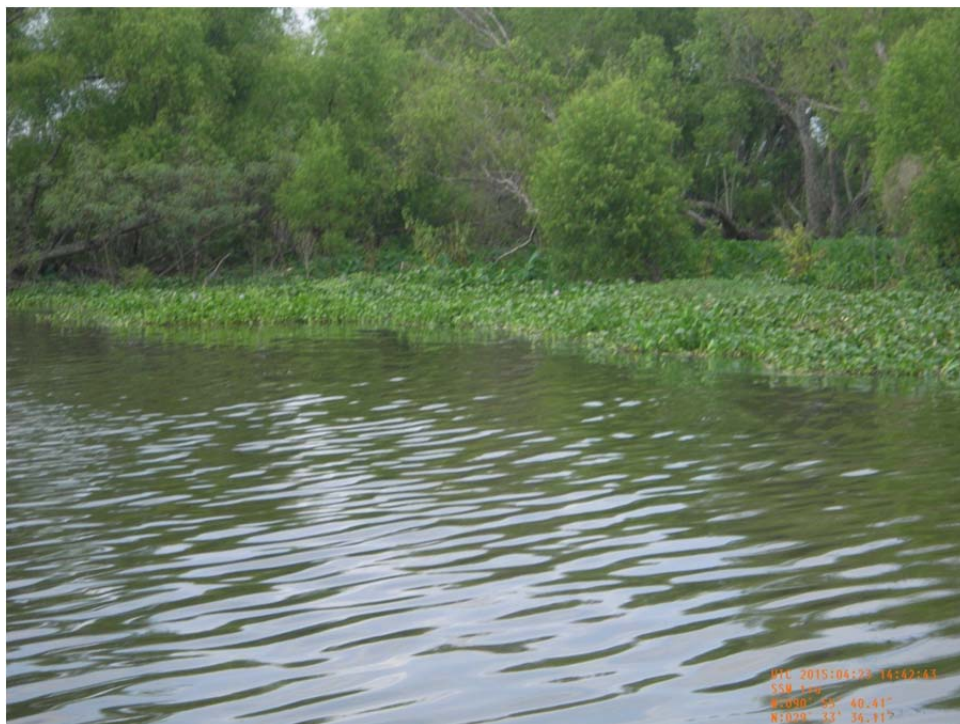
Photo 22: View of rock dike location at the tie-in to the bank at Bayou Copasaw on the east end of the project.
