2014 Operations, Maintenance, and Monitoring Report

Cote Blanche Hydrologic Restoration

State Project Number TV-04
Priority Project List 3

June 2014
St. Mary Parish

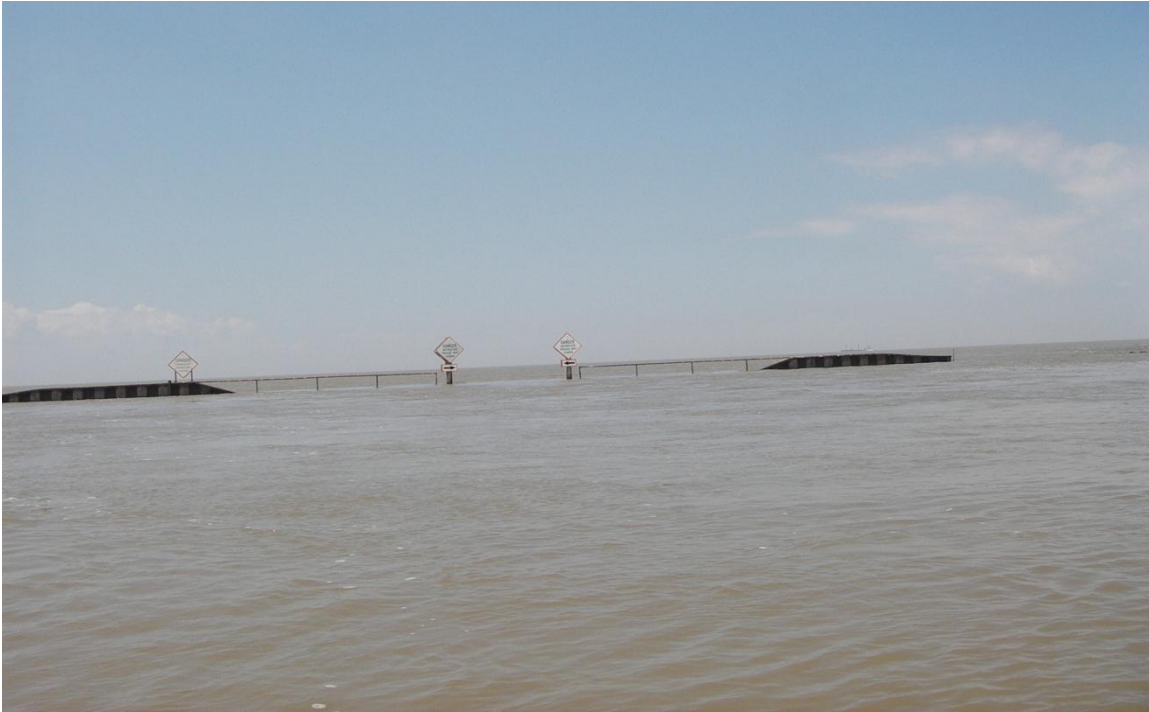
The Mud Bayou structure still appears to be holding up fairly well. Rust on the sheet piles and the pile cap continues but has not gotten significantly worse. The railing continues to erode and will soon become an issue. The north danger sign is missing and will not be replaced. Staff gauges no longer functional. (Photos: Appendix B, Photo 1)

Photo 1--Mud Bayou structure

Item	Condition	Physical Damage	Corrosion	Photo #	Observations and Remarks
Steel Bulkhead / Caps	good			1	Structure in good condition and functioning as intended. Rust continues to be monitored. Staff gauges need to be replaced.
Steel Grating	N/A				
Stop Logs	N/A				
Hardware	good				
Timber Piles	good				
Timber Wales	N/A				
Galv. Pile Caps	N/A				
Cables	N/A				
Signage / Supports	good				
Rip Rap (fill)	good				
Earthen Embankment	N/A

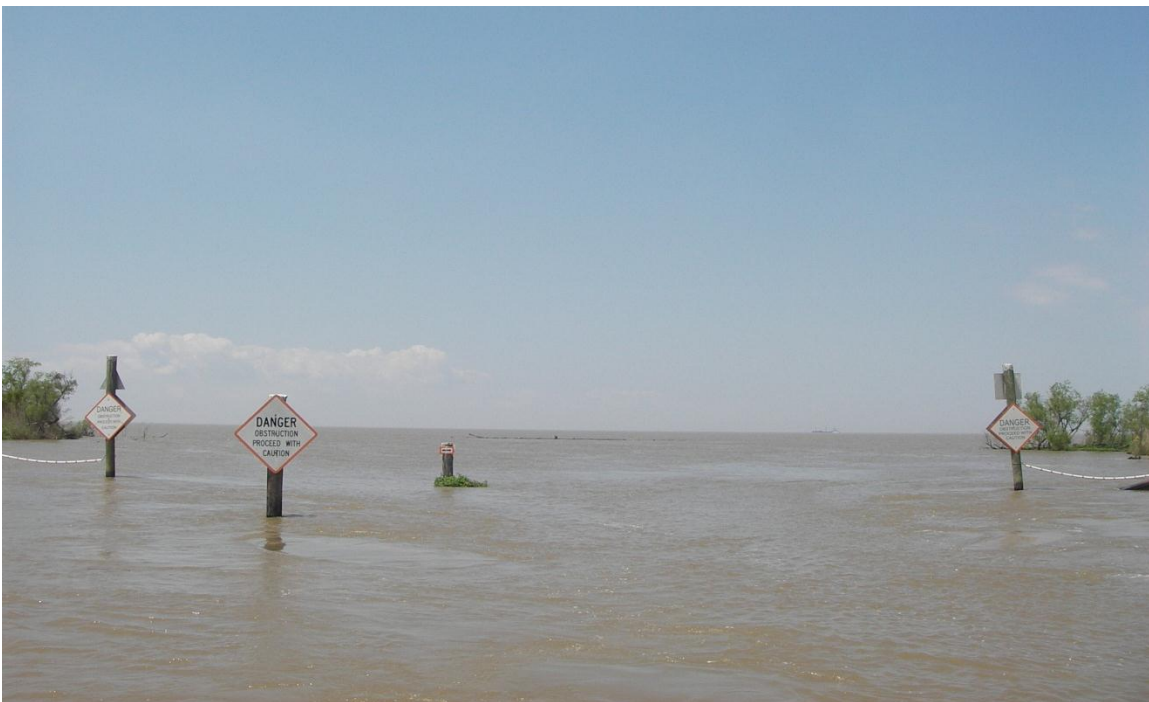
The piling and arrow sign replaced during the last maintenance event (north side) is missing. Sheet piles and rocks on the end of the structure are stable and functioning as intended. Rust on the sheet piles will be monitored. Damaged sections of railing that were replaced by driving timber pilings and attaching stainless steel cables in the sections where the railing was damaged or missing is in excellent shape. The bayshore in front of this structure has eroded considerably over the years. (Photos: Appendix B, Photo 2)

Photo 2--Humble F Canal structure

Item	Condition	Physical Damage	Corrosion	Photo #	Observations and Remarks
				2	Structure in good condition. Some slight rusting of pile caps.
Steel Bulkhead / Caps	good				
Steel Grating	N/A				
Stop Logs	N/A				
Hardware	good				
Timber Piles	good				
Timber Wales	N/A				
Galv. Pile Caps	N/A				
Cables	N/A				
Signage / Supports	good				
Rip Rap (fill)	good				
Earthen Embankment	N/A

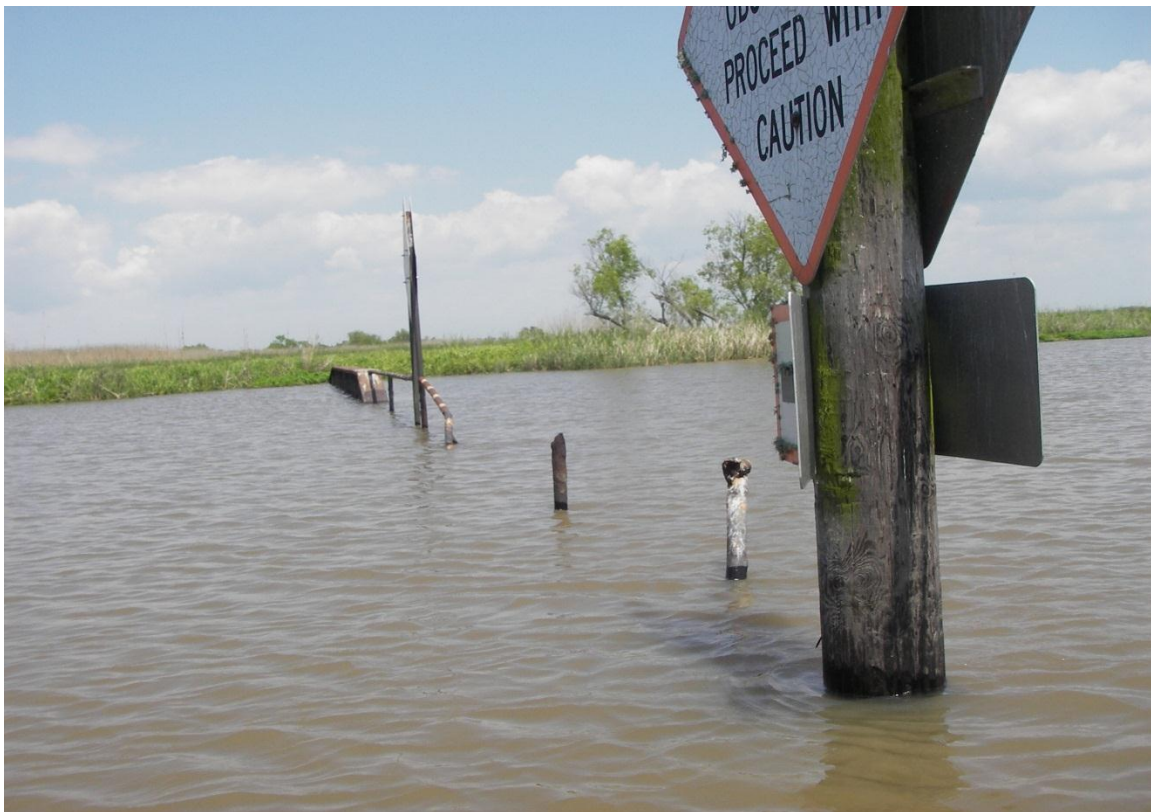
Pilings and SS cables that replaced the railing on the structure is working well, however sections of railing that were not replaced in this manner have rusted to the point of collapse and have become an issue. Rusting on the sheet piles will be monitored. (Photos: Appendix B, Photo 3)

Photo 3—damaged rail on Bayou Long structure

Item	Condition	Physical Damage	Corrosion	Photo #	Observations and Remarks
Steel Bulkhead / Caps	good				
Steel Grating	N/A				
Stop Logs	N/A				
Hardware	good				
Timber Piles	good				
Timber Wales	N/A				
Galv. Pile Caps	N/A				
Cables	N/A				
Signage / Supports	good			3	
Rip Rap (fill)	good				
Earthen Embankment	N/A

- Construction of a new PVC wall approximately 1,970 linear feet in length between Humble Canal and the existing wall is recommended. The specific locations of construction will be prioritized based on severity and budget. The vicinity around Jackson Bayou should be addressed first.
- Railings located on top of the sheet pile cap of the weirs at Mud Bayou and Bayou Long which hasn't been replaced should be replaced with stainless steel cable and timber piles.

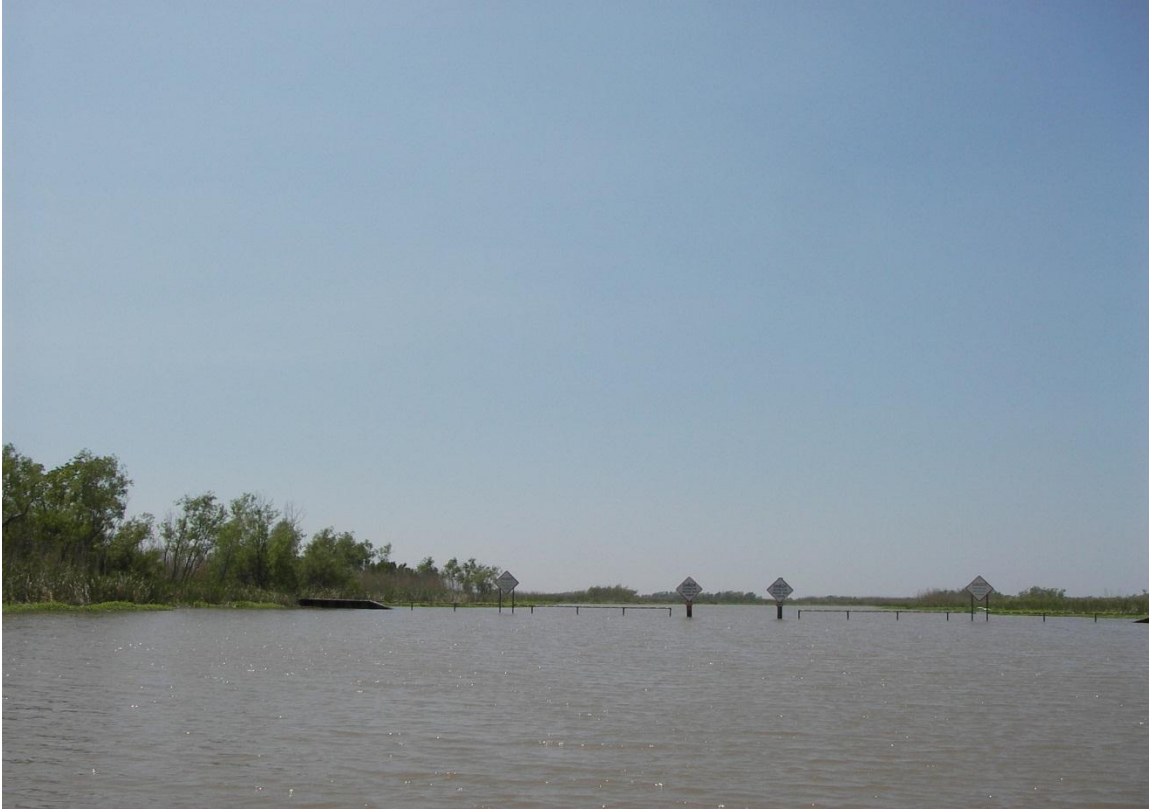
The structure is still in excellent post-construction condition. The Bayou Carlin structure and signage are stable. The coating on the sheet piles is rusting and will be monitored as the others. (Photos: Appendix B, Photo 4)

Photo 4--Bayou Carlin Structure

Item	Condition	Physical Damage	Corrosion	Photo #	Observations and Remarks
Steel Bulkhead / Caps	good			4	Structure in pristine post-construction condition. Some slight rusting of pile caps. No immediate action necessary.
Steel Grating	N/A				
Stop Logs	N/A				
Hardware	good				
Timber Piles	good				
Timber Wales	N/A				
Galv. Pile Caps	N/A				
Cables	N/A				
Signage / Supports	good				
Rip Rap (fill)	N/A				
Earthen Embankment	N/A

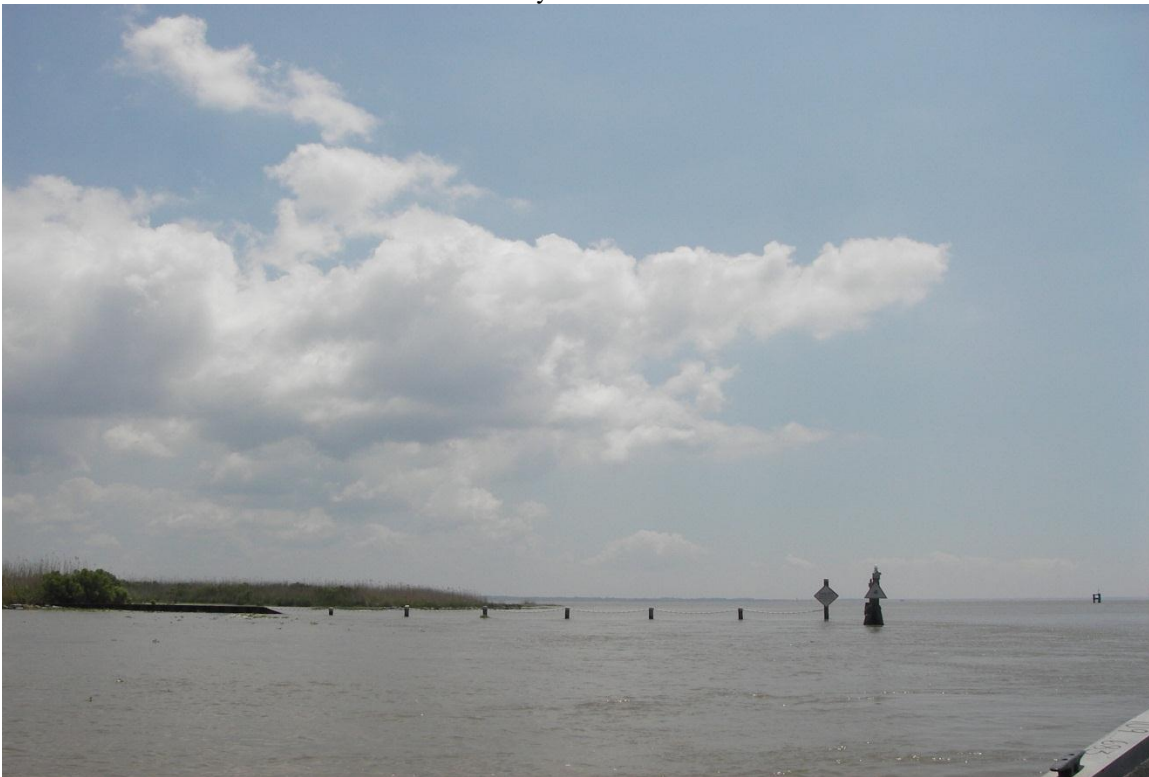
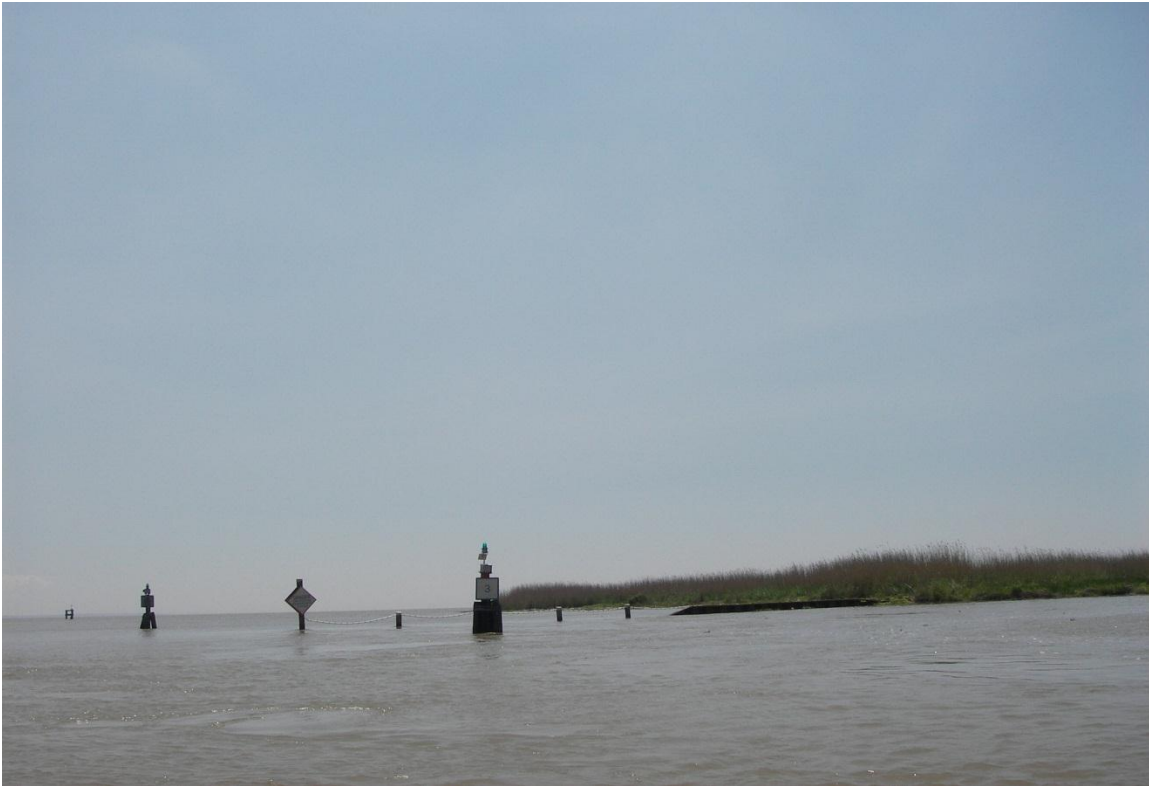
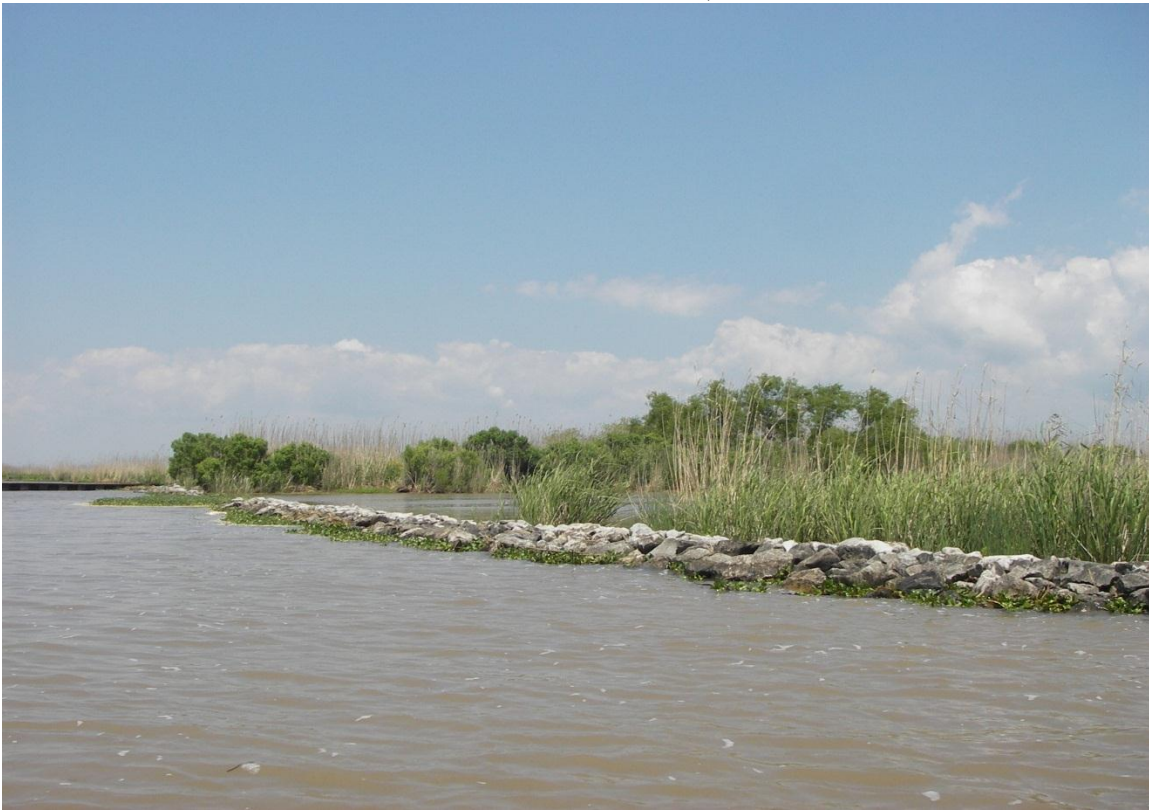
Rail damage on the west end of the structure that was replaced with pilings and SS cables is functioning as intended. Rock that was placed to extend the keyway closure has settled but is in otherwise good shape. Signage all stable. (Photos: Appendix B, Photos 5-7)

Photo 5--Humble Canal structure; east side

Photo 6—Humble Canal structure; west side

Photo 7--rock on east side of Humble Canal

Item	Condition	Physical Damage	Corrosion	Photo #	Observations and Remarks
Steel Bulkhead / Caps	good				Some initial post construction rusting. No immediate action needed.
Steel Grating	N/A				
Stop Logs	N/A				
Hardware	fair				
Timber Piles	N/A				
Timber Wales	N/A				
Galv. Pile Caps	good				
USCG Lights	good			5	
Signage / Supports	good			6	
Rip Rap (fill)	good			7	
Earthen Embankment	N/A

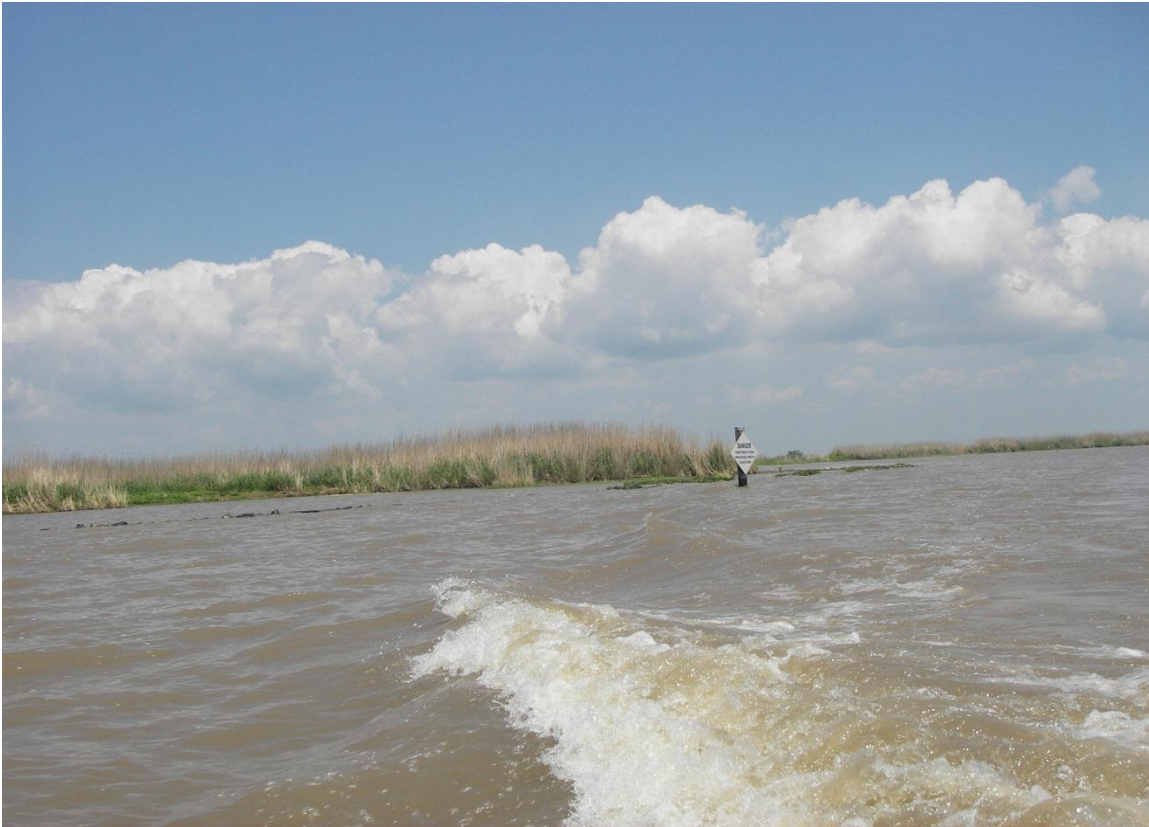
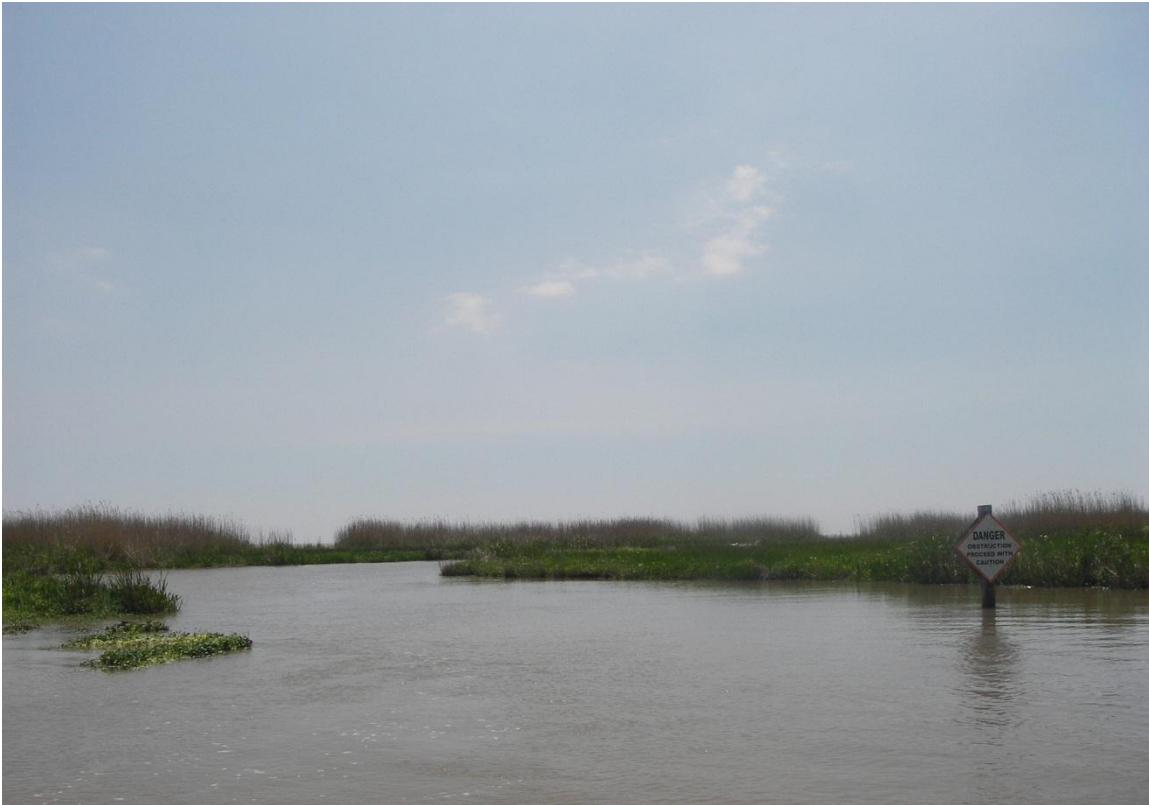
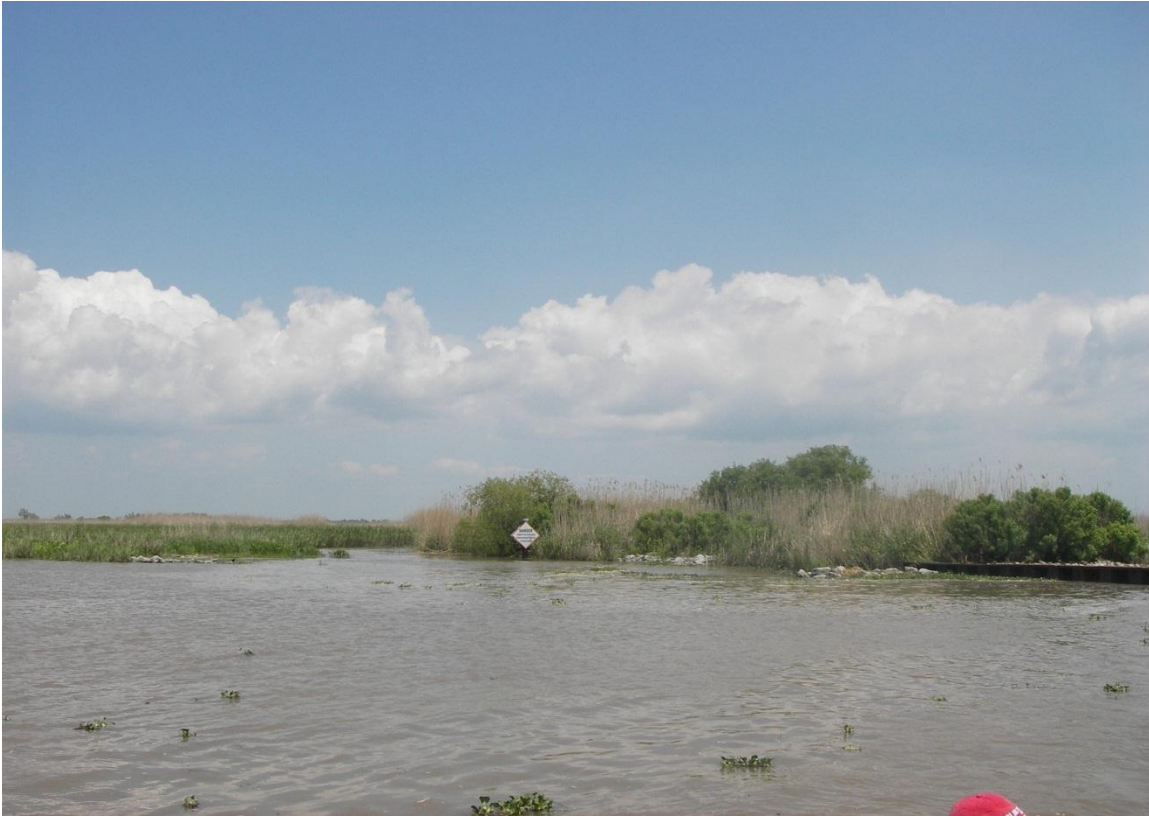
No significant additional settlement of the rock dike was noticed. Water levels were very high, approximately +3.0. Signage along the bay shore is intact. Due to the high water level, no rock was found on the western end of School Bus Bayou at its intersection with Humble Canal, however it is assumed to still be there. Signage at the crossings is ok. (Photos: Appendix B, Photos 8-10)

Photo 8—typical section of School Bus Bayou dike

Photo 9—western weir at School Bus Bayou

Photo 10—eastern weir at School Bus Bayou

Item	Condition	Physical Damage	Corrosion	Photo #	Observations and Remarks
Steel Bulkhead / Caps	N/A				
Steel Grating	N/A				
Stop Logs	N/A				
Hardware	N/A				
Timber Piles	N/A				
Timber Wales	N/A				
Galv. Pile Caps	N/A				
Cables	N/A				
Signage /Supports	Good			8, 9, 10	Signage is intact
Rip Rap (fill)					
School Bus Bayou	Good			8	No significant additional settlement of rock dike.
Low Level Weirs	Good			9,10	
Earthen Embankment	N/A

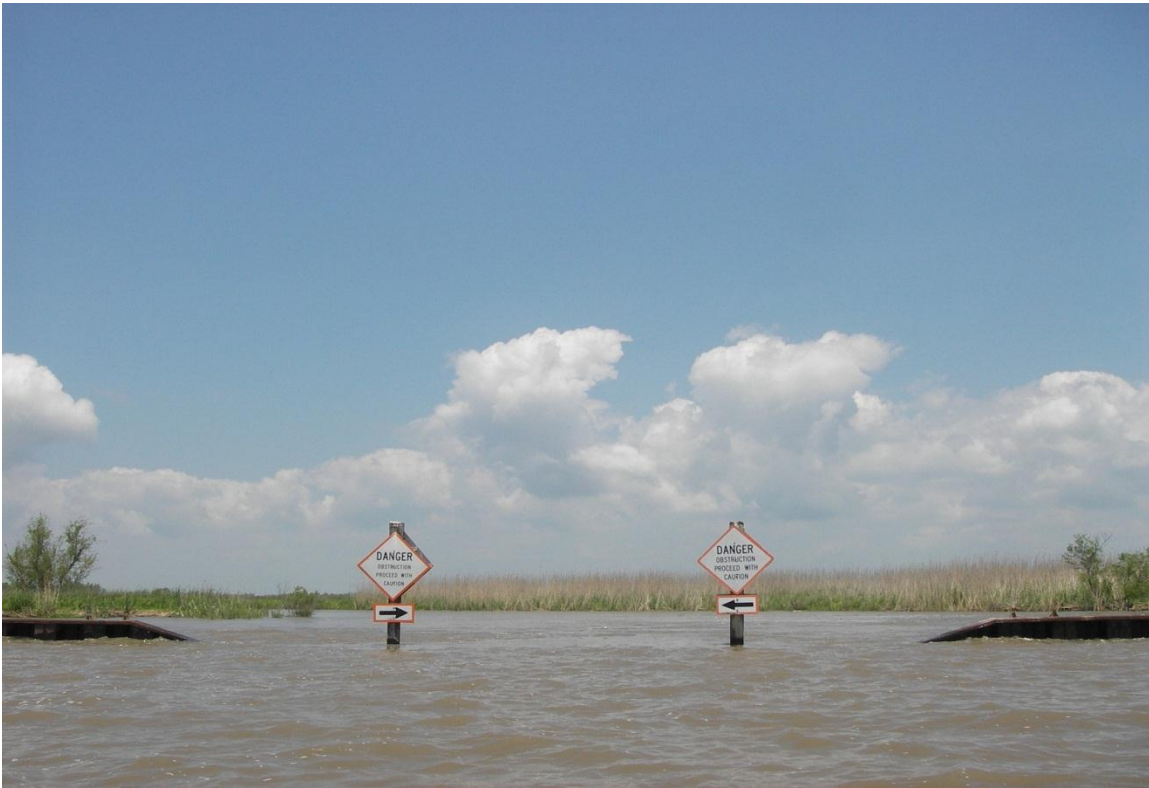
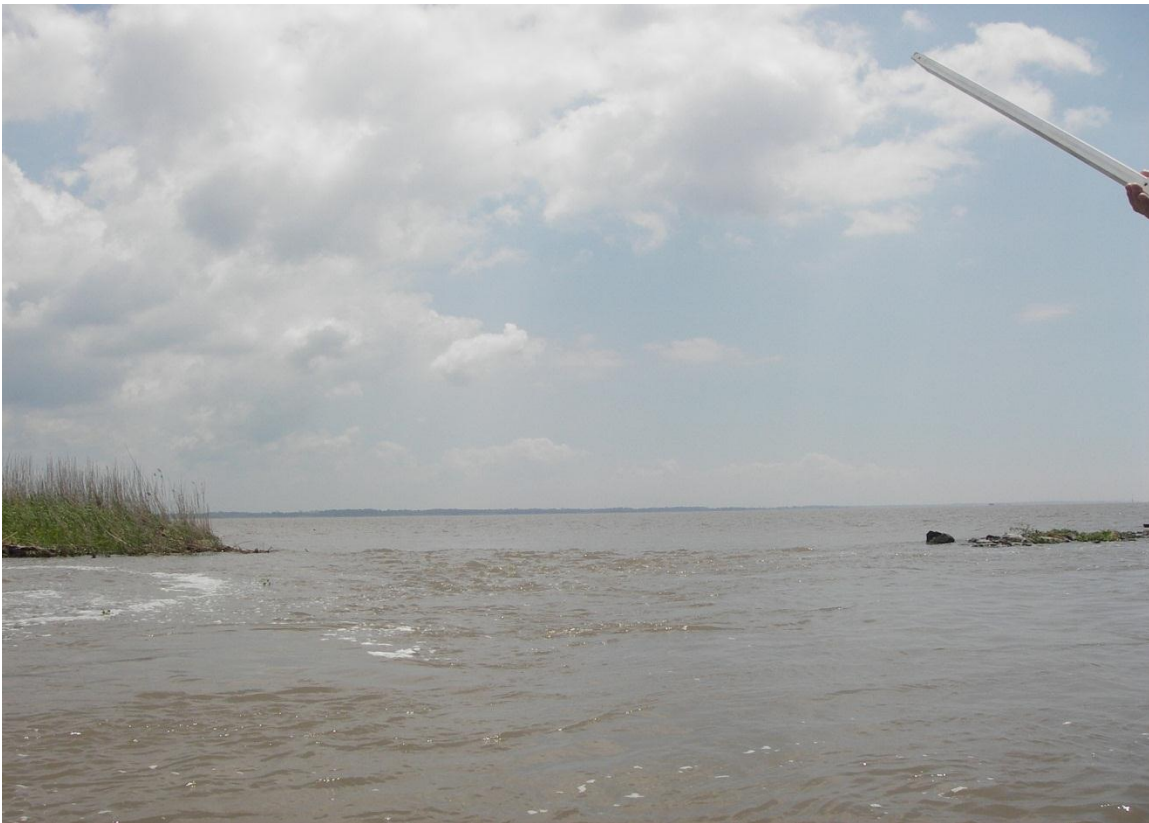
The shoreline on the eastern side of the structure has now eroded all the way through between the rock and the structure. This gap is now approximately 60 feet wide and about 2 ½ feet deep. This area will be addressed in the maintenance event scheduled for the summer of 2014. Rock placed near the western end of the PVC wall will be picked up and placed in this

area to try to stabilize the shoreline. The coating on the sheet piles continues to rust as on the other structures and will be monitored. (Photos: Appendix B, Photos 11-12)

Photo 11—Jackson Bayou structure

Photo 12—breach on eastern end of Jackson Bayou Structure

Item	Condition	Physical Damage	Corrosion	Photo #	Observations and Remarks
Steel Bulkhead / Caps	good			11,12	Some slight rusting of pile caps.
Steel Grating	N/A				
Stop Logs	N/A				
Hardware	good				
Timber Piles	poor				
Timber Wales	N/A				
Galv. Pile Caps	N/A				
Cables	N/A				
Signage / Supports	good				
Rip Rap (fill)	good				Shoreline where rock was placed has stabilized the shoreline however the shore on the eastern end of the structure has eroded to the point that water will soon circumvent the structure. This area will need to be addressed should additional funding be provided.
Earthen Embankment	N/A

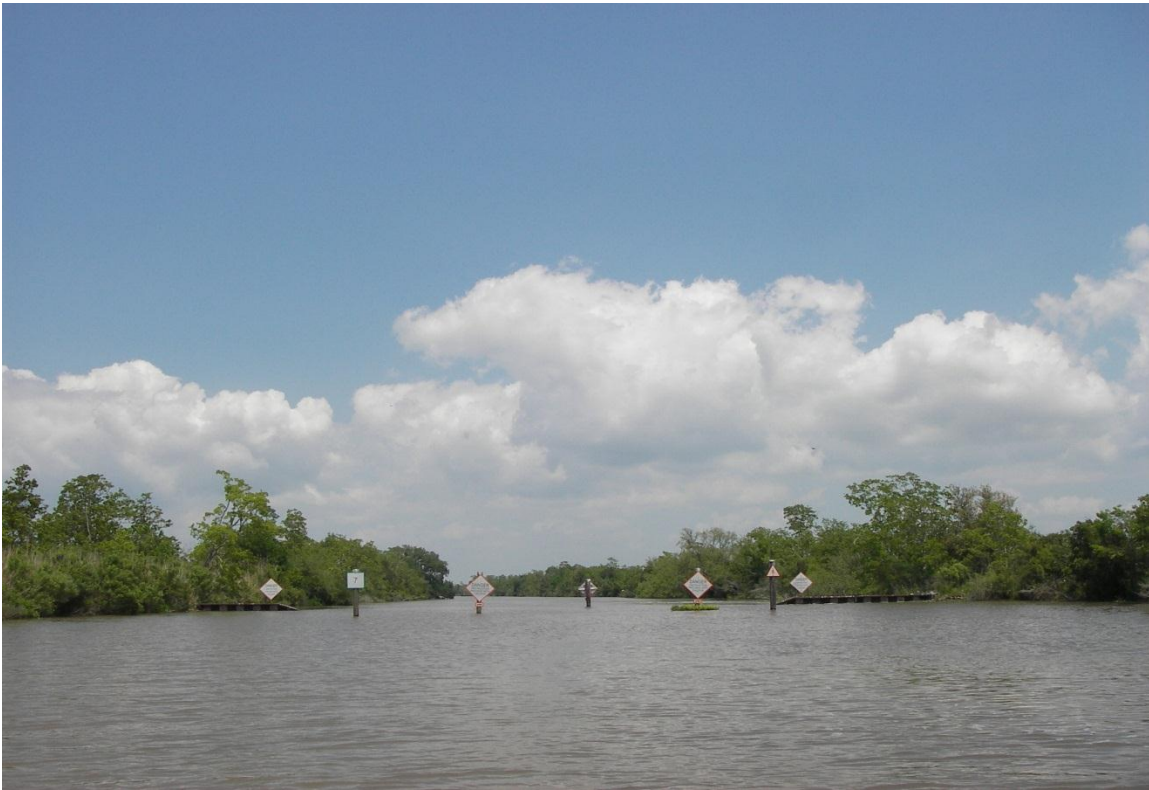
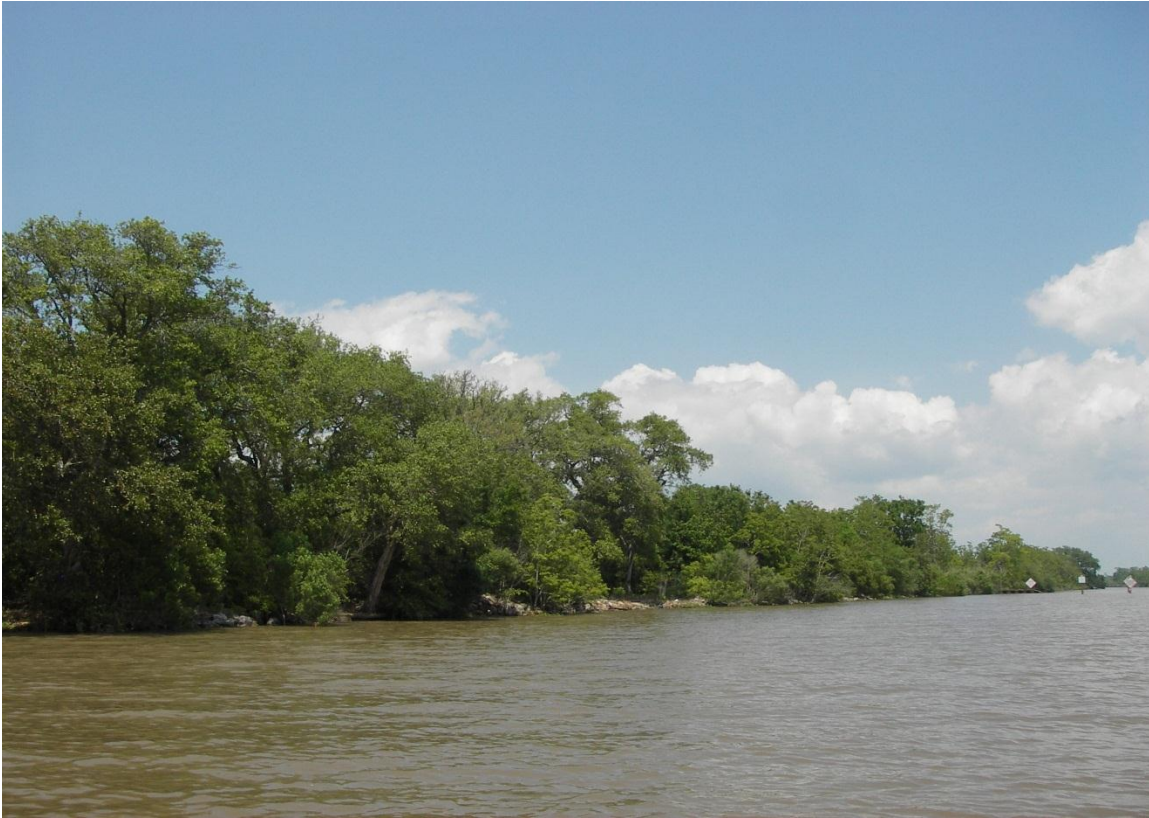
Rust on the sheet piles will be monitored as well. Signage is in excellent shape. Rock along the shoreline between the structure and the PVC wall is also in excellent shape. (Photos: Appendix B, Photos 13-14)

Photo 13—British American Canal Structure

Photo 14—rock along British American Canal

Item	Condition	Physical Damage	Corrosion	Photo #	Observations and Remarks
Steel Bulkhead / Caps	good			13, 14	Some initial post construction rusting. No action needed.
Steel Grating	N/A				
Stop Logs	N/A				
Hardware	good				
Timber Piles	see signage				
Timber Wales	N/A				
Galv. Pile Caps	N/A				
Cables	N/A				
Signage / Supports	fair				
Rip Rap (fill)	good				Rock between PVC wall and shoreline has settled but is still functional.
Earthen Embankment	N/A

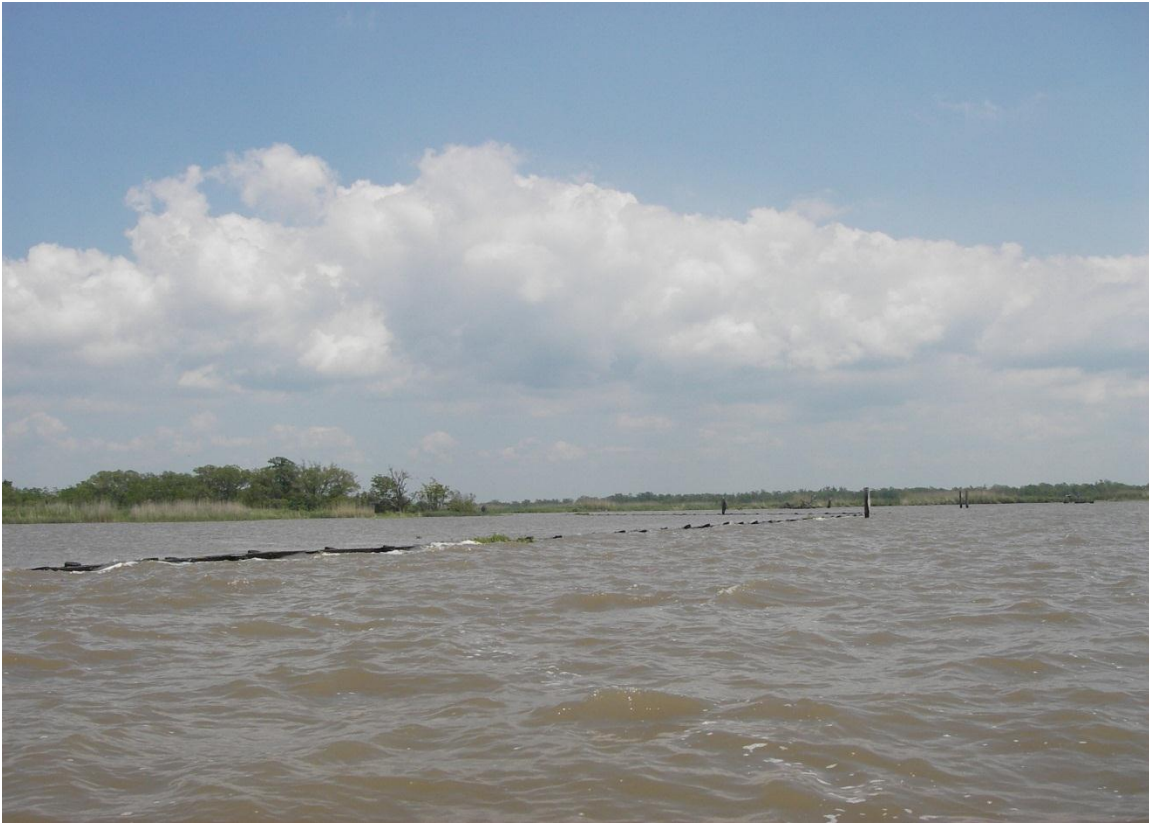
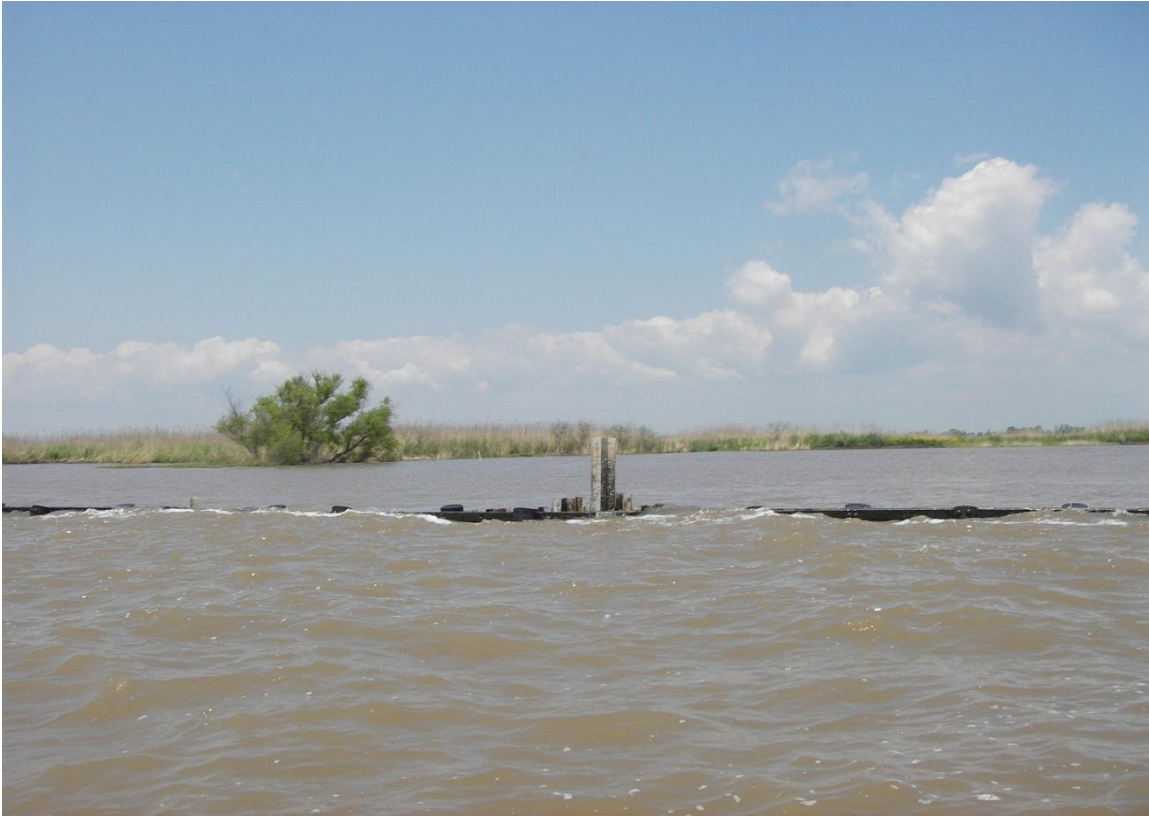
The PVC shoreline protection wall and signage are stable. Even with no pile caps, no noticeable deterioration of the timber piles was noticed. Sheet piles in several locations are missing. In several locations along the wall, sheets have become detached and were seen migrating upward. This was the first time that this was seen and could possibly be due to the high water levels. Replacement of these sheet piles may not be possible due to the rock at the base. The wall is still functioning as intended. Signs are all in place and stable. The maintenance event scheduled for the summer of 2014 will add approximately 1,970 linear feet of PVC wall, (as allowed by the remaining budget) in areas as prioritized between Humble Canal and the existing wall. The area around Jackson Bayou will be addressed first. (Photos: Appendix B, Photo 15-16)

Photo 15—Typical section of PVC wall

Photo 16—rising sheet pile on PVC wall

Item	Condition	Physical Damage	Corrosion	Photo #	Observations and Remarks
PVC sheet piling / Caps	fair			15,16	PVC wall appears to be in post construction condition and holding up well. Some piles have been broken or displaced. No gaps are wider than 3-4 feet however and the wall is still functioning
Steel Grating					
Stop Logs					
Hardware	good				
Timber Piles	good				Nearly all pile caps missing. Attempts to replace these have been unsuccessful. Condition of the piles will be monitored.
Timber Wales	good				
Galv. Pile Caps					
Cables					
Signage / Supports	good				All signs are in place. Some retaping with reflective tape is required.
Rip Rap (fill)	good				Rock placed along the inside and outside of the PVC wall is still in place and functional. No action necessary.
Earthen Embankment
