Coastal Protection and Restoration Authority of Louisiana (CPRA)

2016 Operations, Maintenance and Monitoring Report

Oaks/Avery Canals Hydrologic Restoration

State Project Number T/V-13a
Priority Project List 6

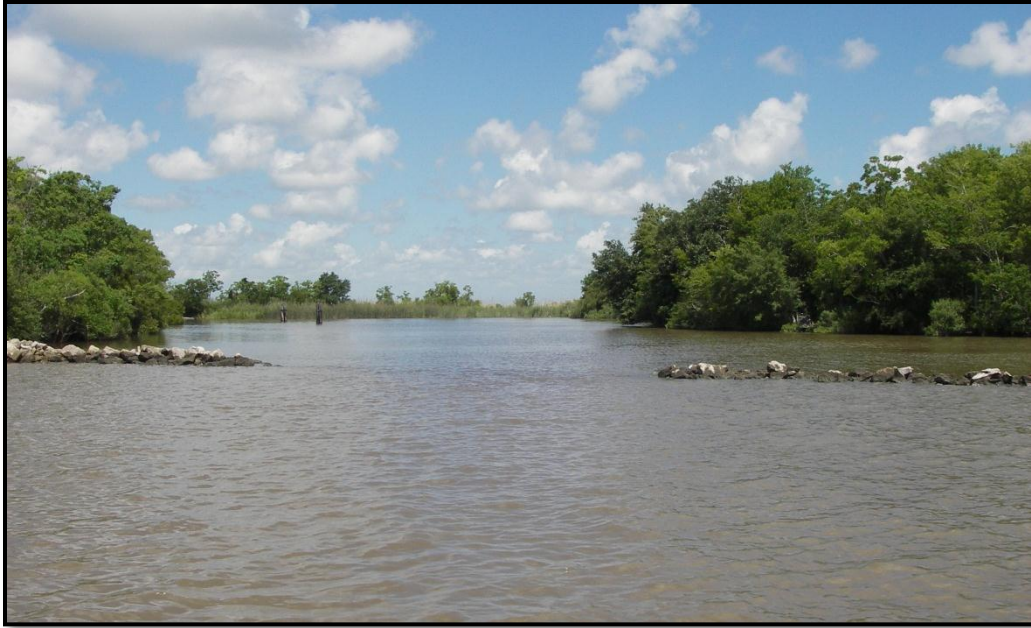
The dike is in excellent condition. Approximately 50 linear feet on the eastern end at an oilfield location canal continues to settle but is in no need of any repairs. This low area is located at N 29° 49' 58.3" and W 91° 59' 25.9". East and west tie-ins are stable; however, there is some minor erosion occurring at the east tie-in which will be monitored on future inspections. (Appendix A; Photo 1)

Photo No. 1, Rock along north bank of GIWW showing low area

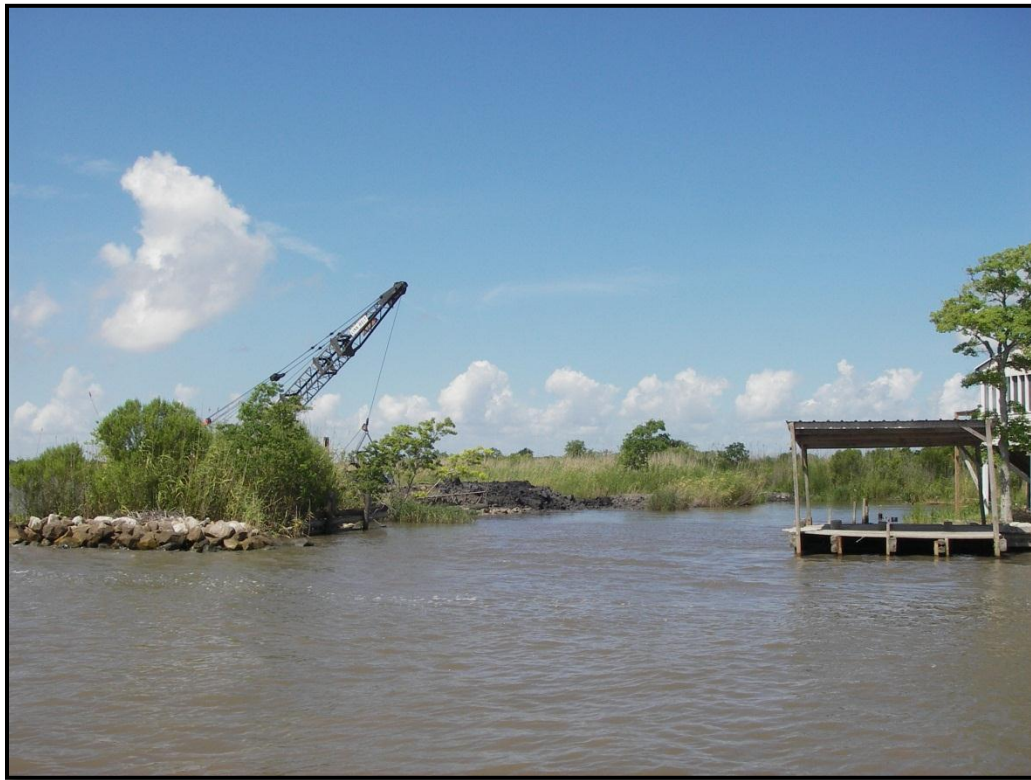
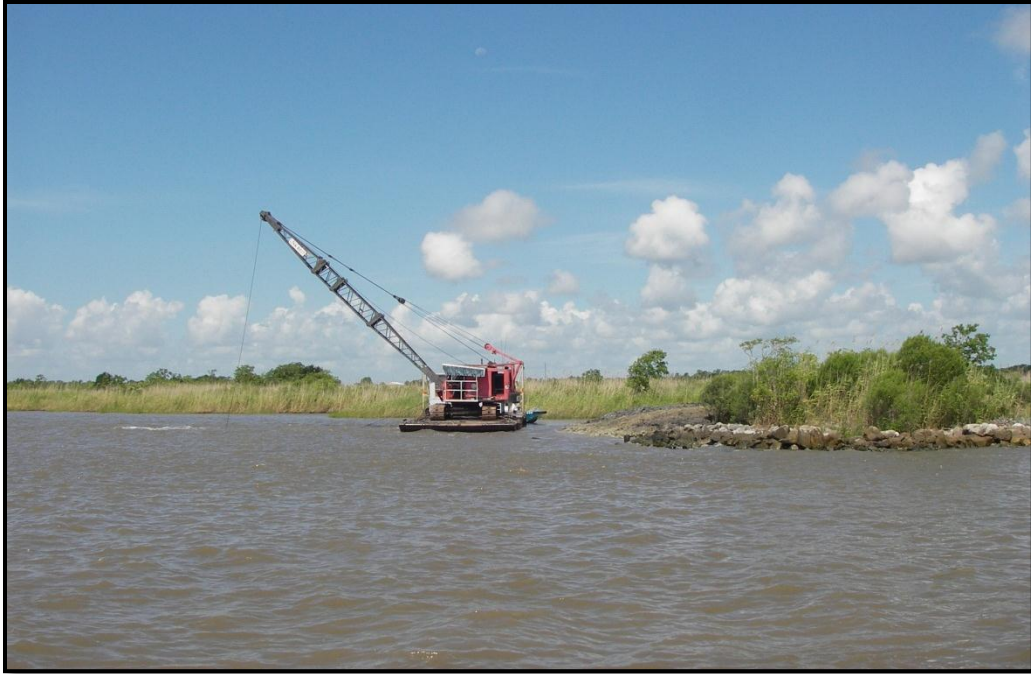
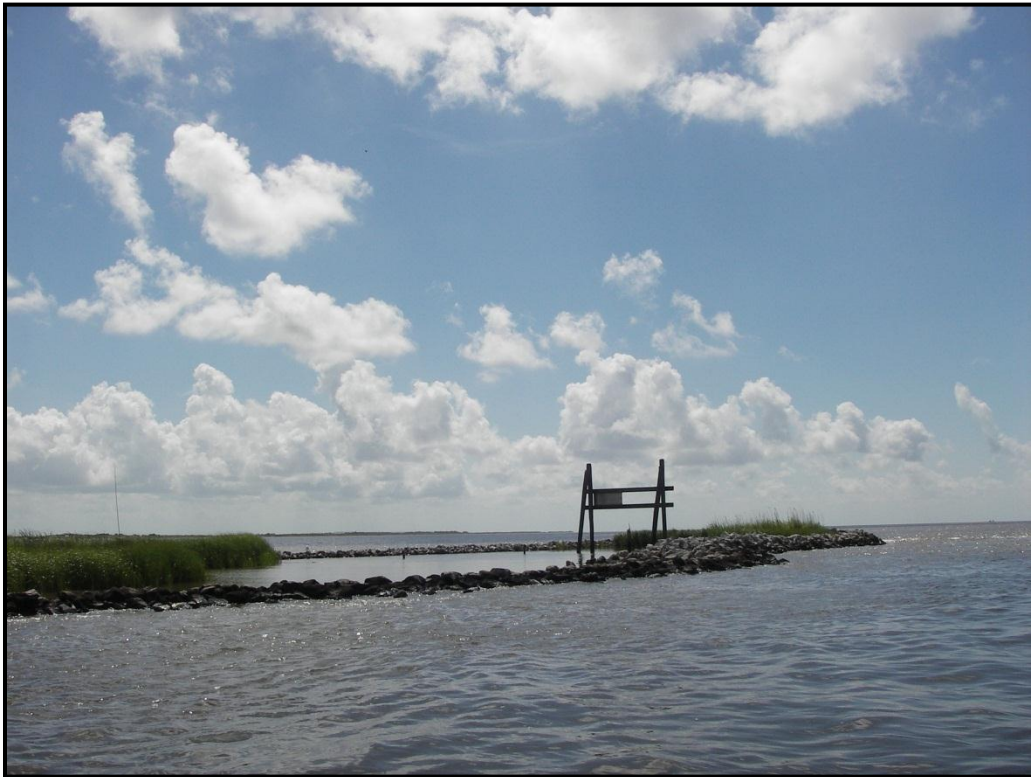
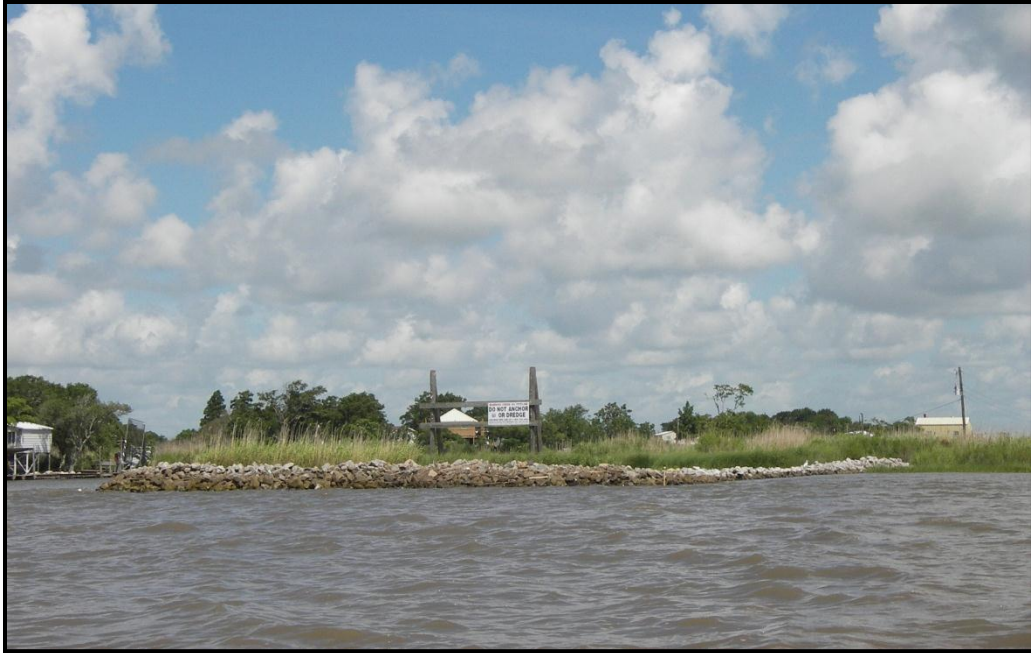
No worsening in this area was evident. The bank between the bay and Bayou Hebert is still only about 6 feet wide and has not gotten any worse. Additional rock has been added to connect the end of the existing rock paving to the rock island protecting two pipelines located on the eastern side of the Oaks Canal. This work was performed by ChevronTexaco Pipeline, LLC-Erath in 2009 through CUP No. 20070581. At the time of inspection the Vermilion Parish Gravity Drainage District was placing dredged spoil on the west side of the mouth of the Oaks Canal at Vermilion Bay. (Appendix A; Photos 2-5)

Photo No. 2, Rock dike at Oaks Canal, west side

Photo No. 3, Rock dike at Oaks Canal, west side

Photo No. 4, Rock dike at Oaks Canal, East side

Photo No. 5, Rock dike at Oaks Canal, East side

Item	Condition	Pysical Damage	Corrosion	Photo #	Observations and Remarks
Steel Bulkhead / Caps	N/A				
Steel Grating	N/A				
Stop Logs	N/A				
Hardware	N/A				
Timber Piles	N/A				
Timber Wales	N/A				
Galv. Pile Caps	N/A				
Vegetation	N/A				
Signage /Supports	N/A				
Rip Rap (fill)	Excellent			2-5	Rock in excellent condition.
Eathem Embankment	N/A

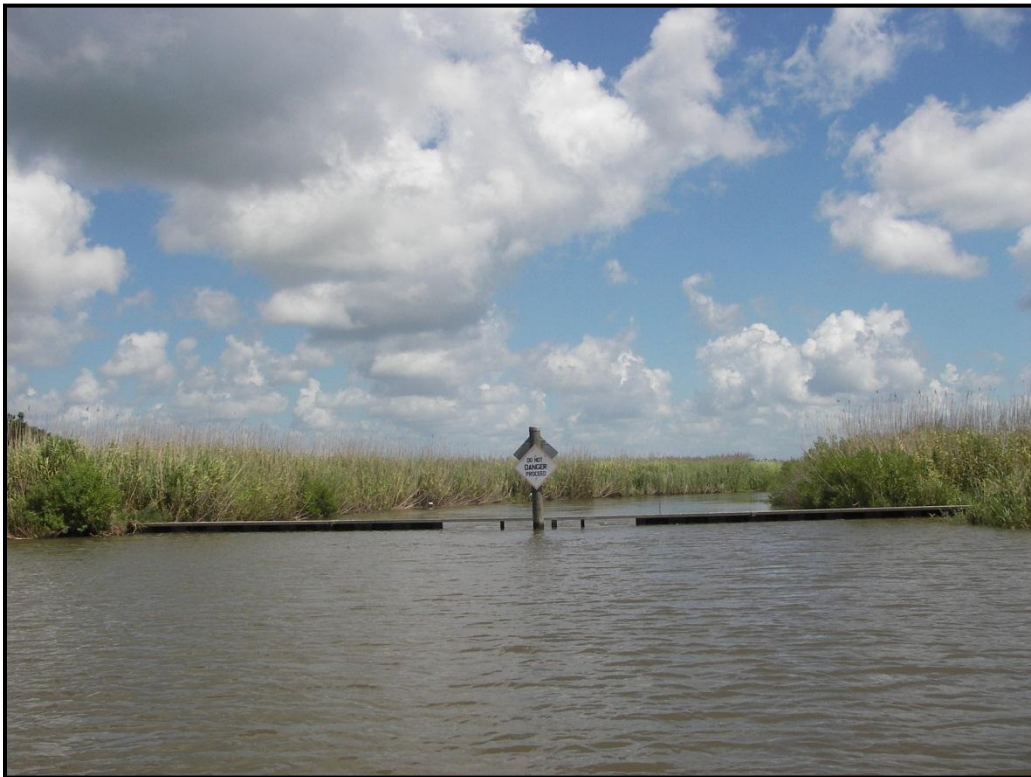
The structure is in good condition and both bank tie-ins are secure. (Appendix A; Photo 6)

Photo No. 6, Cow Path Structure

Item	Condition	Pysical Damage	Corrosion	Photo #	Observations and Remarks
Steel Bulkhead / Caps	Excellent			6	
Steel Grating	N/A				
Stop Logs	N/A				
Hardware	Good			6	
Timber Piles	N/A				
Timber Wales	N/A				
Galv. Pile Caps	Excellent				
Vegetation	N/A				
Signage /Supports	Excellent			6	
Rip Rap (fill)	N/A				
Eathem Embankment	Excellent

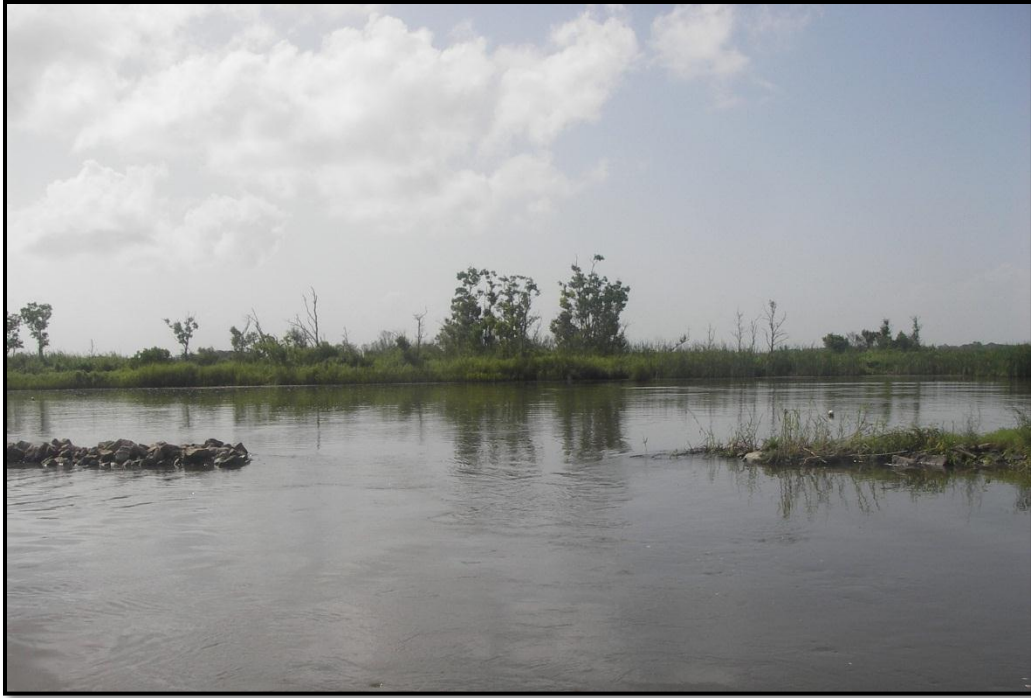
The rock plug located on the north section of the project area near Union Canal has been gapped with the latest maintenance event. This rock plug is no longer accessible and will not be inspected. (Appendix A; Photo 4)

Photo No. 7, Rock plug gapped as part of maintenance event. (photo taken 07/02/2012)

Item	Condition	Pysical Damage	Corrosion	Photo #	Observations and Remarks
Steel Bulkhead / Caps	N/A				
Steel Grating	N/A				
Stop Logs	N/A				
Hardware	N/A				
Timber Piles	N/A				
Timber Wales	N/A				
Galv. Pile Caps	N/A				
Vegetation	N/A				
Signage /Supports	N/A				
Rip Rap (fill)	Poor				Not inspected on this trip. No access to rock plug. No longer a necessary project feature.
Eathem Embankment	N/A

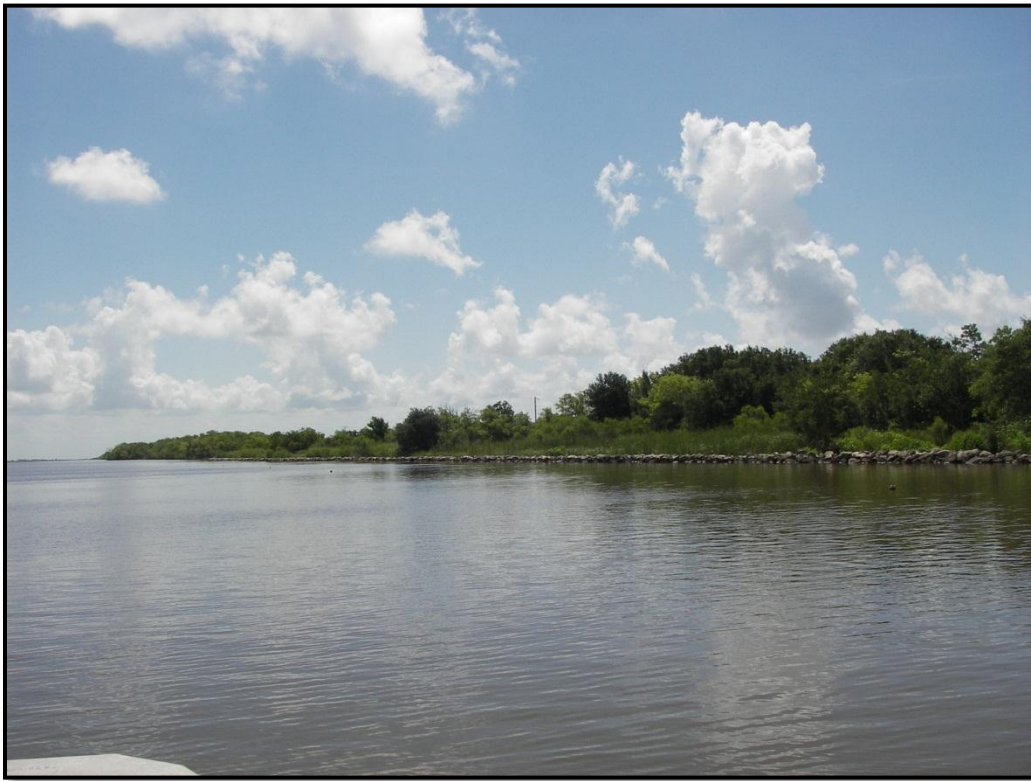
The rock dike is similar to immediate post construction condition and in no need of any repairs. (Appendix A; Photo 8)

Photo No. 8, Rock dike along south bank of GIWW

Item	Condition	Pysical Damage	Corrosion	Photo #	Observations and Remarks
Steel Bulkhead / Caps	N/A				
Steel Grating	N/A				
Stop Logs	N/A				
Hardware	N/A				
Timber Piles	N/A				
Timber Wales	N/A				
Galv. Pile Caps	N/A				
Vegetation	N/A				
Signage /Supports	N/A				
Rip Rap (fill)	Excellent			8	Rock dike is in good condition.
Eathem Embankment	N/A

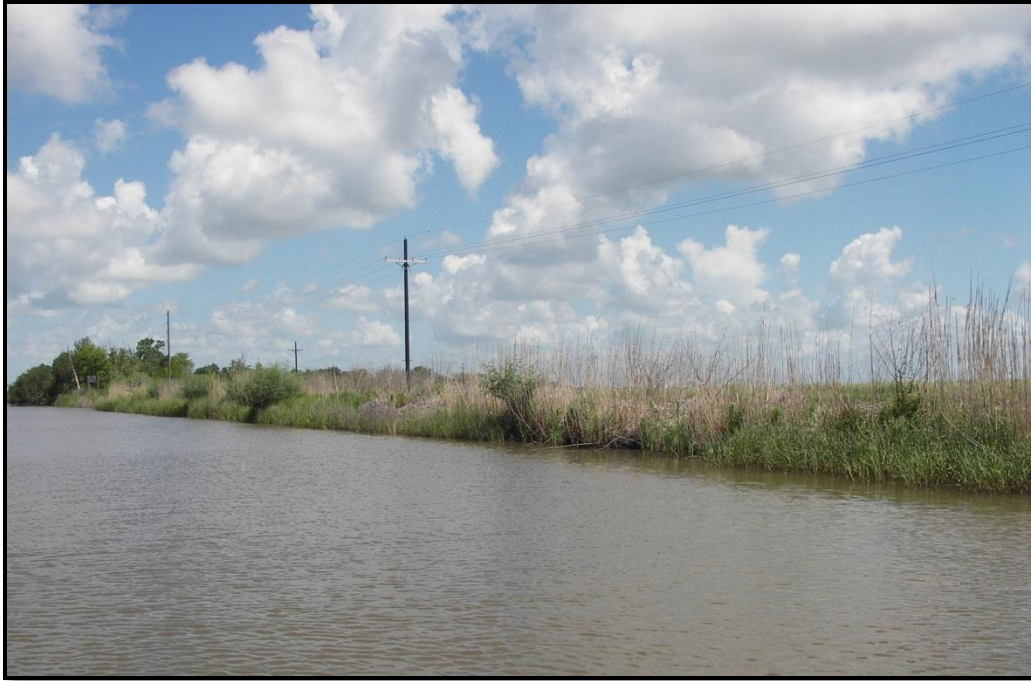
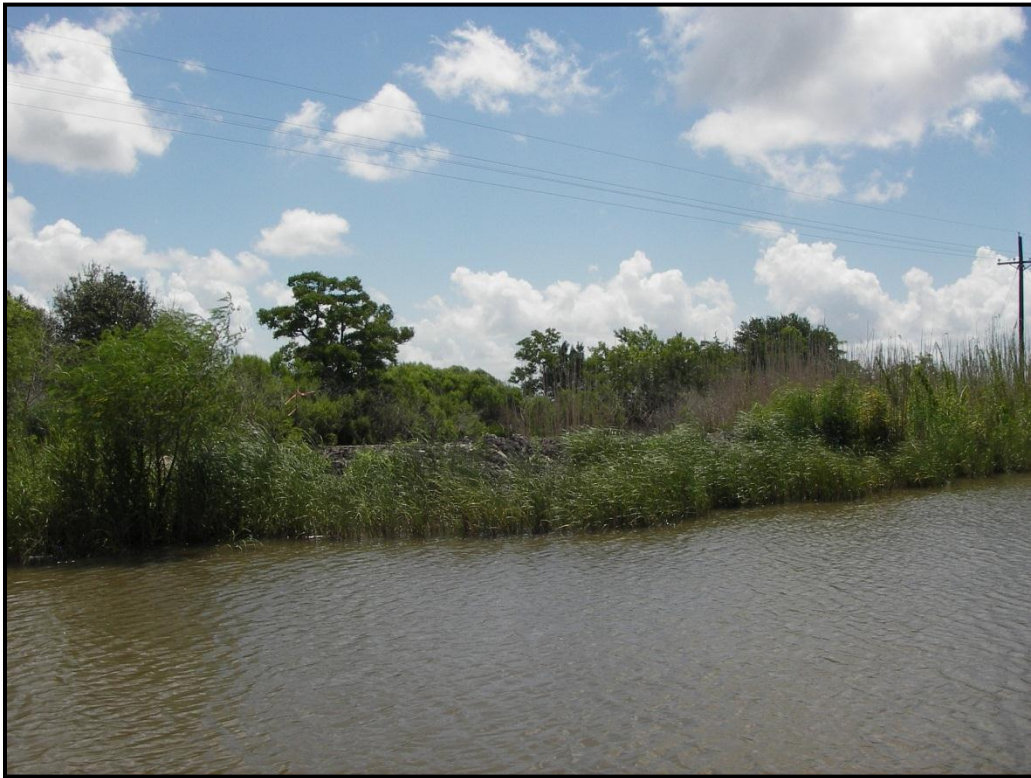
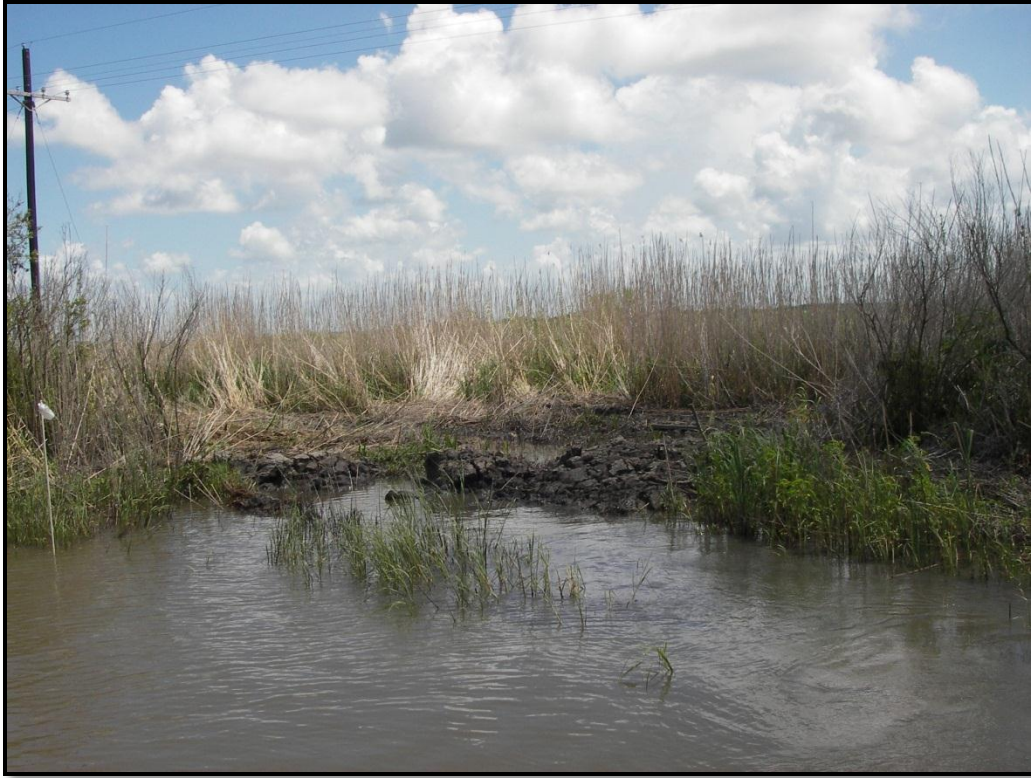
The recently completed spoilbank maintenance on the Oaks canal looks great and was built to a +5.0' elevation. As part of the spoilbank maintenance an old slip that provided access to a landowner camp was plugged. The spoilbank has maintained the constructed elevation. It looks like the Vermilion Parish Drainage District has recently added more dredge material to the plug and it is now at the +5.0' elevation across its length. There is a section of levee within the project boundary, but not a part of the levee refurbishment, that has been damaged (presumably by Slemco's maintenance activities). The land owner representative, Jimmy Delcambre, has been notified of the damage to the Oaks Canal levee. He is pursuing Slemco to seek repair of the damage. (Appendix A; Photo 9-11)

Photo No. 9, Spoilbank Maintenance along Oaks Canal

Photo No. 10, Earthen Canal Plug on Oaks Canal

Photo No. 11, Damage to levee on Oaks Canal

Item	Condition	Physical Damage	Corrosion	Photo #	Observations and Remarks
Steel Bulkhead / Caps	N/A				
Steel Grating	N/A				
Stop Logs	N/A				
Hardware	N/A				
Timber Piles	N/A				
Timber Wales	N/A				
Galv. Pile Caps	N/A				
Vegetation	Good			9-11	Vegetation Flourishing.
Signage /Supports	N/A				
Rip Rap (fill)	N/A				
Earthen Embankment	Good			9-11	Spoilbank is built up to +5' elevation or greater. Earthen canal plug has received additional dredge material from maintenance work done by the Vermilion Parish Gravity Drainage District. Earthen canal plug is stable.

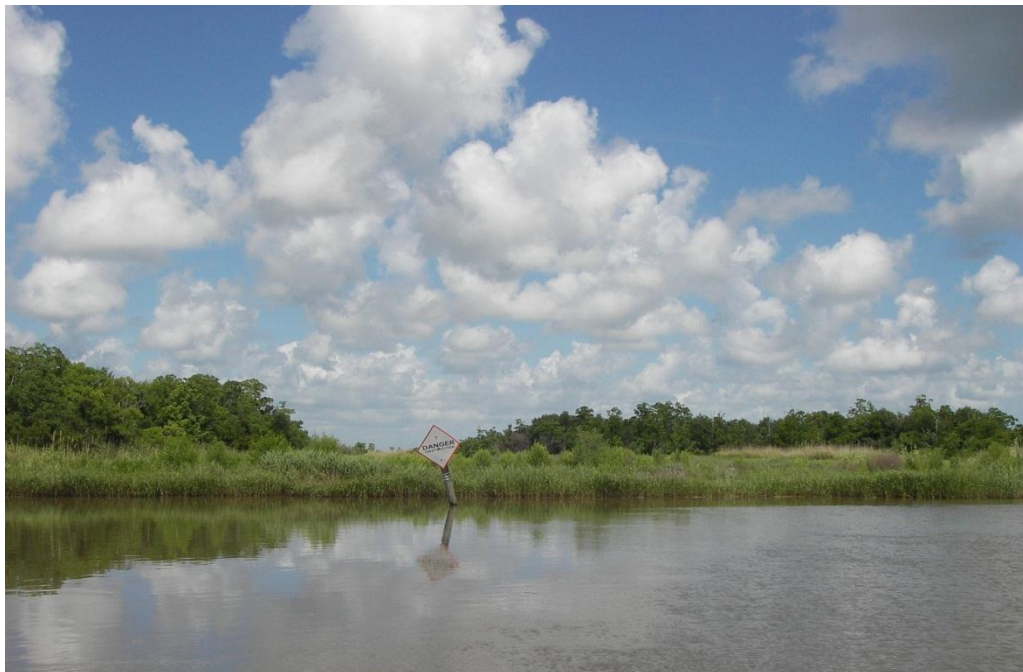
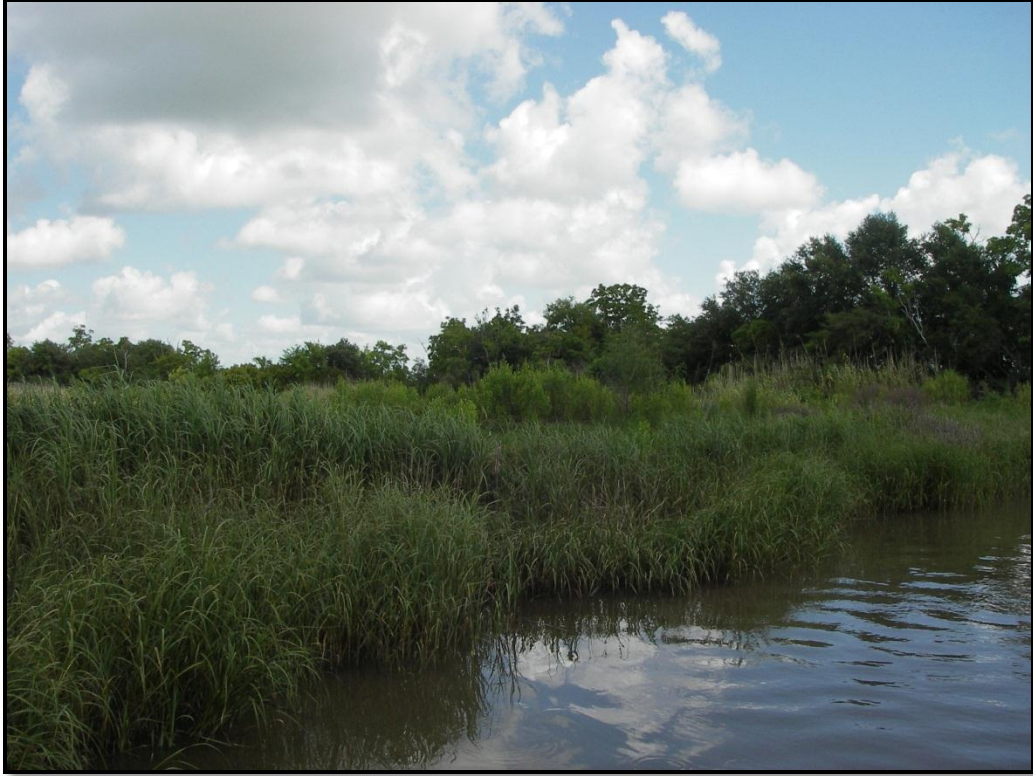
The Earthen Canal plug has experienced some settlement in a 50' section and is approximately at a +2.5' elevation where the settlement occurred. No further settlement has occurred and the vegetation is flourishing. (Appendix A; Photo 12-13)

Photo No. 12, Earthen Canal plug on Union Canal

Photo No. 13, Earthen Canal plug on Union Canal

Item	Condition	Physical Damage	Corrosion	Photo #	Observations and Remarks
Steel Bulkhead / Caps	N/A				
Steel Grating	N/A				
Stop Logs	N/A				
Hardware	N/A				
Timber Piles	N/A				
Timber Wales	N/A				
Galv. Pile Caps	N/A				
Vegetation	Good			12-13	Vegetation Flourishing.
Signage /Supports	N/A				
Rip Rap/dike	N/A				
Eathem Embankment	Good			12-13	The earthen canal plug had experienced settlement intially, but is in good condition and does not require mainten- ance at this time.
