**Coastal Protection and Restoration
Authority of Louisiana (CPRA)**

**2014/2015 Annual Inspection
Report**

**EAST MARSH ISLAND MARSH
CREATION PROJECT (TV-21)**

March 30, 2015
Iberia Parish

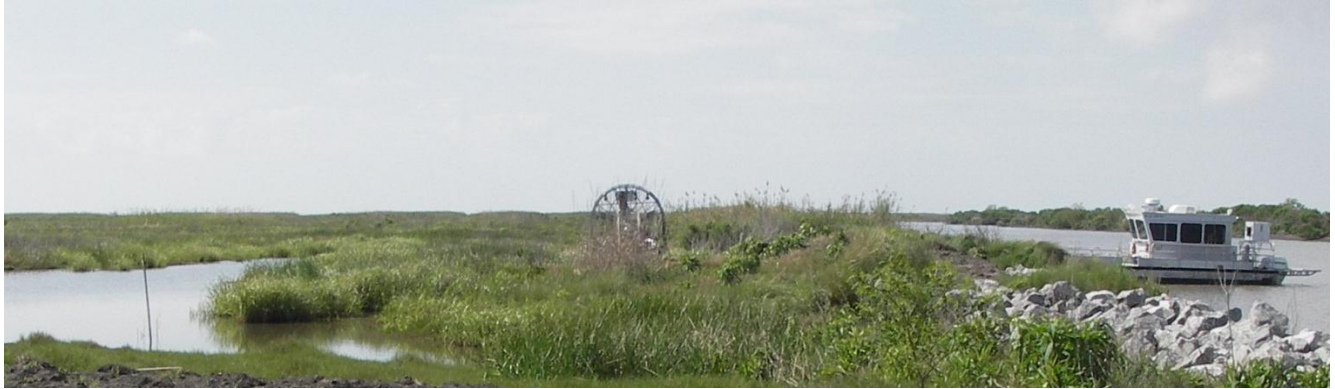
The majority of the remaining containment dike is stable and the natural vegetation continues to expand. Two areas of concern were located at each end of the East-West Pipeline Canal located in Marsh Creation Cell No. 1. Breaches at these locations would make the northeast corner of the project vulnerable to deterioration from the interior. To address these areas, work to repair the breaches were included in the maintenance event recently completed in March 2015. In addition, upon removal of the timber mat plug at Hawkins Lake, an additional gap was excavated. This gap was to supplement tidal exchange to the existing 14 gaps remaining from original construction. (Photos: Appendix B, Photo 1, 3, 4, 5, 6, 8 & 9)

Photo No. 1, Containment Dike along N-S Canal/ Marsh Creation Cell No.1 (Looking South)

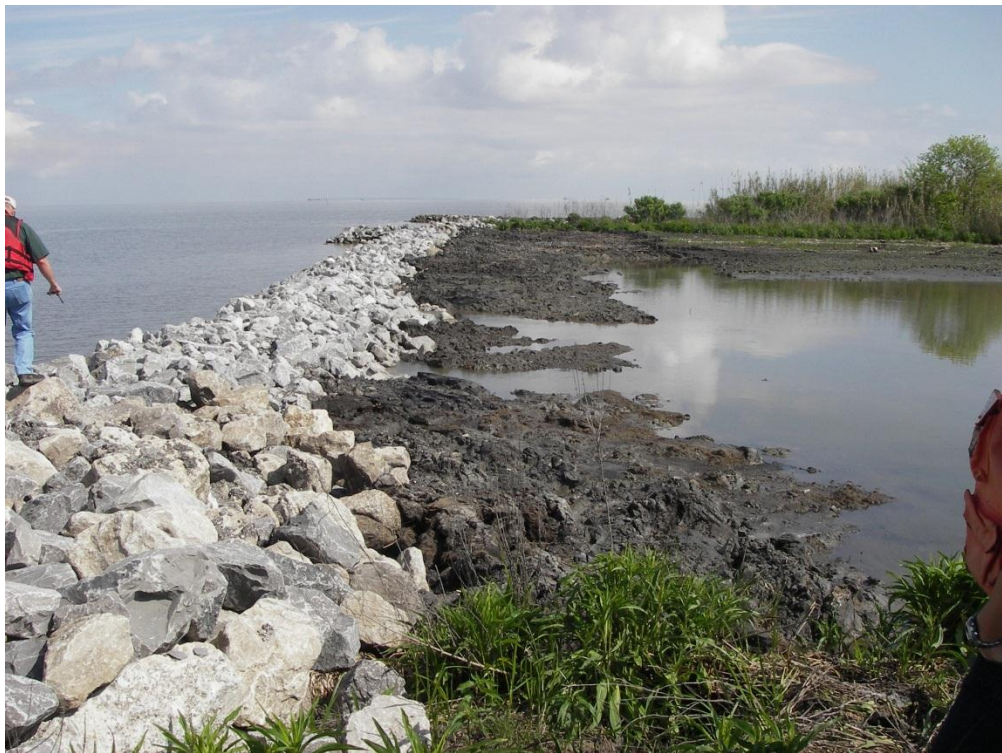
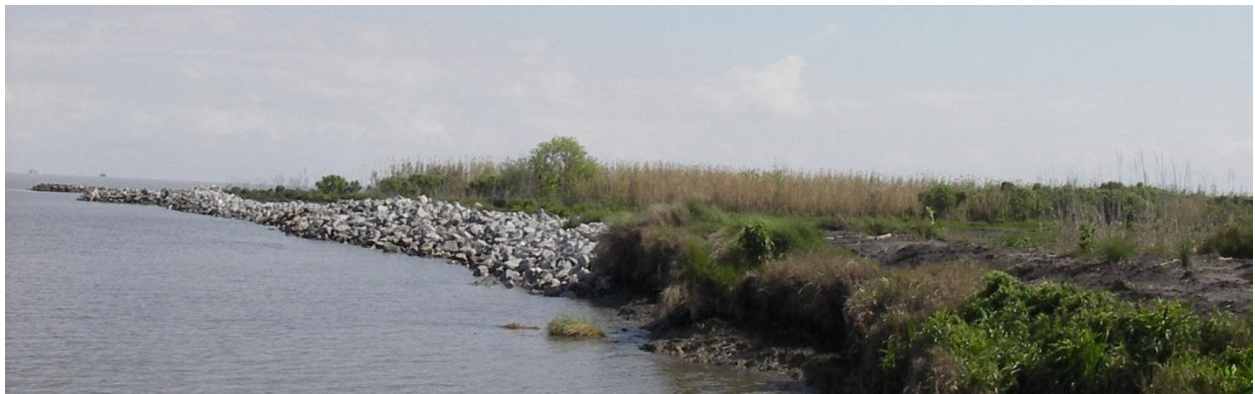
Photo No.2, TV-14 Rock Plug replacement - West end of the E-W Canal at Intersection of N-S Canal

The replaced rock plug has settled slightly in the center.

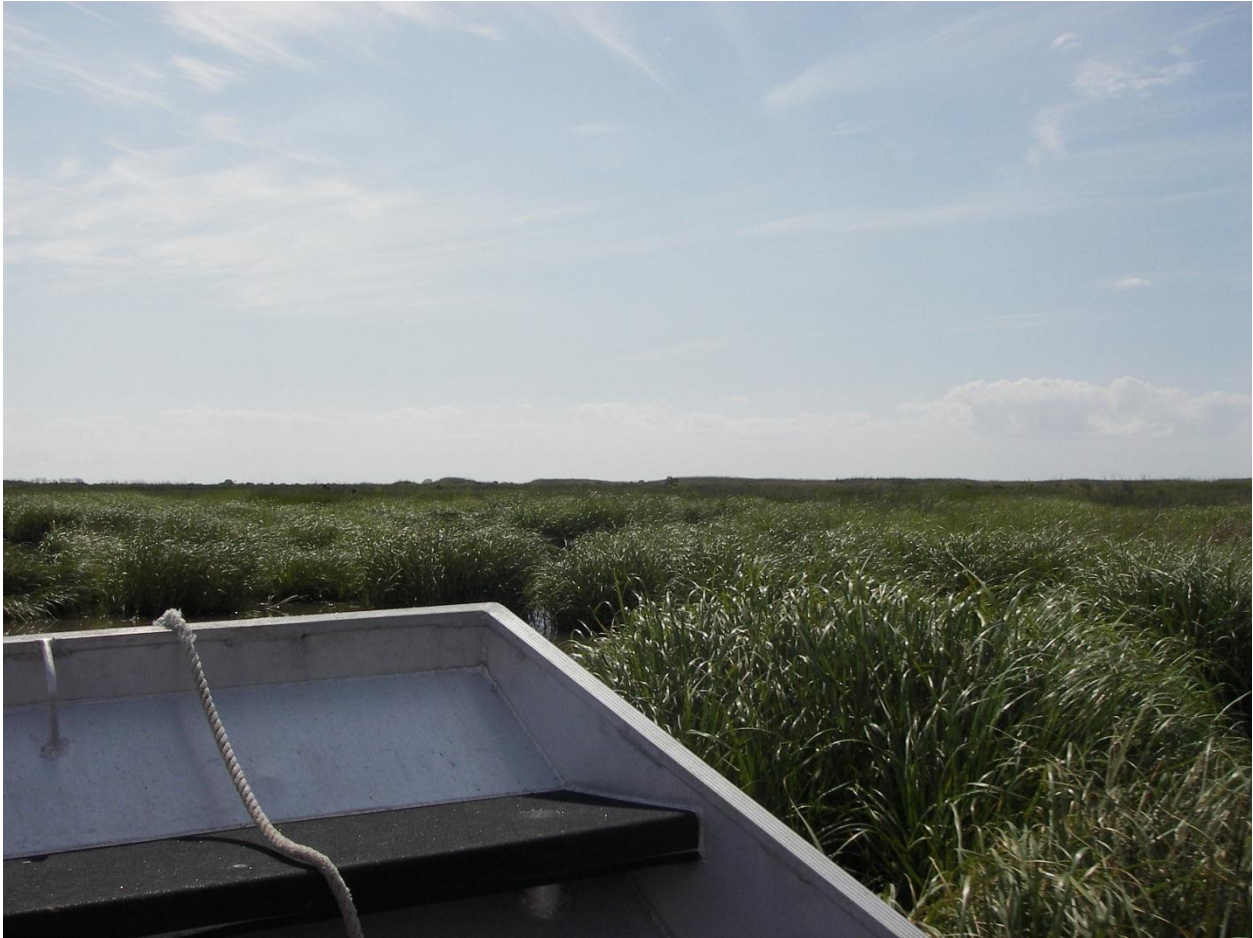
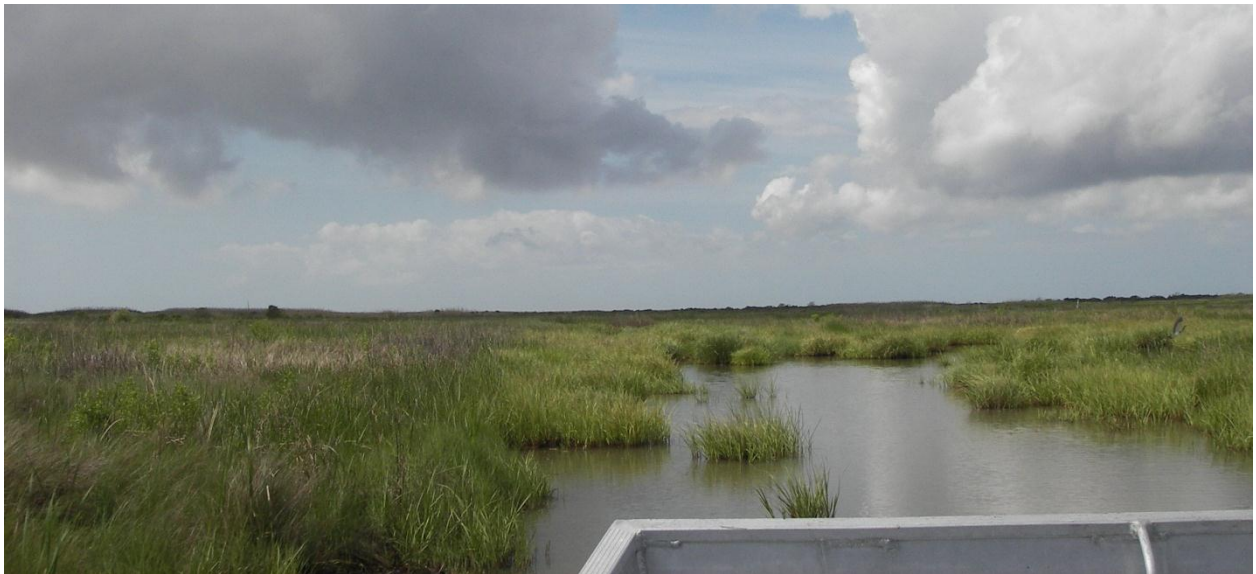
Photo No. 3, Marsh Creation Cell No.1

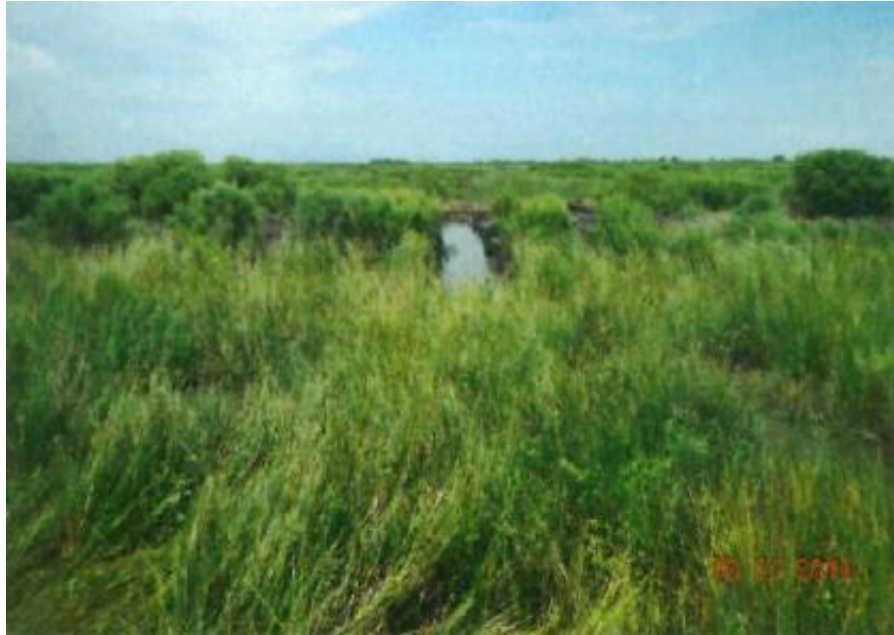
Four interior plugs identified by the Louisiana Wildlife and Fisheries in Nourishment Areas No. 1 & 2 have been excavated to marsh elevation to allow water exchange. (Photos: Appendix B, Photo 4, 5 & 7)

Photo No. 4, Gap N- Marsh Creation Cell No.2 & Nourishment Area No. 3 (Looking North)

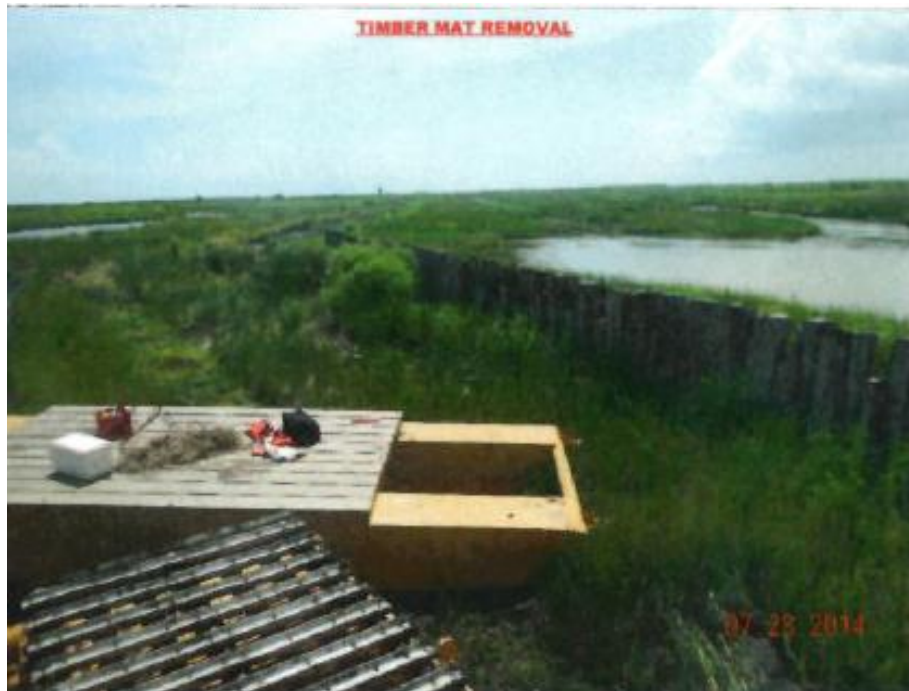
Photo No. 5, Marsh Creation Cell No. 2 & Nourishment Area No.3, Containment Dike at Timber Mat location (Prior to Removal - Looking East)

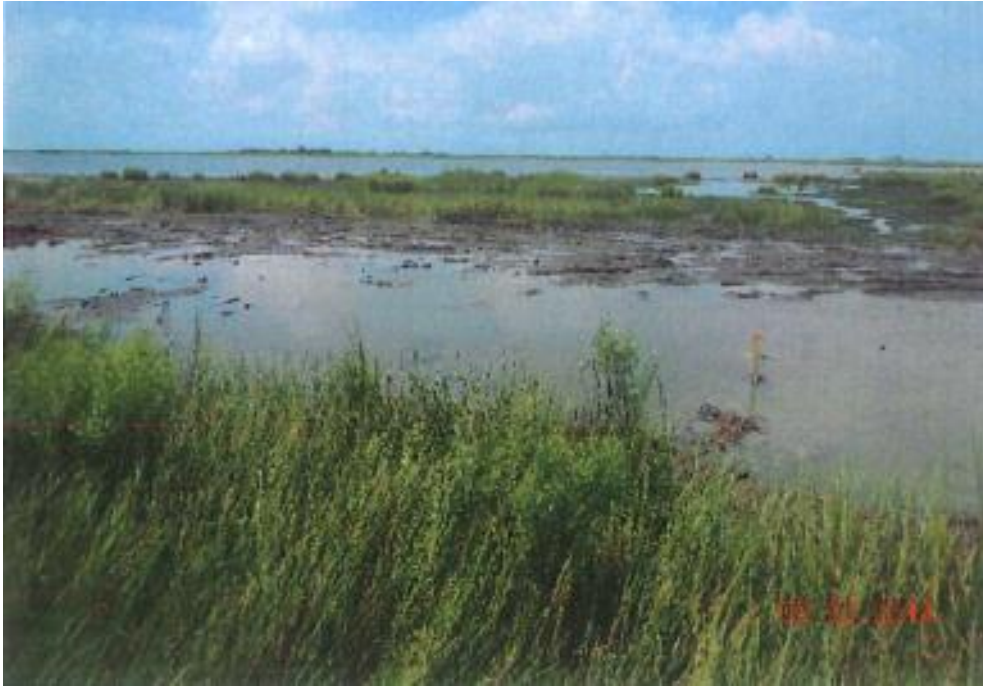
Photo No. 6, Containment Dike Excavation at Timber Mat location (Looking West towards Hawkins Lake)

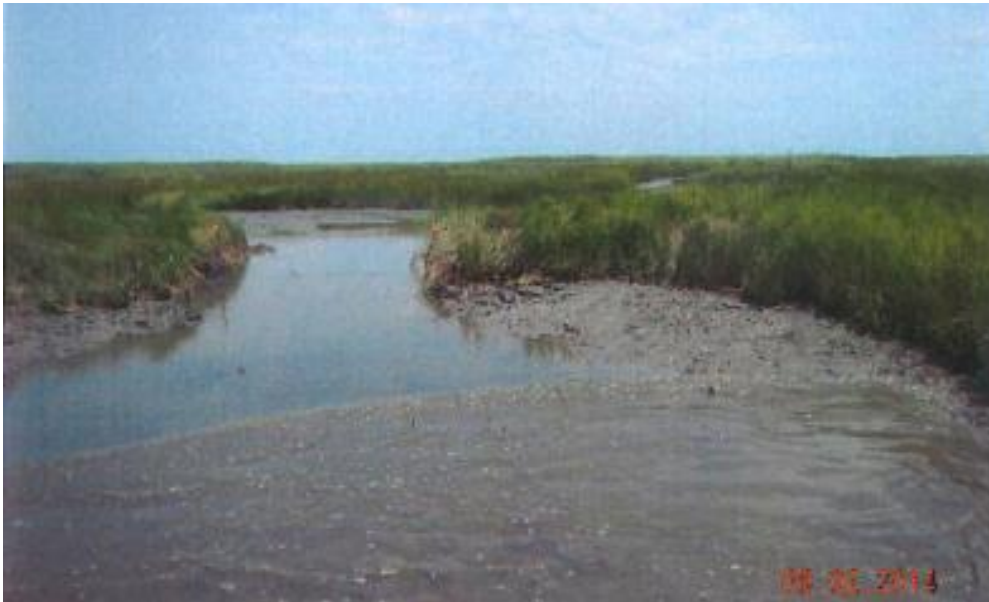
Photo No. 7, Nourished Area No. 2 at Eastern Plug No. 2 removal

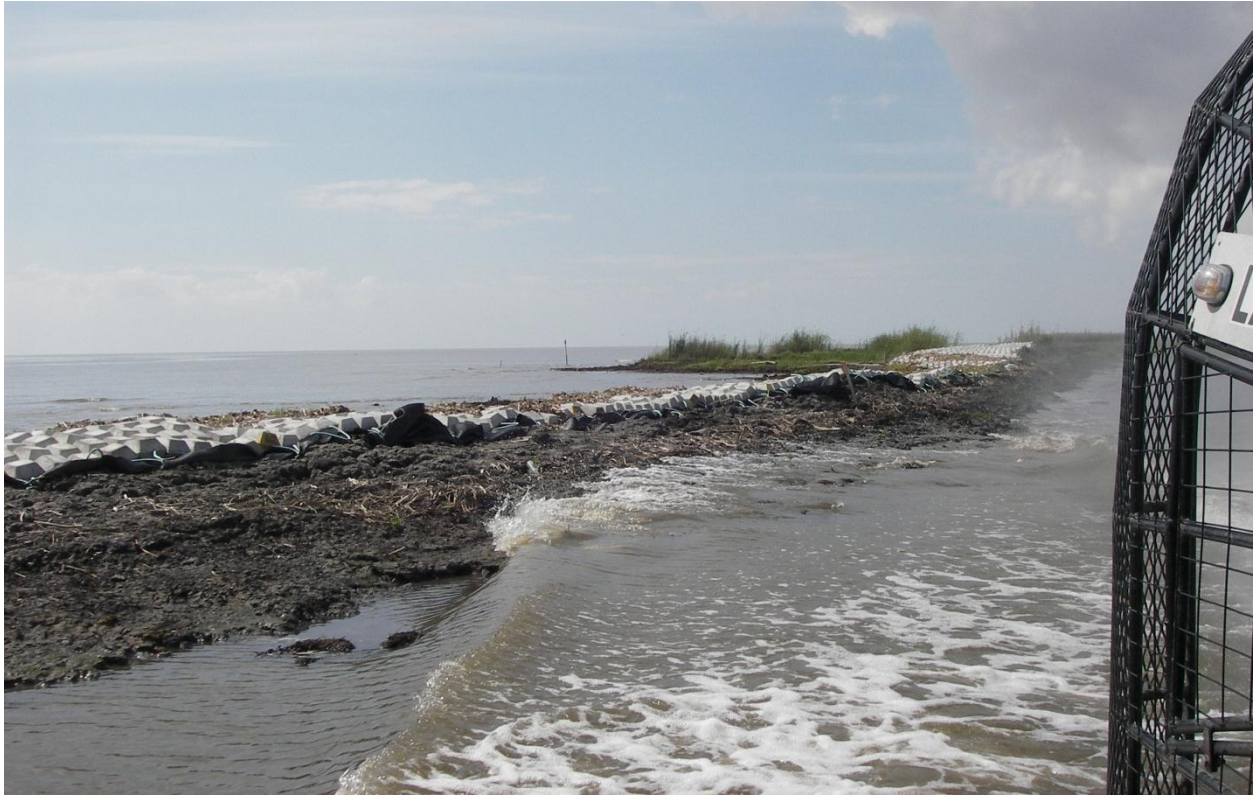
The East Marsh Island Marsh Creation Project is in good condition. The northeast corner of the island remains a concern. The recent maintenance performed to address the breaches near the East-West Canal has experienced settling due to the soil quality and site conditions during construction. Generally where vegetation provided a buffer to the wave action, the mats are stable.

Photo No. 8, Shoreline Protection, Articulated Concrete Mats on Gulfward Shoreline/ MC Cell No. 1

The articulated mats placed along the gulfward shoreline have settled.

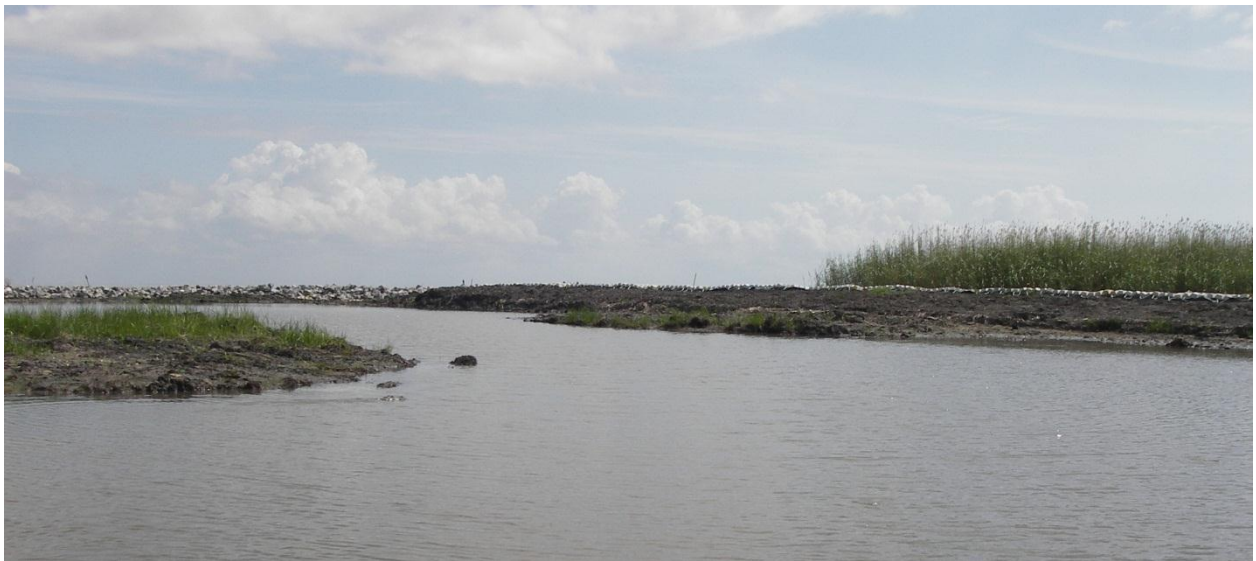
Photo No. 9, Shoreline Protection, Articulated Concrete Mats on Gulfward Shoreline/ MC Cell No. 1
