2011 Annual Inspection Report

Jonathan Davis Wetland Protection

State Project Number BA-20
Priority Project List 2

June 29, 2011
Jefferson Parish

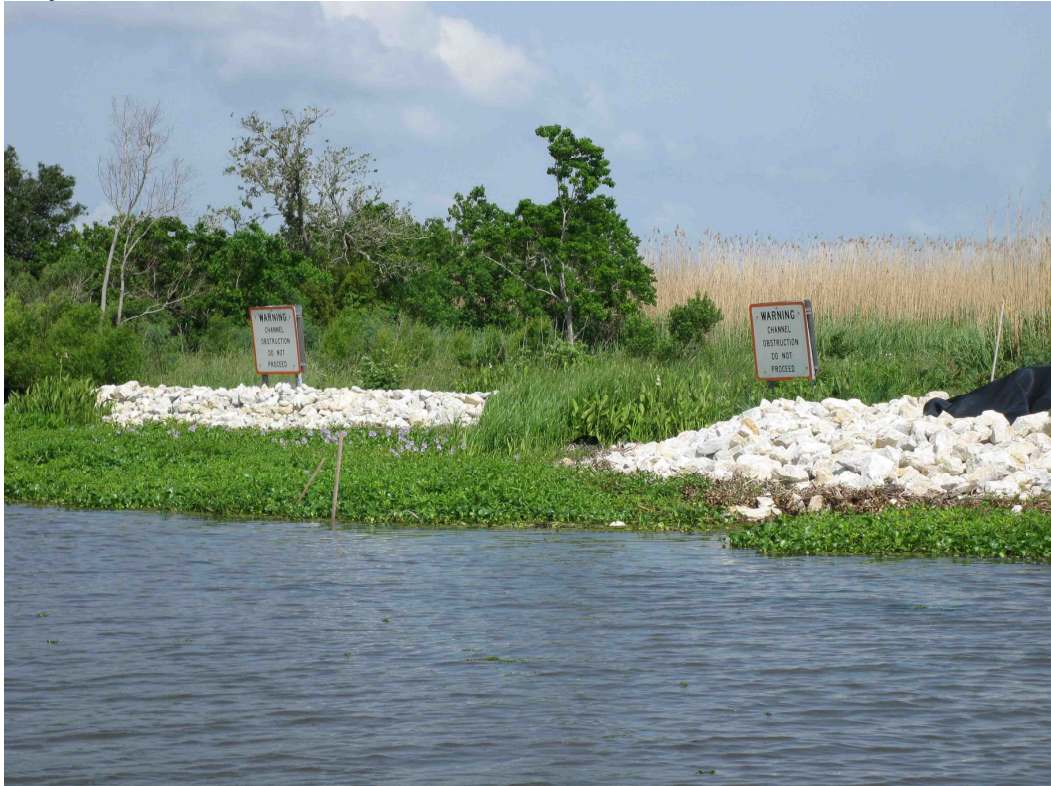
Photo #1 – Structure #14

Approximately 80% of this structure has been repaired. The two breaches were still present at the time of the inspection. The repairs that were effected at the time of the inspection looked good. (Photo #1)

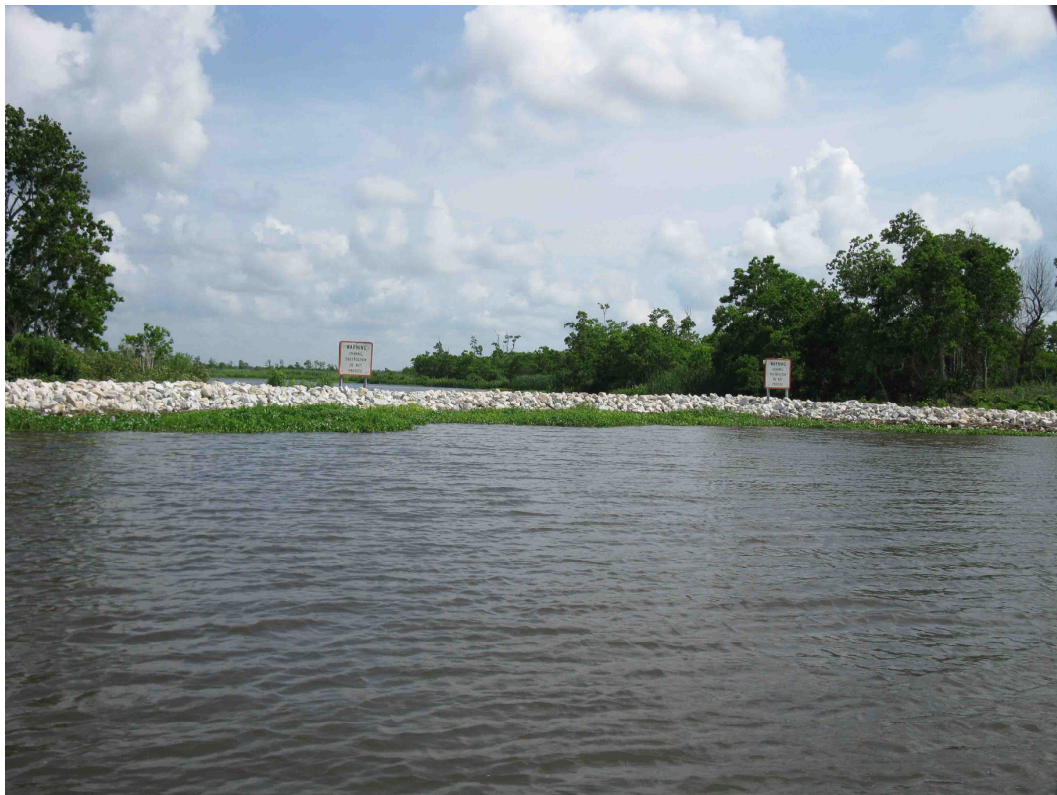
Photo #2 – Structure #15

All maintenance has been performed on this structure during construction of Construction Unit 4. The boat bay has been filled and everything is in good condition. (Photo #2)

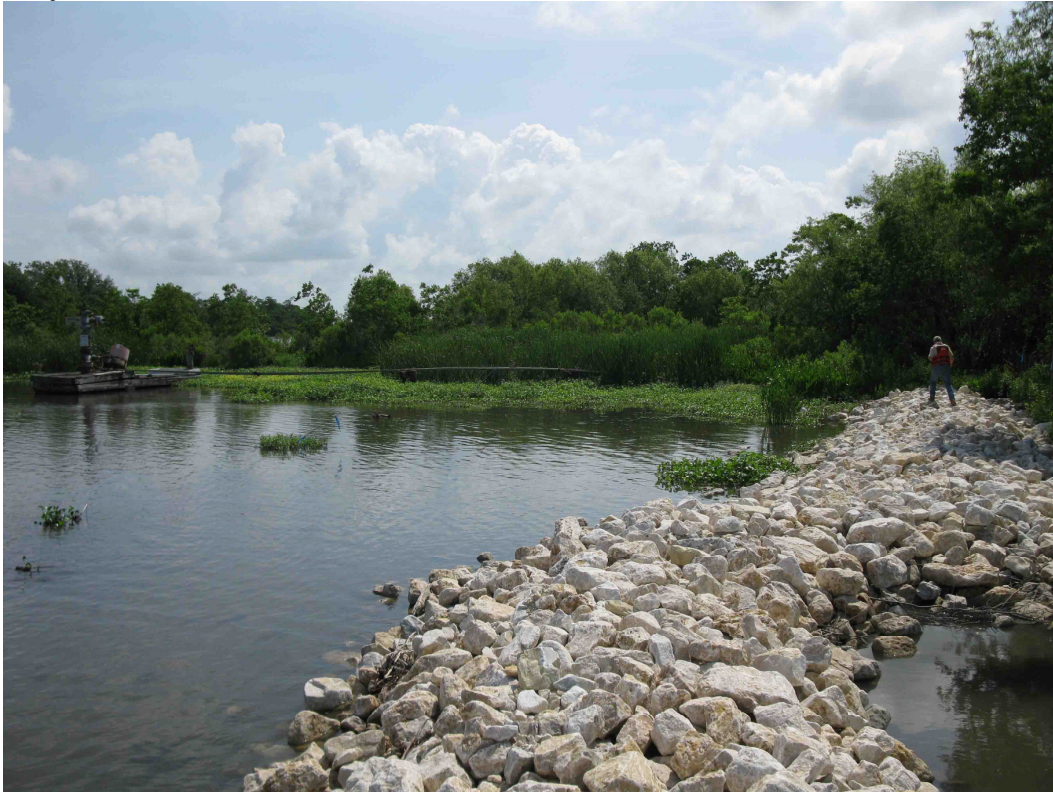
Structure 16 was difficult to inspect due to the amount of vegetation growing on the structure. (Photo #3) It is assumed that this structure has stabilized due to the conditions of the channel and the structure signage. The new construction has tied this in with the rest of the Construction Units and it is recommended that there be no maintenance work at this time.

Photo #3 – New Rock to Structure #16 (under vegetation)

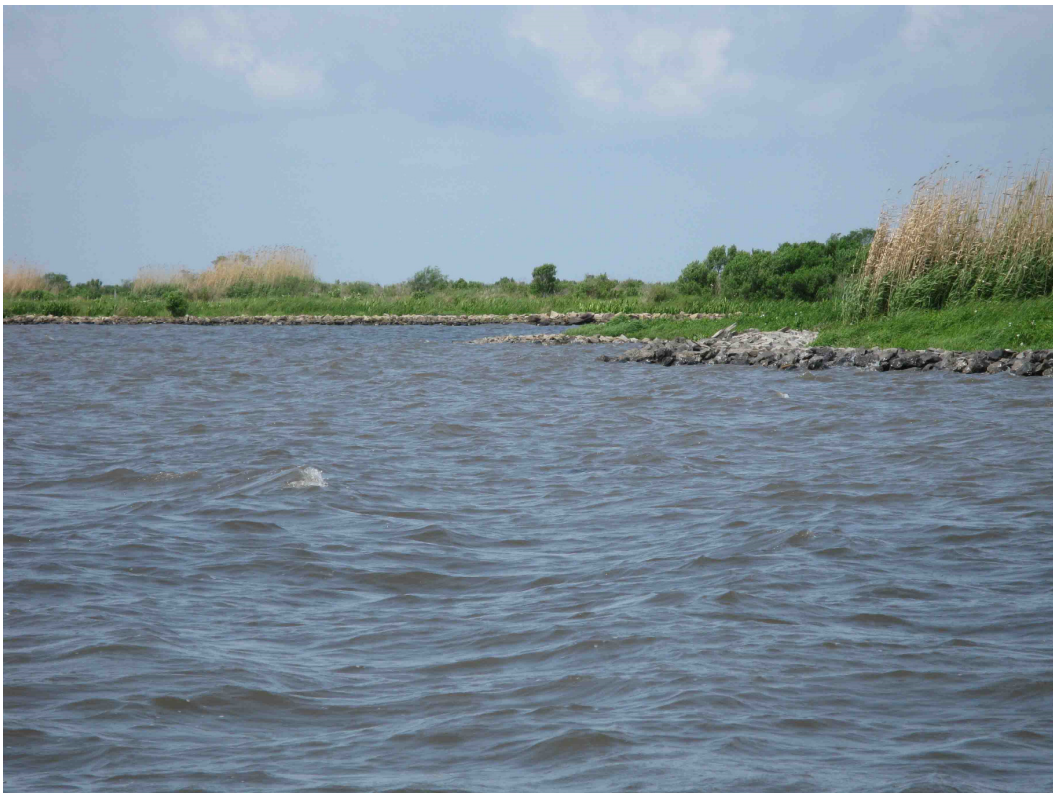
The rock dike along the northern shore of Bayou Rigolettes appears to be in good condition. There is some noticeable settlement near the western end of this feature (Photo #4). Any maintenance work required will be completed in a future maintenance event.

Photo #4 – Low spot near Structure #20
