# **2013 Annual Inspection Report**

## **Hopedale Hydrologic Restoration**

State Project Number PO-24  
Priority Project List 8

August 12, 2013  
St. Bernard Parish

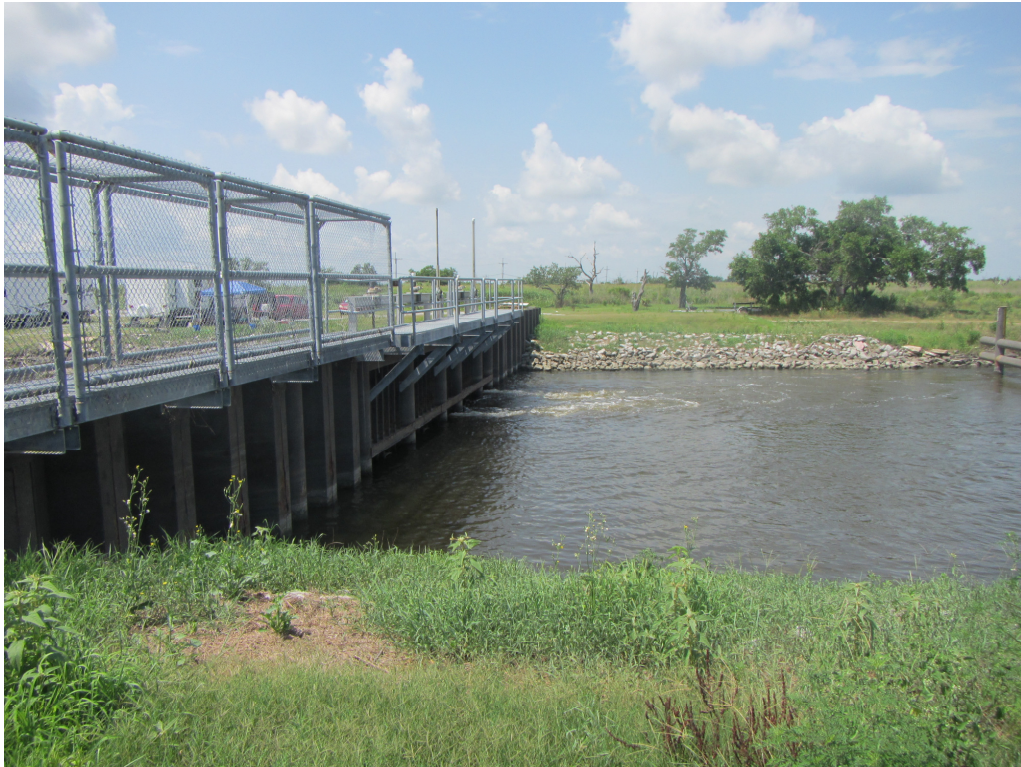
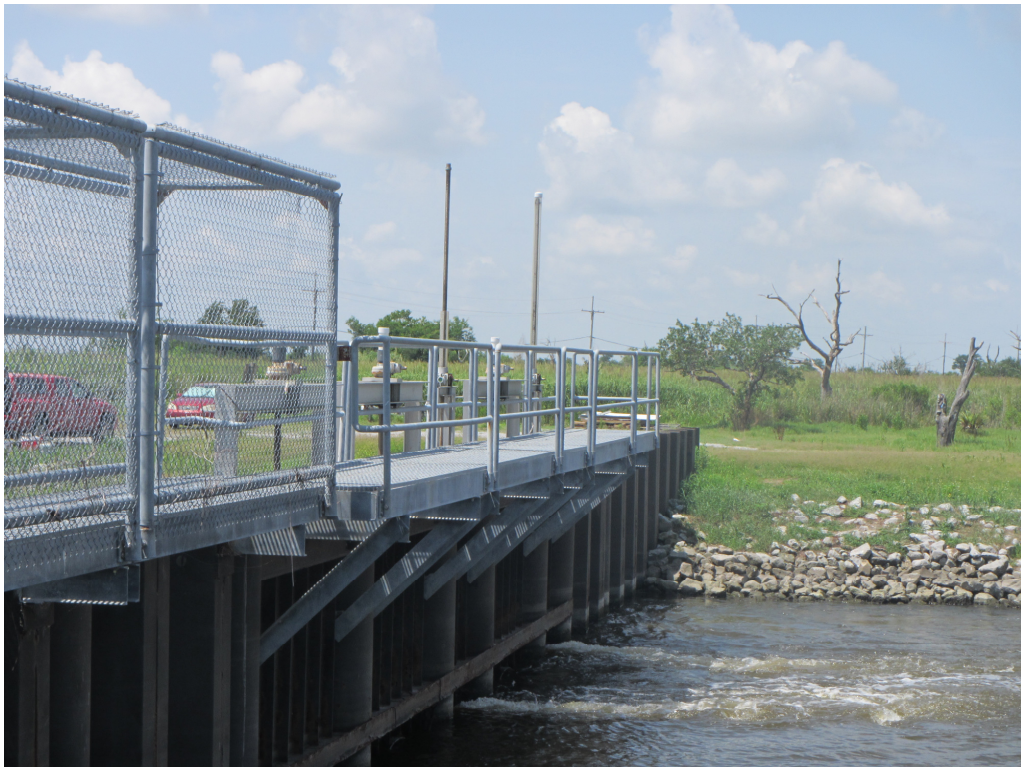
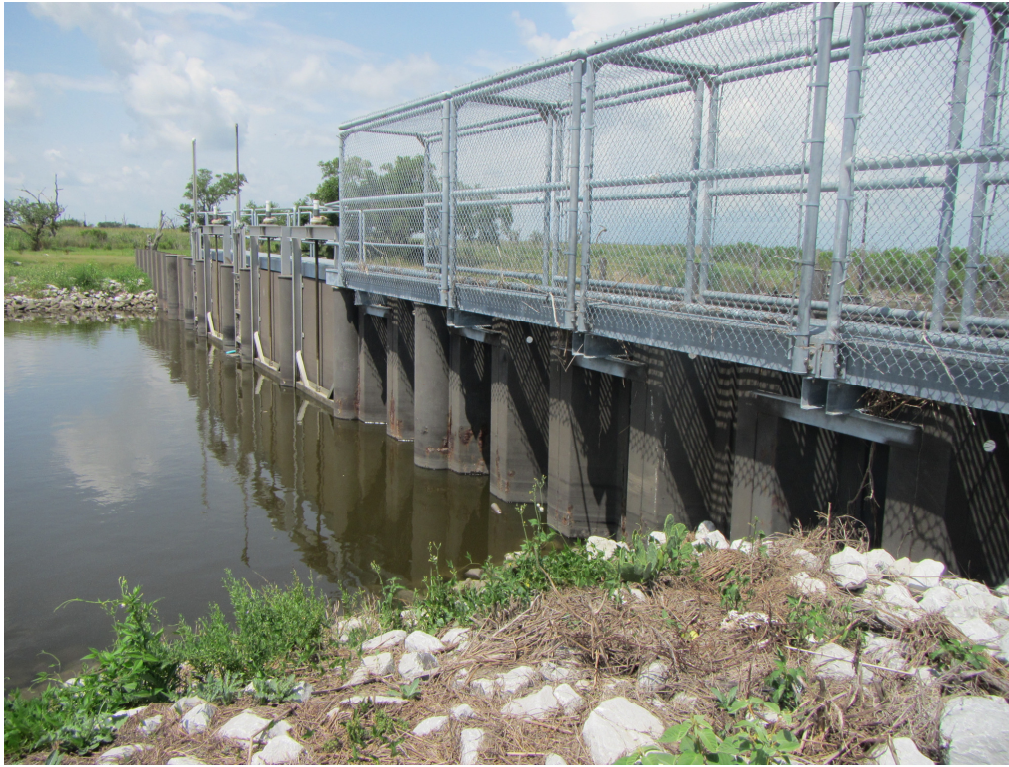
Hurricane Isaac passed through Southeast Louisiana on August 28, 2012. The only damage noted on this structure was a damaged stem cover on one of the Fish Gates.

The fish gates were open at the time of the inspection in accordance with the Operation and Maintenance Plan. Lake Borgne Basin Levee District personnel performed the first round of operations and routine maintenance on September 27, 2011. There have been no operations activities since due to personnel issues. The gates were hand cranked at the inspection to determine functionality and were determined to be in working order. No other issues present at the time of inspection.

- Continue to check gates on structure for operability.
