2014 Annual Inspection Report

NAOMI OUTFALL MANAGEMENT

State Project Number BA-03c
Priority Project List 5

July 7, 2014
Jefferson Parish

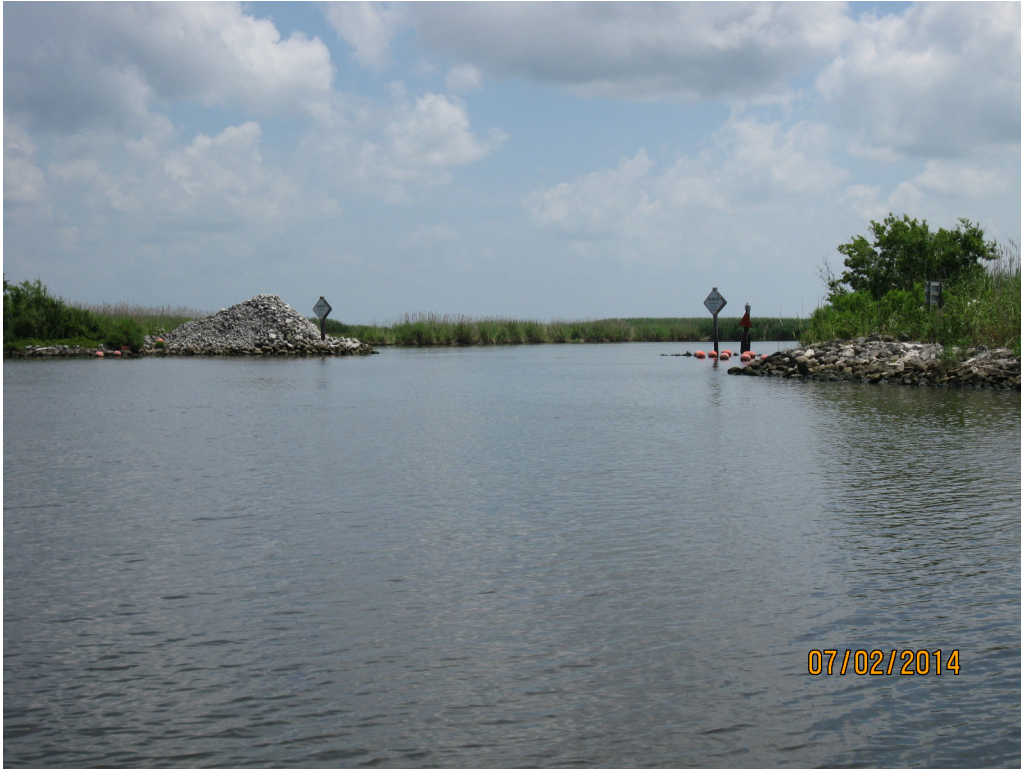
Photo #1 – Bayou Dupont Canal Weir

The structure was altered to facilitate construction of the South Shore of the Pen (BA-41) Project, and remains in this temporary condition to allow access for the Long Distance Sediment Pipeline (BA-43 EB) Project and Bayou Dupont Marsh and Ridge Creation (BA-48) Project, both of which are currently in construction. Rock has been temporarily removed from the weir and stored within the footprint of the structure (Photo #1). The structure will be replaced as designed at a later date.

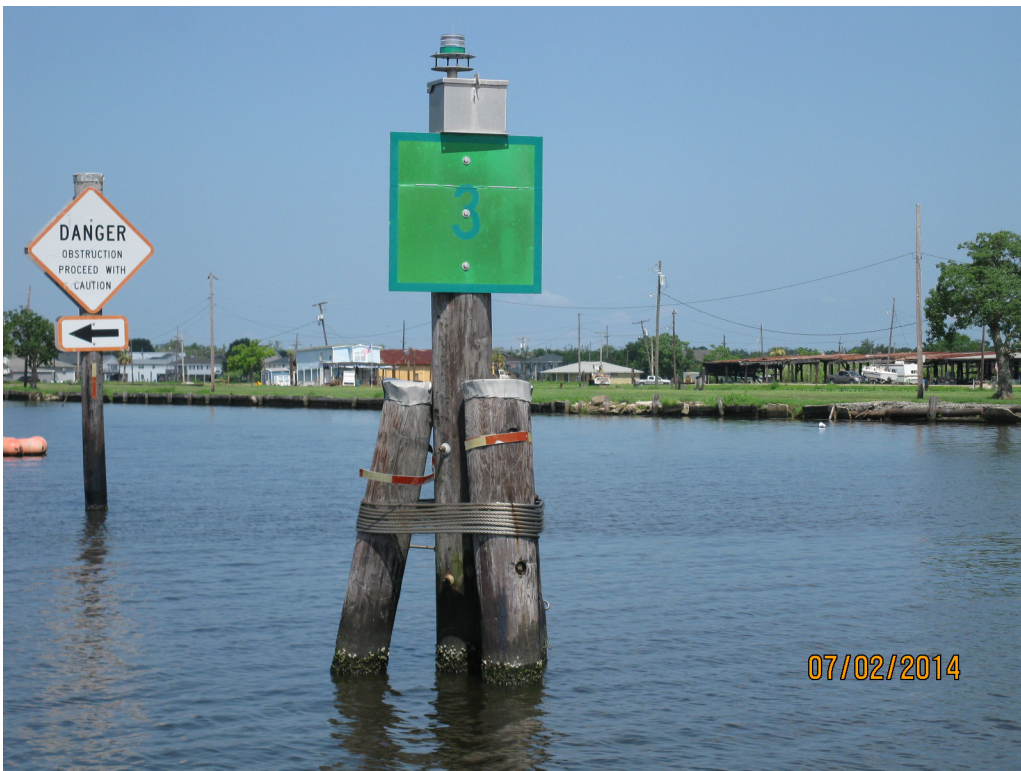
Photo #2 – Goose Bayou Pile Cluster

All pilings appeared free of damage and in good condition. Some of the reflective tape was falling off or missing (Photo #2).

Some of the signs were sun-faded, but were still legible (Photo #2). The orange barrier float buoys on the north side appeared to have been vandalized and were temporarily secured to a pile cluster (Photo #3). A buoy cable on the south side had broken loose from the pile cluster mooring eye, and was secured only by the shore anchor (Photo #4).

Repairs to the Goose Bayou navigation aids are planned in conjunction with the upcoming Barataria Bay Waterway West Shoreline Protection (BA-23) 2014 Maintenance Project.
