2017 Annual Inspection Report

Jonathan Davis Wetland Protection

State Project Number BA-20
Priority Project List 2

March 12, 2018
Jefferson Parish

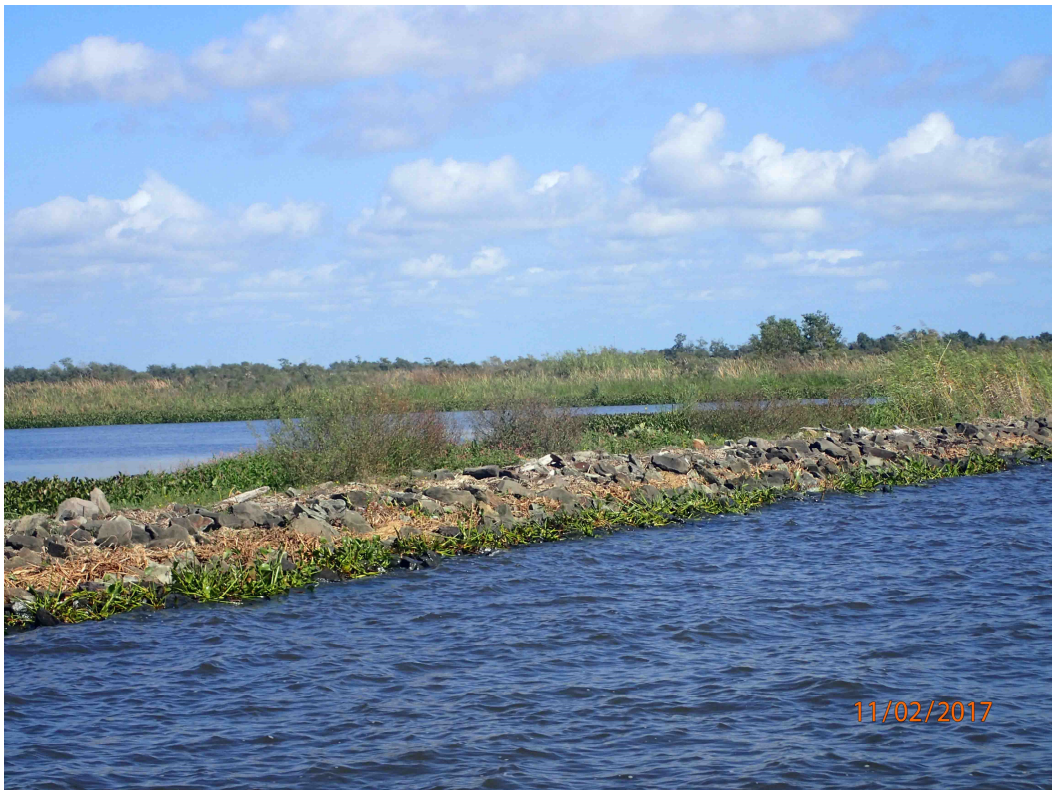
Photo #1 – Bayou Perot Shoreline Protection (CU3)

No significant changes were noted since the last inspection. The rock shoreline protection appeared to be in good condition, with minor settlement in some areas. The areas of lower elevation deserve continued observation on future inspections, but no maintenance needs were identified at this time.

Item	Condition	Physical Damage	Corrosion	Photo #	Observations and Remarks
Rock Dike	Good; see remarks	None	N/A	1	Minor settlement observed in some areas, no repairs needed at this time.
Construction Unit No.3 Structure Description: The rock dike consist of 13,088 linear ft. of rock dike with a 6 ft. top width and a crest elevation of +3.5 ft. The shoreline stabilization extends from Site 12 west to the Gulf Intracoastal Waterway

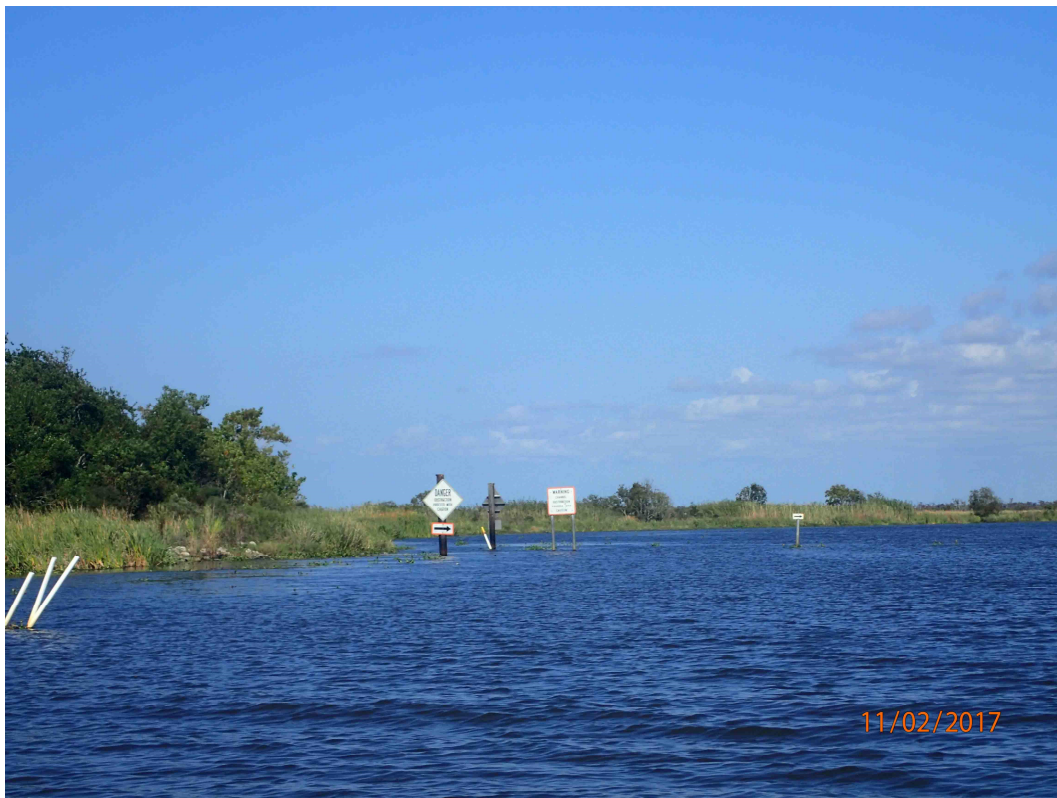
Photo #2 – Structure #13

Structure settlement prevented a detailed inspection of the weir. Signs and timber supports were generally in good condition. No maintenance will be required at this time.

Item	Condition	Physical Damage	Corrosion	Photo #	Observations and Remarks
Signage and supports	Good			2	
Armored Weir	Fair			2	Structure has experienced some settlement, but maintenance is not required at this time.
Construction Unit No.1					
Structure Description: 300 linear ft. rock rip-rap armored rock filled weir with a 50 ft. wide boat bay located north of Bayou Perot and Site 12, west of Bayou Barataria, and east of the GIWW. The crest of the weir is set at an elevation of +1.0 ft. NGV

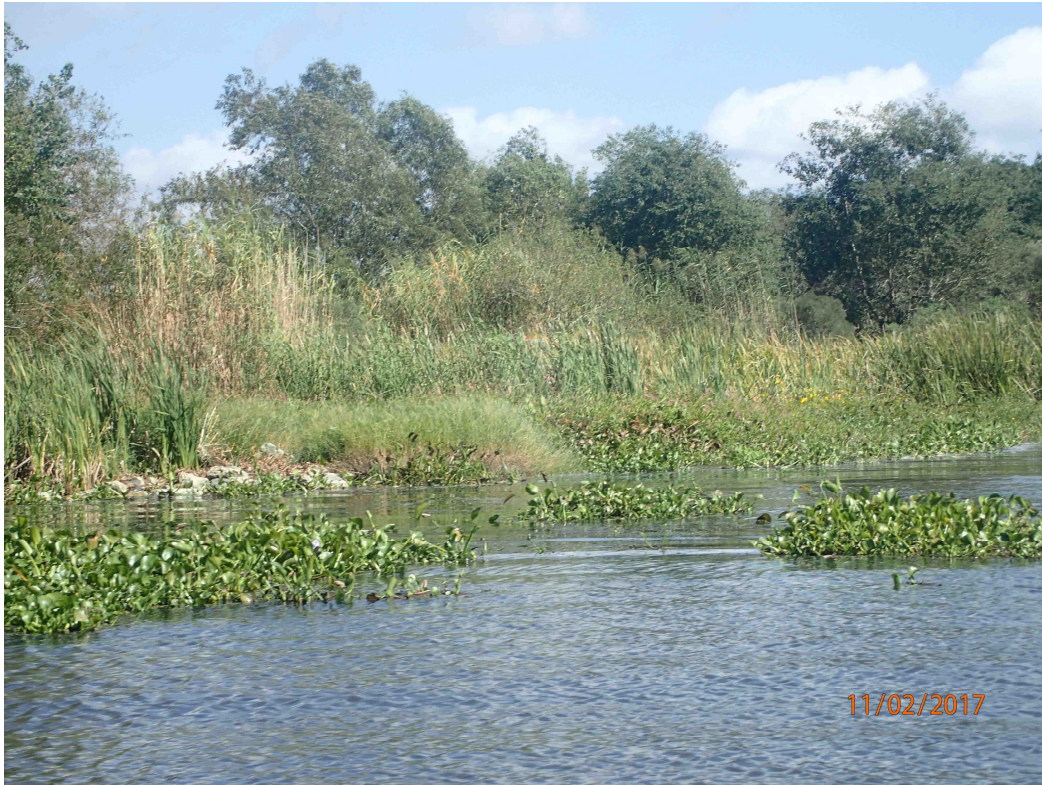
Photo #3 – Structure #14

Structure was in good condition, with some settlement noted. There is currently no need for maintenance on this structure.

Item	Condition	Physical Damage	Corrosion	Photo #	Observations and Remarks
Signage and supports	Good			3	Observations:
Armored Plug	Good			3	Slight settlement noted, but no repairs needed at this time.
Construction Unit No.1					
Structure Description: 138 linear ft. of rock rip-rap armored rock filled channel plug located in a pipeline channel north of Bayou Perot, west of Bayou Barataria and east of GIWW and Site 13. The crest of the plug was constructed to an elevation of +3.2

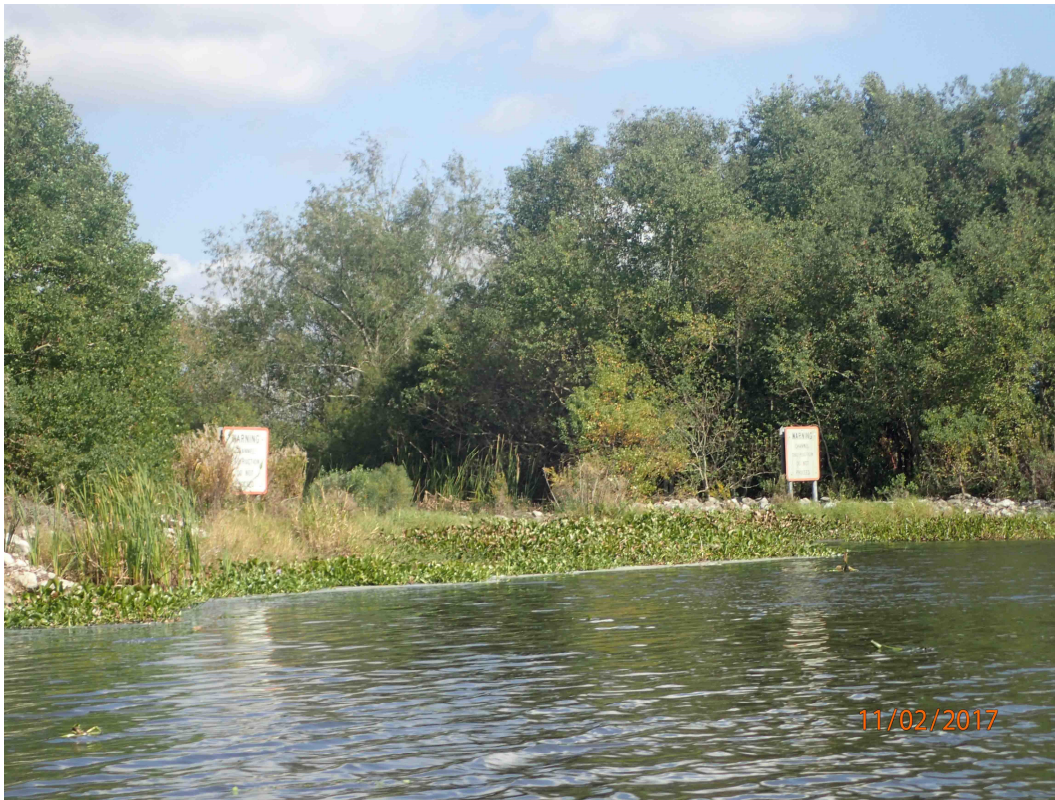
Photo #4 – Structure #15

Weir was converted to a rock plug structure as part of the work effort for Construction Unit 4. No defects were noted during the inspection.

Item	Condition	Physical Damage	Corrosion	Photo #	Observations and Remarks
Signage and supports	Good	None	None	4	
Armored Plug	Good	None	N/A	4	This structure was converted into a channel plug as part of the completed CU4 maintenance work.
Construction Unit No.1					
Structure Description: 132 linear ft. of rock rip-rap armored weir with a 50 ft. wide boat bay located in a pipeline channel north of Bayou Perot, west of Bayou Barataria and east of the GIWW and Site 14. The crest of the rock weir was constructed to an

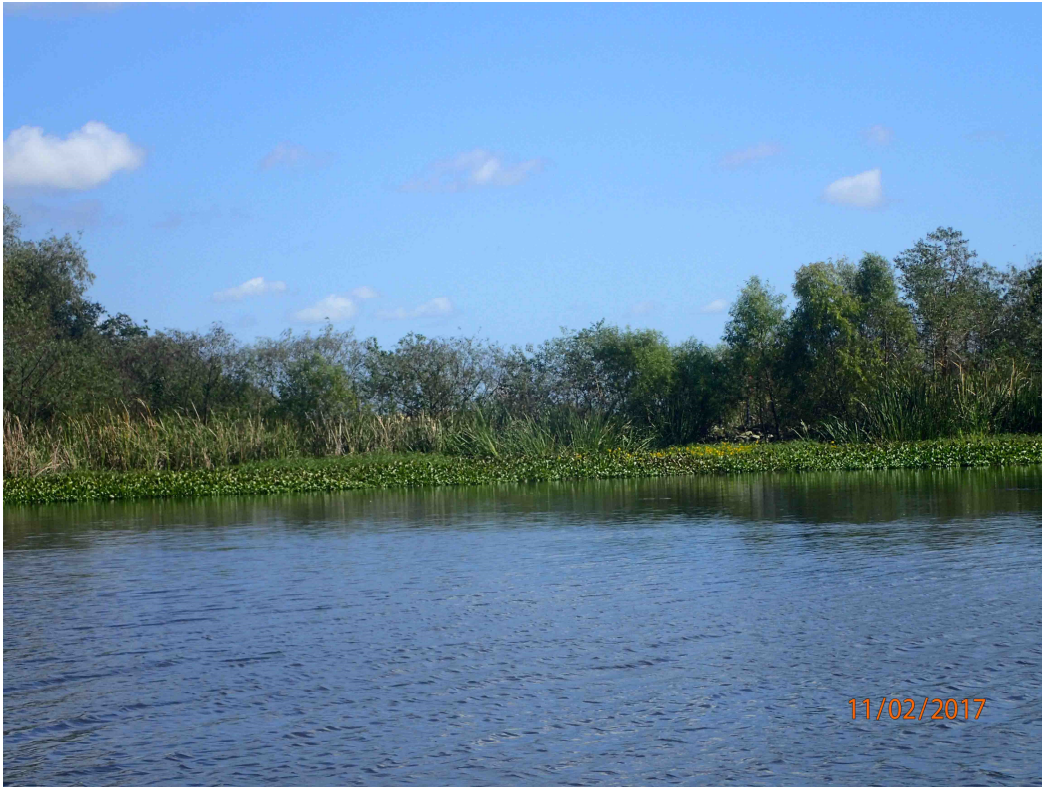
Photo #5 – Structure #16

Rip-rap and warning signs appeared to be in good condition. No immediate maintenance requirements were identified at this structure.

Item	Condition	Physical Damage	Corrosion	Photo #	Observations and Remarks
Signage and supports	Good	None	None	5	
Armored Plug	Fair	None	N/A	5	No maintenance needs identified at this time.
Construction Unit No.1 303 linear ft. of rock rip-rap armored rock filled plug located in a pipeline channel north of Bayou Perot, west of Bayou Baratavia, east of the GIWW and Site 15. The crest of the plug was constructed to an elevation of +4.0 ft. NGVD. The rock filled plug contains 6,483 tons of rock fill and 1,766 tons of rock rip-rap armor. Two (2) aluminum warning signs are located through the rock plug embankment.

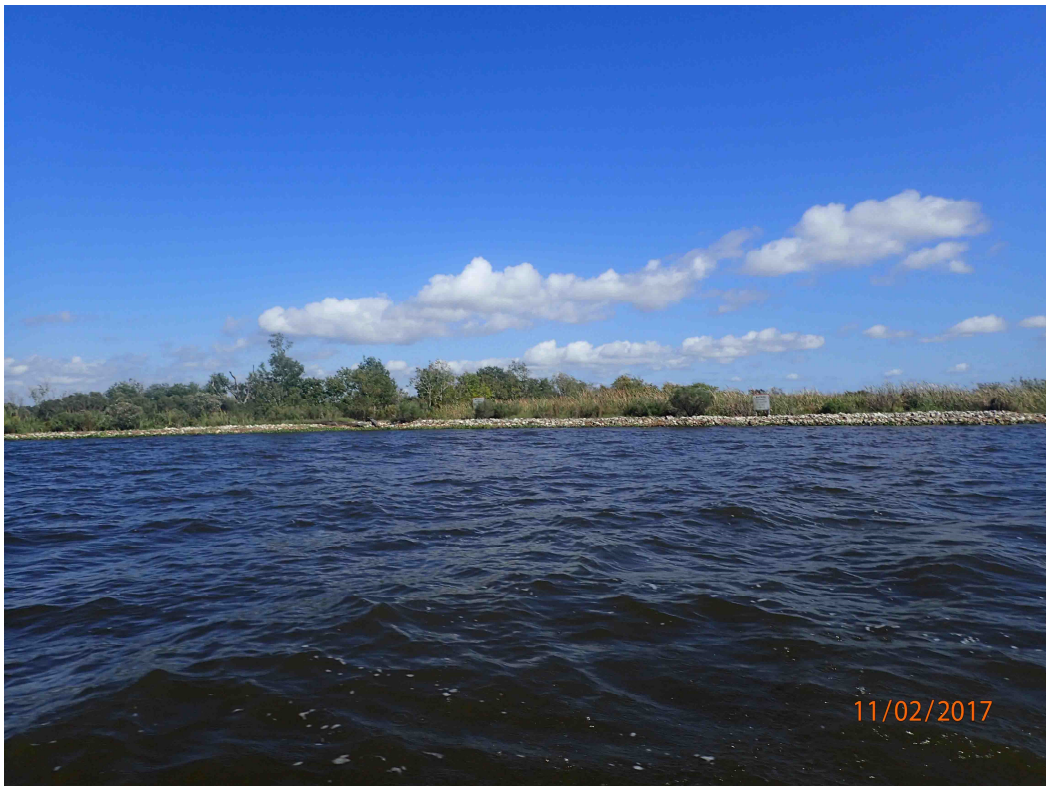
Photo #6 – Structure #17

Plug appeared to be in good condition, with no maintenance needed at this time.

Item	Condition	Physical Damage	Corrosion	Photo #	Observations and Remarks
Signage and supports	Good	None	None	6	
Armored Plug	Good	None	N/A	6	No maintenance is required at this time.
Construction Unit No.1 Structure Description: 197 linear ft. of rip-rap armored rock plug located in a pipeline channel north of Bayou Perot, west of Bayou Barataria, and east of the GIWW. The crest of the plug was constructed to an elevation of 3.8' NAVD. The rock plug was

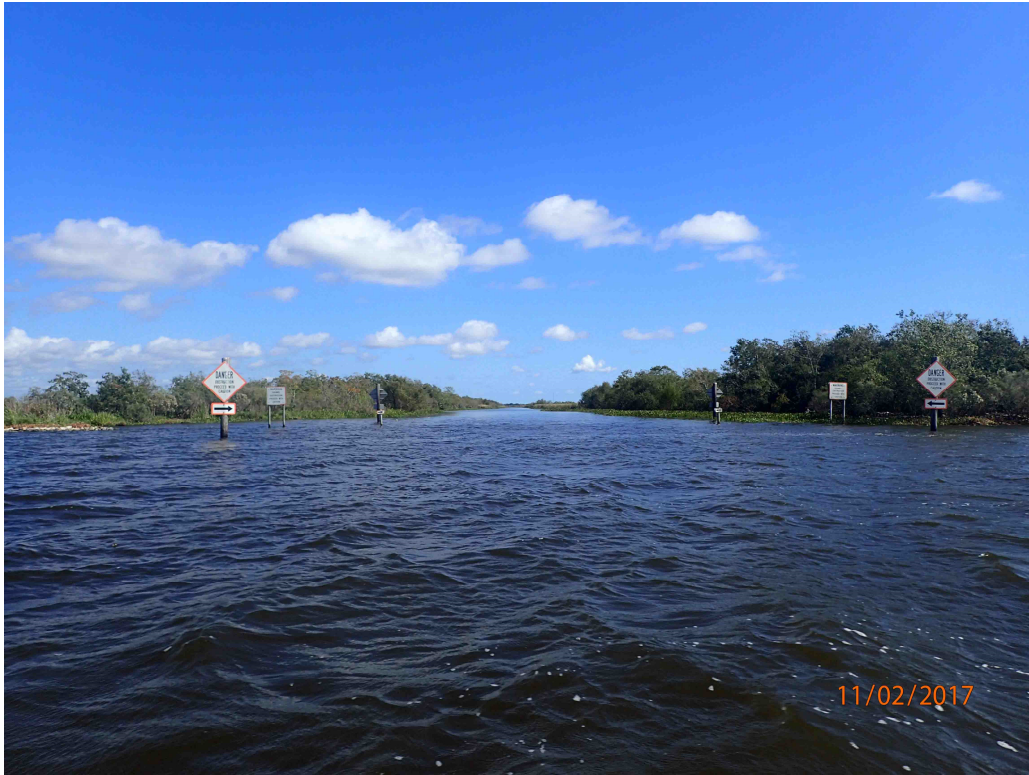
Weir has experienced some settlement, but is performing as designed. Signs and timber supports were generally in good condition. No maintenance will be required at this time.

Photo #7 – Damaged Signs at Structure #19

Item	Condition	Physical Damage	Corrosion	Photo #	Observations and Remarks
Signage and supports	Fair	See remarks	Minor	7	Signage replaced since last inspection; no maintenance needs were identified.
Armored Weir	Good	None	N/A	7	No change since last inspection; no maintenance needs were identified.
Construction Unit No.1 Structure Description: 239 linear ft. of rock rip-rap armored rock filled fixed crest weir with a 60 ft. wide boat bay located in a pipeline channel east of the GIWW, north of Bayou Perot, and west of Bayou Barataria. The crest of the weir was construct

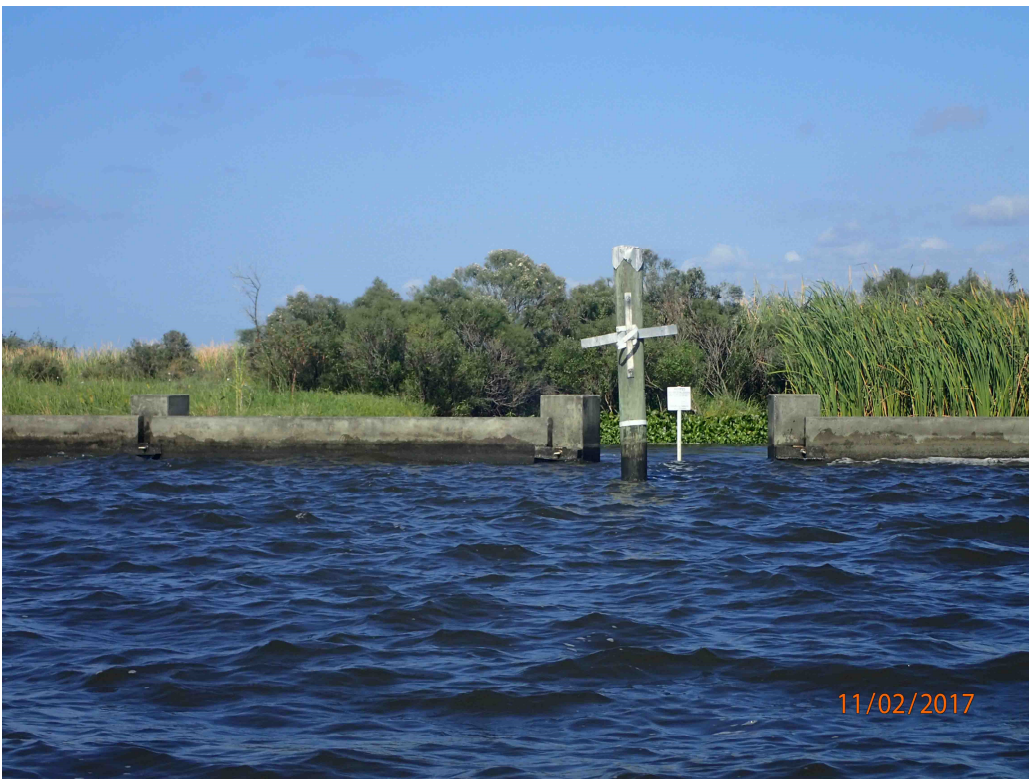
No defects in the concrete panel wall sections were noted; the structure appeared to be in good condition. Minor damage/vandalism to some warning signs was noted and one sign was missing, but all other signs and timber supports are in place and performing as designed. No immediate maintenance needs were identified at this construction unit.

Photo #8 – Missing Sign (CU4)

Item	Condition	Physical Damage	Corrosion	Photo #	Observations and Remarks
Signage and supports	Good	See remarks	Minor	8	Some fading noted, minor spray-paint vandalism to border of one sign was observed, and one sign was missing. Sign faces and text were legible; no repairs needed at this time.
Concrete wall panels, piles, hardware	Good	None	None	9	No defects noted; structure was performing as designed.
Rock Dike	Good	None	N/A		No defects noted; structure was performing as designed.
Construction Unit No.4 Structure Description: The wall consists of approx. 12,850 linear ft. of pre-cast concrete wall sections supported by 848 pre-cast concrete piles, in addition to approx. 4,290 linear feet of rock rip-rap bank stabilization/shoreline protection. C.U. #4 extends across the northern edge of Bayou Rigolettes and Bayou Perot, from just east of Structure #12 to Structure #20.

Maintenance repairs should be performed on the concrete panel wall warning sign at the earliest opportunity. Continue to inspect and assess project conditions annually.

- Rehabilitate the warning signs at the concrete panel wall.

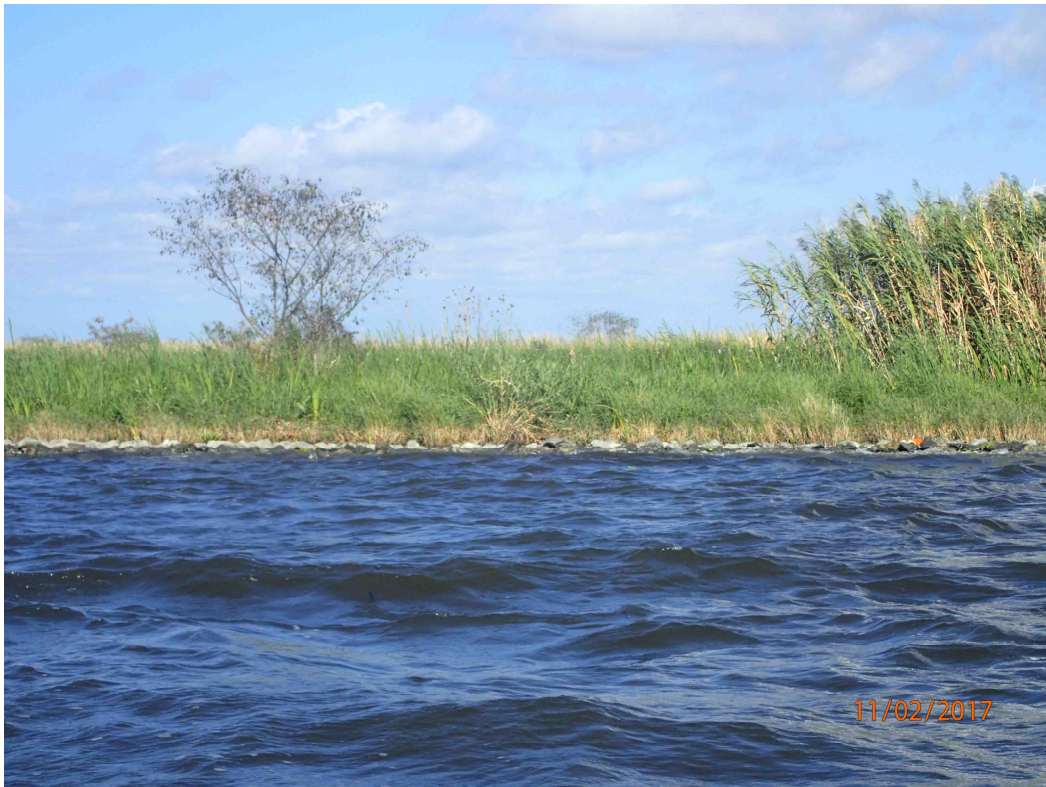
Photo #10 – Bayou Rigolettes Shoreline Protection (CU2)

The rock appears to be in good condition. Minor settlement was observed near the western end of this feature, but the shoreline protection function was being adequately performed. This area should be monitored on future inspections, but no immediate maintenance is required.

Item	Condition	Physical Damage	Corrosion	Photo #	Observations and Remarks
Rock Dike	Good; see remarks			10	Minor settlement observed in some areas, no repairs needed at this time.
Construction Unit No.2 Structure Description: The rock dike consist of 3,967 linear ft. of rock dike with a 6 ft. top width and a crest elevation of +3.5 ft. The shoreline stabilization extends from Site 22A west to Structure No.20.

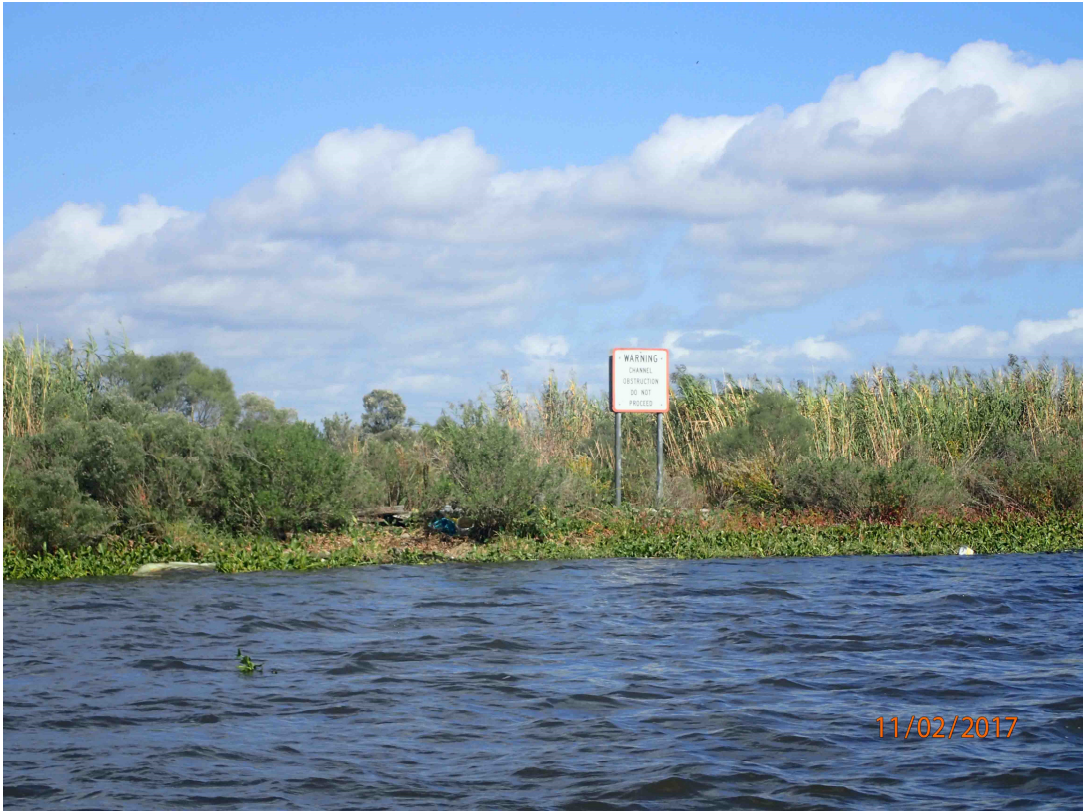
Photo #11 – Structure 21

No significant defects were noted. Structure is generally in good condition and requires no maintenance at this time.

Item	Condition	Physical Damage	Corrosion	Photo #	Observations and Remarks
Signage and supports	Good	None	None	11	
Armored Plug	Good	None	N/A	11	Maintenance is not required at this time.
Construction Unit No.1 Structure Description: 83 linear ft. of rock rip-rap armored rock filled plug located north of Bayou Rigolettes, west of Bayou Barataria, and east of Bayou Perot. The plug crest was constructed to an elevation of +4.0 ft. NGVD. The rock filled plug contains 285 tons of rock fill and 220 tons of rock rip-rap armor. Two (2) aluminum warning signs supported by galvanized pipe are located on each end of the structure through the rock embankment.
