**2008/2009 Annual Inspection
Report**

**SOUTH WHITE LAKE
SHORELINE PROTECTION
PROJECT
(ME-22)**

State Project Number ME-22
Priority Project List 12

October 29, 2008
Vermilion Parish

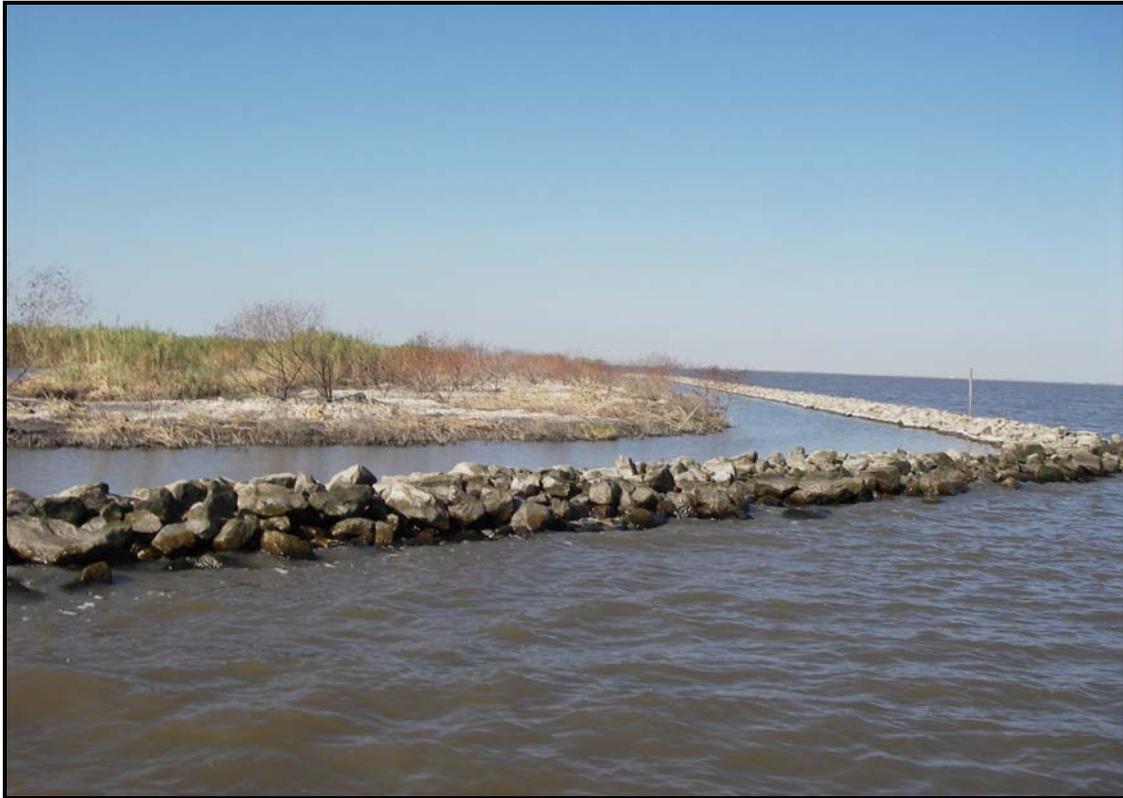
The rock dike is in excellent post construction condition and does not appear to have suffered any major damage from Hurricane Ike. A few low areas were noted along Bear Lake where there was some initial settling during construction. These areas will be monitored during future inspections. Signage along the entire project is also in good condition, however there were a few signs that were leaning and one is completely missing. The spoil bank material placed behind the rock dike generated from the flotation excavation has approximately 90 per cent vegetation cover. Generally, the vegetation of the project area was not severely damaged by Hurricane Ike. The most visible damage was the presence of salt-burned *Sesbania drummondii* (rattlebox) directly behind the rock dike where the flotation spoil was placed. Vegetation further back into the marsh appeared to be lightly to moderately stressed. All observations were made from White Lake. It is likely that vegetation in the project area will recover. (Photos: Appendix B, Photo 1)

Photo No. 1, typical section of rock dike

- Replace missing sign, repair damaged signs.

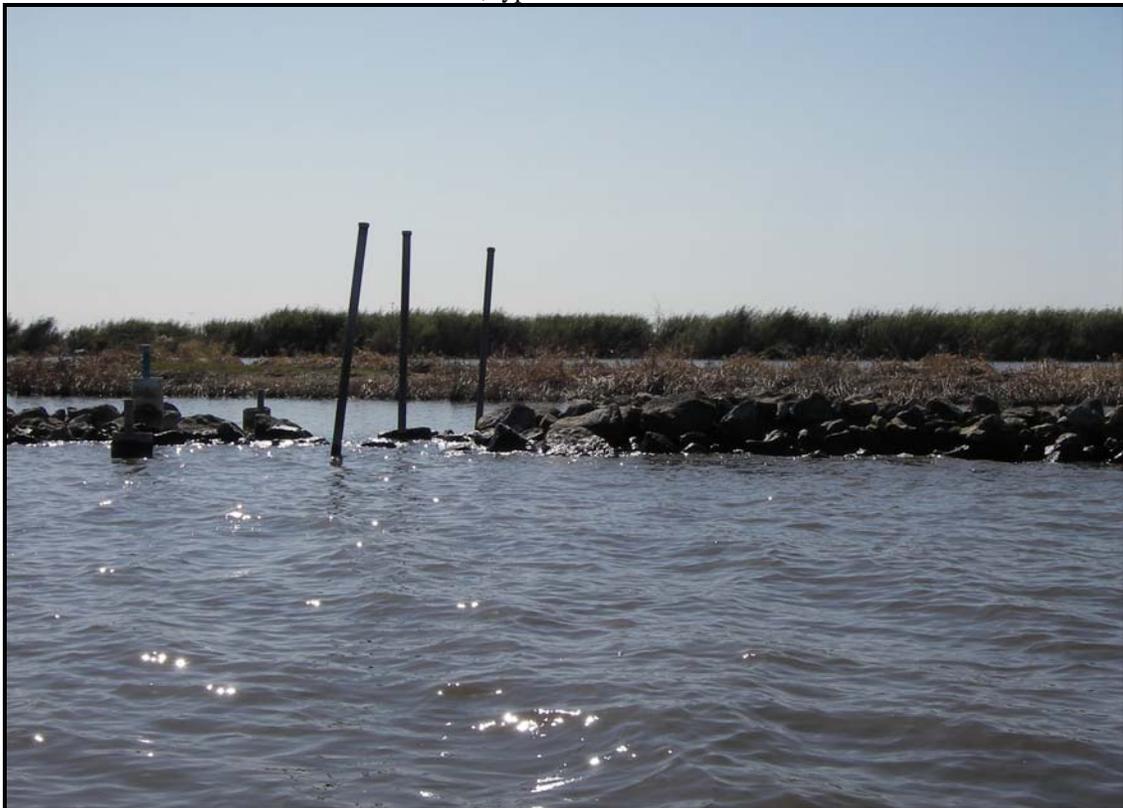
The six different demonstration areas are in good condition and do not appear to look any different than the rest of the project as far as crown width, dike elevation and side slopes. However, there are two areas where some of the rock has been displaced by Hurricane Ike. The various instrumentation devices at each demonstration section are intact. A request was made to get the monitoring data from these instruments from the USACE. (Photos: Appendix B, Photo 2)

Photo No. 2, displaced rock at test section
